Geotechnical Area  
Studies Programme

GASP Report XII

# Territory of Hong Kong

Geotechnical Control Office  
Civil Engineering Services Department  
Hong Kong

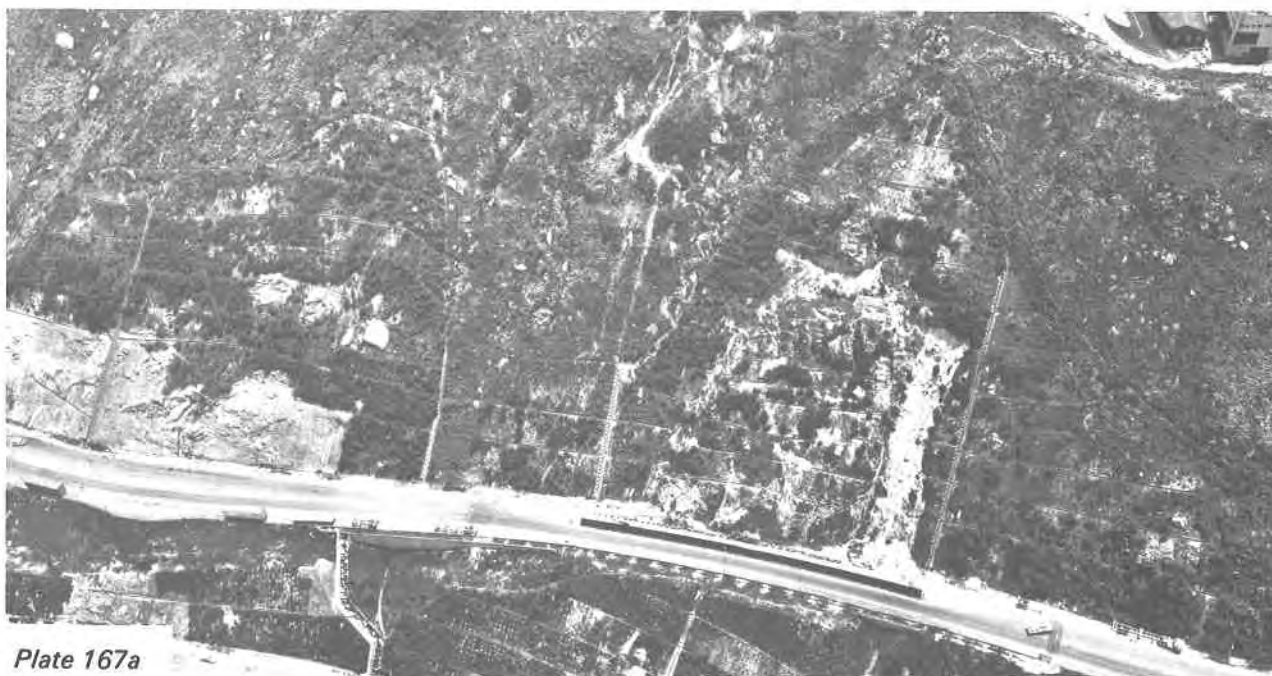
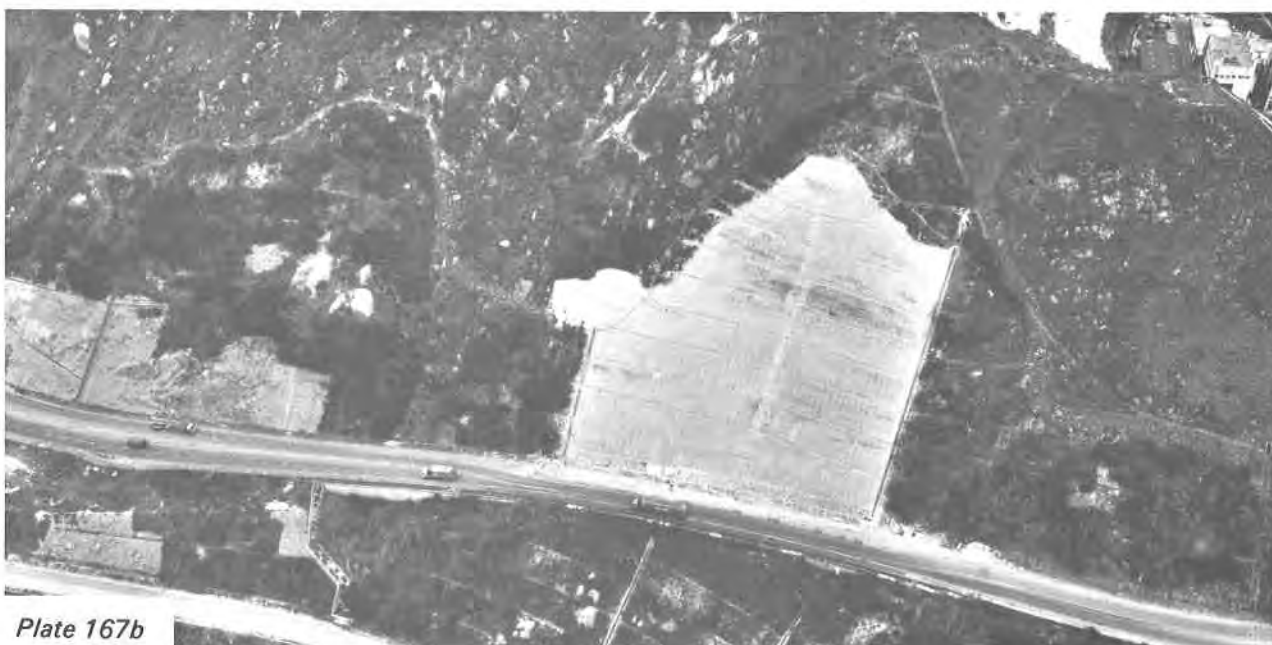
**Plate 167. Views of the Landslip on Tsing Yi Island in 1983 and 1985.** A large landslide (Plate 167a) on a cut slope in decomposed granite occurred in 1982 on the Tsing Yi Road, near Nam Wan. Signs of distress within a large section of a recently constructed  $35^\circ$  cut slope were observed on 28.6.82. The actual date of the failure is unknown, but it probably occurred during the severe rainstorms of May 1982. The slope failed again during heavy rainfall in August 1982. Despite careful site investigation, the location of the slip plane could not be identified with certainty with the boreholes. It is considered probable, however, that the failure surface was 10 m deep in parts. The boreholes revealed that depth to bedrock was much deeper than was assumed for the original design, and some of the original boreholes may have terminated in corestones rather than bedrock. Two piezometers, one near the head of the failure and the other near the toe, were monitored throughout the wet season of 1982. These showed that the piezometric surface was close to the ground surface; this was confirmed by heavy seepage from the lower face of the slope. It appears that horizontal drains, installed in the slope as part of the original design to lower the water table, were not effective following the failure. Boreholes after the failure, established the existence of a perched water table, although the reason for perching was uncertain. It was also unclear as to how this water table was recharged because the catchment area was very small. It was assumed that groundwater flowed towards the slope due to complex geological conditions. The slope surface consists of grassed areas of Grades IV and V decomposed rock, together with large corestones of Grade II rock. The gradation from Grade II to Grade IV is well-defined in places. The geology is complex with large intrusions of granite porphyry and feldspar porphyry through a country rock of equigranular, coarse-grained granite. The country rock is typified by close, mineralised joints and microfracturing. The existence of a deep-seated failure in a slope cut at  $35^\circ$  in decomposed granite should provide a cautionary note for practising engineers in Hong Kong. The failure occurred through a thick zone of weak decomposed material and was due to a high groundwater level. The presence of large boulders of rock at the surface together with similar corestones encountered in the boreholes had possibly been misinterpreted as bedrock during the initial investigation. As a result, the possibility of a critical deep seated failure was not considered at the design stage. Plate 167b shows the slope in 1985 following remedial works designed by the Geotechnical Control Office, (1983/48423 and 1985/57794).

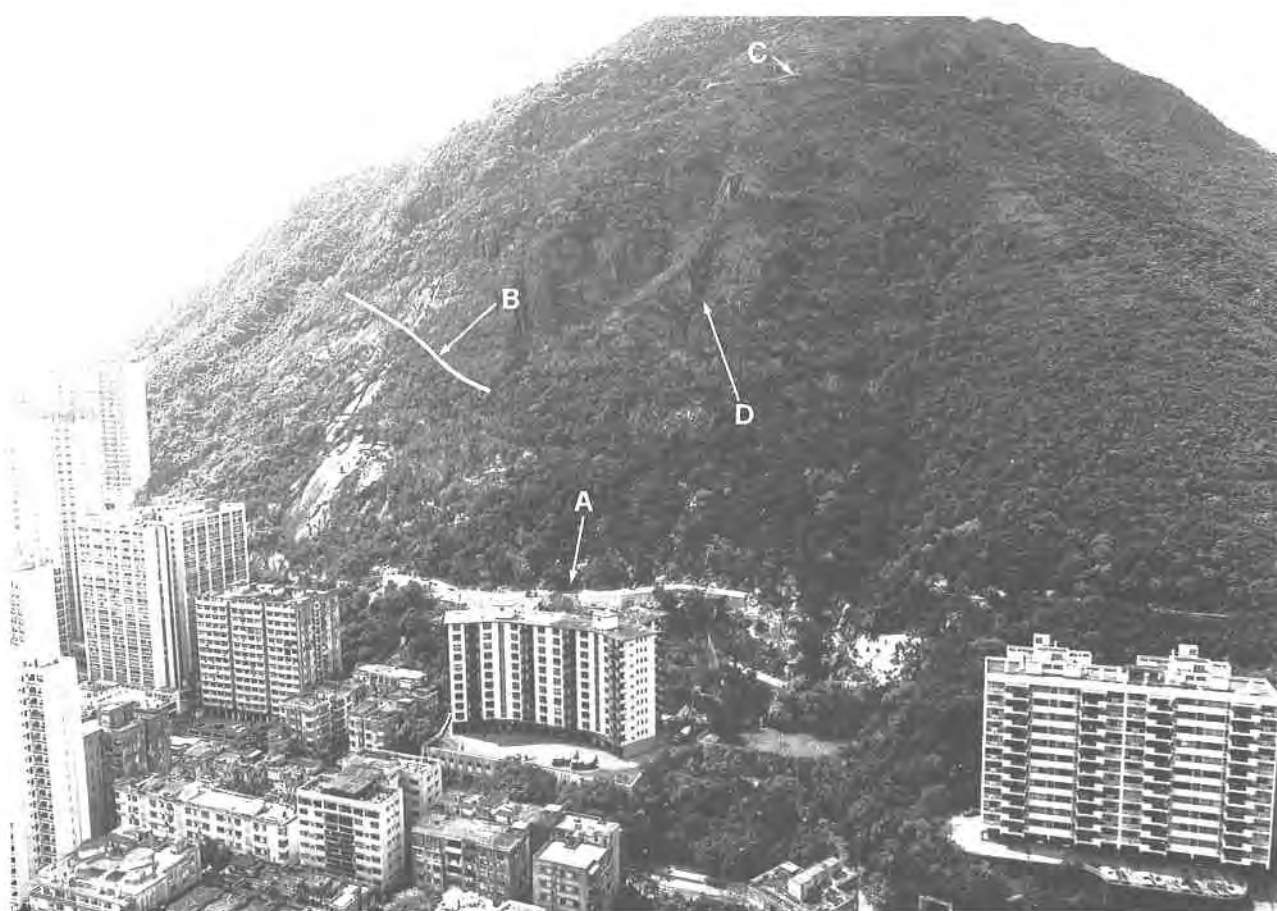
**Plate 168.** *Oblique Aerial Photograph of Boulder Field Stabilization Measures on the Upper Slopes of Victoria Peak in 1985.* This photograph taken in 1985, shows the location of the 'Boulder Fence' (A), upslope of Buxey Lodge. The Fence is located on an extensive boulder field, and was designed by GCO to counter the effects of possible rock and boulder falls from the steep colluvial footslopes and the precipitous cliffs on the north side of Victoria Peak. The geological contact between the volcanics and granitic bedrock is indicated at B. Lugard Road is indicated at C, and the general location of the rock outcrop shown in Plate 170 is shown at D. The natural slope above Conduit Road overlooks an area of intense development and has suffered from a number of boulder falls. In 1926, a 700-tonne boulder fell on a pumping station at 3 Conduit Road. In 1957, a boulder crushed a car parked on Conduit Road. In 1961, a 40-tonne boulder fell onto the west lawn of Buxey Lodge. More recently, incidents have been reported behind Pearl Gardens (1978), Conway Mansion (1979), Buxey Lodge (1981, 1982 and 1985), 39 Conduit Road (1981) and 41C Conduit Road (1982). The boulder field is located on the natural hillside behind 17 (Cliffview Mansion) to 37 (Buxey Lodge) Conduit Road. It is some 300m wide in an E-W direction and extends from the rear of the buildings (150mPD) southwards to the toe of Seymour Cliffs (280mPD). The total area is about 4.5 ha. (GCO/OAP/1985/PS514-5).

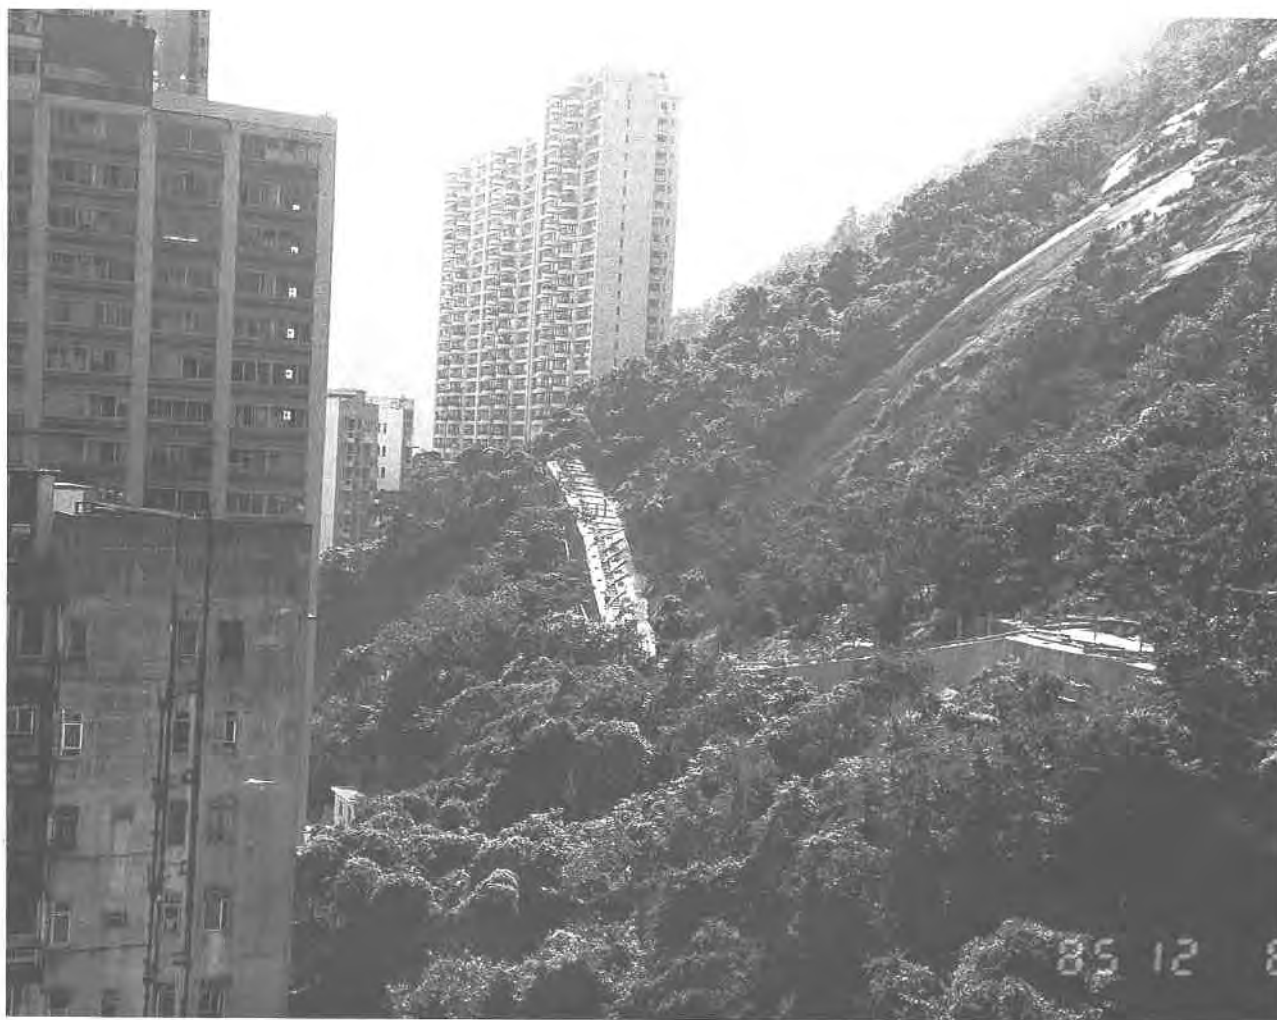
*Plate 169. Boulder Fence below Victoria Peak in 1984.* This photograph, taken from Buxey Lodge on 6.12.85, shows Segments 6 and 7 of the Fence under construction. These works were carried out within the Landslip Preventive Measures Programme. Construction of the Fence and associated boulder stabilization works cost in the order of \$7.5m over a 2-year period. (Contract 1/GCO/93).

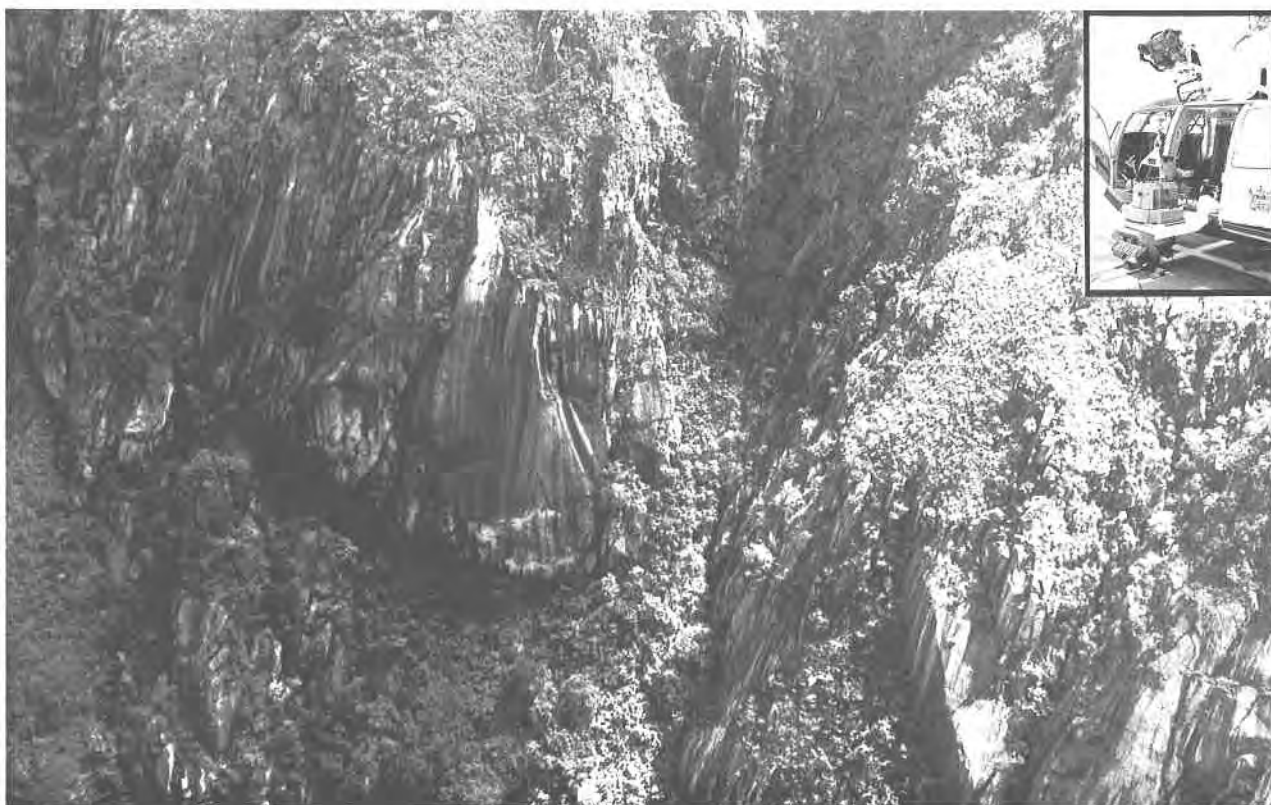
**Plate 170.** *Oblique Aerial Photograph of Highly Jointed Volcanic Cliffs on Victoria Peak in 1979.* This photograph, taken in 1979, shows the highly jointed nature of the volcanic terrain forming the Seymour Cliff area of Victoria Peak. A large boulder field occurs below these slopes. The location of this portion of the cliff face is shown at D in Plate 168. The Air Survey Unit, in collaboration with the RHKAAF, has developed a helicopter-borne oblique mounting system for a Wild RC10 air survey camera. The system was designed specifically for geotechnically-oriented photogrammetric applications on the steep terrain of the Territory. The mount is attached to the rear port door of an Aerospatiale Dauphine Helicopter as shown in the Inset. (GCO/OAP/1979/PS46-14 & 1988/PS658/10).

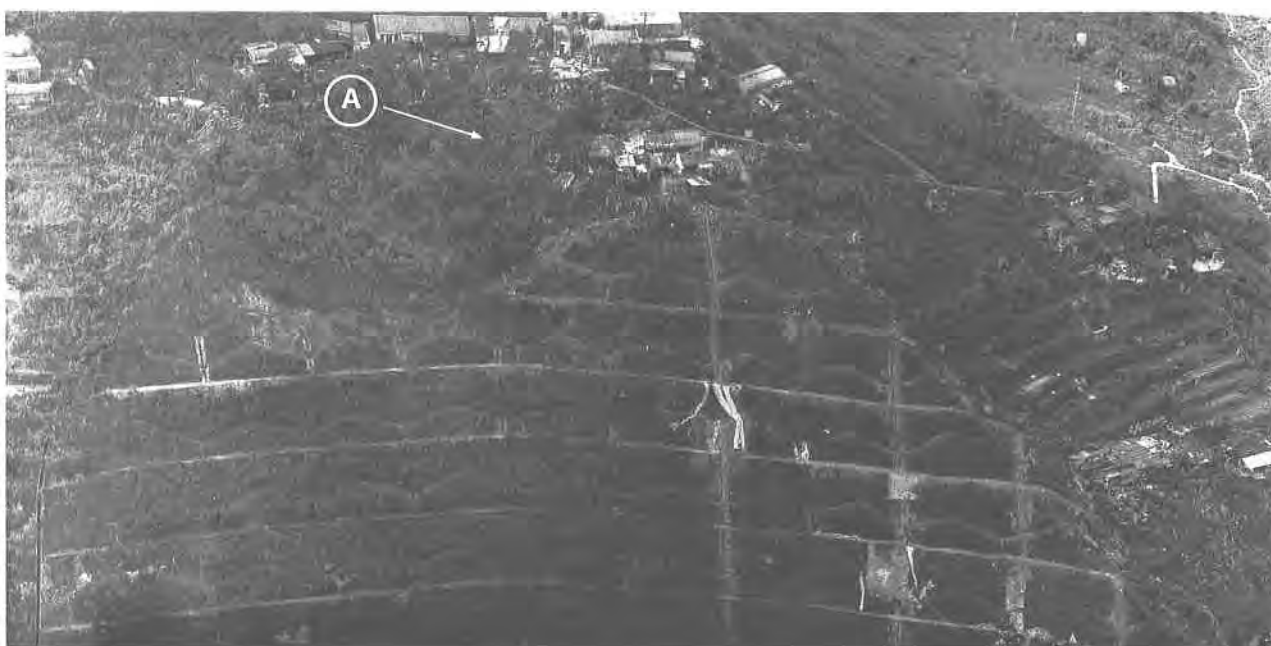
**Plate 171.** *Oblique Aerial Photograph of Slope Failure on a Cut Slope at Pun Shan Tsuen in October 1983.* Site investigation is in progress on the mid to lower portions of the cut slope following the slope failure shown in Plate 172. The general location of Plate 172 is shown at A. (GCO/OAP/1983/PS399-9).

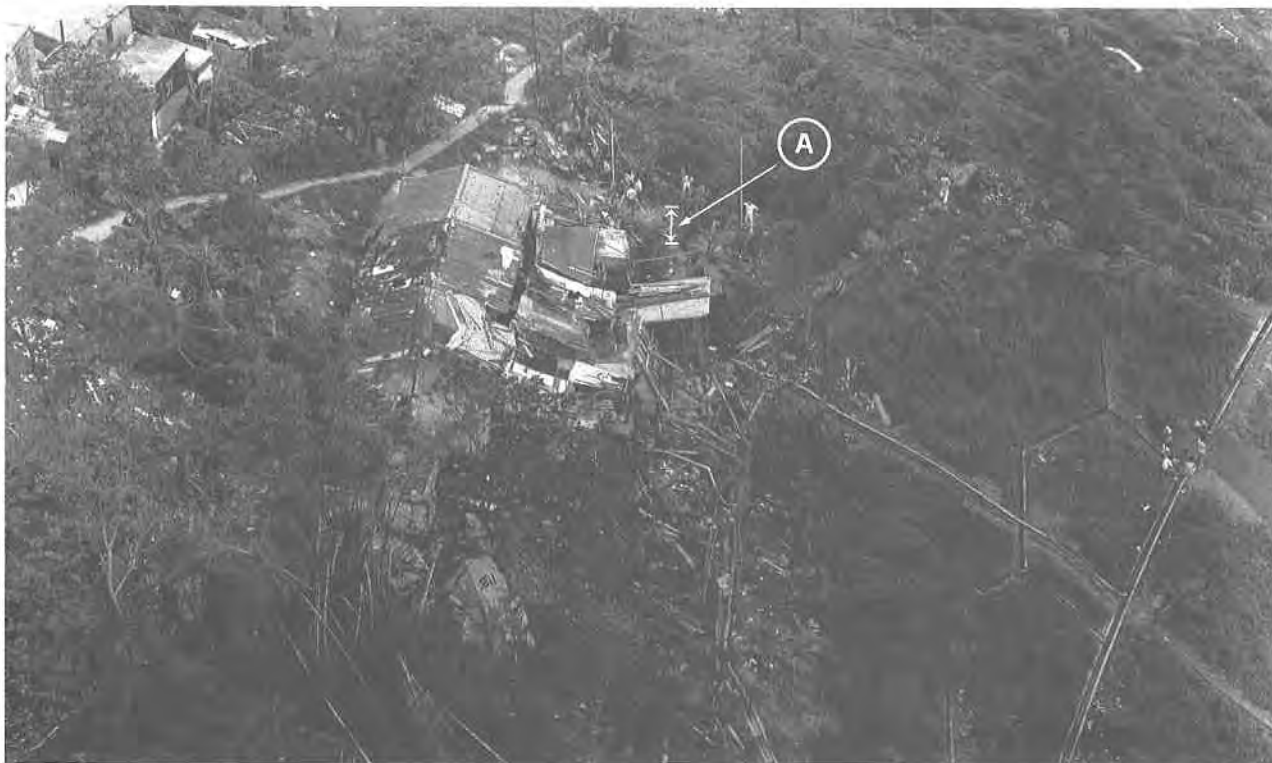
**Plate 172.** *Oblique Aerial Photograph of Slope Failure at Pun Shan Tsuen in October 1983.* The backscar of the landslide caused major distress to a number of huts at the the crest of the slope. A vertical displacement of approximately 1m is evident at (A). A general view of the slope is given in Plate 171. (GCO/OAP/1983/PS400-7).

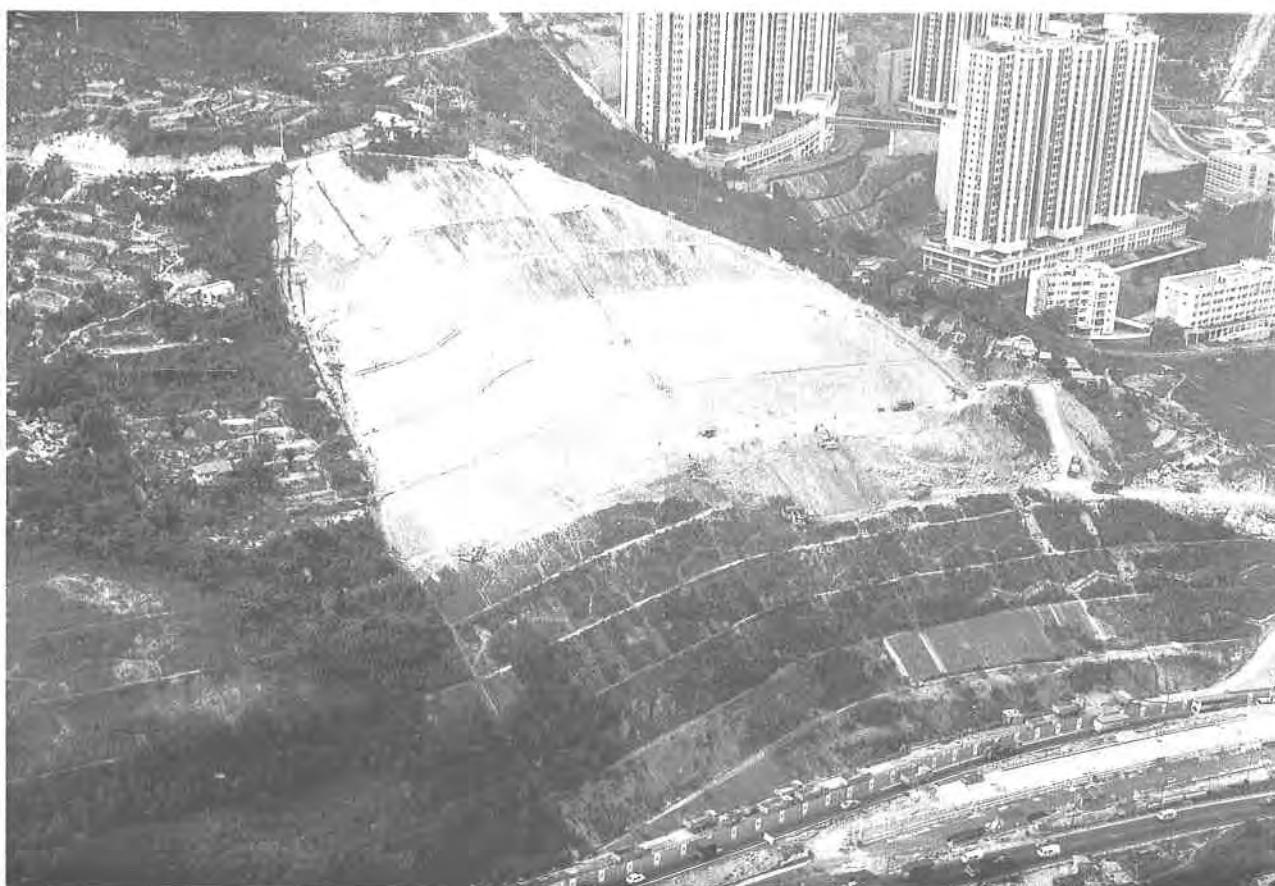
**Plate 173.** *Oblique Aerial Photograph of Remedial Works at Pun Shan Tsuen in May 1984.* The slope has been regraded and surface protection is being applied. (GCO/OAP/1984/PS448-3).

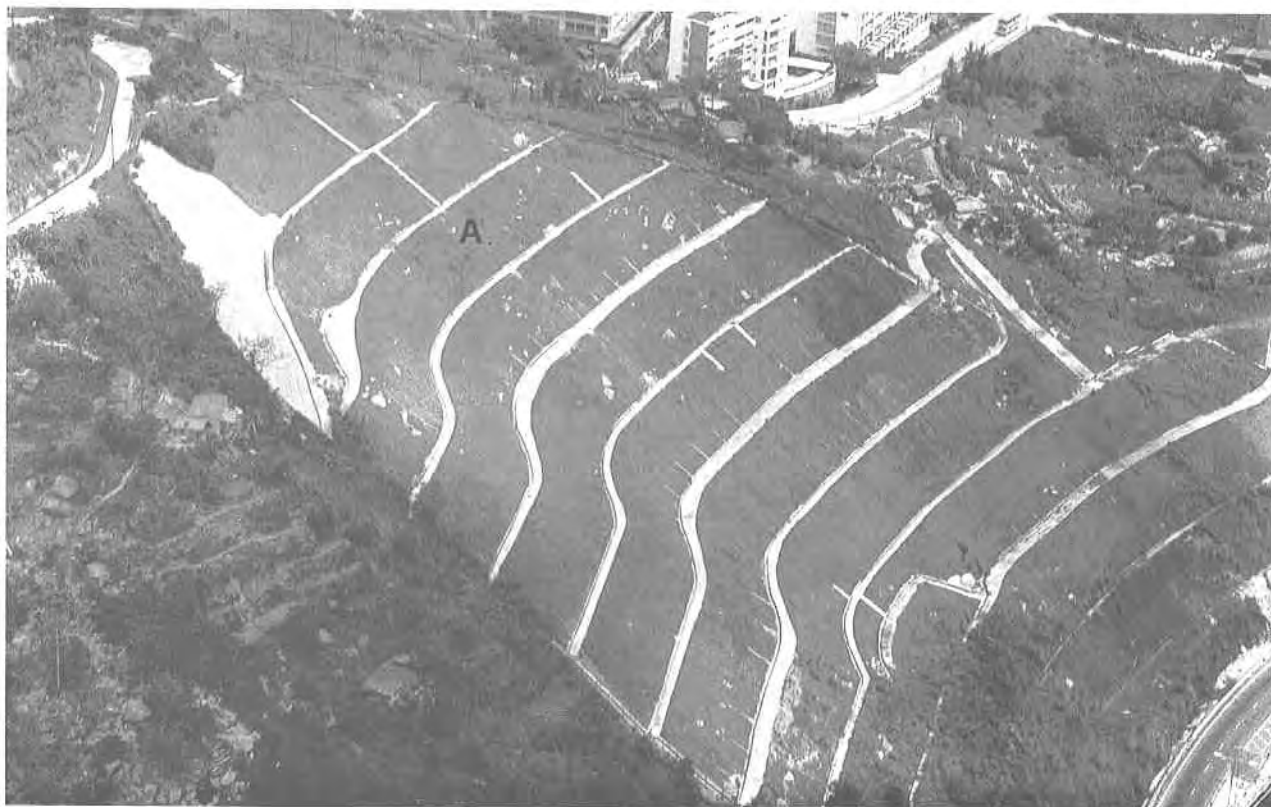
*Plate 174. Oblique Aerial Photograph of Reinstated Cut Slope at Pun Shan Tsuen in September 1985. The slope has been regraded and has an extensive cover of vegetation. Soil piping, tunnel erosion and associated surface erosion are evident around A. (GCO/OAP/1985/PS523-10).*

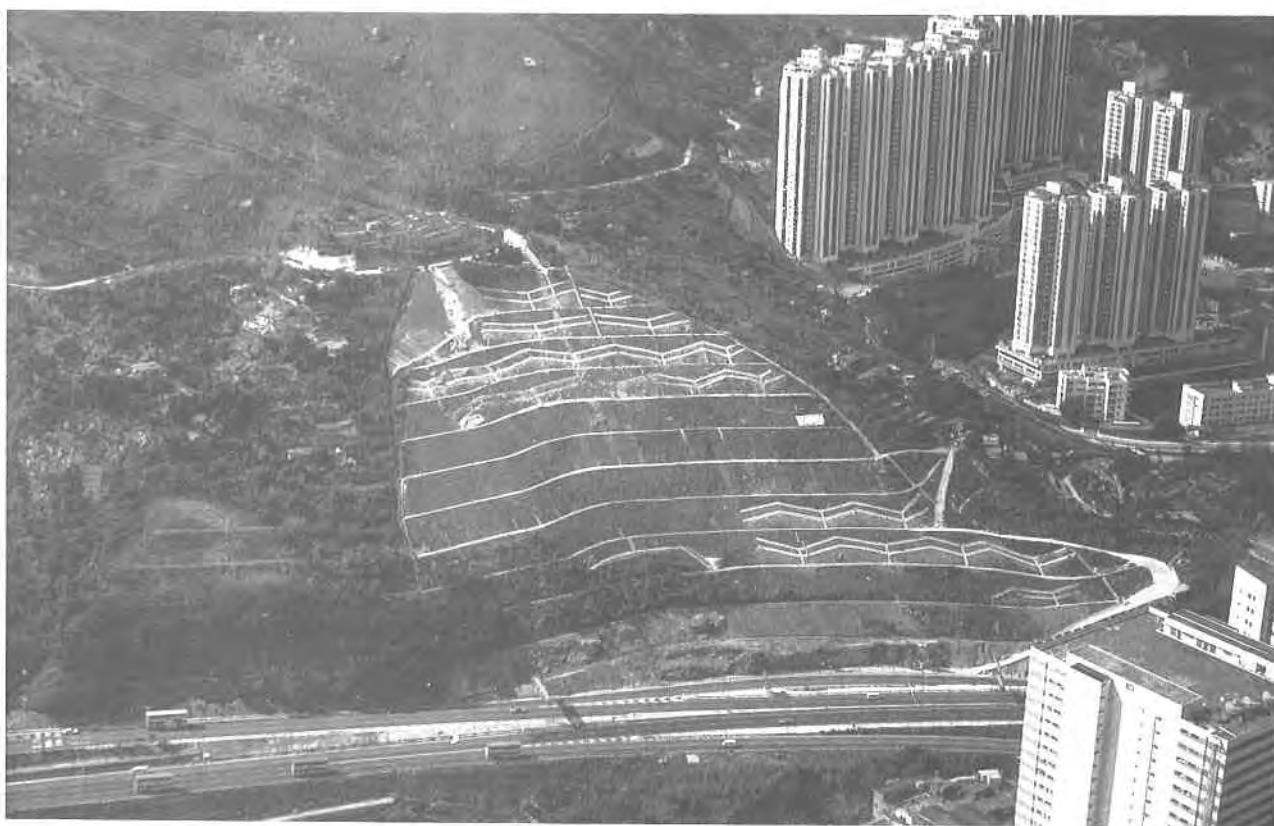
*Plate 175. Oblique Aerial Photograph of Remedial Works to the Cut Slope at Pun Shan Tsuen in May 1986. Part of the upper slope has been chunamed and intensive drainage measures have been installed on the slope. Compare this with Plate 171, which shows the original cut slope in 1983. (GCO/OAP/1986/PS550-11A).*

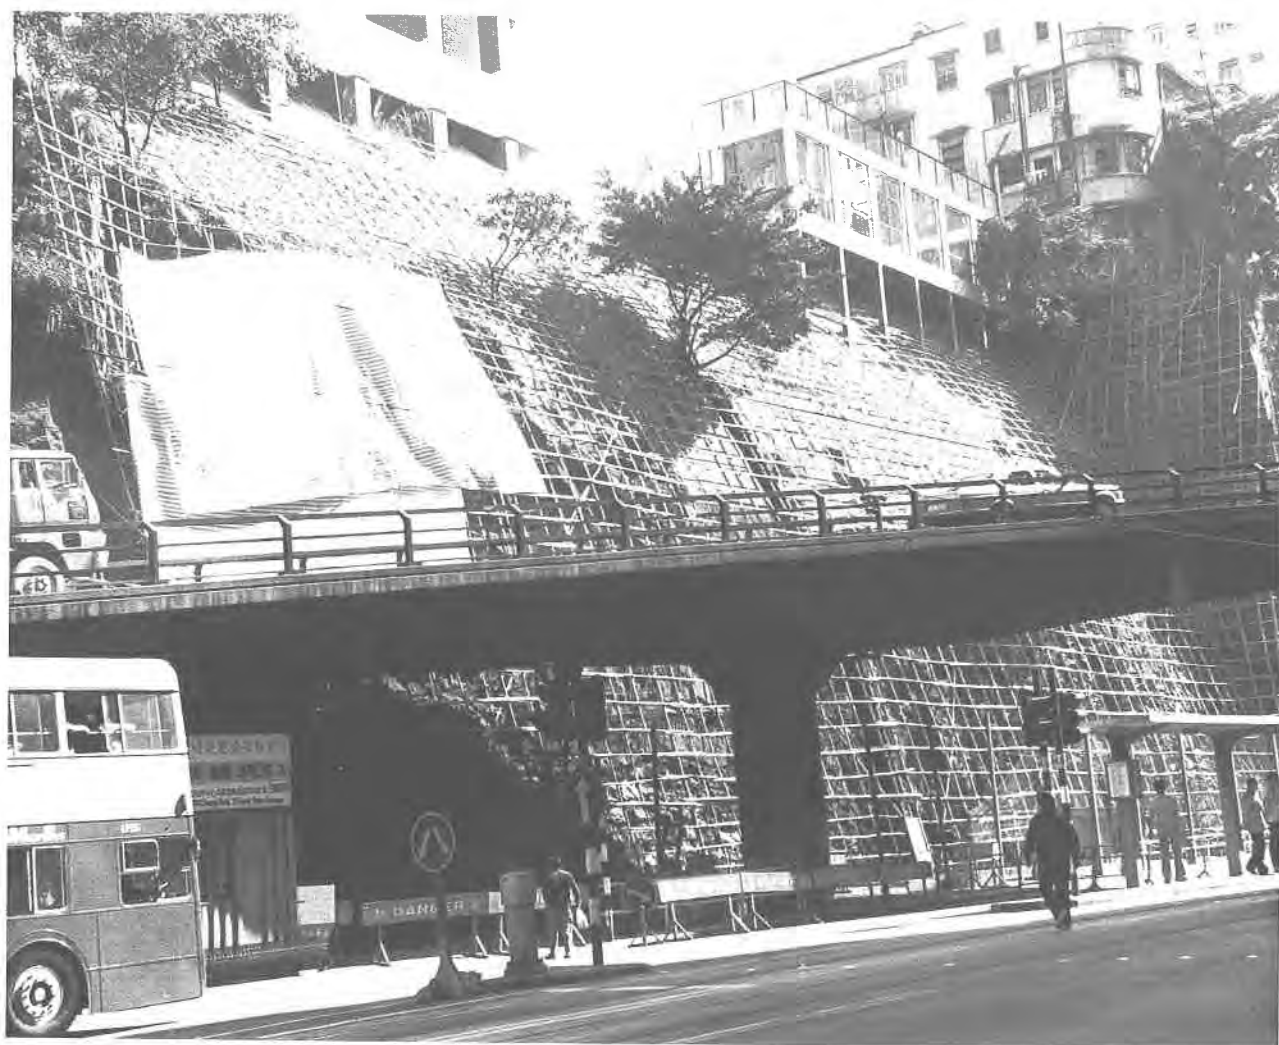
*Plate 176. Stabilization of a Rock Slope on King's Road in December 1983.* This large, almost vertical rock slope was treated by the Geotechnical Control Office within the Landslip Preventive Measures Programme, at a cost of some \$710,000 over a period of 12 months. This photograph was taken on 6.12.83. (3/GCO/82 & 5/GCO/83, 11SE-A/C13 & 14).

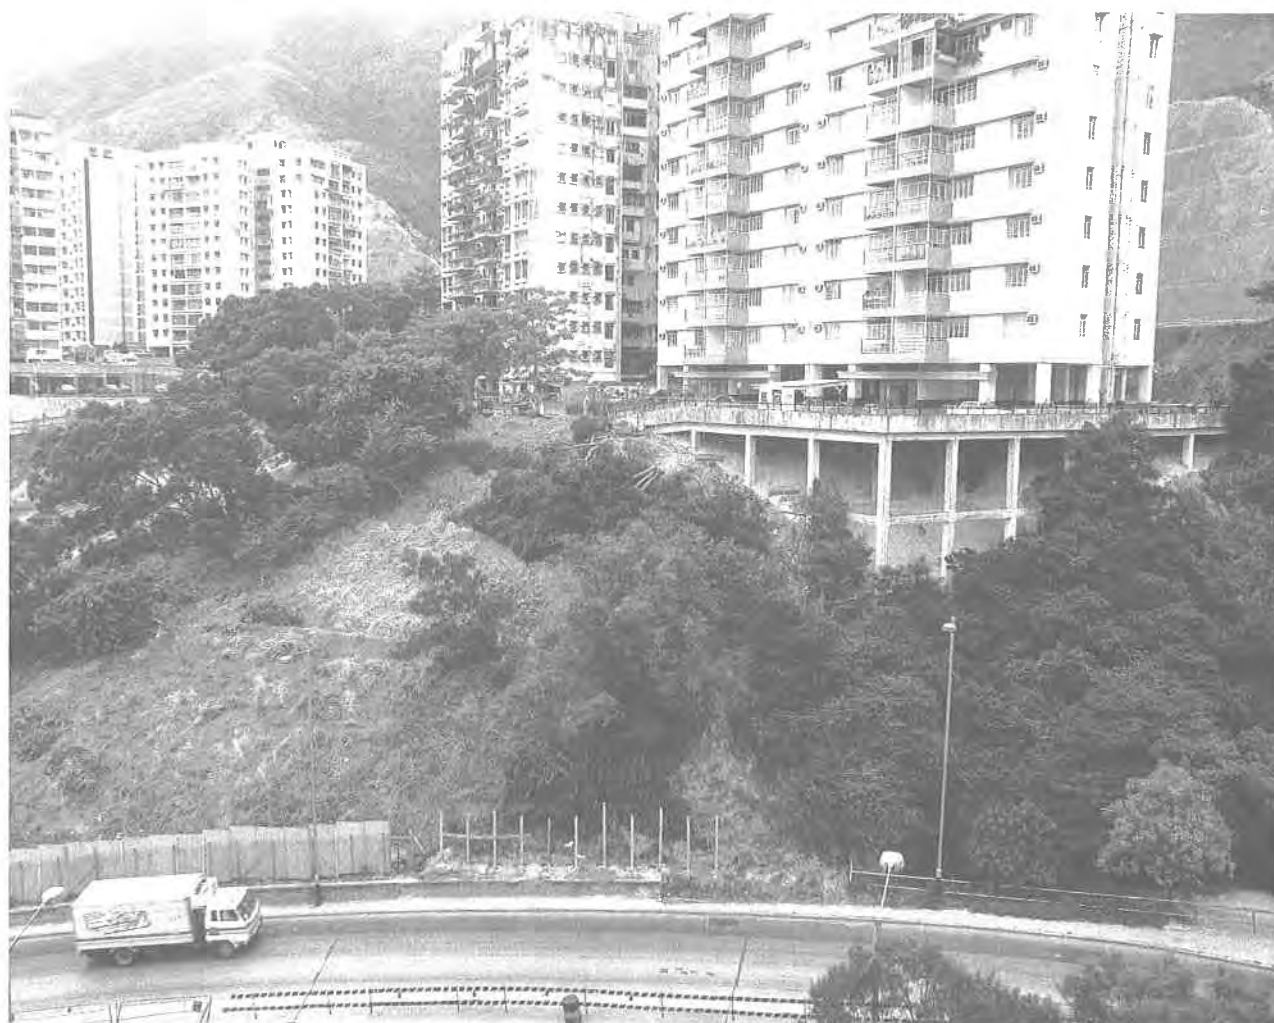
*Plate 177. Rhondda Road Slope in August 1984.* This photograph, taken on 10.8.84, shows the slope prior to reconstruction by the Geotechnical Control Office within the Landslip Preventive Measures Programme. Site clearance and tree felling are in progress. Compare this with Plates 178 and 179. (EDD Contract No. 16/GCO/83-Slope 11NW B/FR 10).

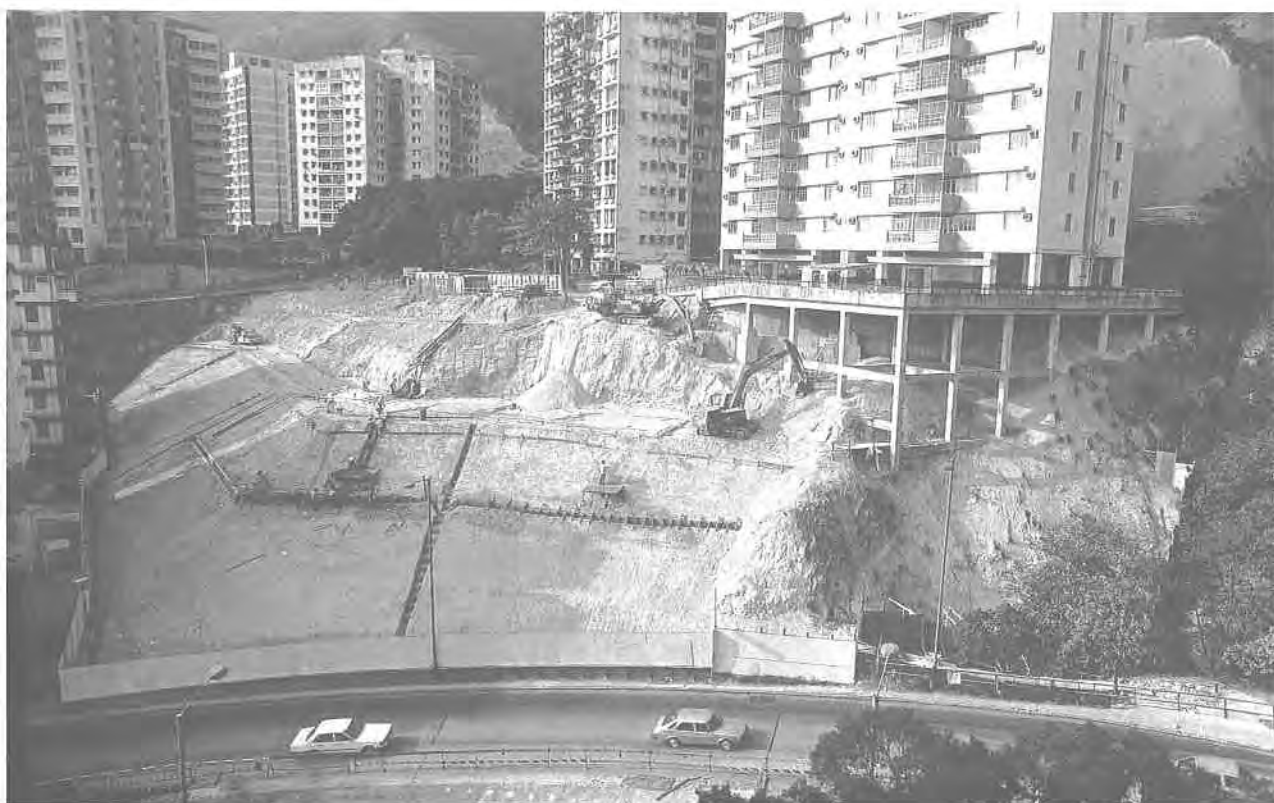
*Plate 178. Stabilization Works on the Rhondda Road Slope in December 1984.* This photograph, taken on 10.12.84, shows recompaction of loose fill and surface drainage works in progress. Compare this with Plates 177 and 179.

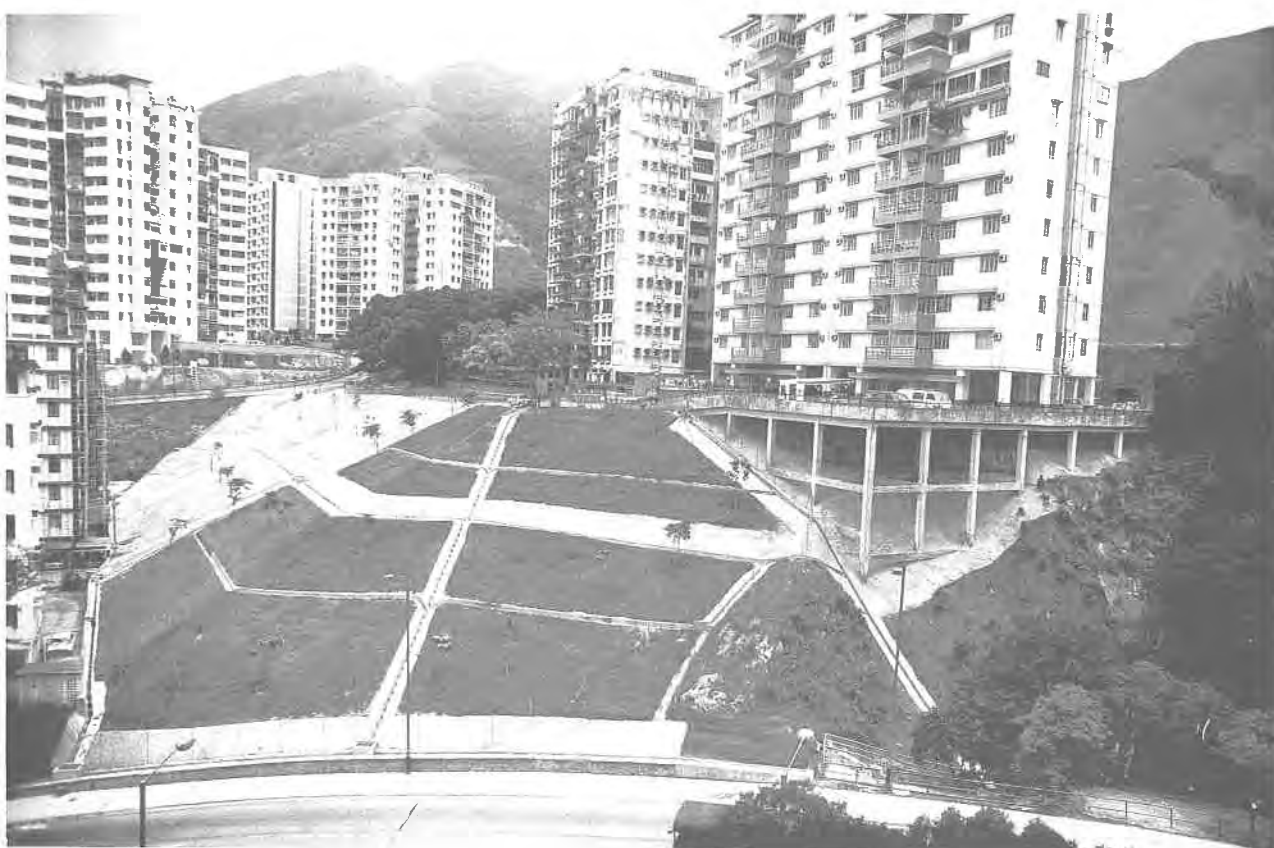
*Plate 179. Stabilization Works on the Rhondda Road Slope in July 1985.* This photograph, taken on 12.7.85, shows a general view following reinstatement of the slope at a cost of some \$1.3m over a 12-month period. Compare this with Plates 177 and 178.

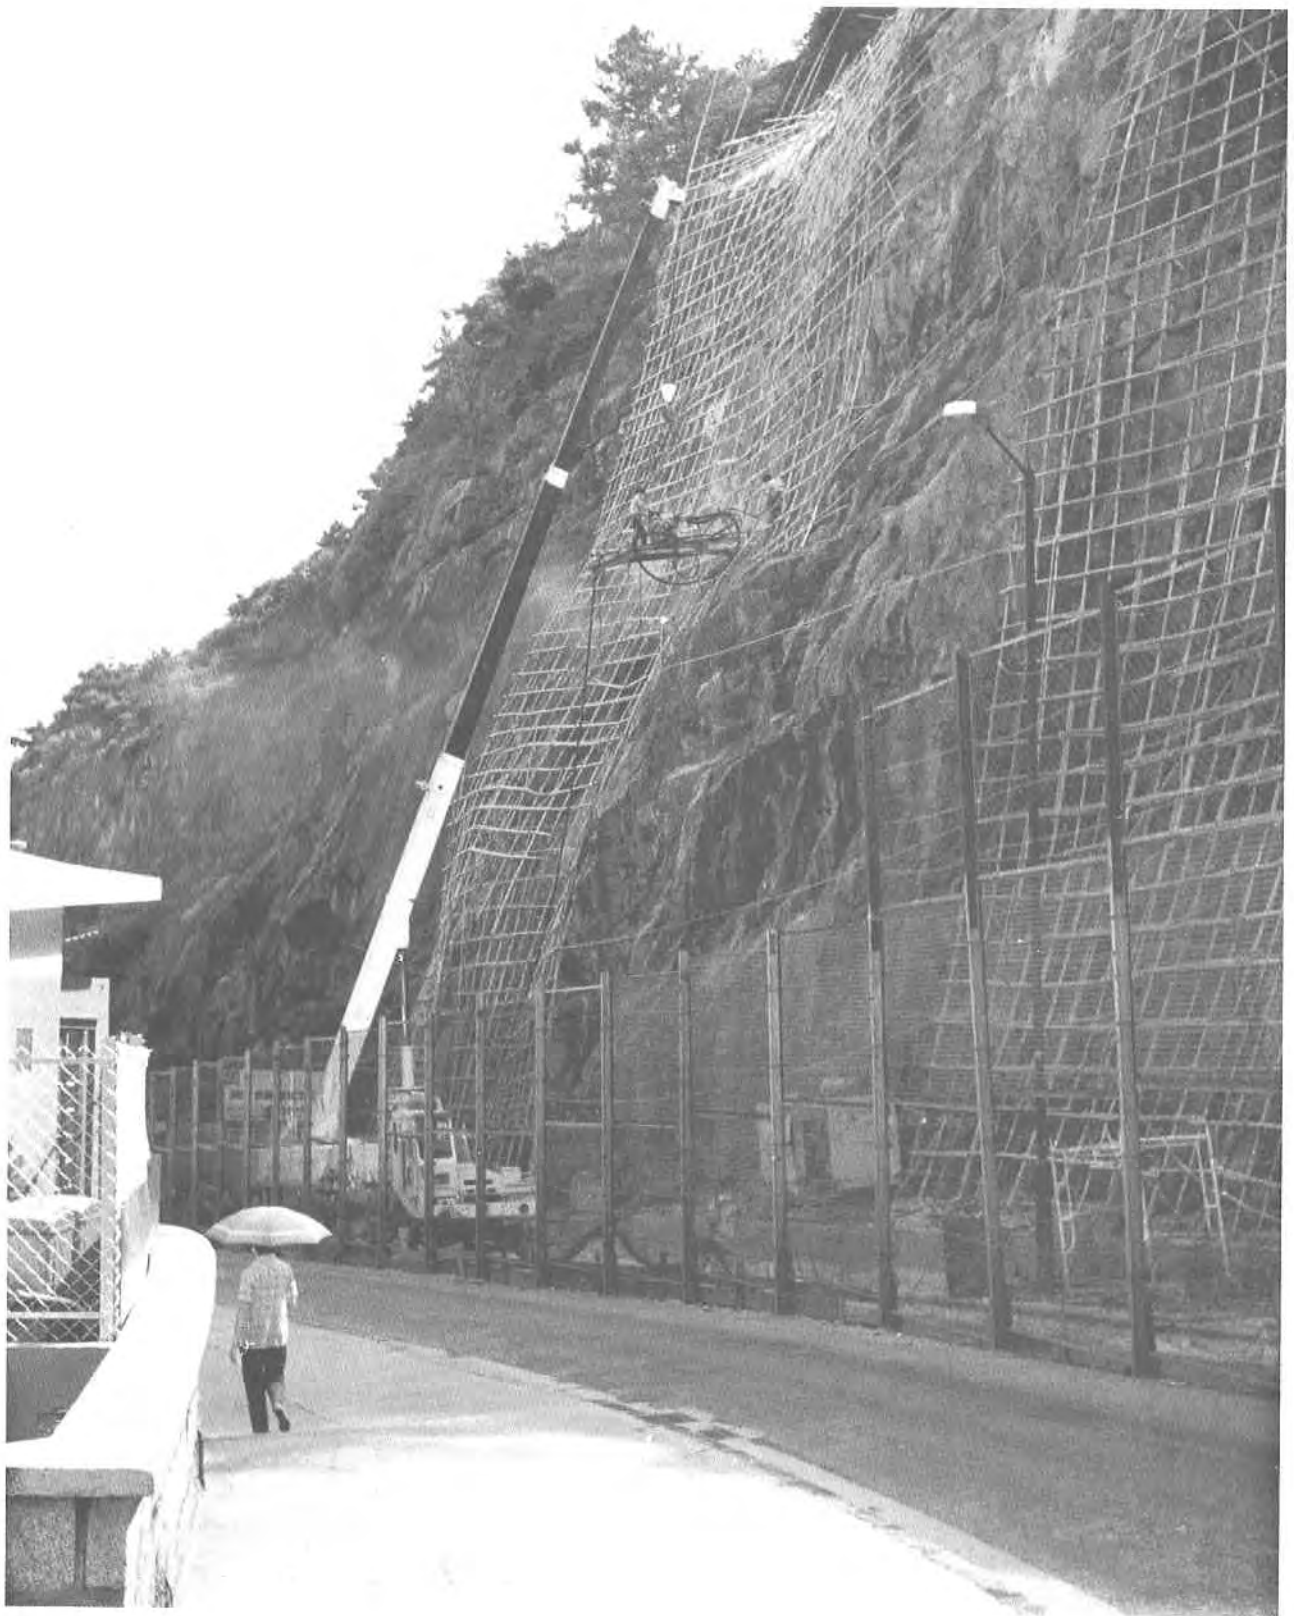
*Plate 182. Remedial Works on Rock Slope at A Kung Ngam Road in July 1983. This photograph, taken on 25.7.83, shows the drilling of a raking drain. This slope was treated within the Landslip Preventive Measures at an approximate cost of \$1.7m over an 18-month period. (3/GCO/82 & 5/GCO/83 Slope 11SE-B/C87).*

**Plate 183.** *Slope Reconstruction at A Kung Ngam Road in June 1985.* This photograph, taken on 29.6.85, shows the slope in the initial stages of remedial treatment within the Landslip Preventive Measures Programme. The rock slope shown in Plate 182 is located in the upper left hand corner of this Plate. Plate 184 shows the slope works nearing completion (Contract No. GC/84/02; Slope 11SE-B/C85 & 86).

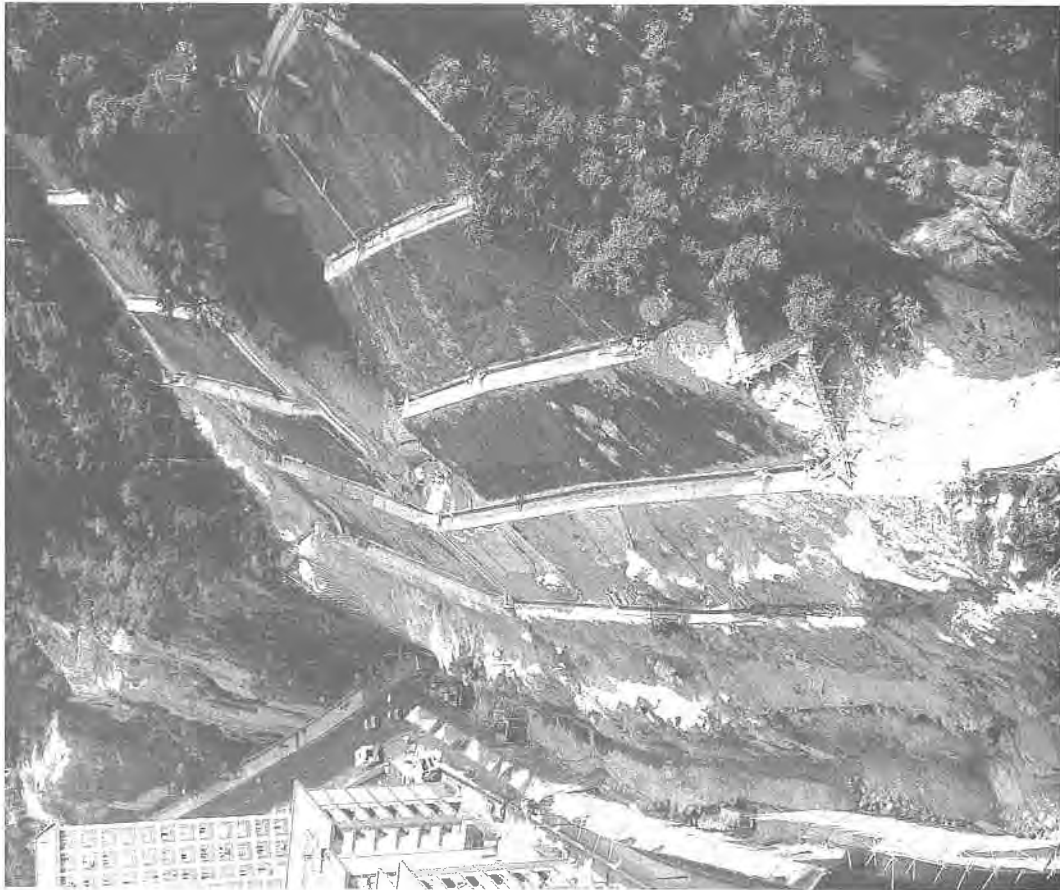
**Plate 184.** *Slope Reconstruction at A Kung Ngam Road in December 1985.* This photograph, taken on 2.12.85, shows the final stages of slope reconstruction. The approximate cost was \$2.6 m over a 12-month period. Horizontal drains are in place on the upper portion of the slope. Compare this with Plate 183. (Contract No. GC/84/02; Slopes 11SE-B/C85 & 86).

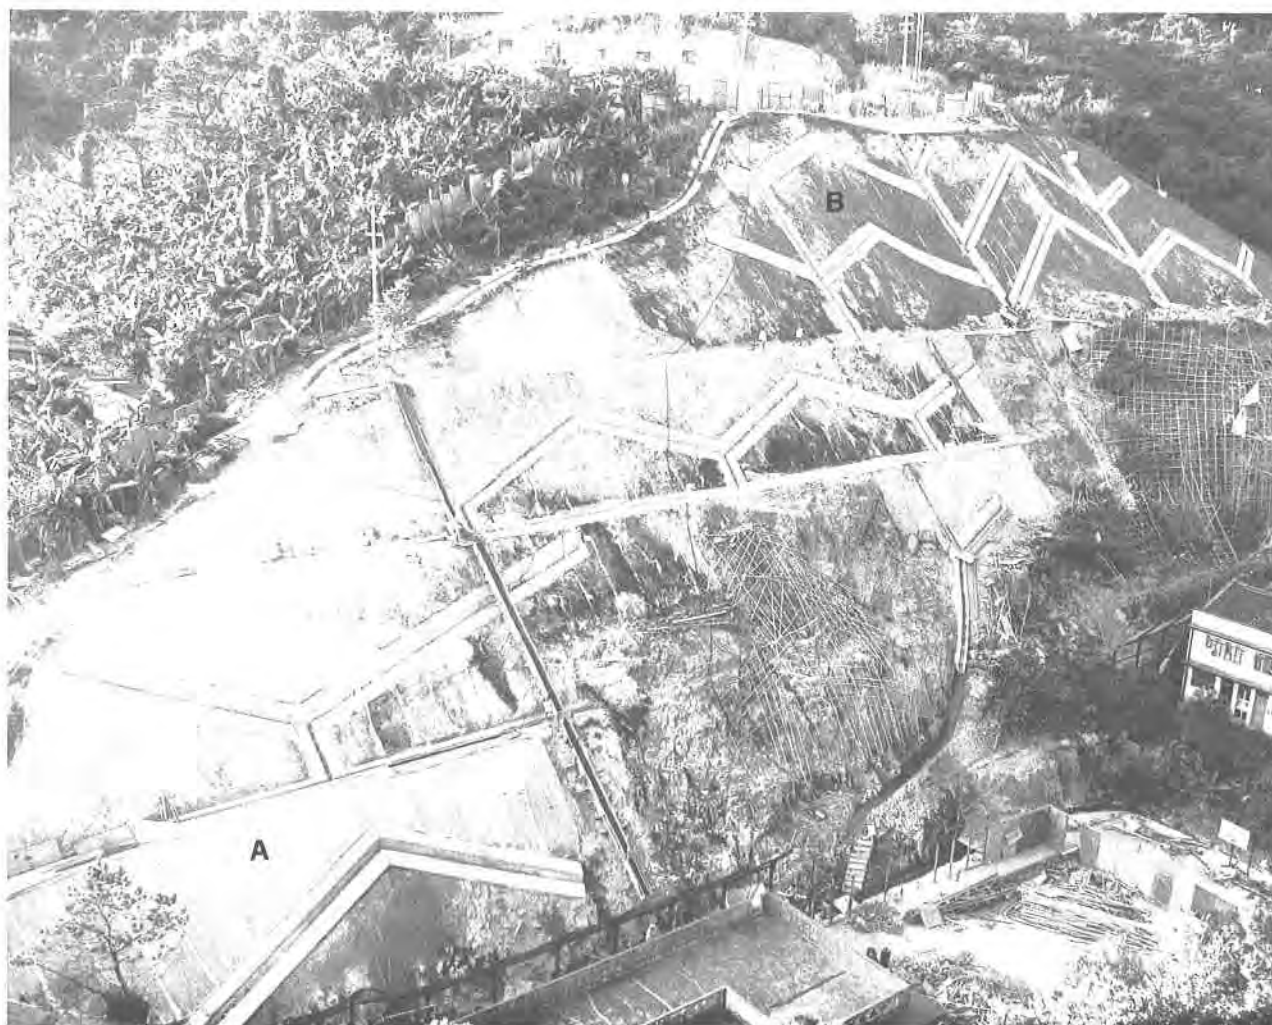
**Plate 186.** *Slope Stabilization at Chung Kwai Chung in October 1986.* This photograph, taken on 31.10.86, shows the slope in the final stages of reconstruction. Total expenditure on slope works was in the order of \$1.3m over a period of 14 months. Surface drainage is in place and netting is evident on many of the lower berms (A). Hydroseeding is applied to the netting, which becomes covered as the grass becomes established (B). Compare this with Plate 185. (Contract No. GC/84/02; Slope 7SW-C/C259/14).
