Geotechnical Area  
Studies Programme

GASP Report XII

# Territory of Hong Kong

Geotechnical Control Office  
Civil Engineering Services Department  
Hong Kong

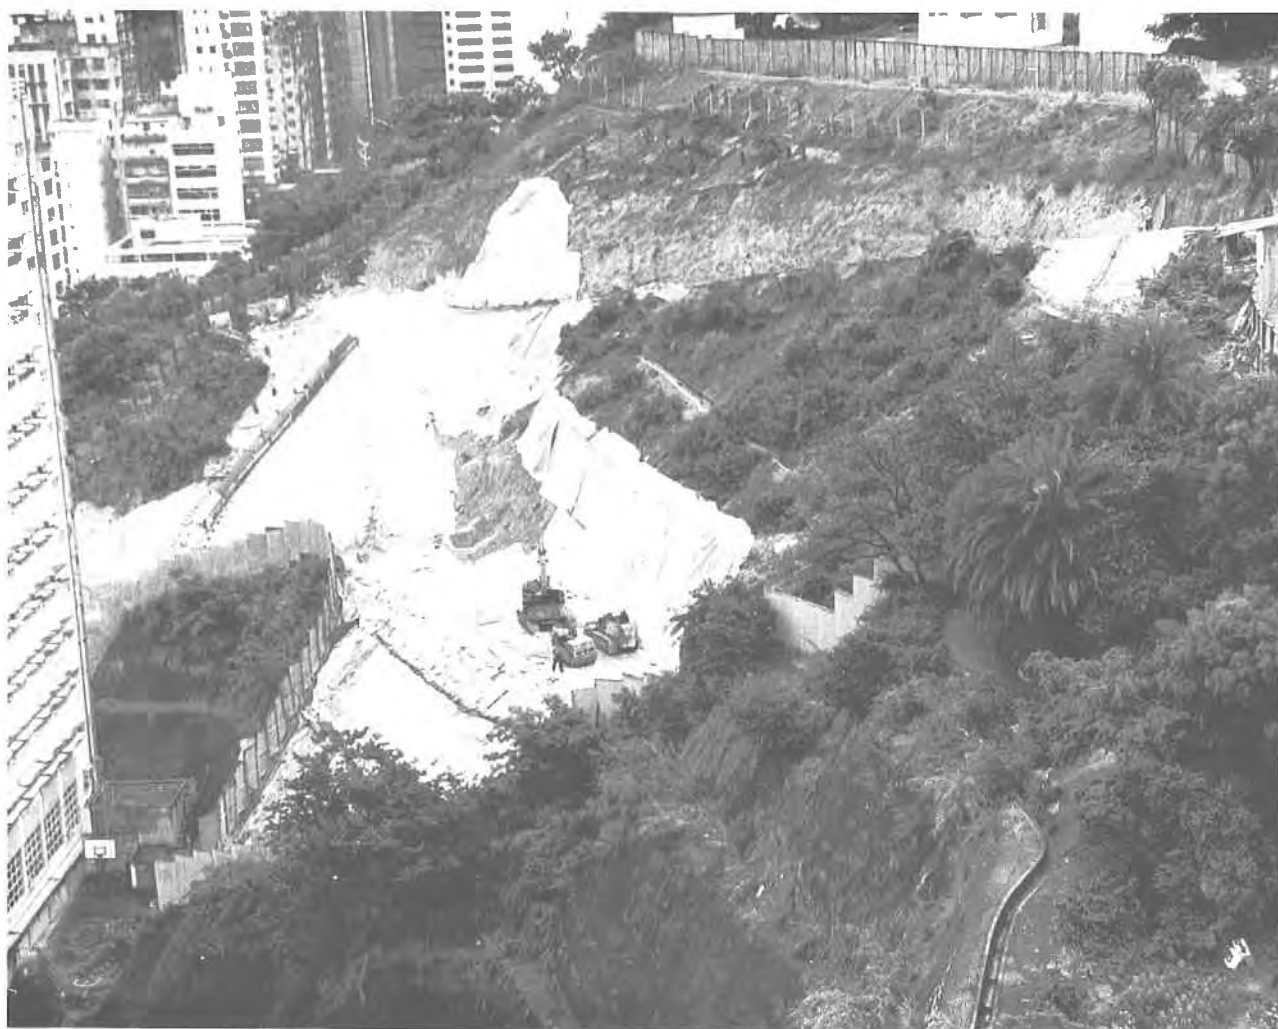
*Plate 187. Slope Reconstruction at King's Park in August 1986.* This photograph, taken on 24.8.86, shows the initial stages of reconstruction of the slope within the Landslip Preventive Measures Programme. Plate 188 shows the slope works nearing completion. (Contract No. GC/84/03; Slope 11SW-D/F97).

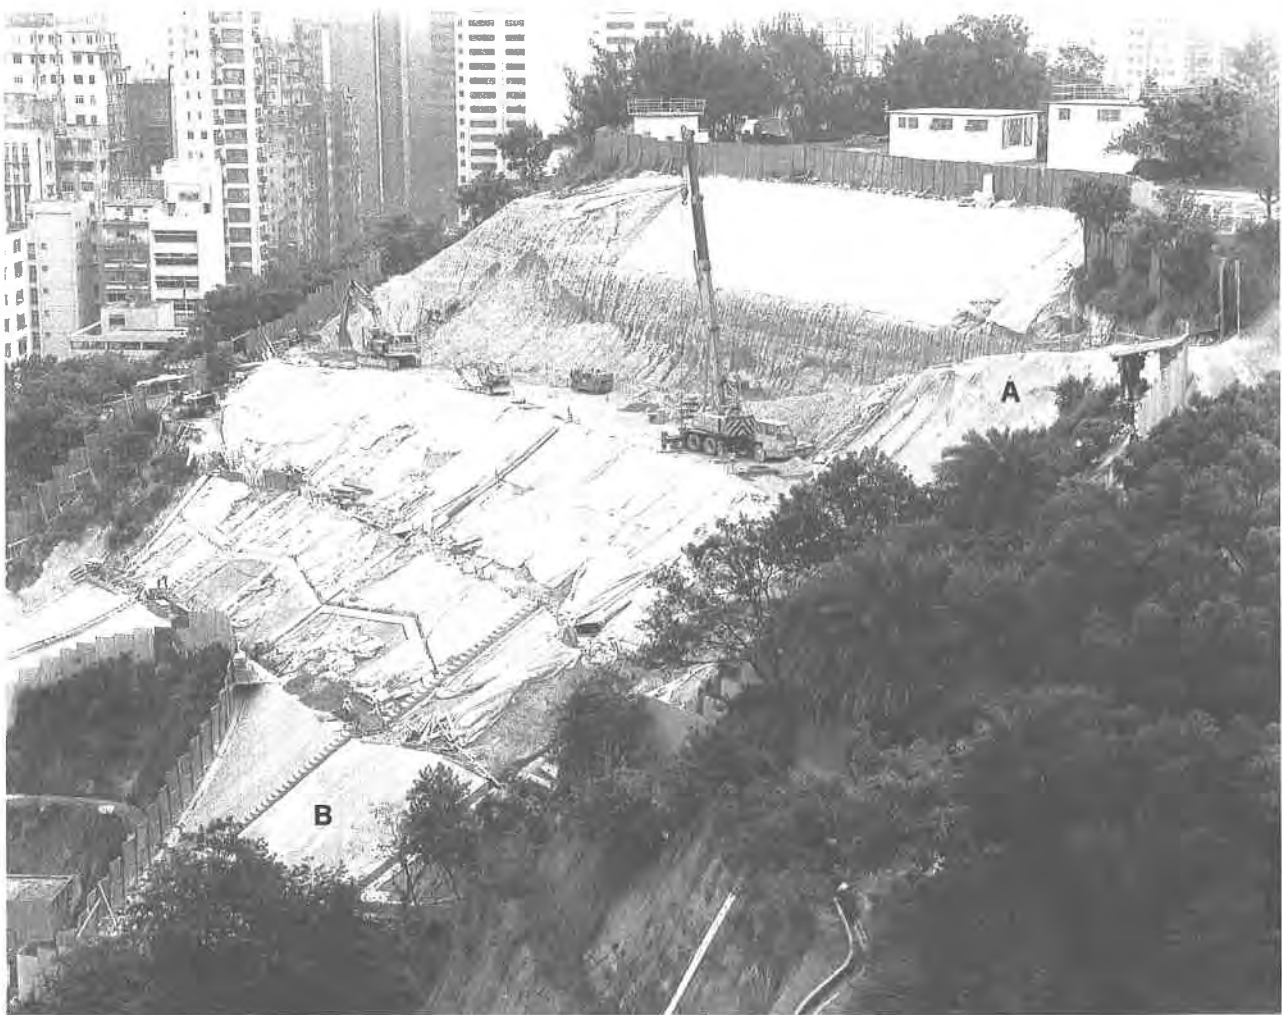
**Plate 188.** *Slope Reconstruction at King's Park in April 1987.* This photograph, taken on 27.4.87, provides a general view of the site. Temporary chunam is evident (A) above 60mPD, and permanent chunam is in place (B) below the first berm. Reconstruction of this fill slope cost in the order of \$1.6m over a 17-month period. (Contract No. GC/84/03; Slope 11NW-D/F97).

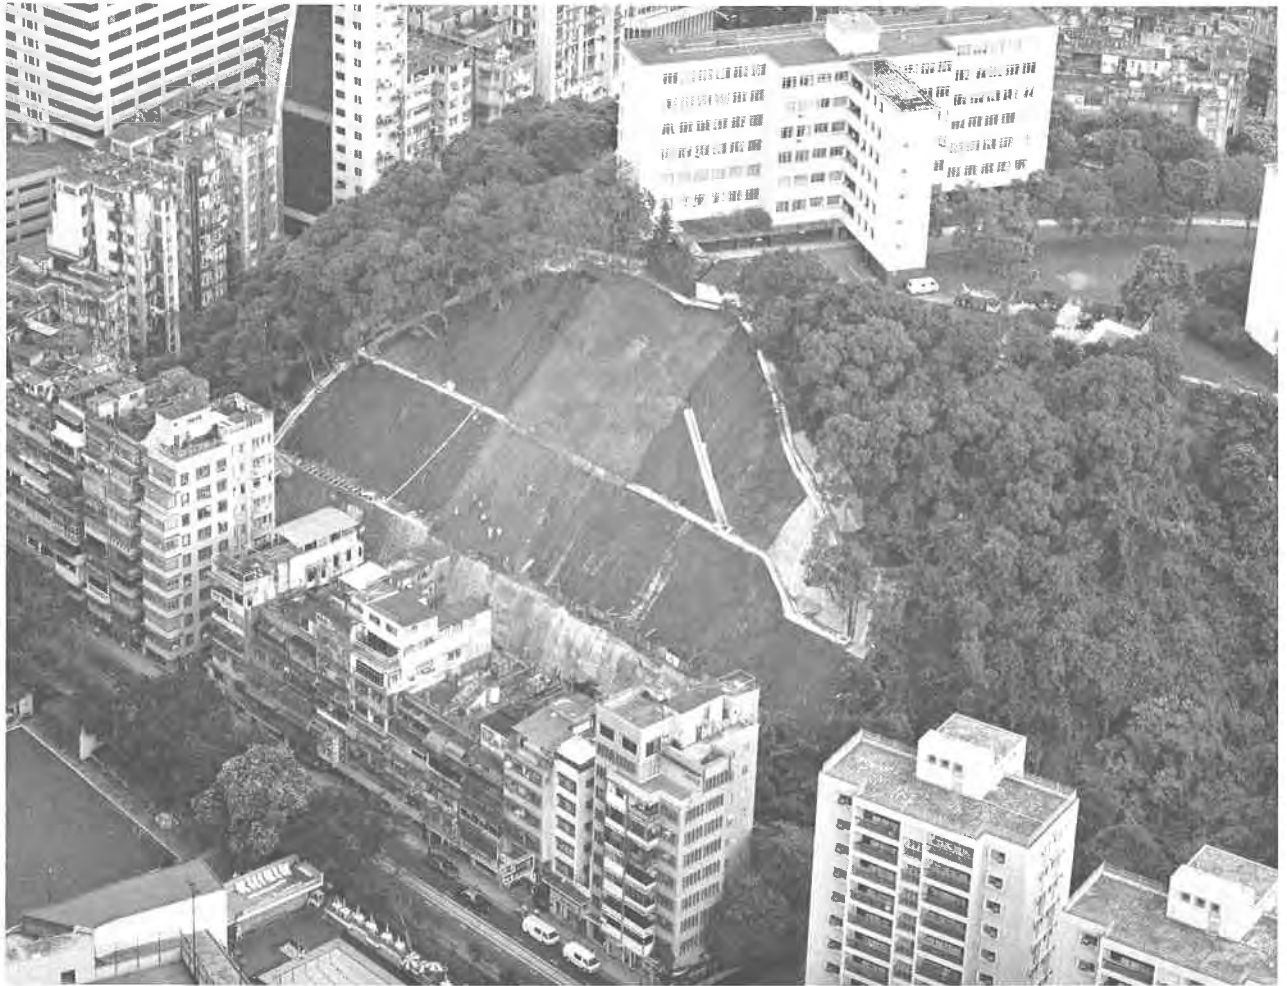
*Plate 189. Oblique Aerial Photograph of Slope Stabilization at Leighton Hill in 1987.* This slope has a history of failure and was reconstructed by the Geotechnical Control Office over an 18-month period between July 1986 and February 1988. Works in the order of \$3.2 million were carried out within the Landslip Preventive Measures Programme. On this occasion, the design required that the finished slope be vegetated rather than chunamed. Geotextiles were used extensively during reinstatement. (GCO/OAP/1987/PS603-6).

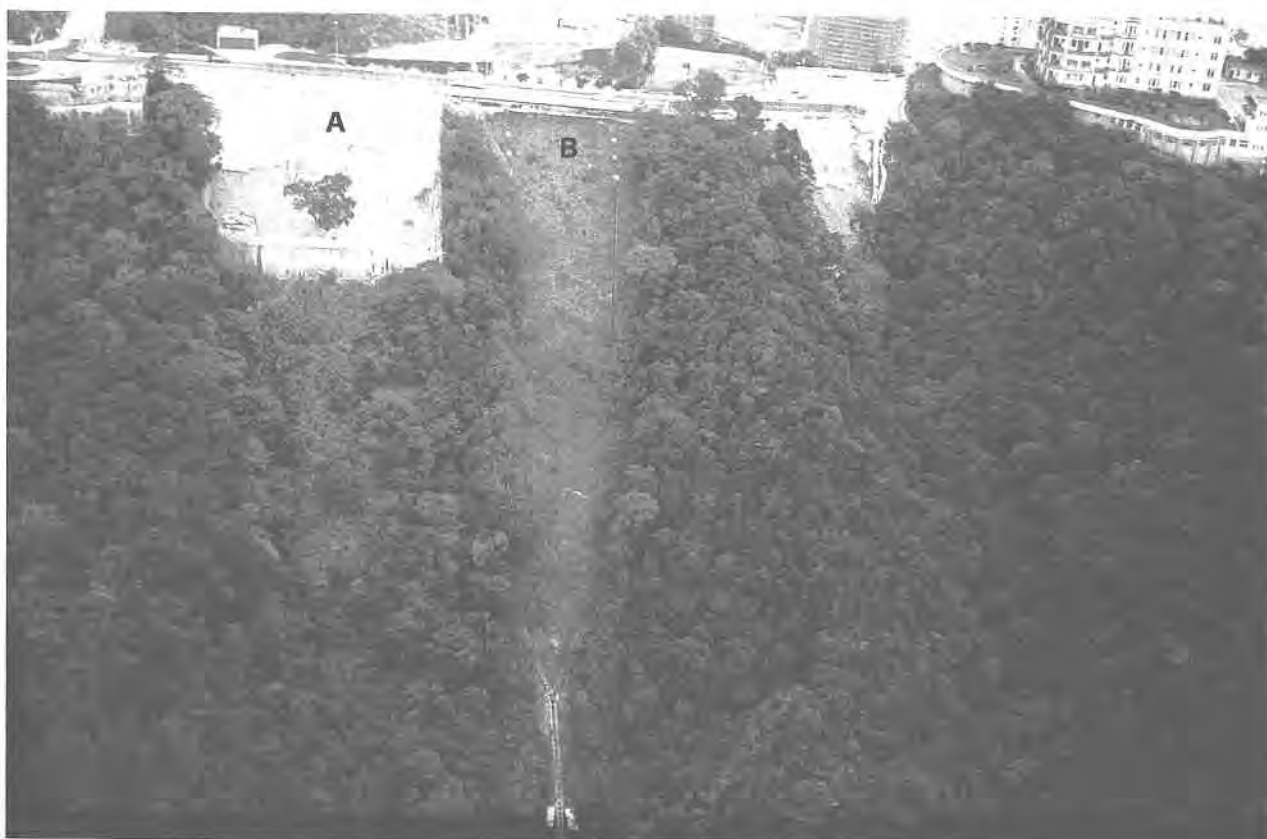
**Plate 190.** *Oblique Aerial Photograph of Remedial Works to the Site of the 1966 Landslip on Peak Road.* This photograph was taken in 1987, and shows remedial works to the site of a landslide in 1966 (A) shown in Plate 58 and also Plate 153. Remedial works were carried out on the old landslide site following a very disruptive failure nearby in 1983. The location of the failure is shown at B in this Plate and in Plate 57. (GCO/OAP/1987/PS607-18).

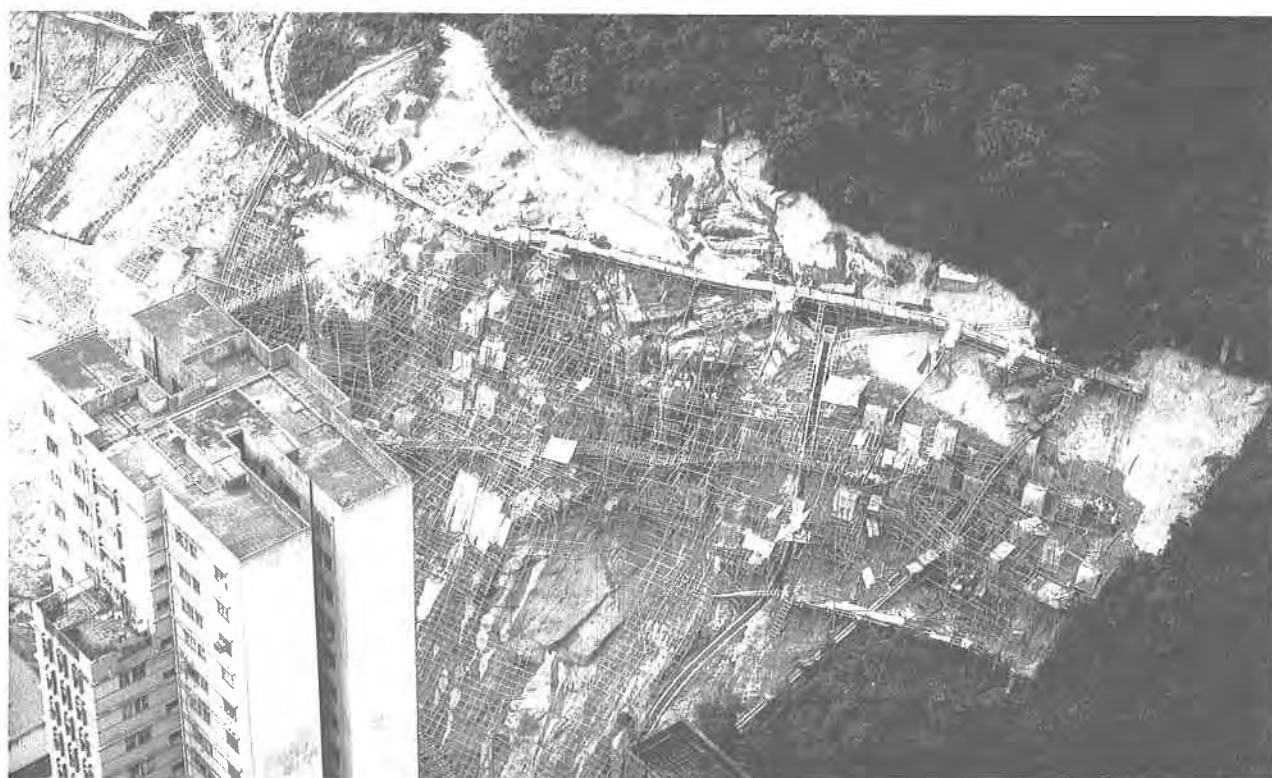
**Plate 191.** *Oblique Aerial Photograph of Slope Works near Quarry Bay in 1987.* Extensive slope works are in progress behind Wai Hang Street. (GCO/OAP/1987/PS604-19).

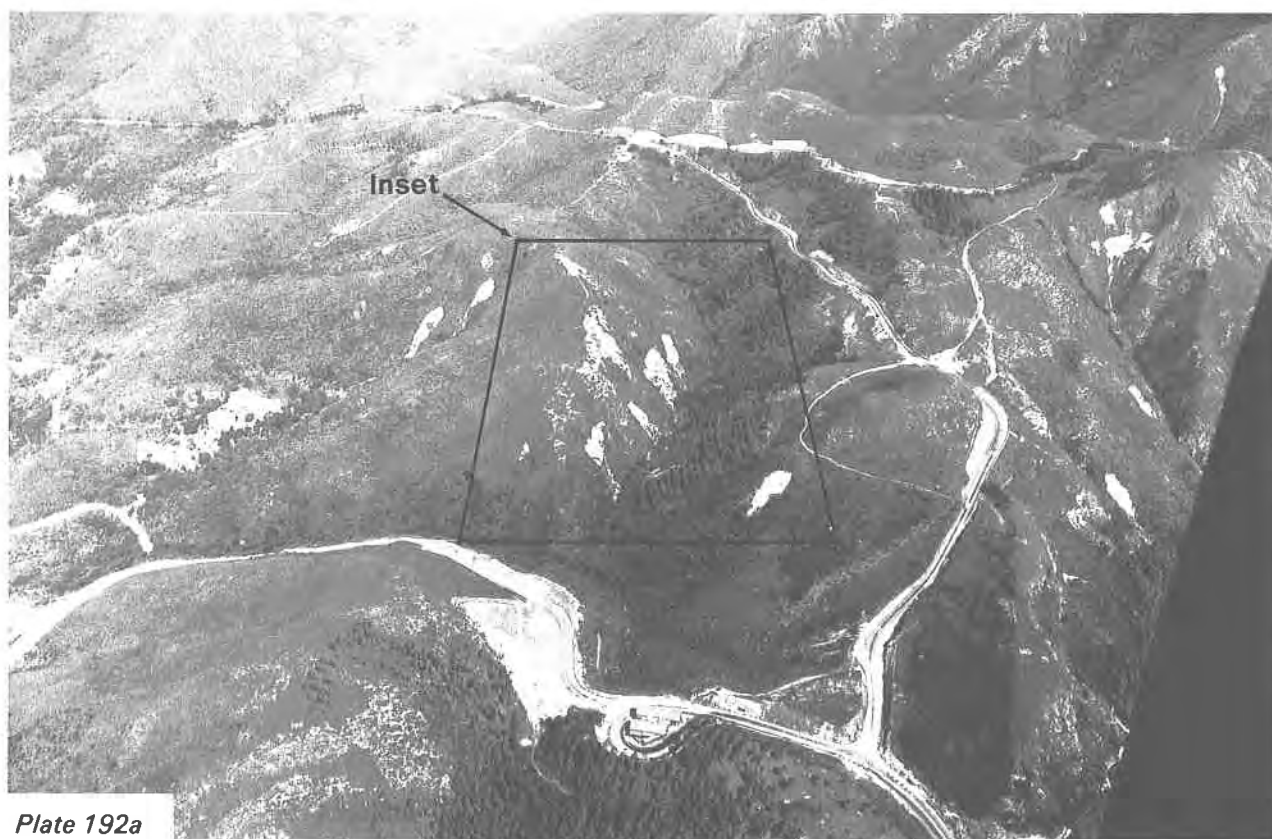
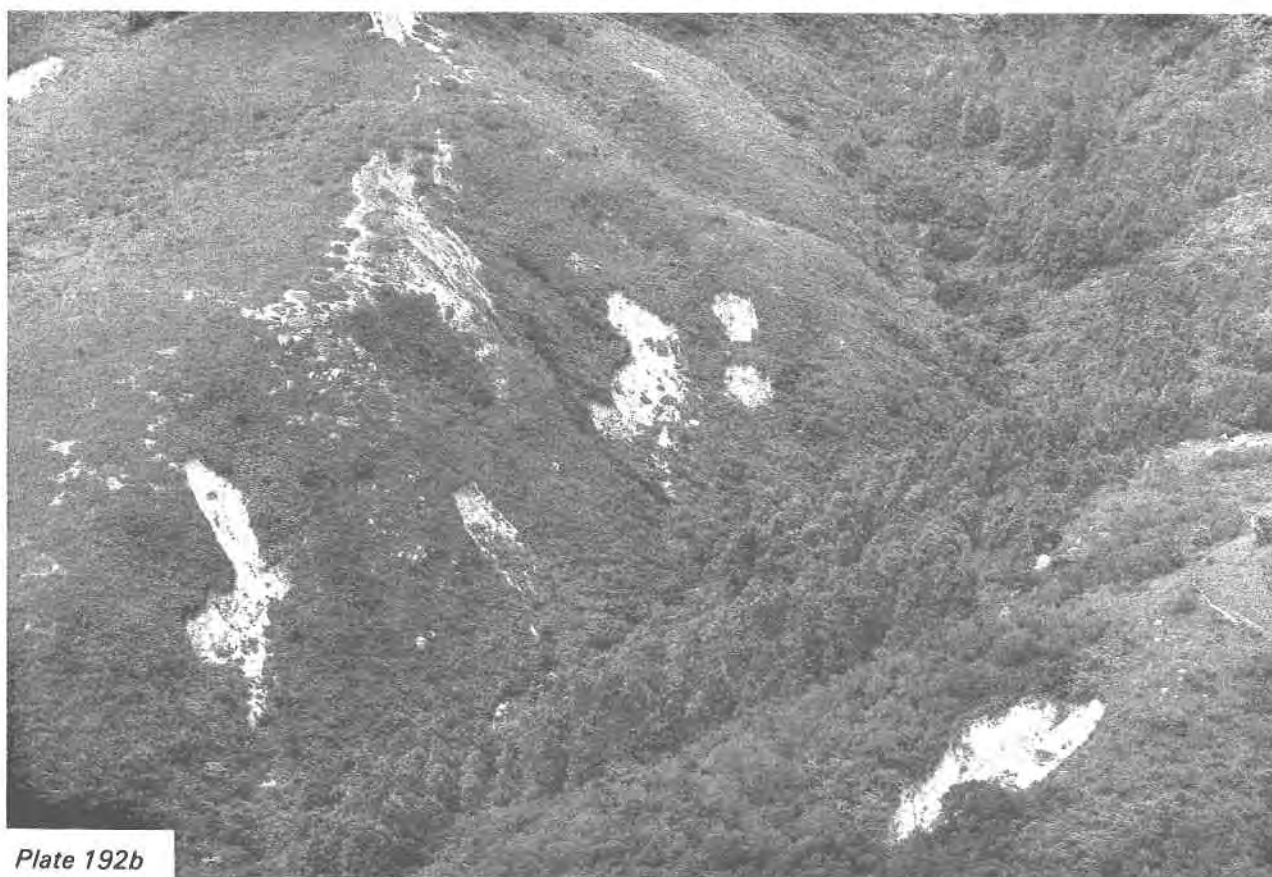
*Plate 192. Comparison of Landslips near Ngong Ping on Lantau Island in 1984 and 1988. Plate 192a shows the location of a number of landslips near the Ngong Ping Road junction in November 1984. Plate 192b illustrates the degree of revegetation and nature of the landslips after four years. (GCO/OAP/1984/PS48-9 and 1988/PS661-10).*

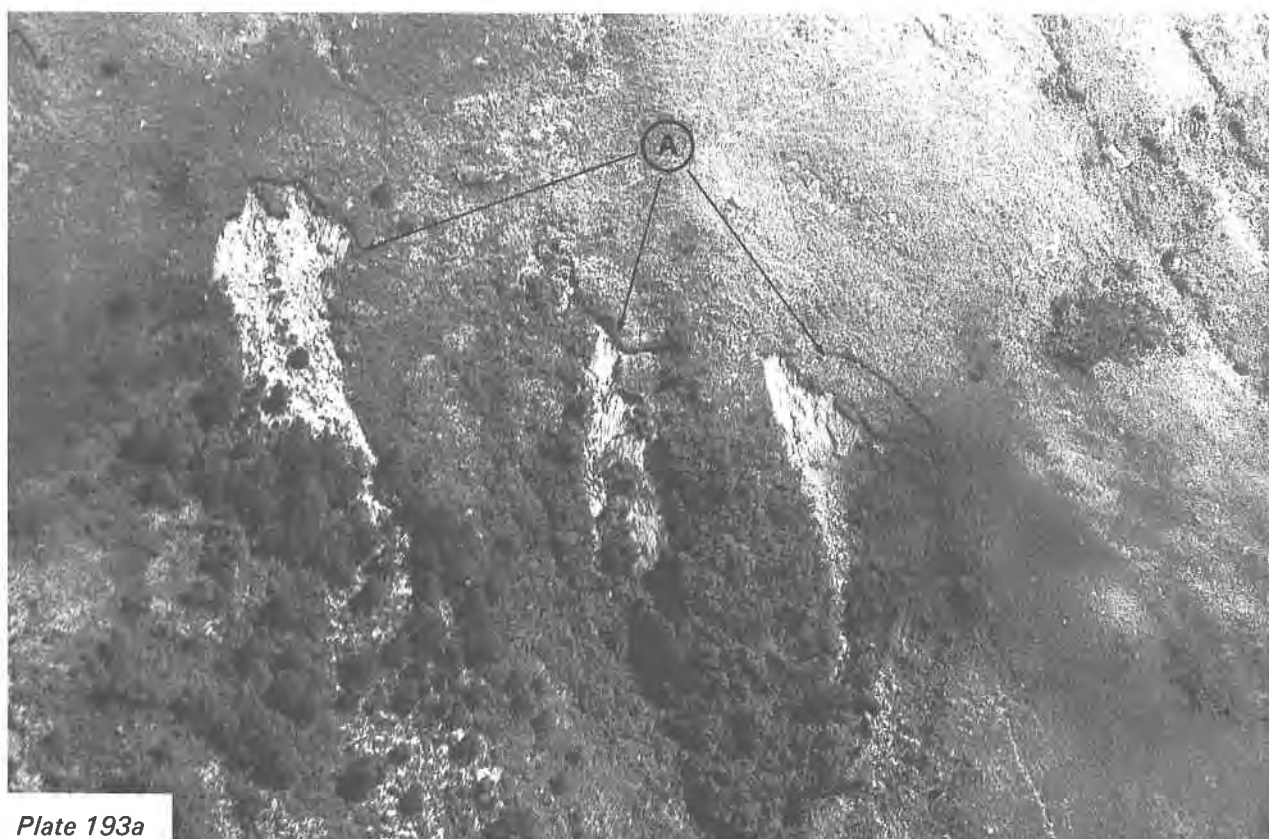
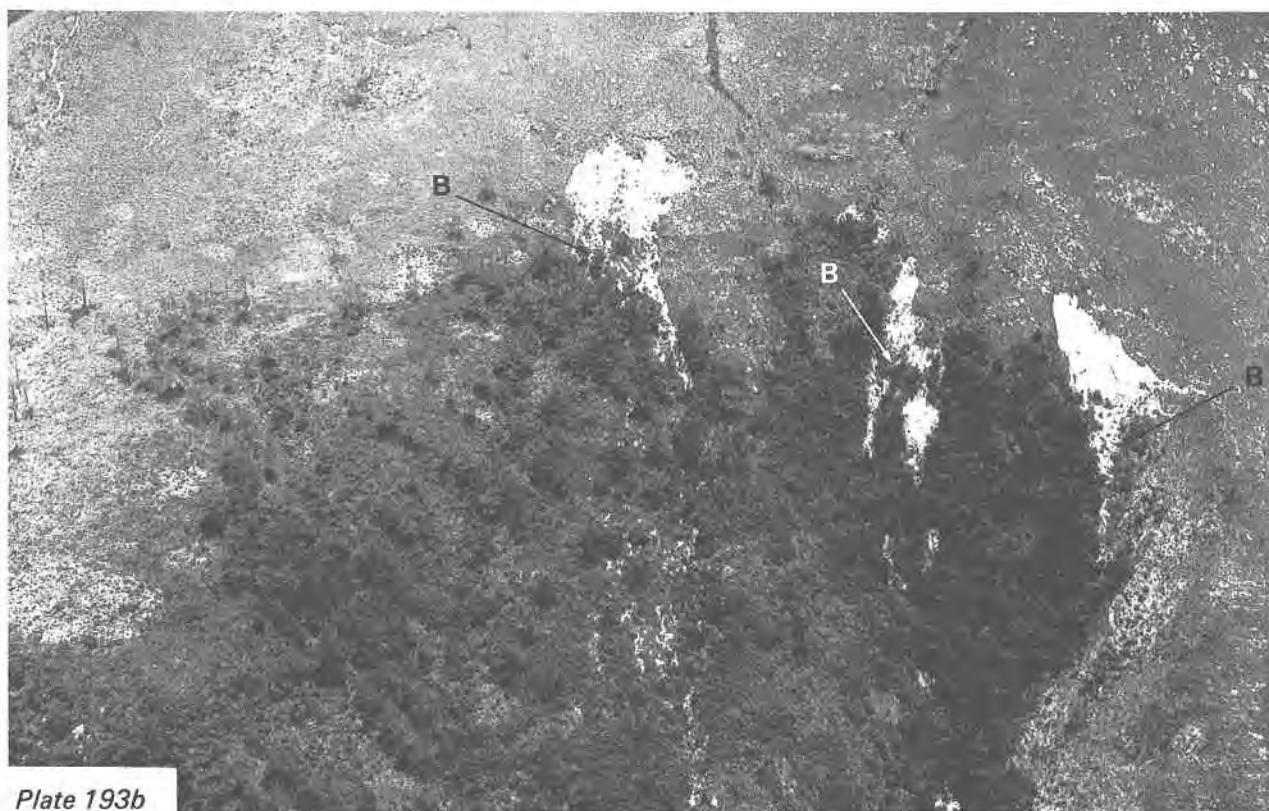
Plate 193. *Comparison of Landslips on the Pat Sin Range in 1980 and 1981.* Plate 193a shows the location of three landslips on midslope terrain, and major tension cracks are clearly evident (A). Plate 193b illustrates the degree of revegetation and nature of the unstable area some 12 months later. Note the establishment of vegetation (B) on the landslide debris and the less distinct nature of the tension cracks. (GCO/OAP/1980/PS45-33A and 1981/PS158-6A).

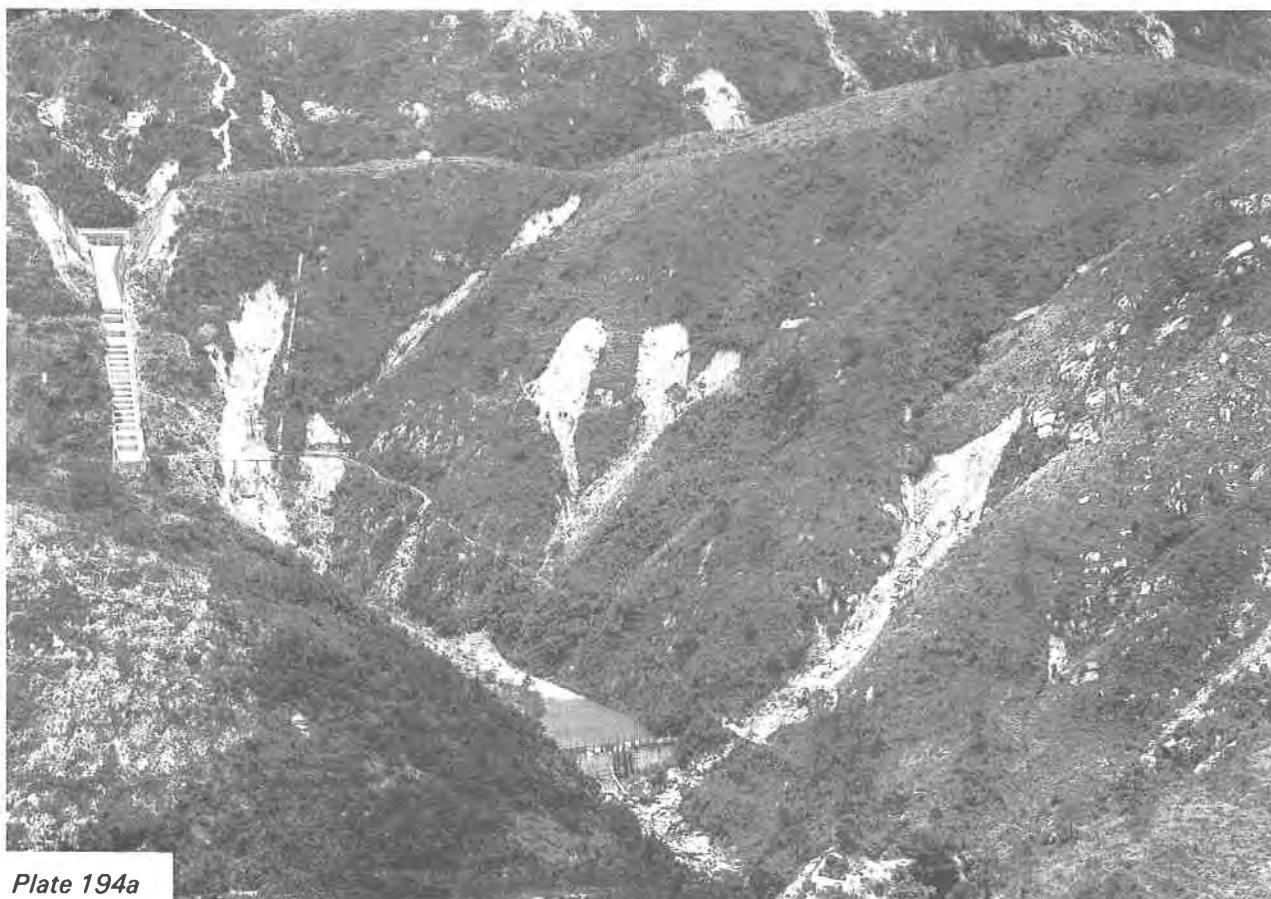
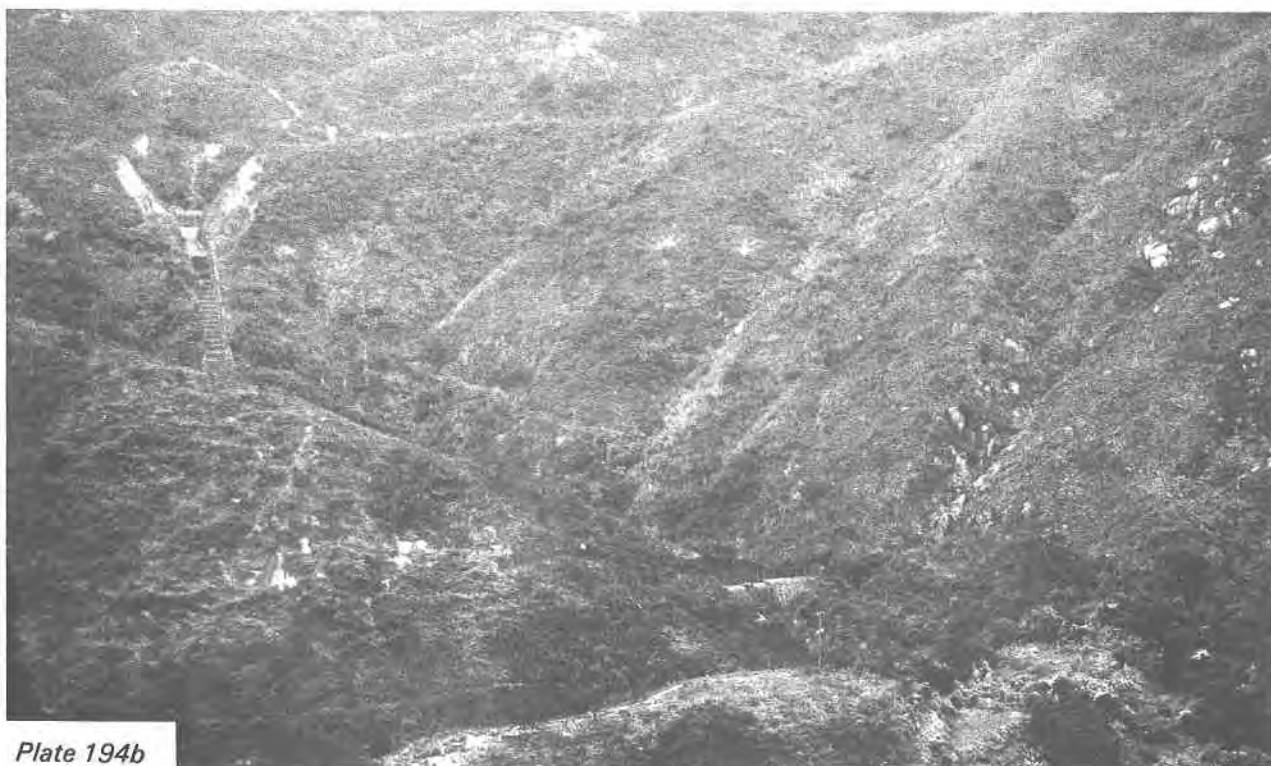
*Plate 194. Comparison of Landslips near the Catchwater at Sham Tseng in 1982 and 1988. A large number of landslips occurred on granitic terrain during intense rainstorms in May 1982, in the Tai Lam Chung Country Park. Plate 194a was taken in June 1982 and shows a number of failures on the slopes to the east of the catchwater overflow. Plate 194b illustrates the condition of the terrain 6 years later in 1988. (GCO/OAP/1982/PS292-10 and 1988/PS666-16).*

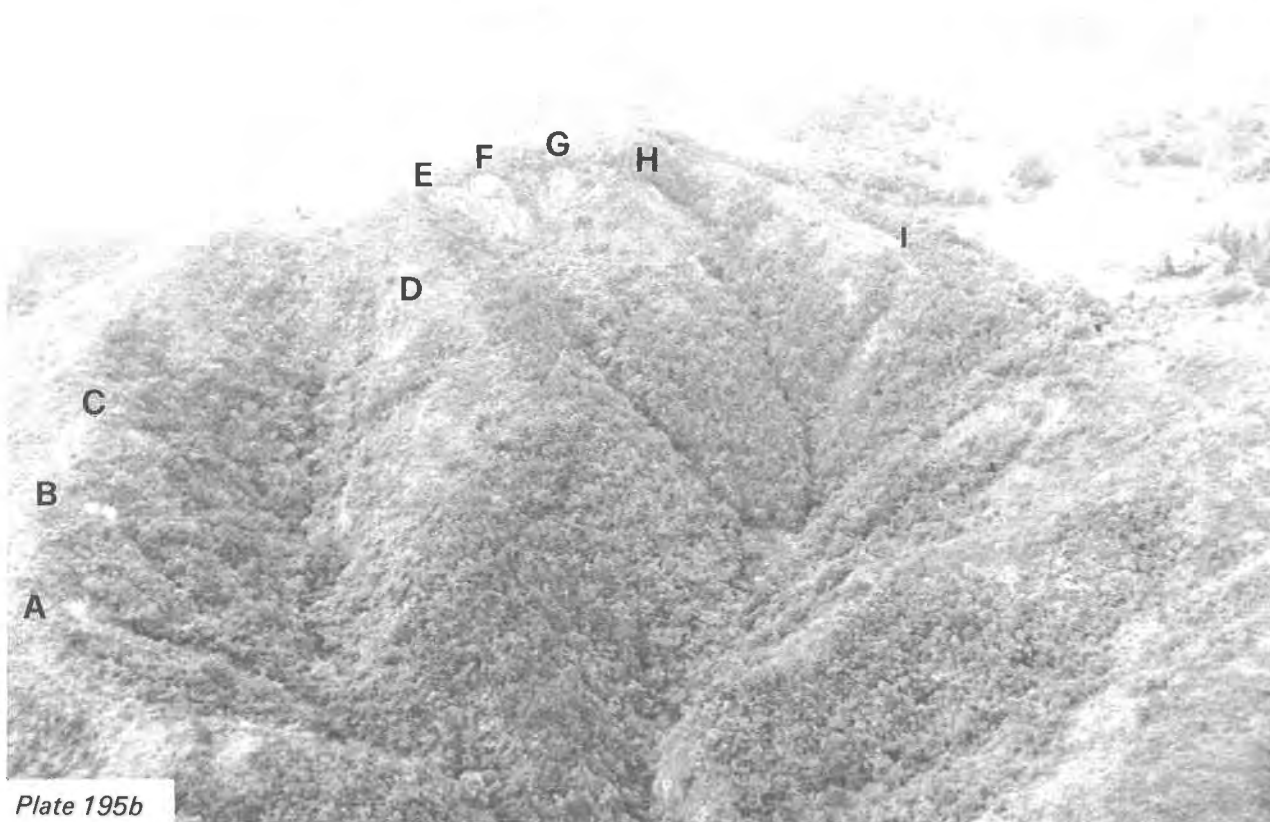
**Plate 195.** *Comparison of Landslips near Tsing Fai Tong in 1982 and 1988.* The granitic terrain north of Sham Tseng was severely affected by landslips during the rainstorms of May 1982. Plate 195a, taken in June 1982, shows that many of the landslips are characterised by backscars which are marginal to the ridge crest and spurlines. This corresponds to the point of oversteepening of the gully heads (Refer Appendix D, Section D.4). Plate 195b illustrates the condition of the terrain 6 years later in 1988. (GCO/OAP/1982/PS306-9A and 1988/PS667-19).

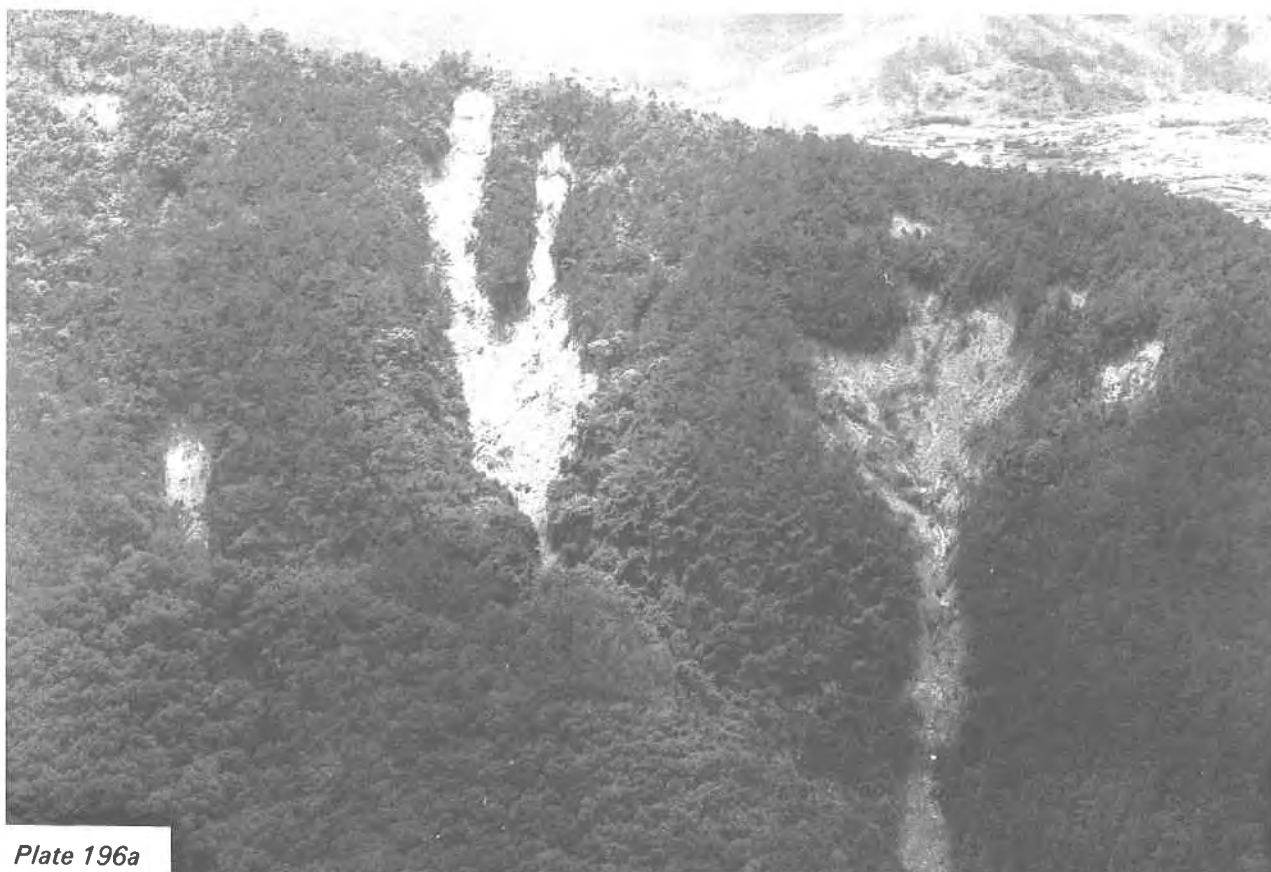
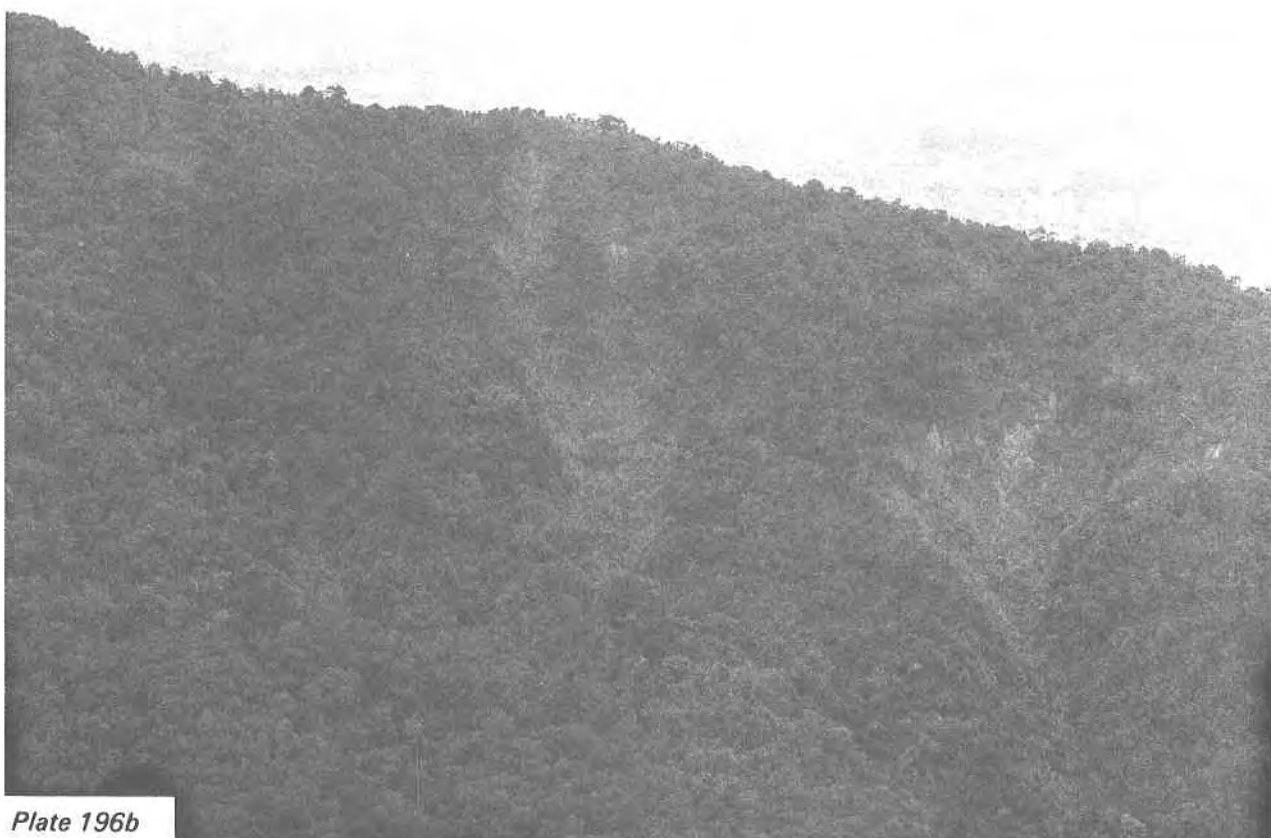
*Plate 196. Comparison of Landslips near Kap Lung in 1982 and 1988. Plate 196a shows a number of landslips on reafforested terrain on the northeastern side of Route Twisk in the Shek Kong Valley in June 1982. Plate 196b illustrates the condition of this terrain 6 years later in 1988. (GCO/OAP/1982/PS295-6 and 1988/PS664-6).*

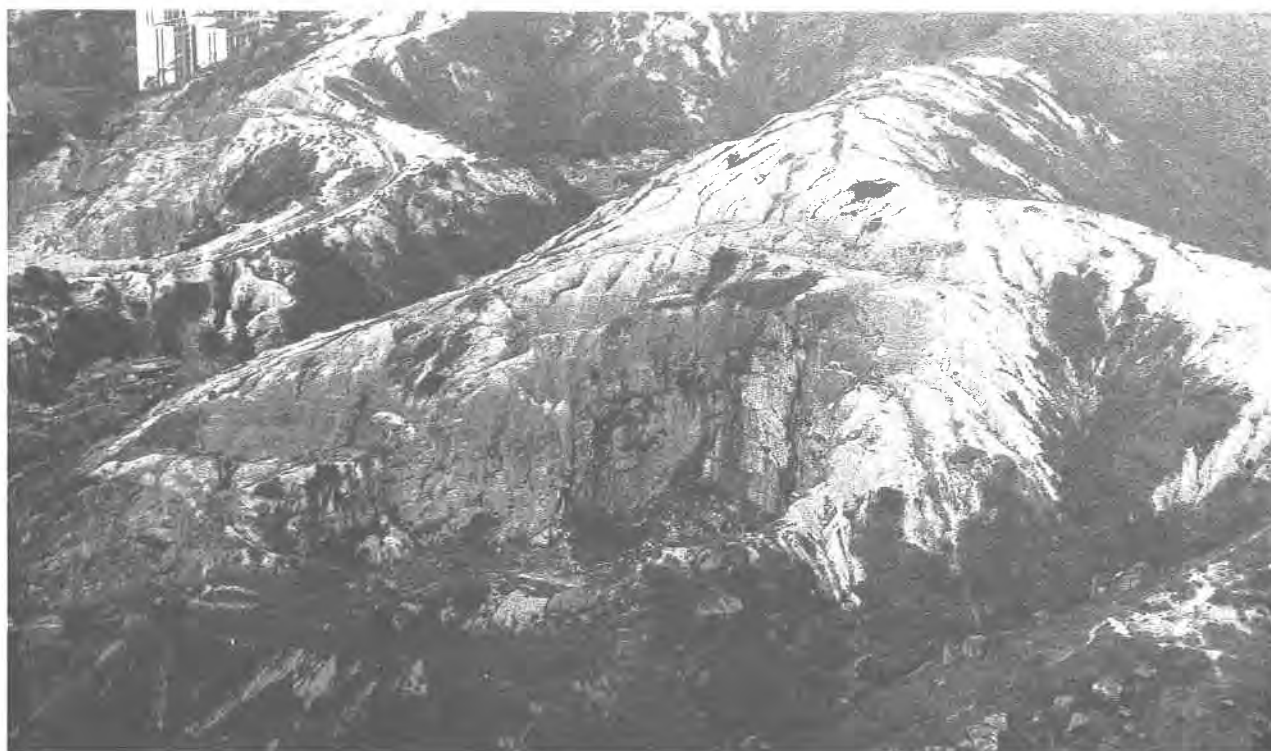
**Plate 197.** *Oblique Aerial Photograph of Severely Eroded Granitic Terrain near Ngau Tau Kok in 1984.* This photograph shows the severely eroded nature of the hillcrests which is characteristic of much of the granitic terrain in the Territory. Gully erosion originates almost at the crest of the ridges and spurlines on this type of terrain. (GCO/OAP/1985/PS525-5A).

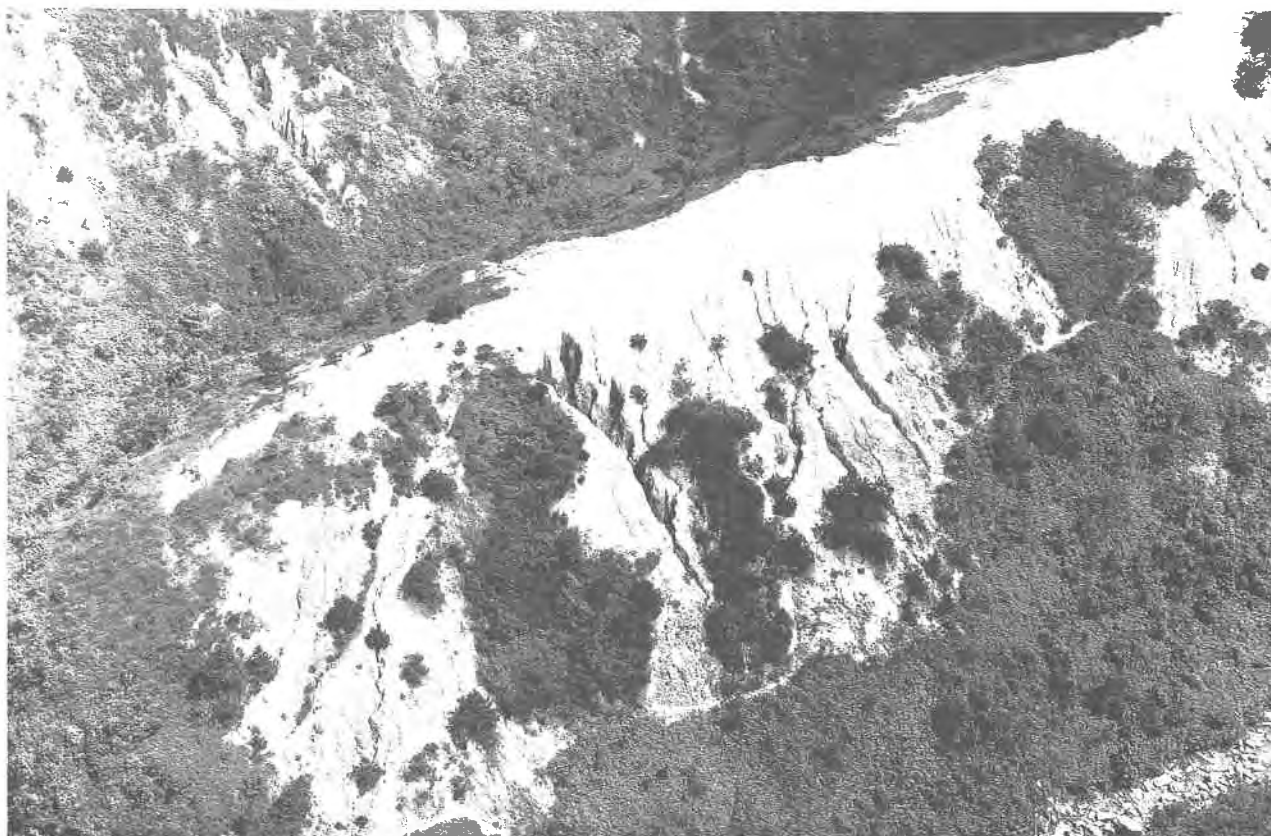
**Plate 198.** *Oblique Aerial Photograph of Severely Eroded Granitic Terrain near Ha Pak Nai in 1978.* This photograph highlights the nature and occurrence of gully erosion on granitic terrain in the western New Territories. Deep gully incision is evident near the crest of the slopes and becomes more shallow in a downslope direction. (GCO/OAP/1983/PS372-10).

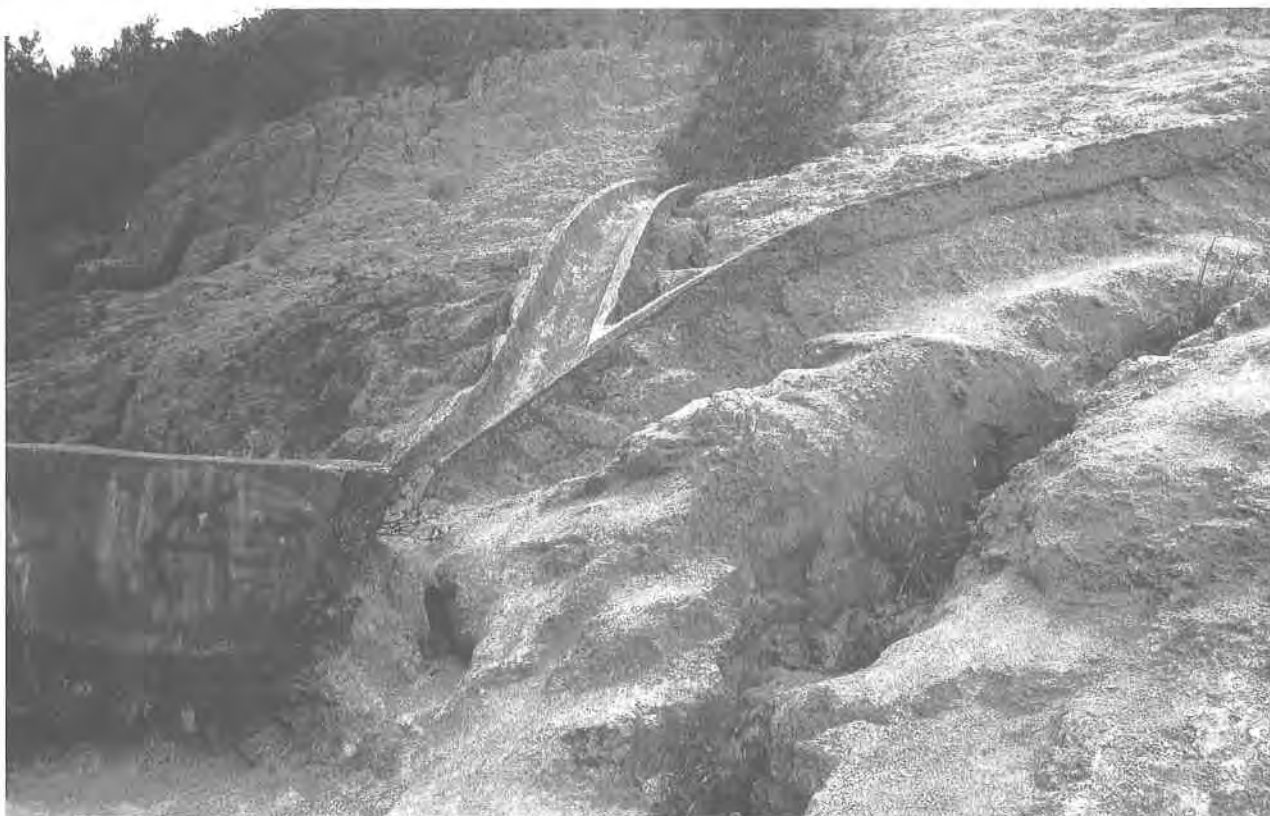
*Plate 199. Severe Erosion affecting Services near Braemar Hill in 1984. Severe sheet erosion marginal to a surface drainage system is evident. Erosion has undermined the drainage channel and culvert and has rendered the drainage system essentially ineffective. (GCO/TP/1984/TP 58-22).*

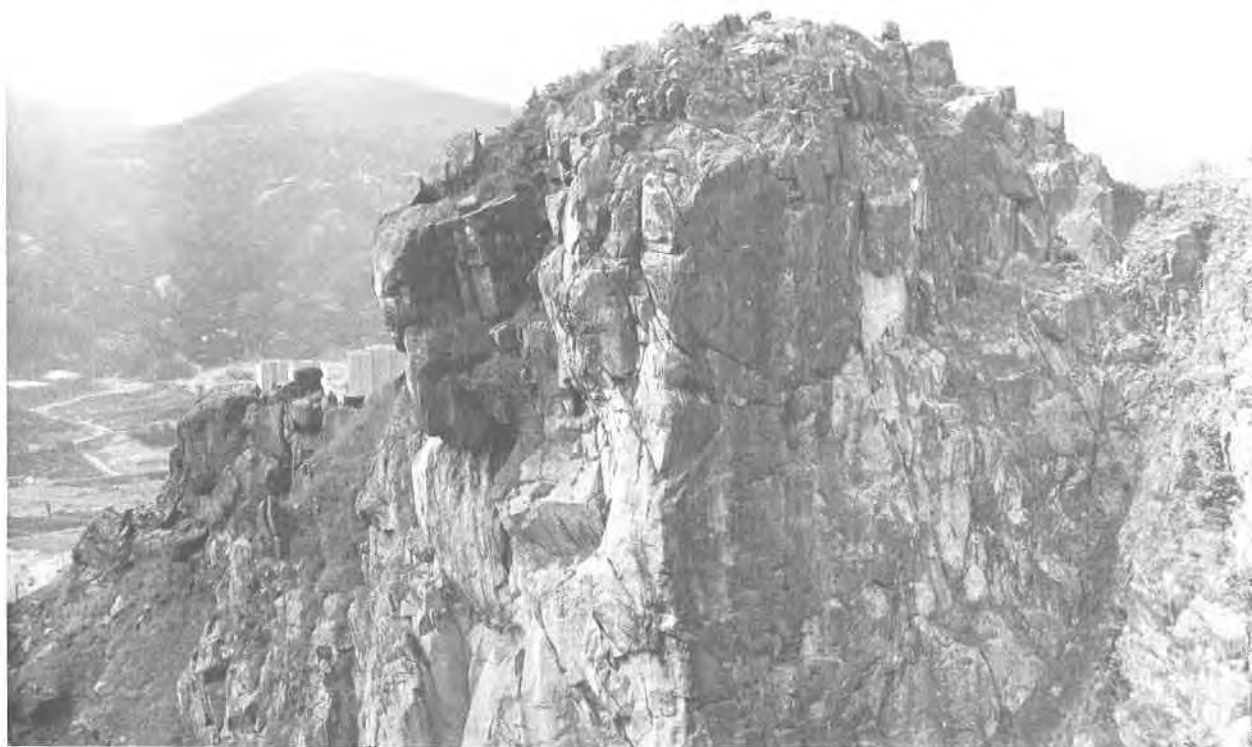
*Plate 200. Surface Erosion near Braemar Hill in 1984. This photograph shows the effects of surface erosion on boulders in granitic terrain. Erosion can gradually undermine the granitic boulders. (GCO/TP/1984/TP58-27).*

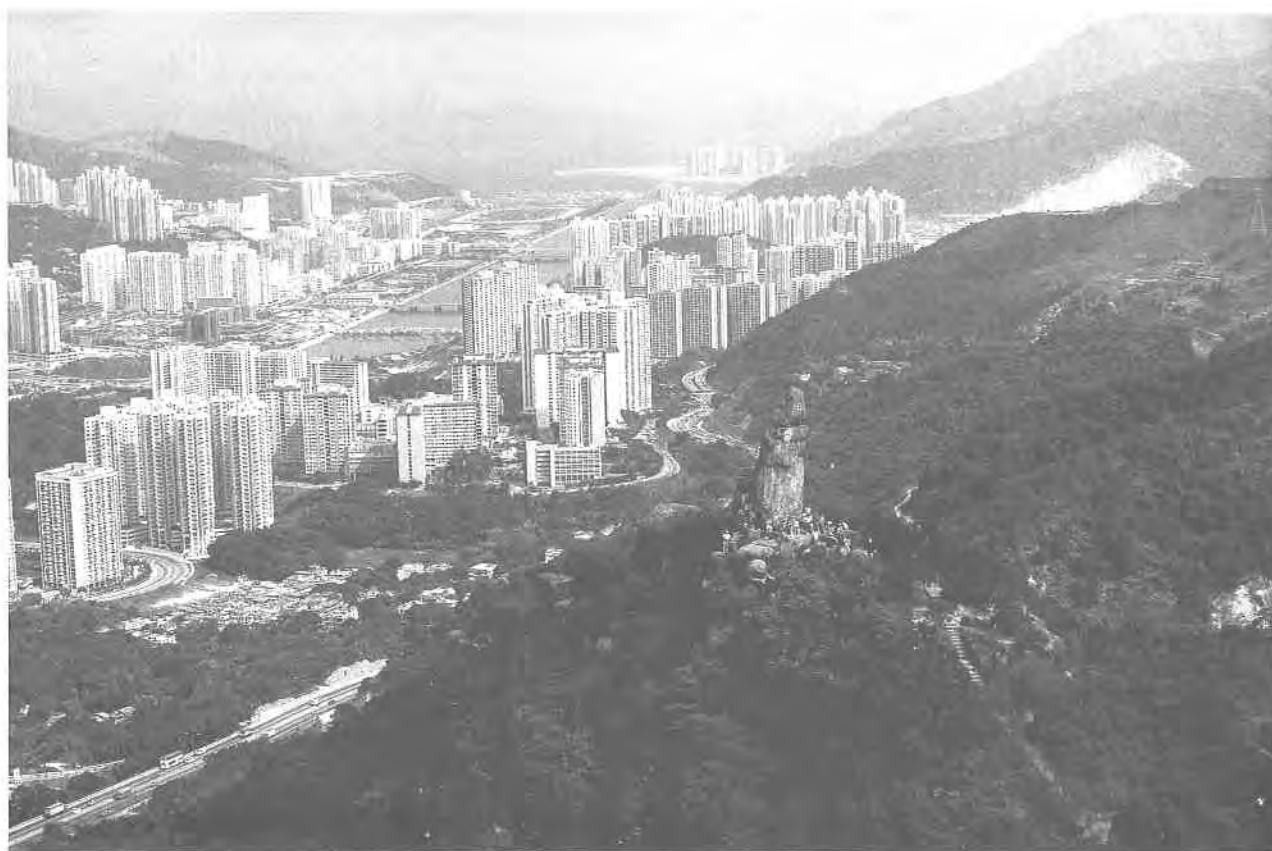
**Plate 201.** *Oblique Aerial Photograph of Lion Rock in 1981.* This view from the south clearly shows the highly jointed and precipitous nature of the fine-grained granite forming the summit of Lion Rock. The rock is a well known feature which dominates the landscape of the Kowloon Hills. (GCO/OAP/PS213/8/16.9.81).

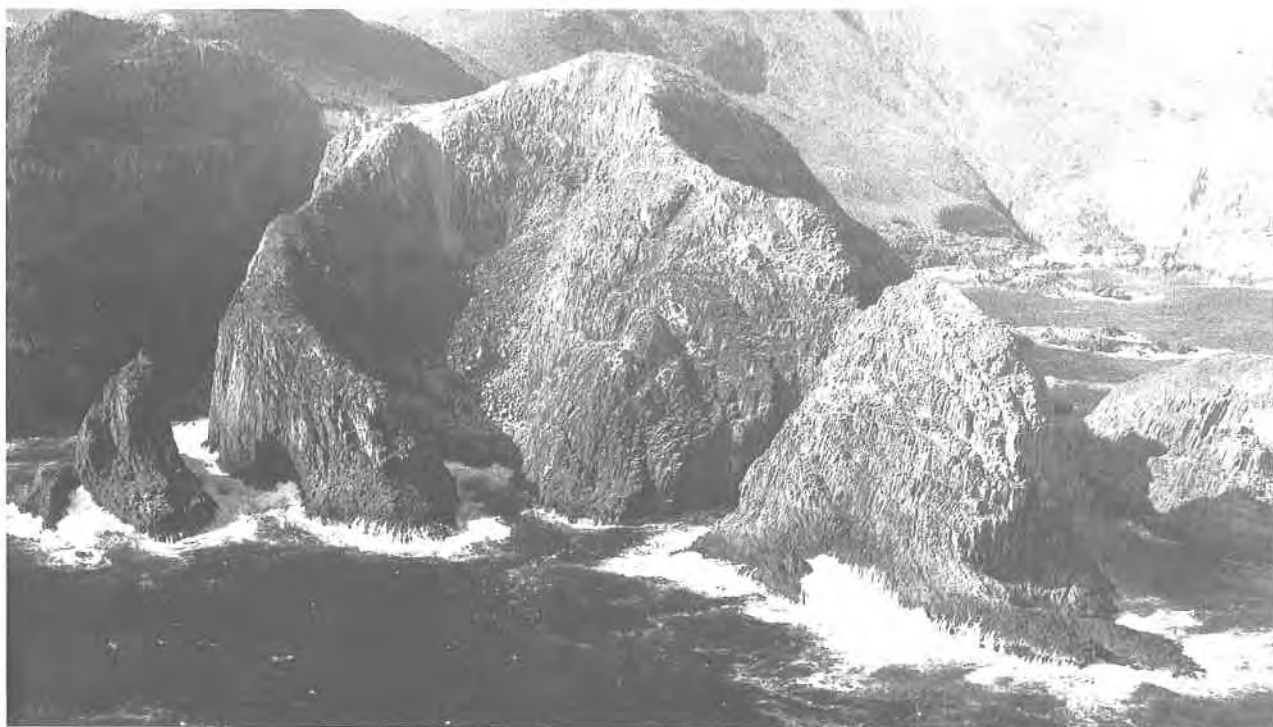
**Plate 202.** *Oblique Aerial Photograph of Amah Rock in 1988.* Amah Rock is another well known geological feature and is located on the southern side of the Sha Tin valley. It is composed of coarse-grained granite with Quartz Monzonite just to the south. (1988/82C/87-2).
