Geotechnical Area  
Studies Programme

GASP Report XII

# Territory of Hong Kong

Geotechnical Control Office  
Civil Engineering Services Department  
Hong Kong

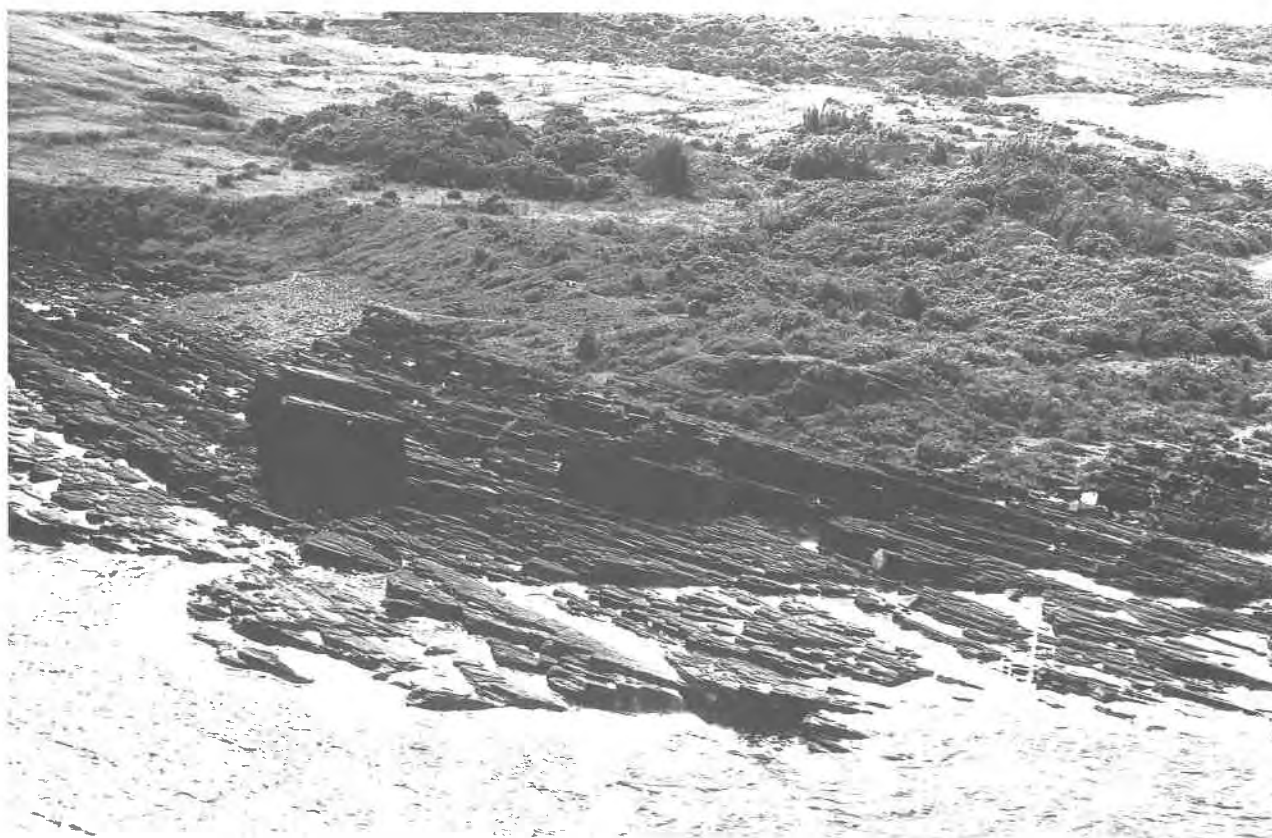
*Plate 205. Oblique Aerial Photograph of the Southwestern Coast of Ping Chau in 1982. This photograph shows the steep cliff face and wave cut platform developed on the southwest-facing metasedimentary terrain of the island. (GCO/OAP/1982/PS344-27).*

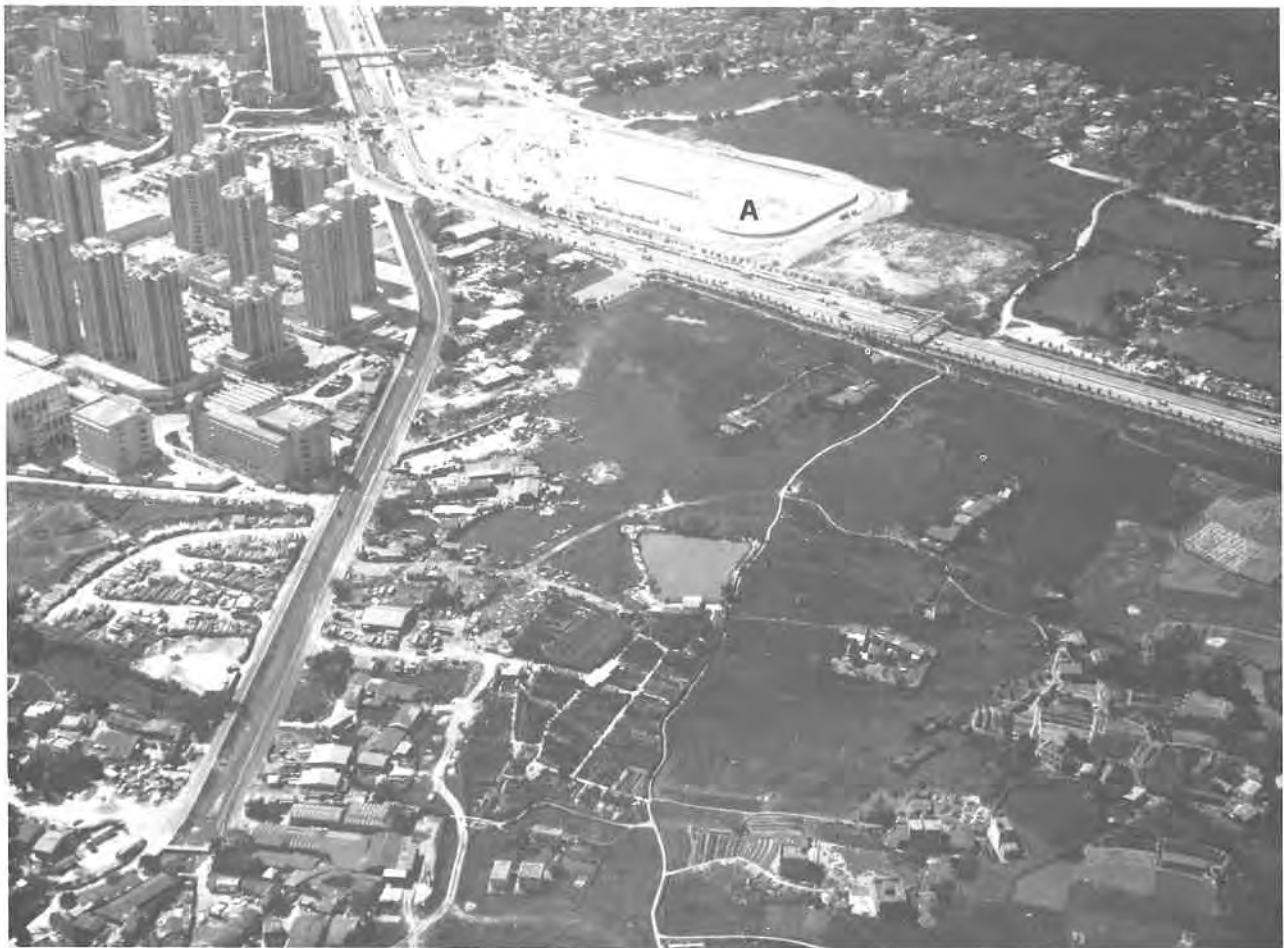
**Plate 222.** *Oblique Aerial Photograph of the Route 5 Road Tunnel in 1987.* The new system of tunnels will improve the road link between Kwai Chung and Sha Tin. (GCO/OAP/1987/PS599-3).

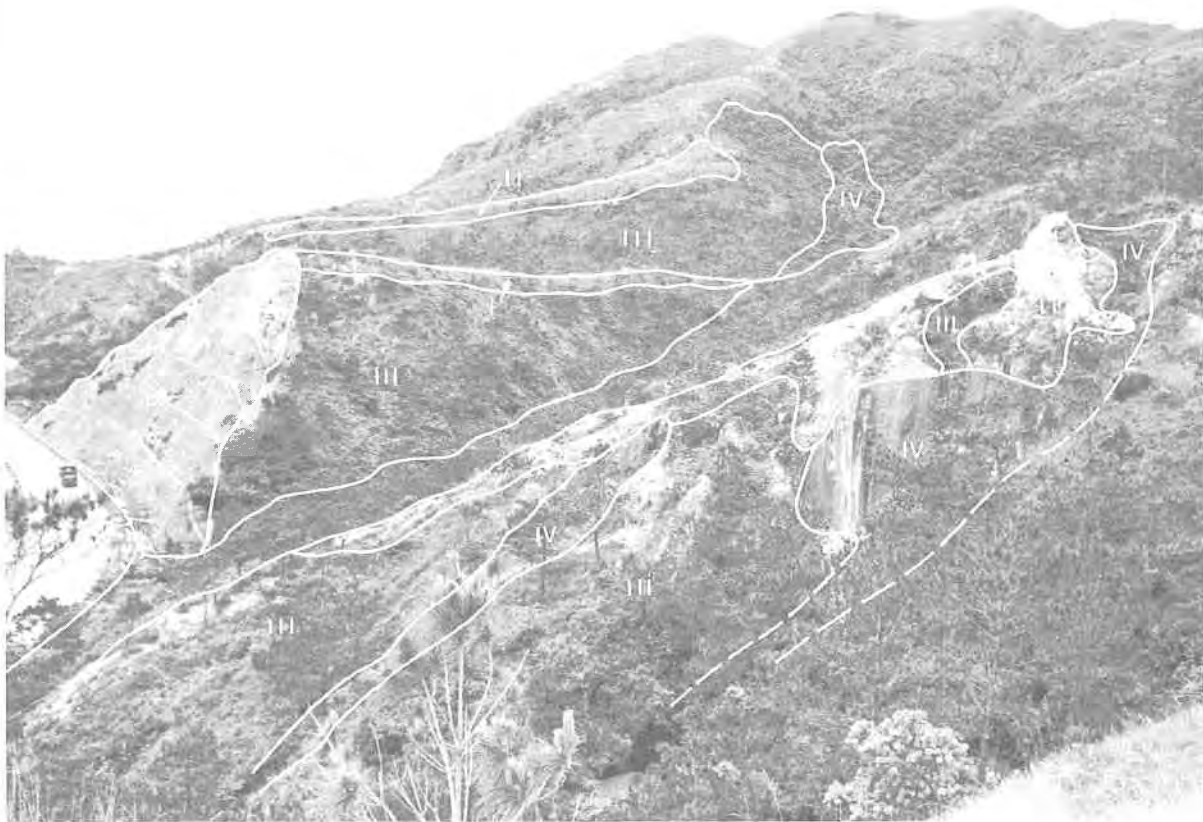
This Figure illustrates a few of the relationships between terrain features and GLUM class:

- (i) GLUM Class I:
  - (a) gently sloping spur crests and lines (slope gradients  $0-15^{\circ}$ ) on insitu terrain.
  - (b) cut platforms on insitu terrain.

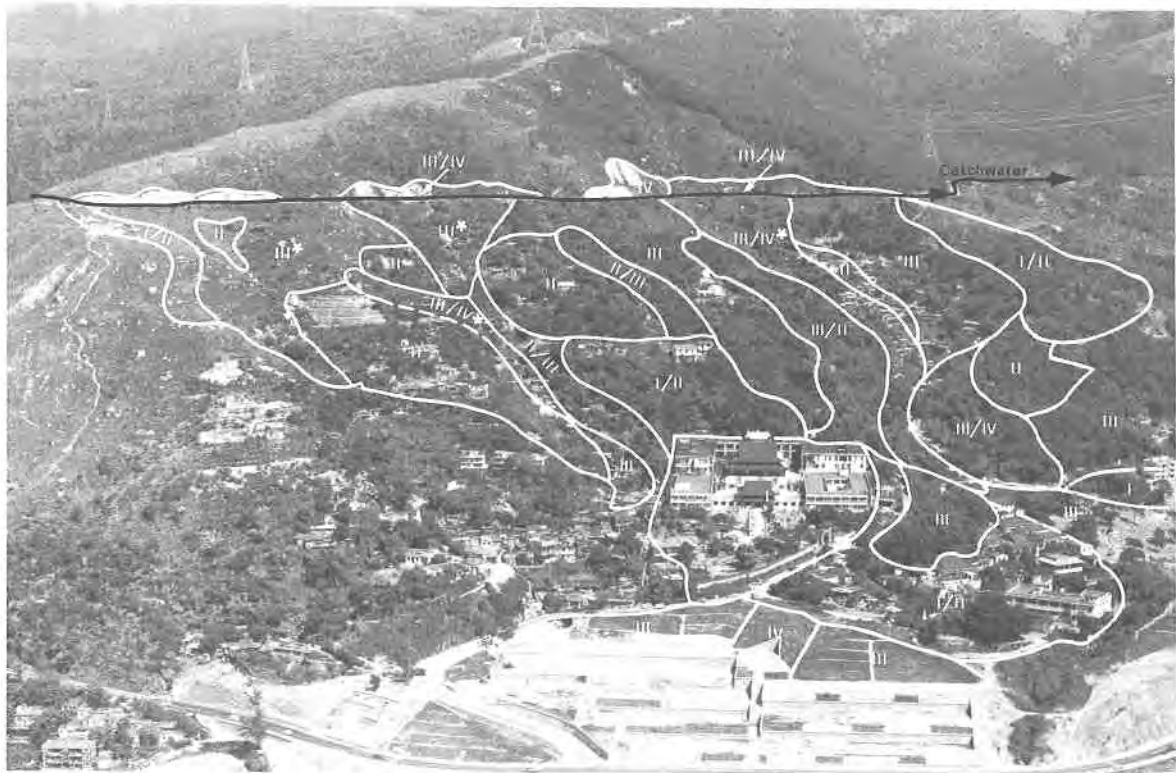
Fig. A3

This Figure illustrates a few of the relationships between features associated with developed terrain and GLUM class. Moderately steep sideslopes and lenticular colluvial deposits aligned along concave drainage depressions typify the GLUM Classes III & IV terrain visible on the sideslopes in the centre of the Plate. Landslips, which are common on the cut slopes above the catchwater, are identified by the chunam surface protection applied to the slide scar (GLUM Classes III & IV visible at the top centre of the Plate). Downslope, concentrations of temporary structures (squatters) occupy the moderately steep sideslopes and some of the colluvial hillside depressions. Terrain marked with an asterisk (\*) are concave depressions which may be locally affected by concentrations of overland flow following intense storm rainfall. In the left portion of the plate, corestones and detrital boulders litter the terrain. These also represent a potential threat to developments downslope. At the bottom of the Plate, low rise, low density development associated with a New Town area encroaches upon the sideslope terrain.

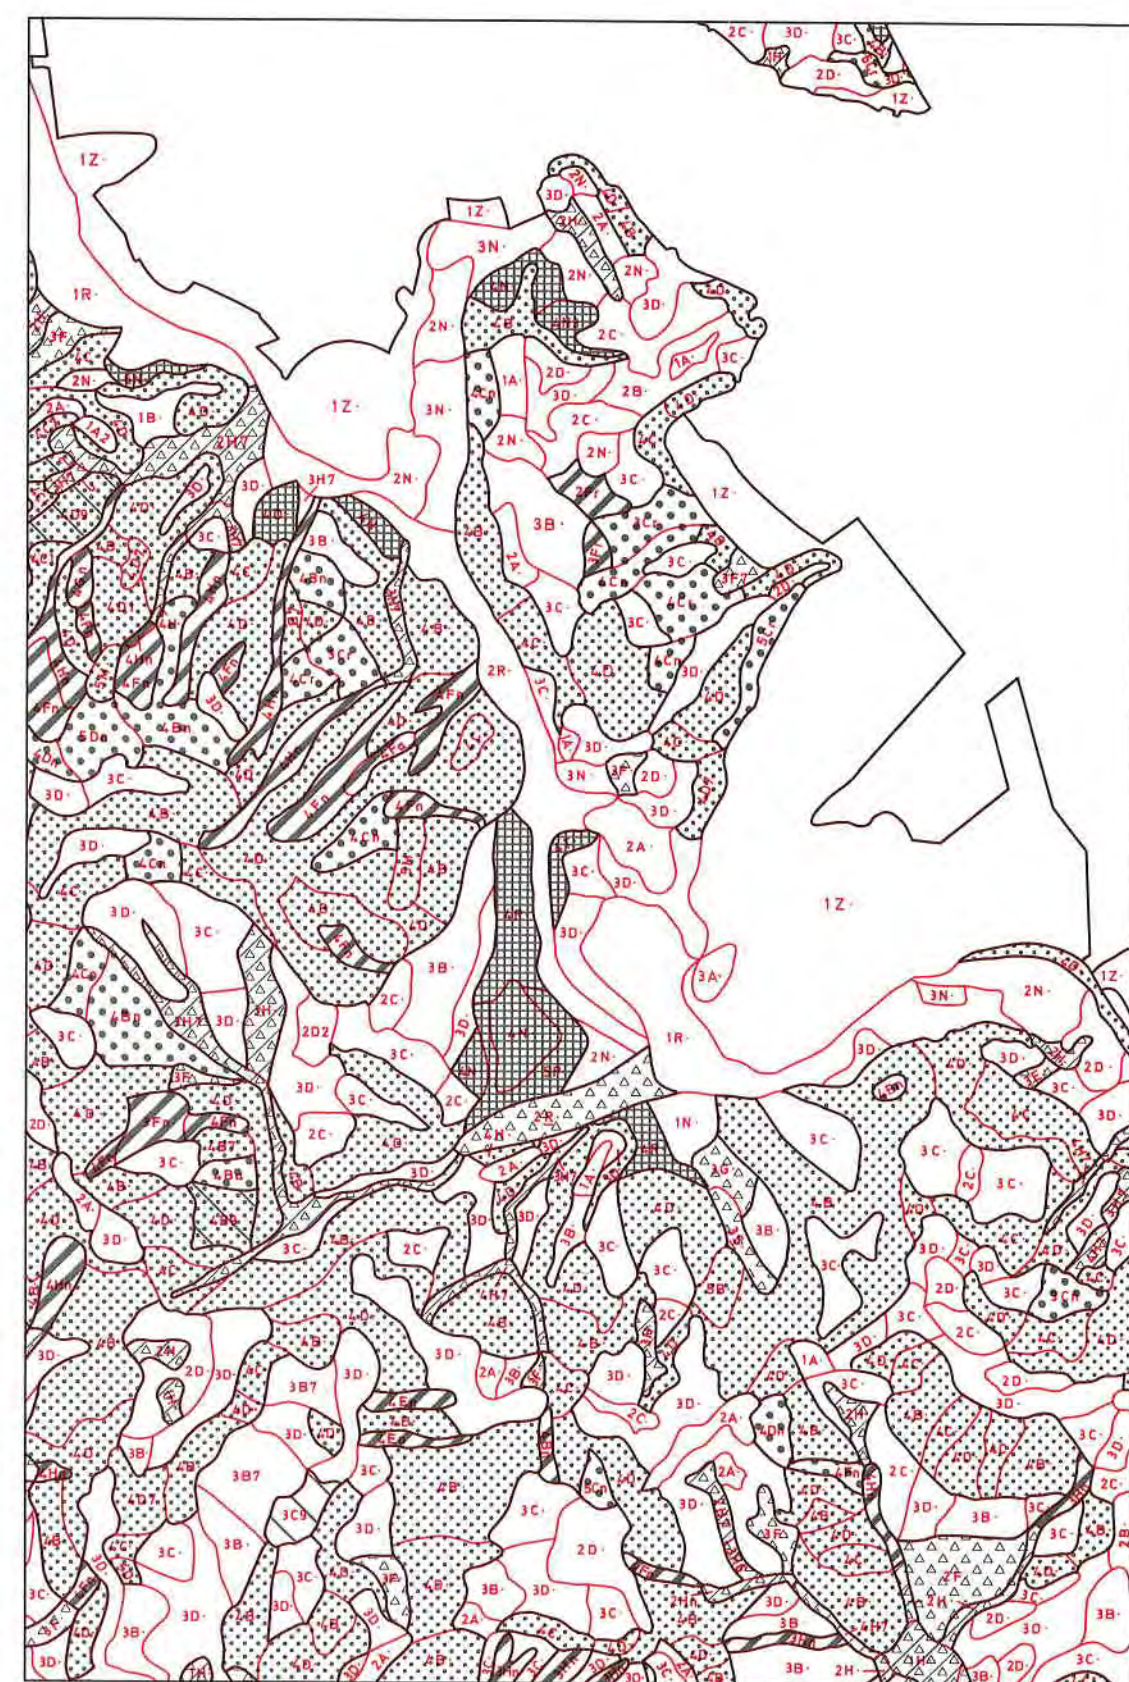
Fig. A10a

Example of the Physical Constraints Map  
(PCM)
