Detailed Study of Selected Natural Terrain Landslides  
at Cloudy Hill

LANDSLIDE SETTING

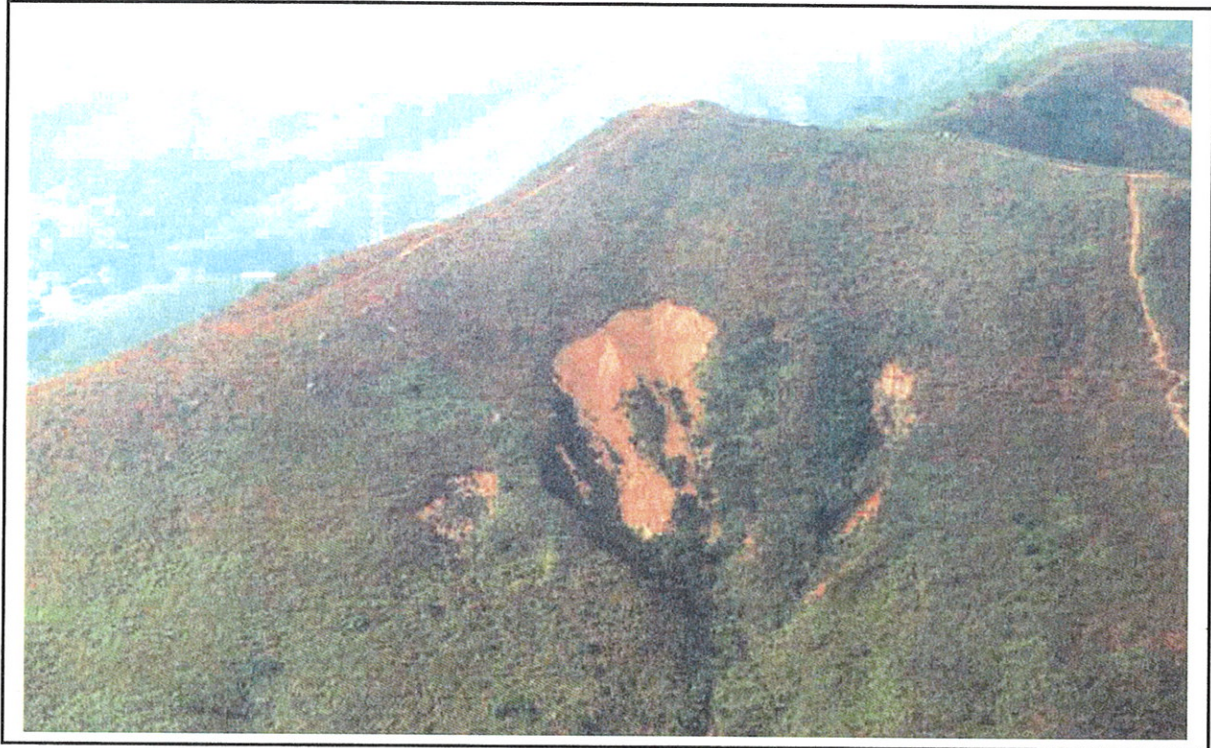
**PLATE 1: Aerial view of the Landslide Source (Photograph Taken 19 October 2001)**

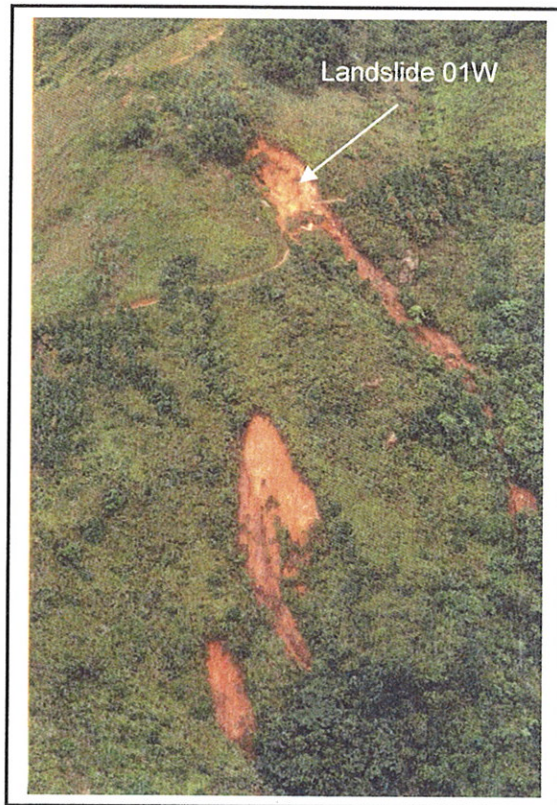
**PLATE 1: View of Source (Photograph Taken 9 July 2001)**

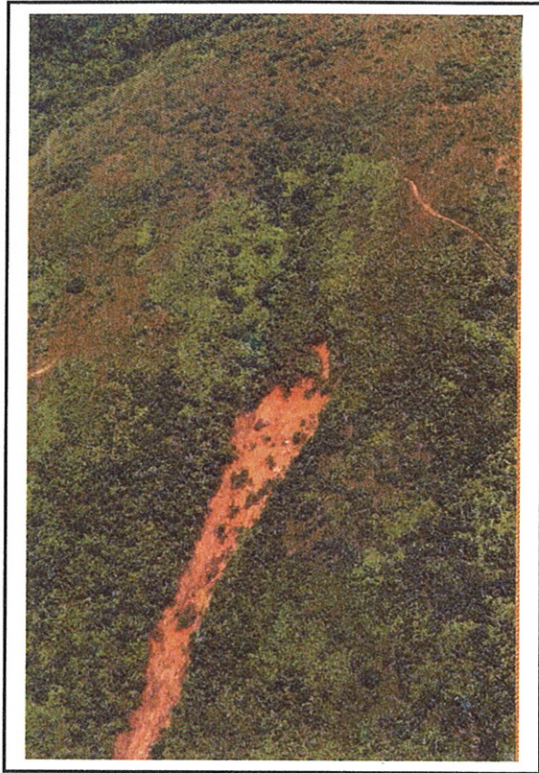
**PLATE 1: View of Landslide Source (Photograph Taken 9 July 2001)**
