DETAILED STUDY OF SELECTED NATURAL TERRAIN LANDSLIDES AT CLOUDY HILL

GEO REPORT No. 207

HALCROW CHINA LIMITED

**GEOTECHNICAL ENGINEERING OFFICE
CIVIL ENGINEERING AND DEVELOPMENT DEPARTMENT
THE GOVERNMENT OF THE HONG KONG
SPECIAL ADMINISTRATIVE REGION**

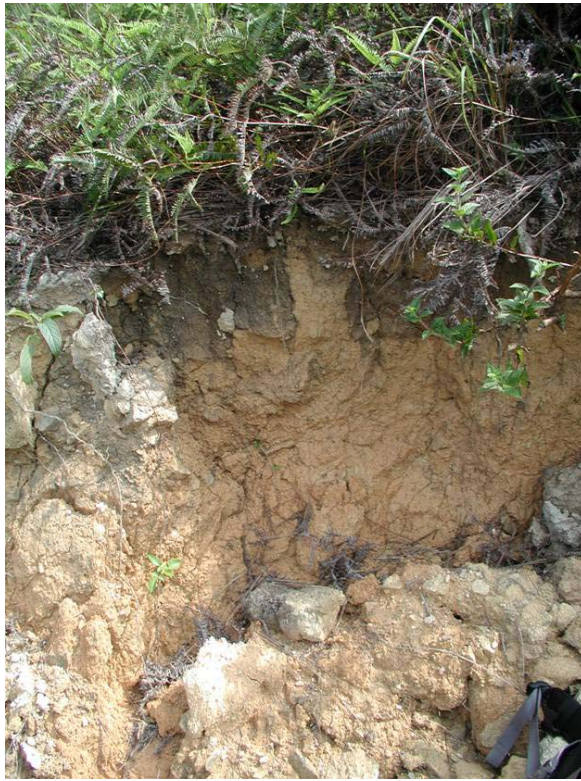
Plate 3 – Fine Colluvium in Main Scarp of Landslide 00B
(Photograph Taken on 10 May 2001)

About 70% of the landslides inspected occurred in colluvial deposits that typically comprised a matrix-supported, loose to medium dense, light reddish brown silty sand (or firm sandy silt) with some gravel and some to many angular cobbles of moderately decomposed tuff (Plate 3). In some landslide scars, cobbly or bouldery clast-supported colluvium was observed (Plate 4). The cobbly or bouldery colluvium was usually very localised and only observed in the flanks of the main scarp, although much of the material mobilised from the source of Landslide 01N appeared to be cobbly and bouldery colluvium (Plate 4).

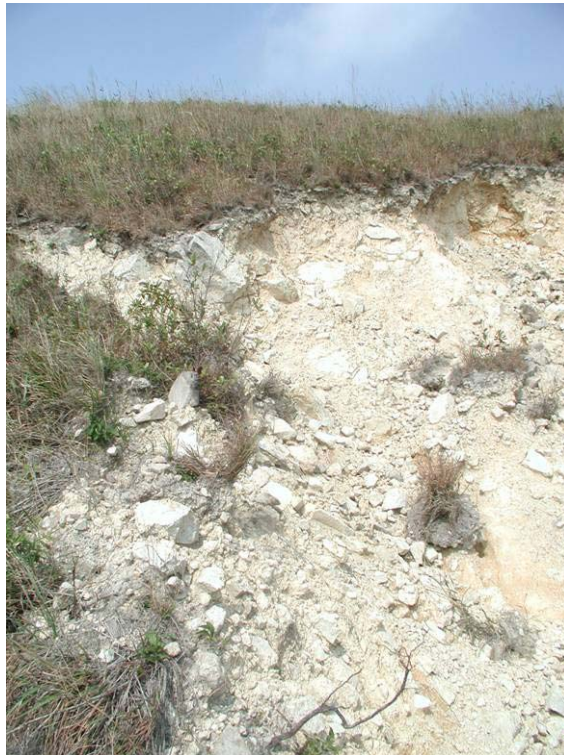
Plate 4 – Bouldery Colluvium in the Main Scarp of Landslide 01N
(Photograph Taken on 19 November 2001)

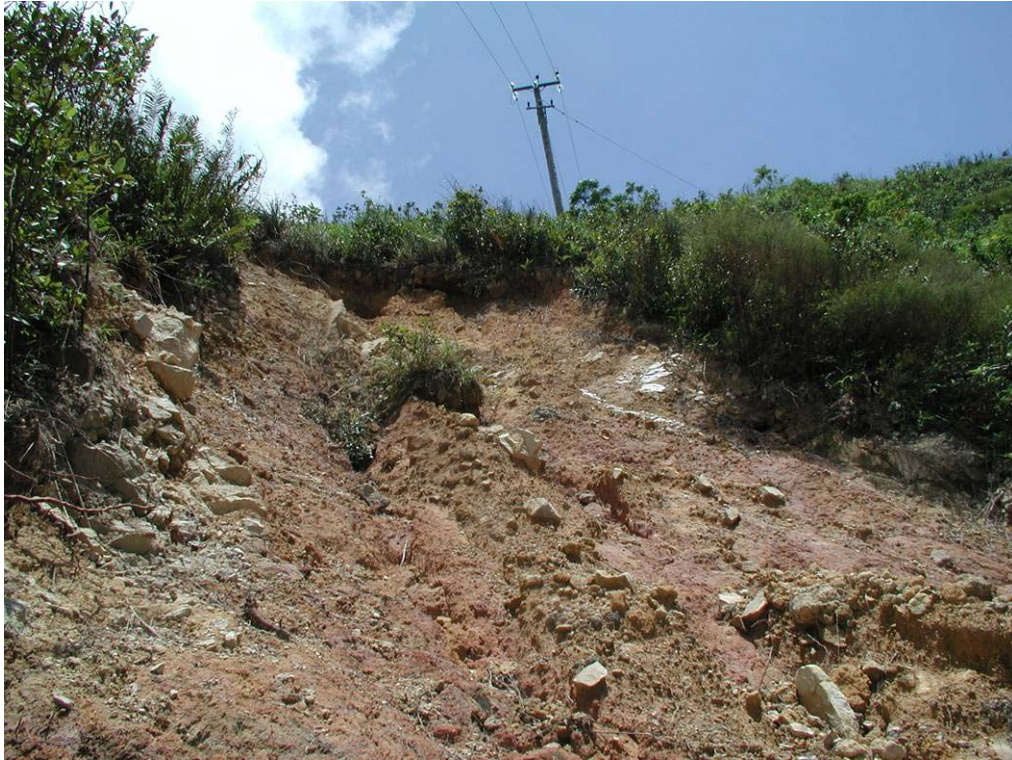
Plate 5 – Surface of Rupture at Landslide 01H
(Photograph Taken on 9 August 2001)

The surface of rupture at most of the landslides was along the colluvium/saprolite interface (e.g. Landslide 01H, Plate 5), although the surface of rupture at some of the landslides (e.g. Landslide 01B, Plate 6) occurred through the saprolite soil. The saprolite, which was exposed at the central portion of the source floor of most landslides, typically comprises completely decomposed tuff (light pinkish to reddish brown silty/clayey sand with occasional fine gravel of quartz).

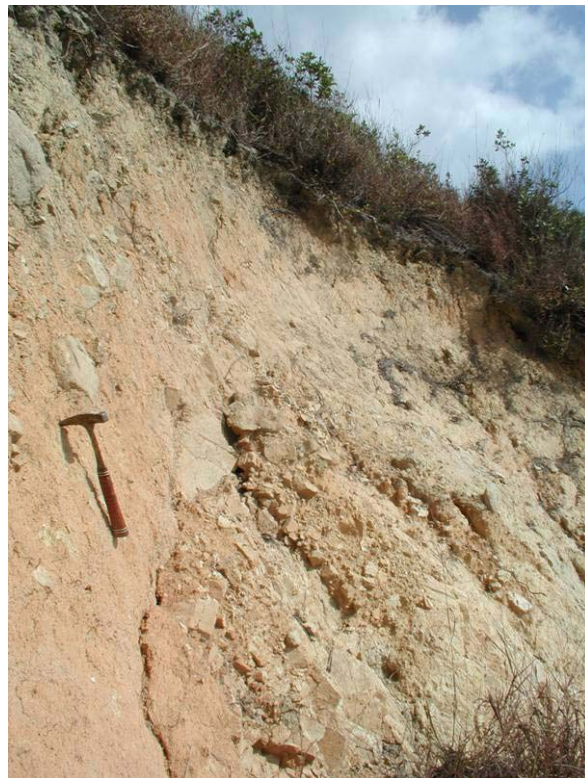
Plate 6 – View of Planar Main Scarp at Landslide 01B
(Photograph Taken on 30 November 2001)

The main scarps at most of the landslides inspected were either planar or slightly concave in shape. Generally, where the surface of rupture was along the colluvium / saprolite interface, the surface of rupture was concave or slightly irregular (e.g. Landslide 00C shown in Plate 7). At landslides where the surface of rupture has cut through the saprolite, the main scarp was typically planar to slightly convex in shape (e.g. Landslide 01B and 01K shown in Plates 6 and 8 respectively).

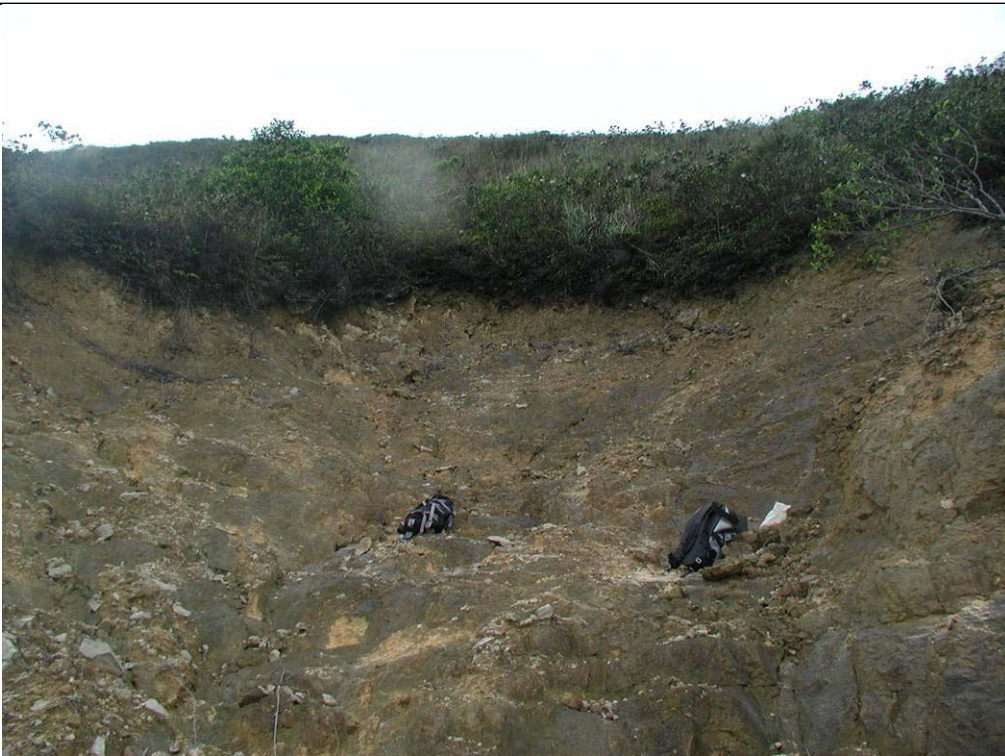
Plate 7 – View of Concave Surface of Rupture at Landslide 00C
(Photograph Taken on 10 May 2001)

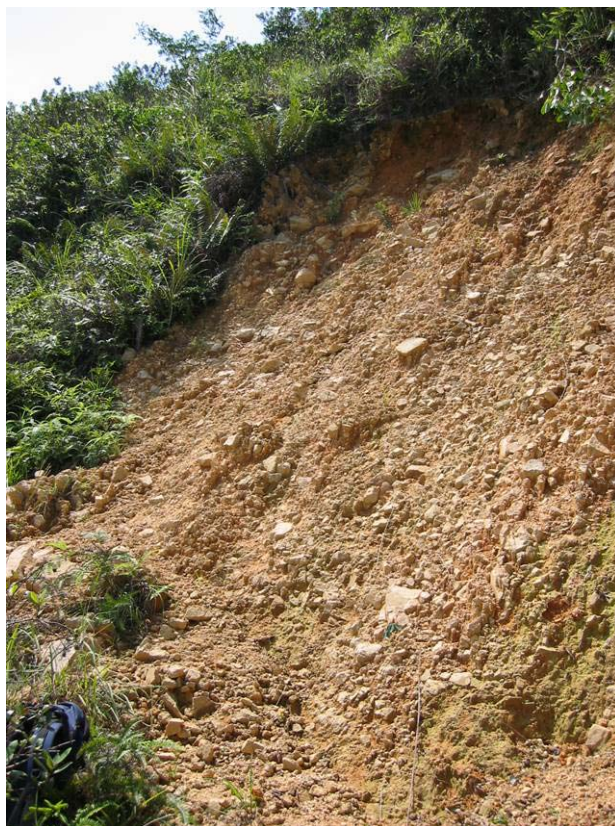
Plate 8 – Planar Surface of Rupture at Landslide 01K
(Photograph Taken on 14 August 2002)

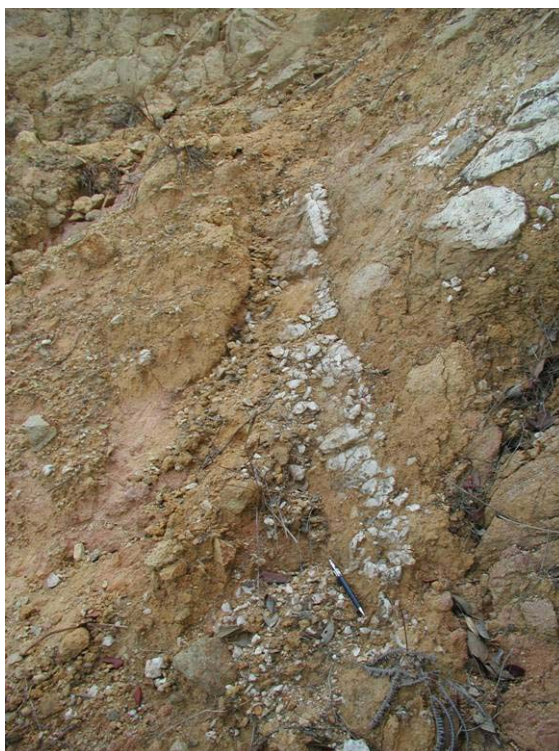
Plate 11 – Quartz Vein Parallel to Floor of Landslide 01H1
(Photograph Taken on 29 November 2001)

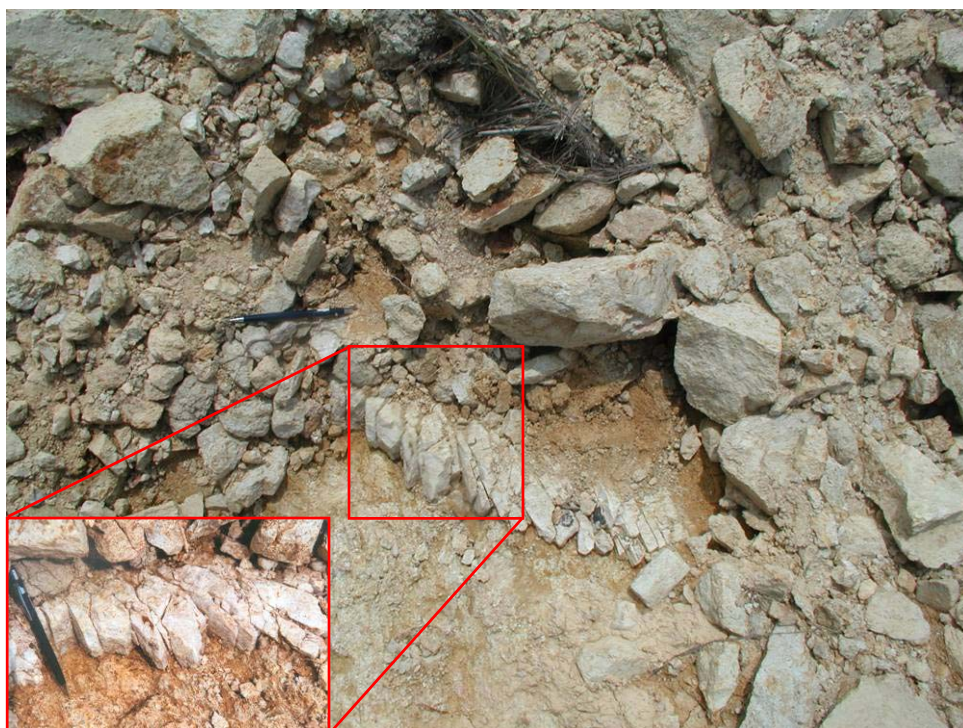
Plate 12 – Quartz Vein Parallel to Surface of Rupture of Landslide 01N
(Photograph Taken on 18 October 2001)

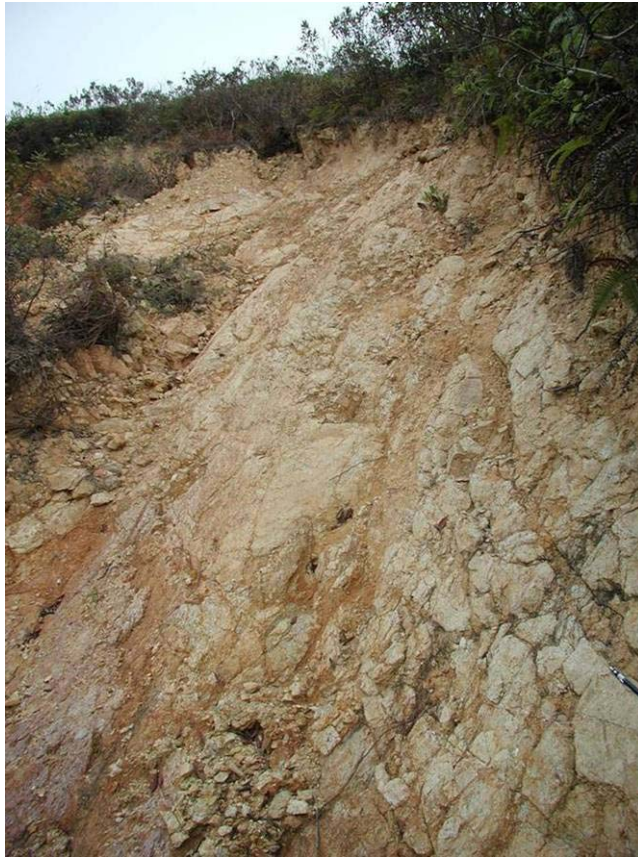
Plate 13 – Planar Persistent Joint along Western Flank of Landslide 01EE
(Photograph Taken on 28 November 2001)

Possible partial structural control was also observed at Landslide 01EE. In the north western flank of the landslide source, moderately decomposed tuff forms a planar surface from which the overlying saprolite and colluvium have been displaced. The surface appears to be a single continuous discontinuity (Plate 13) dipping 45°/100°. Slickensides, with an east-west trend, were observed on the discontinuity surface (i.e. parallel to the direction in which the displaced material was mobilised). Clay-infilled joints and the fractured nature of the rock indicate that deterioration of the condition of the insitu weathered rock had occurred prior to detachment (Plate 14).

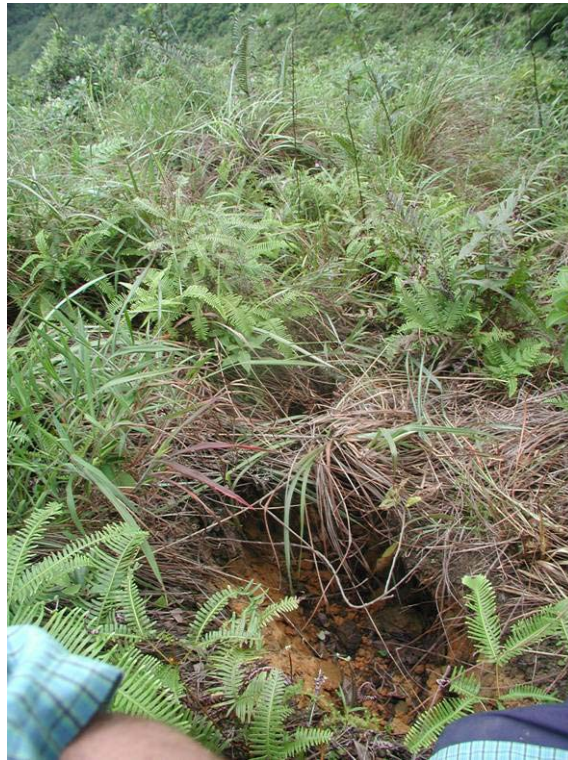
Plate 15 – Tension Crack at Landslide 01DD
(Photograph Taken on 7 September 2001)

Tension cracks were observed at a number of the landslides, with the tension cracks typically located to one side of the landslide crown (Plate 15) and usually discontinuous and less than 1 m long. Significantly, at Landslide 01N, much of the landslide crown is delineated by a continuous tension crack, about 42 m long and 1.5 m high. Only colluvial material below a 12 m wide section near the central part of the tension crack was fully detached during the landslide (Plates 16 and 17).

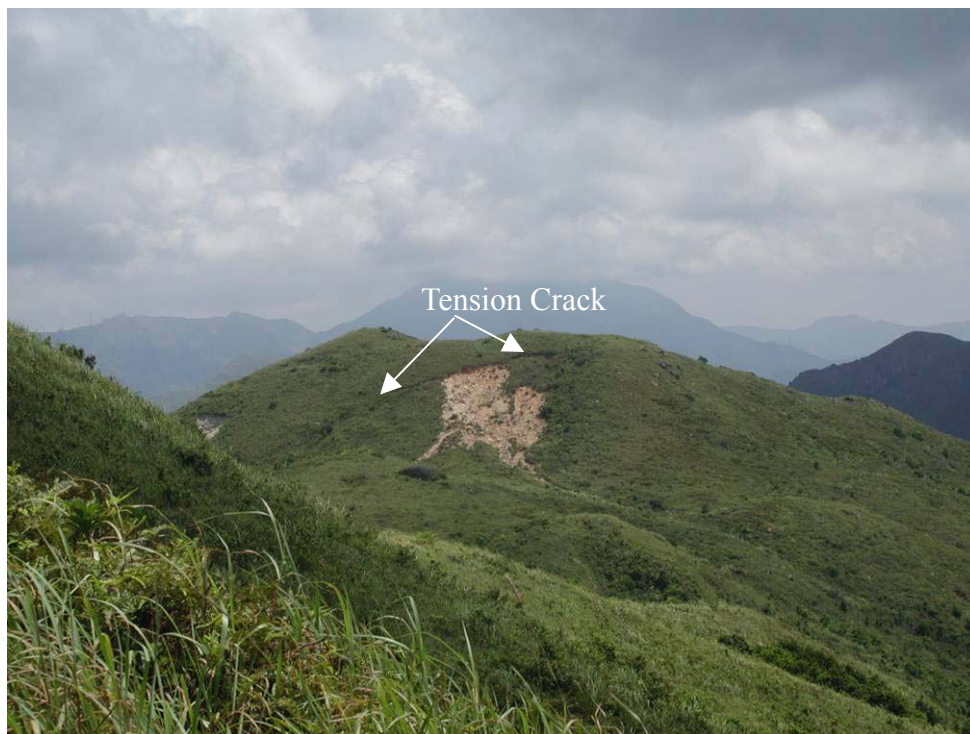
Plate 16 – View of Tension Crack at Landslide 01N
(Photograph Taken on 9 August 2001)

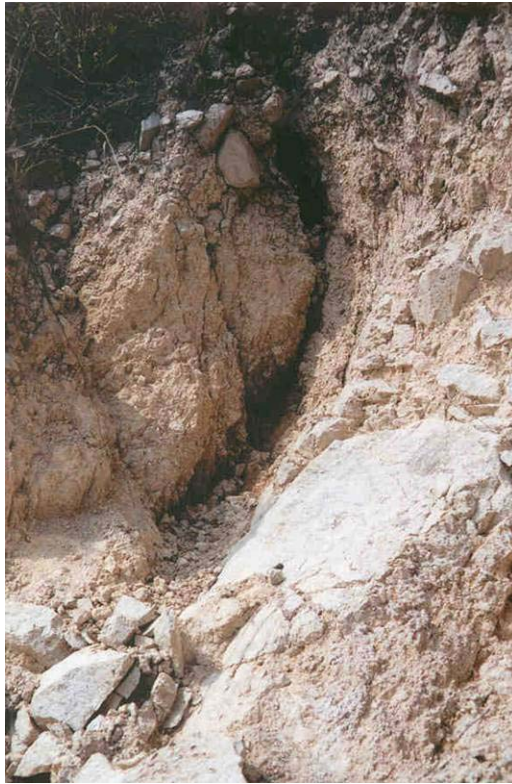
Plate 17 – Partially Displaced Mass Below Tension Crack at Landslide 01N
(Photograph Taken on 18 October 2001)

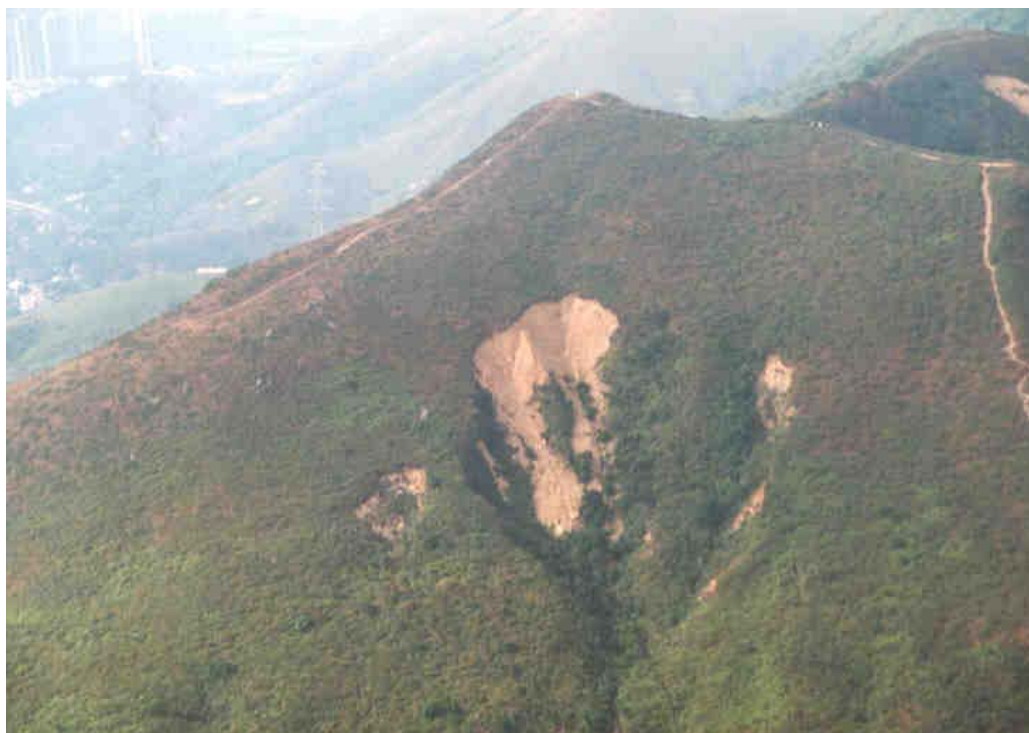
Plate 22 – Aerial View of Landslide 01M
(Photograph Taken on 19 October 2001)

Landslide 01M is an example of a deep-seated retrogressive landslide located on open hillside with toe of the source area feeding into the head of a narrow drainage line (Plate 22). The failure appears to be controlled by adversely orientated relict joints within the completely decomposed tuff and along preferential weathered joints within the moderately decomposed tuff, which daylight from the almost vertical 6 m to 8 m high main scarp.

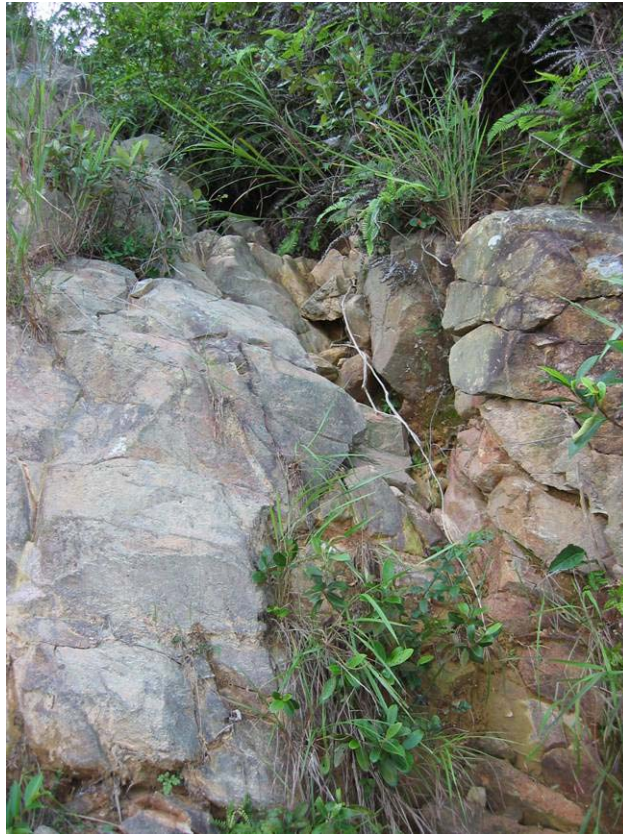
Plate 23 – View of Narrow Drainage Line below Landslide 01M
(Photograph Taken on 19 October 2001)

The narrow (about 1.5 m to 2 m wide) head of the drainage line below the toe of the source (Plate 23), relative to the large size (about 60 m by 80 m) of the relict scar, indicates that the large scar has formed through multiple failures progressively widening the source area rather than a previous single large-scale event.

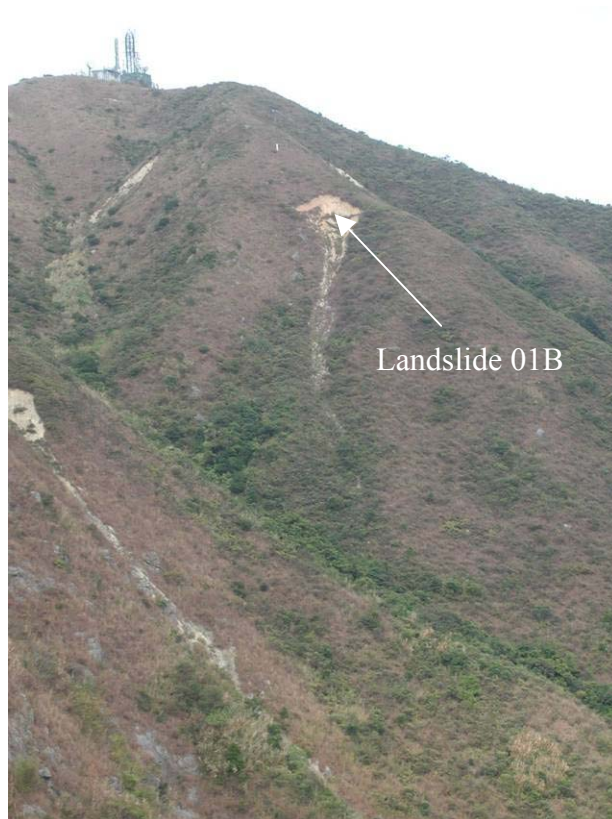
Plate 27 – General View Landslide 01B
(Photograph Taken on 30 November 2001)

The Type I landslide is illustrated in Figure 10. The typical setting for a Type I landslide is above the head of a drainage line or below a ridge line and typically at a prominent convex break in slope. In the field, the landslides usually have a planar main scarp with a slightly convex surface of rupture. The failure generally occurs through the uppermost portion of the deeply weathered saprolite and may include the failure of an overlying thin (typically less than 1 m thick) layer of older weathered colluvium (Plate 26). Landslide 01B and 01K are examples of Type I landslides (see Plates 27 and 28).

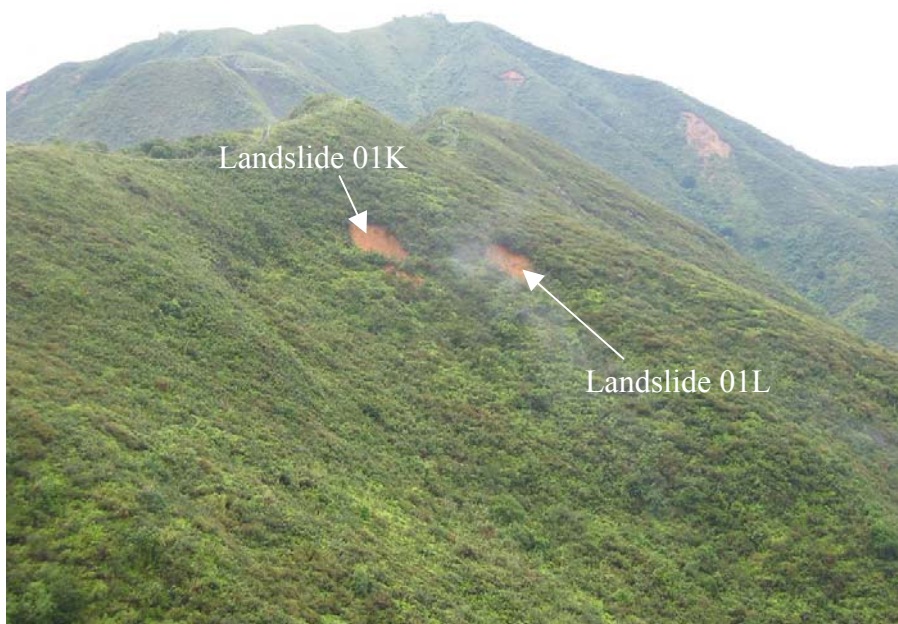
Plate 28 – View of Landslides 01K and 01L
(Photograph Taken on 31 July 2002)
