Chapter 6

Altered and Weathered Rocks

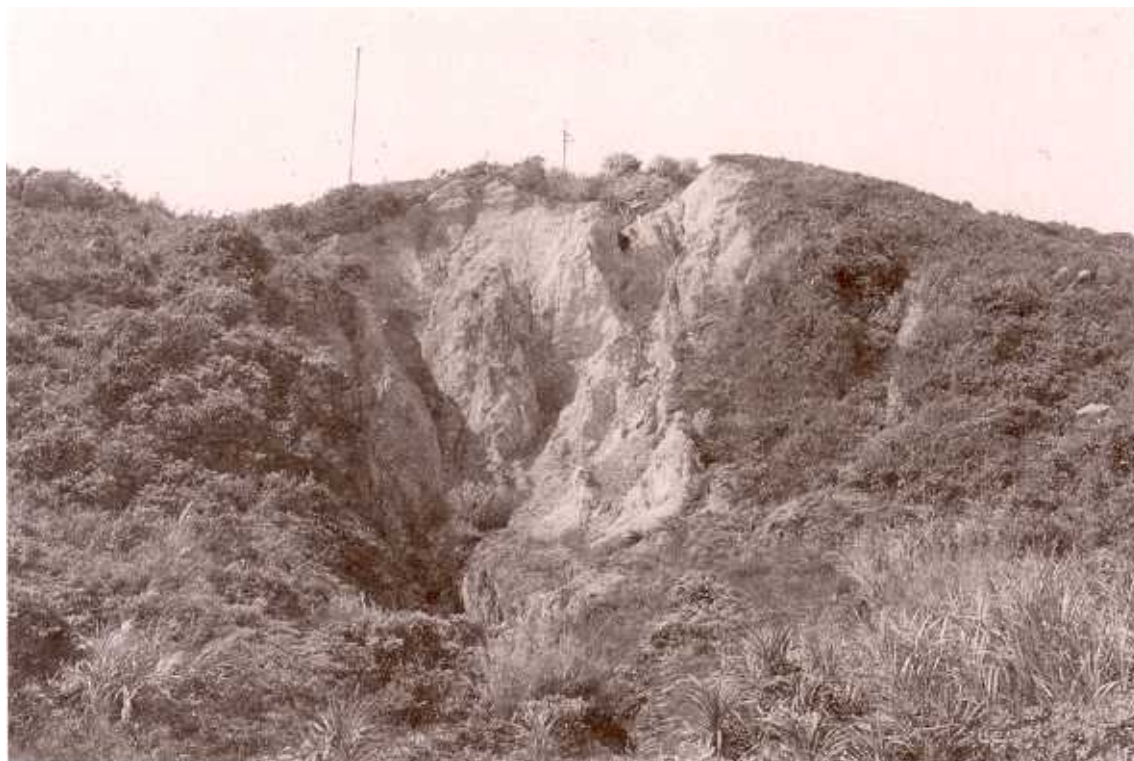
Plate 20 - Abandoned Kaolin and Quartz Mine below the Instrument Approach System, East of Sham Wan (122 199)

Kaolinization has been recorded near the northern tip of the island, the area to the east of Sham Wan having been commercially mined in the 60s. The area is strewn with quartz vein debris and is deeply weathered (Plate 20).

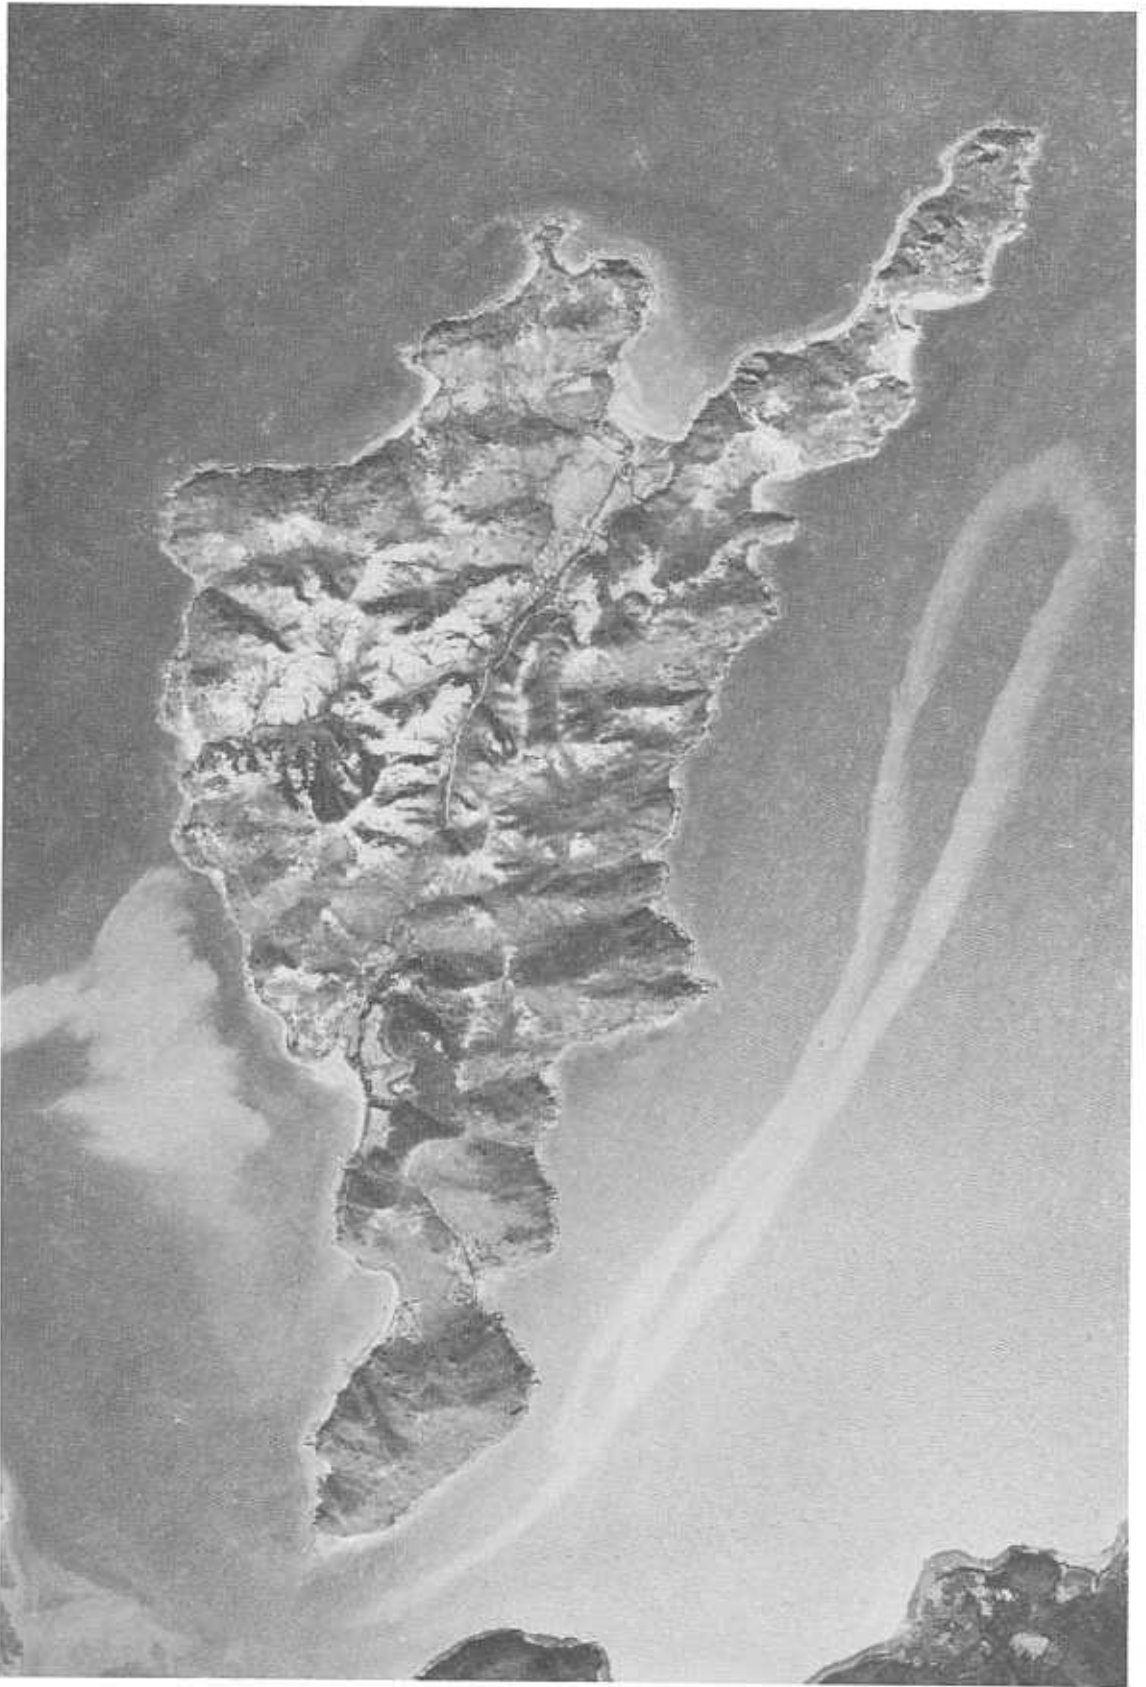
Plate 22 - 1964 Aerial Photograph (2940) Showing Low Vegetation and Extensive Erosion in the Island

The deeply weathered hilltops and ridges are prone to gullying, a process often exacerbated by mining activity. This is well illustrated in the aerial photographs from the early 1960s (Plate 22), which contrasts with the more recent trend towards revegetation over most areas (Plate 23). However, certain deeply gullied areas, outside those areas affected by mining, remain susceptible to further erosion. Plate 24 illustrates the regrowth of dense, low vegetation below steep, gullied weathered granite with quartz veins to the north of Fu Tau Shan (188 111).

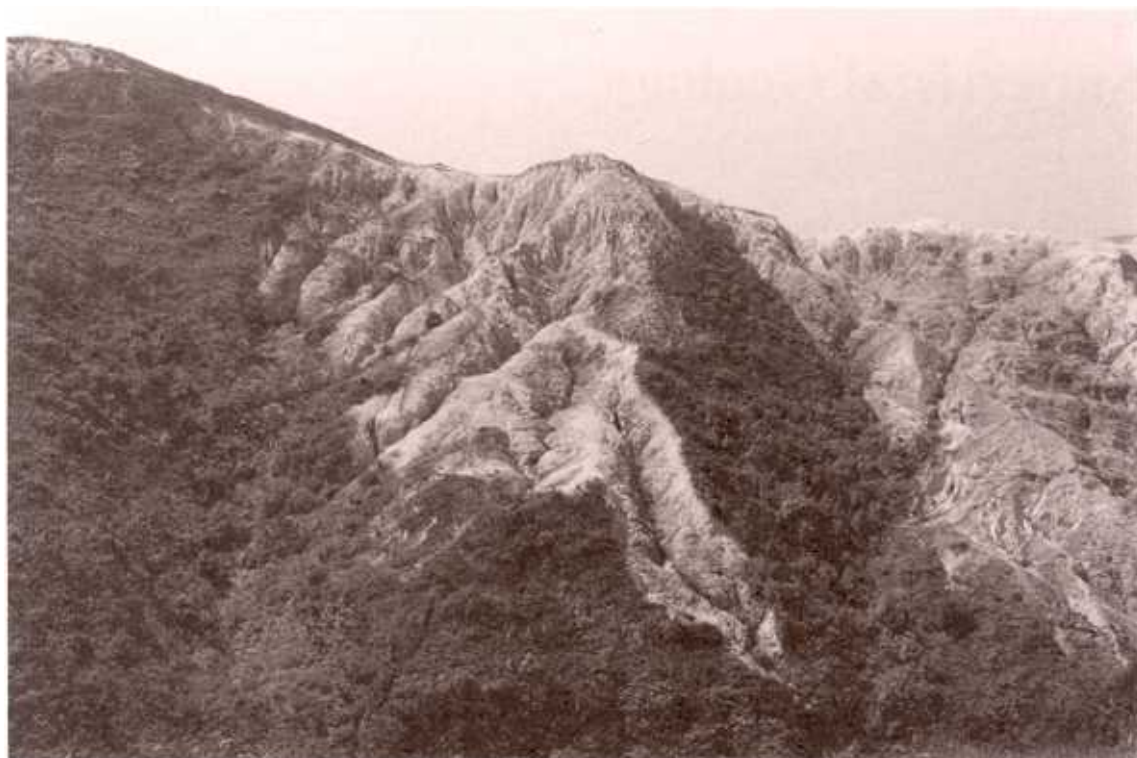
Plate 24 - Vegetation Regrowth Encroaching on Gullied Weathered Granite with Quartz Veins, North of Fu Tau Shan (185 111)
