**CAUSES AND MECHANISMS OF
DISTRESS IN CONCRETE
SEAWALL BLOCKS AT
TSANG TSUI ASH LAGOONS**

GEO REPORT No. 209

R.J. Sewell, K.C. Ho, C.L. Leung & K.Y. Leung

**GEOTECHNICAL ENGINEERING OFFICE
CIVIL ENGINEERING AND DEVELOPMENT DEPARTMENT
THE GOVERNMENT OF THE HONG KONG
SPECIAL ADMINISTRATIVE REGION**

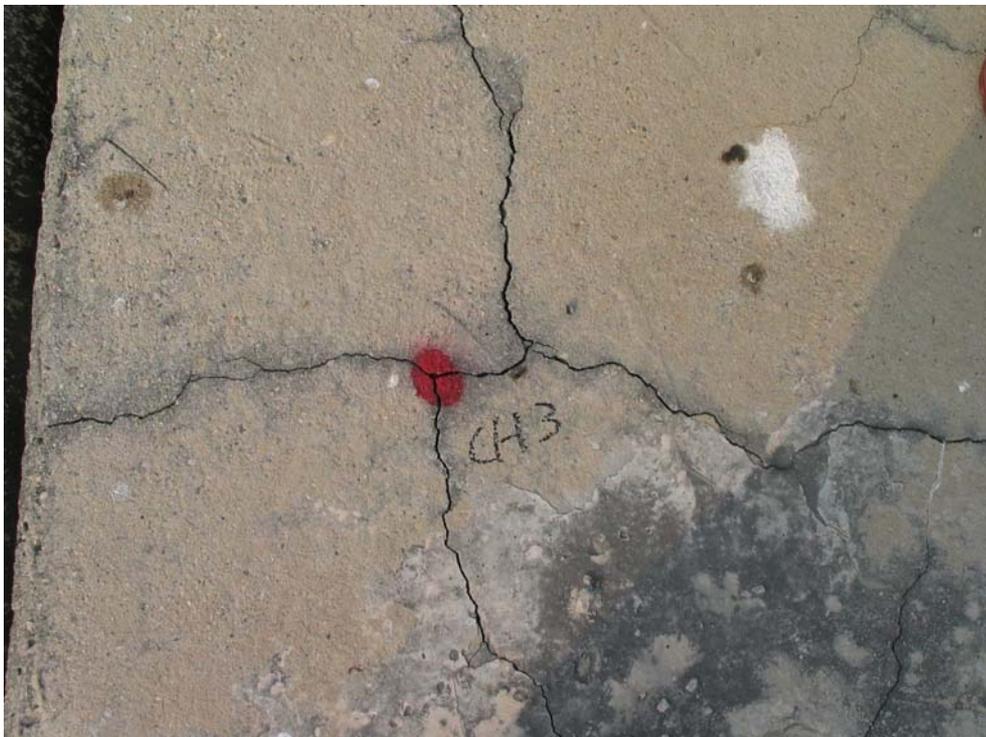
Plate 2 - Typical Location of Concrete Cores at Triple Junction of Major Cracks

Sampling was carried out using water flush drilling with single tube core barrels. Selection of corehole locations on the seawall blocks was based on careful observation of cracking, exudation, and discolouration of concrete surfaces. In general, the coreholes were located at or close to the triple junctions of major cracks in order to obtain the maximum information on the cause of cracking (Plate 2).

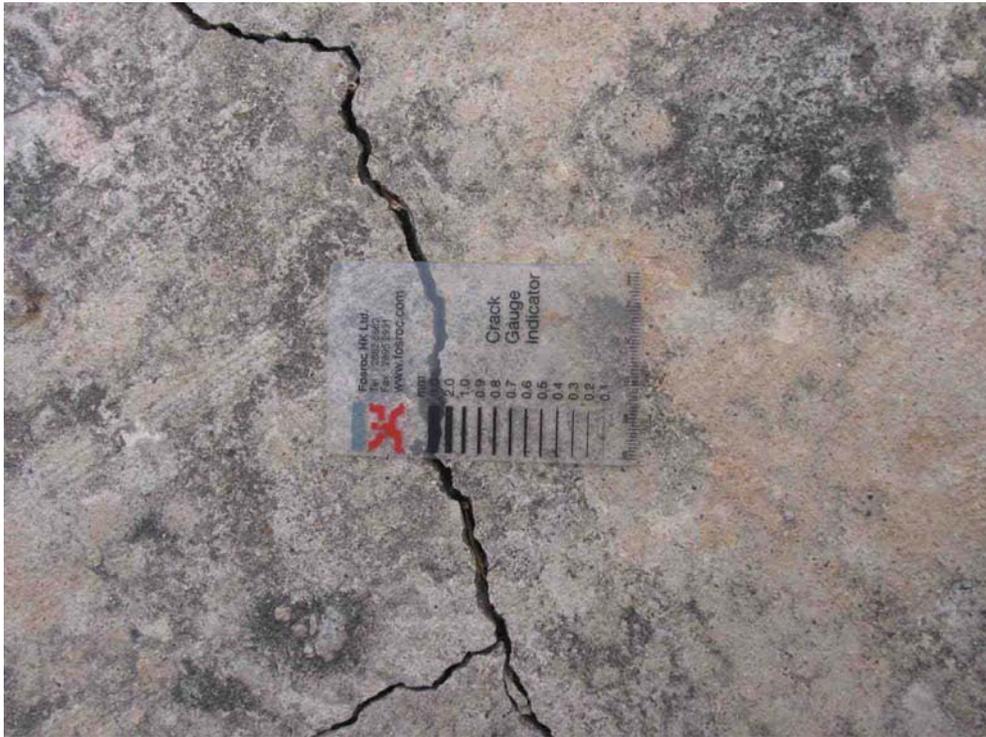
Plate 7 - Crack Ruler

The crack patterns on the upper and landward faces of the six seawall blocks (WW3, WW5, WW9A, WW9B, WW34 & WW35) which contained no PFA, were mapped on tracing paper (Plates 5 & 6). The seaward face of the seawall blocks was not mapped due to lack of safe access to carry out the mapping work. The control seawall block (WW28) showed no appreciable crack pattern and hence was not mapped. A ruler (Plate 7) and a feeler gauge

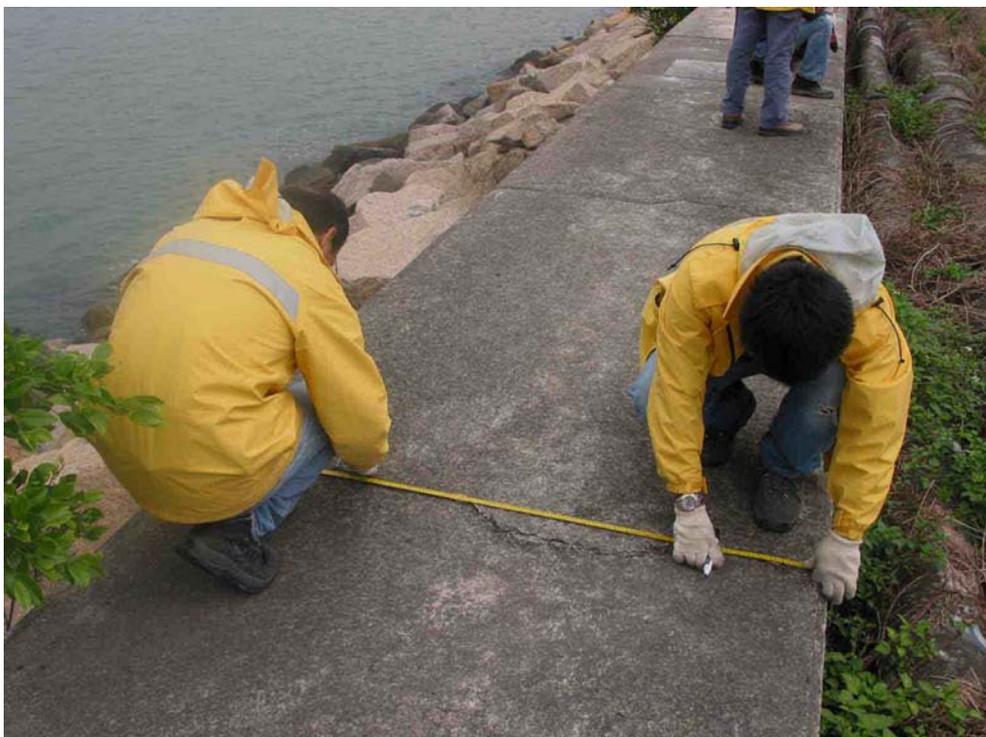
Plate 8 - Dimension Measurement Using a Steel Measuring Tape

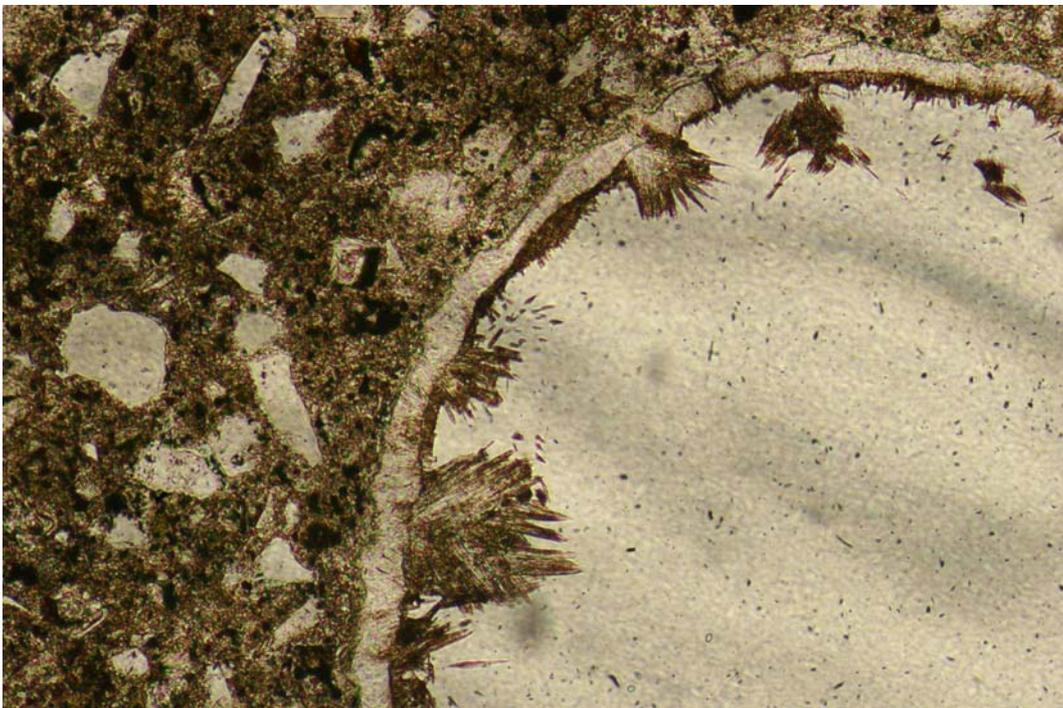
Plate 16 - Radiating Clusters of Acicular Ettringite Needles Growing Out from Margin of Air Void (PPL, Field of View = 1.44 mm, A3A, P0604-158D, 65 - 75 mm, Horizontal)

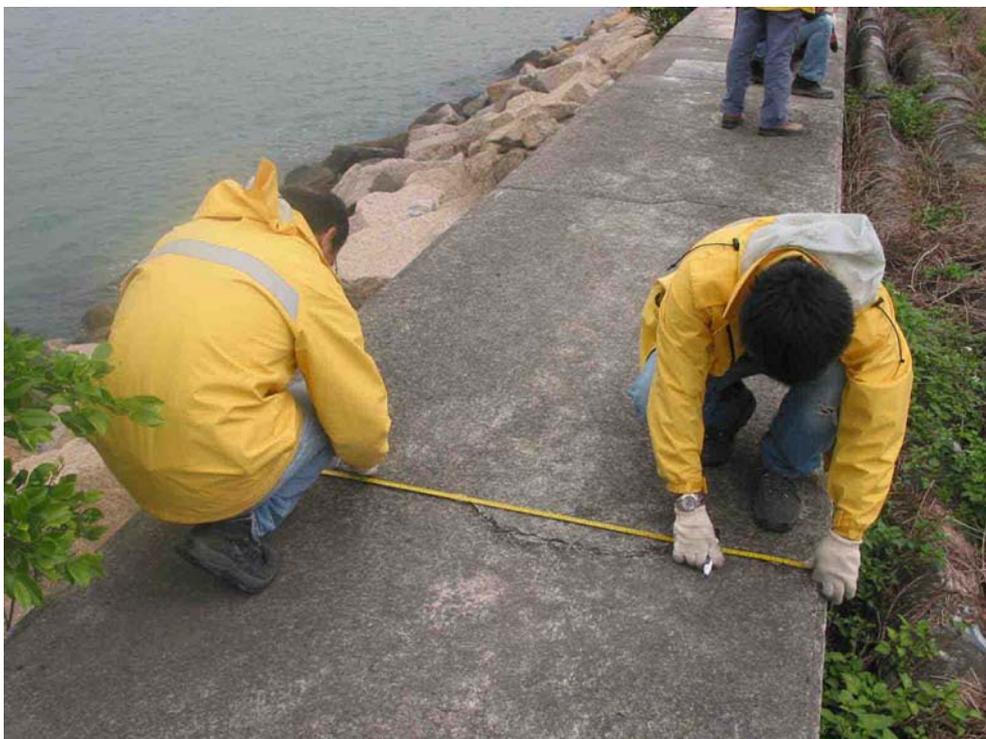
Plate 2 - Dimension Measurement Using a Steel Measuring Tape

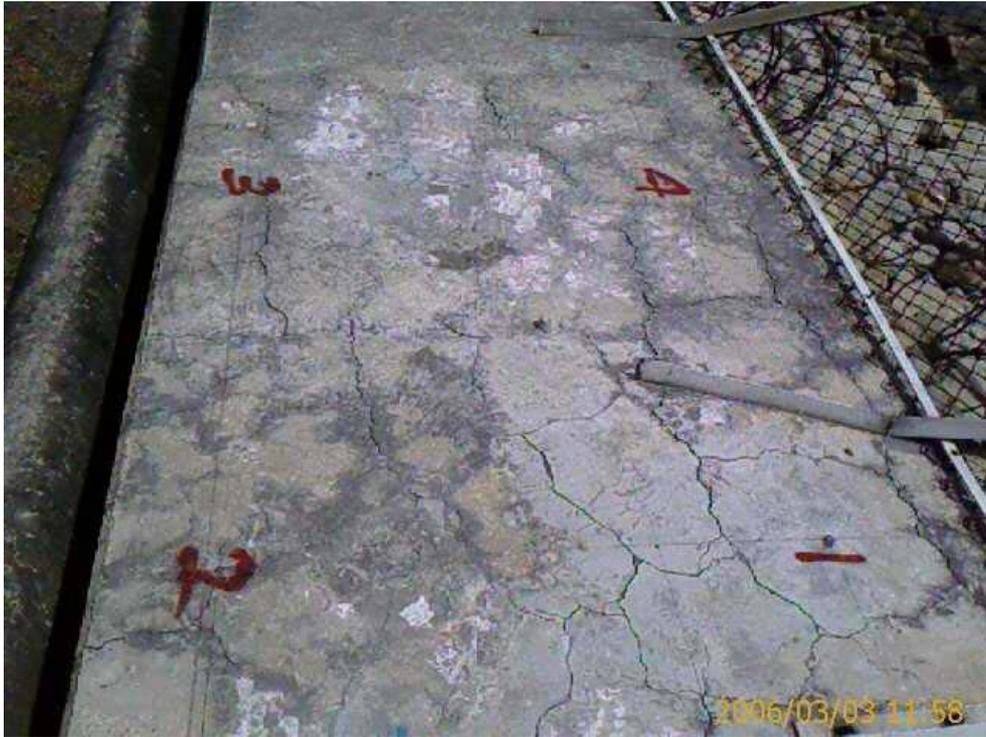
Plate 3 - Location of Monitoring Stations on a Typical Seawall Block

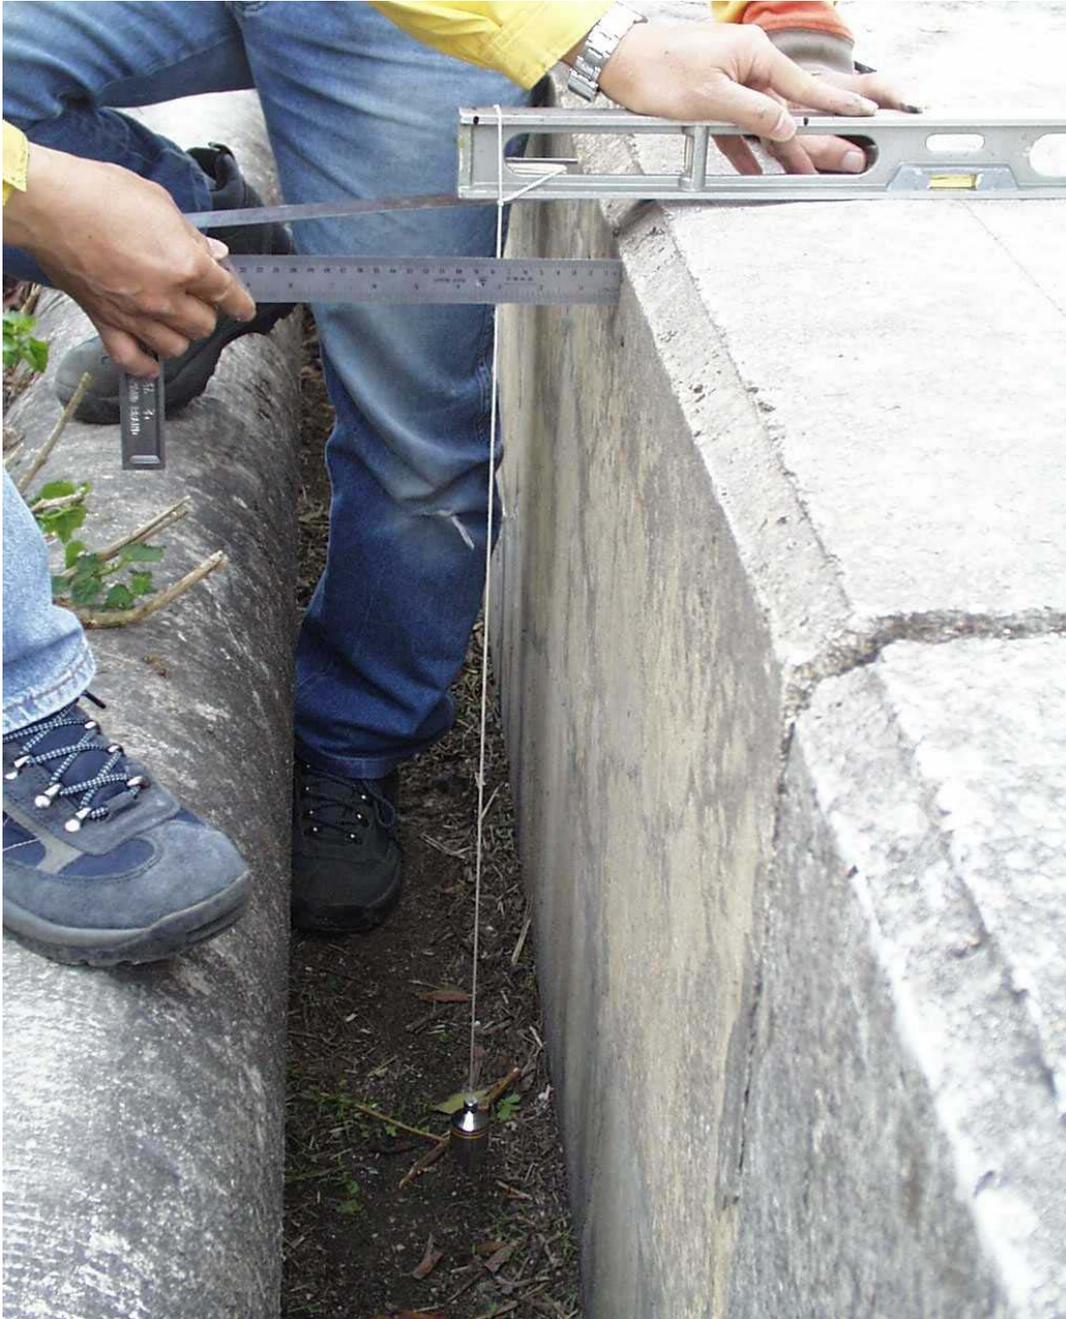
Plate 5 - Inclination Measurement Using a Steel Tape and a Plumb
