FACTUAL REPORT ON HONG KONG RAINFALL AND LANDSLIDES IN 2005

GEO REPORT No. 223

**GEOTECHNICAL ENGINEERING OFFICE
CIVIL ENGINEERING AND DEVELOPMENT DEPARTMENT
THE GOVERNMENT OF THE HONG KONG
SPECIAL ADMINISTRATIVE REGION**

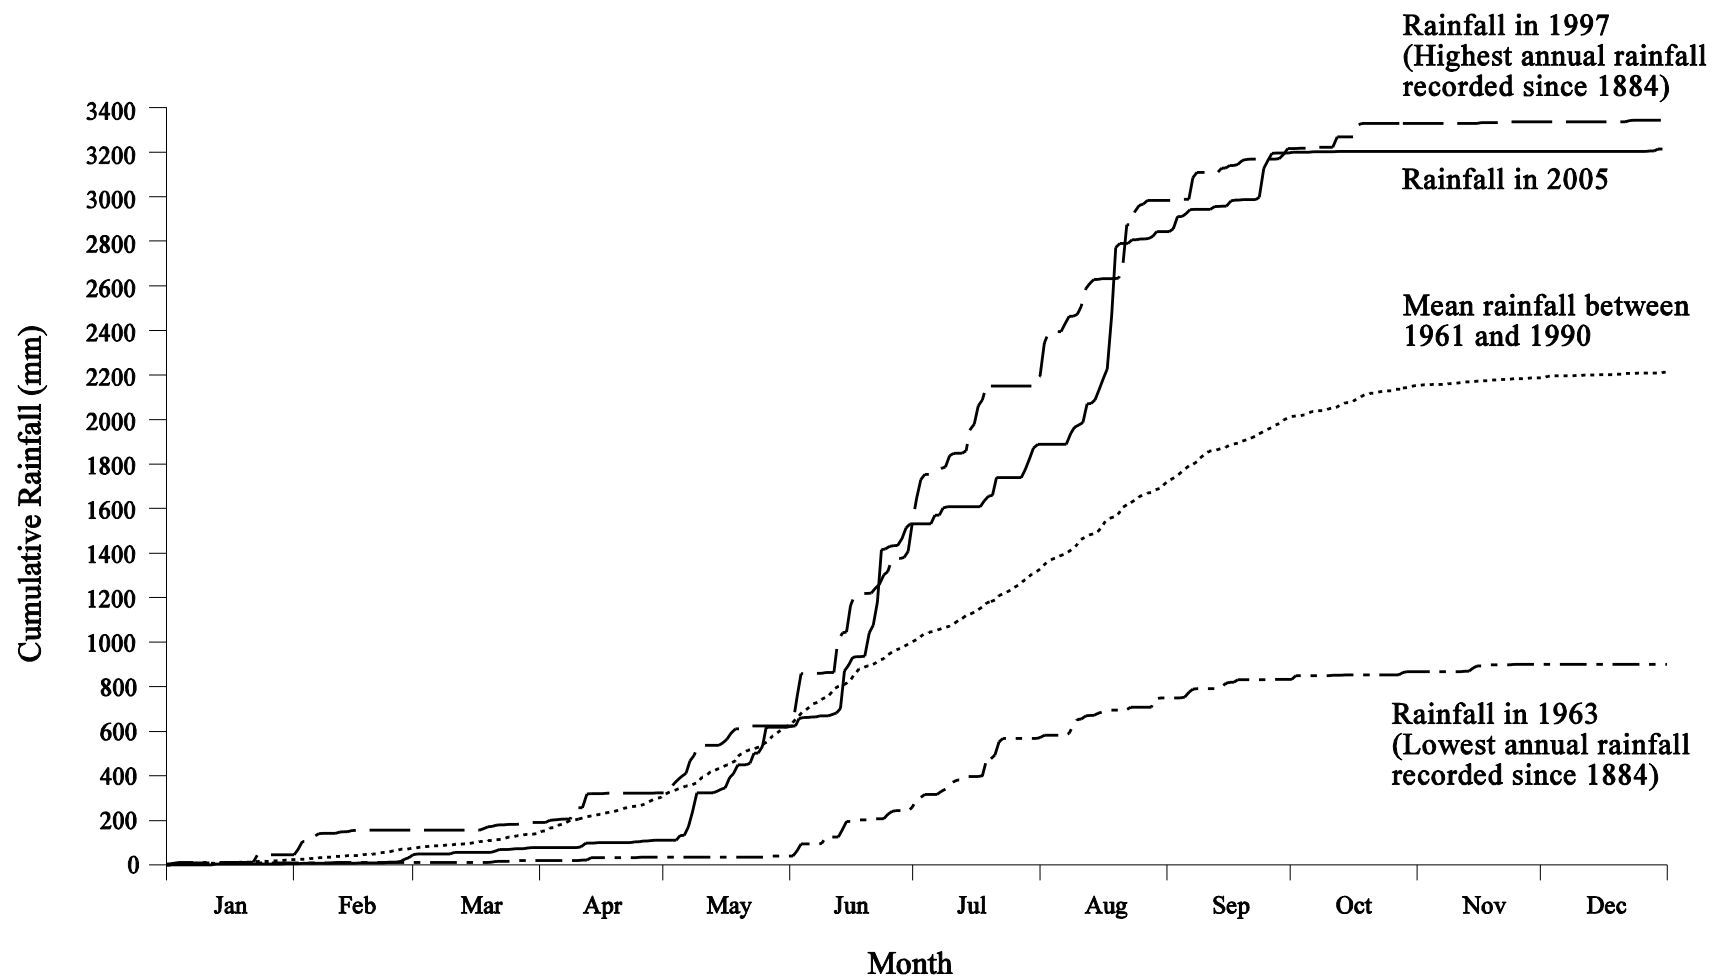
Figure 2 - Cumulative Rainfall for 2005 at the Hong Kong Observatory and its Recorded Highest, Mean and Lowest Cumulative Rainfalls

Note: Rainfall recorded at the Hong Kong Observatory, Tsim Sha Tsui.

Atlantic. Locally in Hong Kong, 2005 was the third wettest year on record, mostly due to a very active southwest monsoon in June and August bringing in plenty of moisture. The total rainfall of 3214.5 millimetres was 45.2 percent above normal. June 2005 was the 4th wettest since records began in 1884, and August 2005 the 2nd wettest. The rainfall in these two months alone amounted to 1865.2 mm, about 84 percent of the normal annual rainfall.”

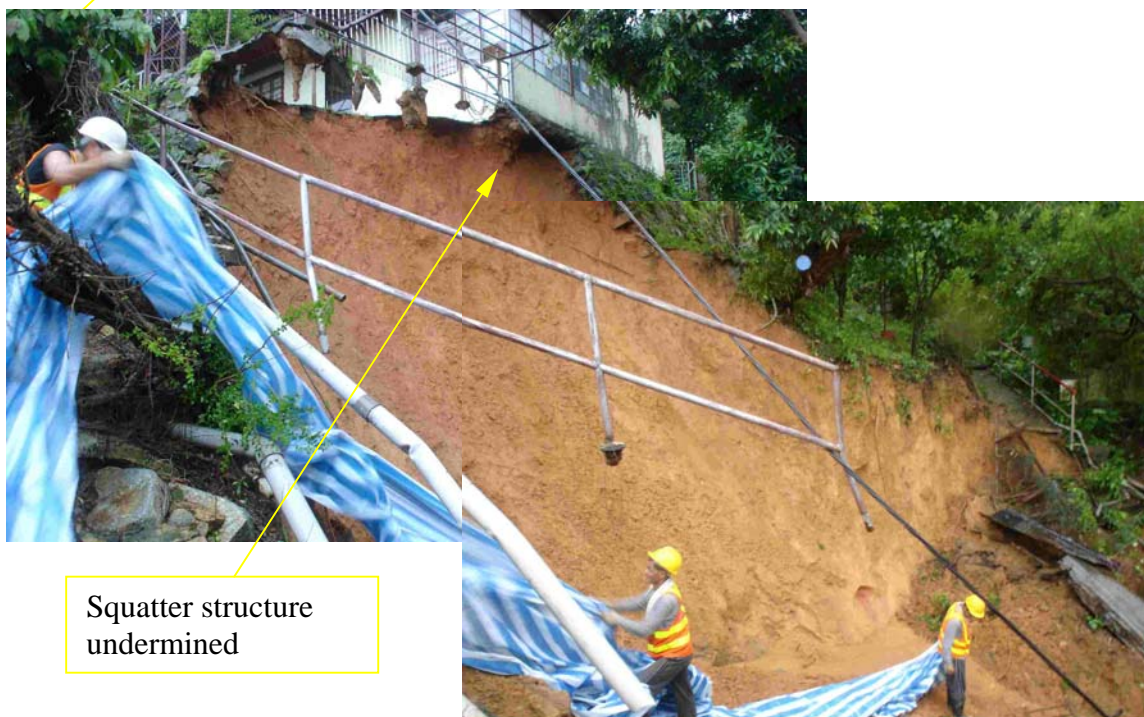
Plate 1 - The 20 August 2005 Landslide incident on a Hillside at Fu Yung Shan Tsuen, Tsuen Wan (Incident No. 2005/8/0362)

Description: A major landslide occurred on a natural hillside that has been disturbed locally by past human activities. The incident resulted in one fatality and permanent evacuation of four squatter structures.

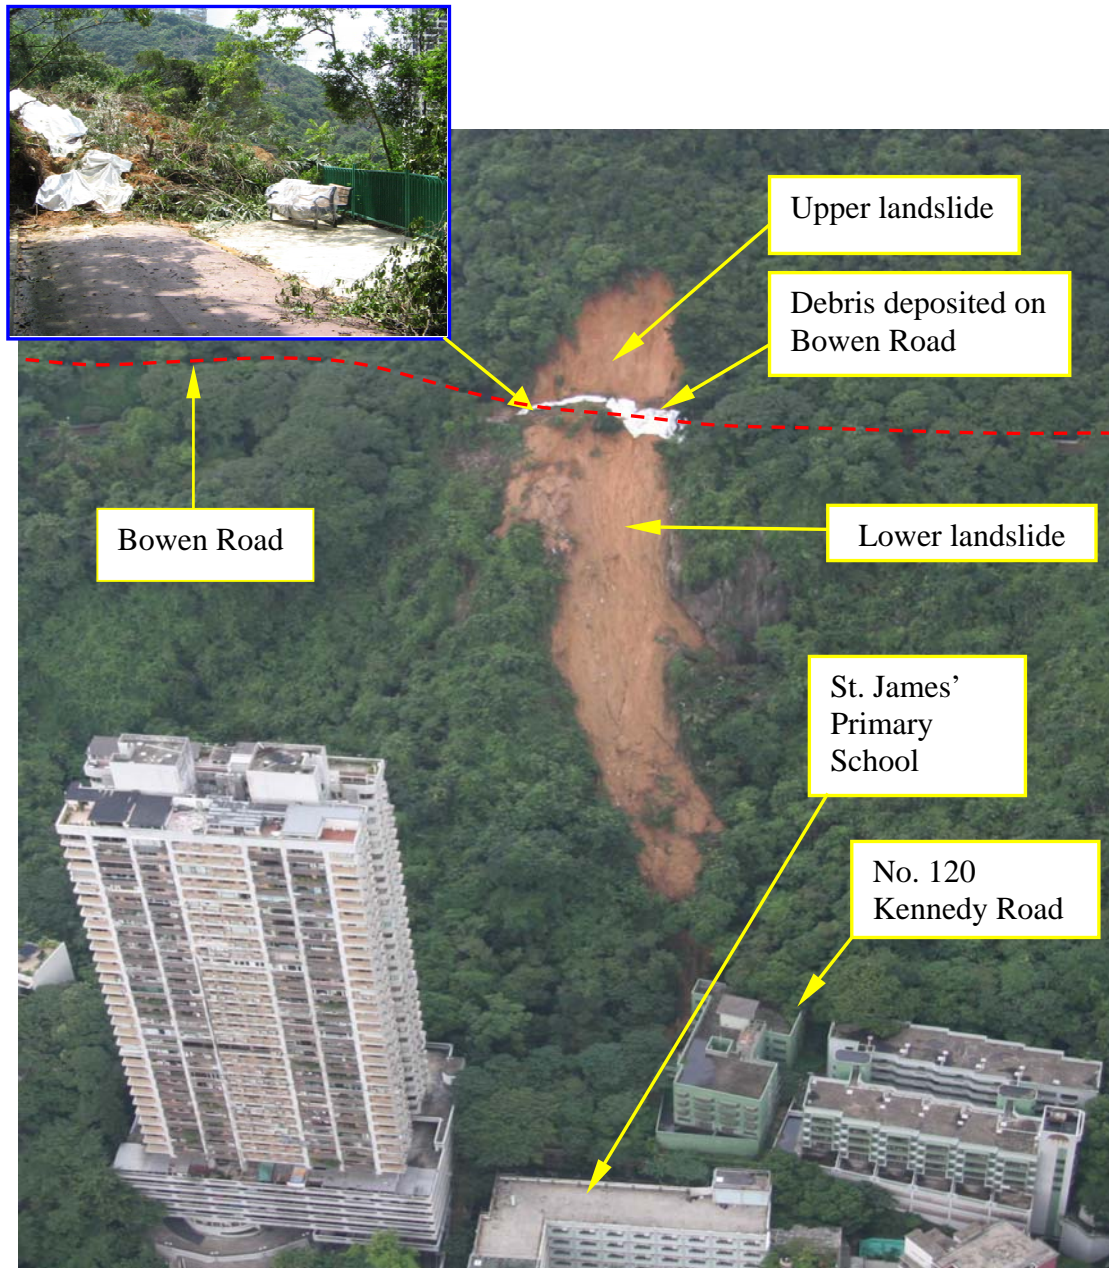
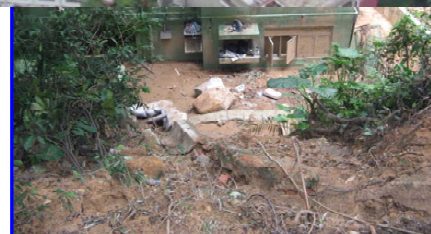
Plate 2 – The 20 August 2005 Landslide Incident on the Natural Hillsides at Bowen Road (Incident No. 2005/8/0304)

Description: Two major landslides affecting predominantly natural hillside above and below Bowen Road which resulted in temporary closure of St. James' Primary School and Nos. 98 and 120 Kennedy Road.

Debris inundated the G/F of No. 120 Kennedy Road

In the morning of 20 August 2005 when the Landslip Warning was in force, two major landslides affected Bowen Road. The upper landslide, involving a failure volume of about 750 m³, occurred on the natural hillside as well as slope No. 11SW-D/C1352 above Bowen Road. The lower landslide, involving a volume of about 200 m³, occurred on the natural hillside and a playground situated on a small fill platform at Bowen Road. Debris from the upper landslide was partly deposited on Bowen Road and the playground. Debris from the lower landslide, together with part of the debris of the upper landslide, travelled along local depressions on the natural terrain and was deposited on a vacant lot (Lot IL2386) and unleased and unallocated Government land, and inundated the ground floor of the unoccupied apartment blocks at No. 120 Kennedy Road.

School was re-opened on 14 September 2005 after completion of the initial phase of the urgent repair works, which comprised debris removal and shotcreting of the failure scars. The Closure Order in respect of the buildings at Nos. 98 and 120 Kennedy Road was lifted on 21 December 2005 after soil nails had been installed within the failure scars. No casualties were reported as a result of the incident.

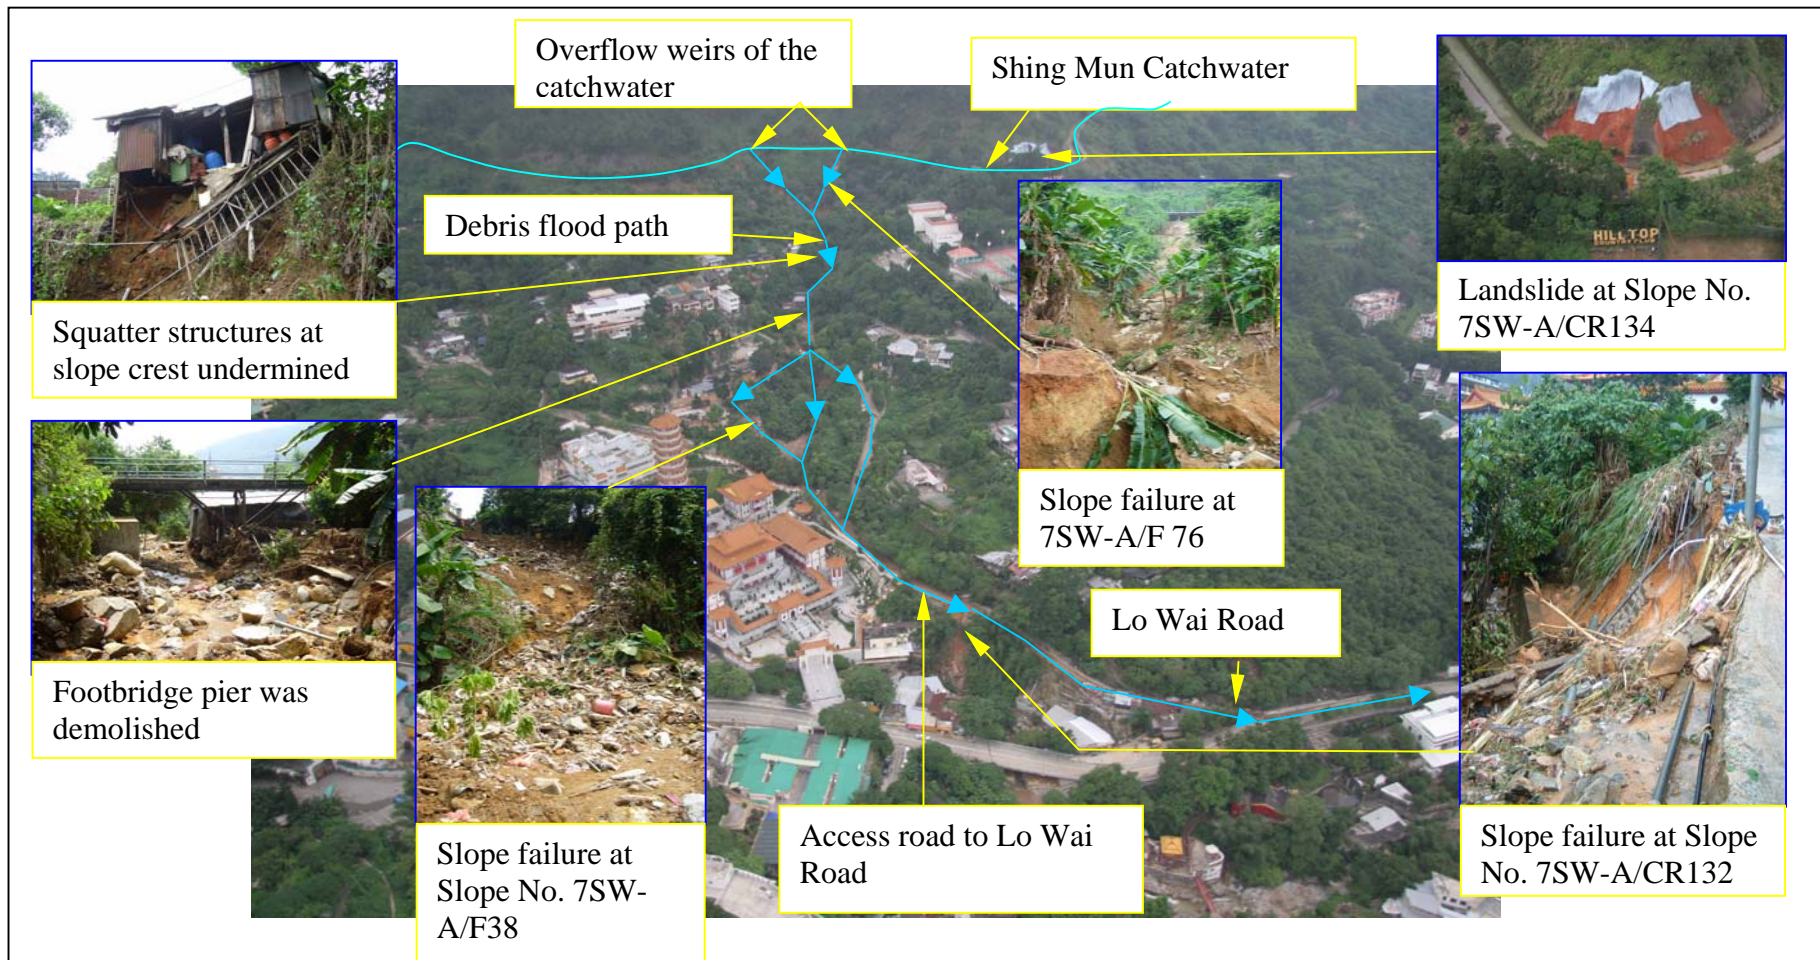
Plate 3 - The 20 August 2005 Debris Flood Incident at Lo Wai, Tsuen Wan (Incident Nos. 2005/8/0338, 2005/8/0348, 2005/8/0402, 2005/8/0417 and 2005/8/0528)

Description: A debris flood running along and beyond a streamcourse which resulted in temporary evacuation of 118 residents and 84 temple visitors and closure of a section of Lo Wai Road.

(A debris flood along a streamcourse which resulted in temporary evacuation of 118 residents and 85 temple visitors, permanent evacuation of 6 squatter structures, damage of the bridge pier near Lung Mo Temple and closure of a section of Lo Wai Road, Plate 3)

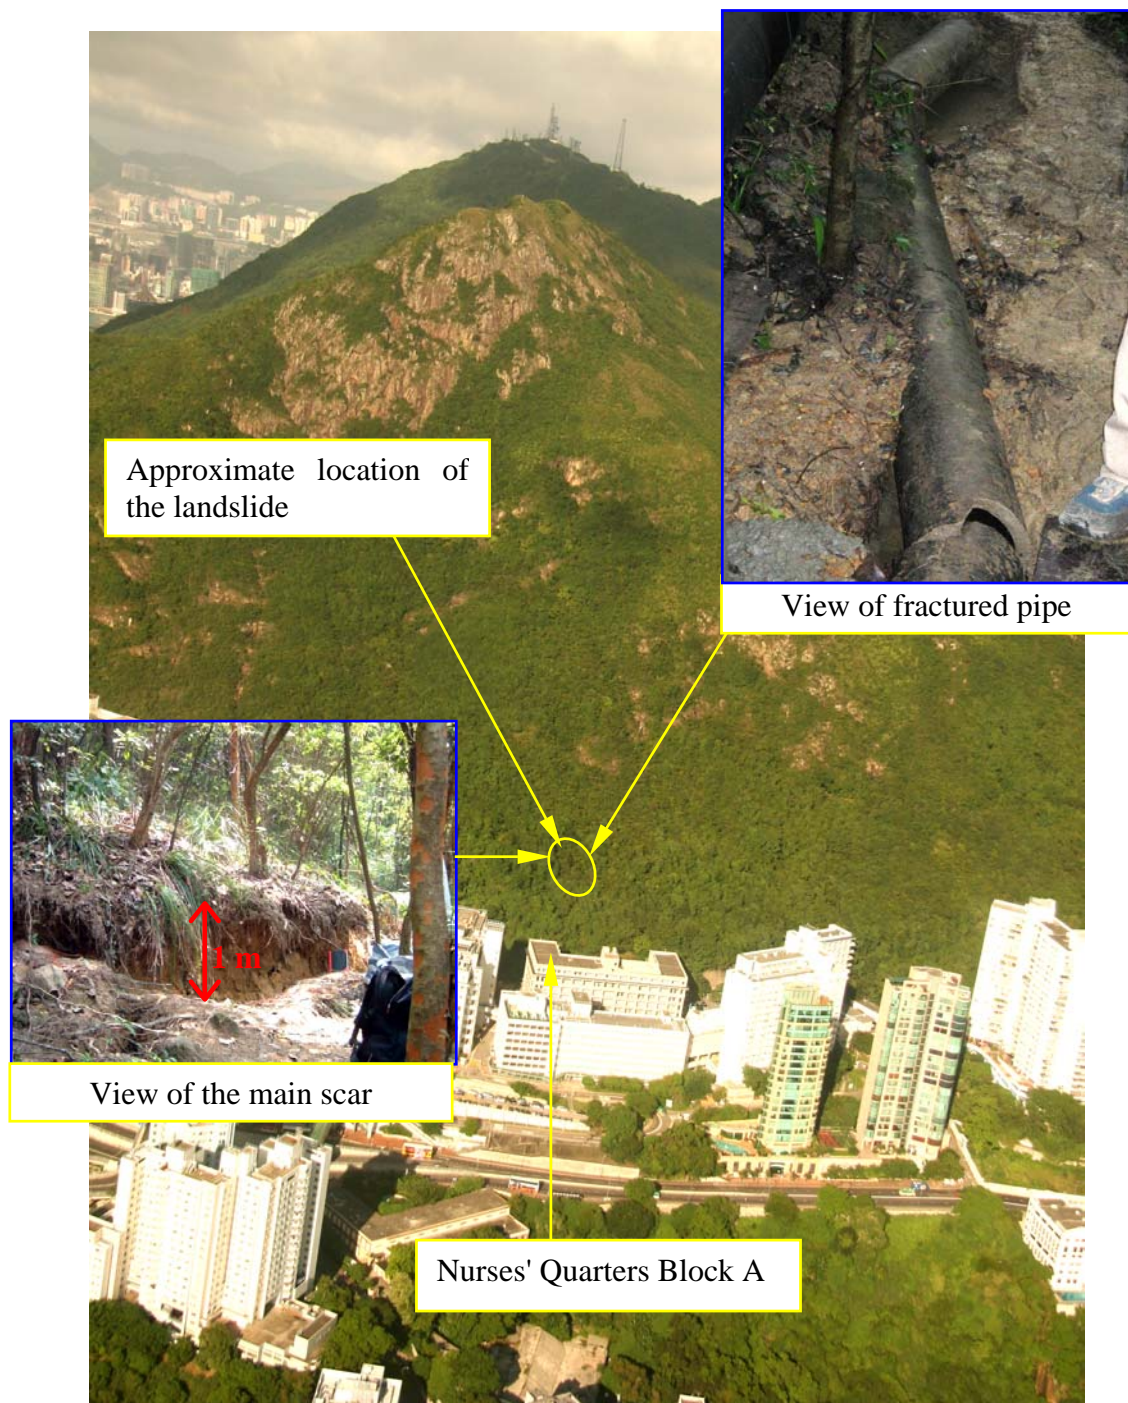
Plate 4 – The 20 August 2005 Landslide Incident on the Natural Hillside behind Nurses' Quarters Block A, Queen Mary Hospital, Pok Fu Lam (Incident No. 2005/8/0464)

Description: Distress on the natural hillside which resulted in the temporary closure of part of the Nurses' Quarters Block A of Queen Mary Hospital.

At about midnight of 20 August 2005 when the Landslip Warning was in force, distress developed on a natural hillside about 90 m upslope of Nurses' Quarters Block A of Queen Mary Hospital in Pok Fu Lam. The slope distress comprised a main scarp (some 17 m long with about 0.8 m horizontal and vertical displacement) and laterally persistent tension cracks, together with secondary scarps over an area extending about 30 m wide by 40 m long. The volume of the displaced ground mass was in the order of 1,000 m³ to 2,000 m³. As a result of the slope movement, an existing pressurised water main traversing the hillside was ruptured. The rupture of the water main, which supplied a service reservoir to the north of the distressed hillside, was noted by the Water Supplies Department (WSD) through the observation of a level drop in the reservoir. Following the incident, the ground floor and first floor of Nurses' Quarters Block A at the toe of the hillside were temporarily closed for about four months. No casualties were reported as a result of the incident.

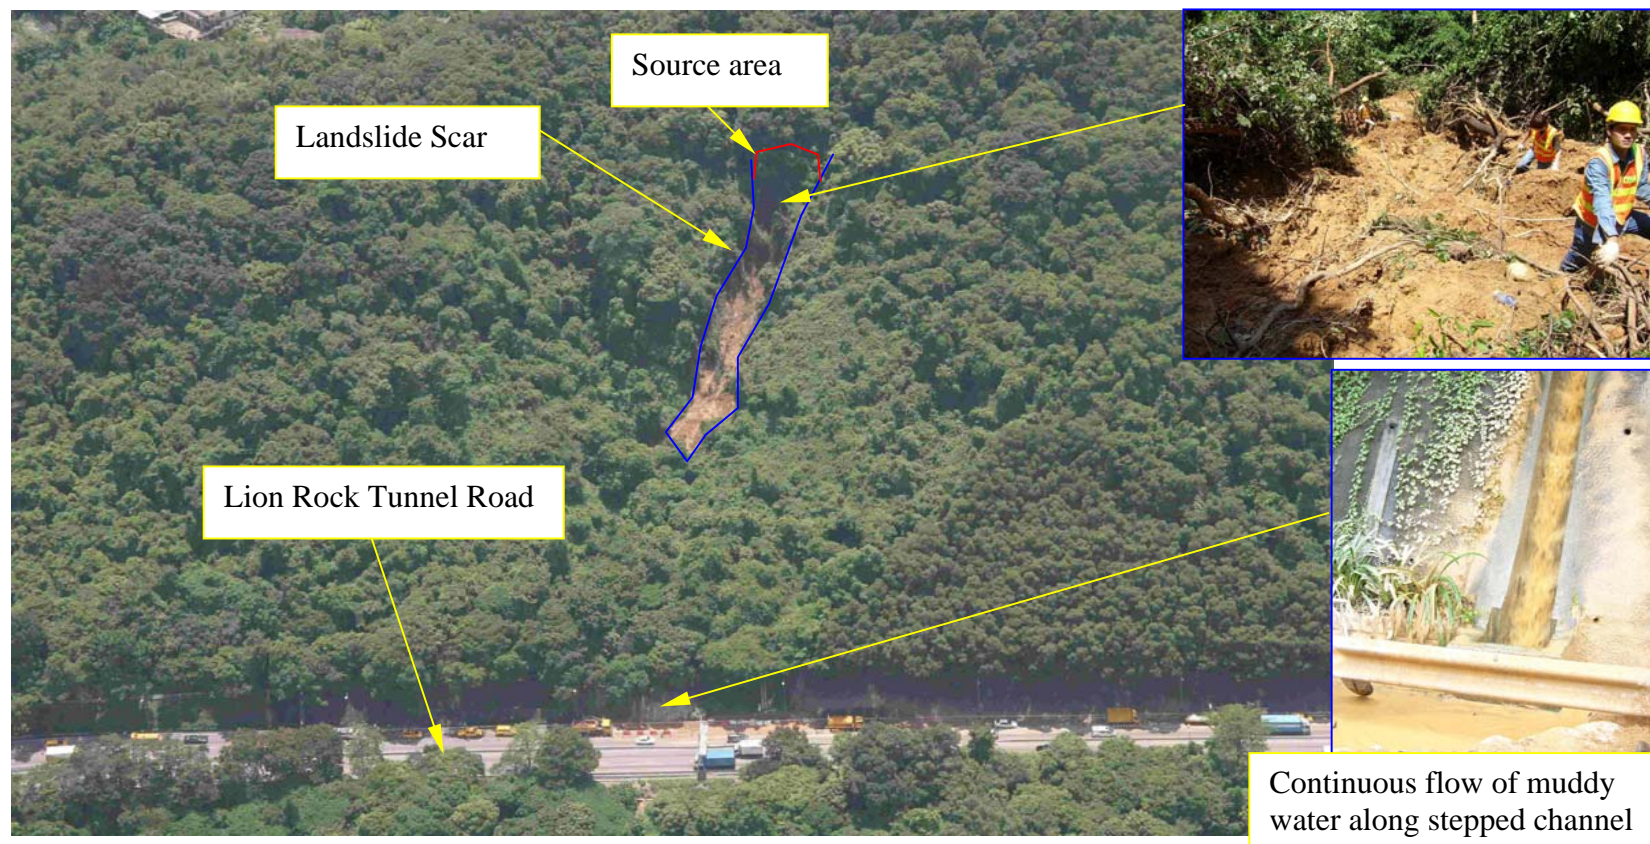
Plate 5 - The 22 August 2005 Landslide Incident on the Natural Hillside above Slope No. 7SW-D/C2, Lion Rock Tunnel Road
(Incident No. 2005/8/428)

Description: A continuous flow of muddy water and soil debris from a major landslide on natural hillside above Slope No. 7SW-D/C2 which resulted in the temporary closure of one southbound lane of Lion Rock Tunnel Road.

In the afternoon of 22 August 2005, when the Amber Rainstorm Warning and Landslip Warning were in effect, continuous flow of muddy water containing soil debris from a landslide on the natural hillside above the roadside cut slope was observed on the stepped channel of Slope No. 7SW-D/C2 which flanks Lion Rock Tunnel Road. The landslide scar was located about 55 m above the Lion Rock Tunnel Road and the estimated failure volume was about 400 m³. The landslide debris was not mobile. No casualties were reported but one of the south-bound lanes of Lion Rock Tunnel Road was temporarily closed after the incident for three days.

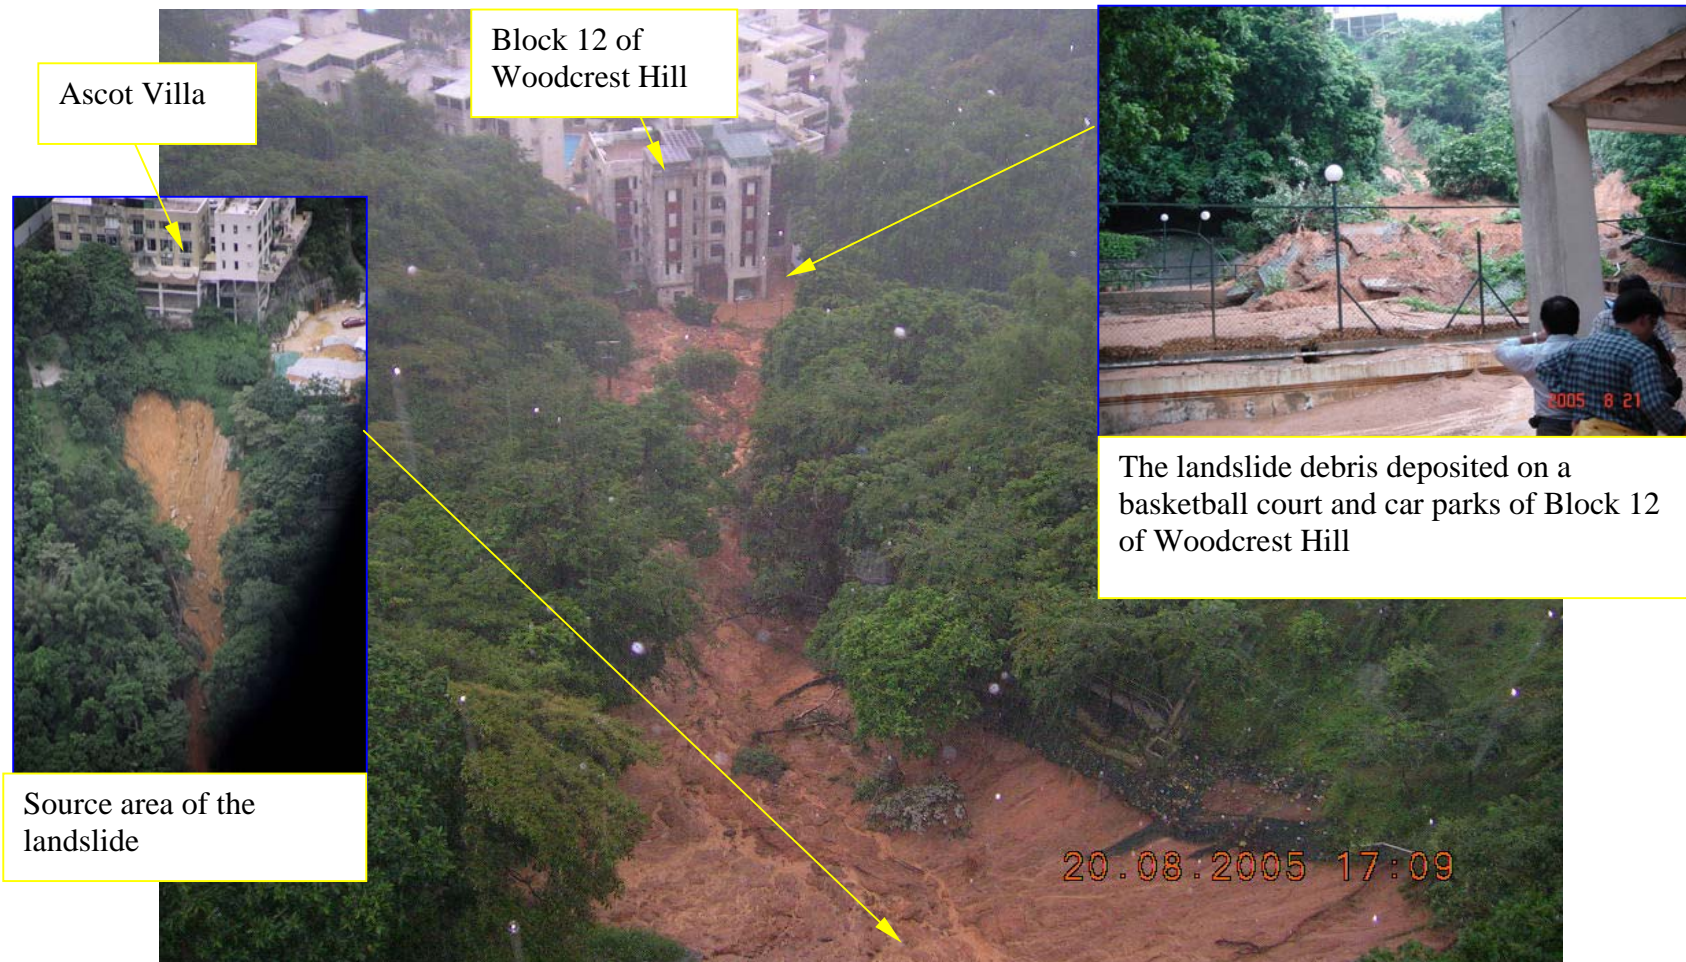
Plate 6 - The 20 August 2005 Landslide Incident on Slope No. 7SW-D/C167 at Shatin Heights (Incident No. 2005/8/0320)

Description: A major landslide occurred on a cut slope which resulted in temporary evacuation of a five-storey and a three-storey residential blocks.

At about 11:53 a.m. on 20 August 2005, when the Amber Rainstorm Warning and Landslip Warning were in effect, a major landslide occurred on Slope No. 7SW-D/C167, which is below Ascot Villa at No. 39 Sha Tin Heights Road and about 100 m upslope of Block 12 of Woodcrest Hill. The total failure volume was about 1,200 m³, comprising detached materials from the failed slope and materials entrained along the debris trail leading down to the toe of the hillside. The landslide debris was deposited on a basketball court and the car parks of Block 12 of Woodcrest Hill, and muddy water flowed along the access road to Woodcrest Hill. As a result, the residents of Ascot Villa and Block 12 Woodcrest Hill were temporarily evacuated until 24 August 2005. No casualties were reported as a result of the incident.

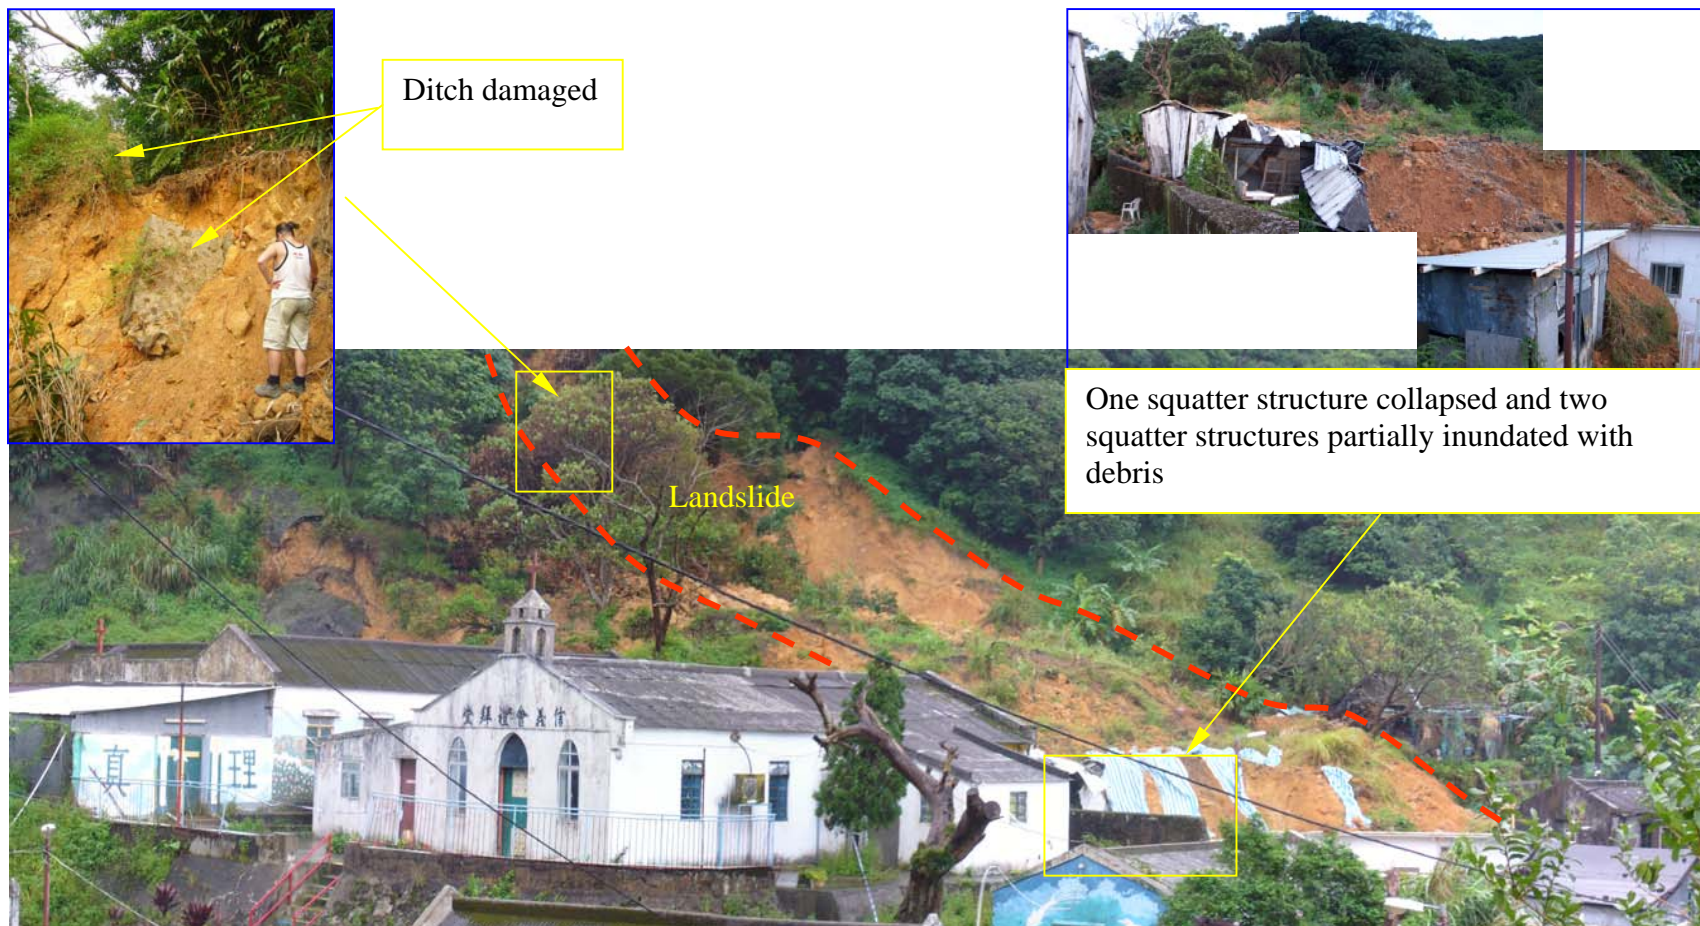
Plate 7 - The 21 August 2005 Landslide Incident on Slope Nos 7SE-B/C195 and 7SE-B/C131 at Ma On Shan Upper Village
(Incident No. 2005/8/0384)

Description: A major landslide from two cut slopes, above and below a ditch which damaged three squatter structures.

(A major landslide involving two cut slopes, which damaged squatter dwellings, Plate 7)

The incident was reported at 8:11 a.m. on 21 August 2005. A major landslide of approximately 1,000 m³ in volume occurred on two cut slopes (Slopes Nos. 7SE-B/C195 and 7SE-B/C131). An abandoned drainage ditch (1.5m wide by 1.5m deep) is located between the two cut slopes. Part of the drainage ditch was damaged by the landslide. Old tension cracks were also observed on the hillside adjacent to the landslide scar. One registered squatter structure at the upper part of the Ma On Shan Upper Village collapsed following impact by the landslide debris and two other registered squatter structures were partially inundated with debris. Subsequent to the landslide, the three affected squatters were permanently evacuated.

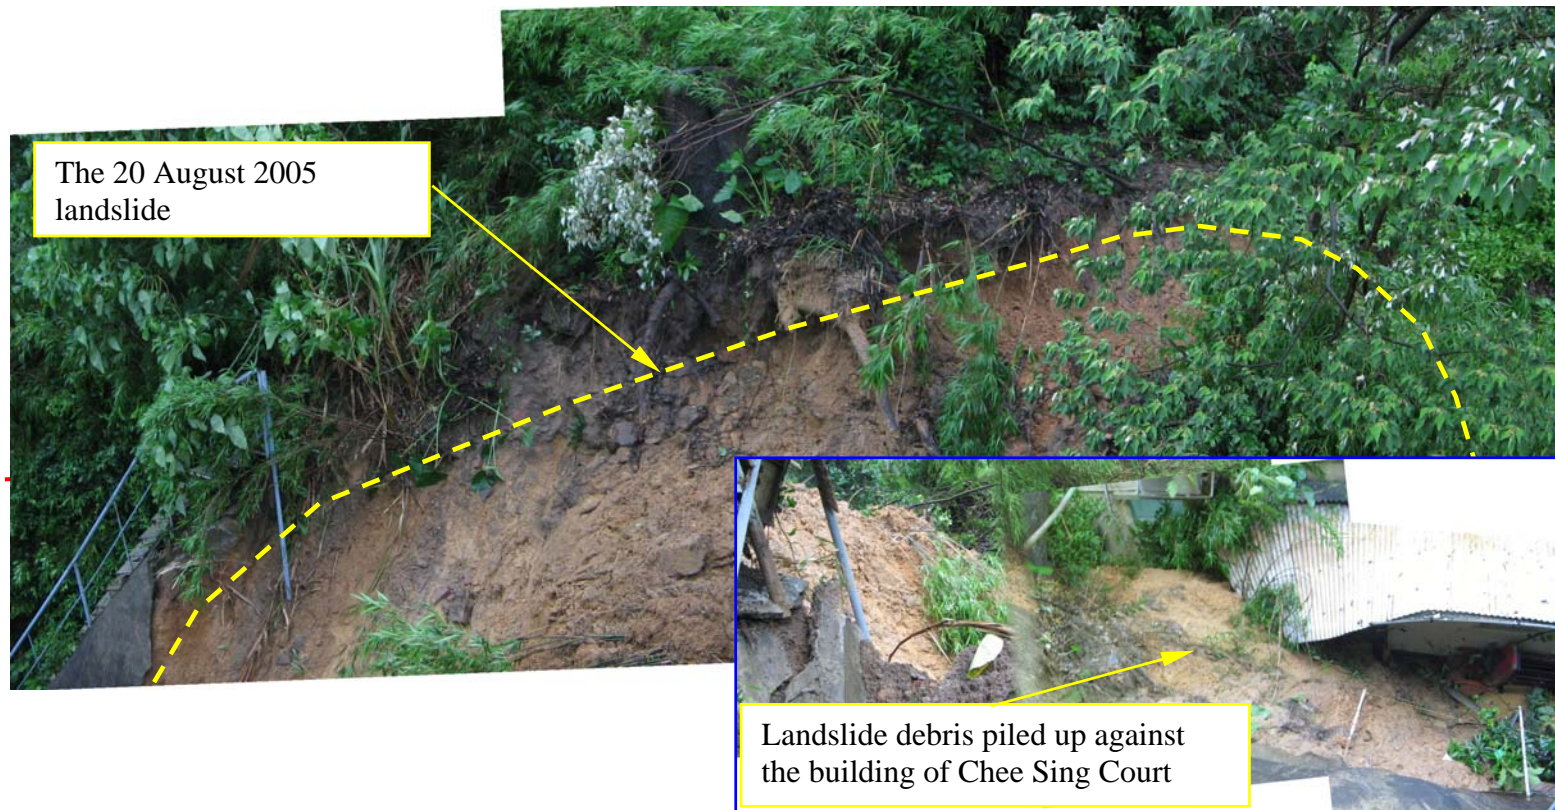
Plate 8 - The 20 August 2005 Landslide Incident on Slope No. 11SW-A/C415 at No. 404 Victoria Road (Incident No. 2005/8/0368)

Description : A major failure involving the crest of a soil cut slope and the natural hillside above, which resulted in temporary evacuation of Chee Sing Kok Social Centre.

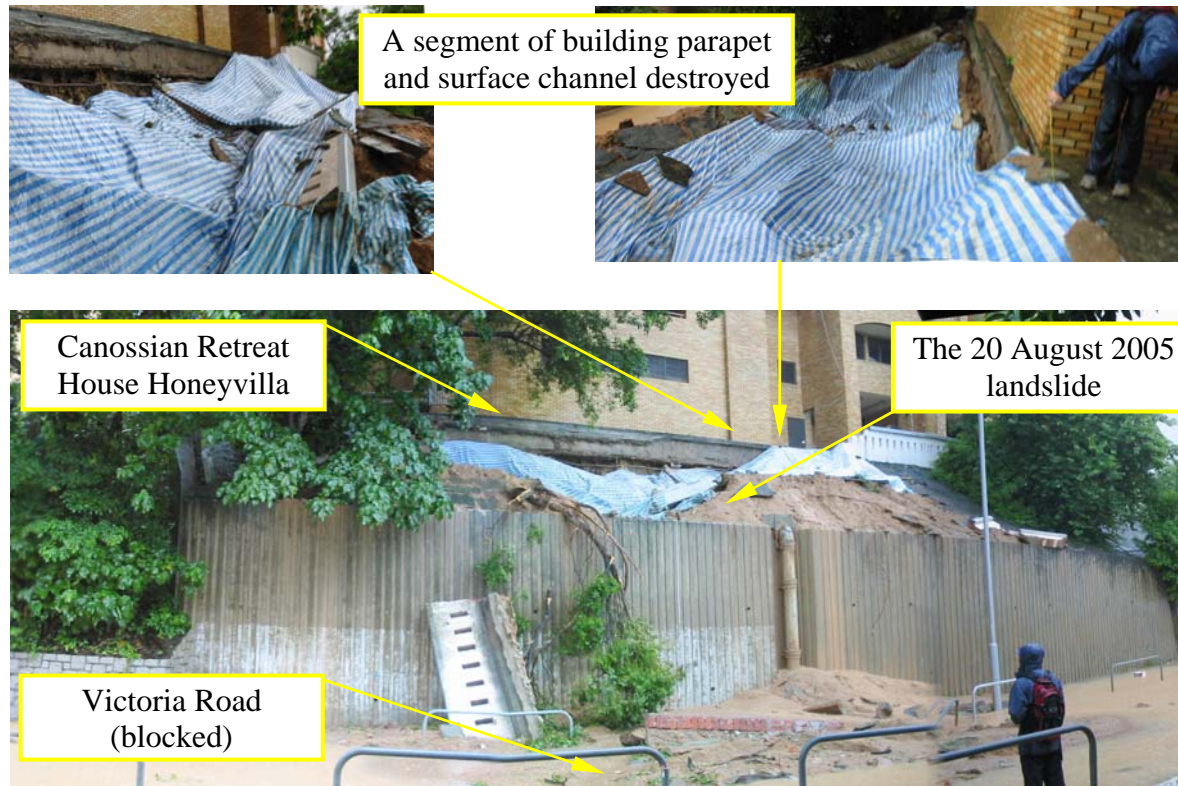
Plate 9 - The 20 August 2005 Landslide Incident on Slope No. 11SW-C/FR126 below Canossian Retreat House Honeyville, Victoria Road (Incident No. 2005/8/0308)

Description: A major landslide on a fill slope which resulted in temporary closure of Victoria Road.

At around 9:30 a.m. on 20 August 2005 when the Amber Rainstorm Warning and the Landslip Warning were in force, a landslide with a failure volume of about 100 m³ occurred on slope No. 11SW-C/FR126 below the Canossian Retreat House Honeyville. The slope comprises a 5 m high fill slope supported by a 5 m high reinforced concrete retaining wall along the toe. The landslide occurred on the upper 30° to 35° shotcreted fill slope portion. The debris completely blocked the two carriageways of Victoria Road. One of the road lanes was re-opened on 21 August 2005 and the other was re-opened on 29 August 2005. No casualties were reported as a result of the incident.

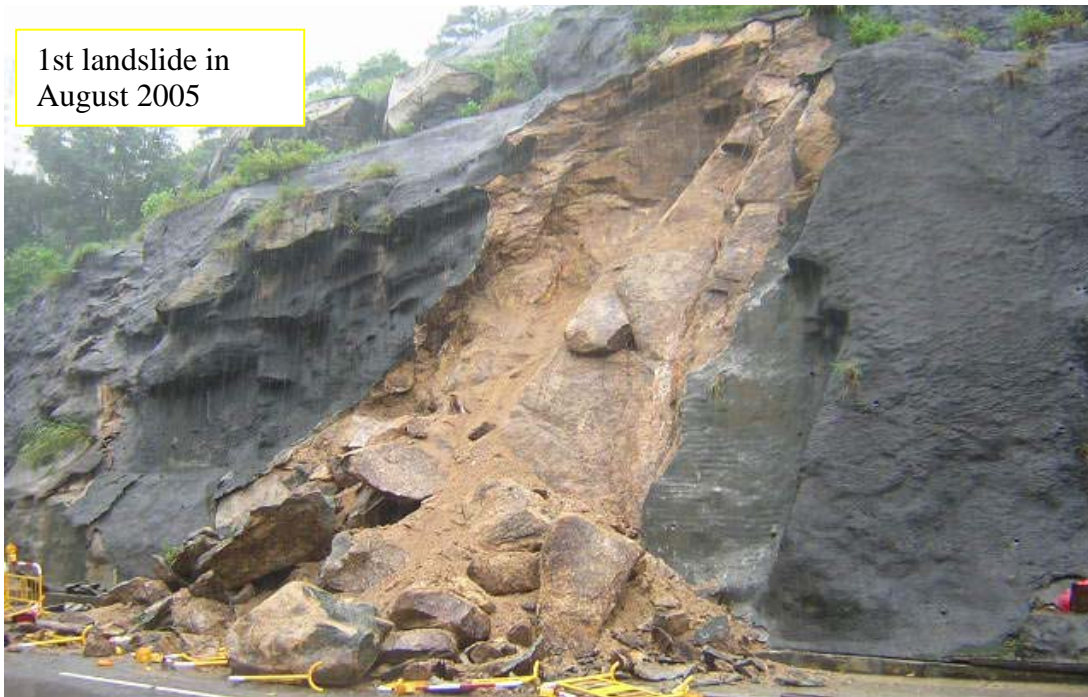
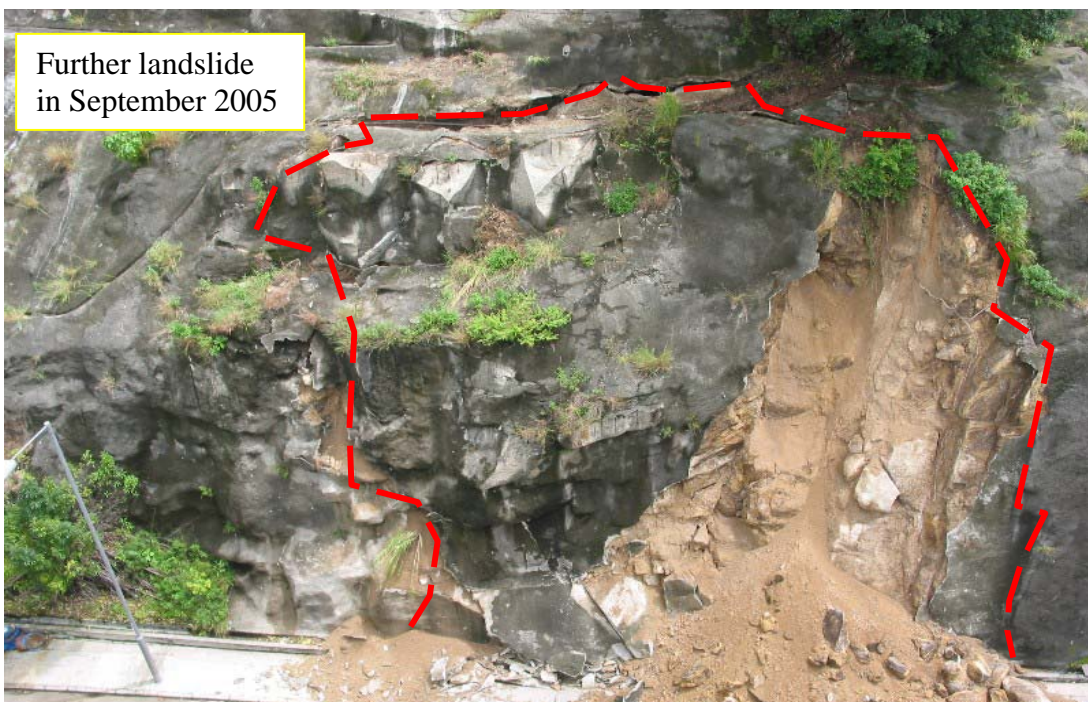
Plate 10 - The 20 August 2005 Landslide Incident on Slope No. 11NE-A/C153 at Ping Ting Road, Ngau Chi Wan (Incident No. 2005/8/0299)

1st landslide in
August 2005

Further landslide
in September 2005

Description: A major failure on the rock portion of a soil/rock cut slope which resulted in closure of Ping Ting Road at the toe and the playground of the Buddhist Hung Sean Chau Memorial College on the opposite side of the road.

(A major failure on the rock portion of a soil/rock cut slope which resulted in closure of Ping Ting Road at the toe, as well as the playground at the Buddhist Hung Sean Chau Memorial College on the opposite side of Ping Ting Road, Plate 10)

The landslide at Ping Ting Road involved two successive failures of cut slope No. 11NE-A/C153. The first failure occurred at about 8:00 a.m. to 9:30 a.m. on 20 August 2005 when the Amber Rainstorm Warning and the Landslip Warning were in effect. About 36 m³ of debris comprising rock blocks and silty sand were deposited on the footpath and the southbound lane of Ping Ting Road. The debris originated from a displaced rock wedge, about 12 m wide at the top and approximately 14 m high, located at the lowermost batter of the northern section of slope no. 11NE-A/C153. Both lanes of Ping Ting Road were temporarily closed. The northbound lane was later re-opened on 22 August 2005. No casualties were reported as a result of the incident.

In the early morning of 13 September 2005, further instability occurred at the same location of the August 2005 incident. Some 120 m³ of debris was deposited on the pedestrian pavement and the southbound lane of Ping Ting Road. Consequently, the playground at the Buddhist Hung Sean Chau Memorial College on the opposite side of the road were temporarily closed. No casualties were reported. The northbound lane was later re-opened on 16 September 2005 when Highways Department had installed temporary struts to support the failed rock slope.

Grades III and IV decomposed granite were exposed in the landslide scar. Seepage from nearby weepholes, raking drains, and cracked shotcrete was observed immediately after the 20 August 2005 incident.

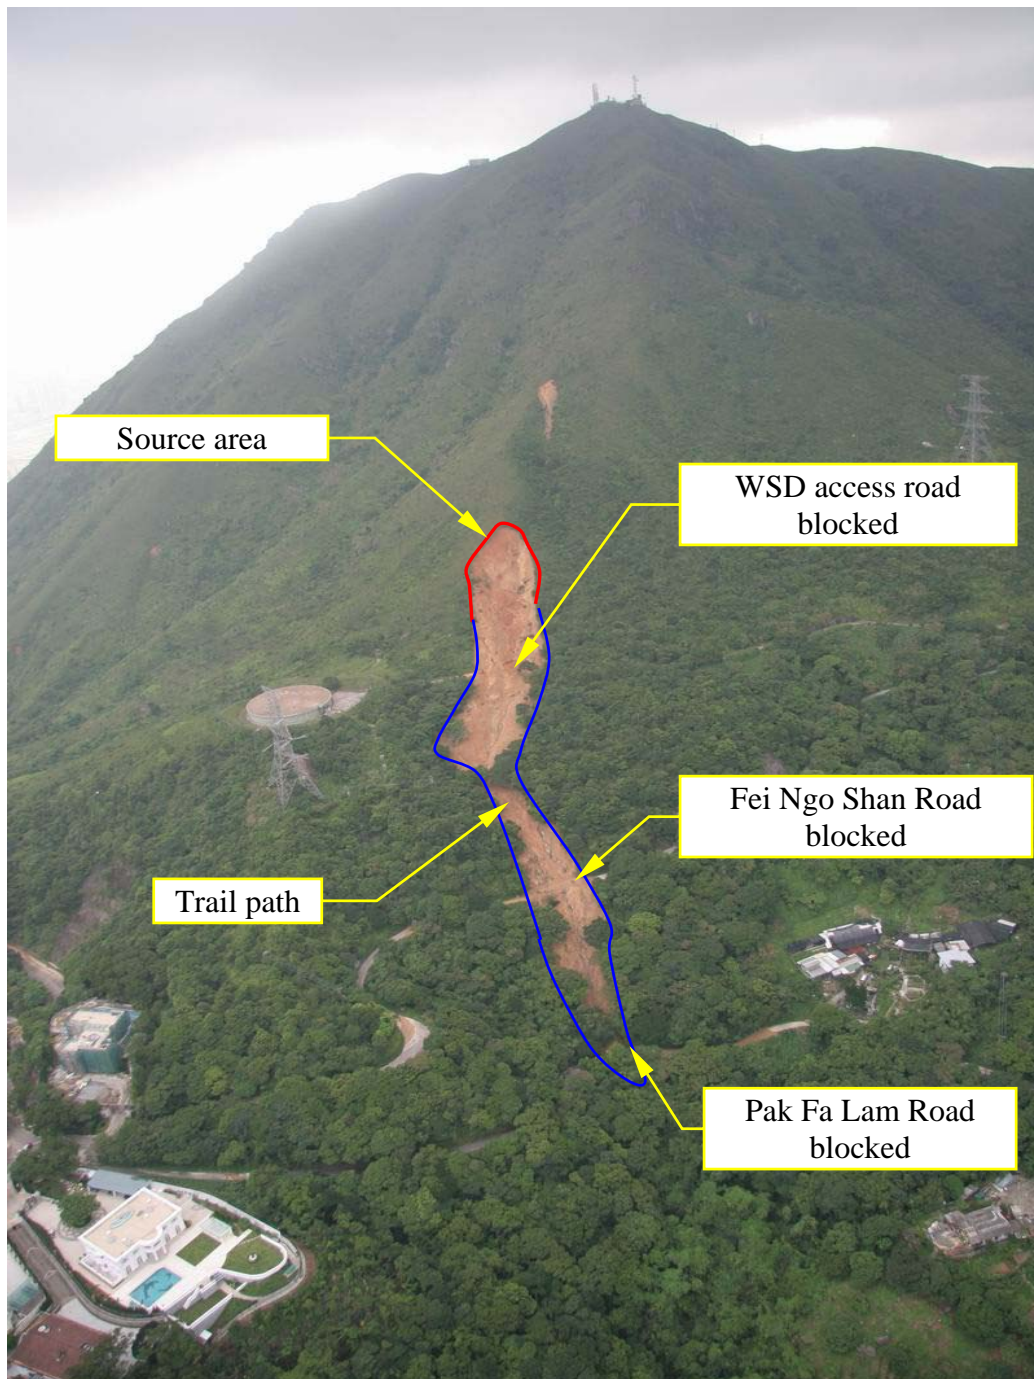
Plate 11 - The 21 August 2005 Landslide Incident on the Natural Hillside above Fei Ngo Shan, Choi Hung (Incident No. 2005/8/0381)

Description: A major natural hillside failure which resulted in the temporary closure of Pak Fa Lam Road, Fei Ngo Shan Road and the Access Road to the WSD Fei Ngo Shan Service Reservoir.

(A natural hillside failure which resulted in temporary closure of Pak Fa Lam Road, Fei Ngo Shan Road and an access road to the Fei Ngo Shan Service Reservoir, Plate 11)

At about 6.00 a.m. on 21 August 2005, following the issue of an Amber Rainstorm Warning on 20 August 2005, a major landslide with a total failure volume of about 3,500 m³ occurred on the hillside west of the Fei Ngo Shan Service Reservoir. The landslide debris reached a natural drainage line beneath the access road to the service reservoir and developed into a channelised debris flow. The debris flow travelled downhill along the drainage line, across Fei Ngo Shan Road and deposited on Pak Fa Lam Road, some 270 m (plan distance) from the landslide crown. Fei Ngo Shan Road was temporarily closed until 30 October 2005. No casualties were reported as a result of the incident.

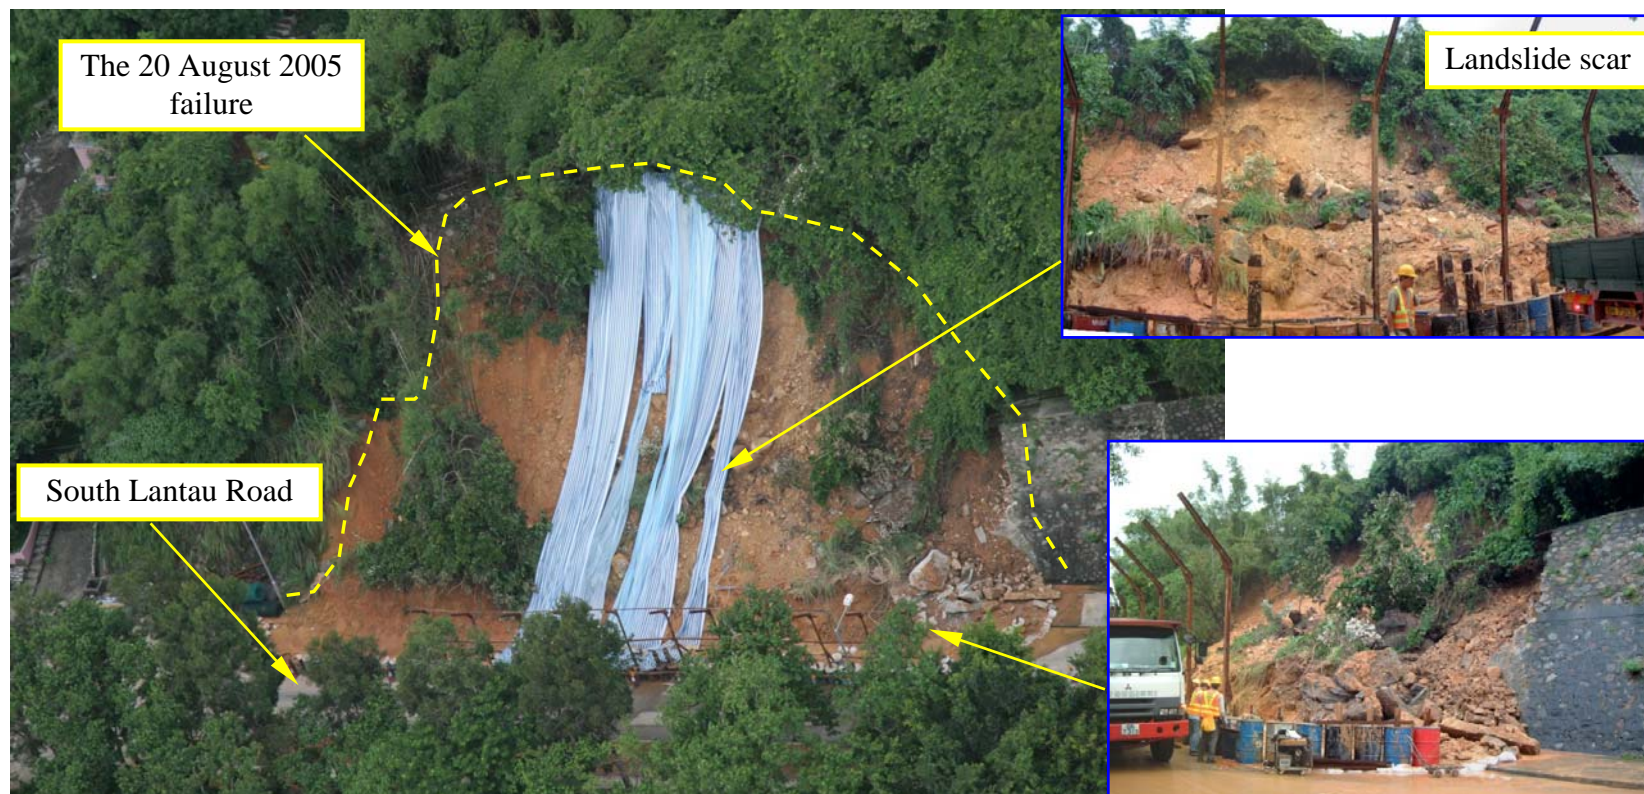
Plate 12 - The 20 August 2005 Landslide Incident on Slope No. 13NE-B/C166 along South Lantau Road, approximate 500 m East of Tong Fuk, Lantau Island (Incident No. 2005/8/0331)

Description: A major landslide on a soil cut slope which resulted in temporary closure of South Lantau Road.

At about 1:00 p.m. on 20 August 2005 when the Landslip Warning was in force, a major landslide with a failure volume of about 750 m³ occurred on slope No. 13NE-B/C166 above South Lantau Road, approximately 500 m east of Tong Fuk. The landslide extended slightly into the hillside above. The source area of the landslide was estimated to be 44 m wide and 12 m high. The landslide debris blocked the two lanes of South Lantau Road. As a result, about 200 tourists were reported to have been trapped near Tong Fuk when they were returning from the monastery in Ngong Ping to Mui Wo. The only route to Tung Chung was via Tung Chung Road, but Tung Chung Road was temporarily closed after a landslide which occurred near Shek Mun Kap earlier at about 9:30 a.m. on that same day. According to the Police, the tourists together with a number of the local residents had to be escorted across the landslide debris to Tong Fuk in order to continue their journeys by bus. One of the lanes of South Lantau Road was re-opened at 10:00 p.m. on 21 August 2005 and the other lane was re-opened at 12:15 p.m. on 20 September 2005. No casualties were reported as a result of the incident.
