FACTUAL REPORT ON HONG KONG RAINFALL AND LANDSLIDES IN 2005

GEO REPORT No. 223

**GEOTECHNICAL ENGINEERING OFFICE
CIVIL ENGINEERING AND DEVELOPMENT DEPARTMENT
THE GOVERNMENT OF THE HONG KONG
SPECIAL ADMINISTRATIVE REGION**

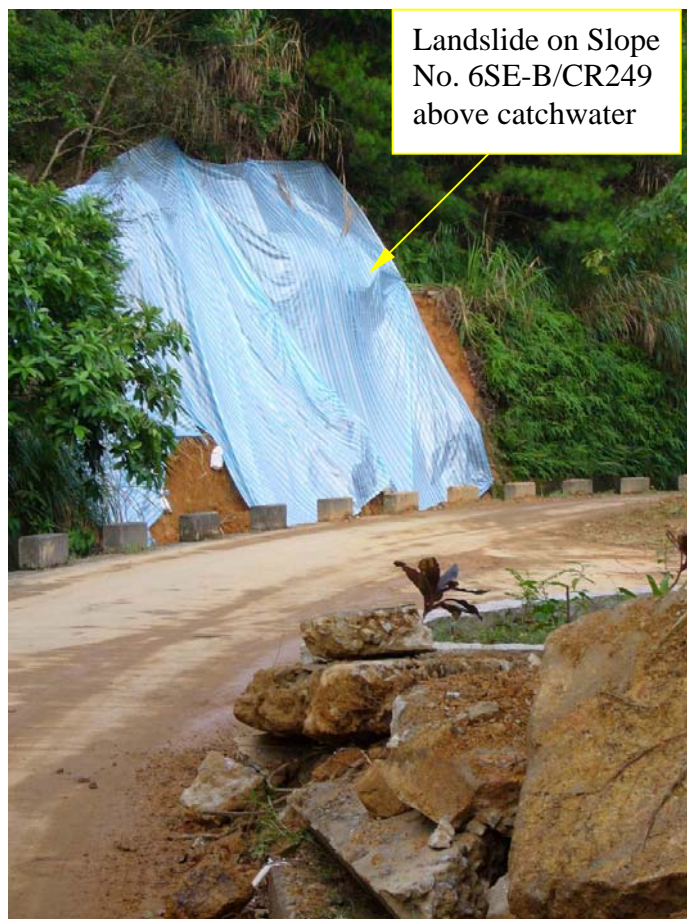
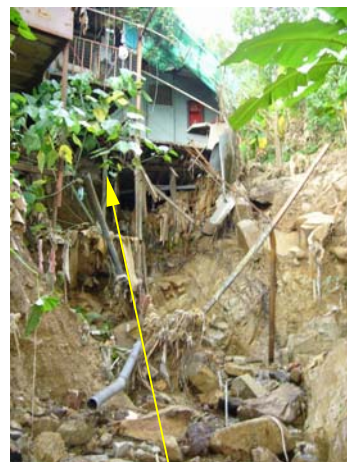
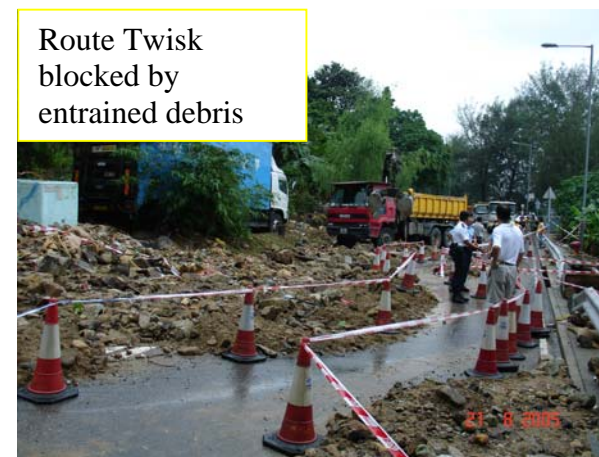
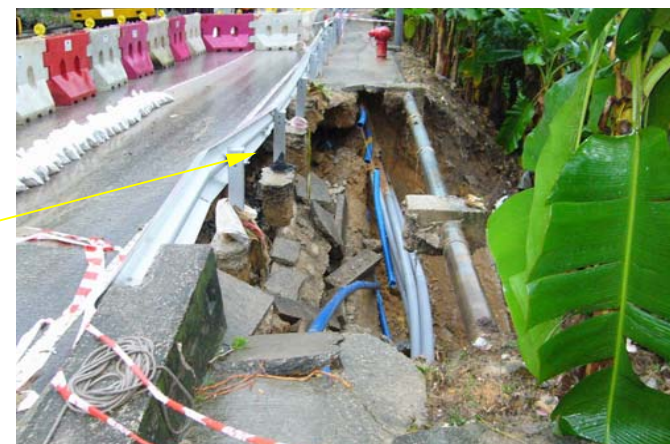
Plate 13 - The 20 August 2005 Landslide Incident at Route Twisk near Kong Pan Tin Tsuen, Tsuen Wan (Incidents Nos. 2005/8/0351A, 2005/8/0351B and 2005/8/0480)

Landslide on Slope No. 6SE-B/CR249 above catchwater

Support of a squatter structure exposed

Route Twisk blocked by entrained debris

Fill Slope No. 6SE-D/FR98 below Route Twisk failed

Description: A major landslide and washout incidents which resulted in permanent evacuation of a squatter structure and closure of a section of Route Twisk.

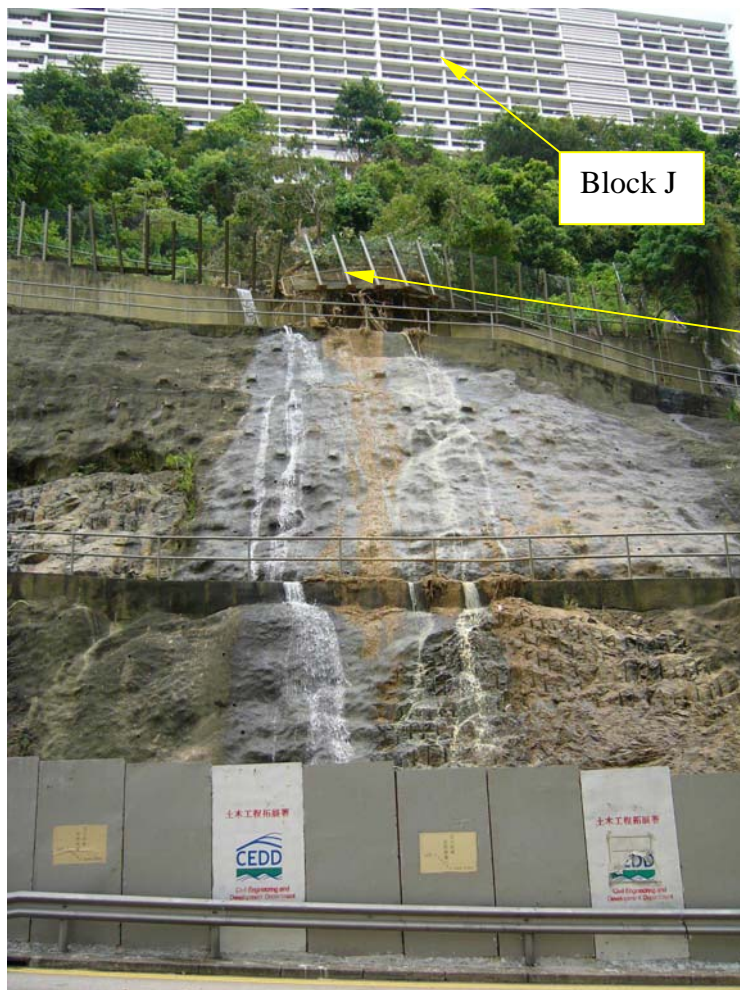
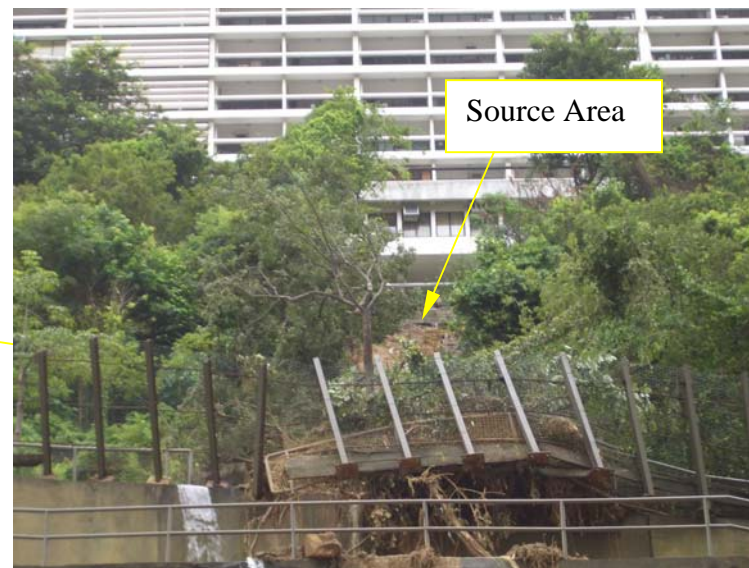
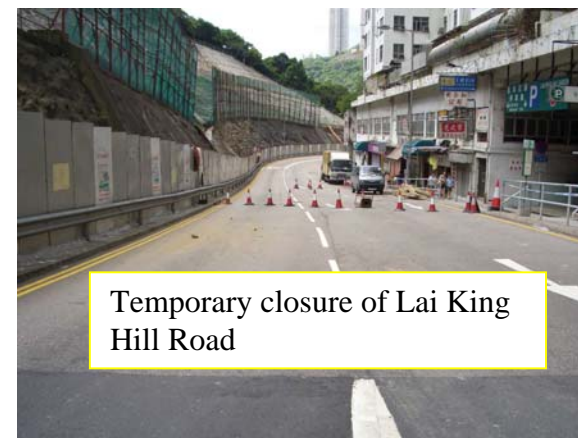
Plate 15 - The 11 August 2005 Landslide Incident on the Natural Hillside above Slope No. 11NW-A/C49 at Lai King Hill Road, Kwai Chung (Incident No. 2005/8/0279)

Description: A landslide on the vegetated natural hillside that resulted in the temporary closure of Lai King Hill Road at the slope toe.

slope No. 11NW-A/C49 was severely damaged and part of it was left over-hanging as a result. Most of the debris was deposited against the hoarding to a construction site below. A few small pieces of rock and some soil debris were deposited on Lai King Hill Road, which was temporarily closed until 7:00 a.m. the next morning. No casualties were reported as a result of the incident.

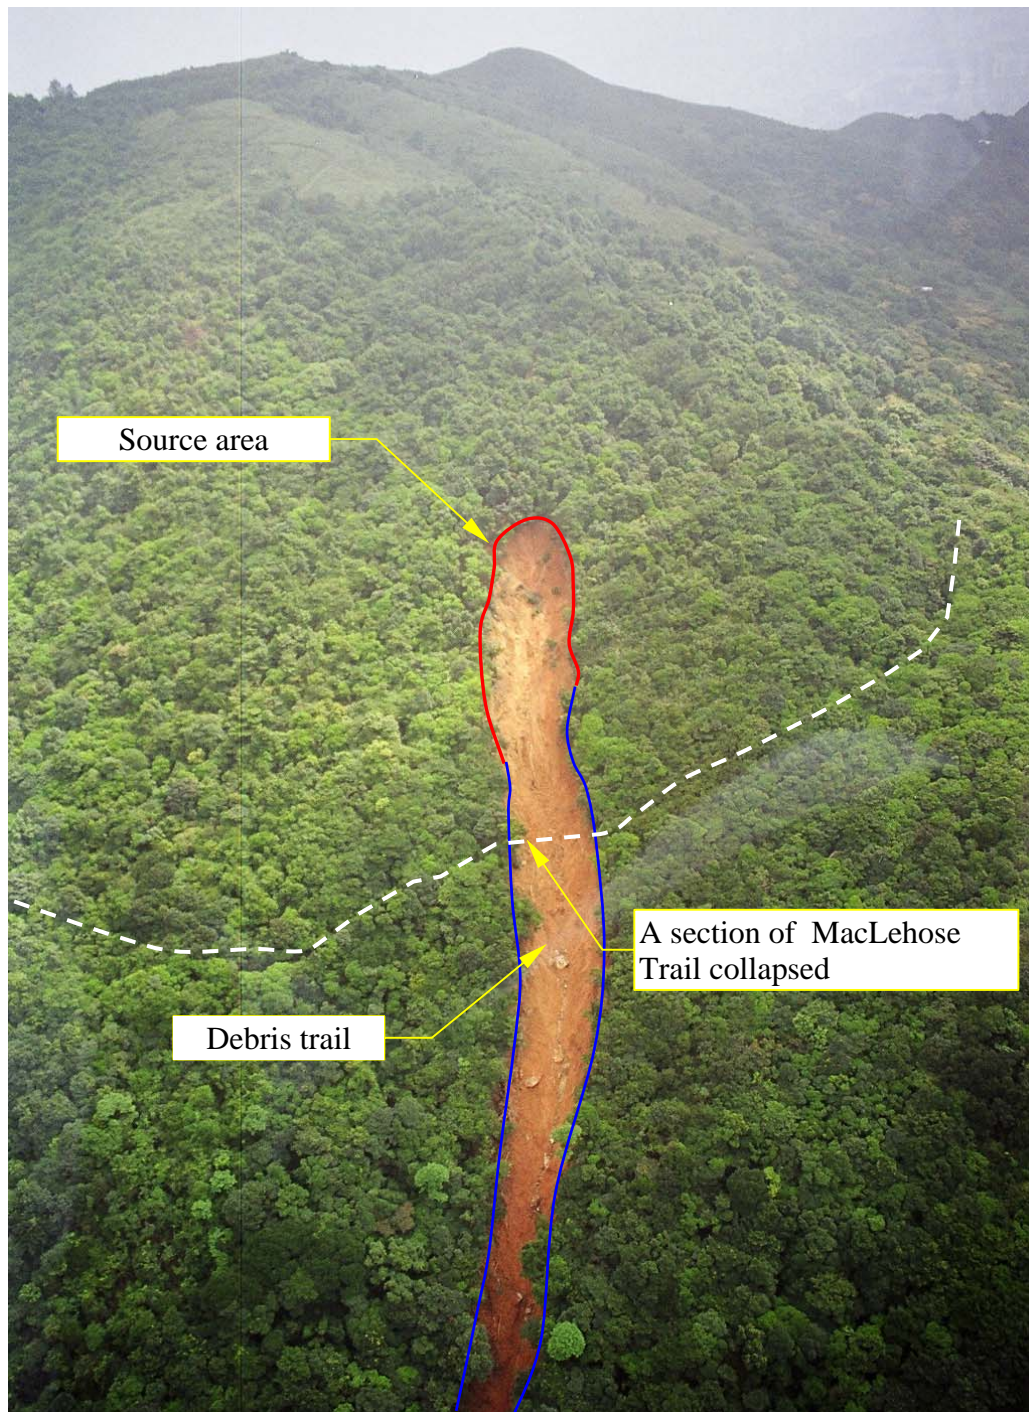
Plate 16 - The 22 August 2005 Channelised Debris Flow Incident on the Natural Hillside at Kwun Yam Shan (Incident No. 2005/8/0422)

Description: A major natural hillside failure which developed into a channelised debris flow and destroyed a section of MacLehose Trail

(A major natural hillside failure, which developed into a channelised debris flow, destroyed a section of MacLehose Trail, with a debris travel distance of about 350 m, Plate 16)

In the morning of 22 August 2005, a major landslide occurred on the natural hillside above Kwun Ping Road, Kwun Yam Shan. The landslide scar was approximately 30 m long and 12 m wide, with a maximum depth of about 3 m. The detached material comprised primarily bouldery colluvium, with the failure surface passing through completely decomposed tuff (CDT), which has numerous thin kaolin veins. The estimated volume of the landslide was approximately 1,000 m³.

A major tension crack (about 100 m in length with a drop of about 1 m and a lateral displacement of up to about 0.5 m) was identified about 30 m uphill of the August 2005 landslide in late March 2006. The exact timing of occurrence of the tension crack is not known, but judging from site evidence it was a new crack.
