**QUANTITATIVE RISK
ASSESSMENT OF LANDSLIDE
HAZARDS AT
FU YUNG SHAN TSUEN,
TSUEN WAN**

GEO REPORT No. 224

H.N. Wong & F.W.Y. Ko

**GEOTECHNICAL ENGINEERING OFFICE
CIVIL ENGINEERING AND DEVELOPMENT DEPARTMENT
THE GOVERNMENT OF THE HONG KONG
SPECIAL ADMINISTRATIVE REGION**

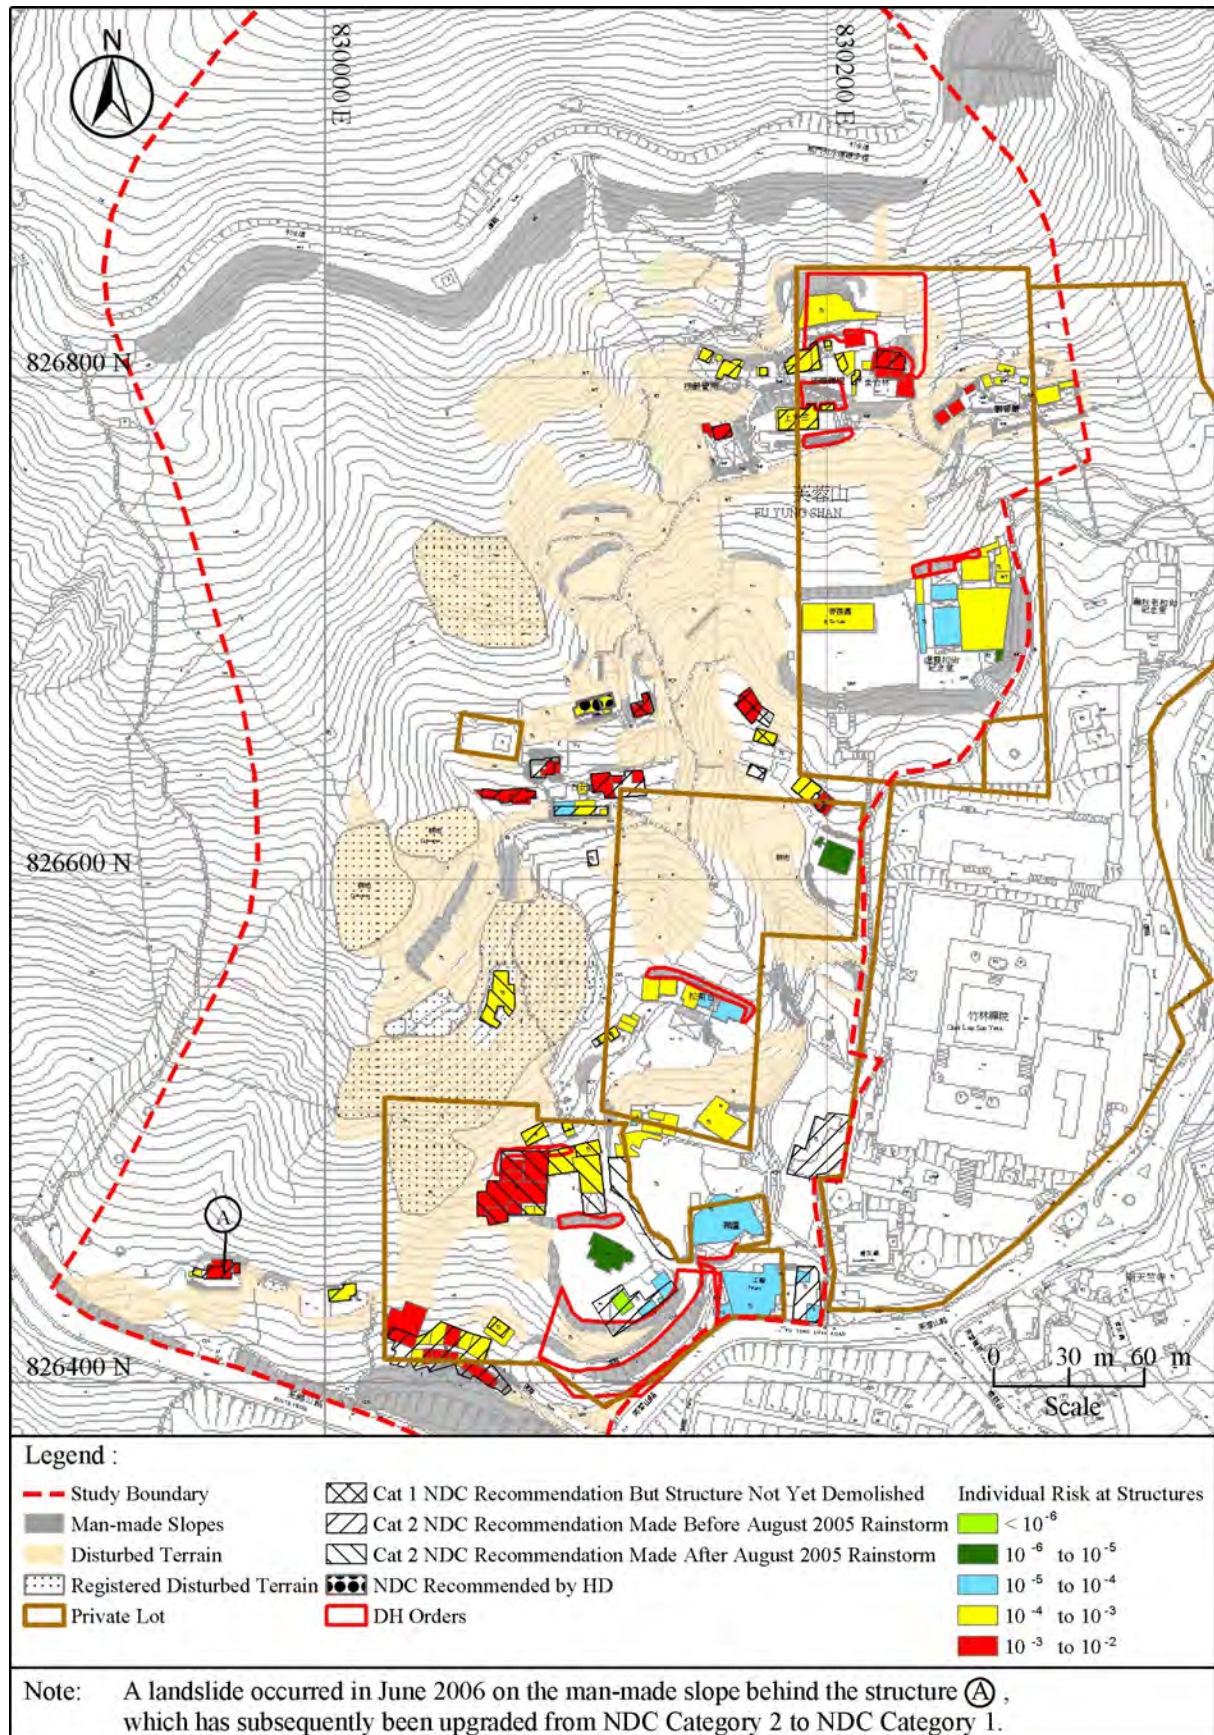
Figure 2 - Spatial Distribution of Personal Individual Risk

- (i) The spatial distribution of the calculated PIR at each of the structures (a total of 100 structures) at risk from landslides (combined man-made and hillside failures) is shown in Figure 2.

- (ii) Structures with NDC recommendations (a total of 62 structures) have high PIR, with about 95% having PIR ranging from $\geq 10^{-4}$ to $< 10^{-2}$ per year. The remaining structures have PIR less than 10^{-4} per year. They are either within a cluster of registered squatter dwellings with high PIR and NDC recommendations, or located over the crest of a steep cut slope, or located near the outlet of a major drainage line which may also be subjected to some additional risks from surface water flows that have not been included in the current PIR figures.

- (iii) Structures without NDC recommendations (a total of 38 structures) have noticeably lower PIR, mostly from $\geq 10^{-6}$ to $< 10^{-3}$ per year. Those structures with PIR from $\geq 10^{-4}$ to $< 10^{-3}$ per year are either within private land or are at risk principally from hillside failures, or both. Also, they are mostly either relatively more substantial or religion-related structures.

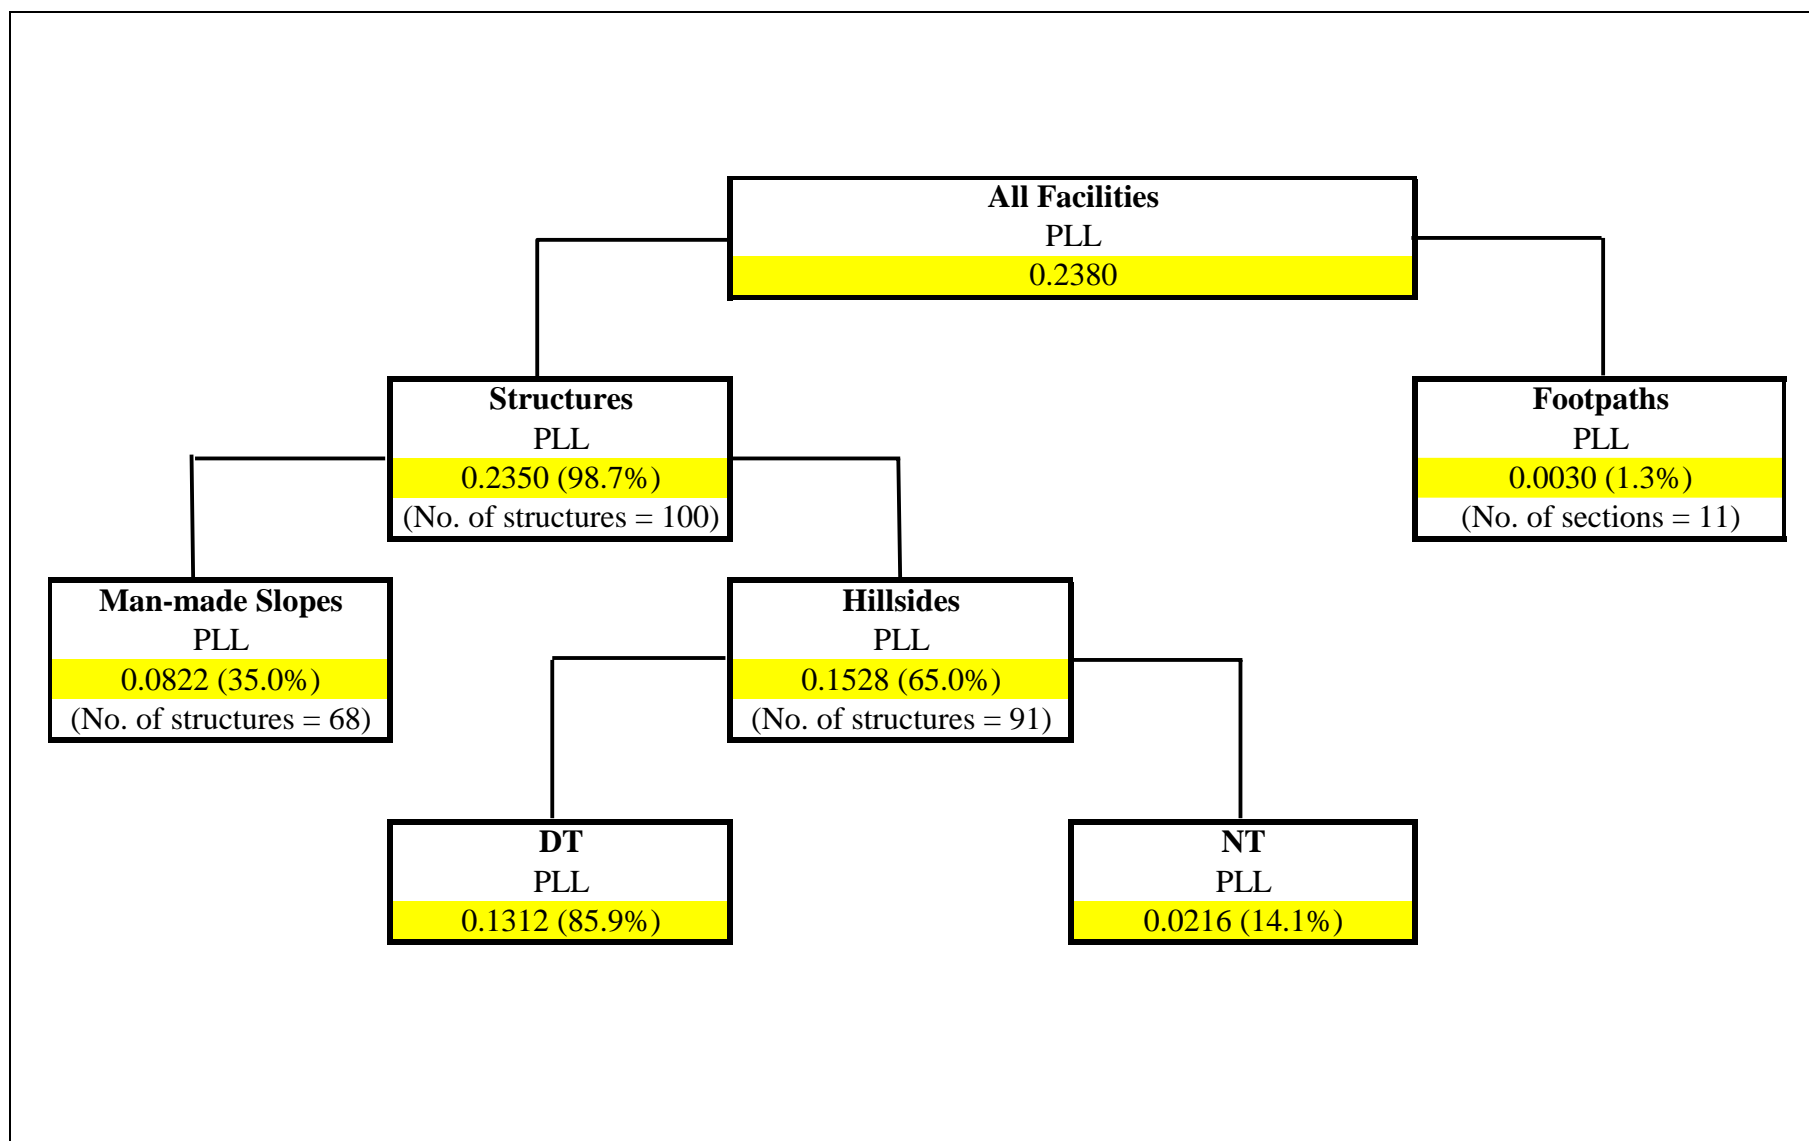
Figure 3 - Summary of PLL for Structures and Footpaths Affected by Man-made Slopes and Hillsides

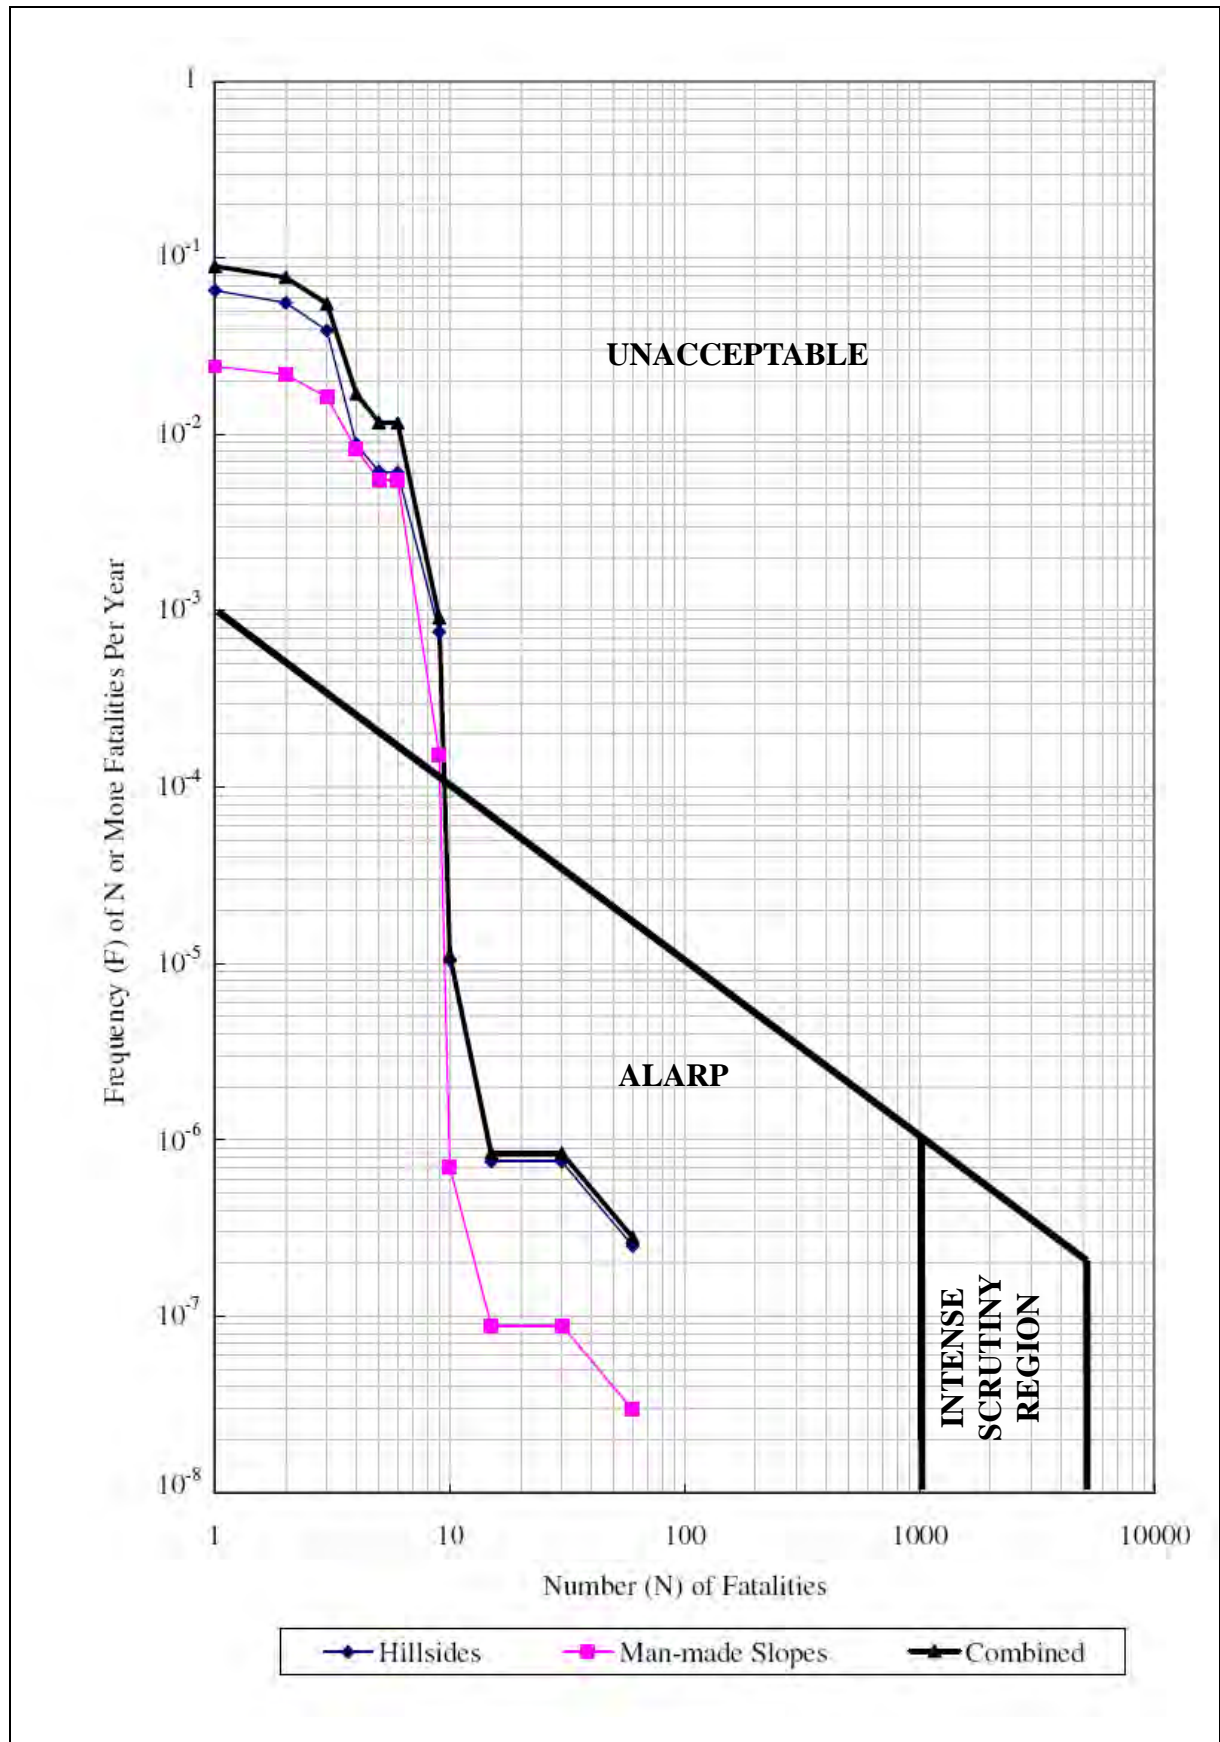
Figure 4 - F-N Curves

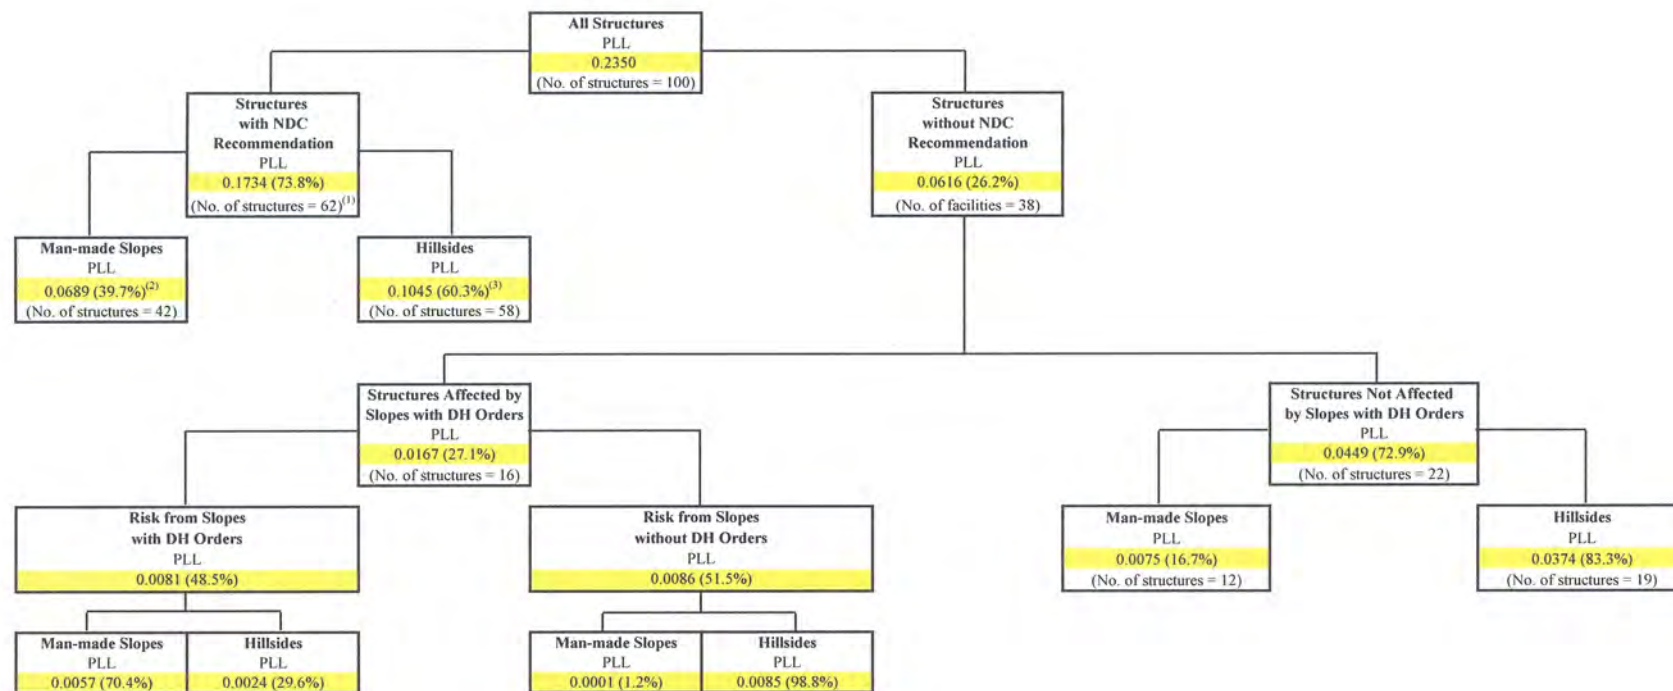
- Notes:
- (1) Of the 62 structures with NDC recommendation, the recommendation was made on 49 structures before the August 2005 rainstorm.
 - (2) The percentage shown is with respect to the total PLL arising from man-made slopes.
 - (3) The percentage shown is with respect to the total PLL arising from hillsides.

Figure 5 - Summary of PLL for Structures with and without NDC Recommendation

- (vi) The breakdown of the calculated PLL according to the structures with and without NDC recommendations is shown in Figure 5, and highlighted as follows:

- Structures with NDC recommendations constitute the majority (PLL = 0.1734 per year, i.e. about 74%) of the total risk. They take up about 84%

(PLL = 0.0689 per year) of the risk from man-made slope failures and about 68% (PLL = 0.1045 per year) of that from hillside landslides.

- Structures without NDC recommendations constitute about 26% (PLL = 0.0616 per year) of the total risk. About 27% (PLL = 0.0167 per year) rests with 16 structures without NDC recommendations but affected by slopes that have been subjected to Dangerous Hillside (DH) Orders. The DH Orders were served principally on man-made slopes (involving PLL = 0.0057 per year), but a small portion of the hillside was also covered (involving PLL = 0.0024 per year). The 16 structures are also at risk from landslides arising from man-made slopes and hillsides that are outside the boundaries of the DH Orders (involving PLL = 0.0086 per year). The remaining 73% (PLL = 0.0449 per year) of the risk rests with 22 structures without NDC recommendations and not affected by slopes that have been subjected to DH Orders. The vast majority of this risk (PLL = 0.0374 per year, i.e. about 83%) comes from hillside landslides.

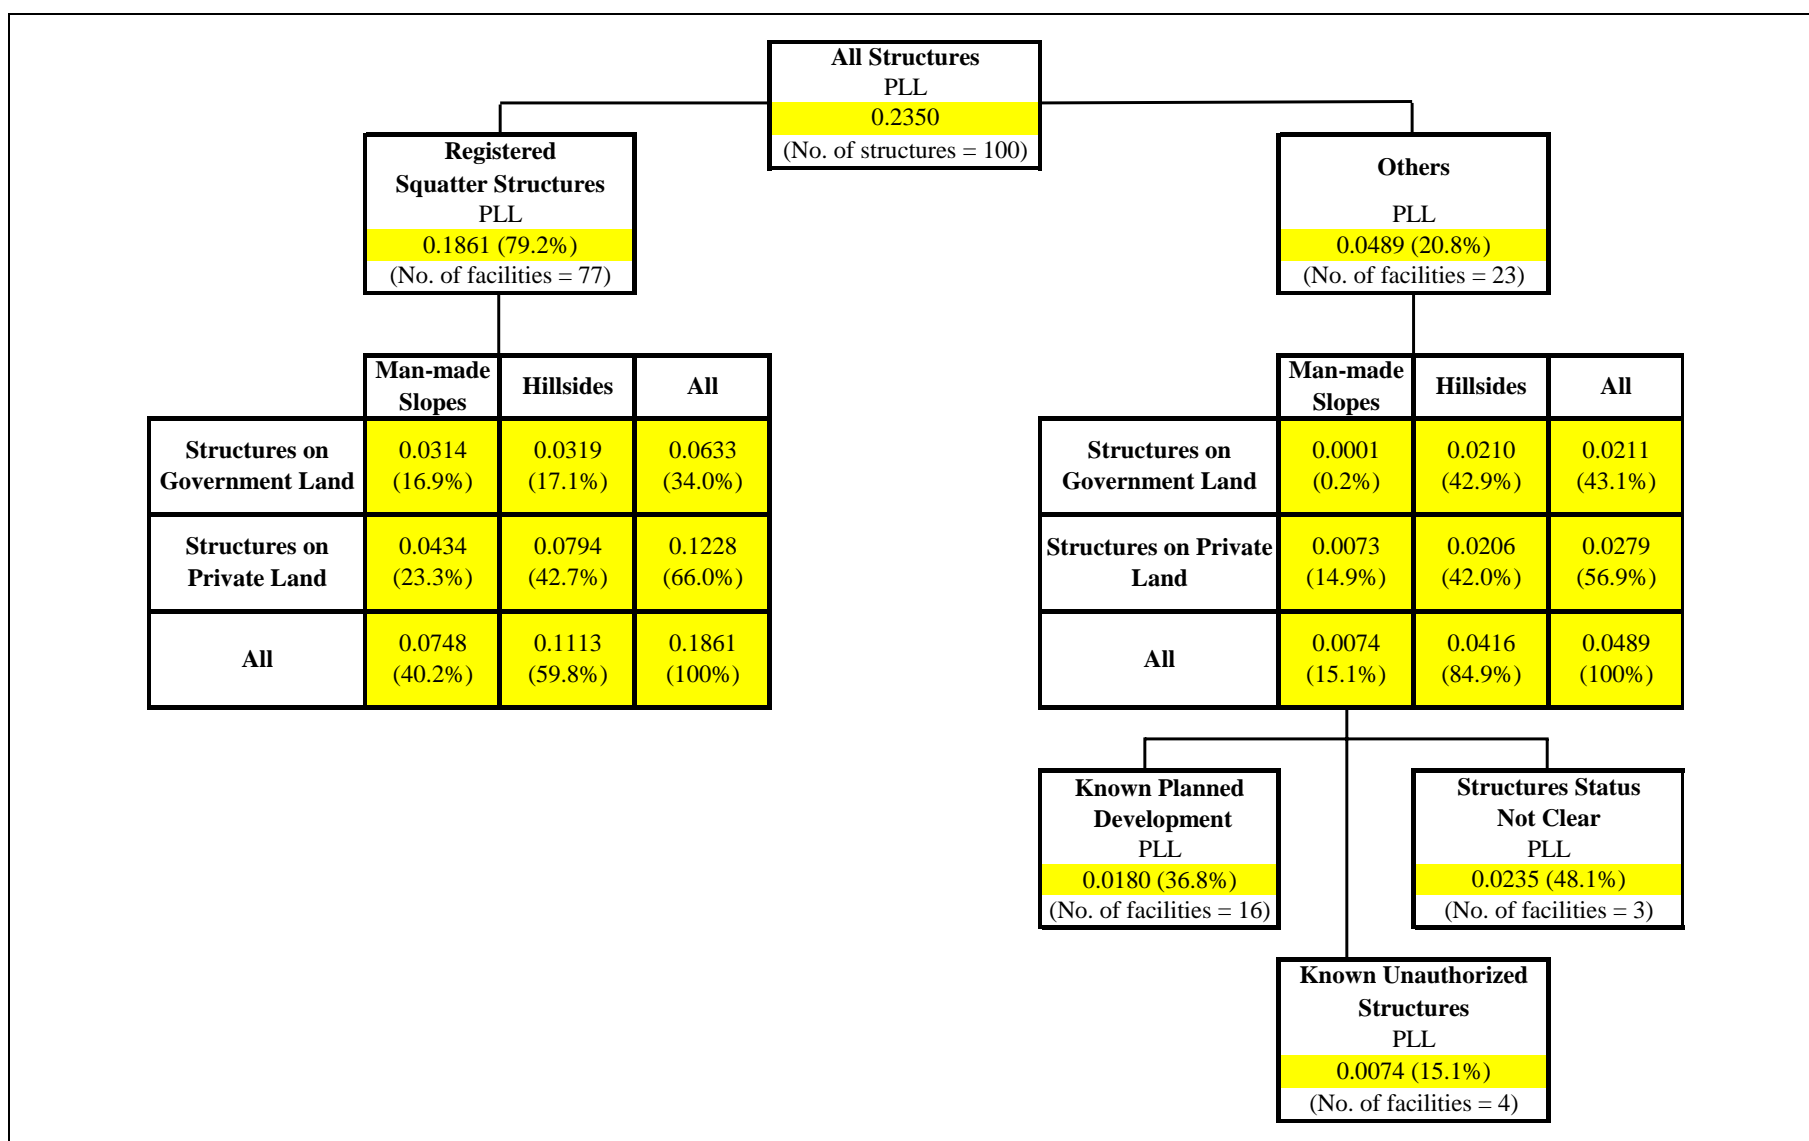
Figure 6 - Summary of PLL for Structures of Different Land/Squatter Registration Status

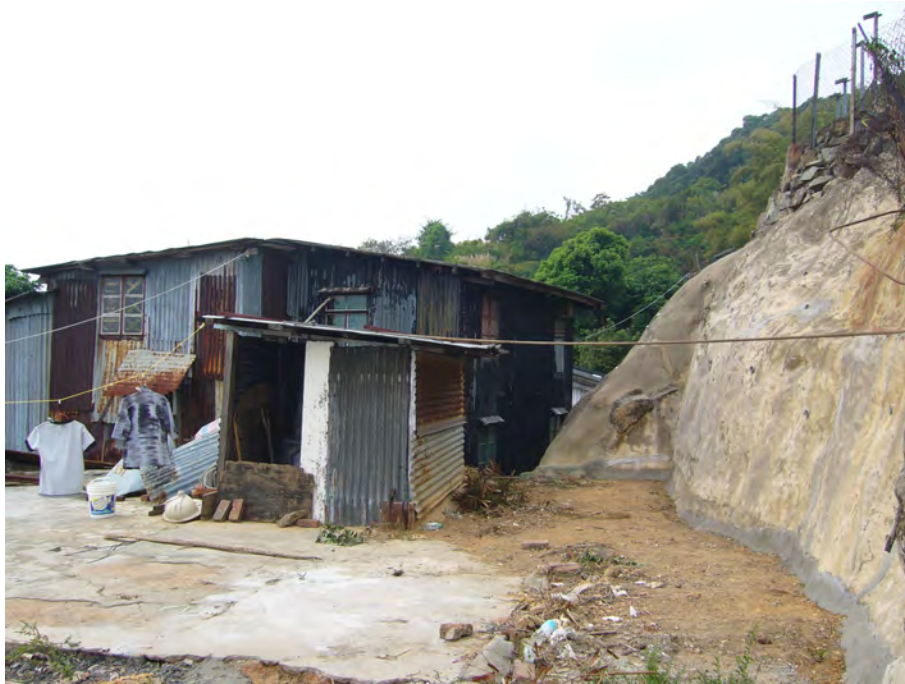
(a) A Structure Affected by Man-made Slopes

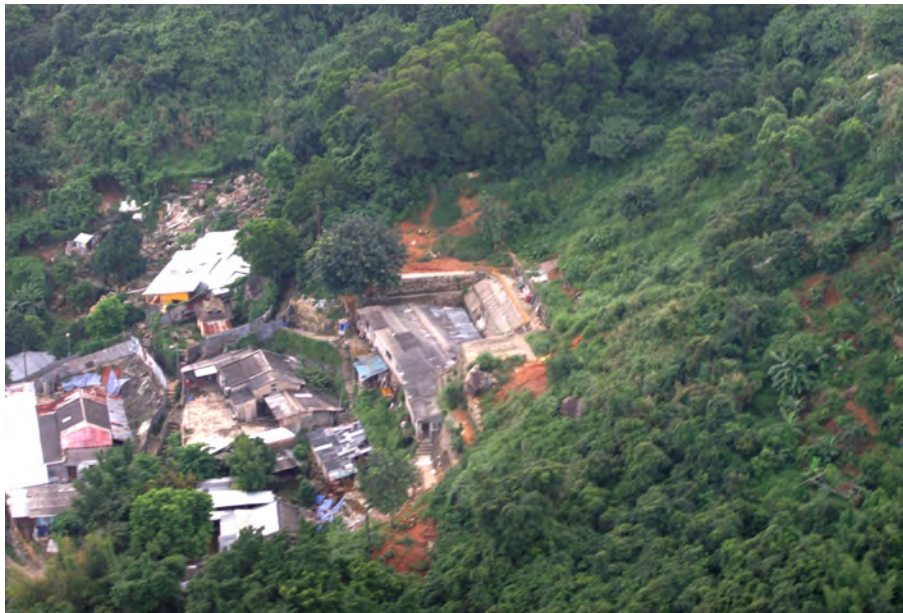
(b) Clusters of Structures Affected by Man-made Slopes,
and Natural and Disturbed Hillsides

Plate 2 - Illustrations of Structures Affected by Man-made Slopes,
Natural and Disturbed Hillsides

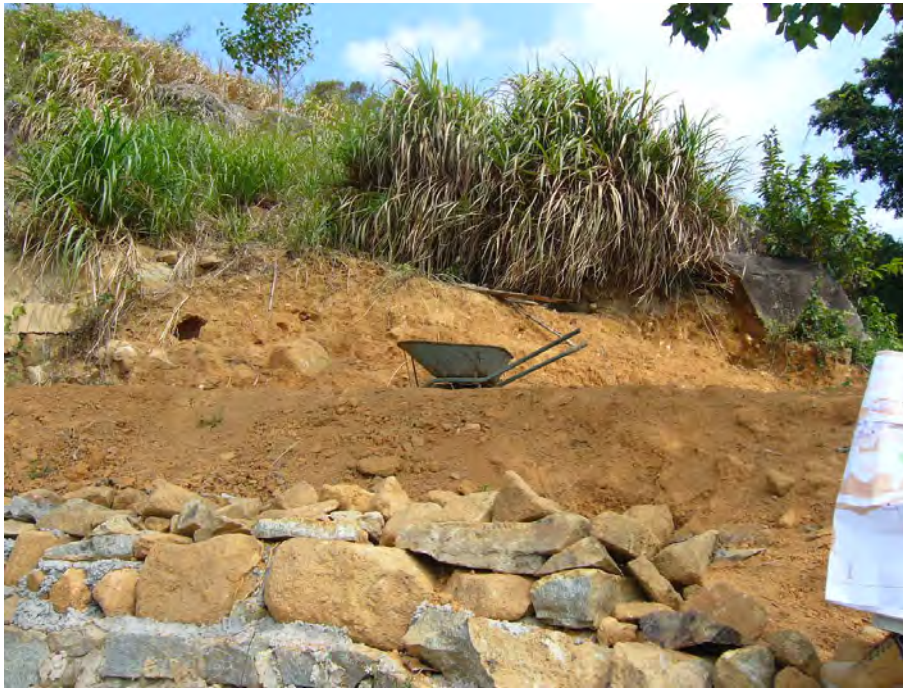
Plate 9 - Area with Unauthorized Cutting and Filling

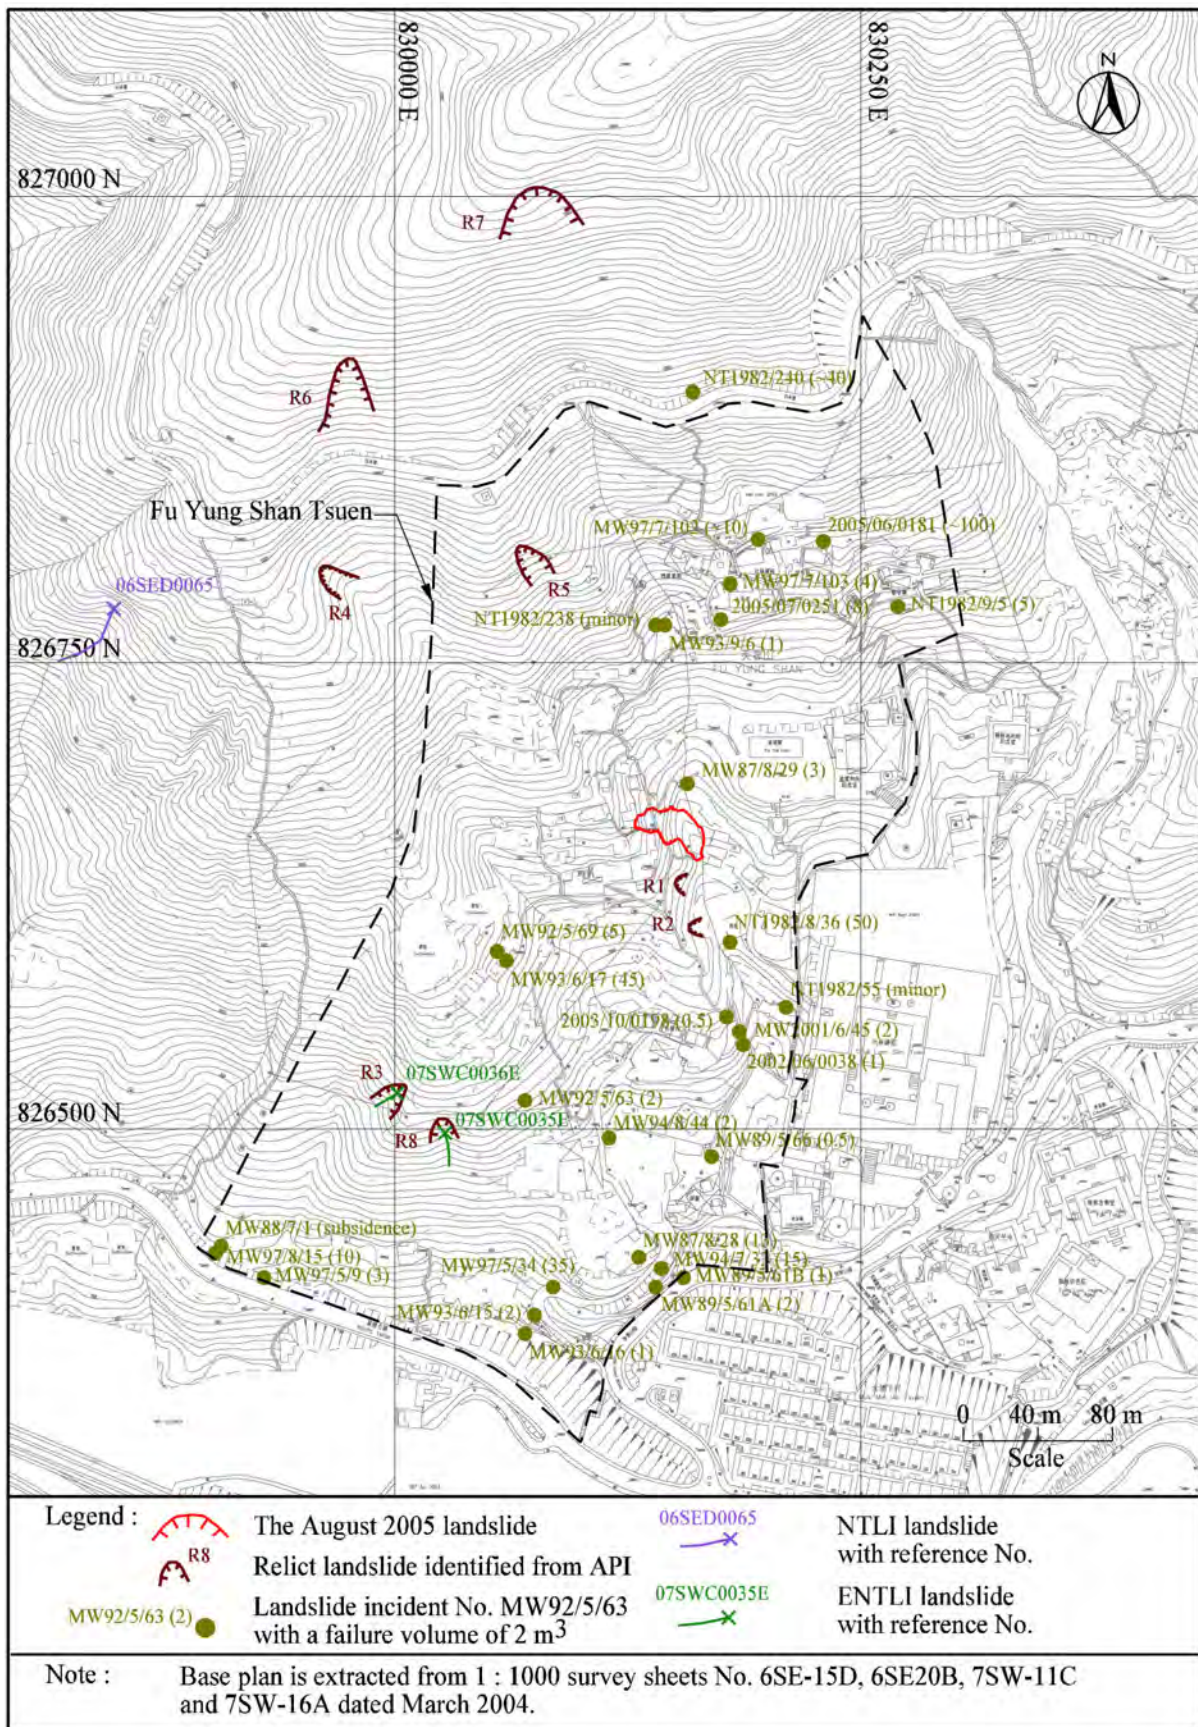
Figure A1 - Historical Landslides within and in the vicinity of Fu Yung Shan Tsuen

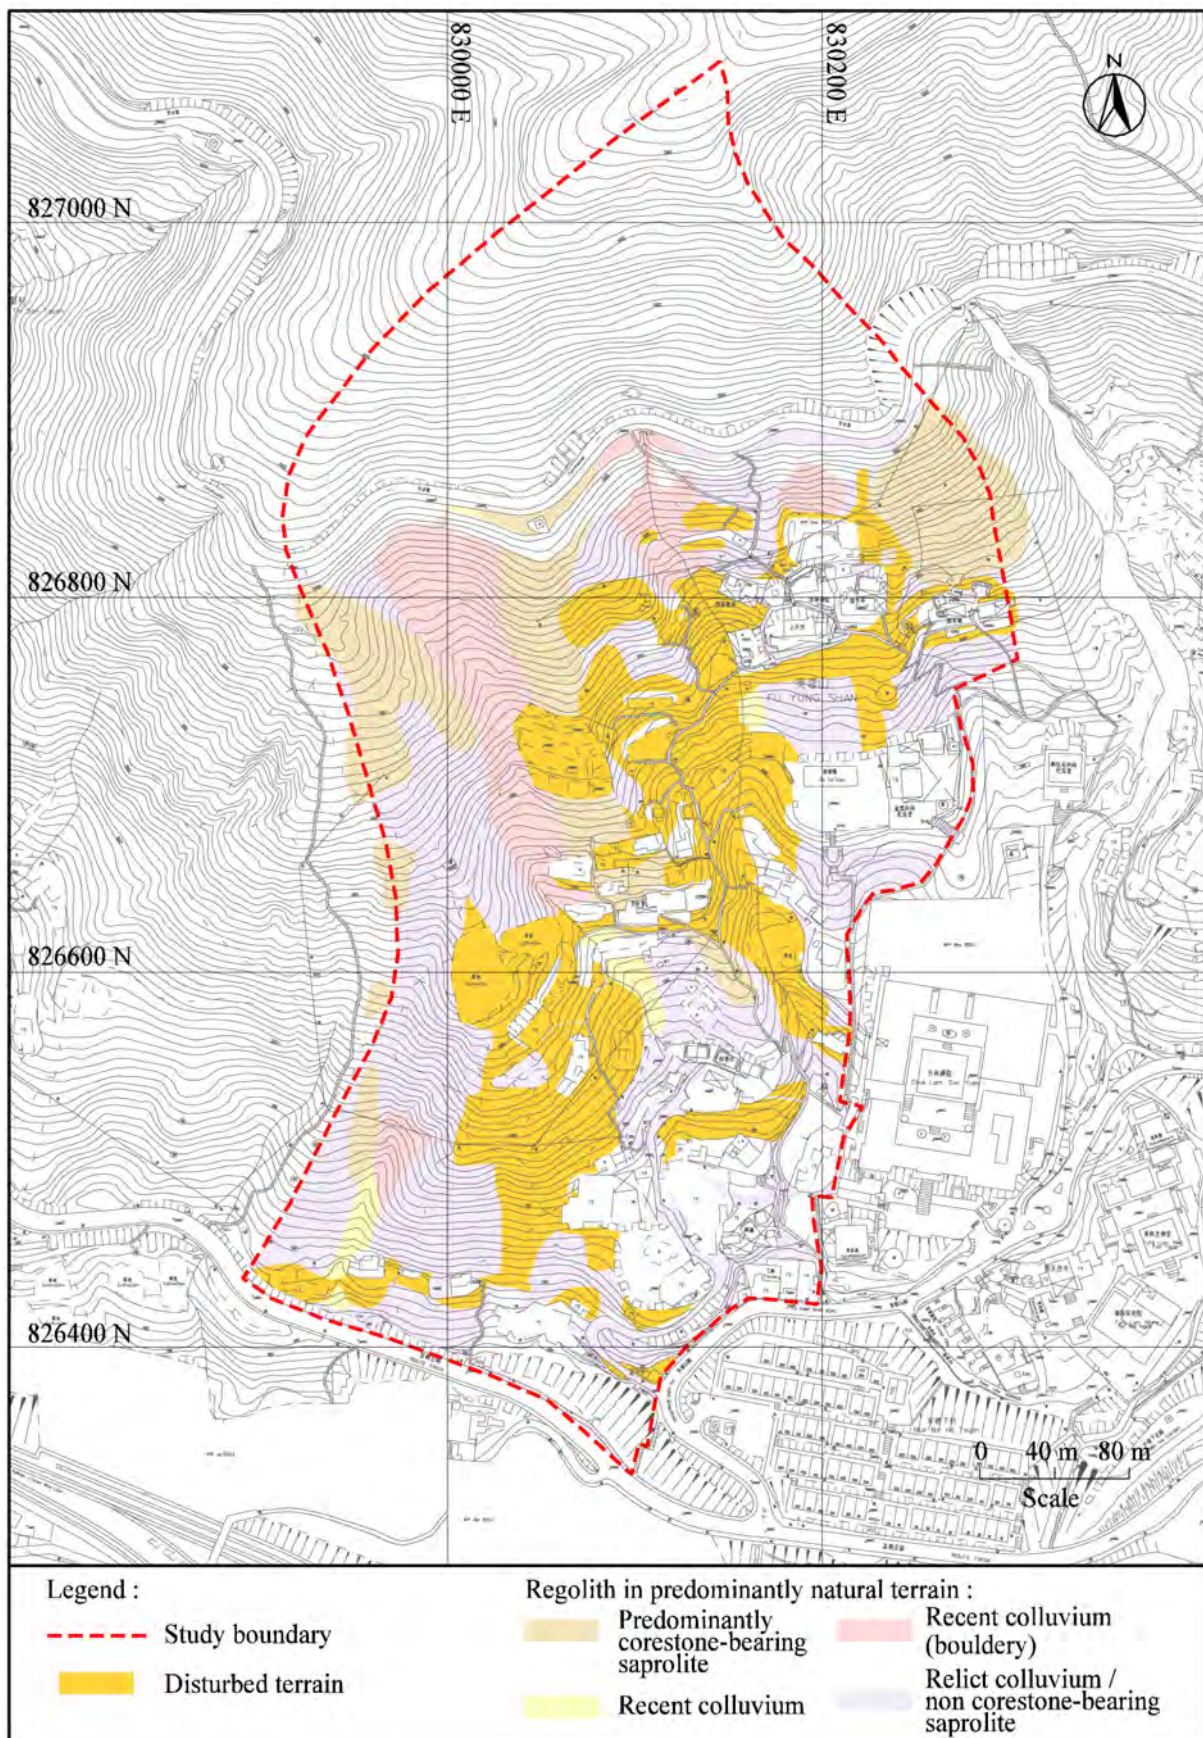
Figure B1 - Identified Regolith Units

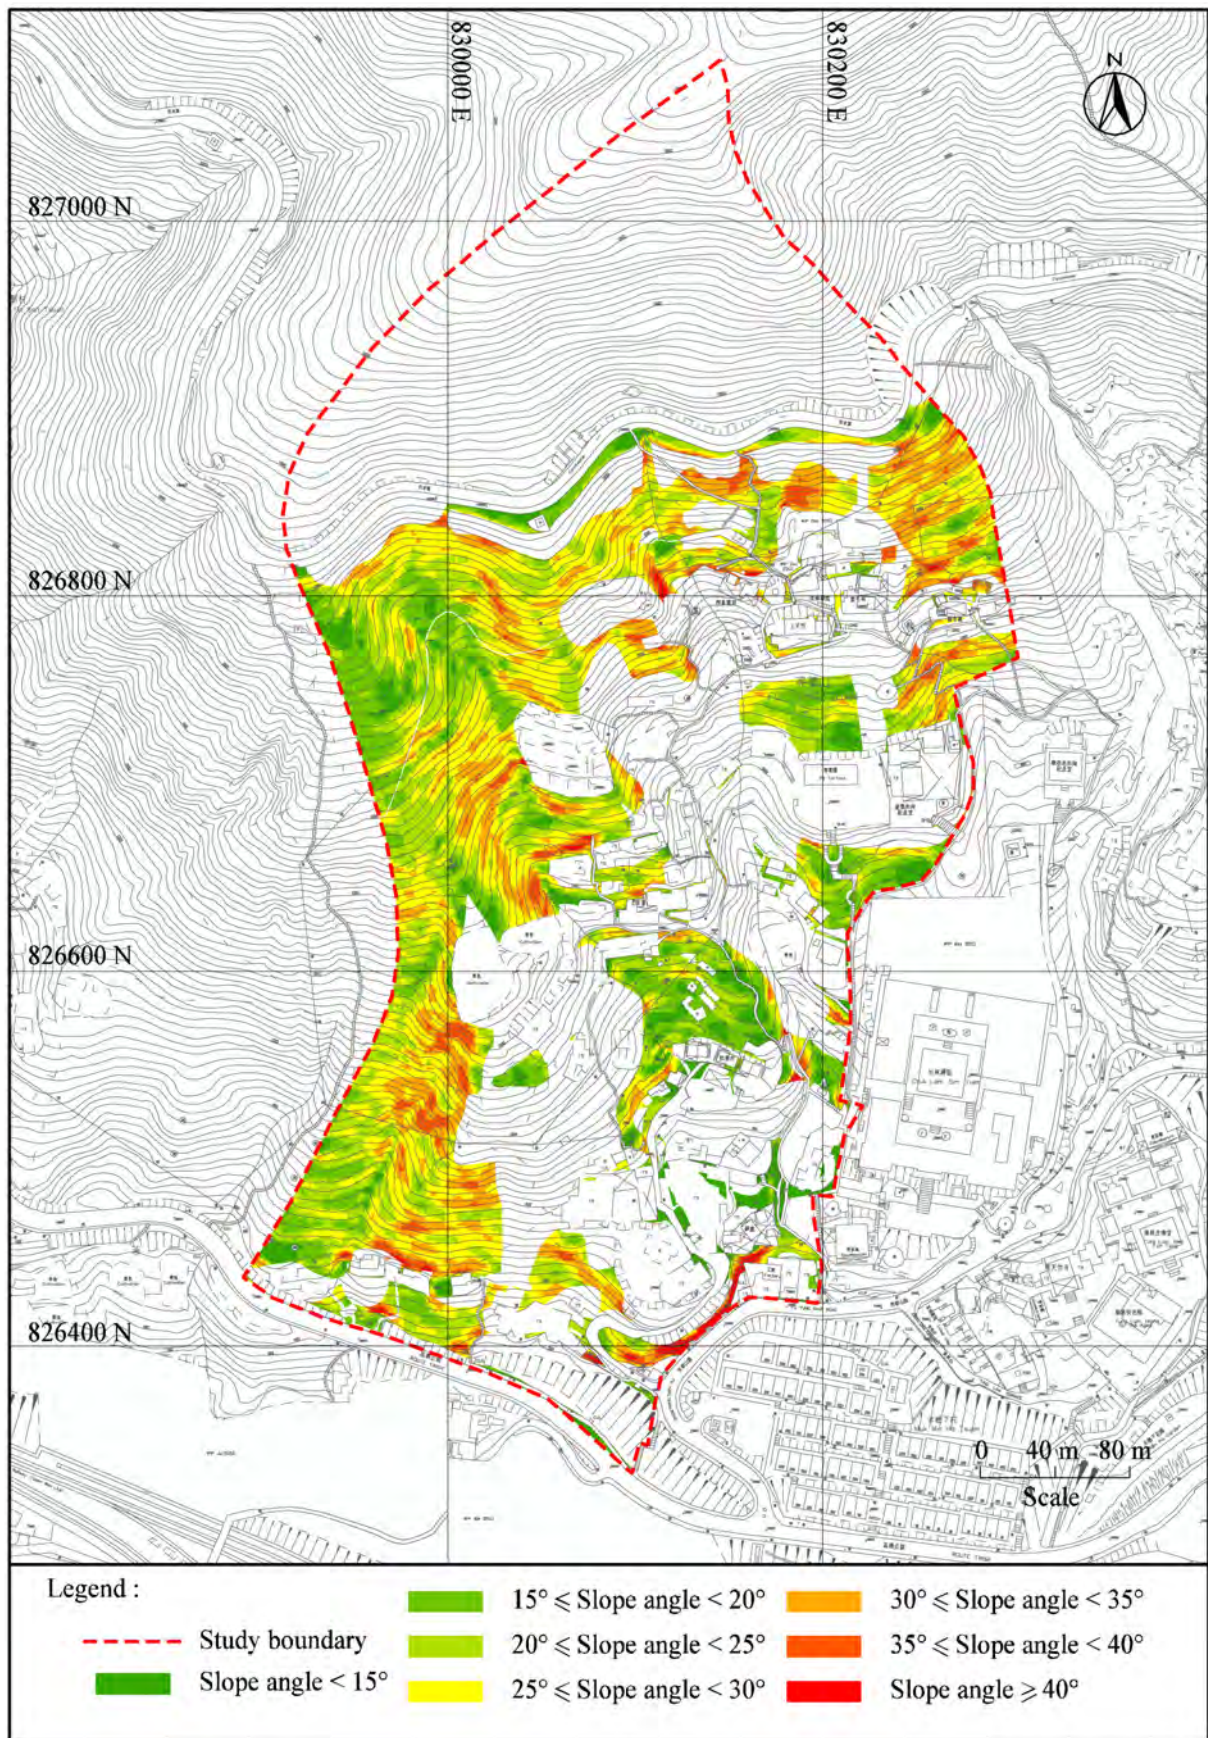
Figure B2 - Spatial Distribution of Different Classes of Terrain Topology on Natural Hillside

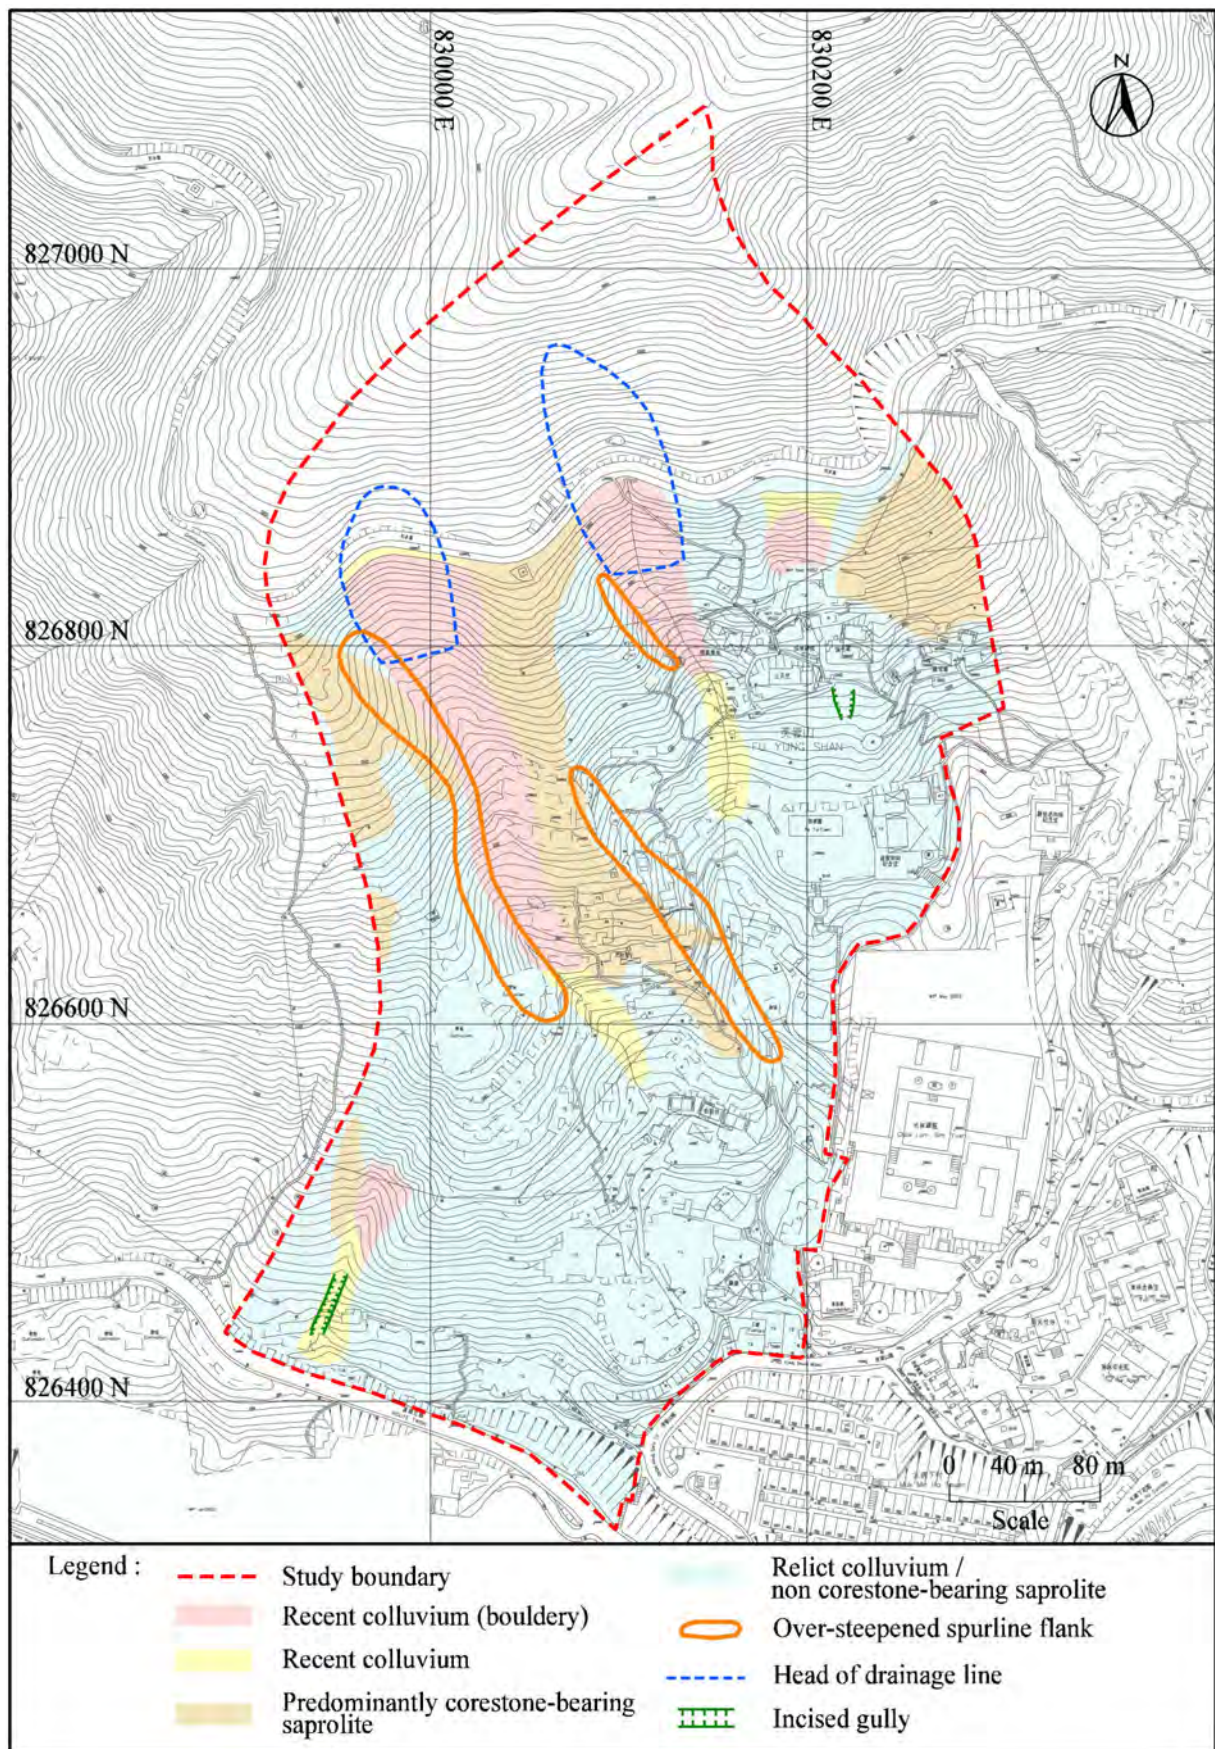
Figure B3 - Spatial Distribution of Other Key Susceptibility Attributes on Natural Hillside

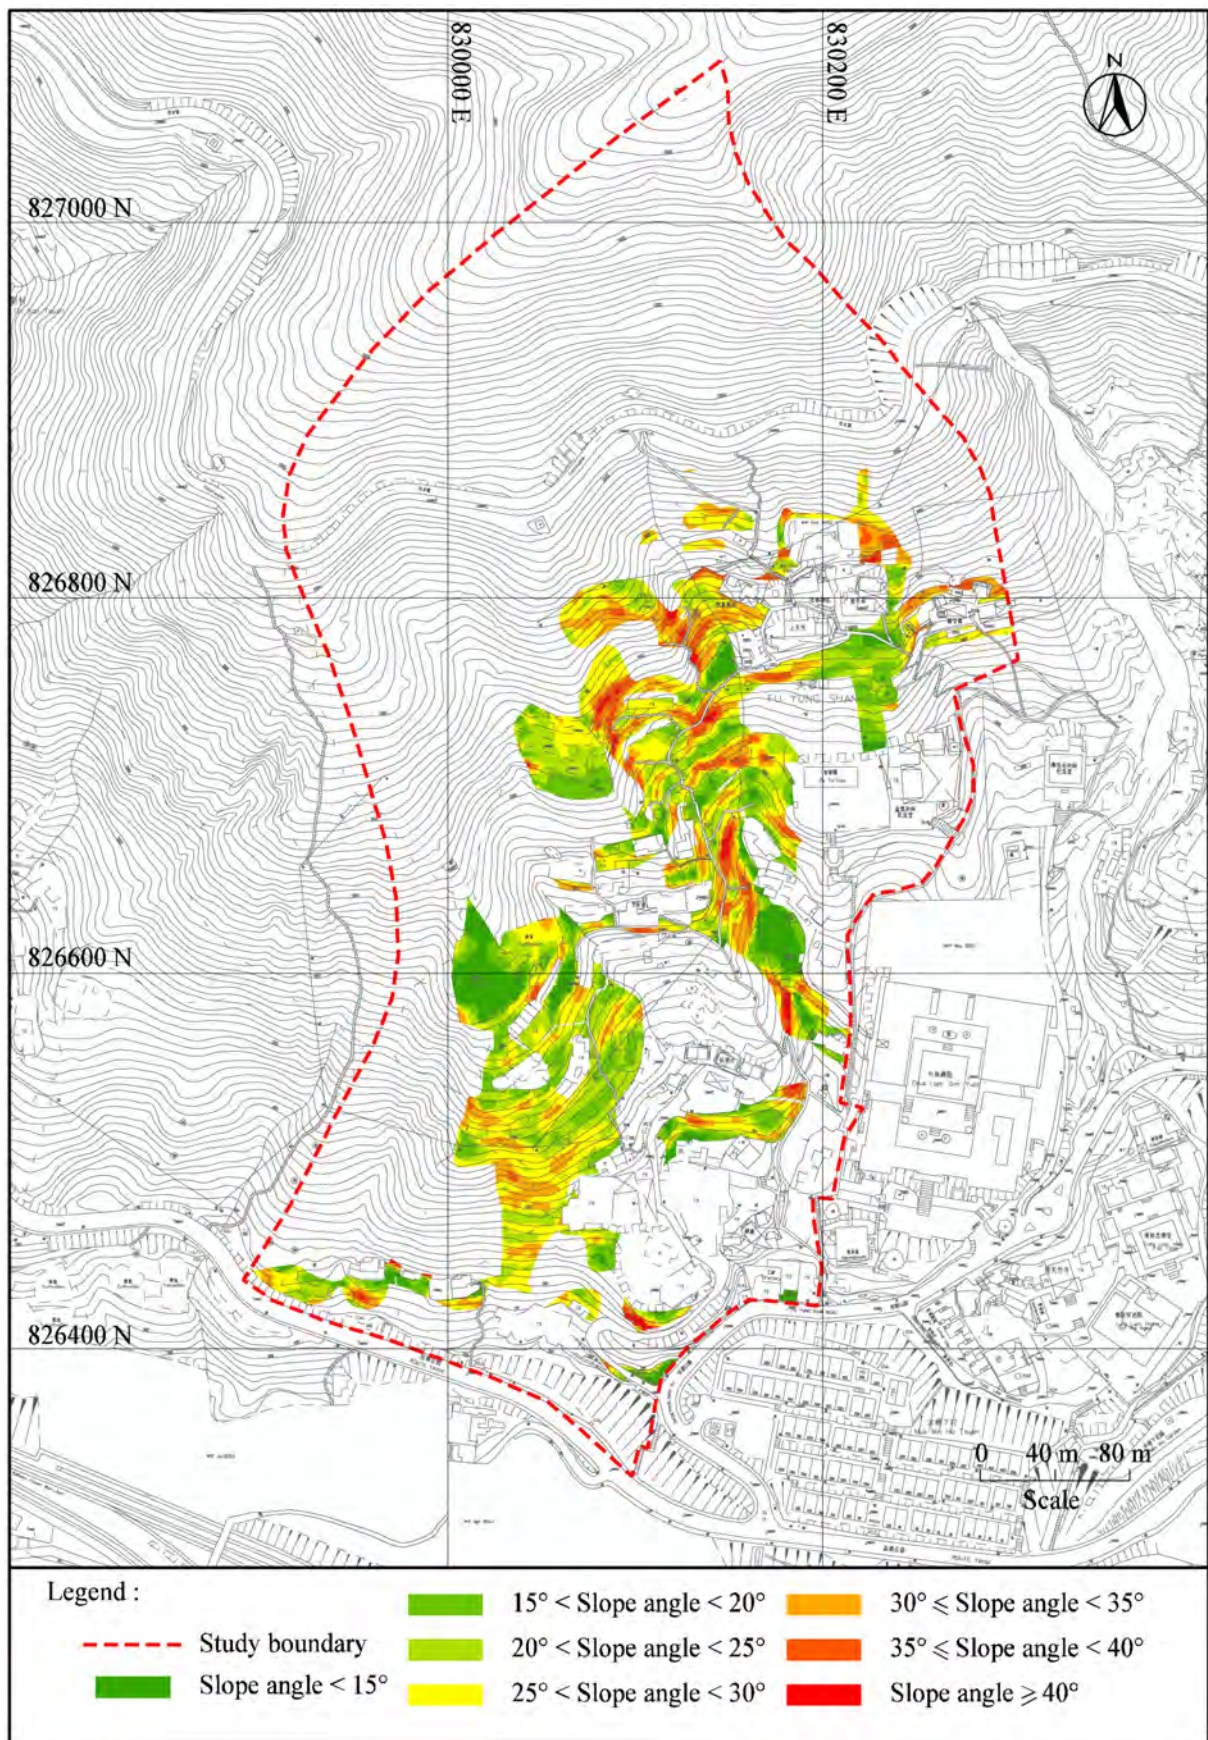
Figure B4 - Spatial Distribution of Different Classes of Terrain Topology on Disturbed Hillside
