**QUANTITATIVE RISK
ASSESSMENT OF LANDSLIDE
HAZARDS AT
FU YUNG SHAN TSUEN,
TSUEN WAN**

GEO REPORT No. 224

H.N. Wong & F.W.Y. Ko

**GEOTECHNICAL ENGINEERING OFFICE
CIVIL ENGINEERING AND DEVELOPMENT DEPARTMENT
THE GOVERNMENT OF THE HONG KONG
SPECIAL ADMINISTRATIVE REGION**

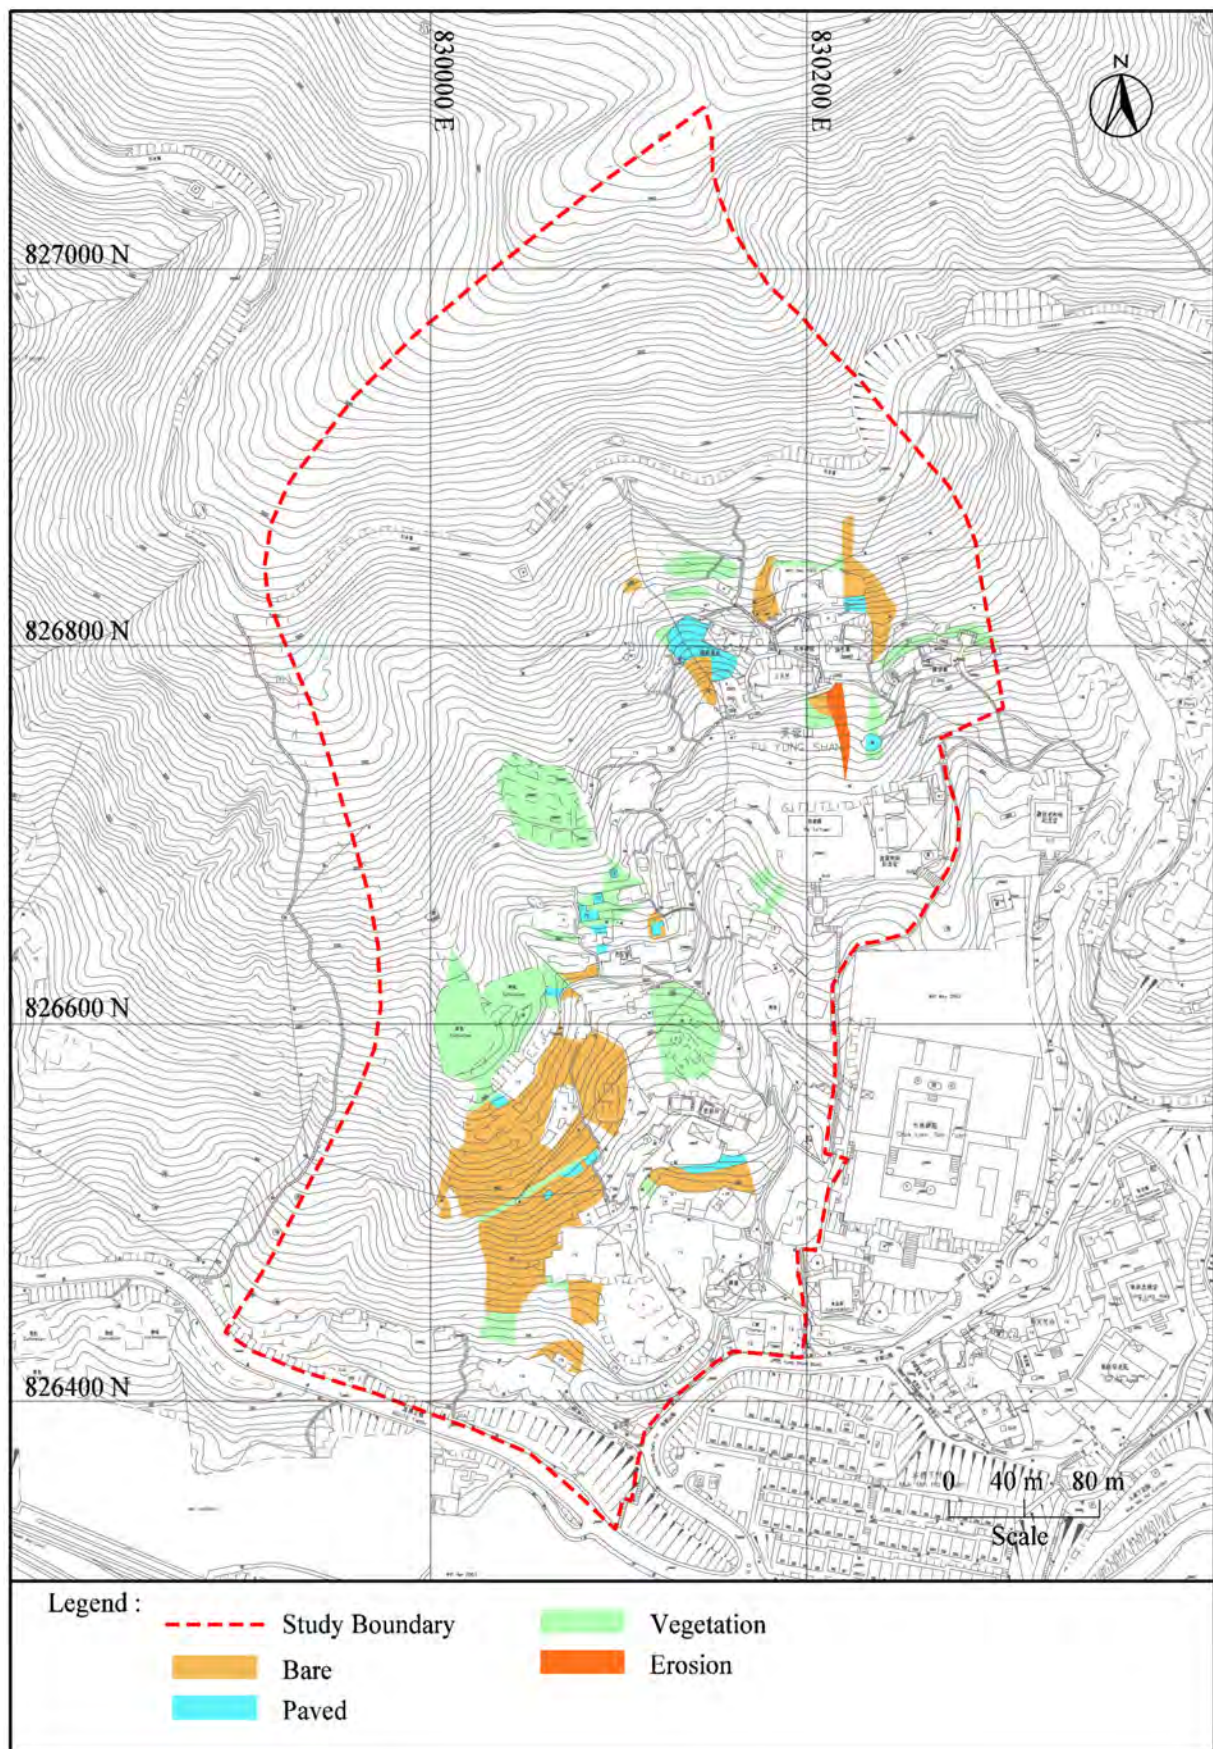
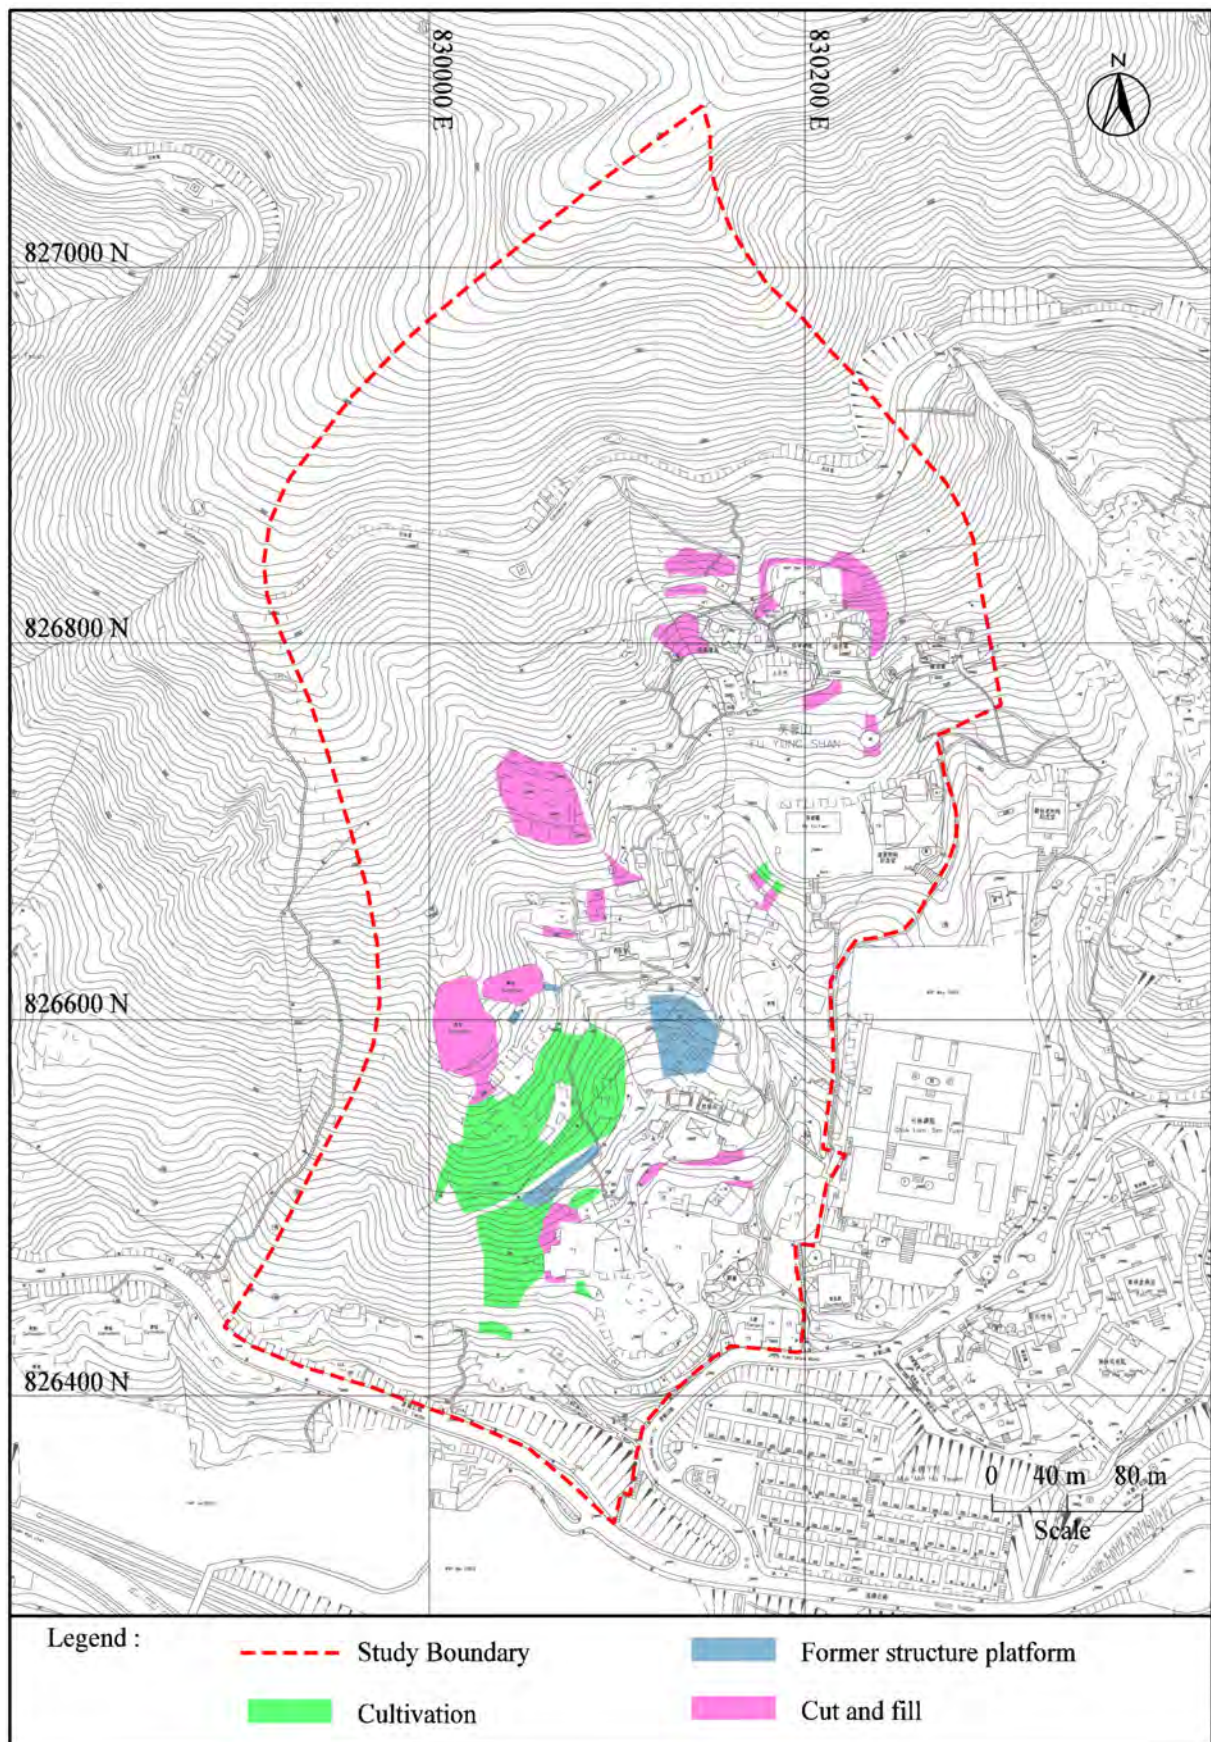
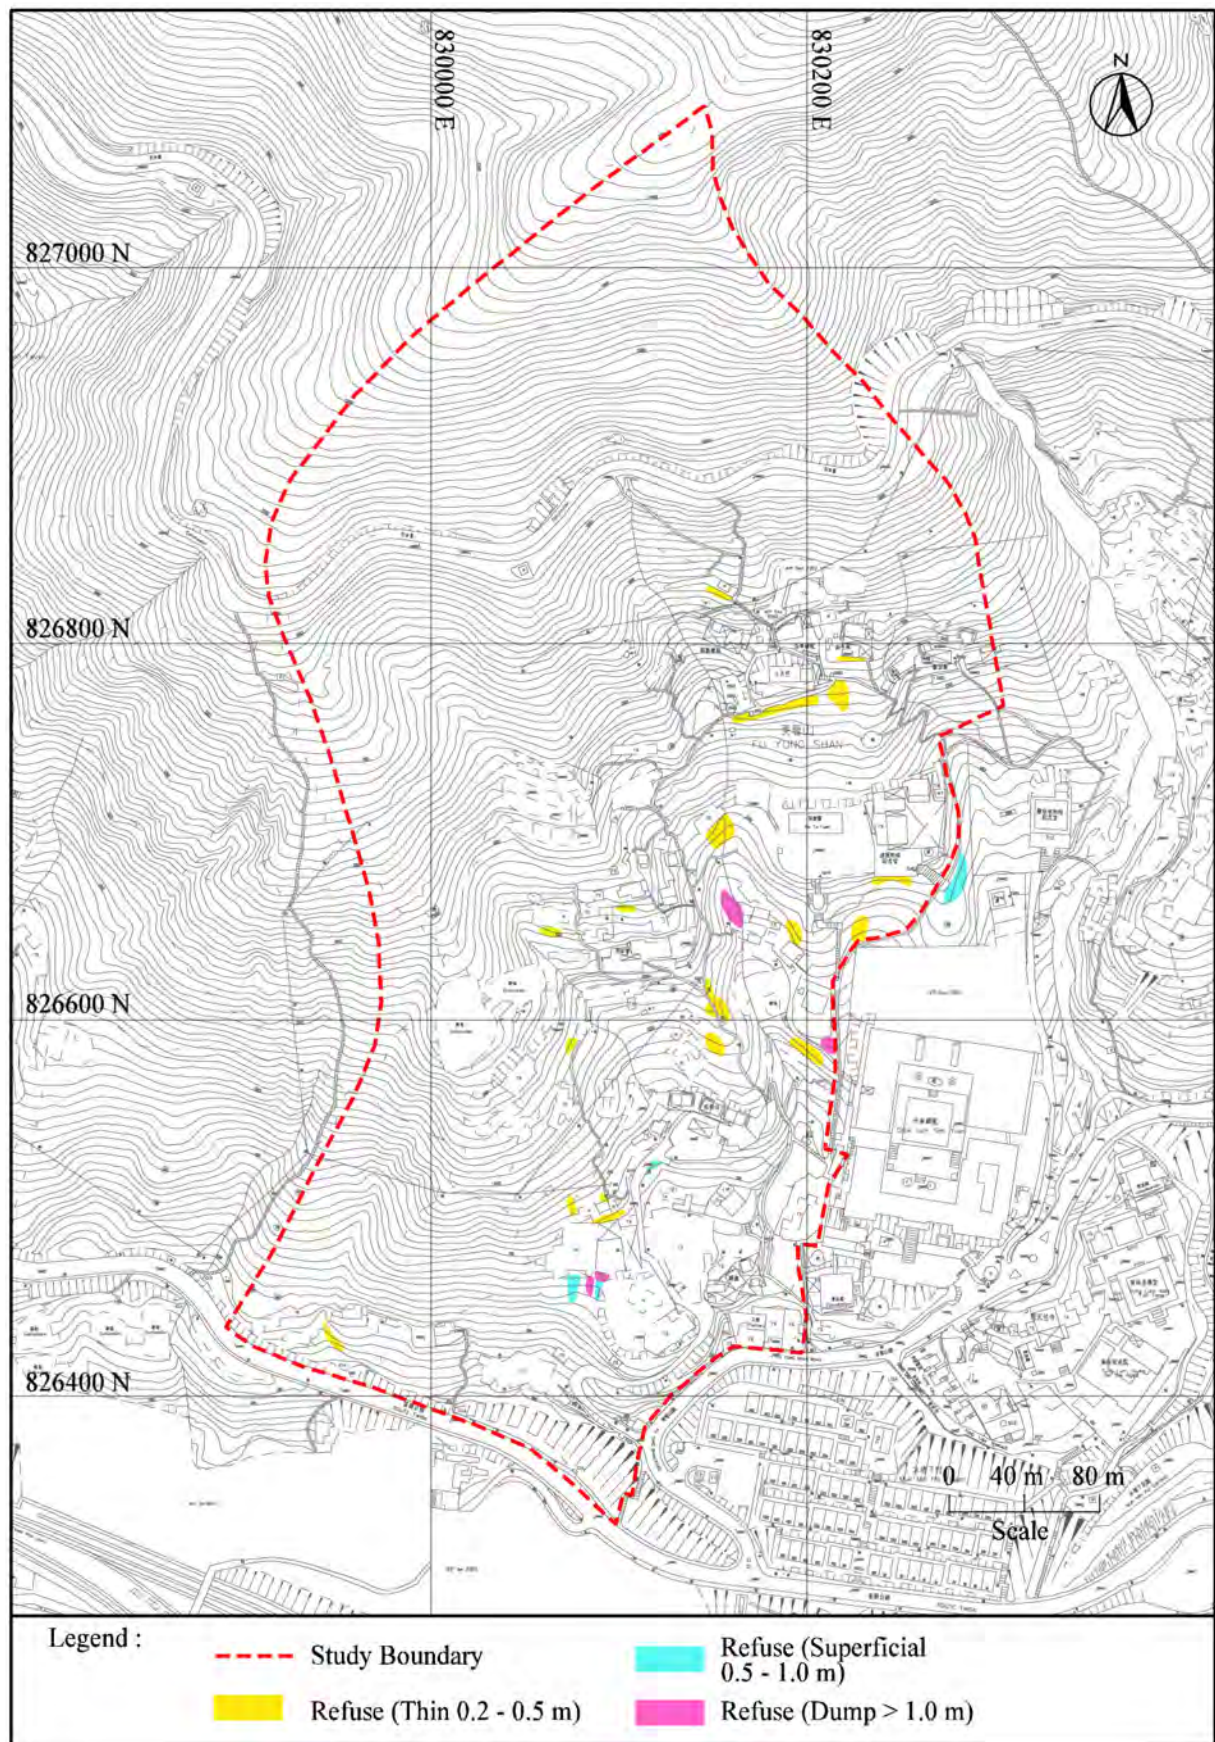
Figure B5 - Spatial Distribution of Different Surface Conditions on Disturbed Hillside (Sheet 1 of 3)

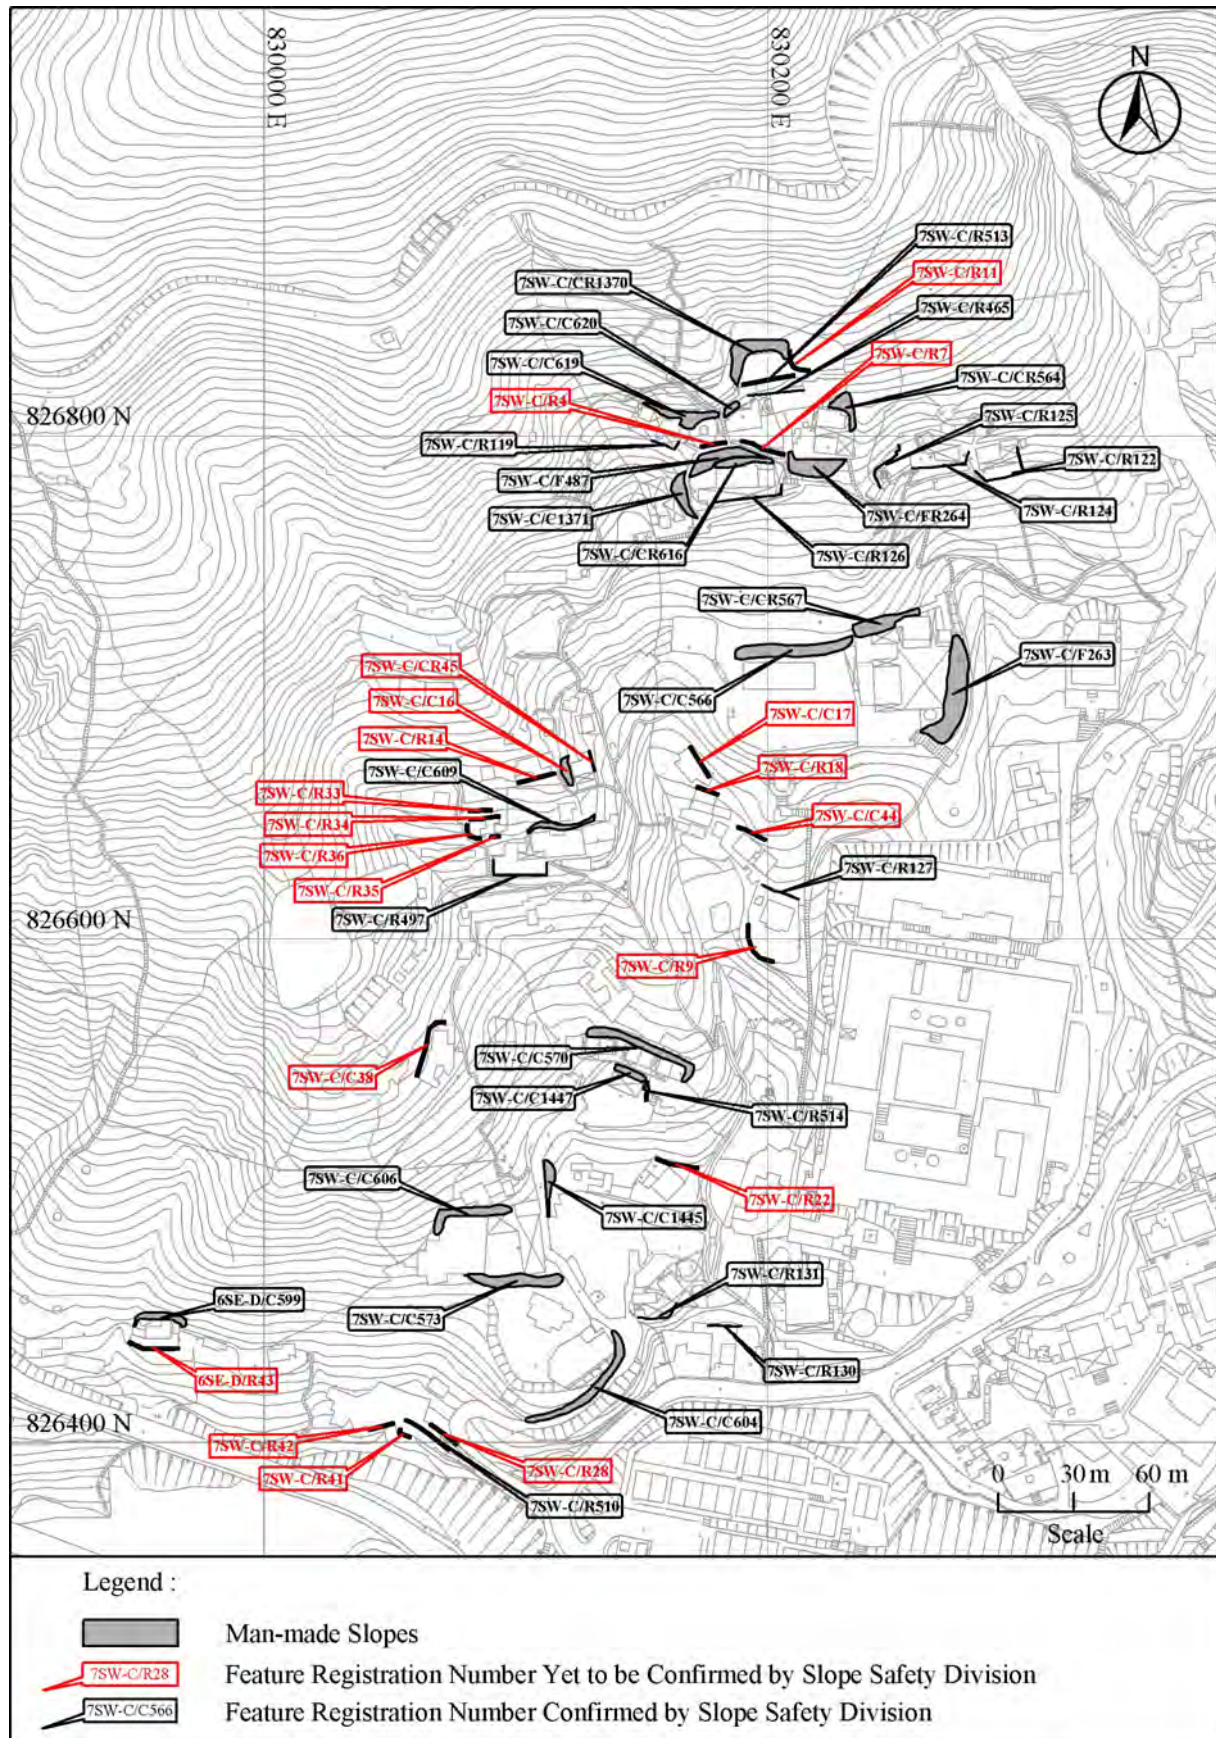
Figure D1 - Spatial Distribution of Man-made Slopes Affecting Facilities

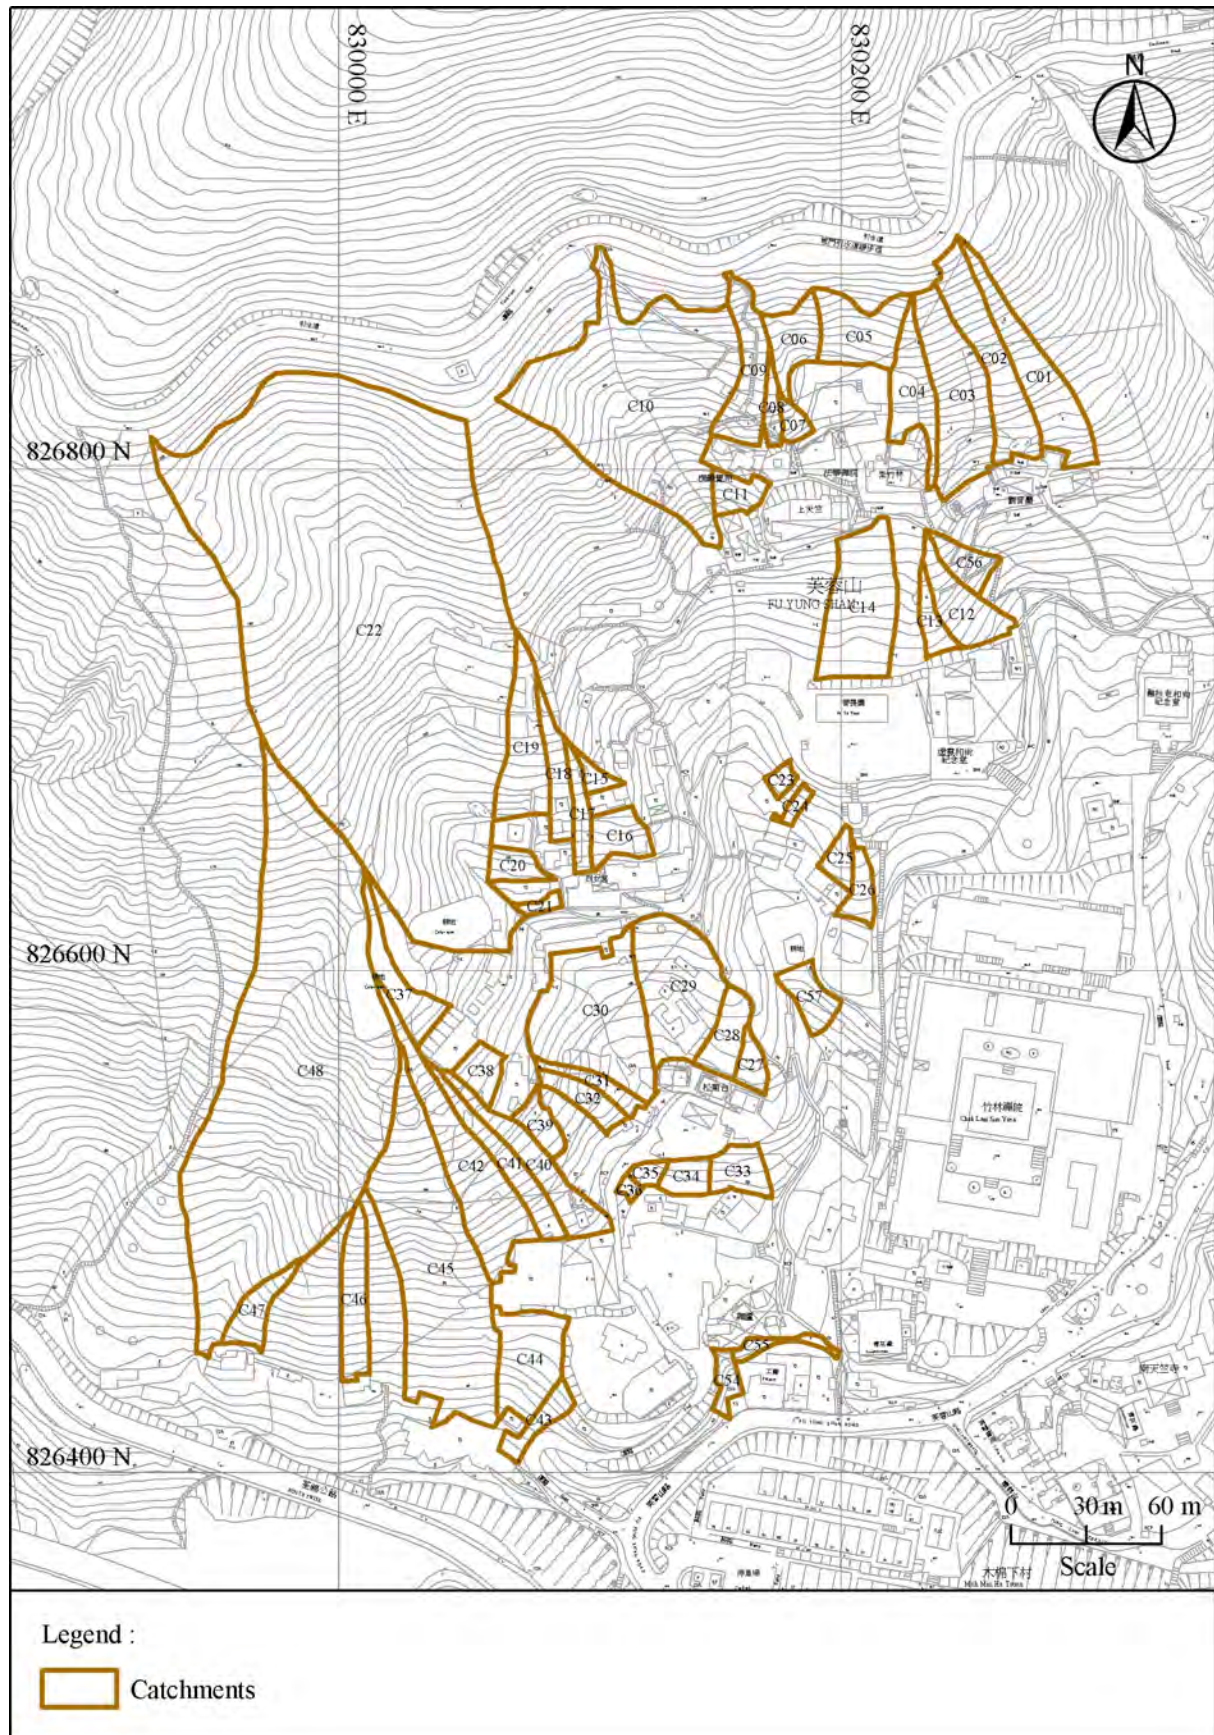
Figure D2 - Spatial Distribution of Hillside Catchments Directly Overlooking Facilities

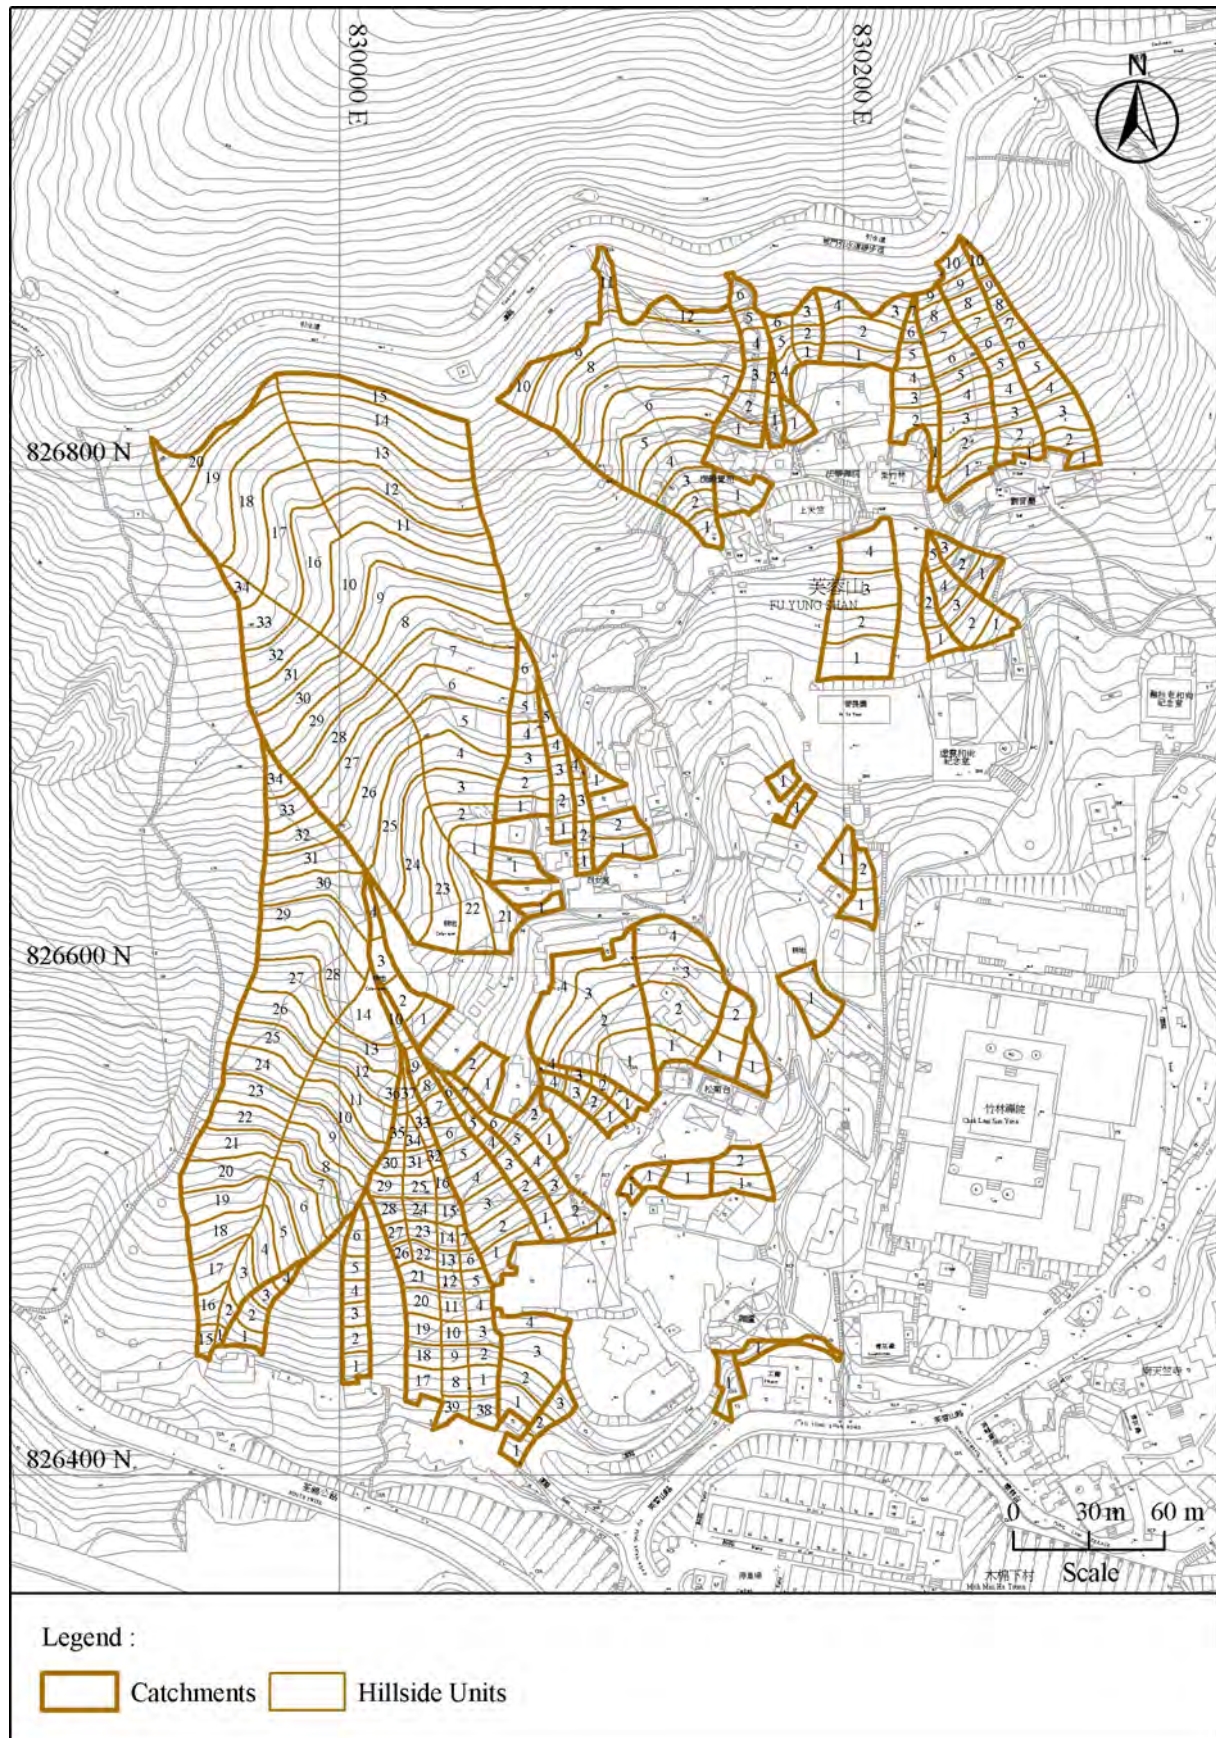
Figure E1 - Layout of Hillside Units

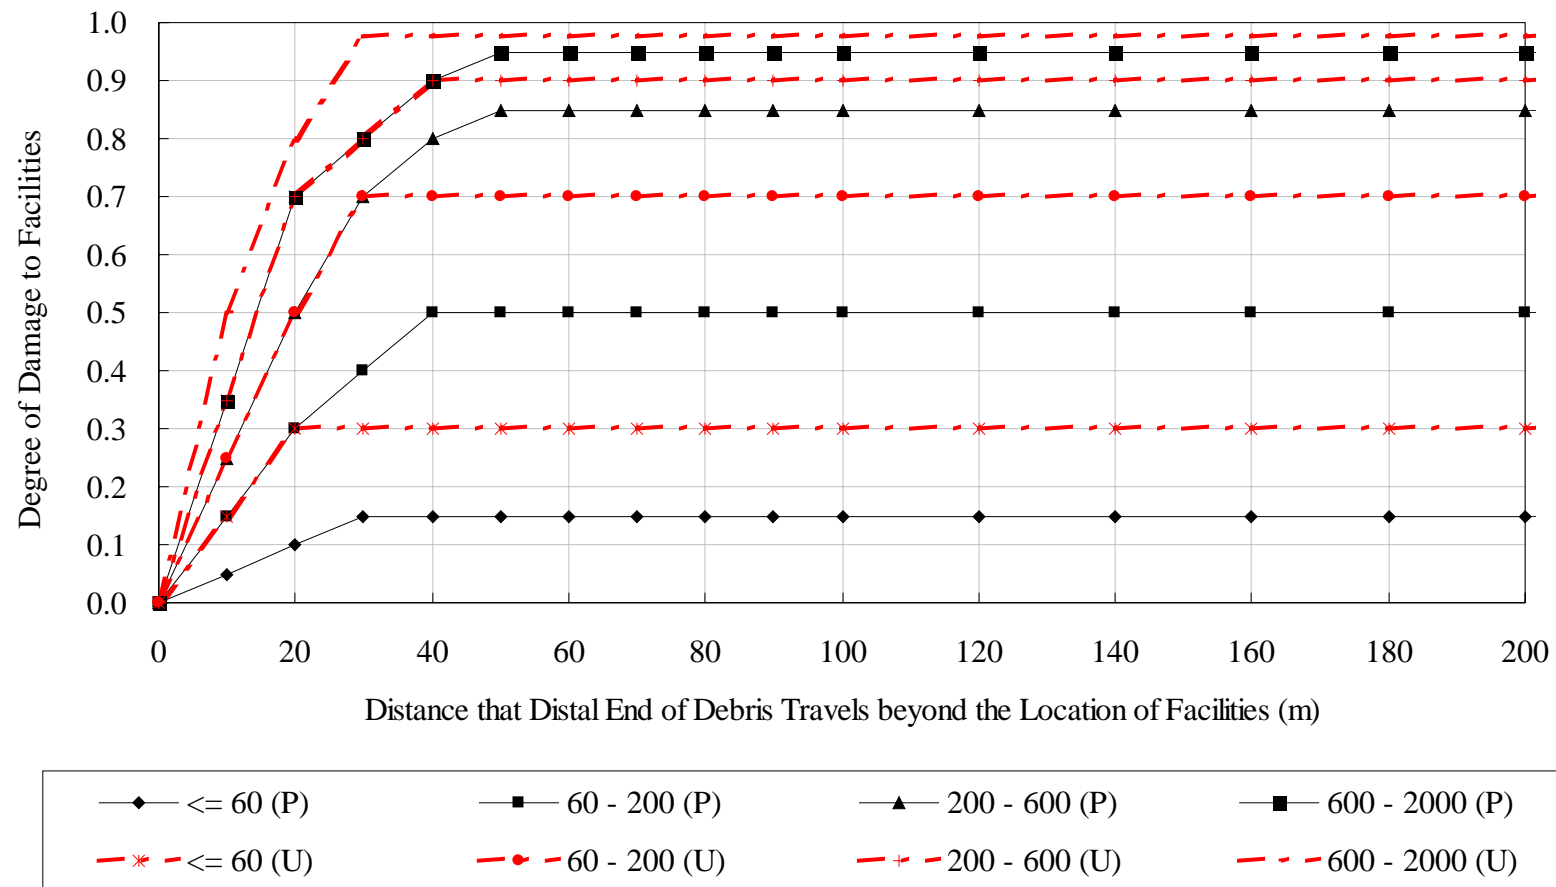
Note: P represents substantial structures while U represents flimsy structures or unprotected facilities.

Figure E2 - Degree of Damage to Facilities Affected by Different Types of Landslide Hazards

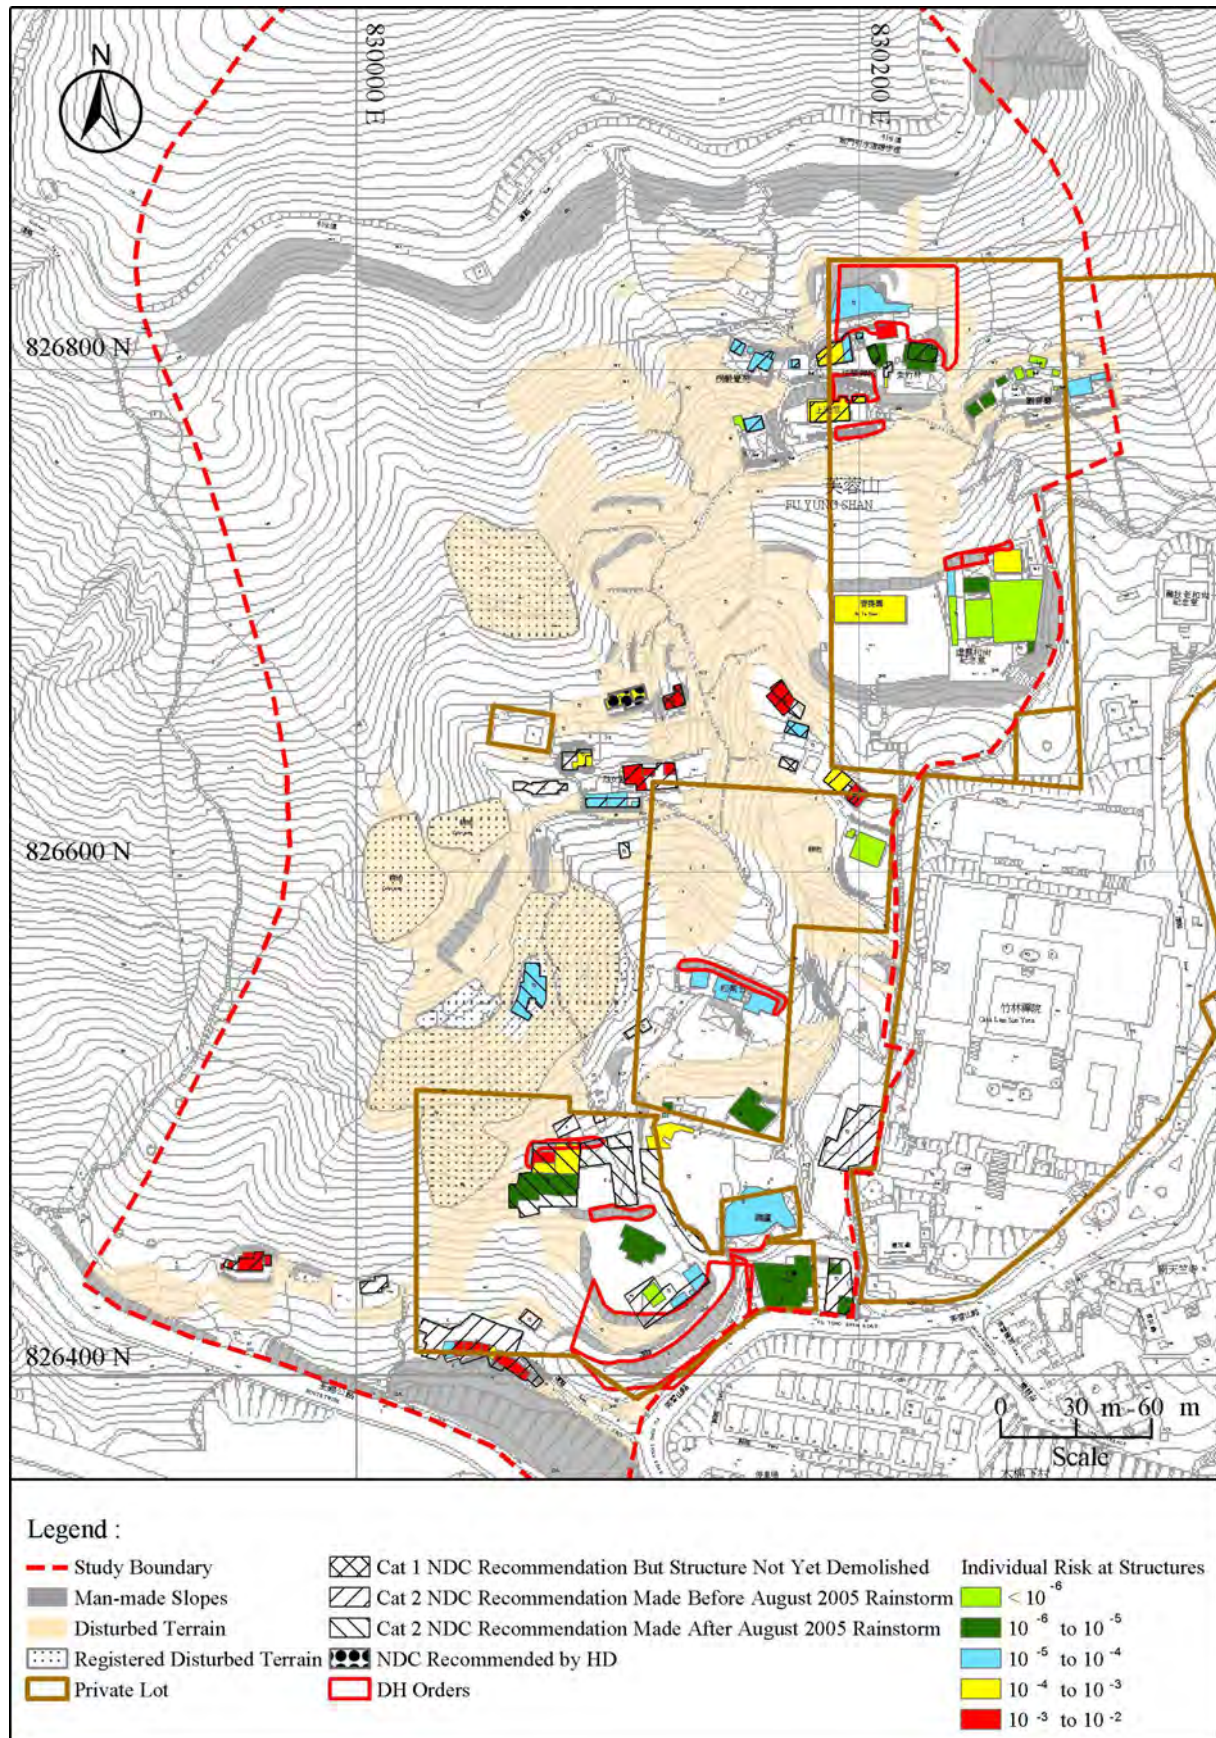
Figure F1 - Spatial Distribution of PIR of Structures Affected by Man-made Slopes

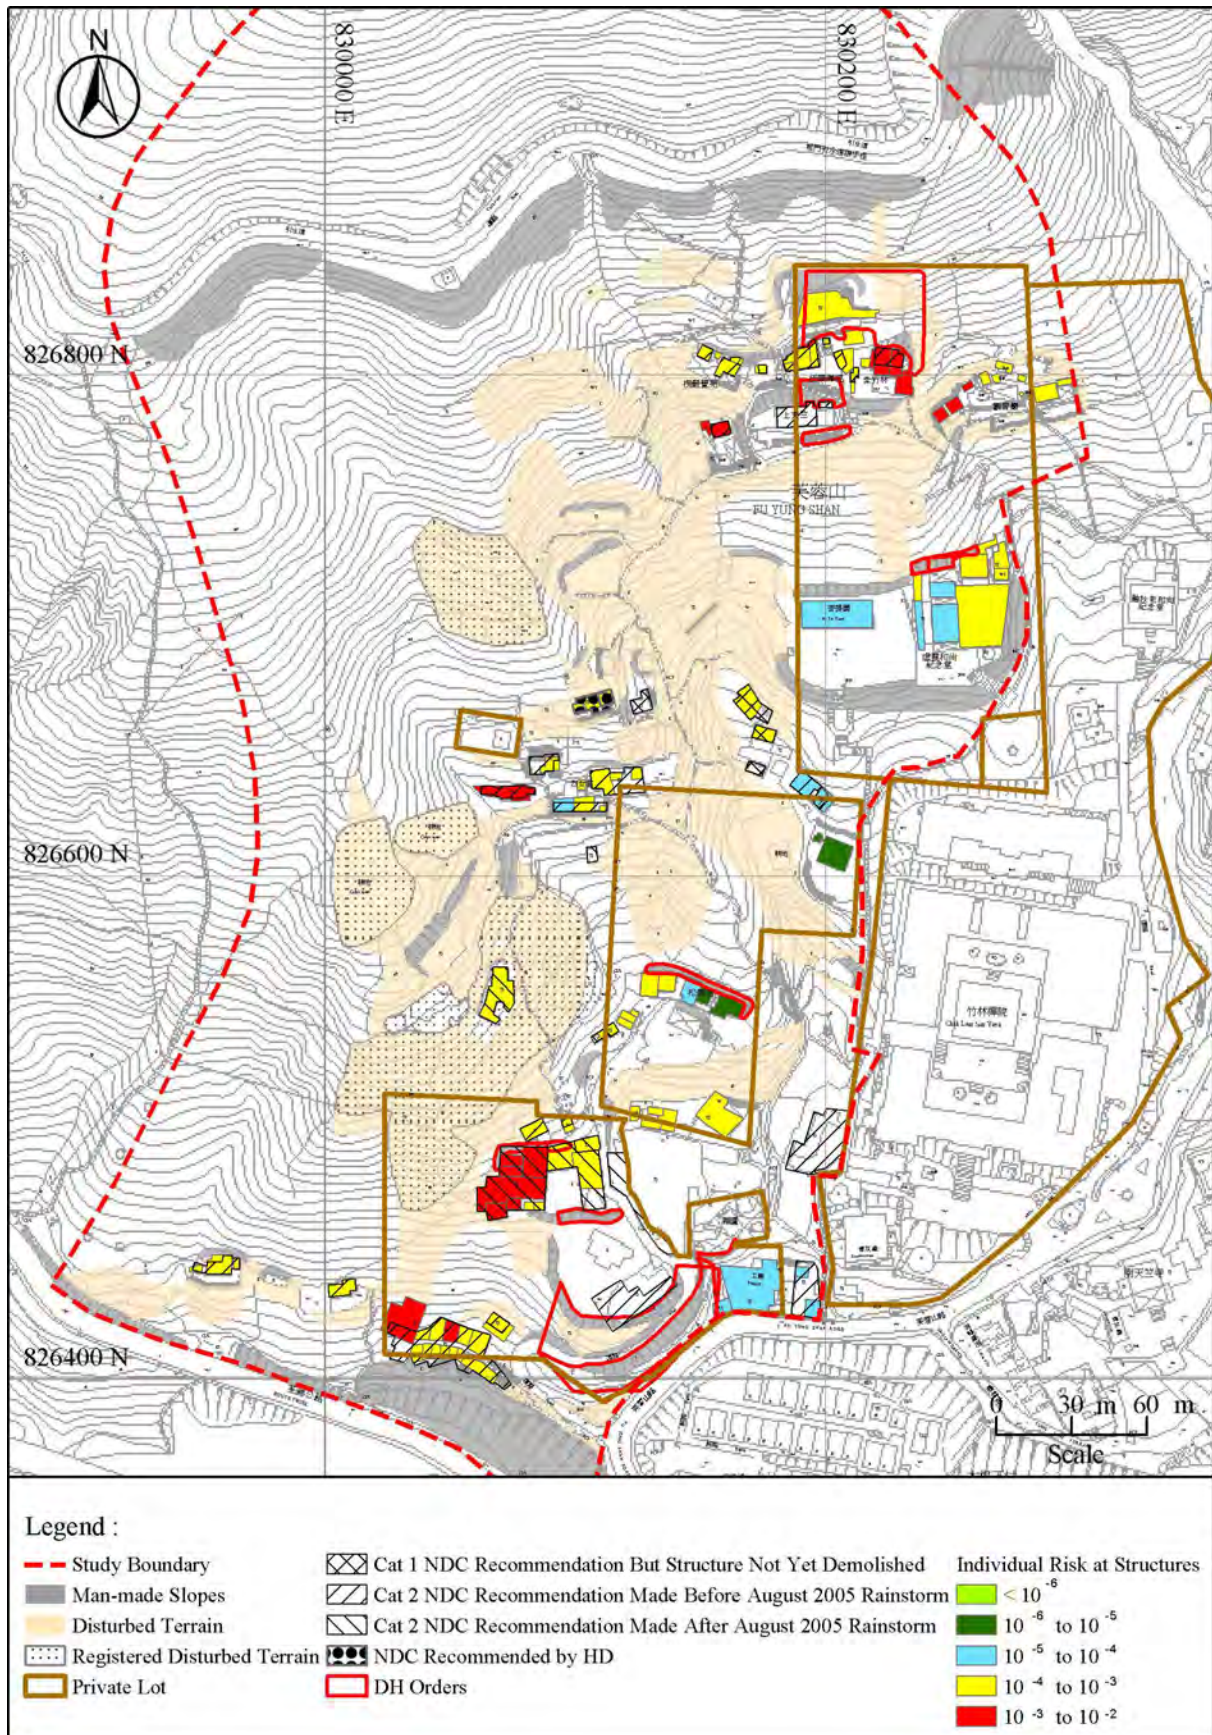
Figure F2 - Spatial Distribution of PIR of Structures Affected by Hillsides

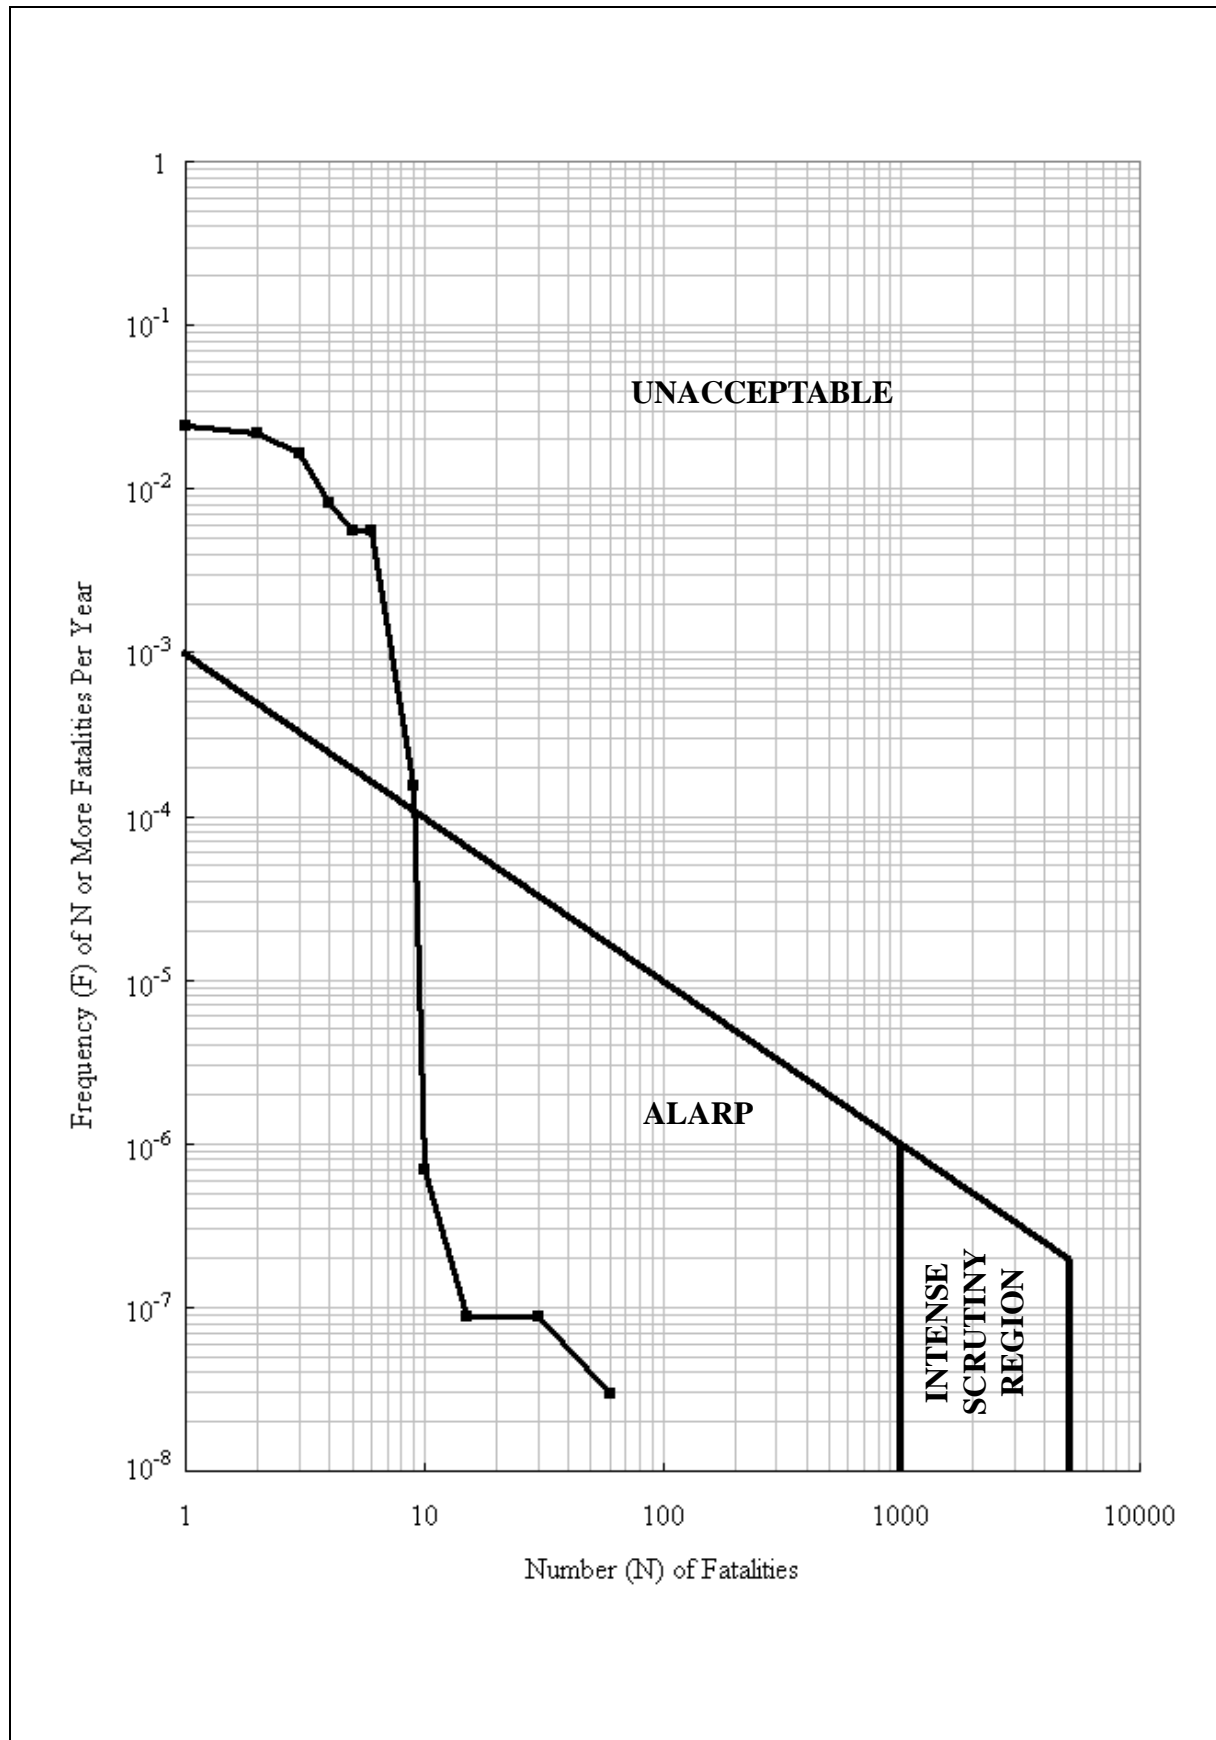
Figure F3 - F-N Curve for Structures Affected by Man-made Slopes

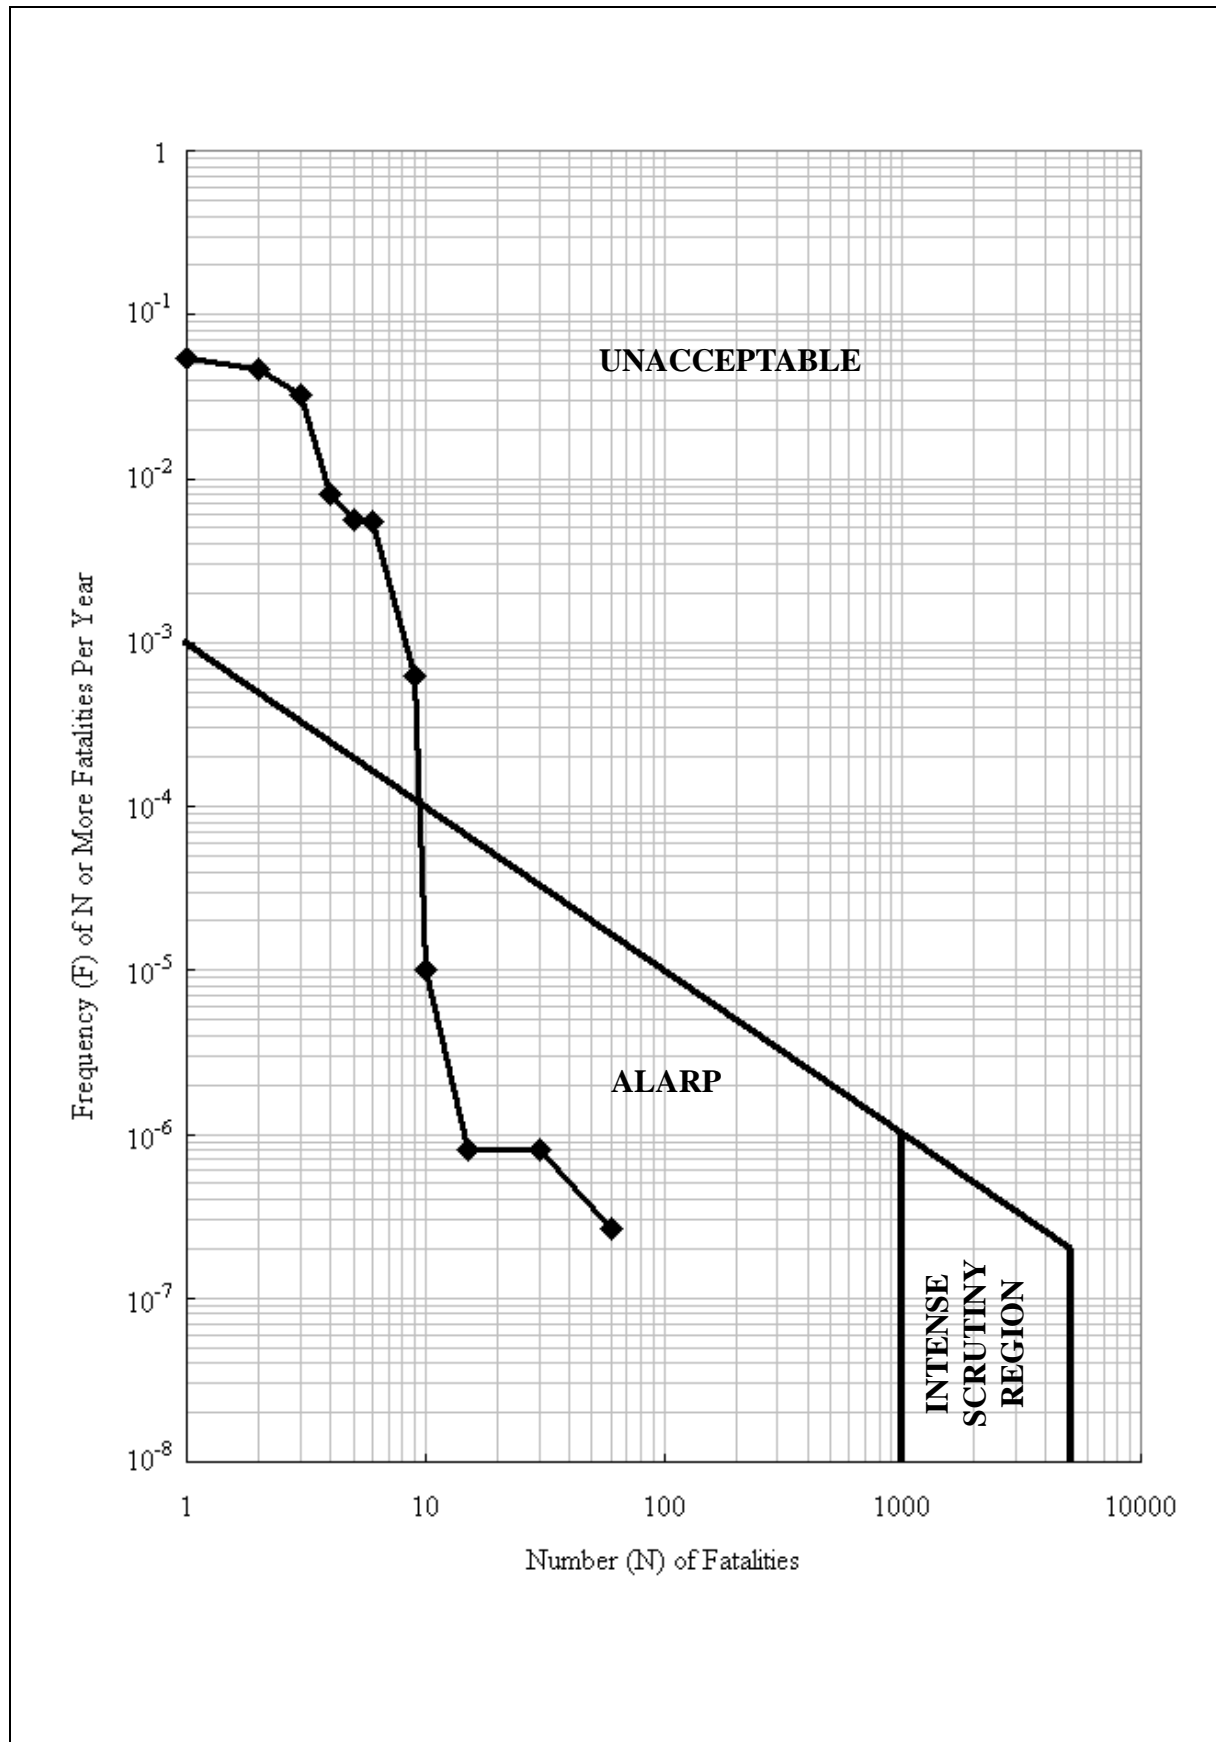
Figure F4 - F-N Curve for Structures Affected by Hillsides
