**QUANTITATIVE RISK
ASSESSMENT OF LANDSLIDE
HAZARDS AT
FU YUNG SHAN TSUEN,
TSUEN WAN**

GEO REPORT No. 224

H.N. Wong & F.W.Y. Ko

**GEOTECHNICAL ENGINEERING OFFICE
CIVIL ENGINEERING AND DEVELOPMENT DEPARTMENT
THE GOVERNMENT OF THE HONG KONG
SPECIAL ADMINISTRATIVE REGION**

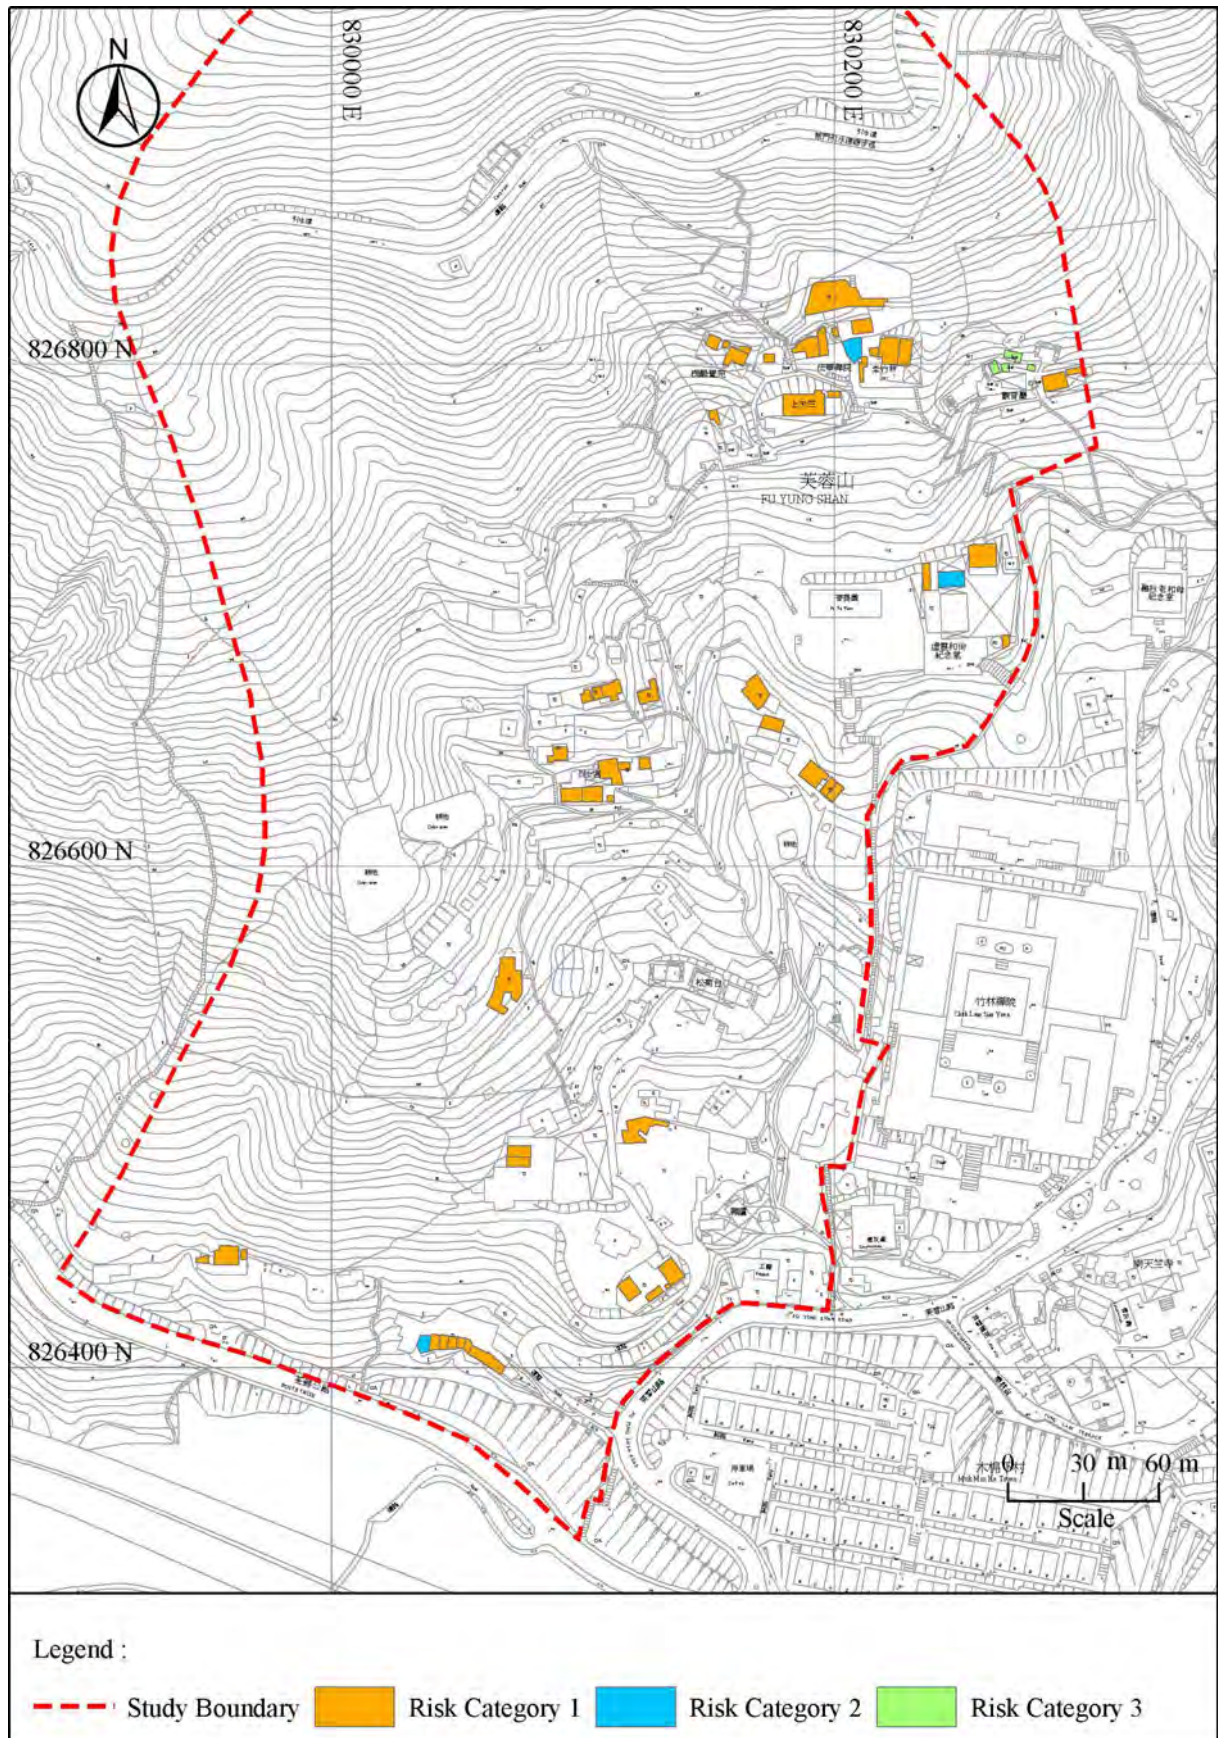
Figure G1 - Results of Qualitative Risk Assessment

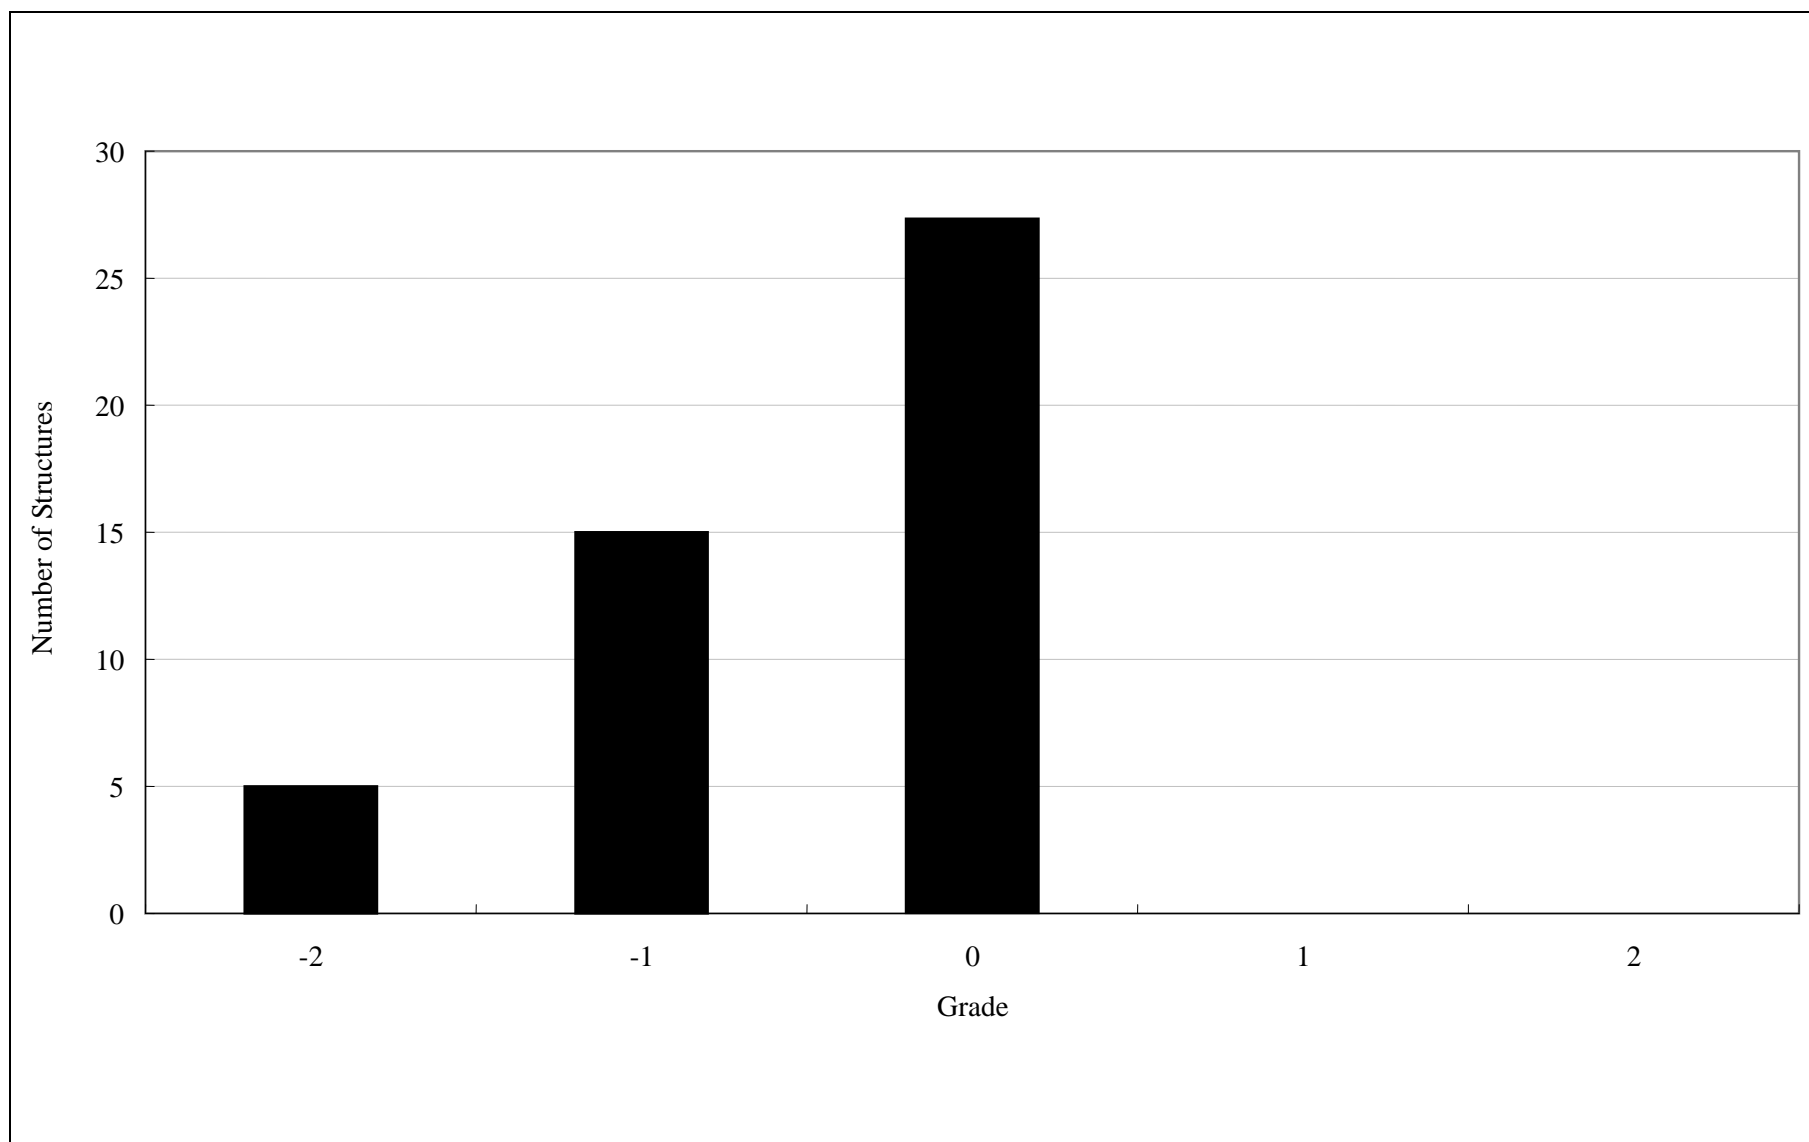
Figure G2 - Distribution of Rating of Comparative Assessment

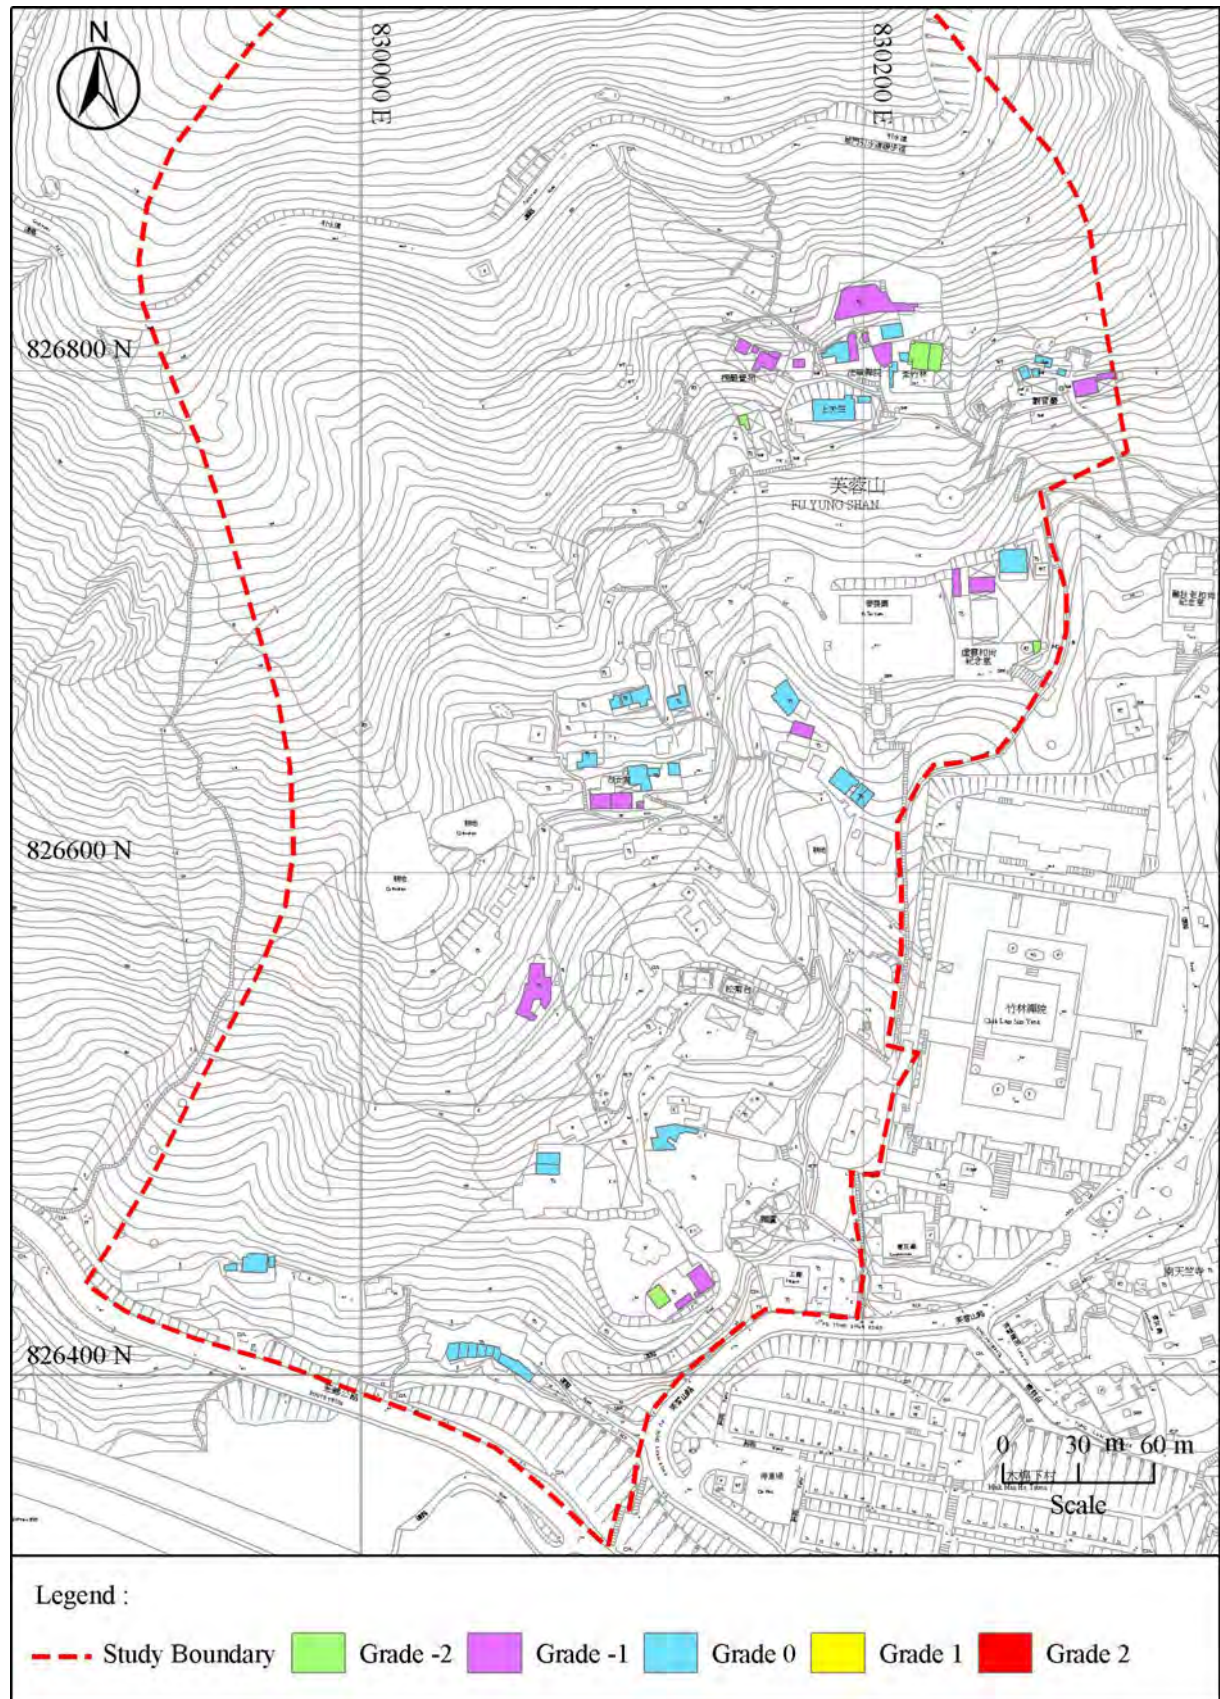
Figure G3 - Results of Comparative Assessment

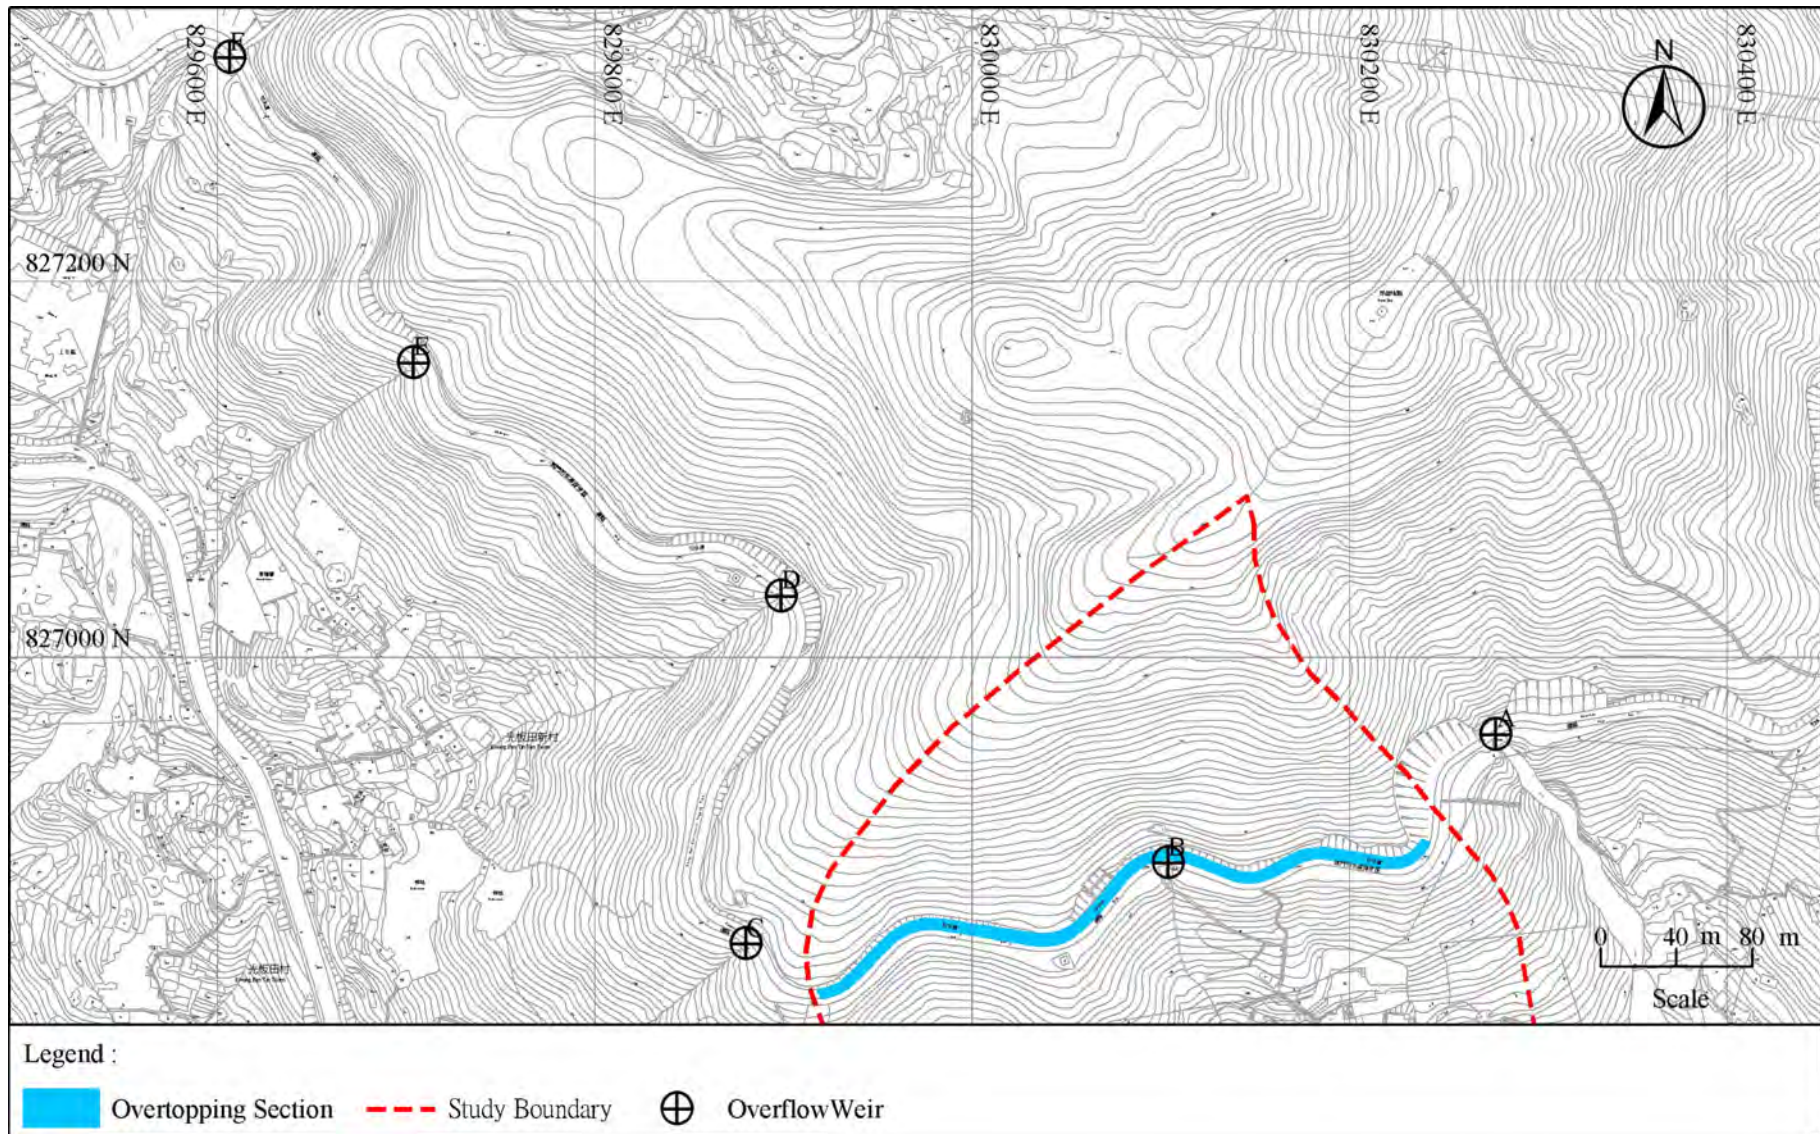
Figure H1 - Location of Overflowing Section of Catchwater and Overflow Weirs

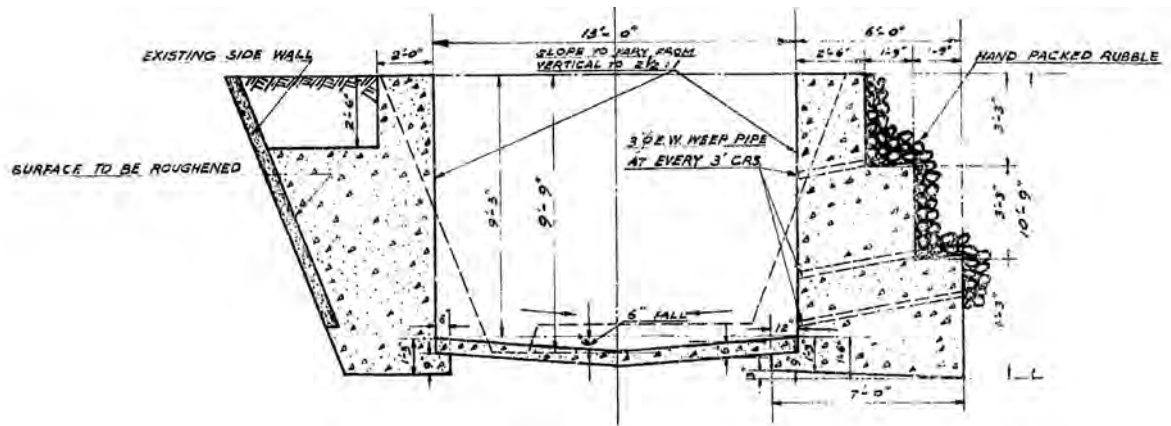
(a) Cross section of catchwater near and upstream of overflow weir A

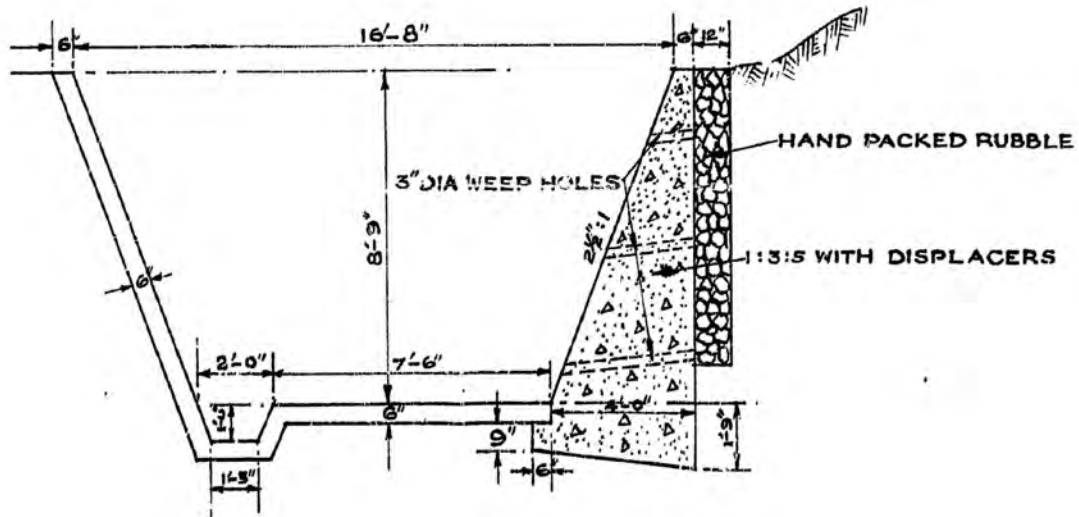
(b) Cross section of catchwater near overflow weirs B to F

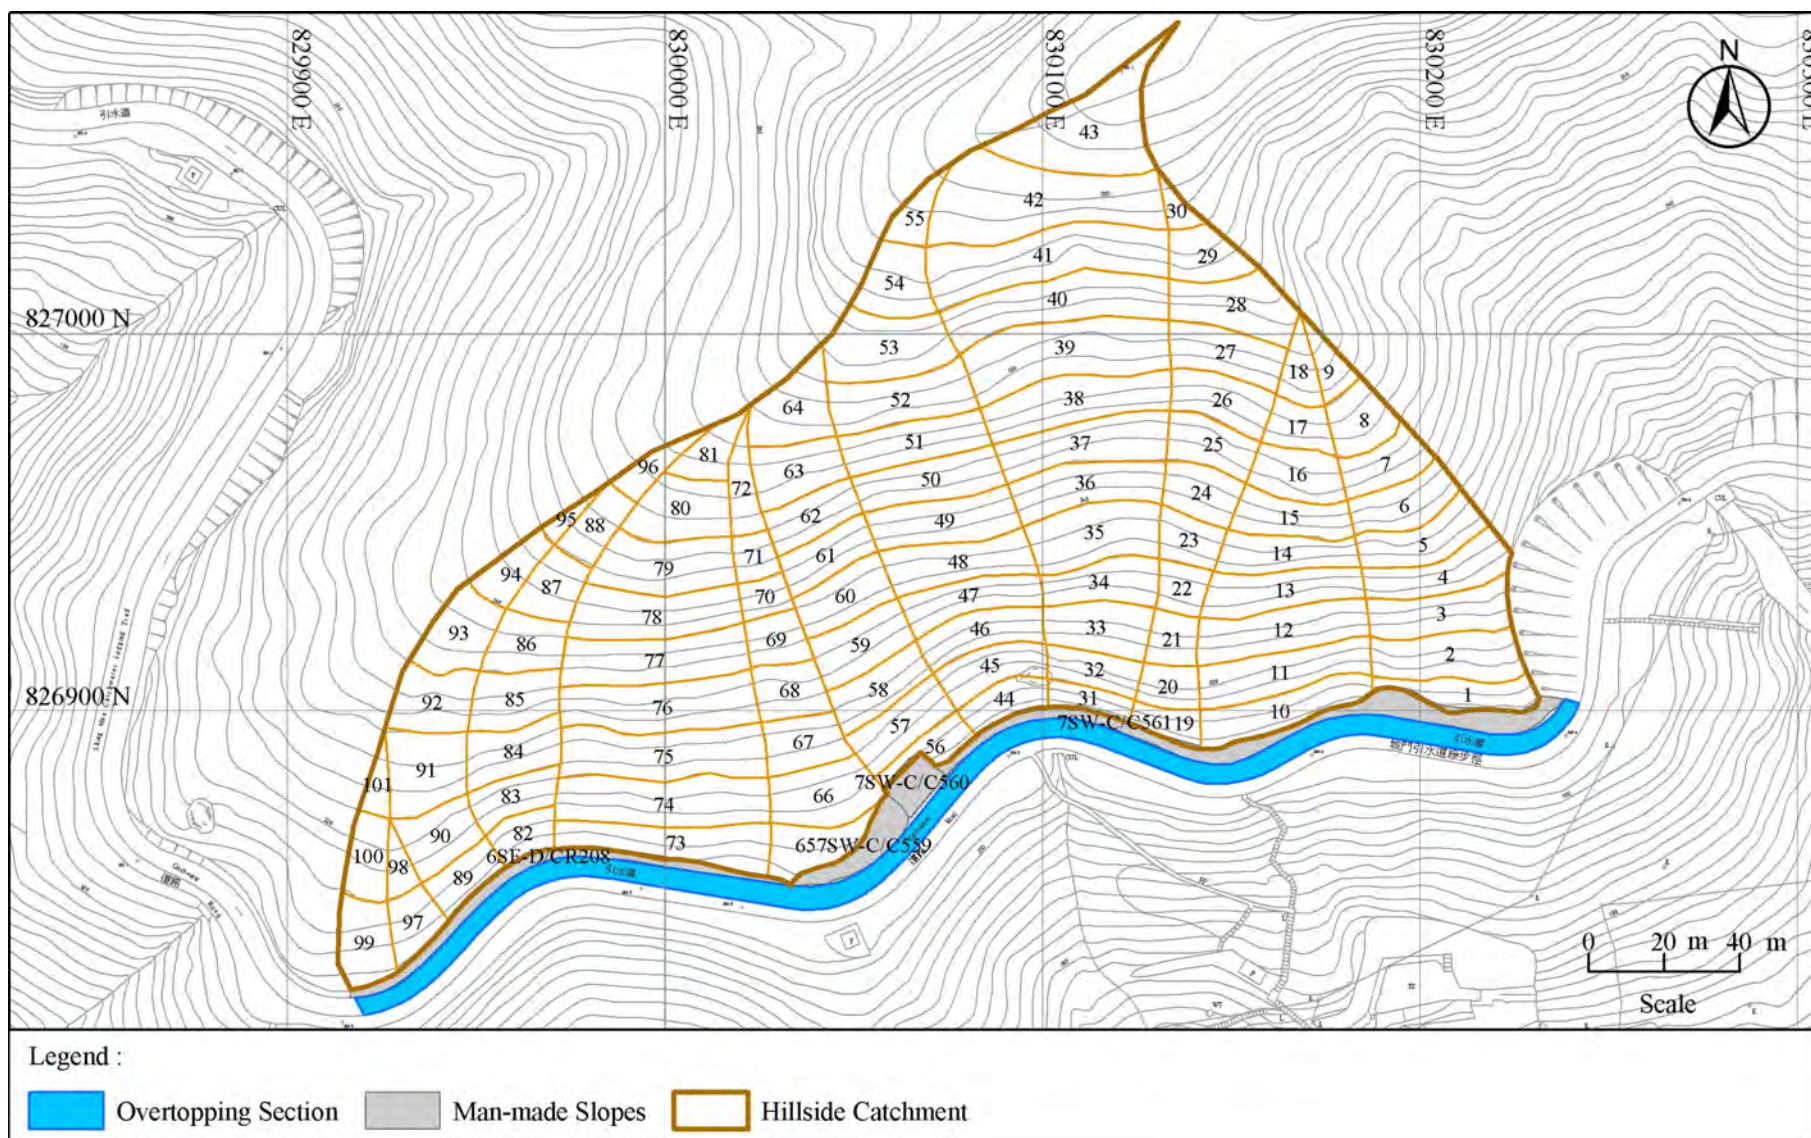
Figure H3 - Man-made Slopes and Boundary of Hillside Affecting Overtopping Section of Catchwater

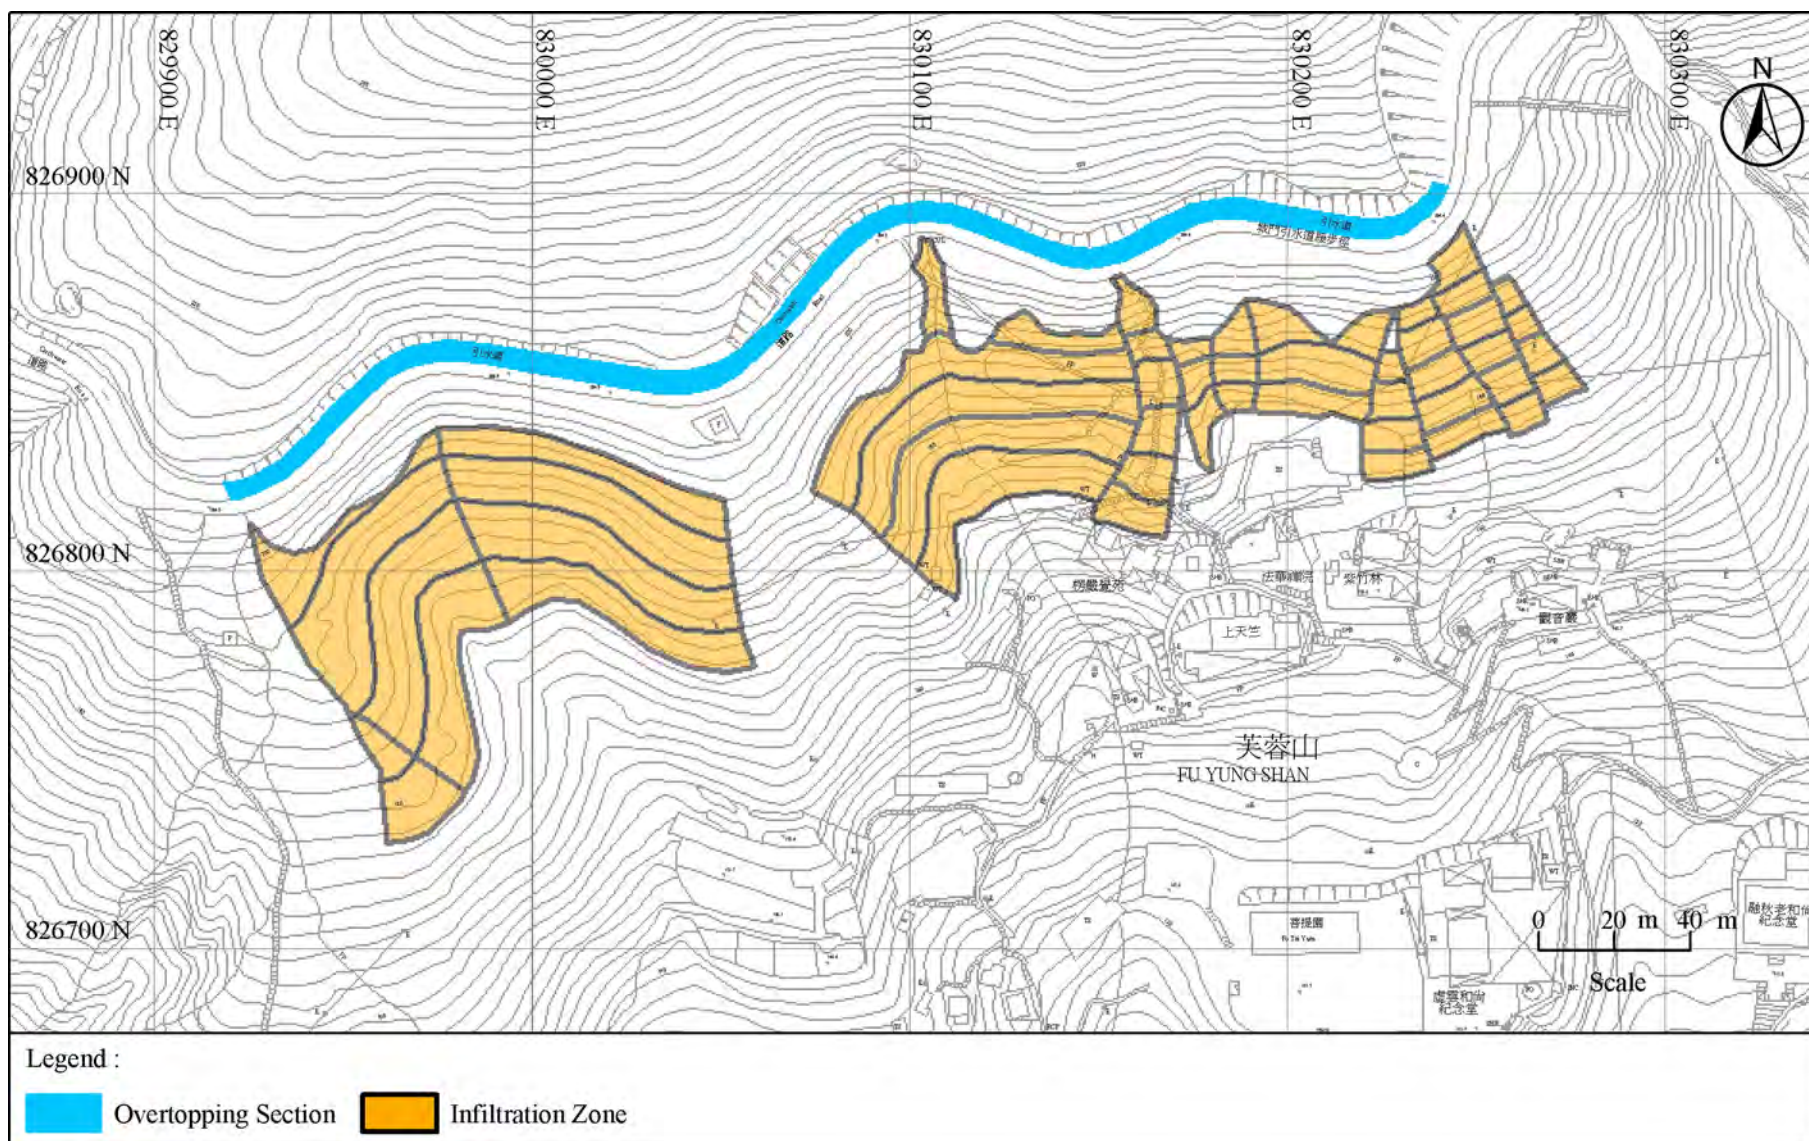
Figure H4 - Boundary of Infiltration Zone
