**QUANTITATIVE RISK
ASSESSMENT OF LANDSLIDE
HAZARDS AT
FU YUNG SHAN TSUEN,
TSUEN WAN**

GEO REPORT No. 224

H.N. Wong & F.W.Y. Ko

**GEOTECHNICAL ENGINEERING OFFICE
CIVIL ENGINEERING AND DEVELOPMENT DEPARTMENT
THE GOVERNMENT OF THE HONG KONG
SPECIAL ADMINISTRATIVE REGION**

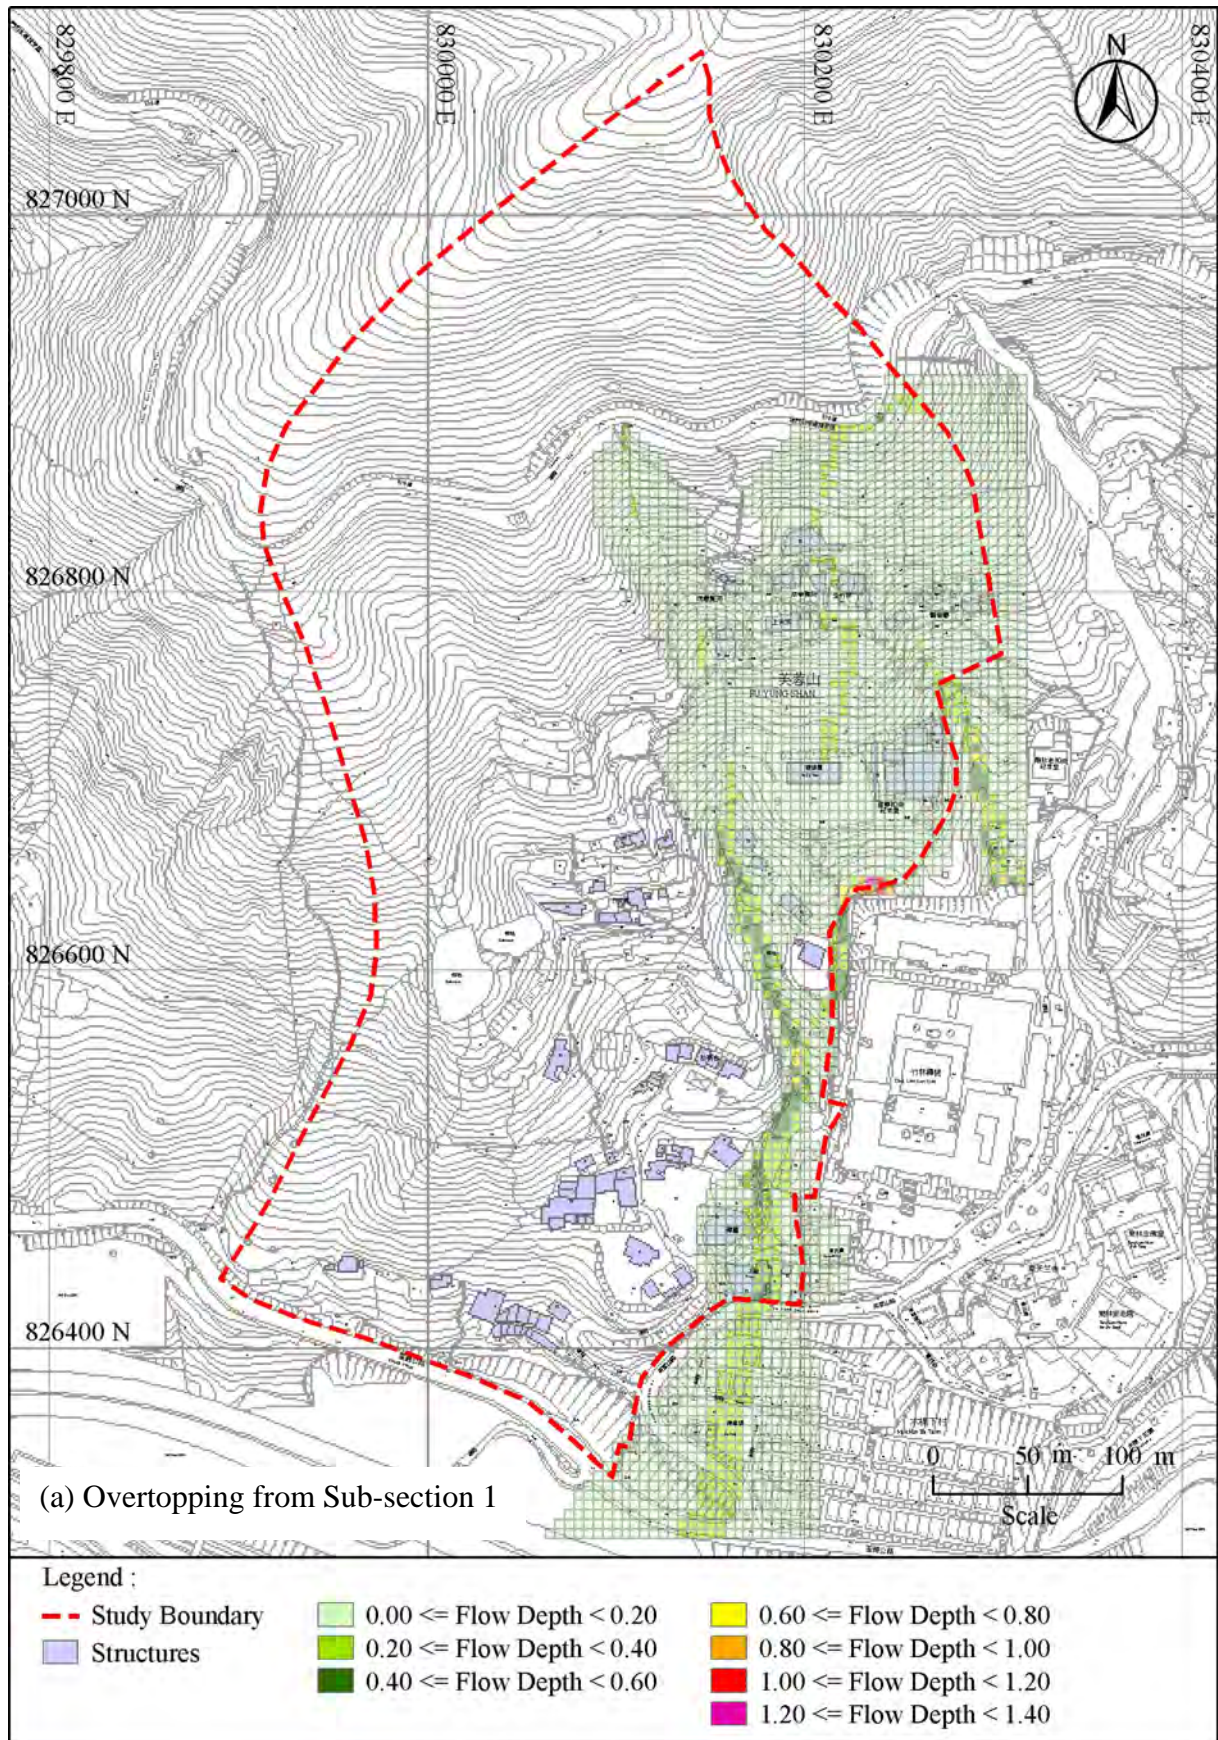
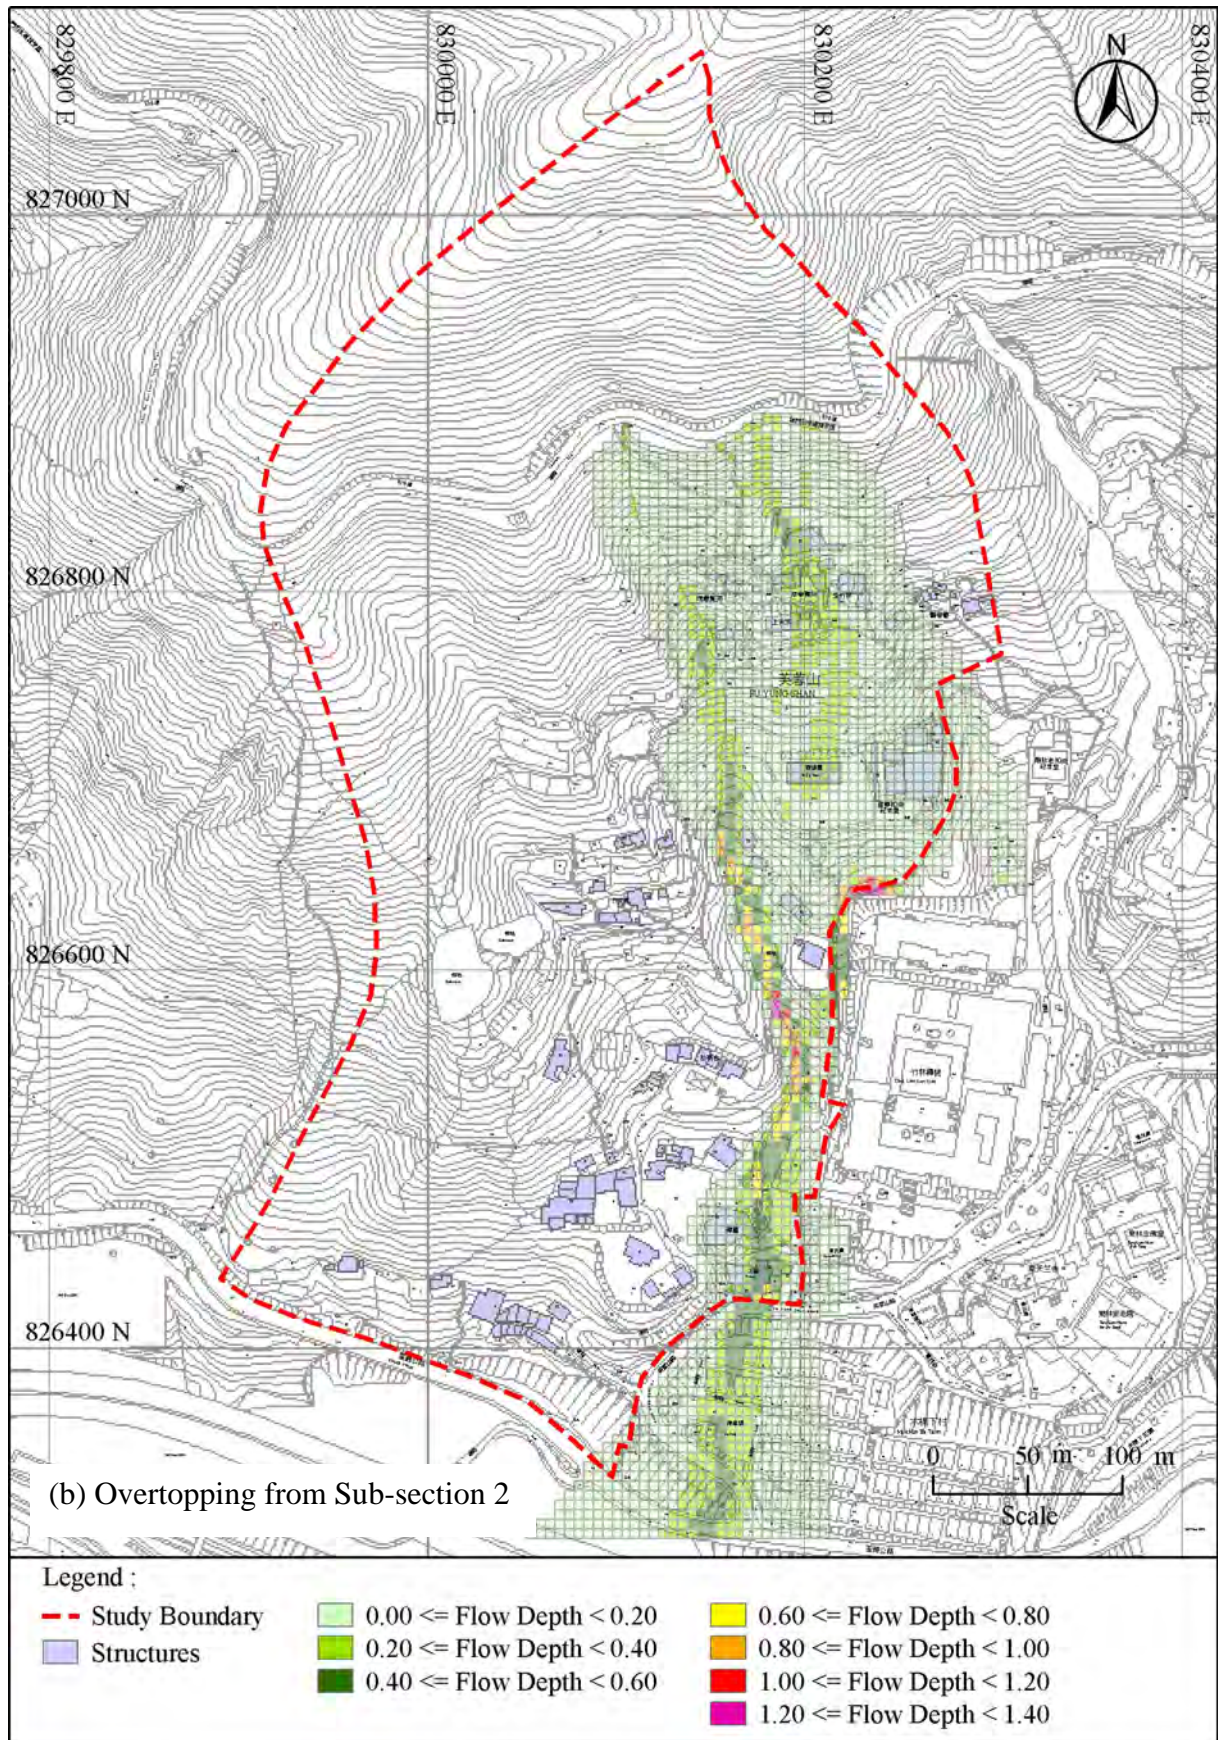
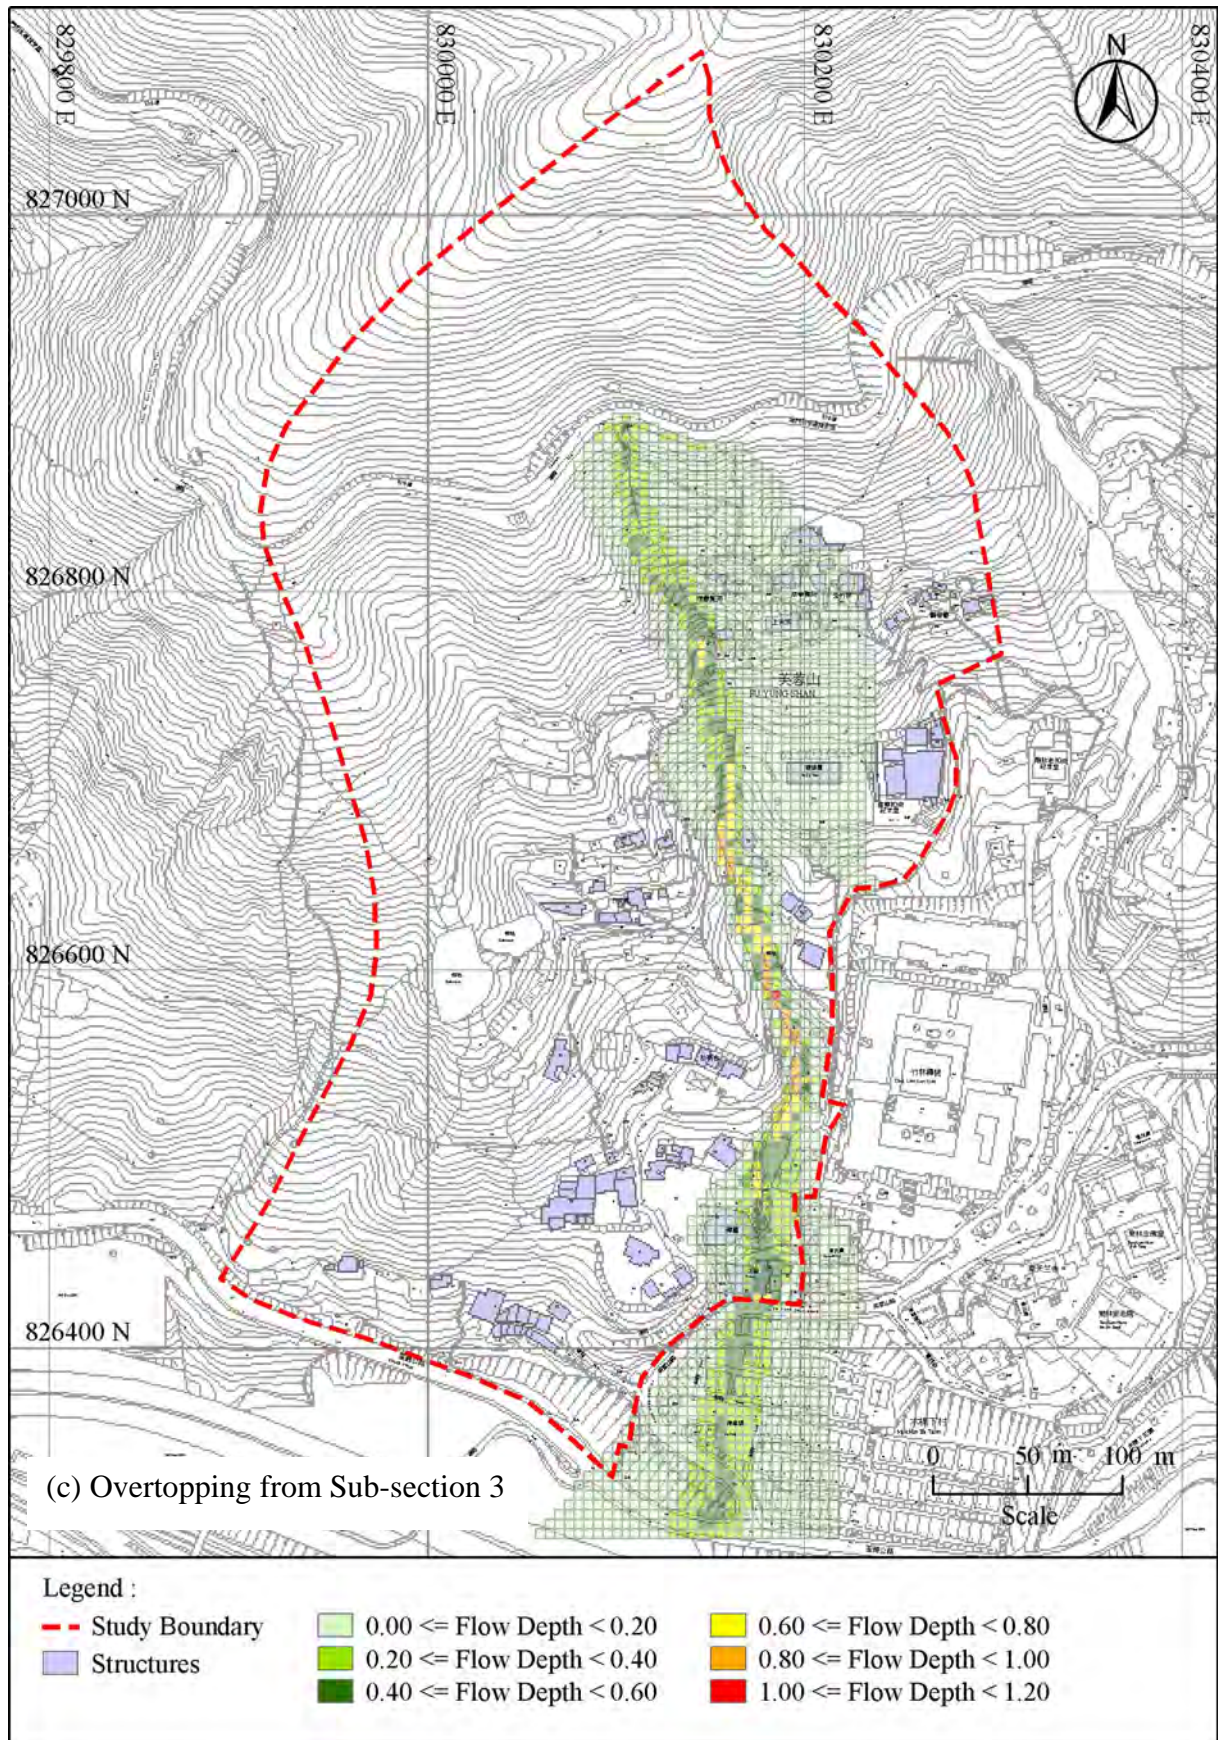
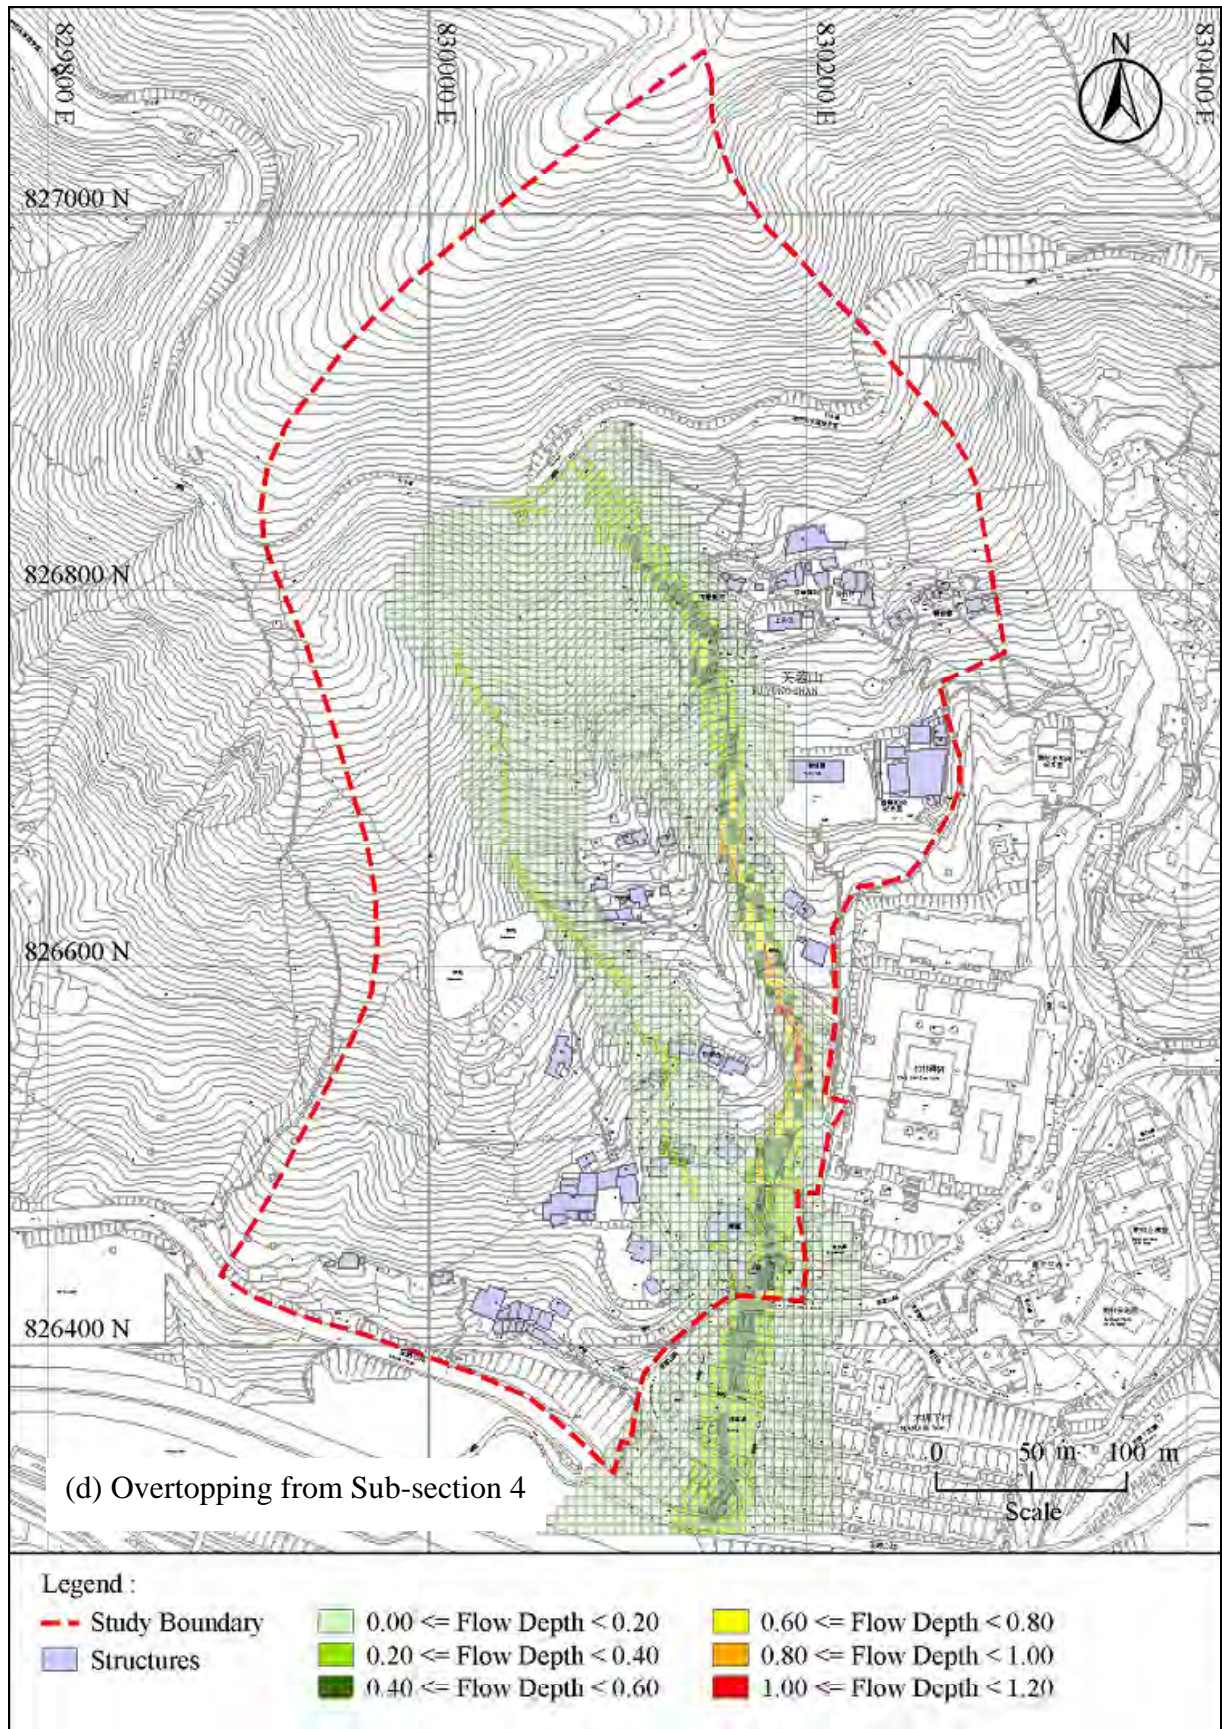
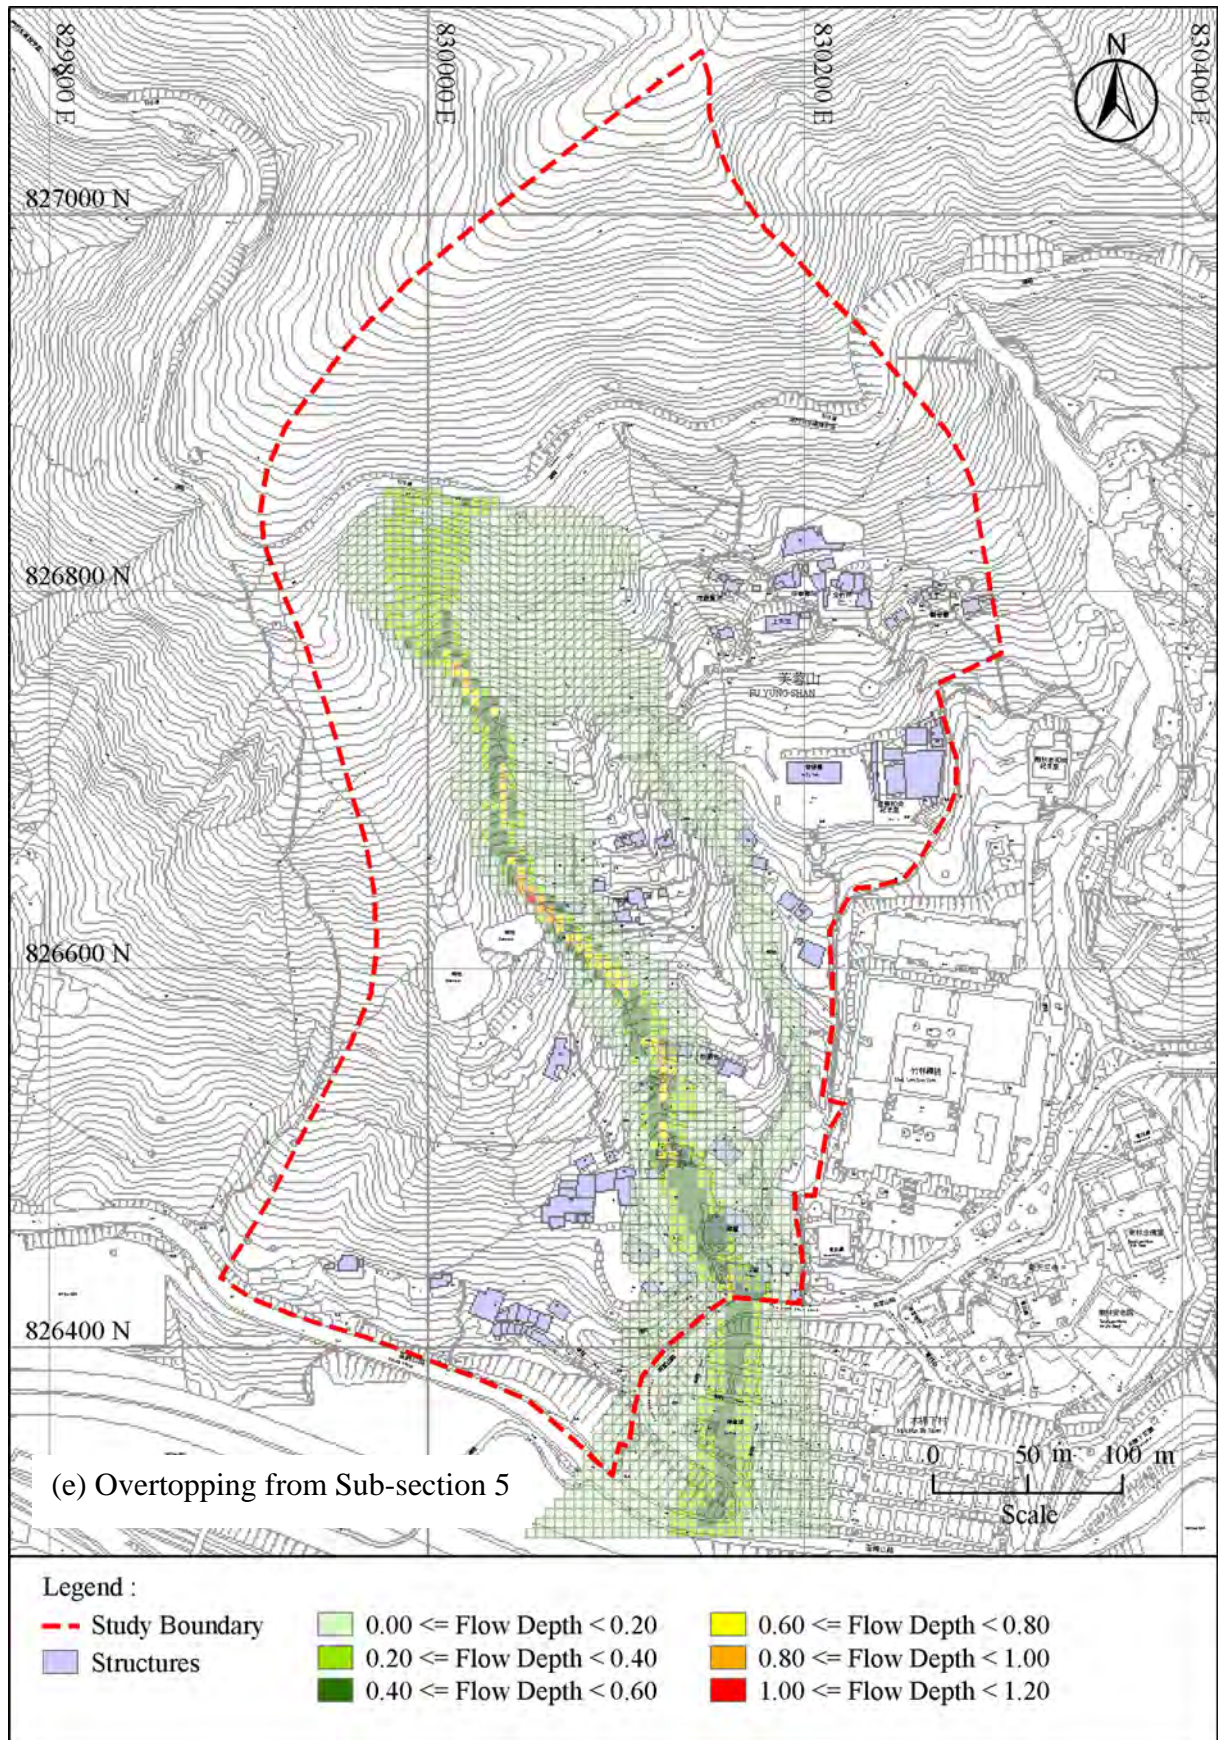
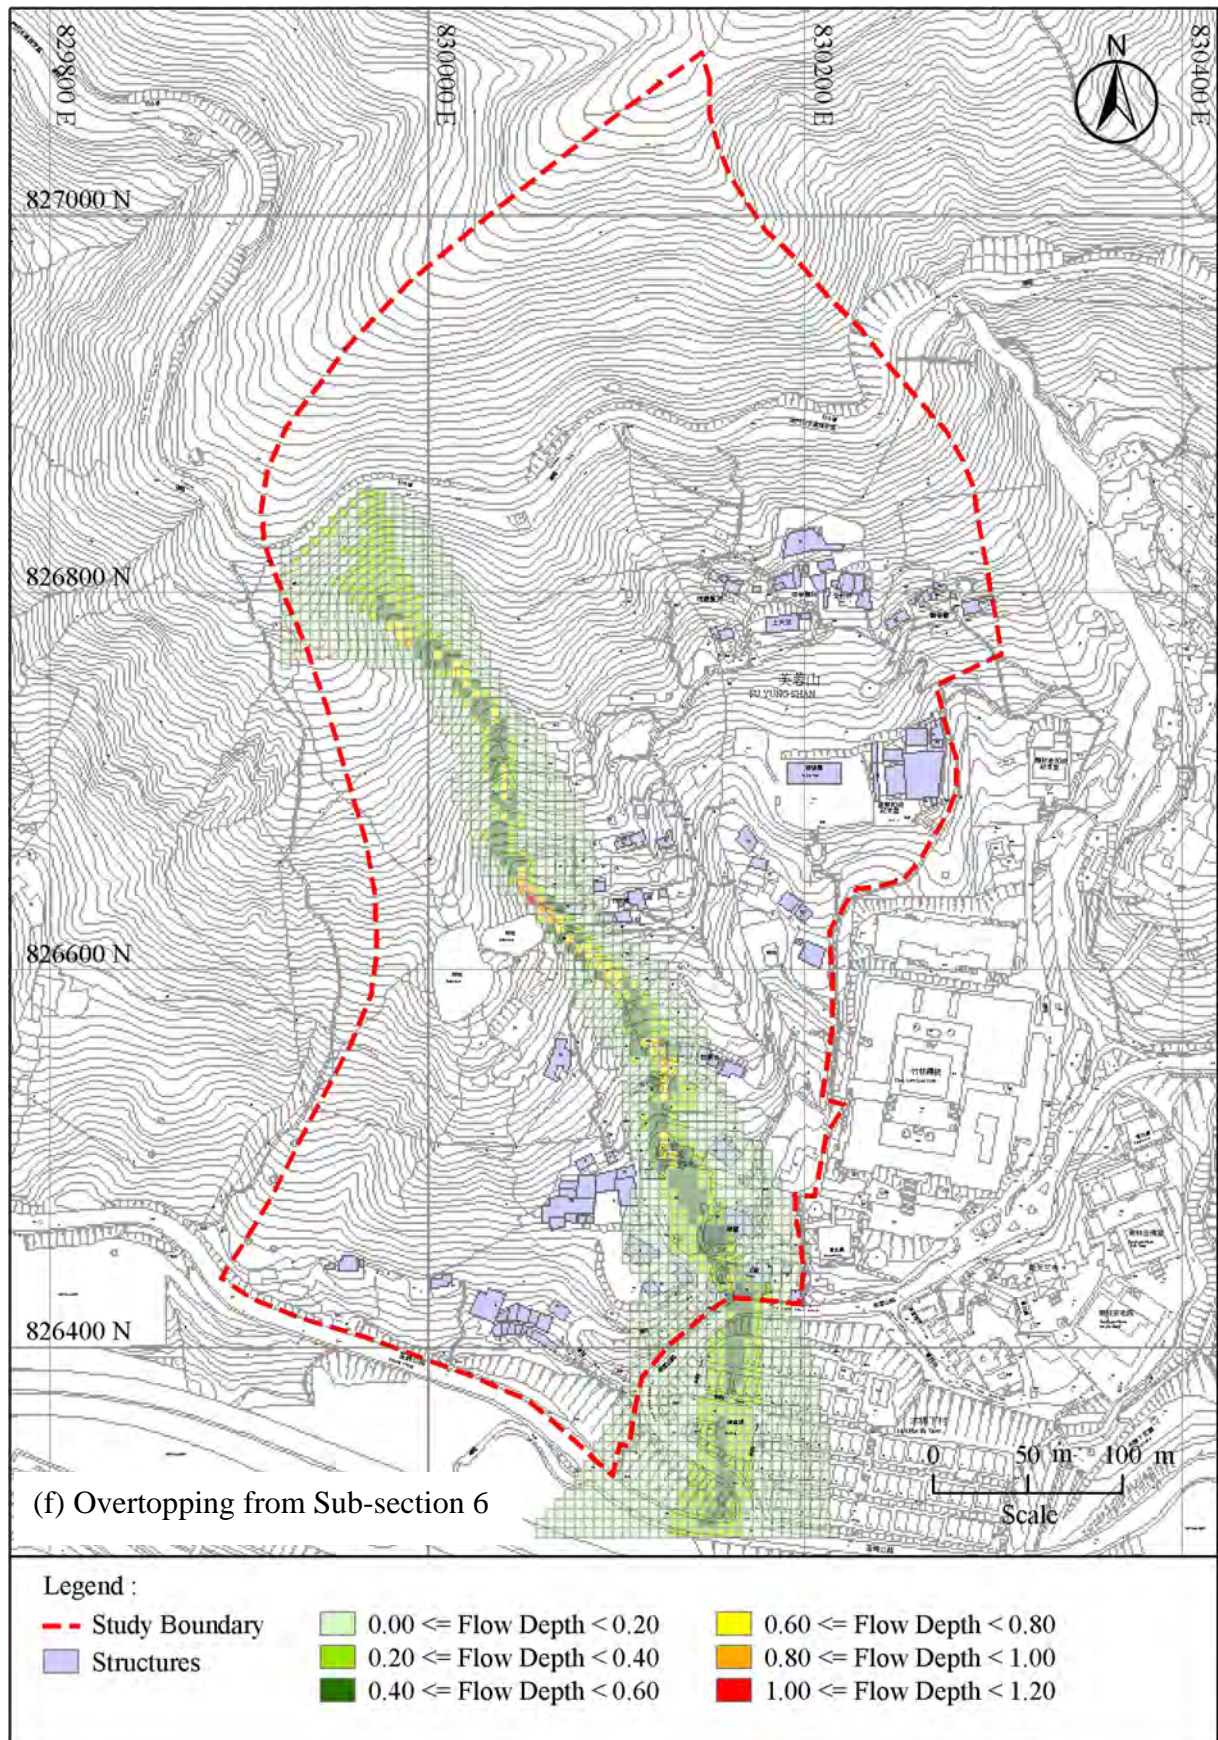
Figure H5 - Influence Zones and Flow Depths of Overland Flow (Sheet 1 of 6)
