**GEO Technical Guidance Note No. 15 (TGN 15)
Guidelines for Classification of Consequence-to-Life
Category for Slope Features**

Issue No.: 1	Revision: B	Date: 27.03.2007	Page: 1 of 14
--------------	-------------	------------------	---------------

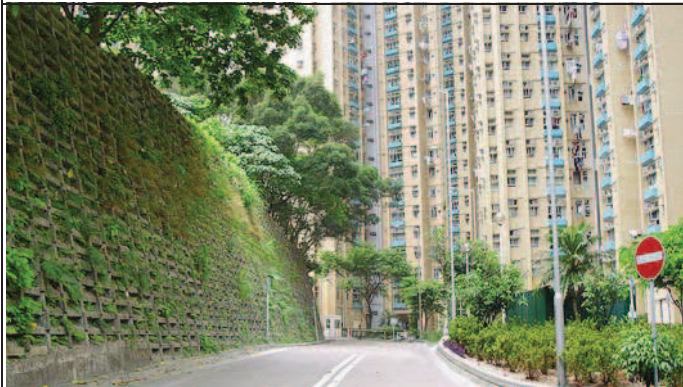
- Height of retaining wall : 8 m
- A residential building is located at 14 m from the toe of the retaining wall
- Shadow angle $\approx 27^\circ$ ($< 30^\circ$) from the crest of retaining wall

The residential building belongs to Facility Group 1(a) but is located beyond the possible extreme travel distance of the debris. The CTL category of the feature should be either “2” or “3” depending on the nature of the intervening facilities.

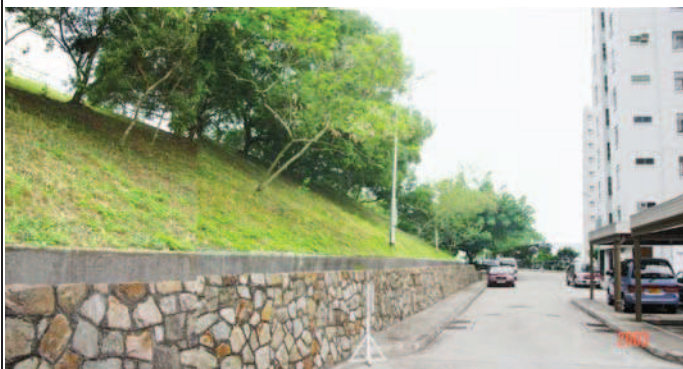
- Height of cut slope : 13.5 m
- A residential building is located at 8.5 m from the toe of the slope
- Shadow angle $\approx 24^\circ$ ($< 25^\circ$) from the slope crest

The residential building is located beyond the expected travel distance of the debris. The CTL category of the feature should be “2” depending on the nature of the intervening facilities.

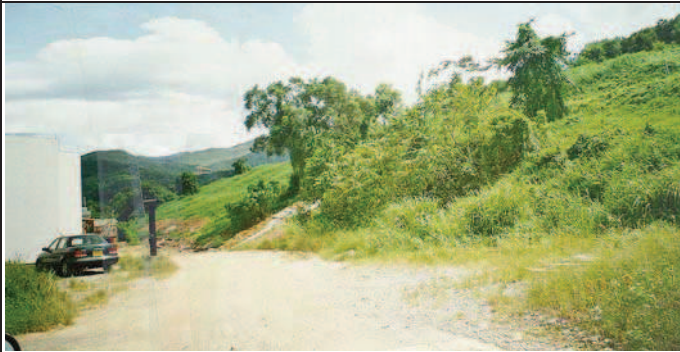
- Height of fill slope : 10 m
- A factory is located at 5 m from the toe of the slope
- Shadow angle $\approx 21^\circ$ ($< 25^\circ$) from the slope crest

The factory belongs to Facility Group 1(a) but is located beyond the expected travel distance of the landslide debris. The CTL category of the feature should be “2” depending on the nature of the intervening facilities.

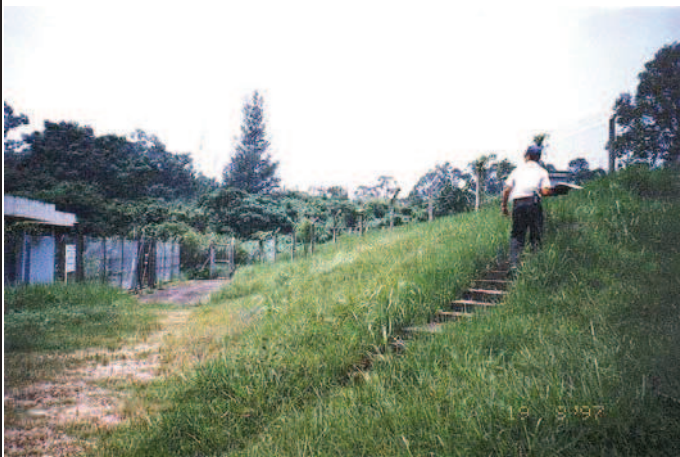
- Height of fill slope : 7 m
- A house is located at about 4 m from the toe of the slope
- Shadow angle $\approx 18^\circ$ ($< 20^\circ$) from the slope crest

The house belongs to Facility Group 1(b) but is located beyond the possible extreme travel distance of the landslide debris. The CTL category of the feature should be either “2” or “3” depending on the nature of the intervening facilities.

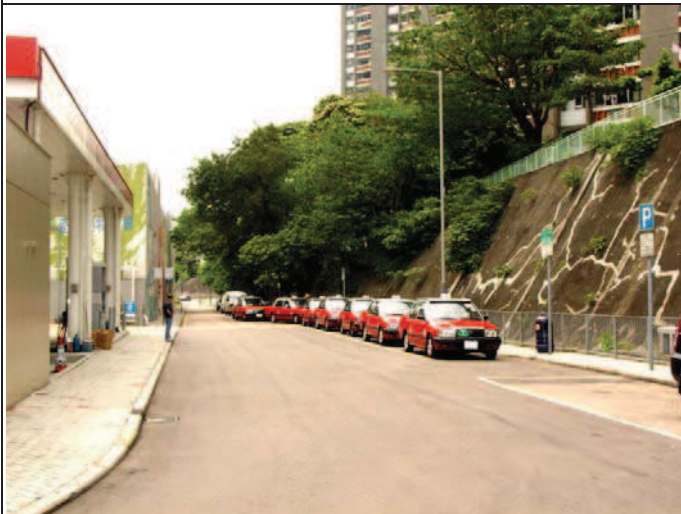
- Height of cut slope : 6 m
- A dangerous goods store is located at 10 m from the toe of the slope
- Shadow angle $\approx 23^\circ$ ($< 30^\circ$) from the slope crest

The dangerous goods store (petrol station) belongs to Facility Group 1(b) but is located beyond the possible extreme travel distance of the landslide debris. The CTL category of the feature should be either “2” or “3” depending on the nature of the intervening facilities.

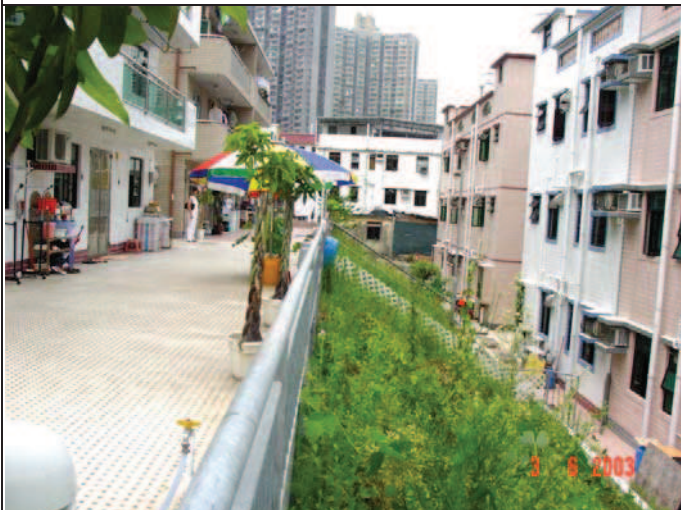
- Height of cut feature : 5 m
- A house is located at about 3 m from the crest of the slope
- Distance of the house from the slope crest $\approx 0.6 \times$ slope height

The house belongs to Facility Group 1(b) but is located away from the expected crest influence zone of the failure. The feature may be assessed as CTL Cat “1” or “2” depending on the proximity of the toe facility.

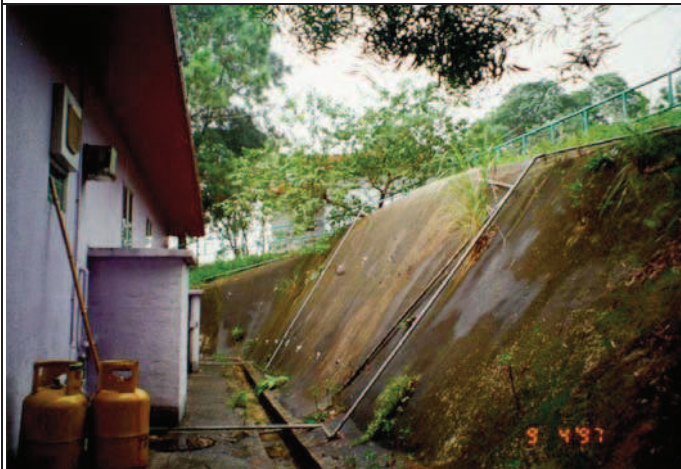
- Height of cut feature : 3.5 m
- A house at the toe of the slope is made of substantial structure
- Open space at crest

The scale of failure from the feature is likely to be small and the structure will provide protection against small landslides. The feature can be assessed to be CTL Cat “2”.

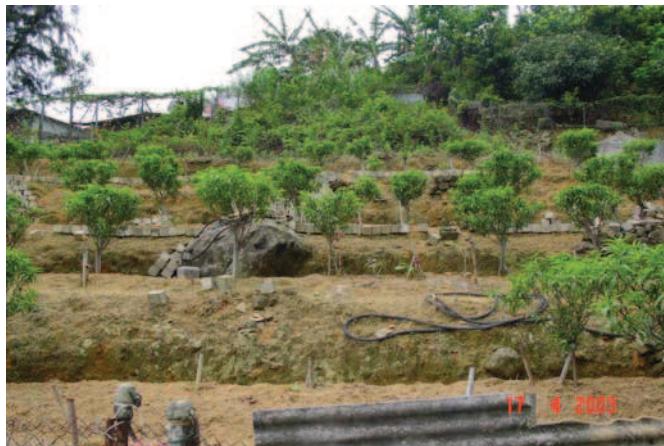
- Feature type : agricultural terraces in disturbed terrain
- Overall height of feature : 24 m
- Overall slope angle : 25° ($< 30^\circ$)

The CTL category of the disturbed terrain depends on the proximity of facility from the localised slope features. In this case, if a Group 1 or 2(a) facility lies beyond the expected travel distance of debris from the localised slope, the CTL category should be “2”.
