**GEO Technical Guidance Note No. 15 (TGN 15)
Guidelines for Classification of Consequence-to-Life
Category for Slope Features**

Issue No.: 1	Revision: B	Date: 27.03.2007	Page: 1 of 14
--------------	-------------	------------------	---------------

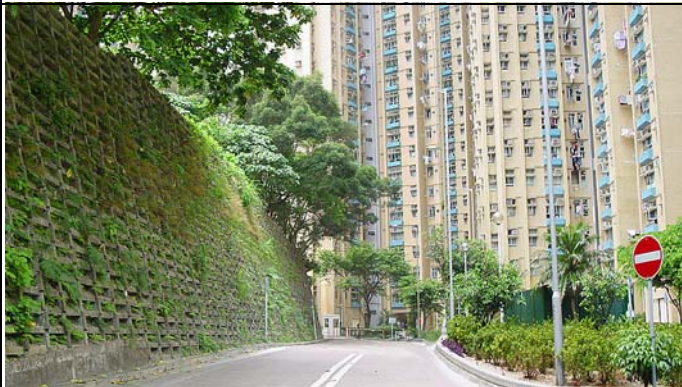
- Height of retaining wall : 8 m
- A residential building is located at 14 m from the toe of the retaining wall
- Shadow angle $\approx 27^\circ$ ($< 30^\circ$) from the crest of retaining wall

The residential building belongs to Facility Group 1(a) but is located beyond the possible extreme travel distance of the debris. The CTL category of the feature should be either “2” or “3” depending on the nature of the intervening facilities.

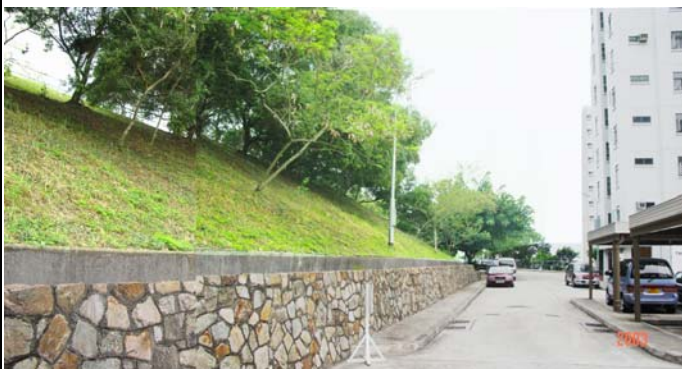
- Height of cut slope : 13.5 m
- A residential building is located at 8.5 m from the toe of the slope
- Shadow angle $\approx 24^\circ$ ($< 25^\circ$) from the slope crest

The residential building is located beyond the expected travel distance of the debris. The CTL category of the feature should be “2” depending on the nature of the intervening facilities.

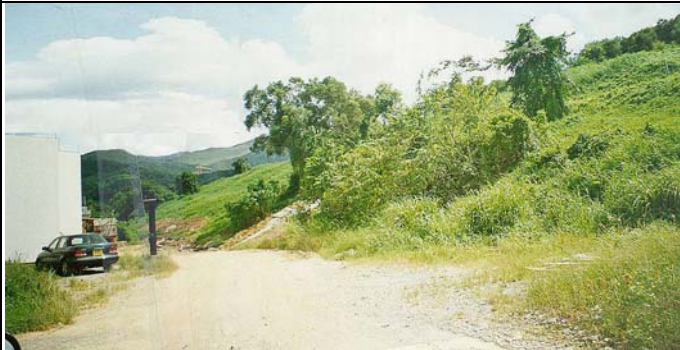
- Height of fill slope : 10 m
- A factory is located at 5 m from the toe of the slope
- Shadow angle $\approx 21^\circ$ ($< 25^\circ$) from the slope crest

The factory belongs to Facility Group 1(a) but is located beyond the expected travel distance of the landslide debris. The CTL category of the feature should be “2” depending on the nature of the intervening facilities.

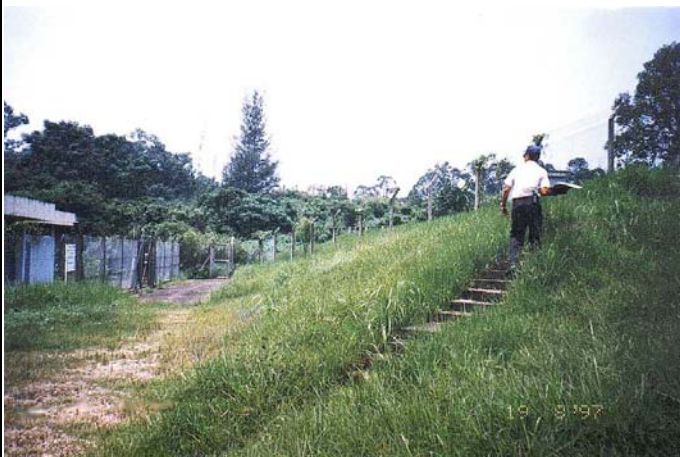
- Height of fill slope : 7 m
- A house is located at about 4 m from the toe of the slope
- Shadow angle $\approx 18^\circ$ ($< 20^\circ$) from the slope crest

The house belongs to Facility Group 1(b) but is located beyond the possible extreme travel distance of the landslide debris. The CTL category of the feature should be either “2” or “3” depending on the nature of the intervening facilities.

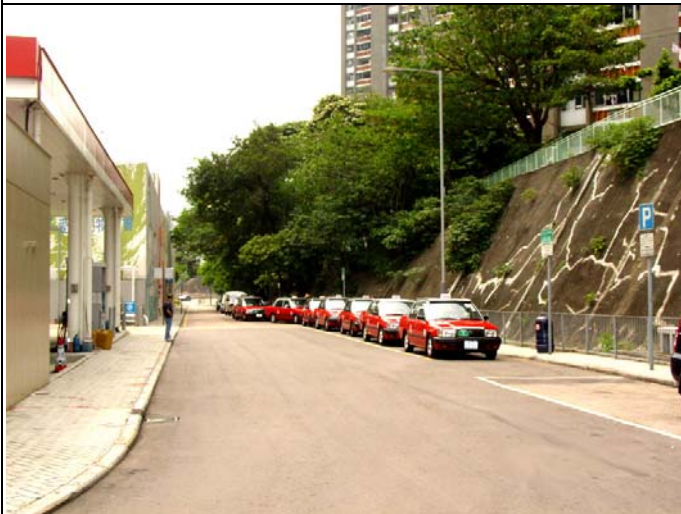
- Height of cut slope : 6 m
- A dangerous goods store is located at 10 m from the toe of the slope
- Shadow angle $\approx 23^\circ$ ($< 30^\circ$) from the slope crest

The dangerous goods store (petrol station) belongs to Facility Group 1(b) but is located beyond the possible extreme travel distance of the landslide debris. The CTL category of the feature should be either “2” or “3” depending on the nature of the intervening facilities.

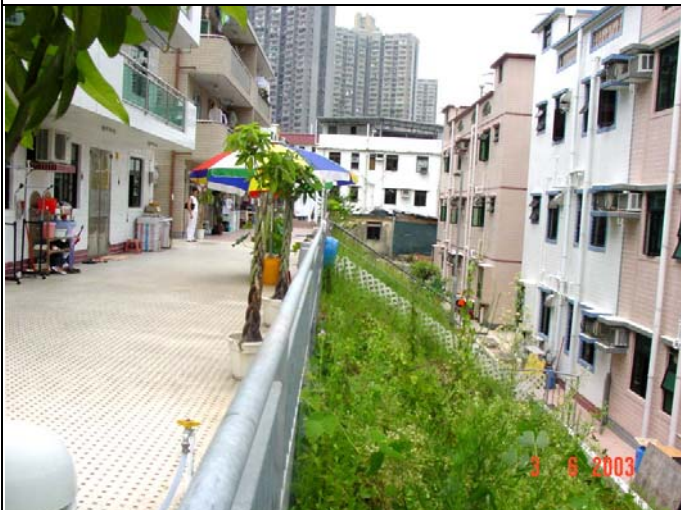
- Height of cut feature : 5 m
- A house is located at about 3 m from the crest of the slope
- Distance of the house from the slope crest $\approx 0.6 \times$ slope height

The house belongs to Facility Group 1(b) but is located away from the expected crest influence zone of the failure. The feature may be assessed as CTL Cat “1” or “2” depending on the proximity of the toe facility.

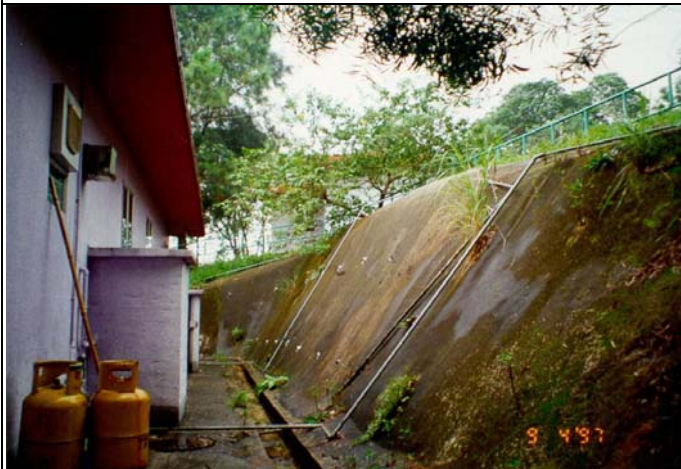
- Height of cut feature : 3.5 m
- A house at the toe of the slope is made of substantial structure
- Open space at crest

The scale of failure from the feature is likely to be small and the structure will provide protection against small landslides. The feature can be assessed to be CTL Cat “2”.

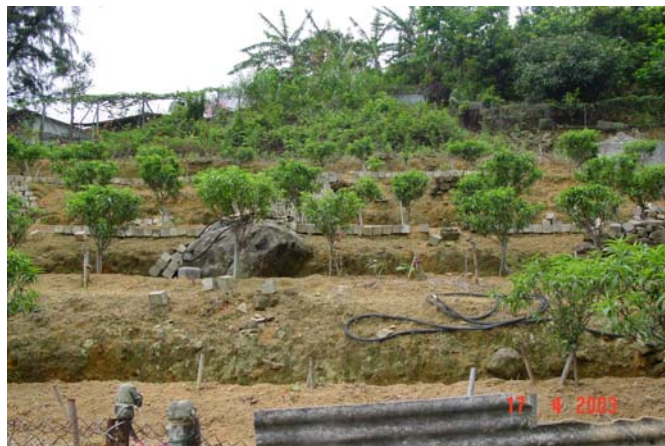
- Feature type : agricultural terraces in disturbed terrain
- Overall height of feature : 24 m
- Overall slope angle : 25° (< 30°)

The CTL category of the disturbed terrain depends on the proximity of facility from the localised slope features. In this case, if a Group 1 or 2(a) facility lies beyond the expected travel distance of debris from the localised slope, the CTL category should be “2”.
