Figure 1 - TDR Test Results at an LPM Site in Chai Wan

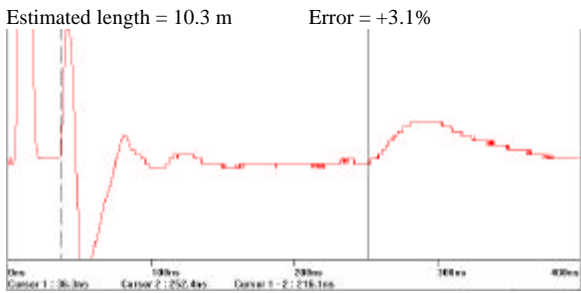
Pulse width = 10 ns

Soil Nail No. R12-N3,
Wire with blue plastic
sheath

Measurements are taken at
Side A

Figure 2 - TDR Test Results at an LPM Site in Chai Wan

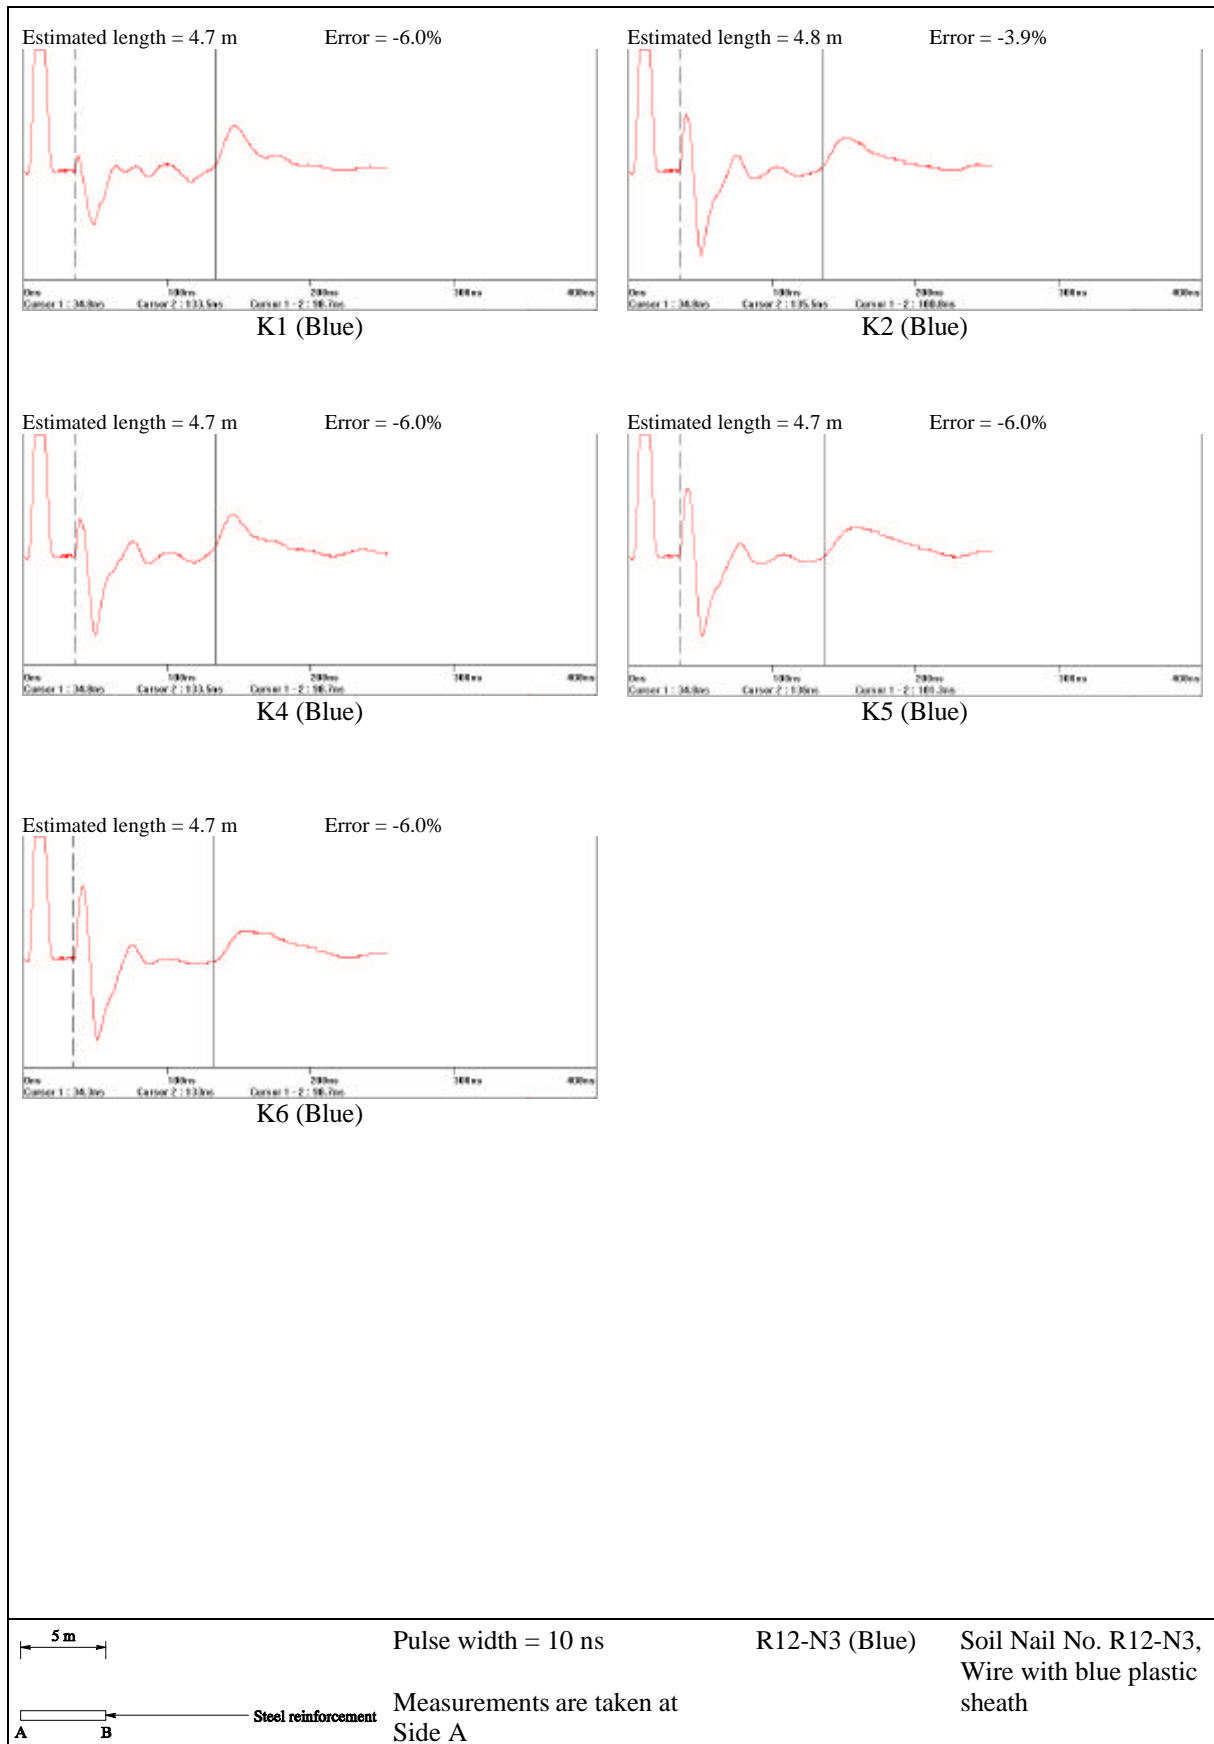
Figure 3 - TDR Test Results at an LPM Site in Chai Wan

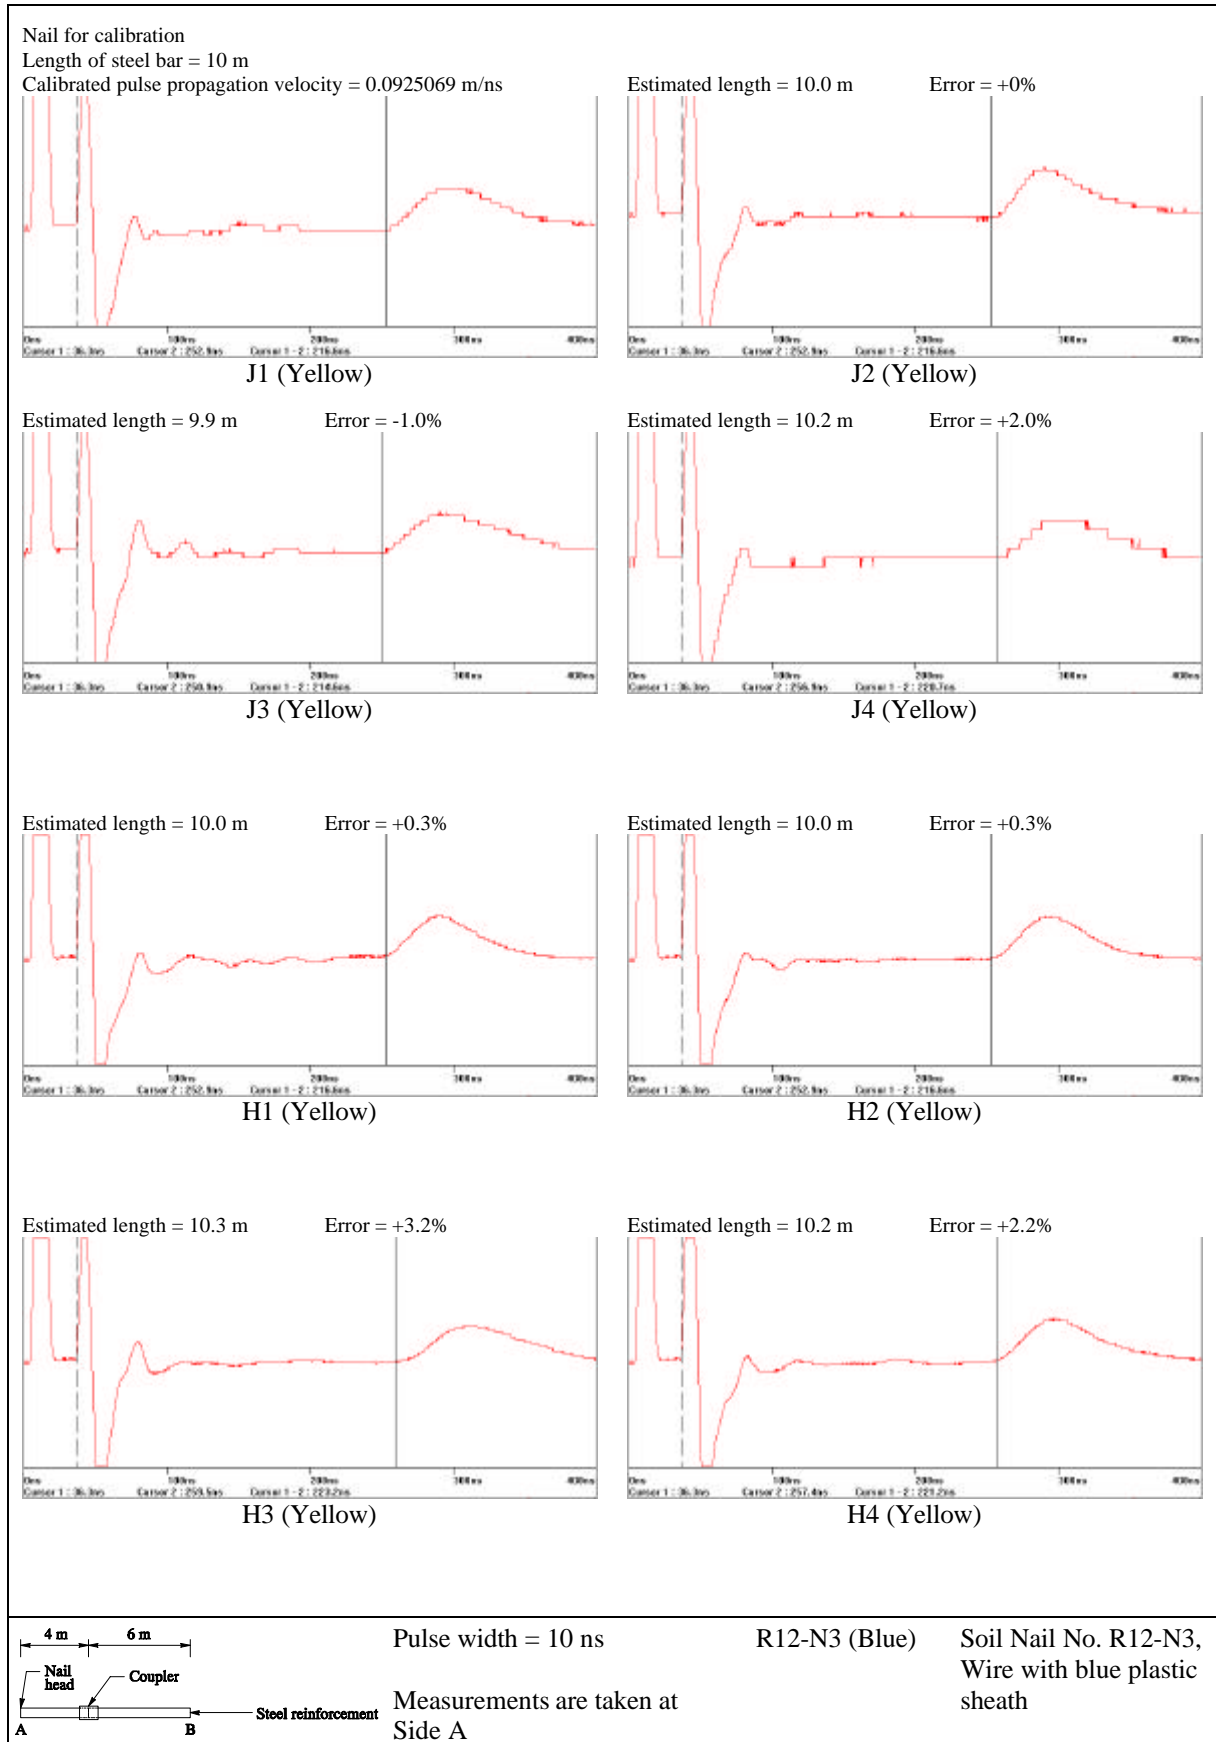
Figure 4 - TDR Test Results at an LPM Site in Chai Wan

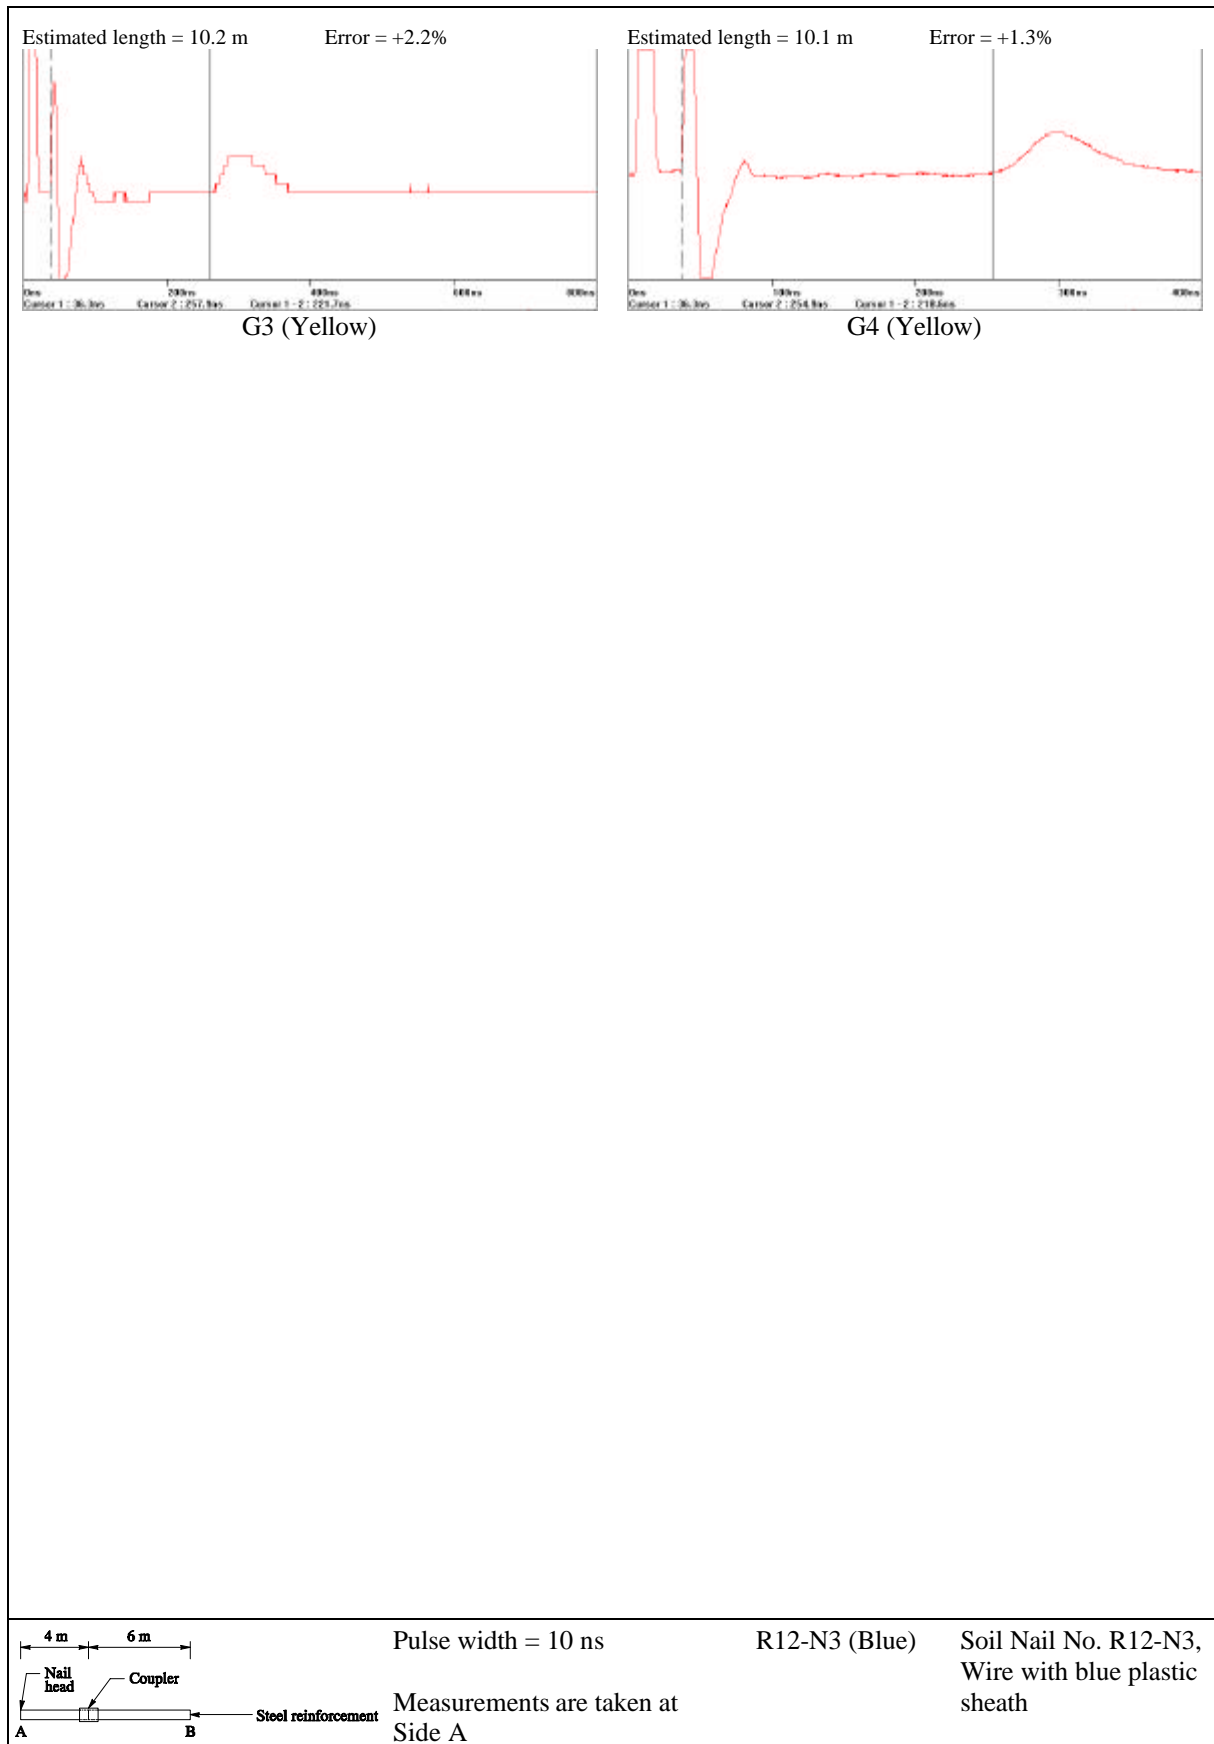
Figure 5 - TDR Test Results at an LPM Site in Chai Wan

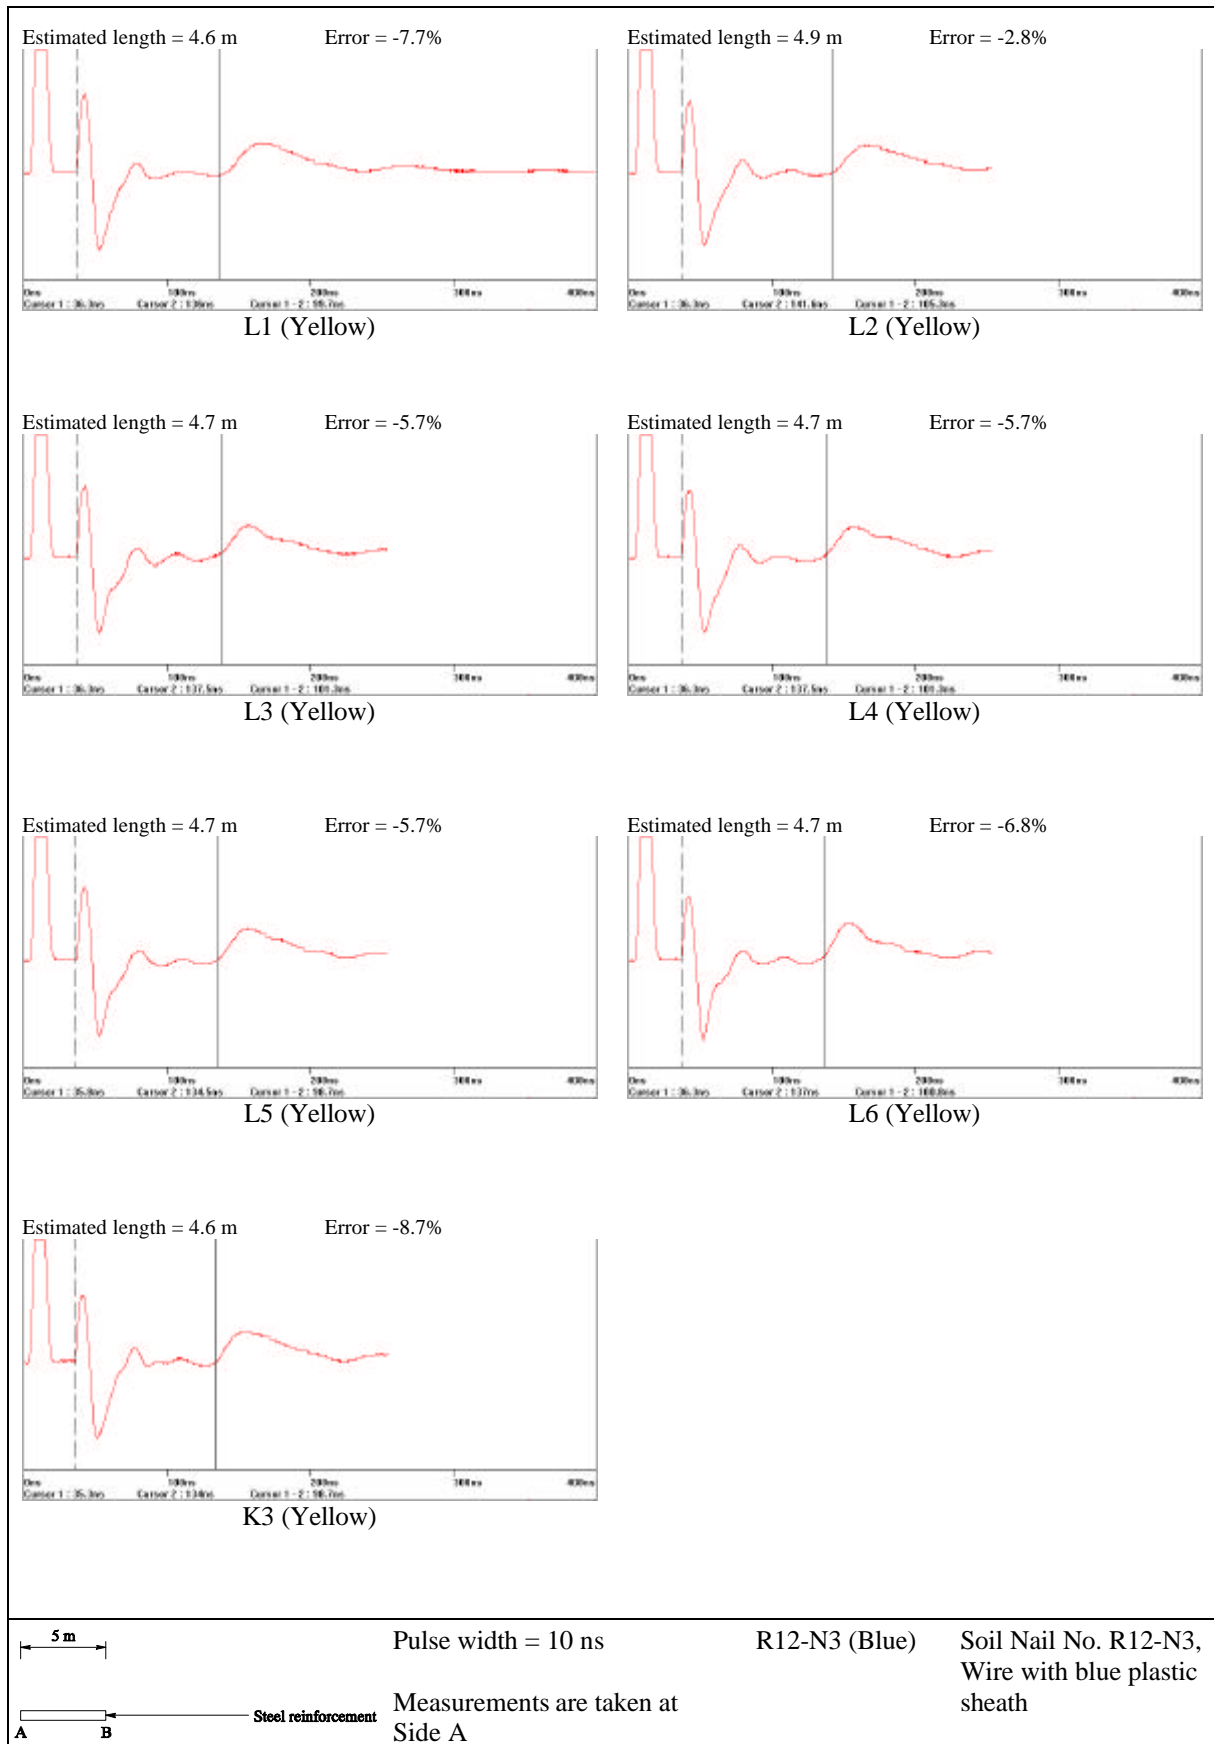
Figure 6 - TDR Test Results at an LPM Site in Chai Wan
