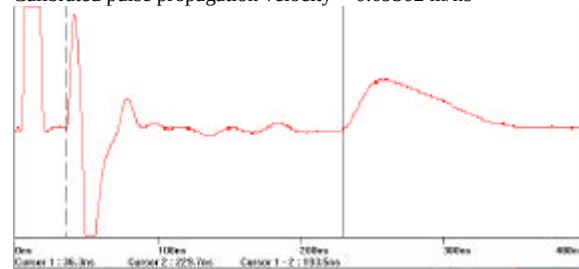
R2-S10 (Red)

Estimated length = 9.1 m

Error = +0.5%
