FACTUAL REPORT ON HONG KONG RAINFALL AND LANDSLIDES IN 2006

GEO REPORT No. 244

**GEOTECHNICAL ENGINEERING OFFICE
CIVIL ENGINEERING AND DEVELOPMENT DEPARTMENT
THE GOVERNMENT OF THE HONG KONG
SPECIAL ADMINISTRATIVE REGION**

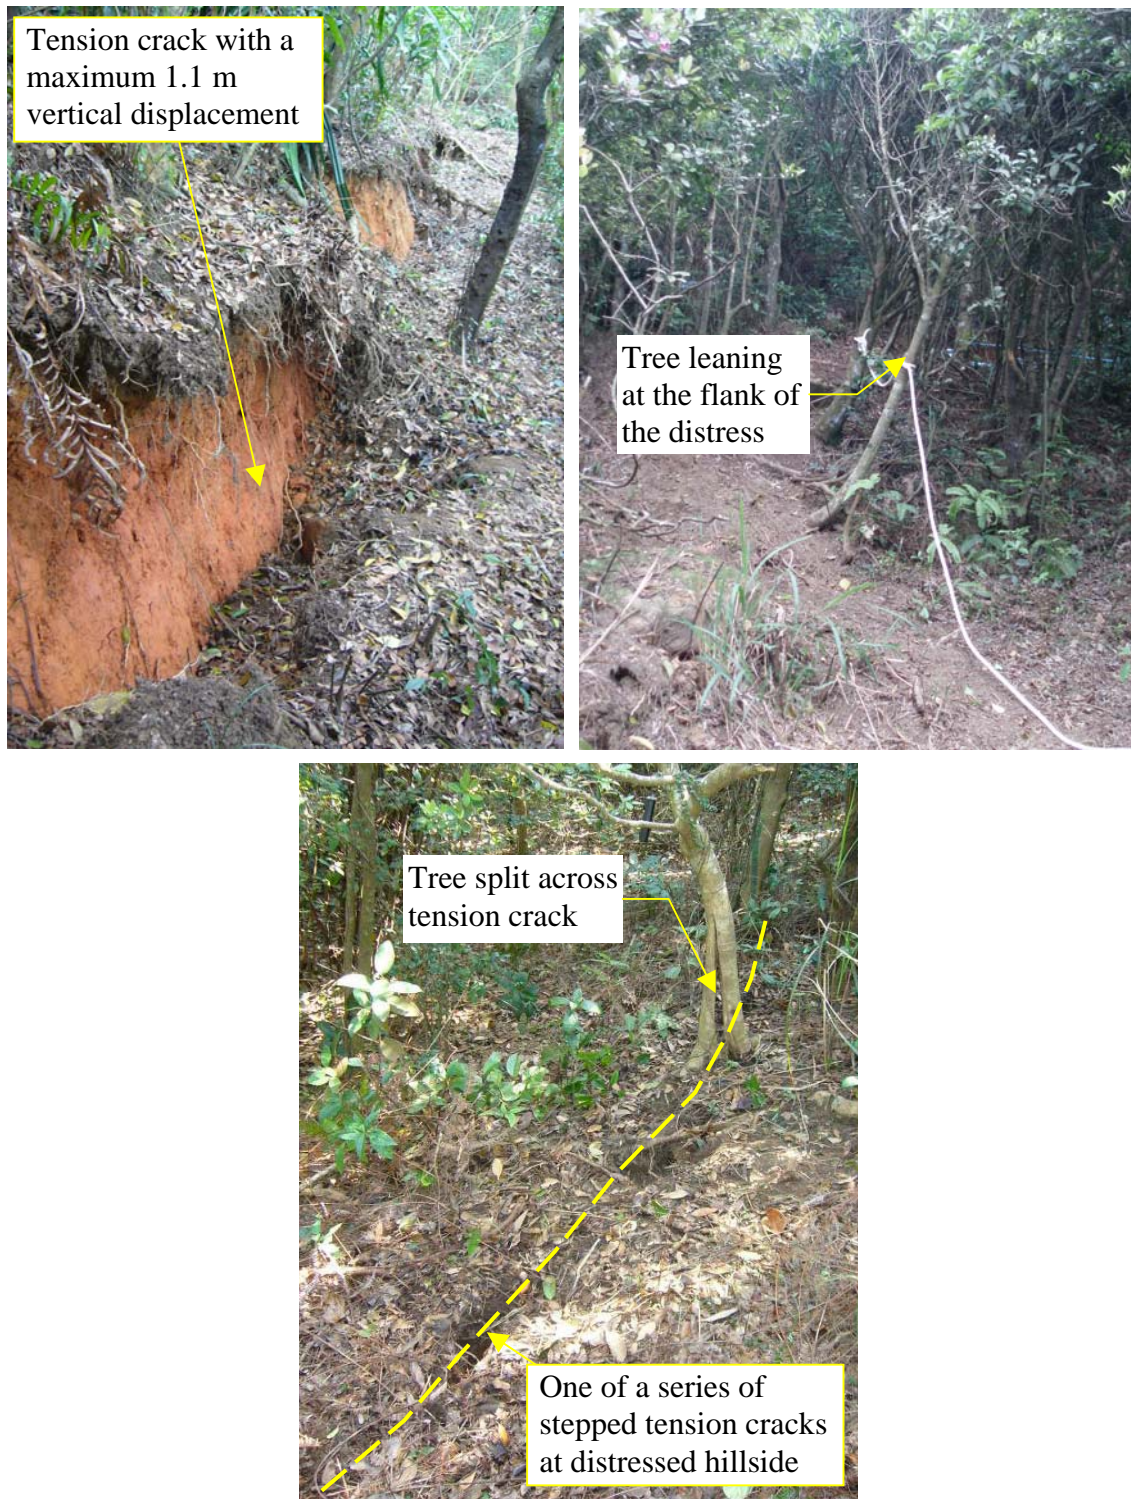
Plate 1 - Significant Signs of Distress on the Natural Hillside at Kwun Yam Shan, North of Tate's Ridge (Incident No. LI2006/03/2001)

Description: Significant signs of distress were identified on the natural hillside above the source of the August 2005 landslide at Kwun Yam Shan, Sha Tin.

Significant signs of distress, comprising a system of extensive and continuous tension cracks, were identified in March 2006 by the Landslide Investigation Consultants (Maunsell Geotechnical Services Ltd.), during a site inspection of the August 2005 landslide at Kwun Yam Shan (Incident No. 2005/08/0422, see GEO (2006)). The tension cracks were up to a total length of about 100 m with a local maximum vertical displacement of about 1.1 m, a maximum depth of about 1.7 m and a horizontal separation of up to about 300 mm.

The tension cracks, together with the August 2005 landslide, defined an area of distressed hillside where a hummocky morphology with concave and convex breaks-in-slope, relatively smaller scale tension cracks, cavities/ground collapse features and erosion gullies were located.

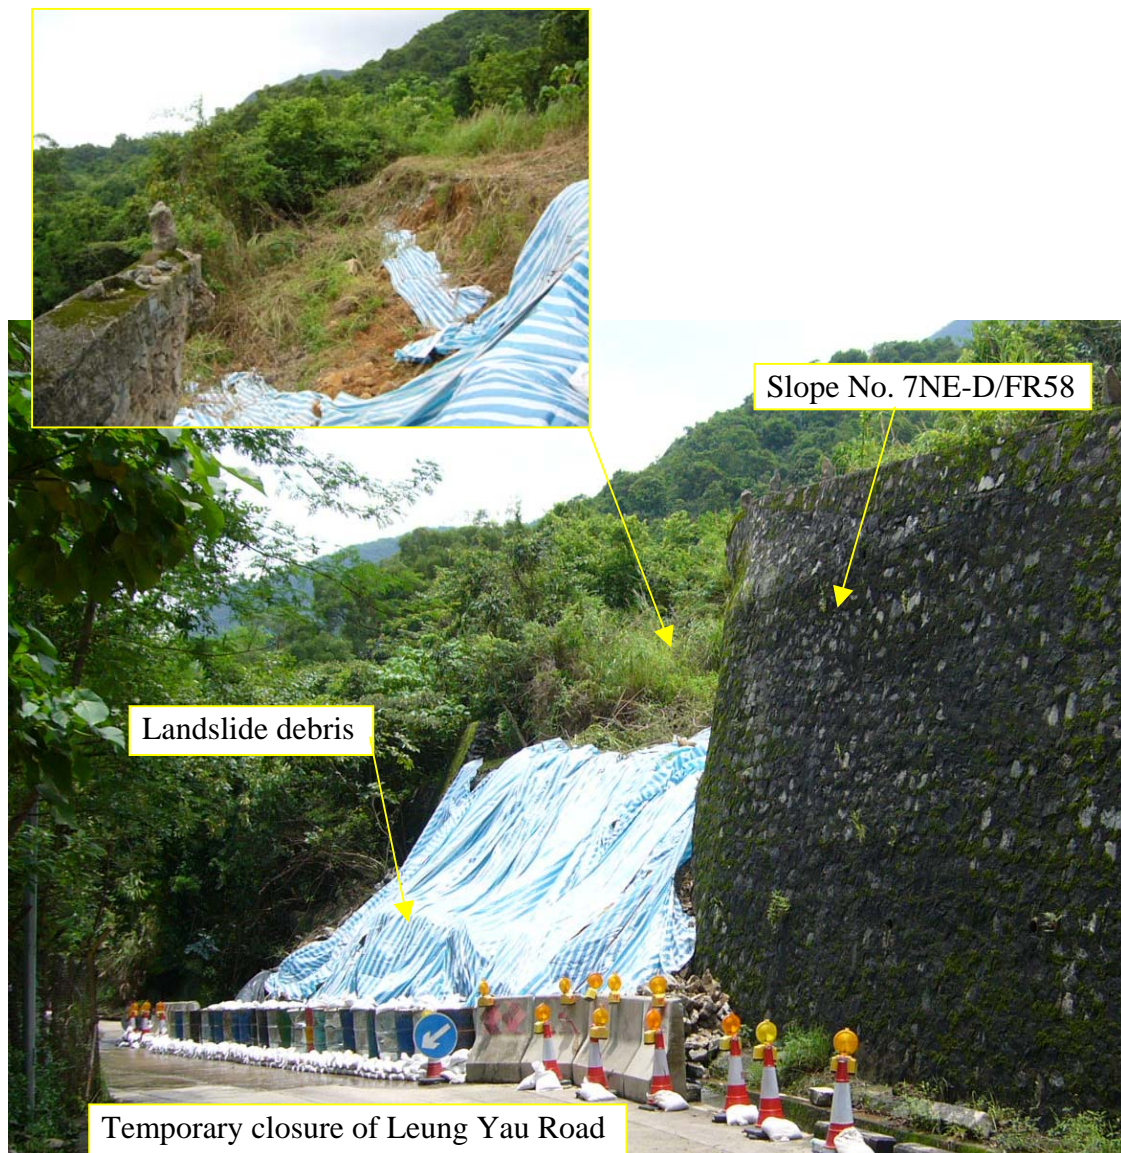
Plate 2 - The 2 June 2006 Landslide Incident on Slope No. 7NE-D/FR58 at Ma On Shan Tsuen, Leung Yau Road (Incident No. 2006/06/0623)

Description: A major failure of a masonry retaining wall which resulted in temporary closure of Leung Yau Road.

(A major failure of a masonry retaining wall which resulted in temporary closure of Leung Yau Road, Plate 2)

At about 2:45 p.m. on 2 June 2006, when the Red Rainstorm Warning and the Landslip Warning were in effect, a major landslide with a failure volume of about 350 m³ occurred on slope No. 7NE-D/FR58 along Leung Yau Road, which is the sole access to Ma On Shan Tsuen. The landslide debris was deposited on Leung Yau Road. As a result, Leung Yau Road was temporarily closed for about half a day. No casualties were reported as a result of the incident.

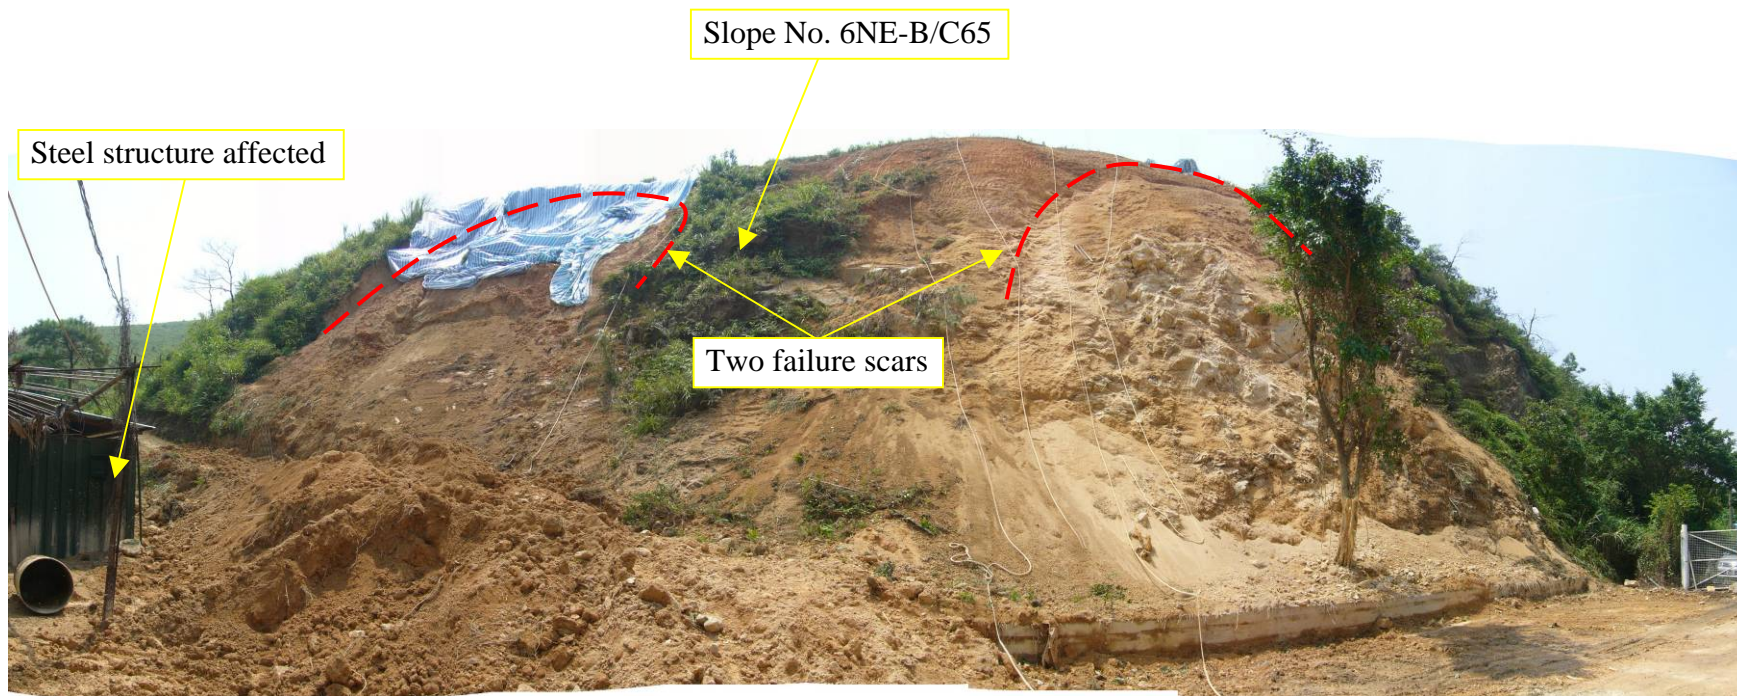
Plate 3 - The 13 September 2006 Landslide Incident on Slope No. 6NE-B/C65 at Hong Kong Horse Riding School, Kam Ting Road (Incident No. 2006/09/0726)

Description: A major landslide on a cut slope which affected the operation of the Hong Kong Horse Riding School.

At about 7:45 p.m. on 13 September 2006, when the Amber Rainstorm Warning and the Landslip Warning were in effect, a landslide comprising two failure scars, with a total failure volume of about 100 m³, occurred on slope No. 6NE-B/C65 at the Hong Kong Horse Riding School at Kam Tin Road. Most of the debris was deposited on the open area near the school entrance. The operation of the Horse Riding School and a steel structure located at the slope toe were affected as a result of the incident. No casualties were reported.

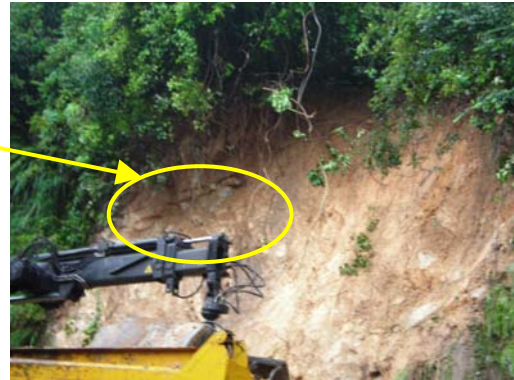
Plate 4 - The 13 September 2006 Landslide Incident on Slope No. 15NE-B/C17 along Shek O Road (Incident No. 2006/09/0710)

Grade II/III volcanic rock core-slab with sub-horizontal joints

Description: A minor landslide involving a soil/rock cut slope, which resulted in temporary closure of Shek O Road.

landslide with a failure volume of about 20 m³ occurred on slope No. 15NE-B/C17 located above the north-bound lane of Shek O Road. Landslide debris was deposited on the road and no casualties were reported as a result of the incident. One lane of Shek O Road was temporarily closed for 5 days until completion of the urgent repair works.
