# **FACTUAL REPORT ON HONG KONG RAINFALL AND LANDSLIDES IN 2007**

**GEO REPORT No. 254**

**J.W.C. Lau & C.H.W. Chan**

**GEOTECHNICAL ENGINEERING OFFICE  
CIVIL ENGINEERING AND DEVELOPMENT DEPARTMENT  
THE GOVERNMENT OF THE HONG KONG  
SPECIAL ADMINISTRATIVE REGION**

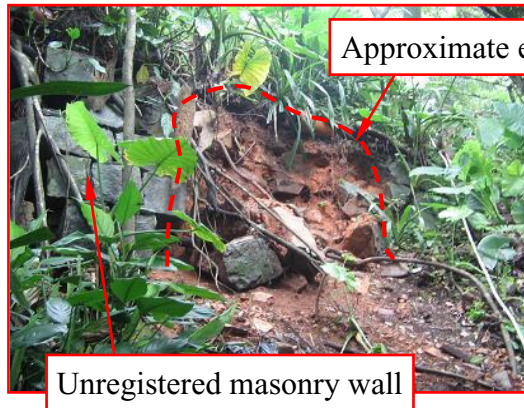
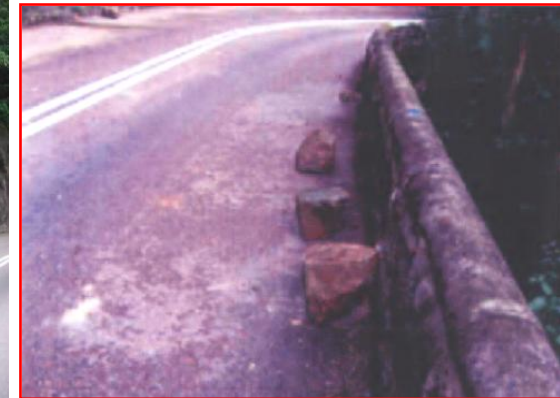
Plate 3 - The 3 June 2007 Failure on an Unregistered Retaining Wall on Disturbed Hillside above Slope No. 11SW-D/C258, Peak Road (Incident No. 2007/06/0020)

In the morning of 3 June 2007, a failure occurred on an old, about 2.2 m high squared masonry wall located on the disturbed hillsides about 12 m above cut slope No. 11SW-D/C258, Peak Road. The failure involved the detachment of several masonry blocks from the subject masonry wall, amongst which the largest one measured 0.5 m by 0.3 m by 0.3 m. Some of the detached masonry blocks were deposited on the hillside, while some travelled further downslope, which came to rest on Peak Road. As a result, one lane of Peak Road was temporarily closed. Signs of distress in the form of bulging of the wall face and missing masonry blocks were noted on the masonry wall after the incident. In addition, tree root wedging action was evidenced on the wall face. No casualties were reported as a result of the failure.

Close-up view of the failure scar

Approximate extent of the failure scar

Probable trajectory of the detached rock blocks

Close-up view of the fallen masonry blocks

Description: Detachment of several sizeable masonry blocks from an unregistered masonry retaining wall, which resulted in the temporary closure of one lane of Peak Road.
