FACTUAL REPORT ON HONG KONG RAINFALL AND LANDSLIDES IN 2008

GEO REPORT No. 273

GEOTECHNICAL ENGINEERING OFFICE CIVIL ENGINEERING AND DEVELOPMENT DEPARTMENT THE GOVERNMENT OF THE HONG KONG SPECIAL ADMINISTRATIVE REGION

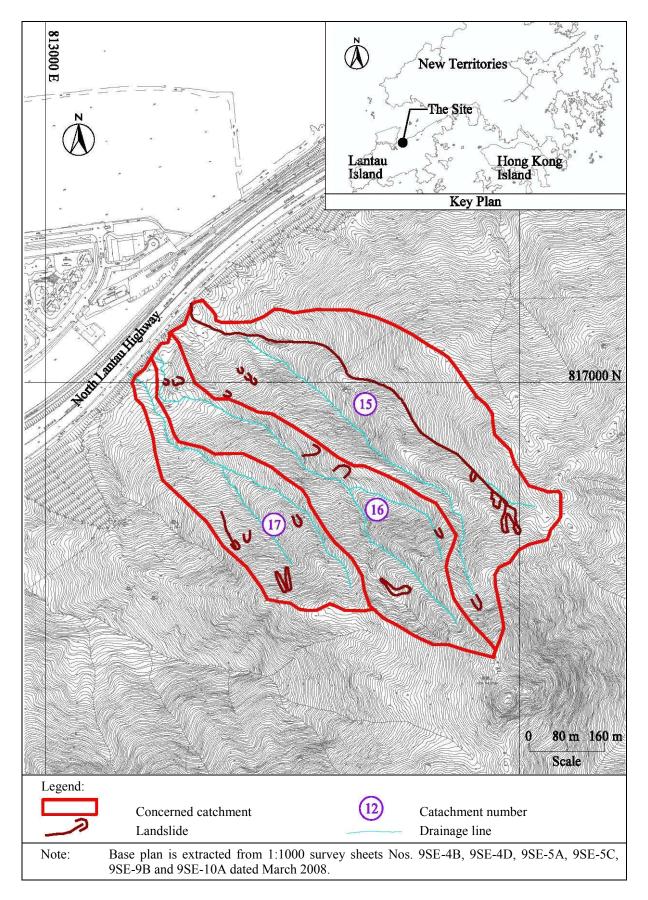
Some 20 failures occurred on a natural hillside above North Lantau Highway (NLH) in the morning of 7 June 2008 (see location plan in Figure 21). The failure volumes ranged from less than 5 m³ to 310 m³. The largest failure occurred in catchment No. 15 at about 9:00 a.m.. The debris from this failure area and that from other three smaller failures in the vicinity entered a drainage line and developed into a debris flood, with a long run-out distance of about 1 km. The total volume of the four failures was about 670 m³. Most of the debris was deposited on the drainage line. About 80 m³ of the debris reached NLH and blocked the road drainage system, resulting in severe flooding of a 200 m section of NLH and temporary closure of the affected road section for about 16 hours (Plate 8). No casualties were reported.

Figure 21 - Report Landslide Incidents on Natural Hillside above North Lantau Highway, Tung Chung

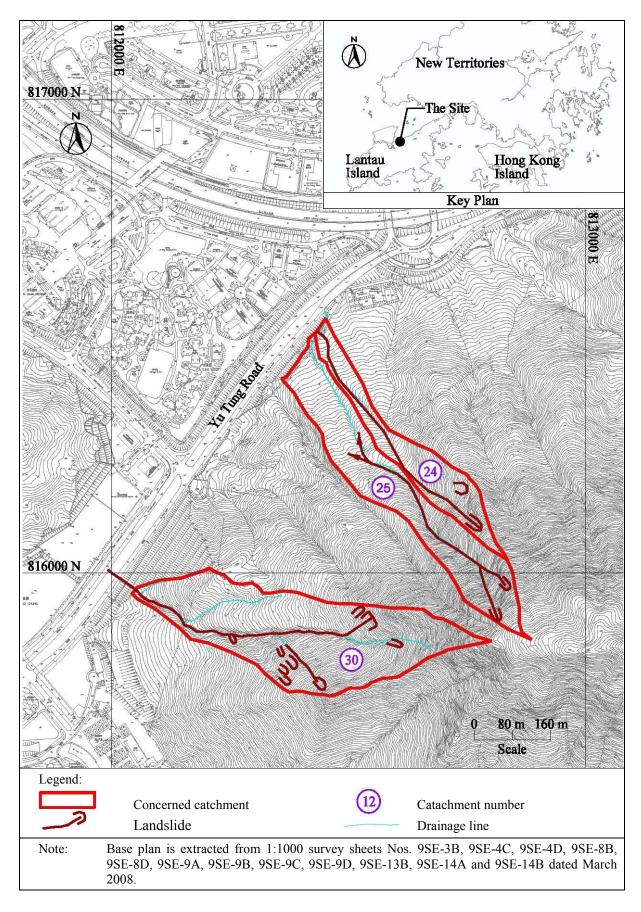
Some 13 failures occurred on a natural hillside above Yu Tung Road (YTR) in the morning of 7 June 2008 (see location plan in Figure 22). The failure volumes ranged from 30 m³ to 2,350 m³. The largest failure occurred in catchment No. 30, which involved a volume of about 2,350 m³. The debris from the failure source area entered a drainage line and developed into a 3,300 m³ debris flow through material entrainment, with a run-out distance of about 600 m. The debris blocked the westbound lanes of Yu Tung Road. One lane of the road was temporarily closed until 11 August 2008 while the other was not opened until 14 April 2009 (Plate 9). The other failures were relatively minor, and the debris largely

Figure 22 - Report Landslide Incidents on Natural Hillside above Yu Tung Road, Tung Chung

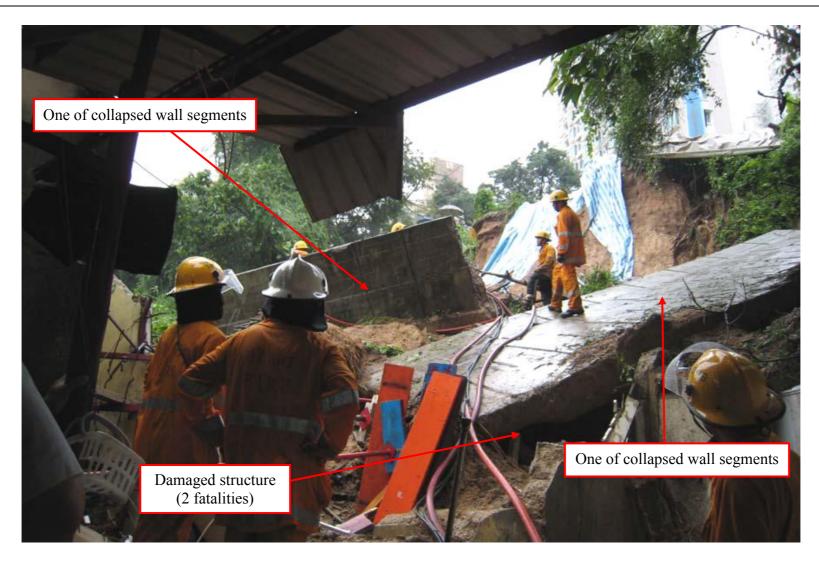
At about 6:30 a.m. on 7 June 2008, a landslide occurred on slope No. 6SW-C/CR797, involving the collapse of about 25 m length of an approximately 2.8 m high crest concrete retaining wall and part of the slope below (Plate 1). The failure volume was about 300 m³. The landslide debris, comprising soil and large segments of the collapsed concrete wall, hit a squatter structure at the toe of the slope and demolished part of it, resulting in two fatalities.

Plate 1 - The 7 June 2008 Landslide Incident on Slope No. 6SW-C/CR797 at Cafeteria Old Beach, Tuen Mun (Incident No. 2008/06/0129)

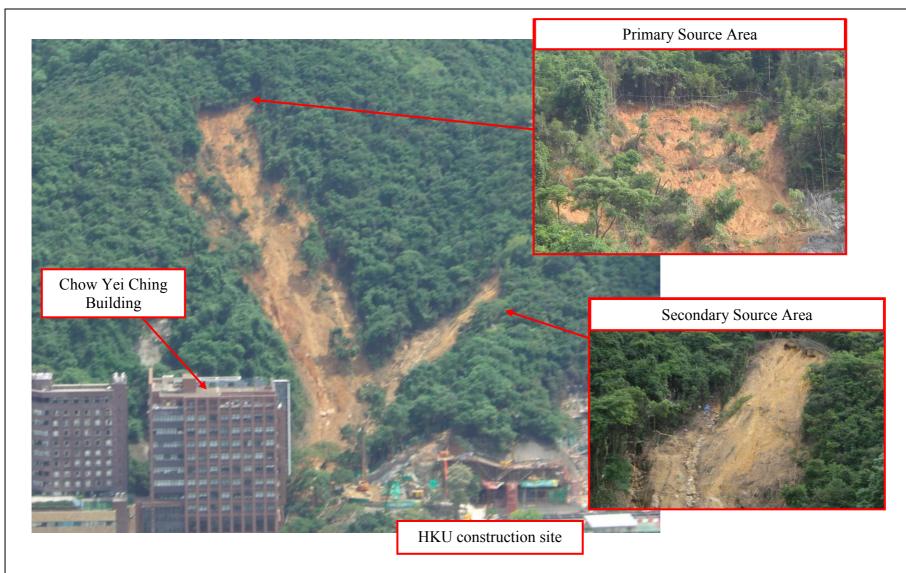
Between 7:30 a.m. and 9:30 a.m. on 7 June 2008, a landslide occurred on the natural hillside behind Chow Yei Ching Building at the University of Hong Kong, Pok Fu Lam (Plate 2). The landslide was shallow but spatially extensive, involving a total failure volume of about 1,960 m³ and comprising a primary and a secondary source area. The detached material travelled about 210 m down the hillside and came to rest adjacent to Chow Yei Ching Building. A 200 mm diameter fresh water main, associated with a paved footpath traversing the primary source area was damaged. A temporary footbridge adjacent to Chow Yei Ching Building was also destroyed. Some outwash debris went further into the lower floors and carpark of Chow Yei Ching Building. The outwash debris continued into Pok Fu Lam Road and partly flooded the eastbound carriageway and proceeded downhill towards Hill Road. No causalities were reported as a result of the landslide.

Plate 2 - The 7 June 2008 Landslide Incident on Natural Hillside behind Chow Yei Ching Building at the University of Hong Kong, Pok Fu Lam (Incident No. 2008/06/0193)

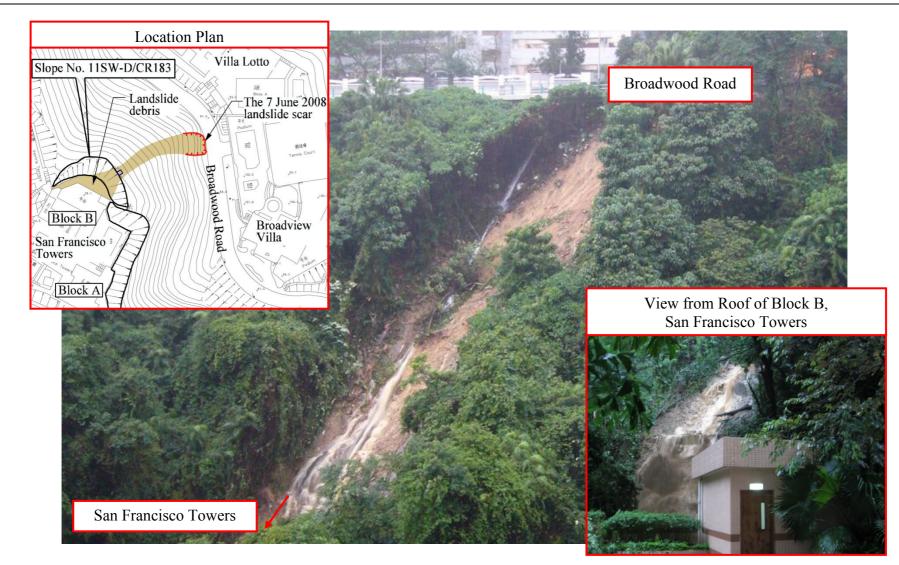
At 6:49 a.m. on 7 June 2008, a landslide occurred on the hillside below Broadwood Road, overlooking San Francisco Towers (Plate 3). The landslide source was approximate 12 m wide and up to 15 m long, and about 0.8 m deep. The estimated volume of failure was about 75 m³. The landslide debris travelled some 60 m, finally coming to rest against the outer wall of the level 3 basement carpark at the rear of Block B, San Francisco Towers. The debris blocked the stormwater drains at the toe of the hillside and contributed to the flooding of the carpark in San Francisco Towers. No casualties were reported as a result of the landslide.

Plate 3 - The 7 June 2008 Landslide Incident on Hillside above San Francisco Towers, Happy Valley (Incident No. 2008/06/0131)

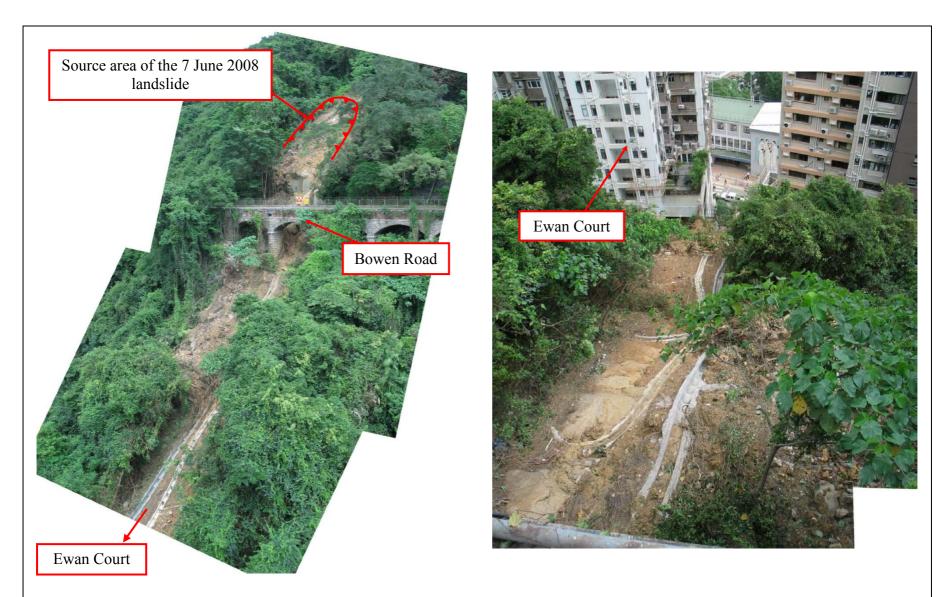
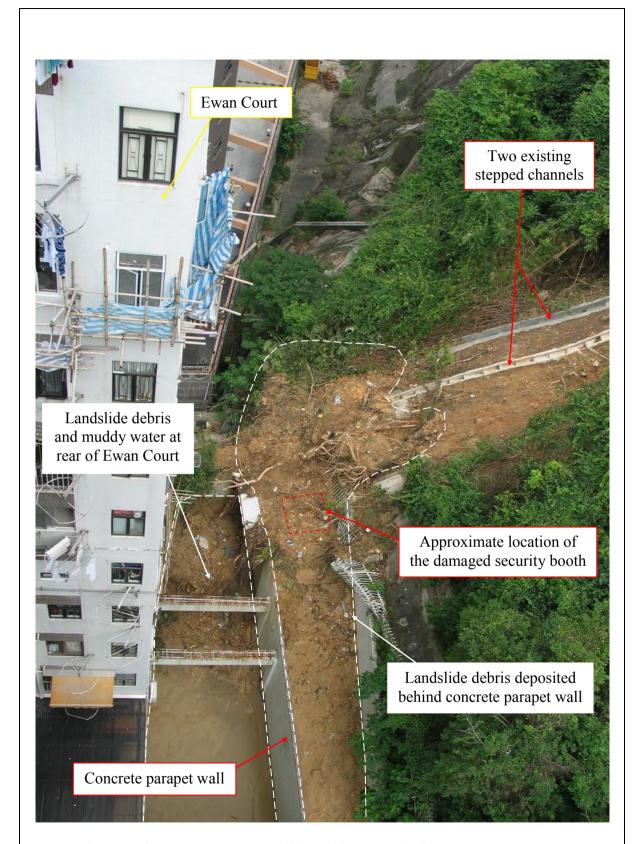
Between 7:00 a.m. and 7:30 a.m. on 7 June 2008, a landslide occurred on the north-facing hillside behind Ewan Court at 54-56 Kennedy Road, Wanchai (Plates 4 and 5). The failure with an estimated volume of 200 m³ occurred on a natural hillside. The failure also involved an unpaved fill platform on the hillside, at the crest of the landslide. The natural hillside was densely vegetated and steeply inclined at an angle of up to about 40°. The landslide debris travelled about 80 m and came to rest at the rear alleyway of Ewan Court. A vacant security booth at the rear of Ewan Court was destroyed and a section of the concrete parapet wall was damaged. Some landslide debris also went into the carpark at the ground floor level via the access ramp. No casualties were reported as a result of the landslide.

Plate 4 - The 7 June 2008 Landslide Incident on Hillside above Ewan Court, Kennedy Road (Incident No. 2008/06/0182)

Plate 5 - The 7 June 2008 Landslide Incident on Hillside above Ewan Court, Kennedy Road (Incident No. 2008/06/0182)

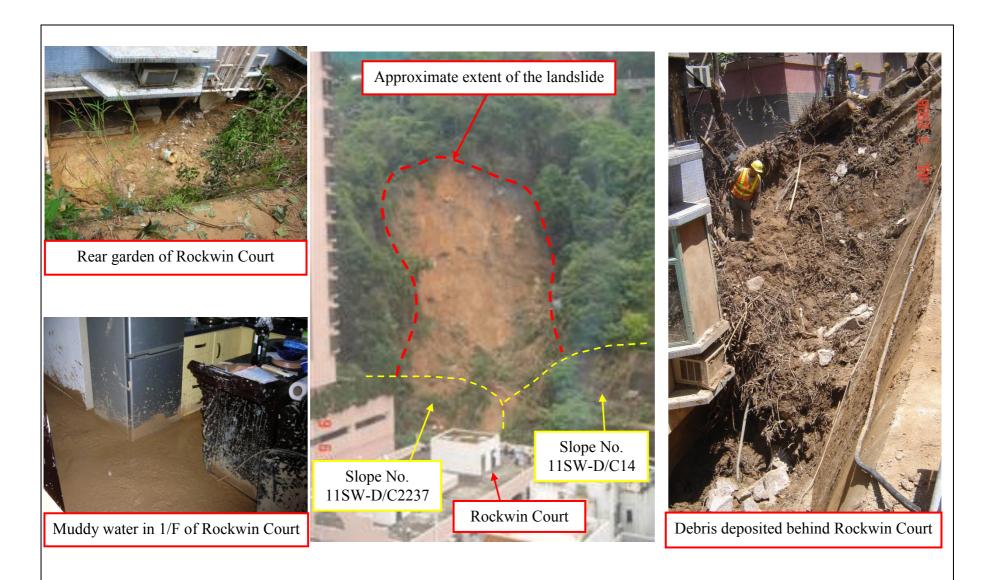
In the morning of 7 June 2008, a landslide occurred on the natural hillside above slope No. 11SW-D/C2237, adjacent to Rockwin Court, Fung Fai Terrace (Plate 6). The estimated failure volume was 500 m³. The landslide debris deposited on the cut slope and some travelled further down to the rear garden of Rockwin Court. Some landslide debris and muddy water also went into the flats of Rockwin Court adjacent to the toe of the hillside. Residents in nine affected flats of Rockwin Court were temporarily evacuated. No casualties were reported as a result of the landslide.

Plate 6 - The 7 June 2008 Landslide Incident on Natural Hillside above Fung Fai Terrace, Happy Valley (Incident No. 2008/06/0156)

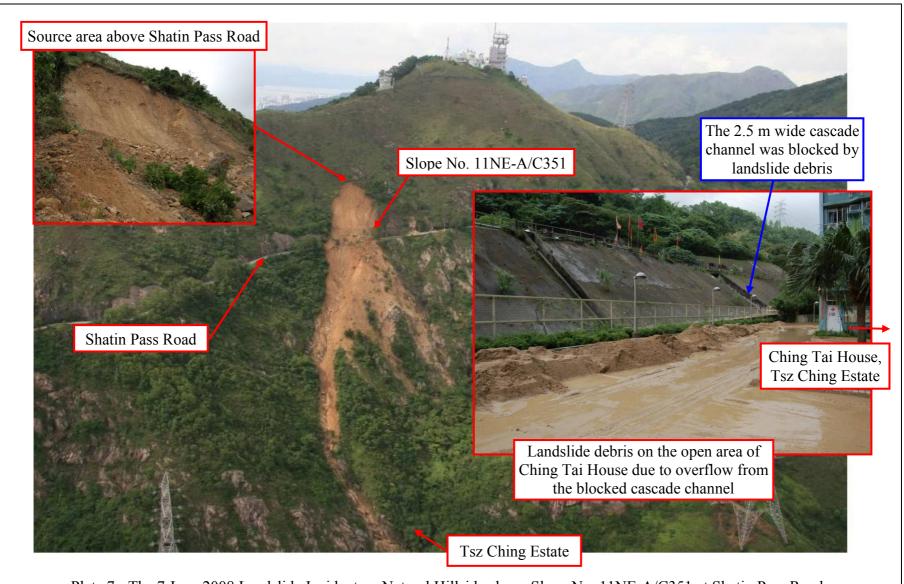
In the morning of 7 June 2008, a landslide occurred on a natural hillside above Shatin Pass Road (Plate 7). The failure involved roadside slope No. 11NE-A/C351 and part of the hillside above. The total failure volume was about 3,550 m³. Some debris came to rest on Shatin Pass Road at the toe of the cut slope. The rest of the debris travelled further down and entered a drainage line, developing into a channelised debris flow with a run-out distance of about 600 m. The debris reached Tsz Ching Estate, blocked a 2.5 m wide cascade channel and resulted in flooding of an open area near Ching Tai House of the public housing estate. No casualties were reported as a result of the landslide.

Plate 7 - The 7 June 2008 Landslide Incident on Natural Hillside above Slope No. 11NE-A/C351 at Shatin Pass Road (Incident No. 2008/06/0170)

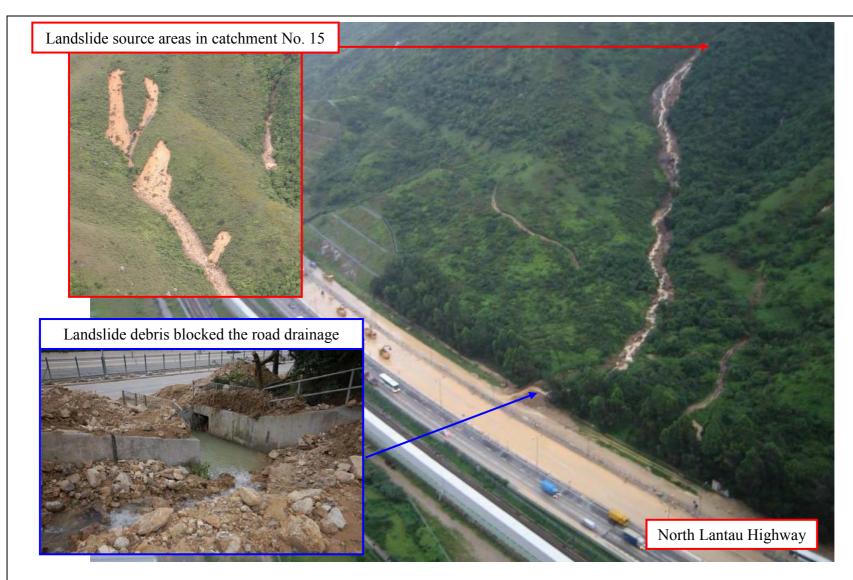
Plate 8 - The 7 June 2008 Landslide Incident on Natural Hillside in Catchment No. 15 above North Lantau Highway, Tung Chung (Incident No. 2008/06/0346)

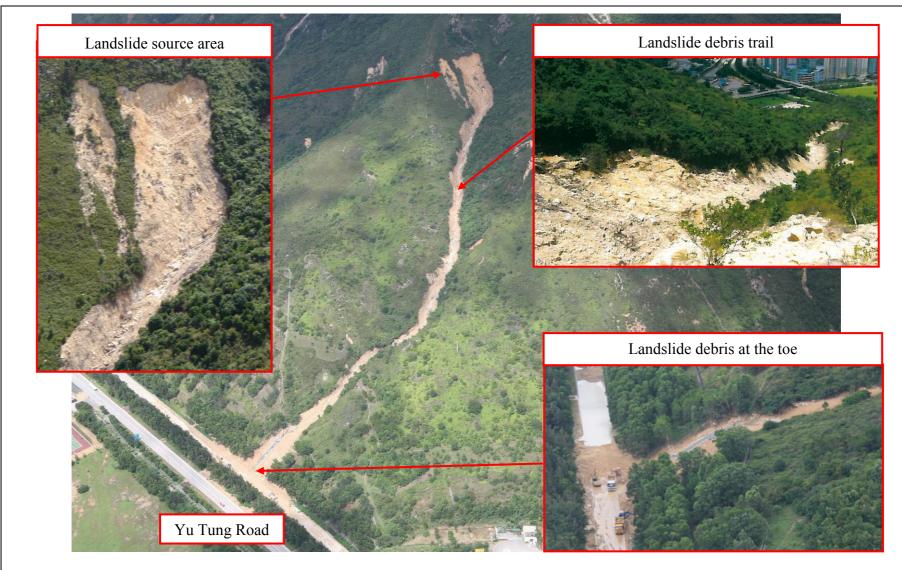
Plate 9 - The 7 June 2008 Landslide Incident on Natural Hillside in Catchment No. 30 above Yu Tung Road, Tung Chung (Incident No. 2008/06/0344)

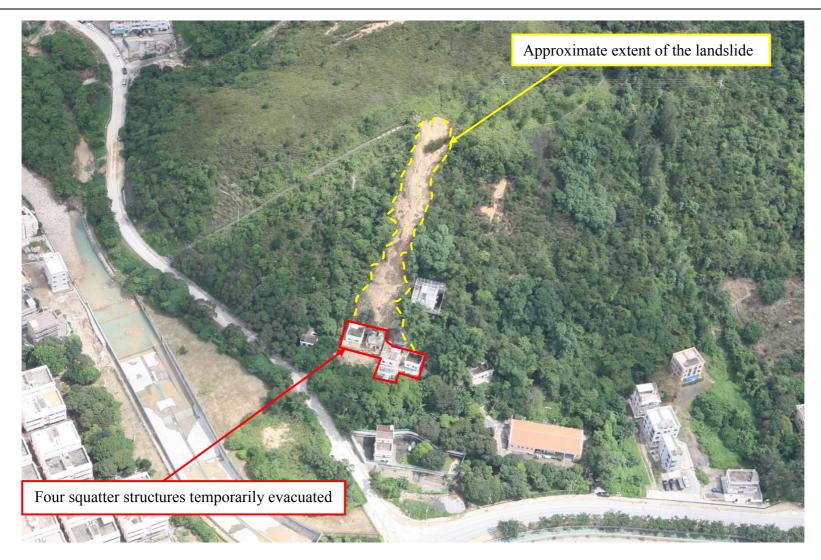
On 7 June 2008, a shallow open hillslope landslide occurred on the natural hillside at Fui Yiu Ha, near Sheung Ling Pei in Tung Chung (Plate 10). The failure volume was about 180 m³ at the landslide source, with a maximum run-out distance of about 50 m. The landslide debris damaged a squatter structure and affected another three at the toe of the hillside. The four squatter structures were temporarily evacuated immediately after the landslide. Compulsory clearance (i.e. Category 1 Non-Development Clearance (NDC)) of these squatter structures was subsequently recommended to Lands Department. No casualties were reported as a result of the landslide.

Plate 10 - The 7 June 2008 Landslide Incident on Natural Hillside at Fui Yiu Ha, Sheung Ling Pei, Tung Chung (Incident No. 2008/06/0232)

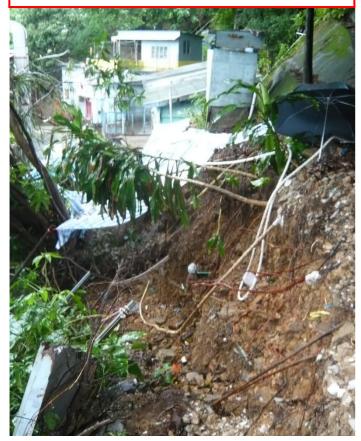
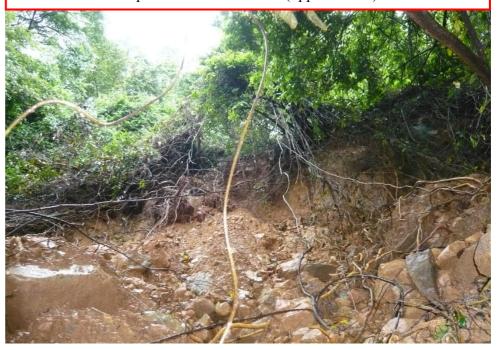
Two landslides occurred on the south-facing hillside behind Kwan Tai Temple (關帝廟) at Kat Hing Back Street, Tai O at around 7:00 a.m. on 7 June 2008 (Plate 11). The incidents involved the collapse of a 5 m high cut slope (No. 9SW-D/CR177) and the associated concrete retaining wall as well as the natural hillside above. The volume of failure at the cut slope feature is about 35 m³ and the debris destroyed part of a structure at the slope toe. On the hillside above, the failure volume is about 150 m³ at the landslide source with about 50 m³ of the detached material remained on the hillside and the rest travelled downslope reaching a single-storey building at the toe of the hillside.

Landslide on slope No. 9SW-B/CR177 (lower failure)

Landslide on natural hillside above slope No. 9SW-B/CR177 (upper failure)

Plate 11 - The 7 June 2008 Landslides on Slope No. 9SW-D/CR177 and Natural Hillside behind Kwan Tai Temple, Kat Hing Back Street, Tai O (Incident Nos. 2008/06/0376A and 2008/06/0376B)

No casualties were reported. However, four affected squatter structures were temporarily evacuated immediately after the landslide. A Category 1 NDC recommendation was subsequently made to Lands Department to clear the affected squatter structures.

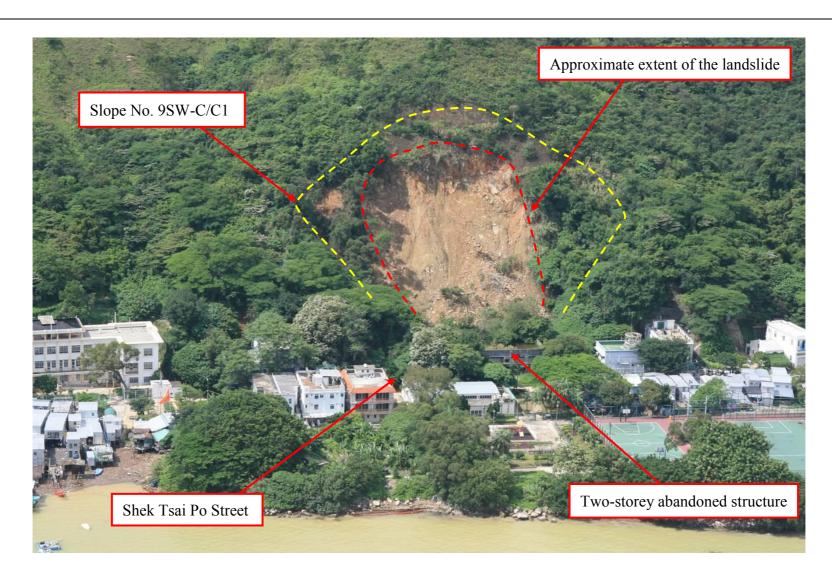
Plate 12 - The 7 June 2008 Landslide Incident on Slope No. 9SW-C/C1 at Shek Tsai Po Street, Tai O (Incident No. 2008/06/0381)

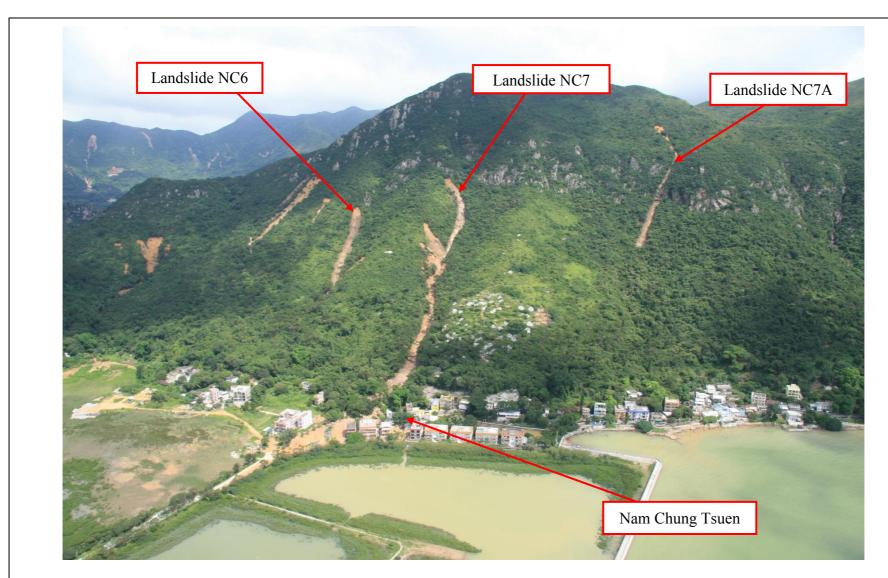
Landslide NC6 involved three failure source areas with a total estimated failure volume of about 320 m³. The debris from the source areas entered a drainage line and developed into a debris flow, with a run-out distance of about 350 m. Some debris was deposited on the Lantau Trail blocking a section of the Trail. Some travelled further downhill reaching several squatter structures at Nam Chung Tsuen.

Landslide NC7 involved two failure source areas, with an estimated failure volume of about 95 m³ and 35 m³ respectively. The landslide debris entered an ephemeral drainage line and developed into a debris flow, with a run-out distance of about 470 m. Some debris reached Nam Chung Tsuen affecting five squatter structures. The affected structures were temporarily evacuated following the incident.

Landslide NC7A comprised a single failure source area with an estimated failure volume of 230 m³. The landslide debris entered a drainage line and developed into a debris flow, with a run-out distance of about 220 m. Some landslide debris was deposited on an open area at the toe of the hillside and some reached Nam Chung Tsuen resulting in temporary evacuation of five squatter structures and one village house.

Plate 13 - The 7 June 2008 Landslide Incidents on Natural Hillside above Nam Chung Tsuen, Tai O (Incident Nos. 2008/06/0261, 2008/06/0481 and 2008/06/0483)

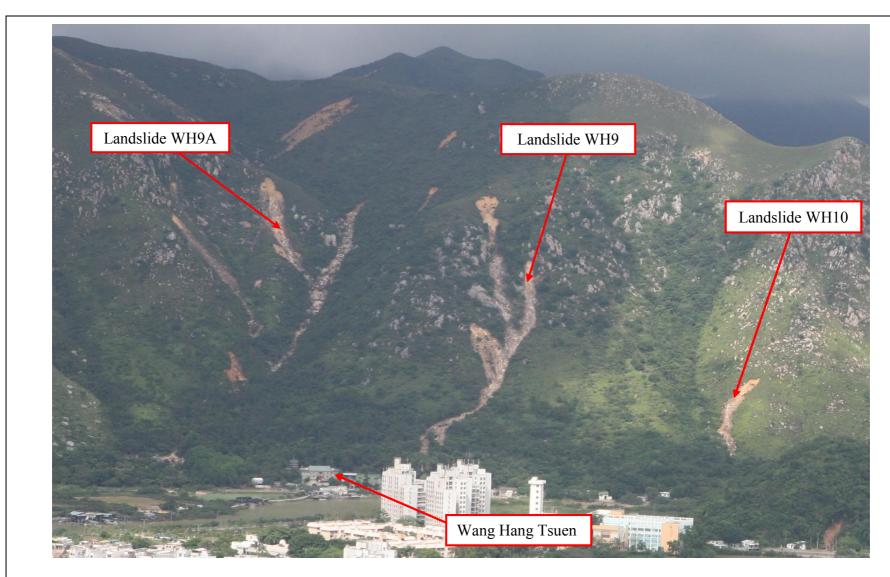
Landslide WH9 involved three failure source areas. The estimated failure volume of each source area ranged from 200 m³ to 400 m³. The landslide debris entered a drainage line and developed into a debris flow, with a run-out distance of about 400 m. The landslide affected a village house at Wang Hang Tsuen, which was temporarily evacuated.

Landslide WH9A involved multiple source areas with estimated failure volumes ranging from 200 m³ to 450 m³. The landslide debris entered a drainage line and developed into a debris flow, with a run-out distance of about 670 m, reaching an abandoned hut at Wang Hang Tsuen.

Landslide WH10 is an open hillslope failure with an estimated failure volume of 400 m³. The landslide debris travelled along a topographic depression, with a run-out distance of about 60 m. All the landslide debris was deposited on the hillside and did not affect any facilities.

Plate 14 - The 7 June 2008 Landslide Incidents on Natural Hillside above Wang Hang Tsuen, Tai O (Incident Nos. 2008/06/0382, 2008/06/0396 and 2008/06/0479)

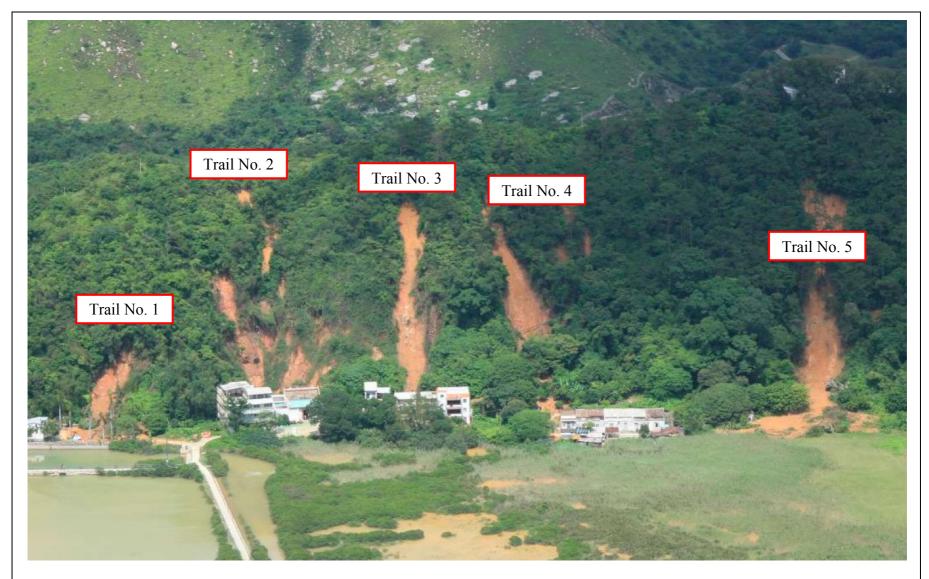
At about 7:00 a.m. on 7 June 2008, five landslides, viz. Trail No. 1 (2008/06/0383), Trail No. 2 (2008/06/0385), Trail No. 3 (2008/06/0238), Trail No. 4 (2008/06/0388) and Trail No. 5 (2008/06/0389), occurred on the natural hillside above Tai O San Tsuen (Plate 15). The landslides comprised ten sources of shallow open-hillslope failure. The failure volume of each source area ranged from about 25 m³ to 160 m³. Some of the landslide debris reached the Tin Hau Temple and nine village houses at the toe of the hillside. The affected temple and village houses were temporarily closed/evacuated from 13 June to 11 July 2008. No casualties were reported as a result of the landslides.

Plate 15 - The 7 June 2008 Landslide Incidents on Natural Hillside above Tai O San Tsuen (Incident Nos. 2008/06/0238, 2008/06/0383, 2008/06/0385, 2008/06/0388 and 2008/06/0389)

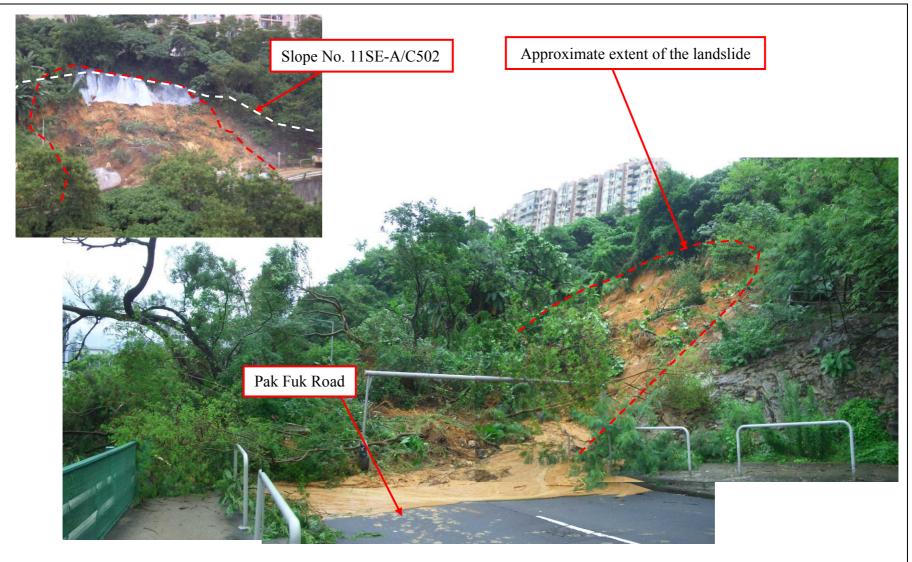
Plate 16 - The 7 June 2008 Landslide Incident on Slope No. 11SE-A/C502 at Pak Fuk Road, North Point (Incident No. 2008/06/0144)

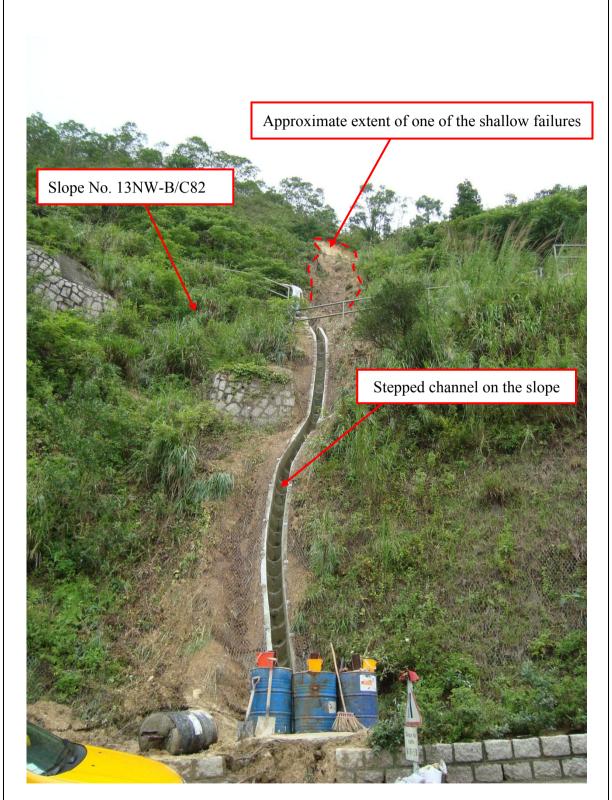
Landslide KS1, occurred on the natural hillside above slope No. 13NW-B/C82 at Keung Shan Road (Plate 17), comprised two failures, both with an estimated source volume of about 80 m³. The landslide debris from one of the failures travelled down the hillside through a stepped channel on the cut slope and completely blocked Keung Shan Road. The landslide debris from the other failure source was less mobile, and most of which came to rest on the upper portion of the cut slope.

Plate 17 - The 7 June 2008 Landslide Incident (Landslide KS1) on Natural Hillside above Slope No. 13NW-B/C82, Keung Shan Road, Lantau Island (Incident No. 2008/06/0132)

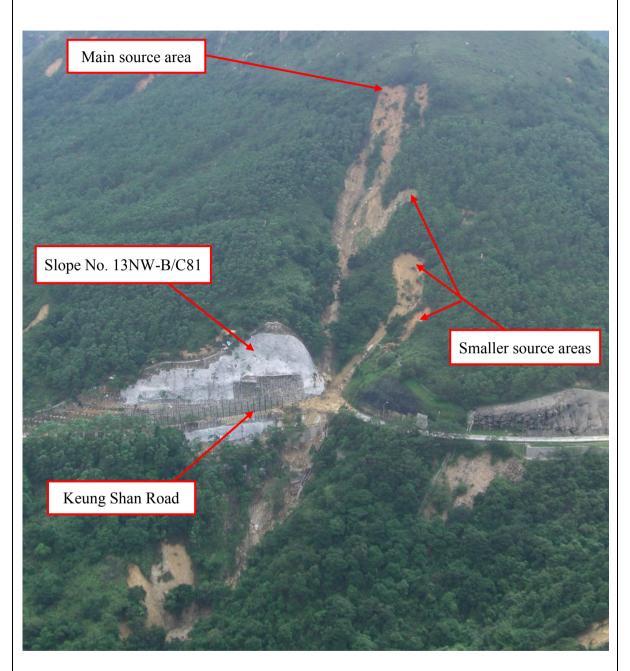
Landslide KS2, occurred on the natural hillside above slope No. 13NW-B/C81 at Keung Shan Road (Plate 18), comprised a main source area with an estimated failure volume of about 3,000 m³ and three smaller source areas with failure volumes ranging from about 50 m³ to 100 m³. The landslide debris entered a drainage line and developed into a debris flow reaching Keung Shan Road. Some of the landslide debris was deposited on Keung Shan Road, whilst other travelled further downhill reaching another streamcourse. The overall run-out distance of the debris flow was about 200 m.

Plate 18 - The 7 June 2008 Landslide Incident (Landslide KS2) on Natural Hillside above Slope No. 13NW-B/C81, Keung Shan Road, Lantau Island (Incident No. 2008/06/0208)

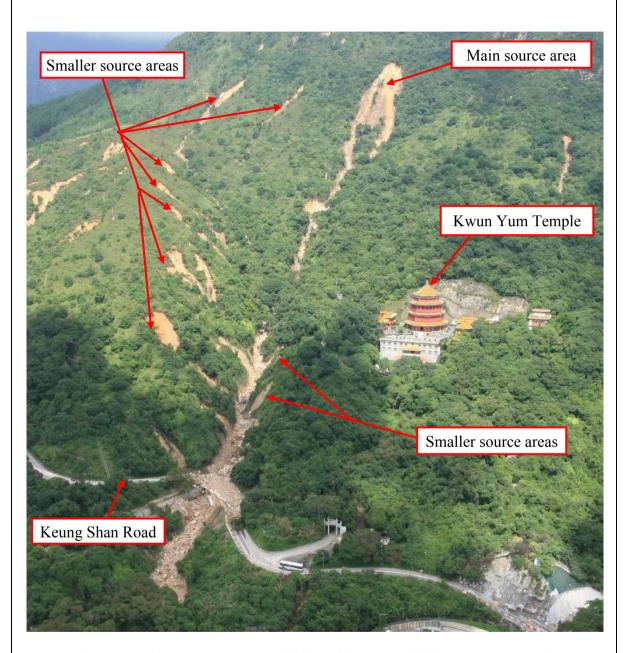
Landslide KS3 occurred on the natural hillside above Keung Shan Road, near the Kwun Yum Temple (Plate 19). The landslide comprised a main source area with an estimated failure volume of about 725 m³ and nine smaller source areas, with failure volumes ranging from about 30 m³ to 377 m³. The debris travelled along two distinct paths before

Plate 19 - The 7 June 2008 Landslide Incident (Landslide KS3) on Natural Hillside above Keung Shan Road near Kwun Yum Temple, Lantau Island (Incident No. 2008/06/0499)

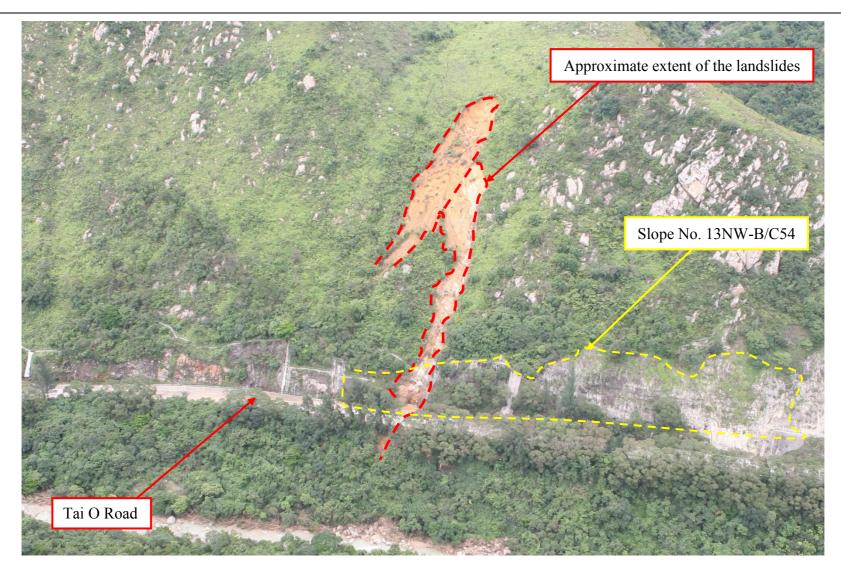
On 7 June 2008, two landslides occurred on the natural hillside above slope No. 13NW-B/C54 at Tai O Road (Plate 20). One of them involved an open hillslope failure with an estimated source volume of 300 m³, and the landslide debris travelled about 100 m before coming to rest on the hillside. The other failure source had an estimated volume of 200 m³, and the landslide debris entered an ephemeral drainage line and developed into a debris flow with a run-out distance of about 150 m, reaching Tai O Road below. One lane of Tai O Road was temporarily closed. No casualties were reported as a result of the landslides.

Plate 20 - The 7 June 2008 Landslide Incidents on Natural Hillside above Slope No. 3NW-B/C54, Tai O Road (Incident Nos. 2008/06/0500 and 2008/06/0501)

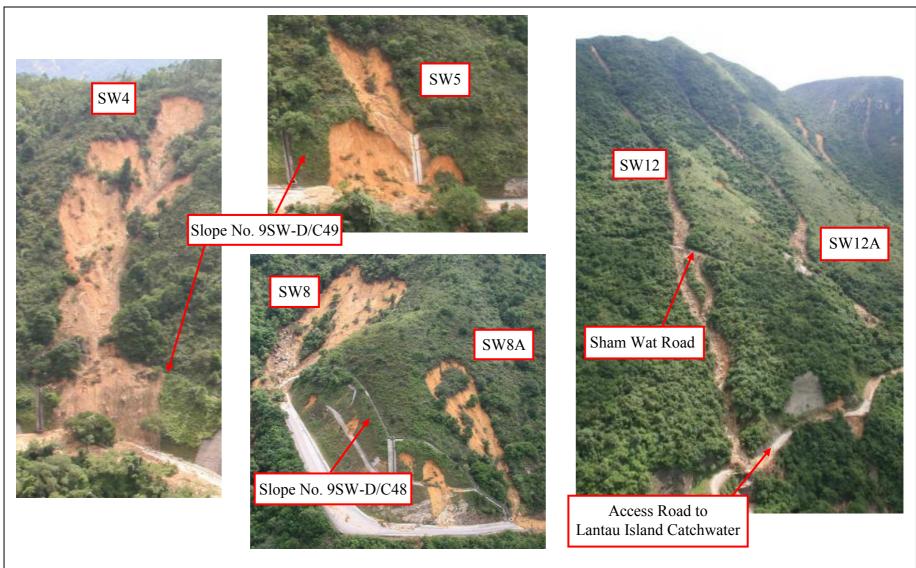
Landslides SW4 and SW5 involved open hillslope failures above roadside slope No. 9SW-D/C49. The source volumes for the failures at SW4 and SW5 were about 675 m³ and 190 m³ respectively. The debris from the landslides terminated at Sham Wat Road.

Landslides SW8 and SW8A involved two open hillslope failures above roadside slope No. 9SW-D/C48. The source volumes for the failures at SW8 and SW8A were about 300 m³ and 400 m³ respectively. The debris from both landslides terminated at Sham Wat Raod.

Landslides SW12 and SW12A involved two open hillslope failures above Sham Wat Road. The source volumes for the failures at SW12 and SW12A were about 70 m³ and 100 m³ respectively. The landslide debris were channelised and developed into debris flows, both with a run-out distance of about 620 m. The debris crossed over Sham Wat Road and continued downhill till it reached the access road leading to the Lantau Island Catchwater. The debris did not result in blockage to the access road.

Plate 21 - The June 2008 Landslide Incidents above Sham Wat Road (Incident Nos. 2008/06/0435, 2008/06/0439, 2008/06/0440, 2008/06/0441, 2008/06/0555 and LI/2008/06/2013)

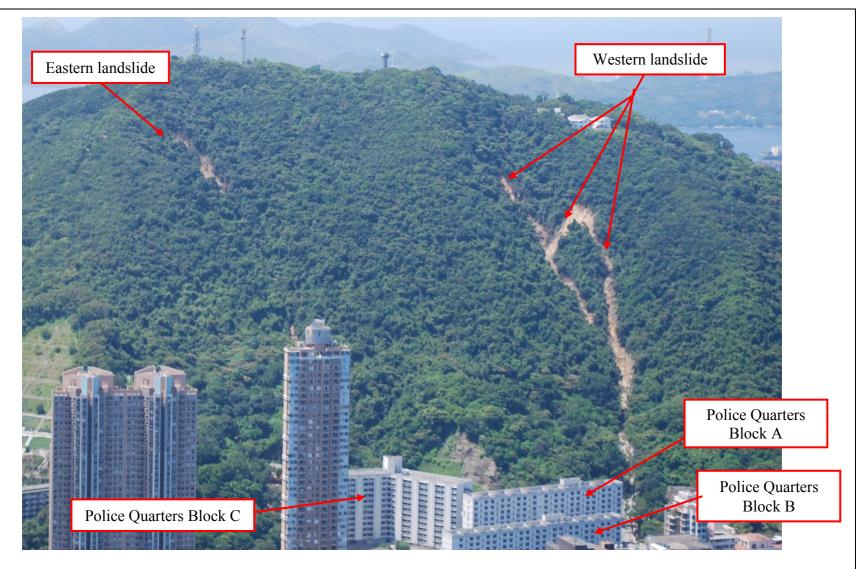
One of the landslides occurred on the western part of the natural hillside above Police Quarters Block A. The incident involved two failure source areas with a total failure volume of about 435 m³. The debris entered a drainage line and developed into a debris flow, with a run-out distance of about 400 m. Approximately 610 m³ of landslide debris was deposited on the building platform. Subsequent outwash of the landslide debris went further downhill into the ground floor of Police Quarters Block B and some also reached the playground of Hong Kong Institute of Vocational Education.

Plate 22 - The 7 June 2008 Landslide Incidents on Natural Hillside at Mount Davis above Kennedy Town Police Quarters (Incident Nos. 2008/06/0183 and 2008/06/0451)
