Factual Report on Hong Kong Rainfall and Landslides in 2011

GEO Report No. 310

**Geotechnical Engineering Office
Civil Engineering and Development Department
The Government of the Hong Kong
Special Administrative Region**

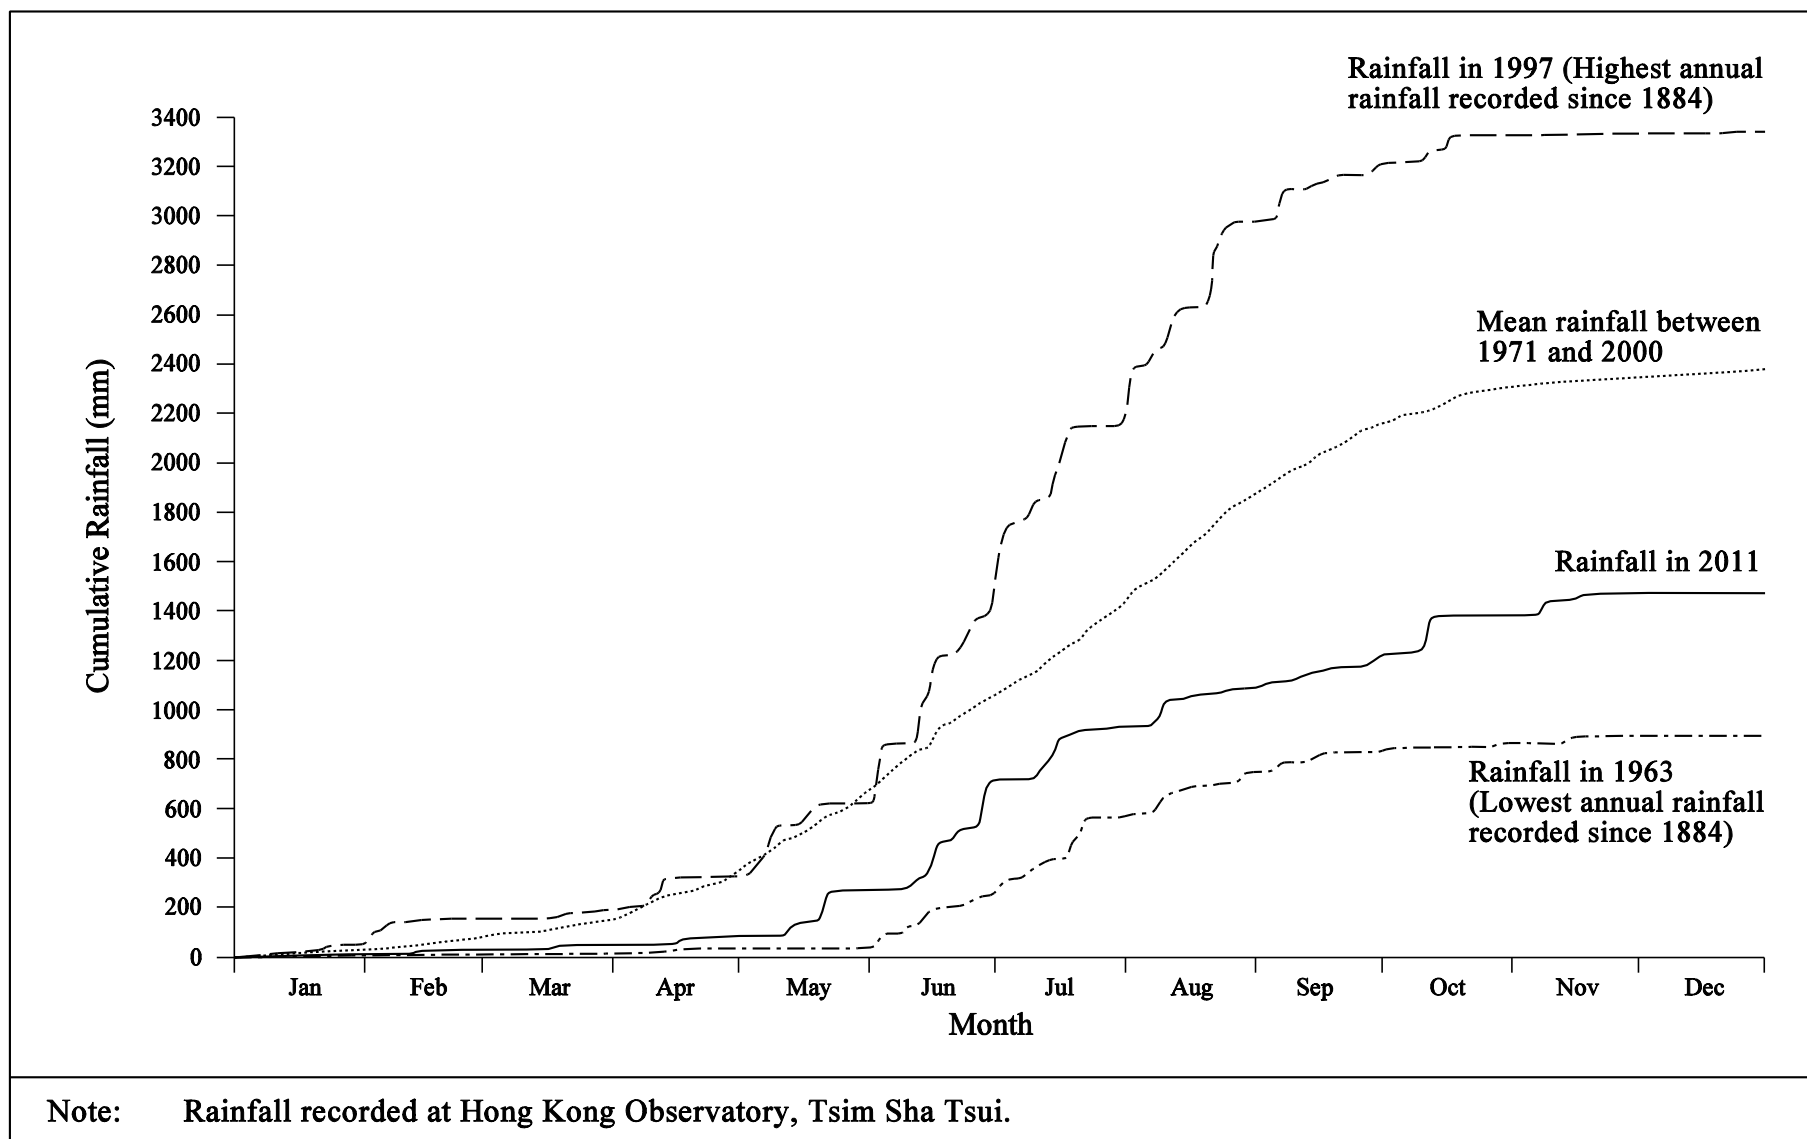
Figure 2.2 Cumulative Rainfall for 2011 at the Hong Kong Observatory and its Recorded Highest, Mean and Lowest Cumulative Rainfalls

“The year 2011 was also an exceptionally dry year. With well below normal rainfall in the first nine months, the annual rainfall of 1,476.7 millimetres was about 38 per cent below normal, the lowest since 1963.”

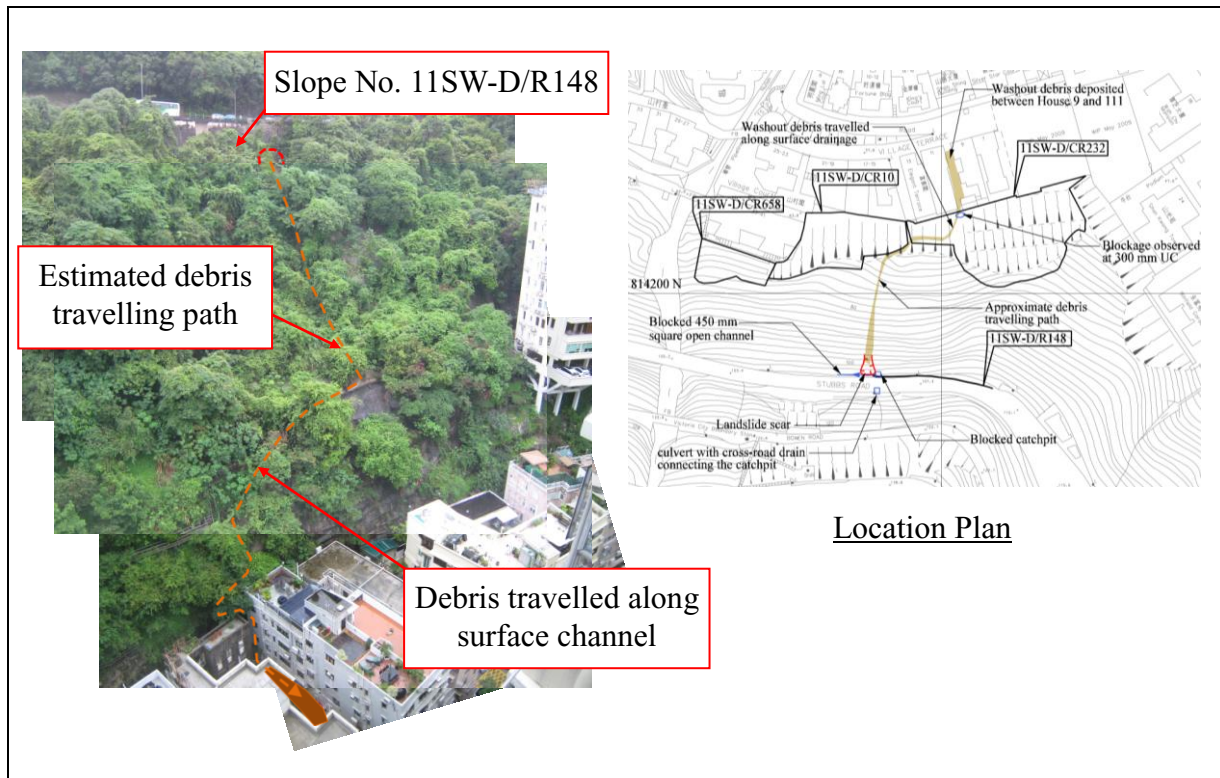
At about 9:10 a.m. on 16 June 2011 when Amber Rainstorm Warning was in effect, a 30 m³ landslide occurred at the natural hillside beneath Stubbs Road, below a retaining wall (slope No. 11SW-D/R148). The source area was about 4 m wide, 6 m long, and 0.5 m deep. The landslide debris and muddy water travelled down the hillside and along the surface drainage channels near the slope toe to Village Terrace below. Landslide debris inundated the open area between Houses No. 9 and No. 11 in Village Terrace. No injury or casualty was reported.

Figure 4.1 General View of the 16 June 2011 Landslide on Natural Hillside Beneath Stubbs Road, Happy Valley (Incident No. 2011/06/1110)
