# **A Review of Slope-specific Early Warning Systems for Rain-induced Landslides**

**GEO Report No. 316**

**Geotechnical Engineering Office  
Civil Engineering and Development Department  
The Government of the Hong Kong  
Special Administrative Region**

**This report was originally produced in October 2013  
as GEO Technical Note No. TN 4/2013**

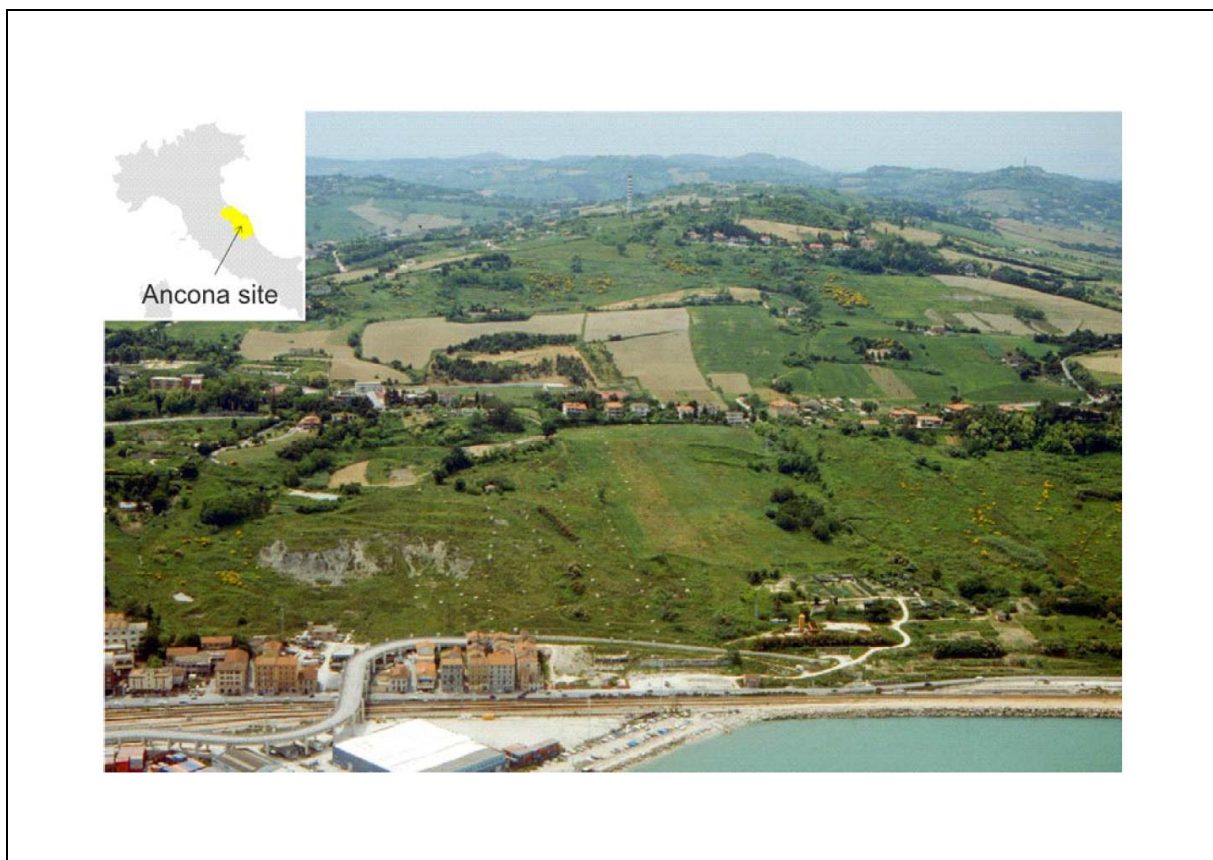
**Figure A1 General View of the Slope under Monitoring at Ancona, Italy**  
(Supper et al, 2012)

Ancona city, Italy is located on the East coast of the Adriatic Sea (Figure A1). On 13<sup>th</sup> December 1982, the Montagnolo hill at the northern part of the city started to slide towards the sea. It damaged private houses, strategic buildings and infrastructures; about 3000 people were urgently evacuated. Railway and main roads were blocked, and gas and water supplies were interrupted. The landslide involved about 180 millions m<sup>3</sup> of clay and silty clay layers (Pliocene-Pleistocene), with different OCR parameters, alternated with thin sand layers. The instability was caused by a rotational slip plane 120 m below ground (Cotecchia, 2006). The landslide scarp was identified at 80 m above sea level and the landslide toe was reported to be below the level of Adriatic Sea. Records of movements of the landslide body can be traced back to 1773. The landslide is prone to reactivation. For example, the landslide was reactivated in March 2011 after a persistent heavy rainfall event.

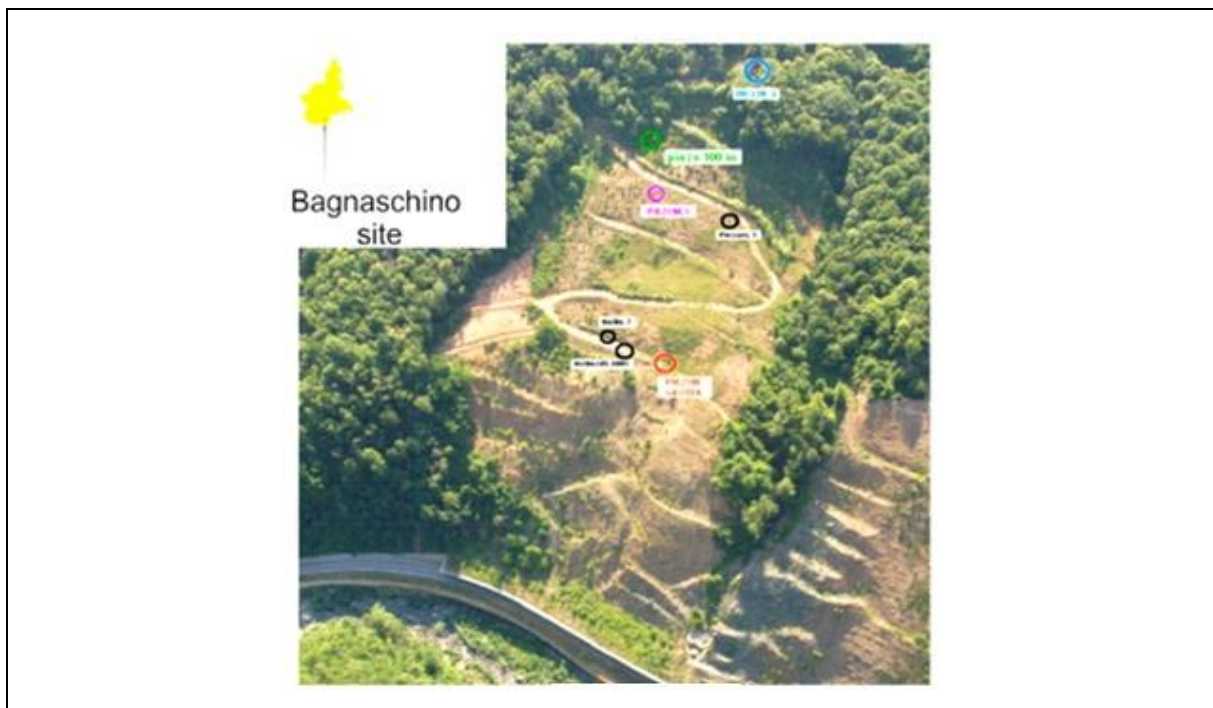
**Figure A2 General View of the Site (Supper et al, 2012)**

The Bagnaschino site represents a complex landslide reactivated within an old deep-seated gravitational slope deformation mass on a hillside of the Casotto Valley about 4 km away from Torre Mondovi, Italy (Figure A2). The related hillside portion had a long history of movement which was first detected in 1994. Landslide investigations commenced in 1996. The landslide site has an estimated plan area of 150,000 m<sup>2</sup>, comprising a displaced material of about 1.2 Mm<sup>3</sup>. The landslide could affect traffic road No. 164 at its toe.

A possible slip plane is located at about 8 m below ground. It penetrates through colluvium and tectonically densely jointed mica-schist rocks. It was considered to be a deep-seated gravitational deformation. Noticeable creeping of the impending landslide mass was detected. The maximum observed velocity of the slide was about 1 m/year in 2009. According to Supper et al (2012), the displacement could be correlated with rainfall events or snow melting. Perched groundwater was considered to be one of the triggering factors of the reactivation.

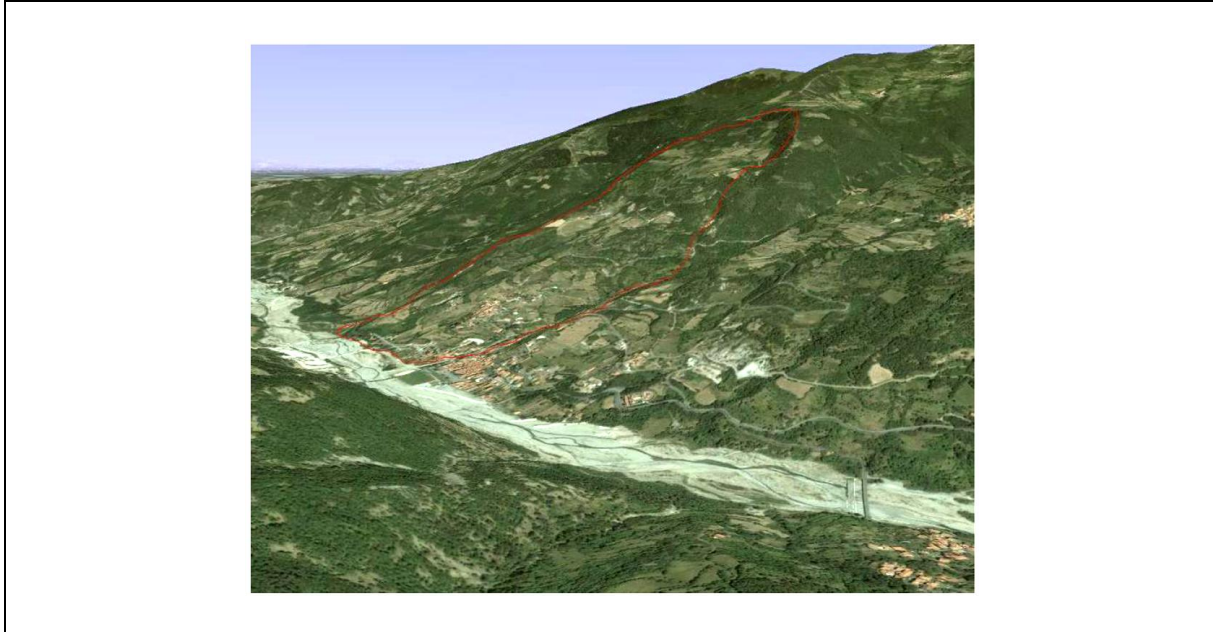
**Figure A3 Overview of the Hillside at Casella; Landslide Area Outlined in Red (Lovisololo, 2012)**

An impending landslide mass was located on a hillside in Casella, Italy (Figure A3). The landslide has a long history of movements since 1993. The volume of the landslide was estimated to be 30 Mm<sup>3</sup>, and the plan area of the landslide could be up to 1.2 km<sup>2</sup>. According to Lovisolo (2012), the landslide movement could be of translational-rotational

type. The principal sliding surface could be about 20 m below ground, which could pass through heterometric clayey and calcareous clastic in silty and clayey matrix. Noticeable movements were recorded after heavy rainfall events. For example, displacement of over 13 mm was detected in the wet season of 2004. The landslide could affect settlements and a regional highway at its toe area.

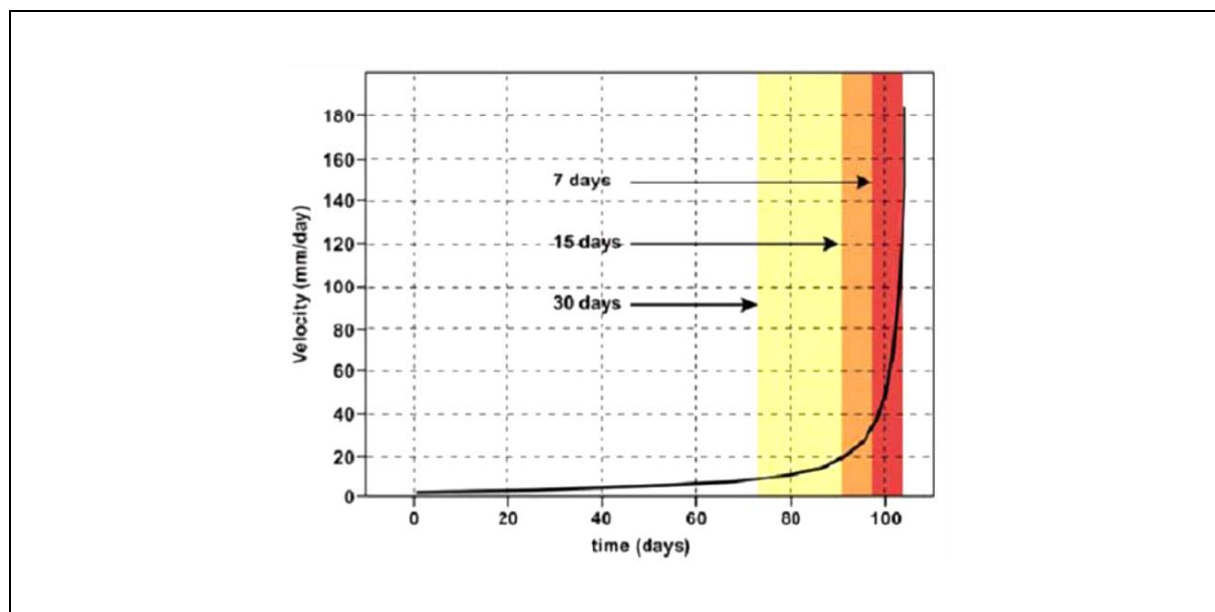
**Figure A6 The Early Warning Threshold Levels Established by Crosta & Agliardi (2003)**

The threshold velocity for triggering early warning had been established based on the “accelerating creep theory” proposed by Voight (1988). The theory provides a basis for investigating the relationship between velocity and failure time of a creeping material. Crosta & Agliardi (2003) developed the threshold values based on 5-years’ monitoring data. Three early warning threshold levels corresponding to different emergency plan actions were established (see Figure A6). Federico et al (2012) reported a study of the correlation between rainfall and displacement. However, Crosta & Agliardi (op cit) commented that the accelerating creep theory could only give an order of magnitude of the failure time and accurate forecast of slope failure may not be feasible. Therefore, the established trigger levels should be used to support judgment of experts for giving early warning.

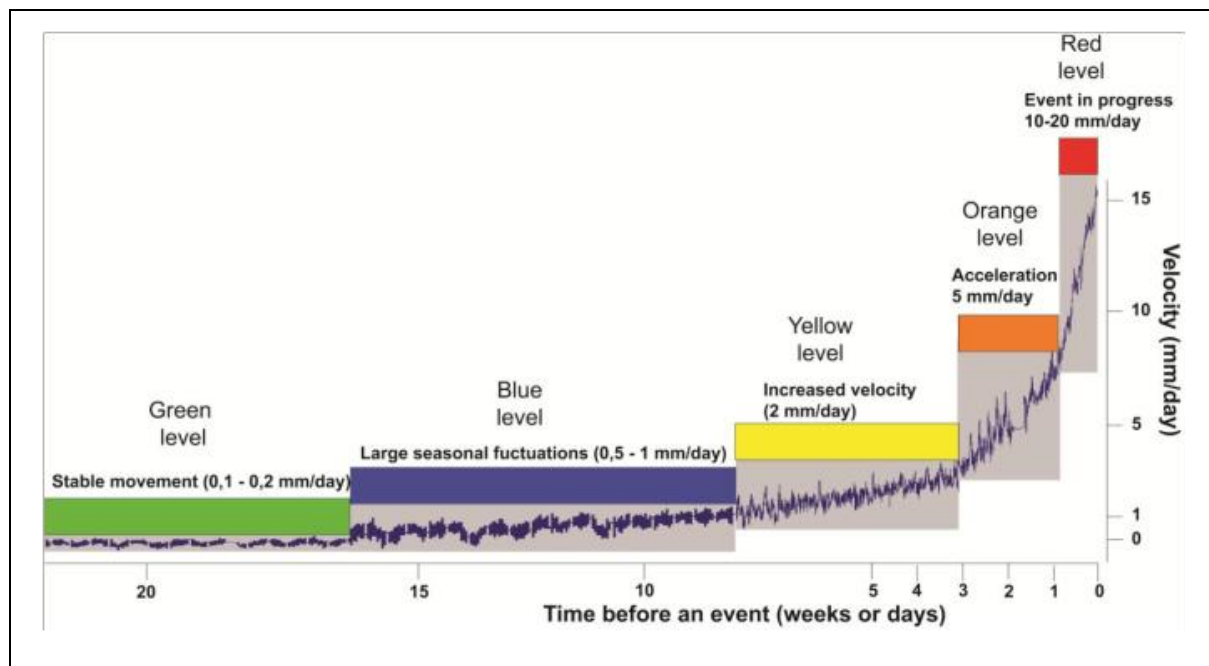
**Figure A9 The Five Level of Velocity Established in the Early Warning System (Kristensen et al, 2010)**

The decision to issue an early warning is based on the velocity inferred from displacement data. Five levels of velocity had been set (Figure A9). They were established on the basis of normal movement rate and seasonal fluctuation recorded previously. The seasonal fluctuation was found to be correlated with snowmelt and temperature variations. The monitoring data could embed noise. Officers in the Early Warning Centre would check the overall monitoring data in a holistic manner before an early warning is issued.

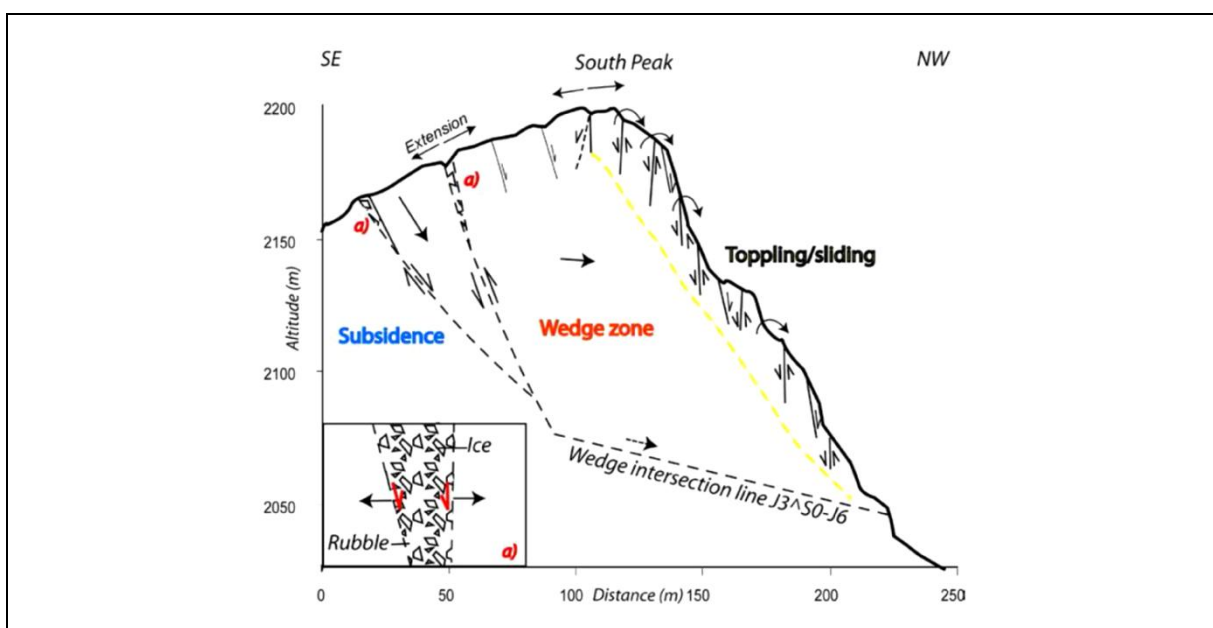
**Figure A11 Geological Model of the Potential Unstable Rock Mass (Froese et al, 2009)**

According to Moreno et al (2011), the instability of the South Peak could be controlled by at least two steep joint sets. A geological model of the potential unstable rock mass is presented in Figure A11. Limit equilibrium stability assessment indicates that the hillside is marginally stable. Water pressure in the rock joints plays an important role in determining the stability condition of the hillside.

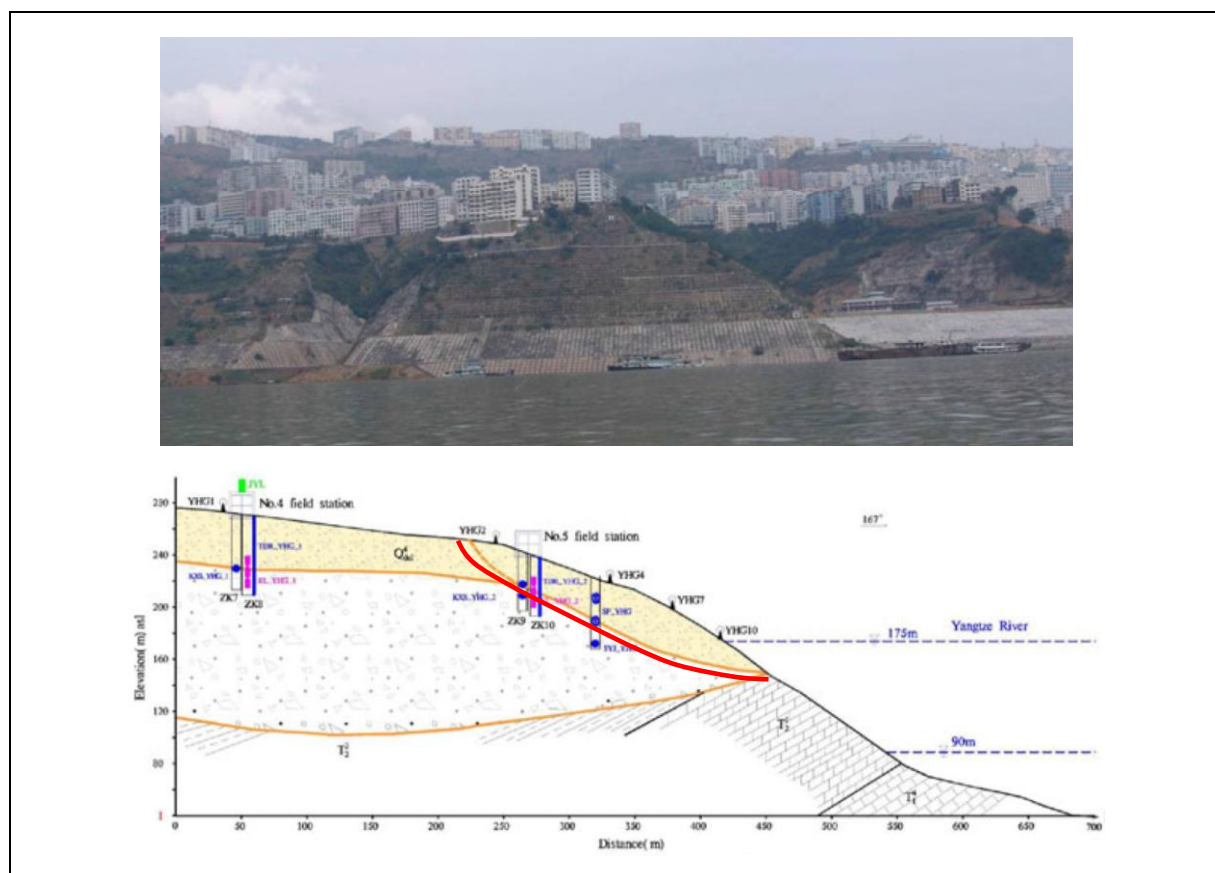
**Figure A14 Overview of the Slope and a Cross-section of the Slope; Potential Slip Plane is Shown in a Red Line (Yin et al, 2010)**

Monitoring works on a continuously creeping slope on the northern bank of Yangtze River in Wushan Town have been carried out. Yin et al (2010) reported that the slope is part of the scar of an ancient landslide. The slope dips towards the Yangtze River and the creeping mass is about 435 m long and 292 m wide (Figure A14). The maximum displacement rate is about 2 mm/month.

The bedrock geology of the creeping slope comprises mainly limestone. The potential slip plane could be 30 m below ground and could daylight from the slope. Originally, the toe of the slip plane was above the water level of the Yangtze River. However, due to the increase in the water level caused by the construction of the Three Gorges Reservoir, the toe of the slip plane is now under the water level. According to Yin et al (2010), this is considered to be the triggering factor of the slope displacement. Failure of the slope would affect Wushan Town.
