Factual Report on Hong Kong Rainfall and Landslides in 2013

GEO Report No. 321

**Geotechnical Engineering Office
Civil Engineering and Development Department
The Government of the Hong Kong
Special Administrative Region**

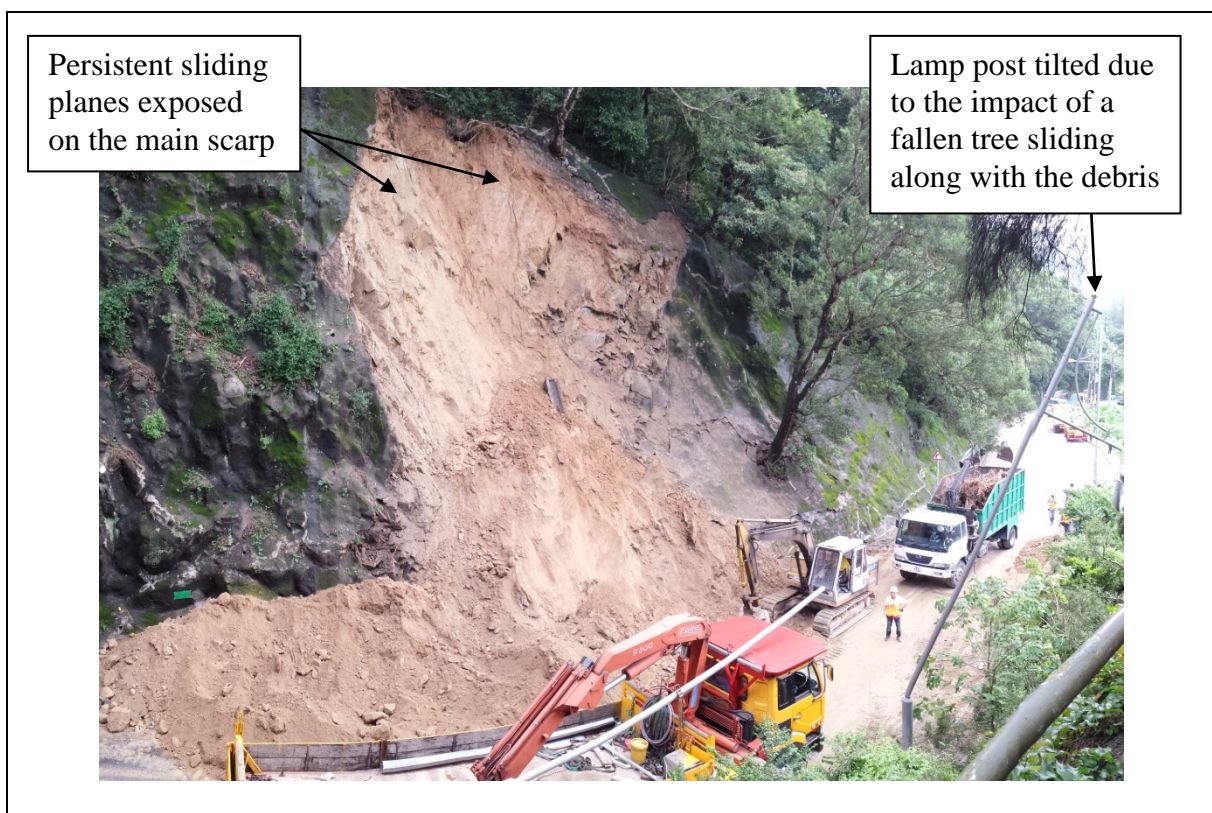
At about 6:14 a.m. on 3 August 2013, a major landslide occurred on a soil/rock cut slope (Feature No. 6NE-D/C2) at Lam Kam Road, Yuen Long (Figure 4.3). The landslide scar measured about 11 m wide, 14 m high and 2 m deep, with an estimated failure volume of about 120 m³. It was a structural controlled failure with two persistent failure planes exposed on the scar which formed the sliding planes of the wedge of failed weathered rock materials. The landslide debris completely blocked Lam Kam Road at the slope toe and the failure resulted in temporary closure of a section of Lam Kam Road for a day. No injury or casualty was reported. The incident occurred in the early hours of the day. It was another ‘near-miss’ case which could have resulted in much more serious consequence.

Figure 4.3 General View of the 3 August 2013 Landslide on Slope No. 6NE-D/C2 at Lam Kam Road, Yuen Long (Incident No. 2013/08/1424)

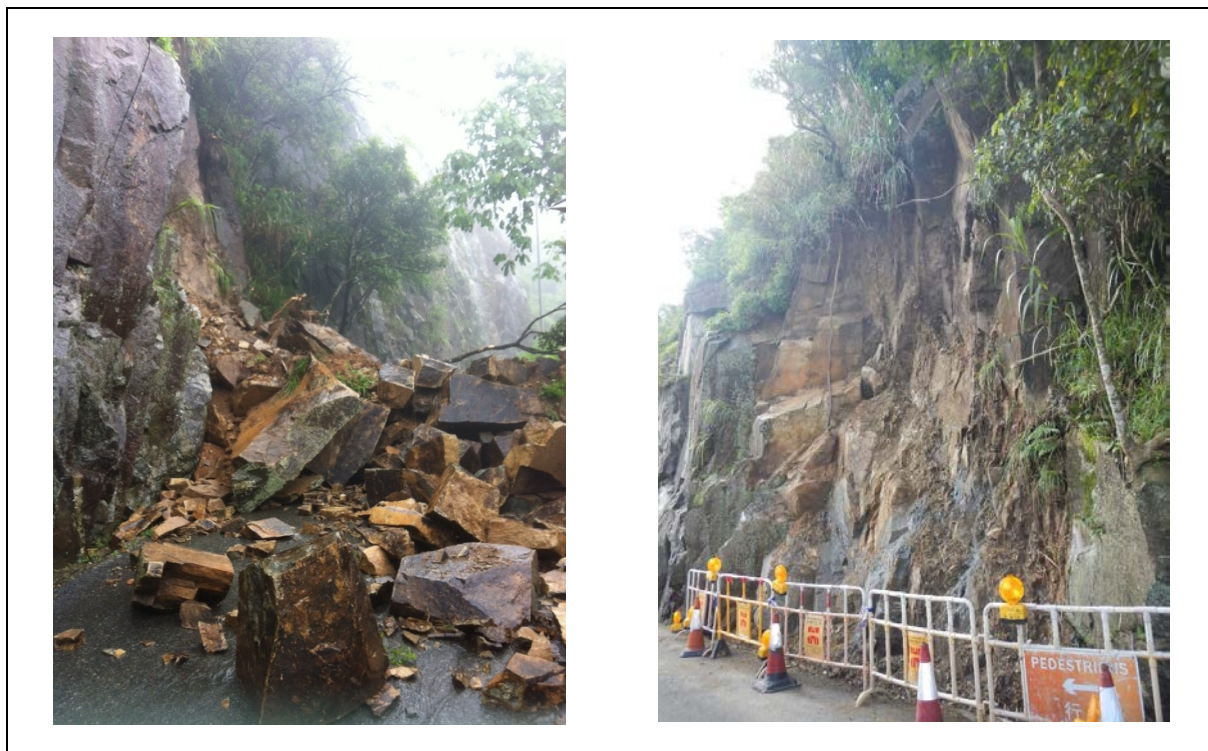
At about 11:00 p.m. on 14 June 2013, a rockfall incident occurred on the bare rock portion of a soil/rock cut slope (Feature No. 11NE-A/C351) at Shatin Pass Road, Tsz Wan Shan (Figure 4.4). The failure scar measured about 5 m wide, 8 m high and up to 1 m deep, with an estimated failure volume of about 25 m³. The debris comprised fallen rock fragments with size up to 1.5 m³. Shatin Pass Road, approximately 2.5 m wide, at the slope

toe was completely blocked by the debris. The incident resulted in temporary closure of a section of Shatin Pass Road for a day in undertaking the emergency repair works. No injury or casualty was reported. It was a recurrent rockfall incident. A relatively small scale rockfall incident with a failure volume of 2 m³ (Incident No. 2013/05/1347) occurred earlier on 30 May 2013 adjoining the June 2013 failure scar.

Figure 4.4 General View of the 14 June 2013 Rockfall on Slope No. 11NE-A/C351 at Shatin Pass Road, Tsz Wan Shan (Incident No. 2013/06/1376)
