# **Factual Report on Hong Kong Rainfall and Landslides in 2014**

**GEO Report No. 329**

**Geotechnical Engineering Office  
Civil Engineering and Development Department  
The Government of the Hong Kong  
Special Administrative Region**

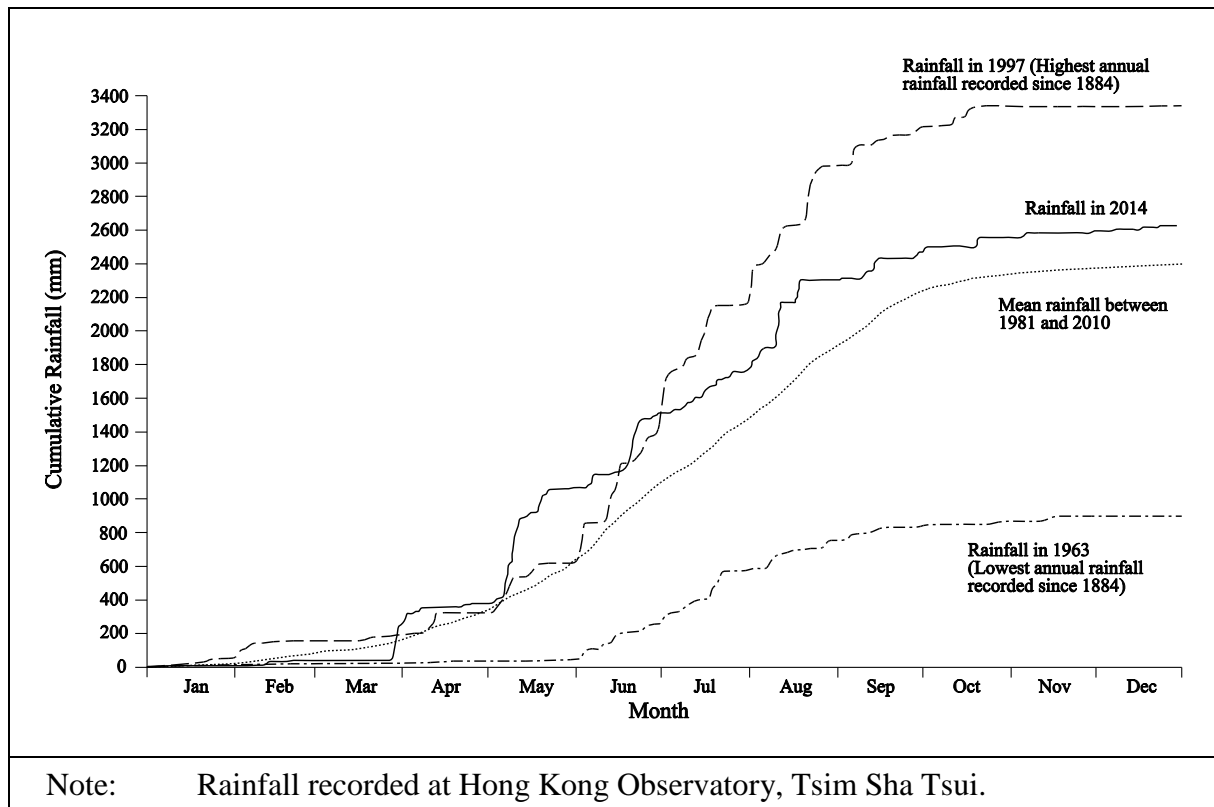
**Figure 2.2 Cumulative Rainfall for 2014 at the Hong Kong Observatory and its Recorded Highest, Mean and Lowest Cumulative Rainfalls**

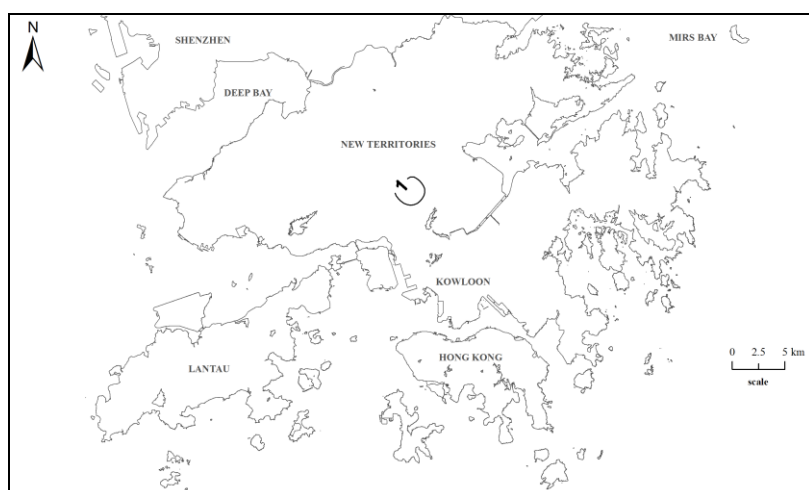
Note: Isohyets are based on the GEO and HKO raingauges.

**Figure 2.3 Monthly Rainfall Distribution in 2014 (Sheet 1 of 4)**

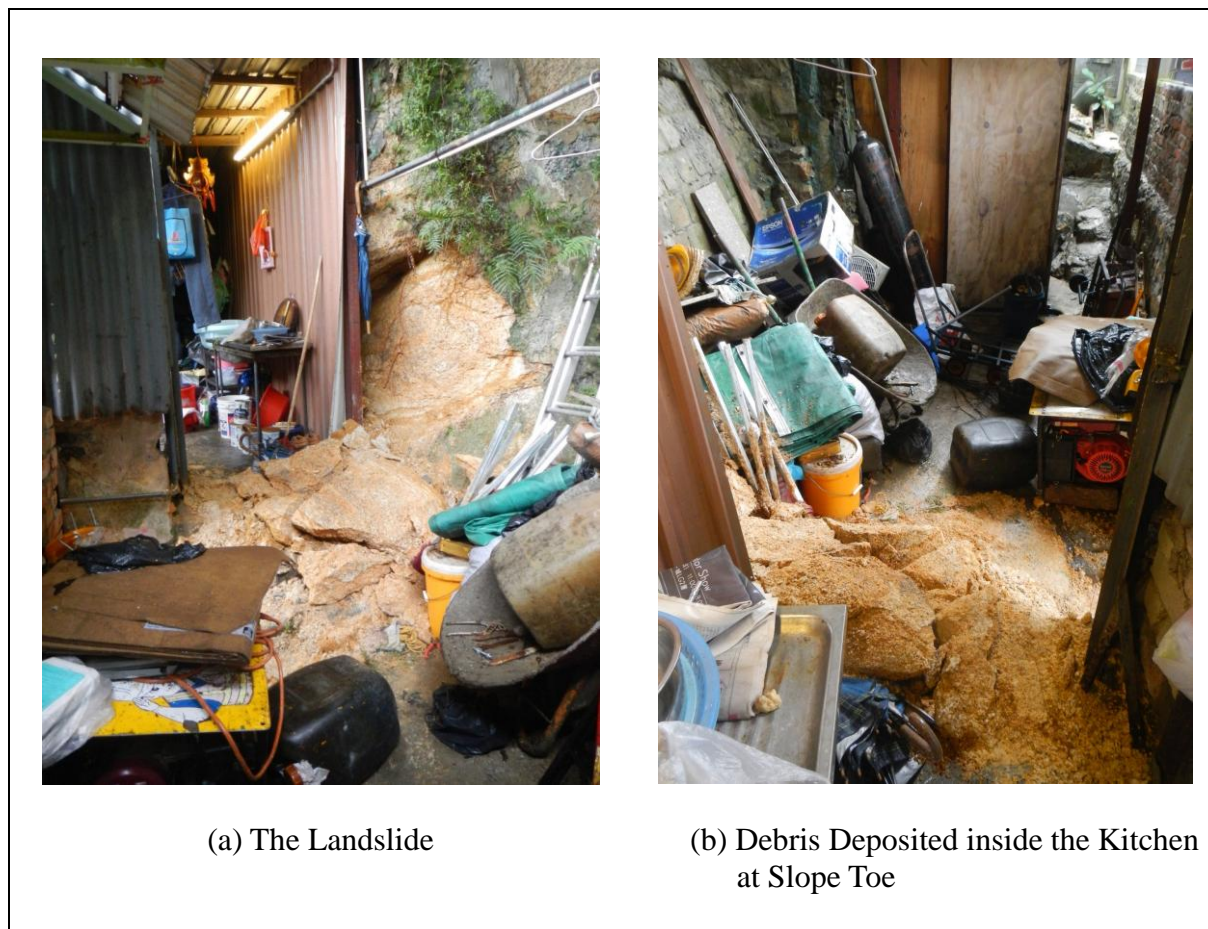
At about 6:00 a.m. on 12 May 2014 when Landslip Warning was in effect, a landslide occurred at the middle portion of a soil/rock cut slope (Feature No. 11SE-B/C435) behind a squatter dwelling at No. 28C Cha Kwo Ling Tsuen, Kwun Tong Figure 4.3(a). The landslide, with an estimated failure volume of  $0.5 \text{ m}^3$ , involved a shallow detachment from the lower slope portion. The debris, comprising highly decomposed rock and some pieces of chunam, was deposited at the kitchen of a flimsy squatter dwelling at toe and a back alley leading to it Figure 4.3(b). Following the landslide, the squatter dwelling concerned was permanently evacuated under a Category 1 Non-development Clearance<sup>1</sup> recommended by the GEO. No casualty was reported.

**Figure 4.3 Views of the 12 May 2014 Landslide on Slope No. 11SE-B/C435 behind No. 28C Cha Kwo Ling Tsuen, Kwun Tong (Incident No. 2014/05/1533)**
