Factual Report on Hong Kong Rainfall and Landslides in 2016

GEO Report No. 342

R.C.T. Wai, R.W.H. Lee & V.W.W. Kong

**Geotechnical Engineering Office
Civil Engineering and Development Department
The Government of the Hong Kong
Special Administrative Region**

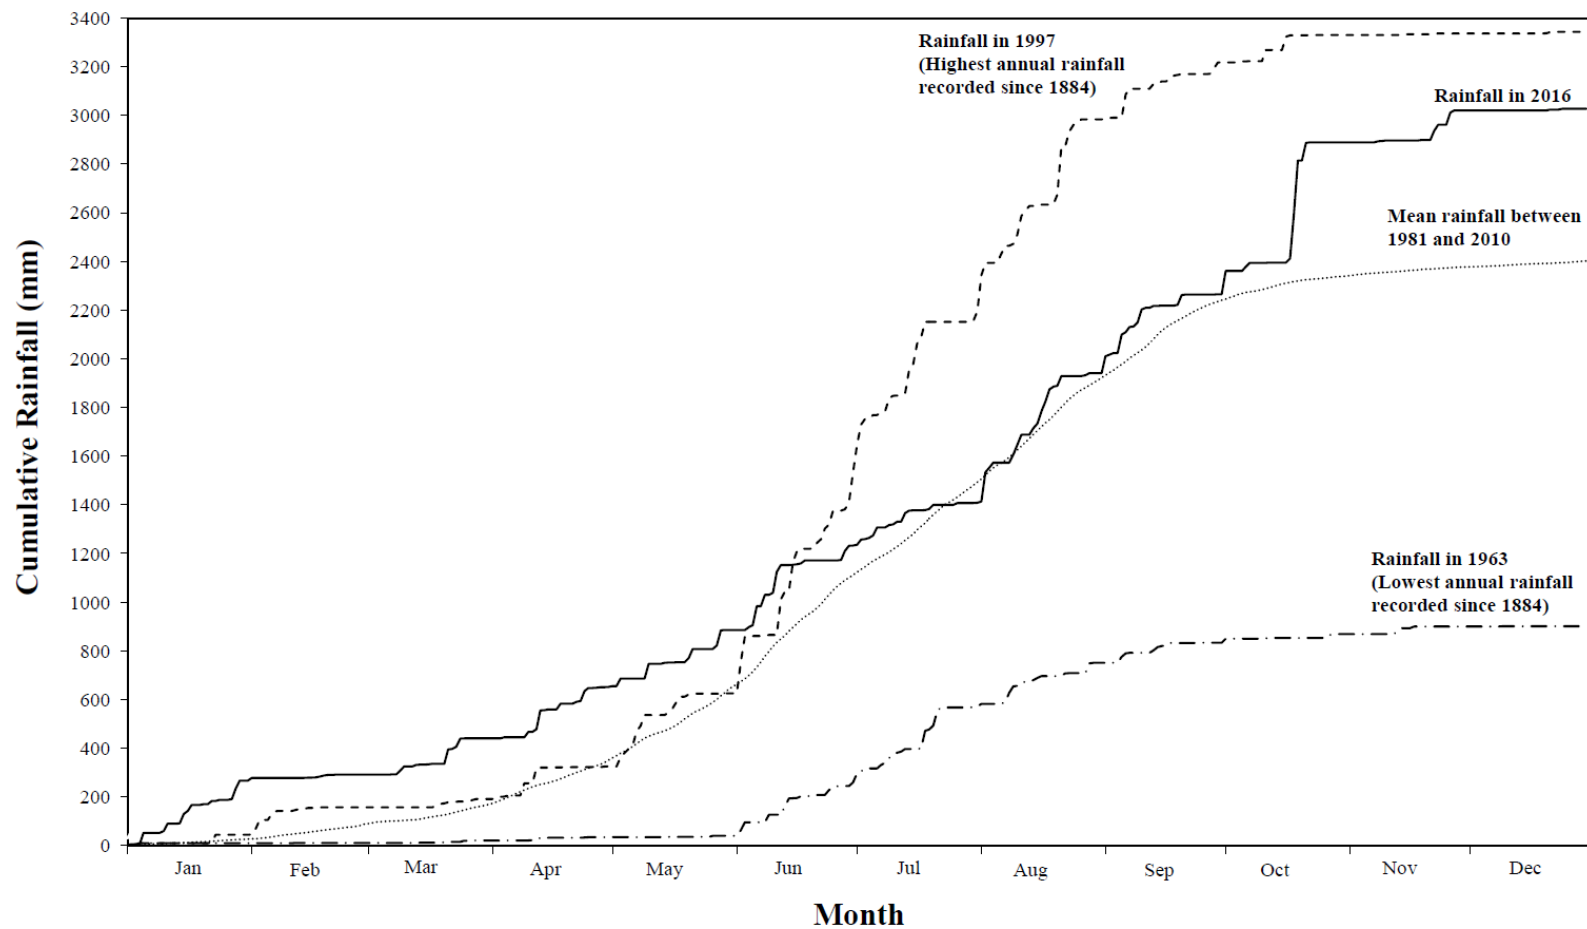
Figure 2.2 Cumulative Rainfall for 2016 at the Hong Kong Observatory and its Recorded Highest, Mean and Lowest Cumulative Rainfalls

Note: Rainfall recorded at Hong Kong Observatory, Tsim Sha Tsui.

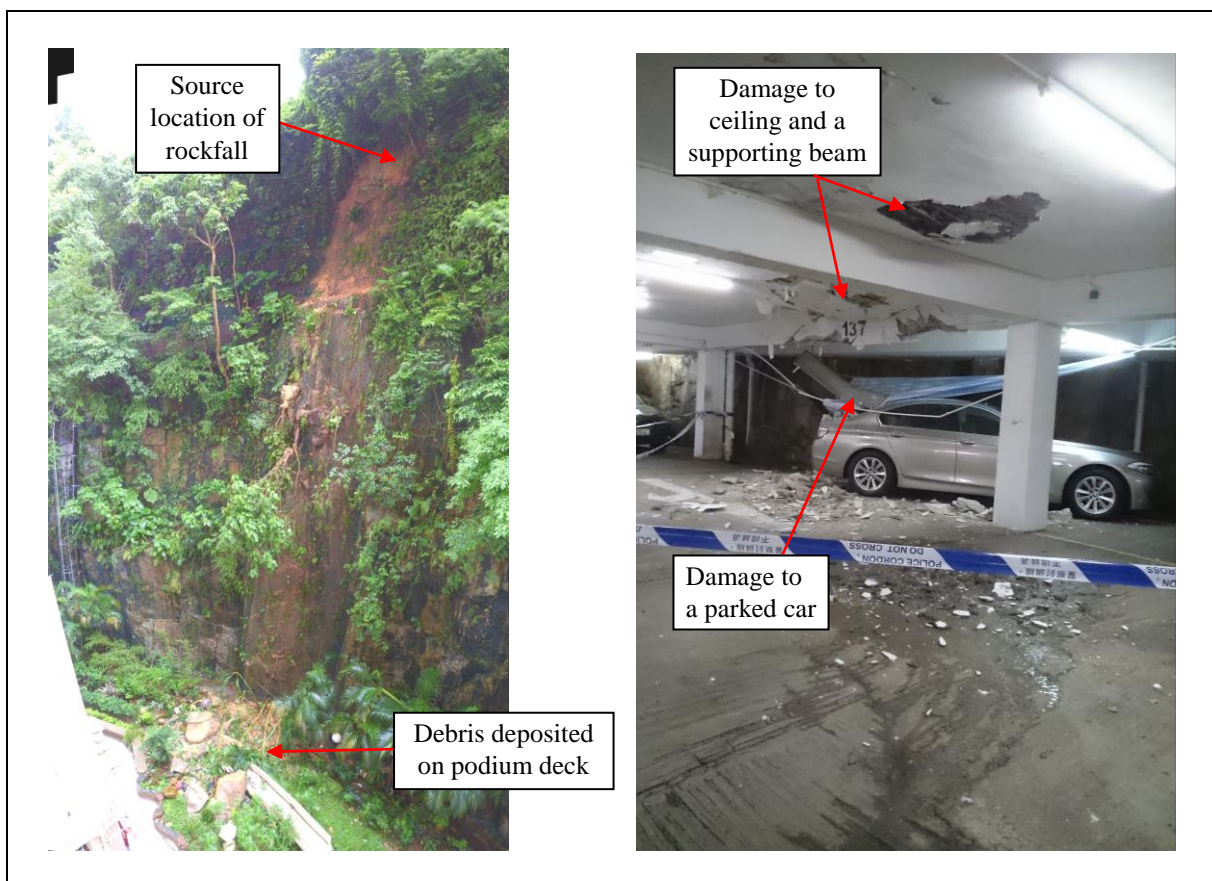
Figure 4.1 Views of the 17 August 2016 Rockfall from the Hillside behind Swiss Towers (Incident No. 2016/08/1896)

At about 4:00 a.m. on 17 August 2016, a rockfall incident occurred on the hillside behind Swiss Towers, 113 Tai Hang Road (Figure 4.1). The rockfall, with an estimated failure volume of about 9 m³, impacted the podium damaging the ceiling and a supporting beam of the covered car park underneath. Detached concrete fragments from these structural elements resulted in damage of a parked car. The residents in the lowest three floors of Block GH of Swiss Towers were temporarily evacuated. No casualty was reported as a result of the incident.

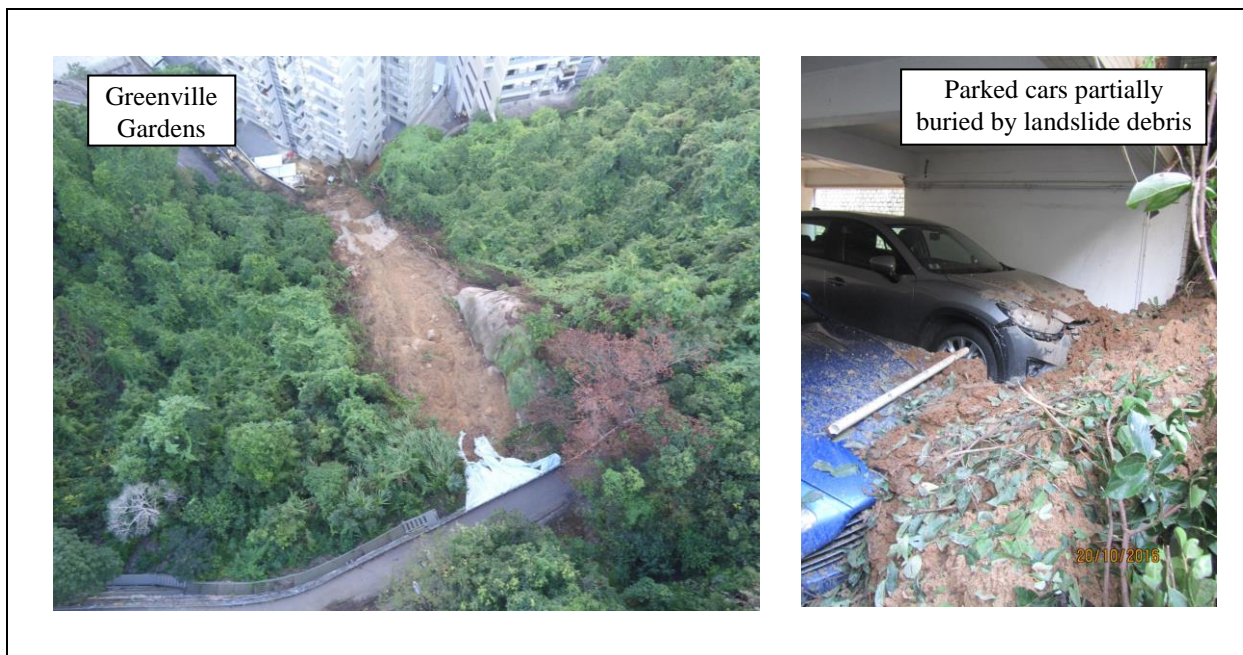
Figure 4.2 Views of the 19 October 2016 Landslide on the Natural Hillside behind Greenville Gardens (Incident No. 2016/10/1941)

At about 4:09 p.m. on 19 October 2016 when both Landslip Warning and Black Rainstorm Warning were in effect, a landslide occurred on the natural hillside behind Greenville Gardens, Nos. 14-17 Shiu Fai Terrace (Figure 4.2). The landslide involved an estimated failure volume of about 65 m³. The landslide debris largely deposited behind Block B of Greenville Gardens and partially buried three parked cars. No casualty was reported as a result of the landslide.

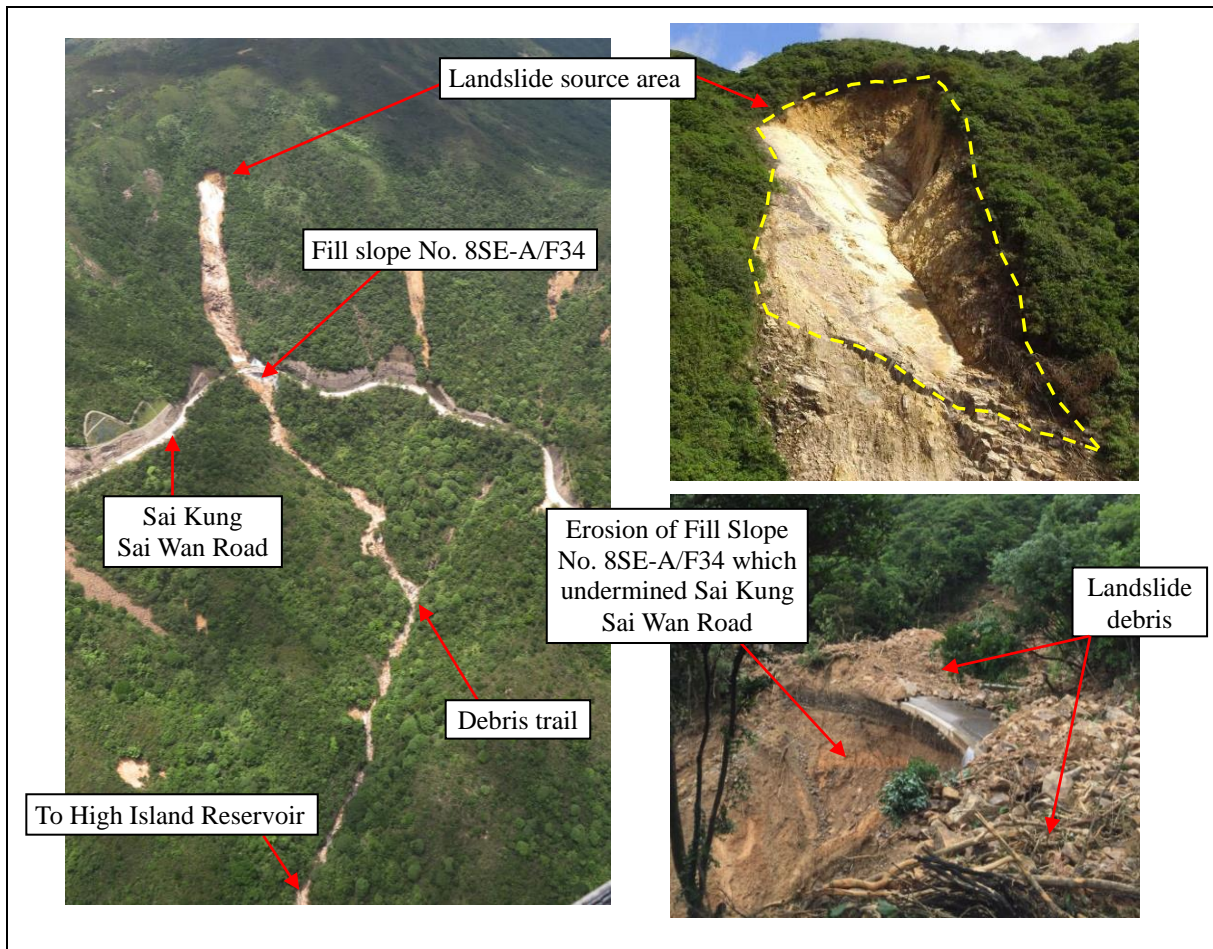
Figure 4.3 Views of the 21 May 2016 Landslide on the Natural Hillside above Sai Kung Sai Wan Road (Incident No. 2016/05/1823)

In the morning of 21 May 2016, a landslide occurred on the natural hillside above Sai Kung Sai Wan Road, Sai Kung (Figure 4.3). The landslide involved a planar rock slide with an estimated source volume of about 2,100 m³. The detached material travelled a distance of about 500 m down the hillside eventually coming to rest in a natural drainage line above High Island Reservoir. Sai Kung Sai Wan Road was completely blocked with debris and the fill slope (Slope No. 8SE-A/F34) supporting Sai Kung Sai Wan Road was severely eroded resulting in road closure for more than three months. Some outwash debris was transported into the reservoir. No casualties were reported as a result of the landslide.

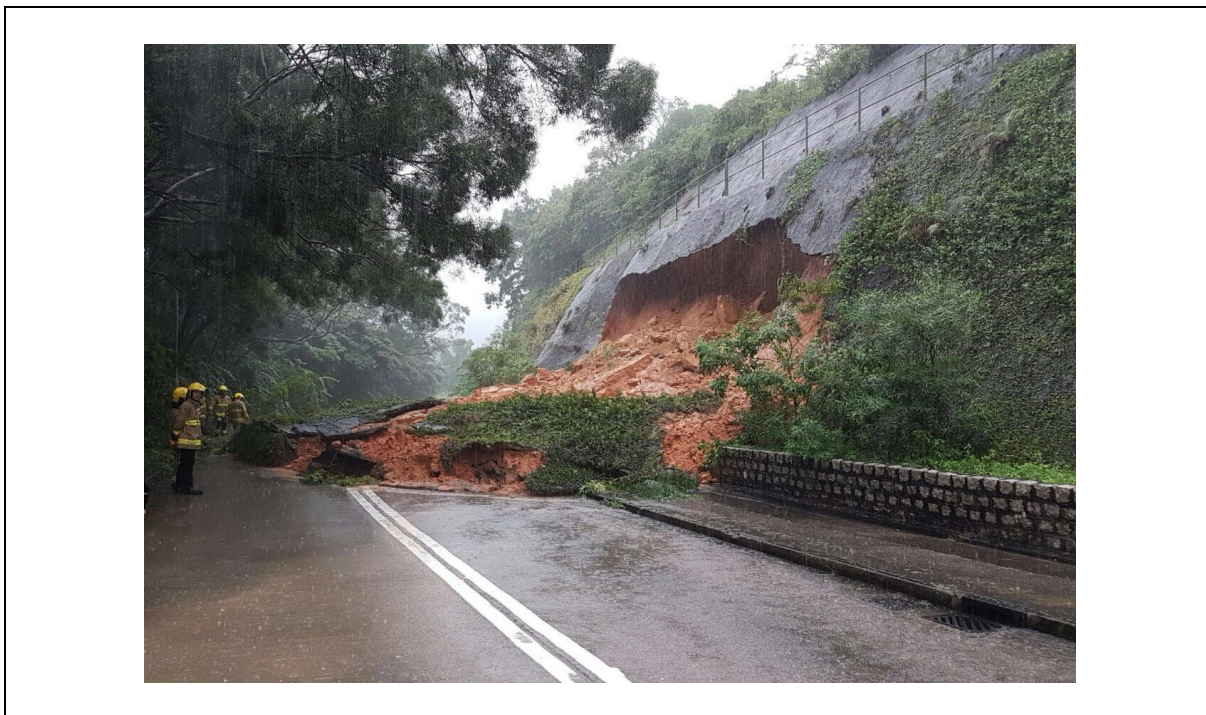
Figure 4.4 General View of the 7 September 2016 Landslide on Slope No. 13NE-A/C78 at South Lantau Road (Incident No. 2016/09/1917)

At about 12:15 p.m. on 7 September 2016, a landslide occurred on a soil cut slope (Feature No. 13NE-A/C78) at South Lantau Road, Lantau (Figure 4.4). The landslide involved an estimated failure volume of about 100 m³ with the debris blocked both lanes of South Lantau Road. As a result of the landslide, the affected section of road was completely closed for several hours which had resulted in substantial traffic disruption. The land traffic connection between Tai O and Tung Chung was suspended for hours and the public had to rely on ferry or cable car services to travel in and out of Tai O. One of the traffic lanes was re-opened several hours following the incident and the whole section of the road was subsequently re-opened on 10 September 2016. The incident was widely reported by the mass media. No casualty was reported.
