# **Some Suggested Detailing of Flexible Barriers Traversing a Stream Course for Drainage Purposes**

**GEO Report No. 344**

**E.H.Y. Sze & H.W.K. Lam**

**Geotechnical Engineering Office  
Civil Engineering and Development Department  
The Government of the Hong Kong  
Special Administrative Region**

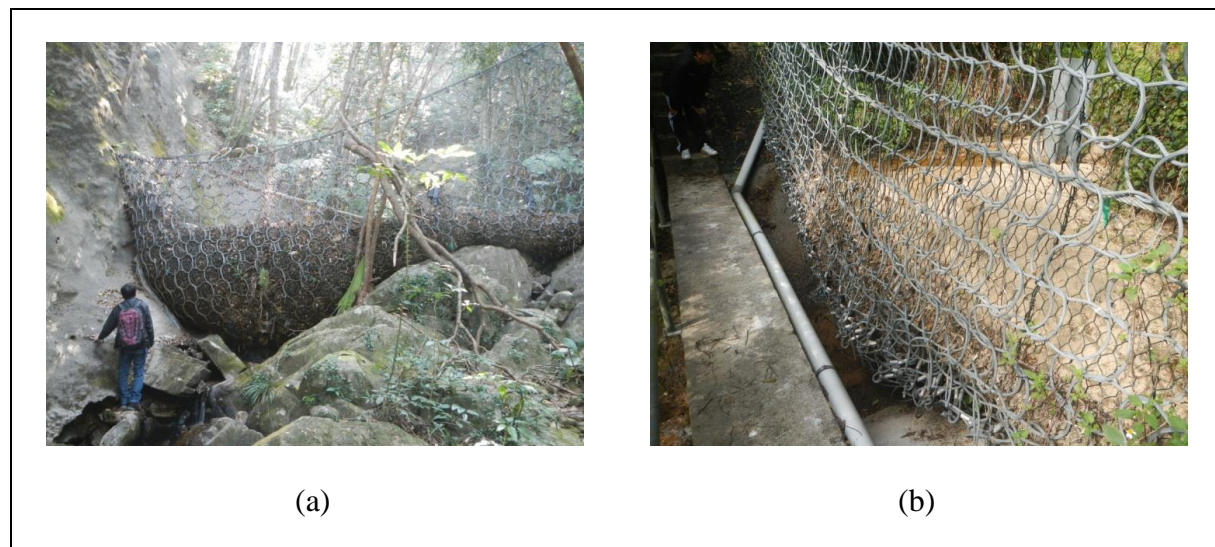
**Figure 3.1 Other Cases of Trapping of Stream Loads by Flexible Barriers Traversing across Stream Course at: (a) Kwun Yam Shan; and (b) Fo Tan**

- (a) The flexible barriers in the three cases are provided with secondary mesh. The principal nets of these barriers are extended down to the base of stream course.
- (b) The stream courses in the three cases are perennial where continuous stream flow is observed throughout the year.
- (c) The stream loads trapped by the flexible barriers in the three cases comprise mainly sand to boulder-sized materials with fallen leaves or branches.

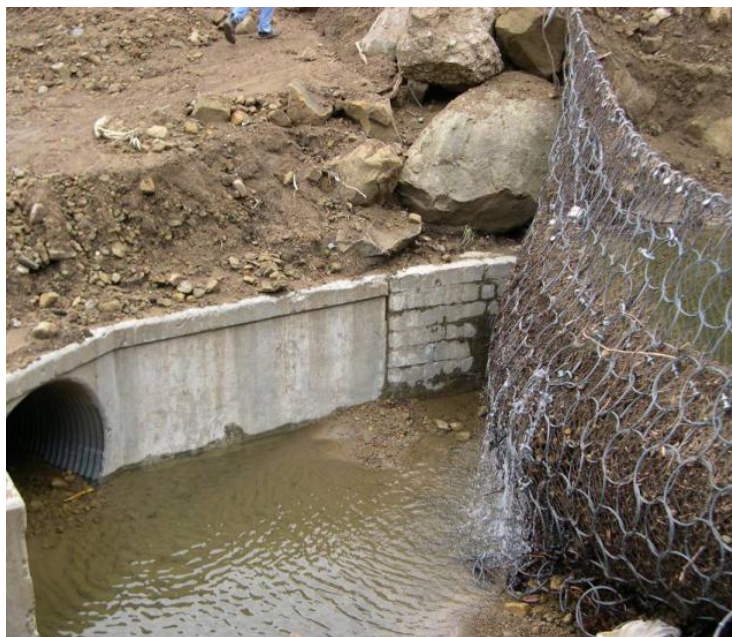
**Figure 4.1 Detailing of Debris-resisting Flexible Barriers in Different Countries  
(Sheet 1 of 3)**

**Case 1 - Geobruigg (2009)**

Location: California, USA

Installation of a ring net barrier with secondary mesh to retain debris flow material from reaching the culverts

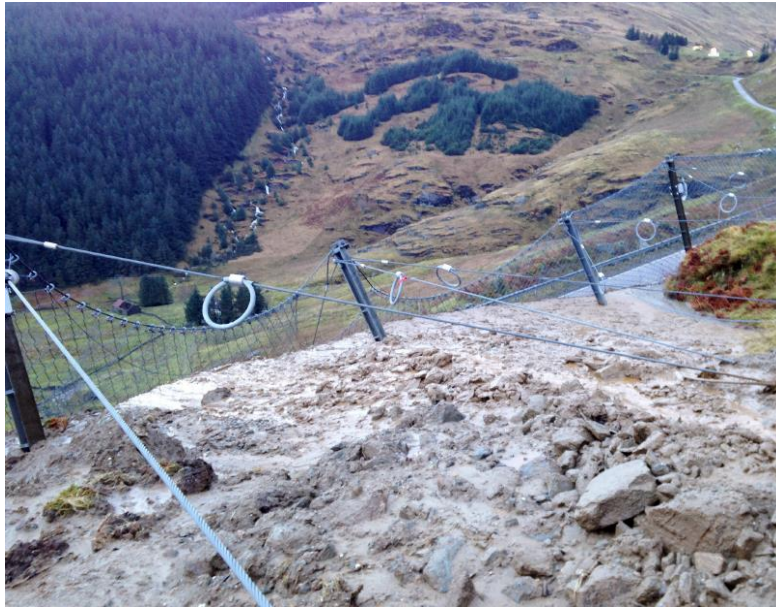
### Case 2 - Geobruigg (2016)

Location: Rest and be Thankful, Scotland

Installation of a shallow landslide barrier with secondary mesh to retain debris flow material from reaching the highway A83

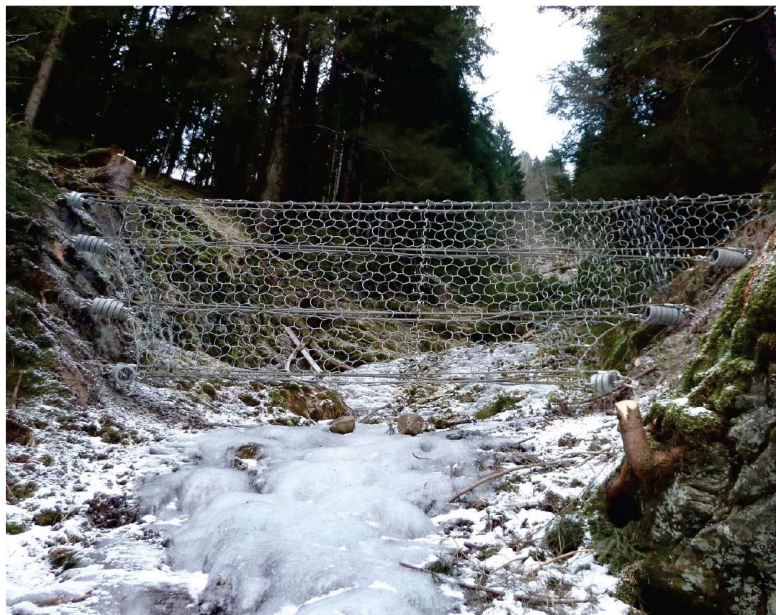
**Figure 4.1 Detailing of Debris-resisting Flexible Barriers in Different Countries**  
(Sheet 2 of 3)

### Case 3 - Trumer (2013b)

Location: Canada

Installation of omega net structure without secondary mesh but basal opening of around 1.5 m to facilitate passage of drift wood under normal stream flow

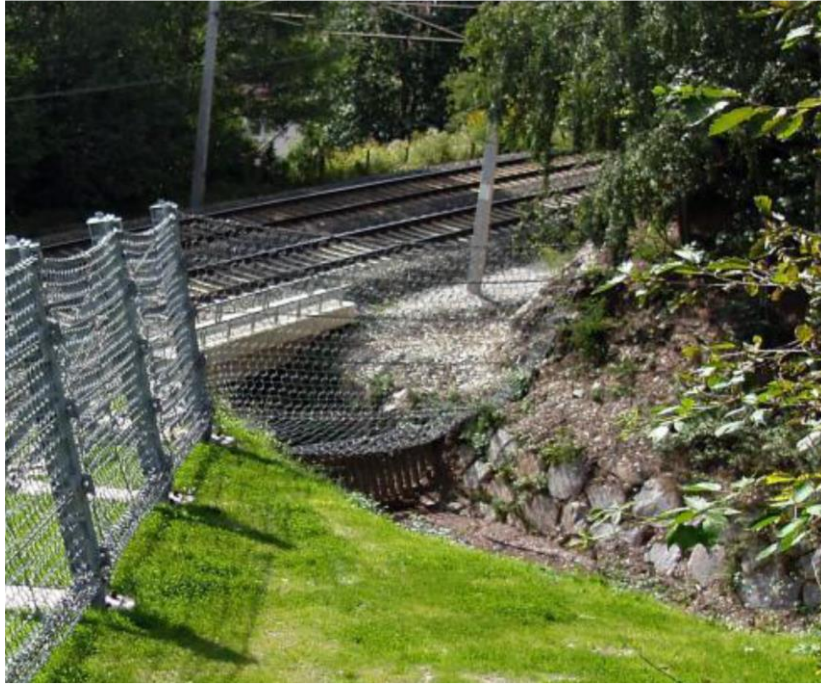
**Figure 4.1 Detailing of Debris-resisting Flexible Barriers in Different Countries  
(Sheet 3 of 3)**

#### **Case 4 - Trumer (2013b)**

Location: Leogang, Austria

Installation of omega net structure without secondary mesh but a slitting structure between the barrier base and the stream course

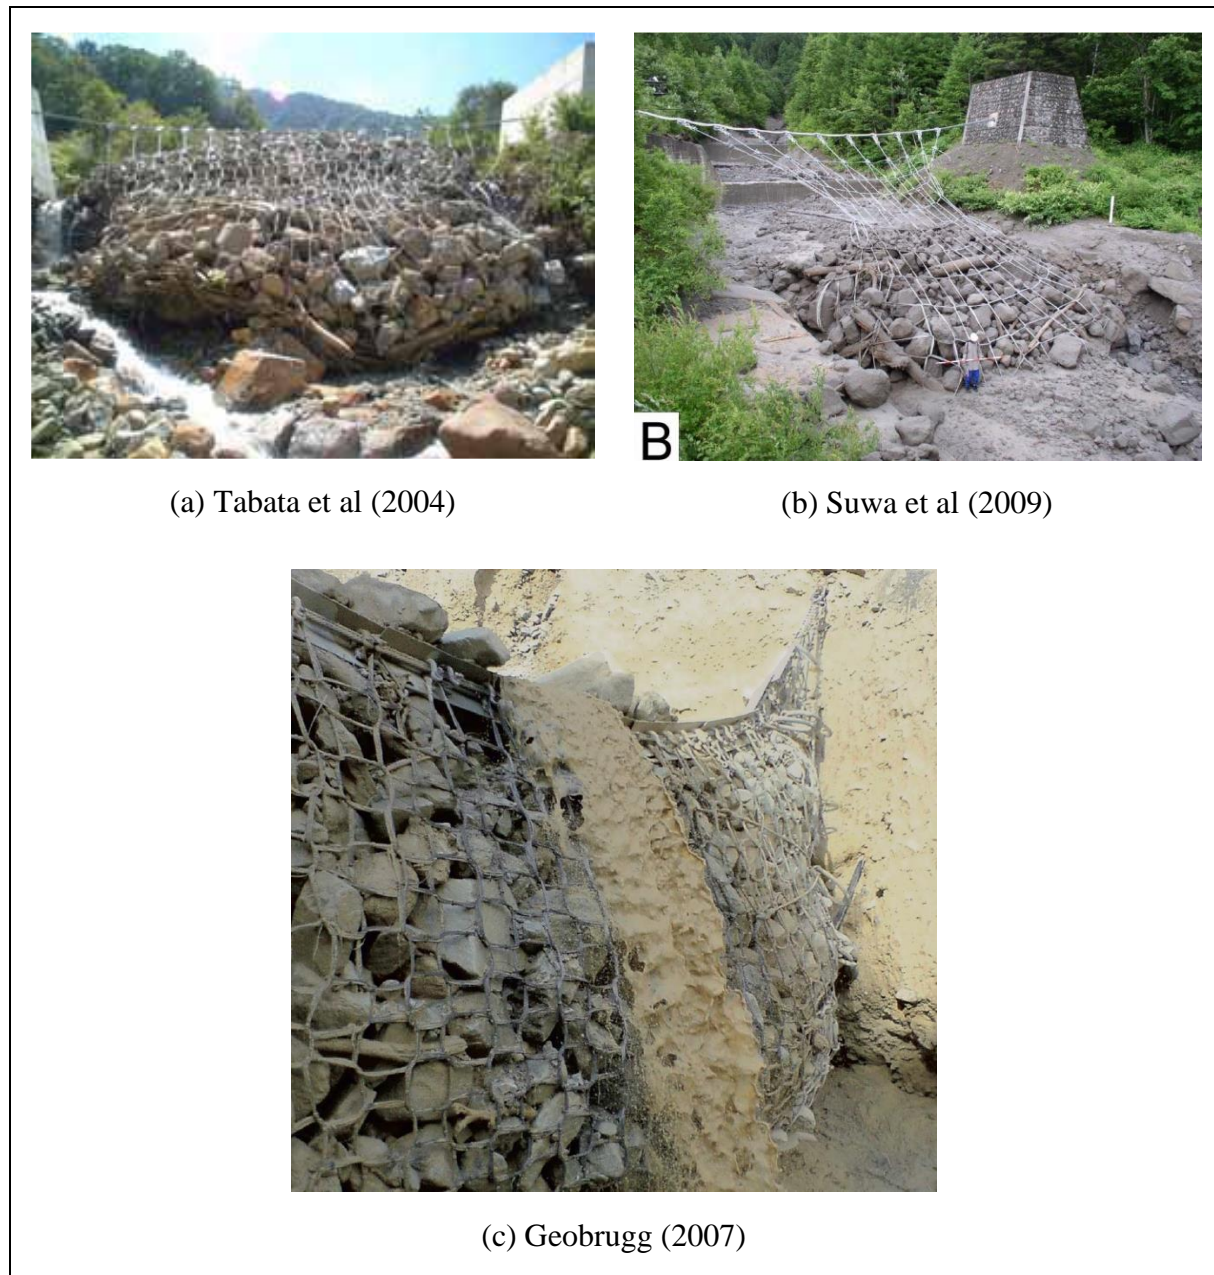
**Figure 4.2 Examples where the Flexible Net Structure could Retain Debris Material Composed of Particles Smaller than the Net Opening**

A literature review was carried out on the relation between the size of opening of the principal net and the debris retention capacity of a flexible barrier. Relevant studies indicate that if the size of a net opening is small enough (e.g. less than two times of the maximum clast diameter of debris materials), a plug could be formed when the net is subjected to debris impact. A summary of the literature review is given in Appendix B. As shown in Figure 4.2, a flexible net structure is capable of retaining debris material composing of particles smaller than the net opening soon after a debris plug is formed, probably due to the arching effect.

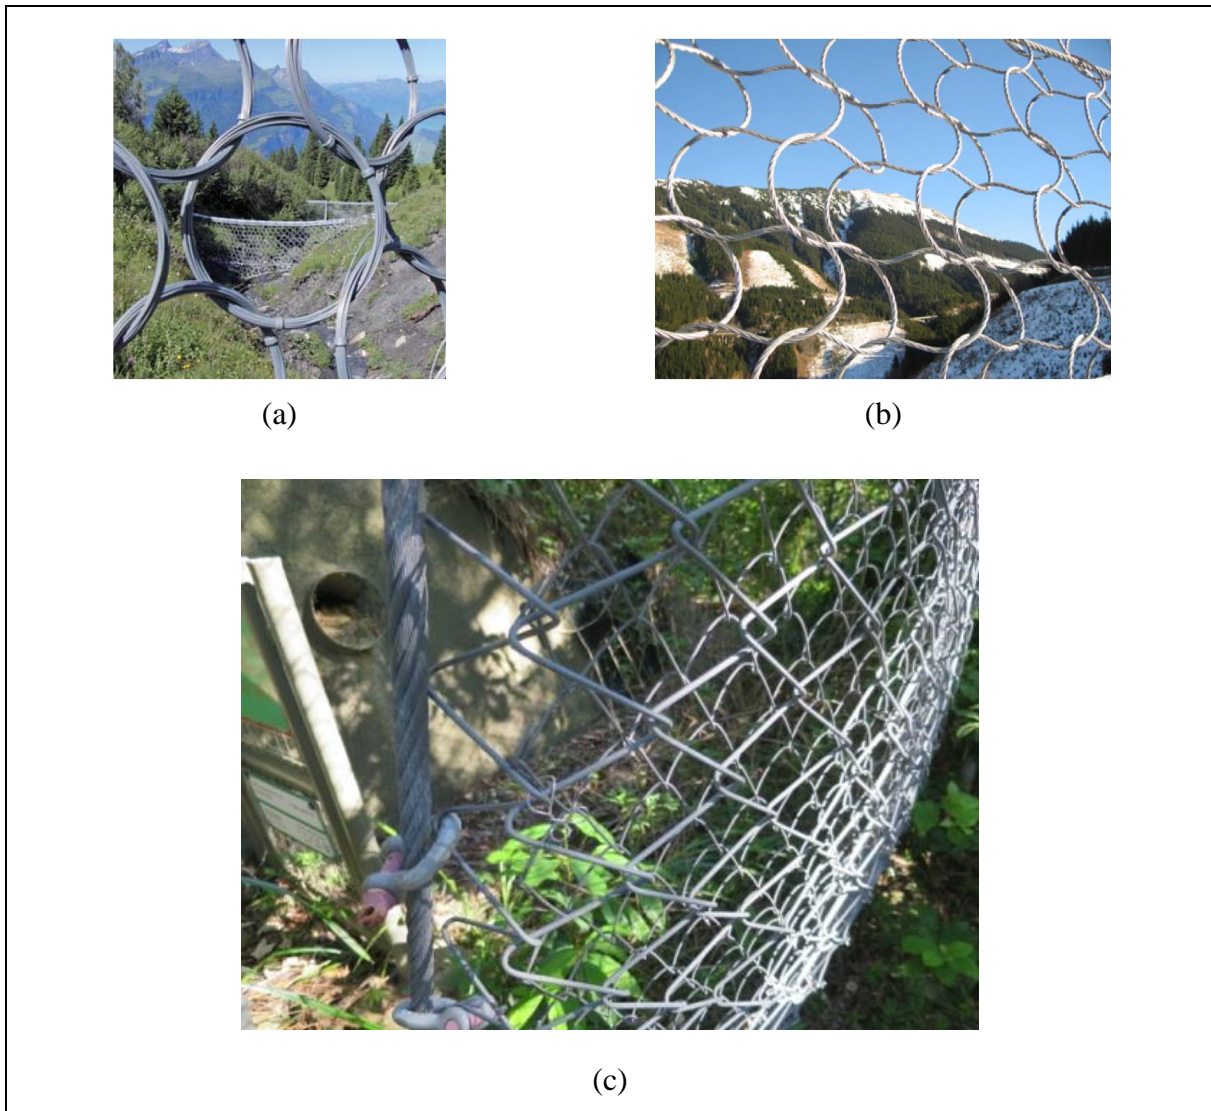
**Figure 5.1** Different Types of Principal Nets Commonly Used in Hong Kong: (a) Ring Net (Geobruigg, 2009); (b) Omega Net (Trumer, 2013a); and (c) Steel Wire Mesh

Different types of principal nets that are commonly used in Hong Kong are shown in Figure 5.1. In general, the opening size of these principal nets ranges from 80 to 420 mm (in diameter or in-circle diameter) as given in Table 5.1

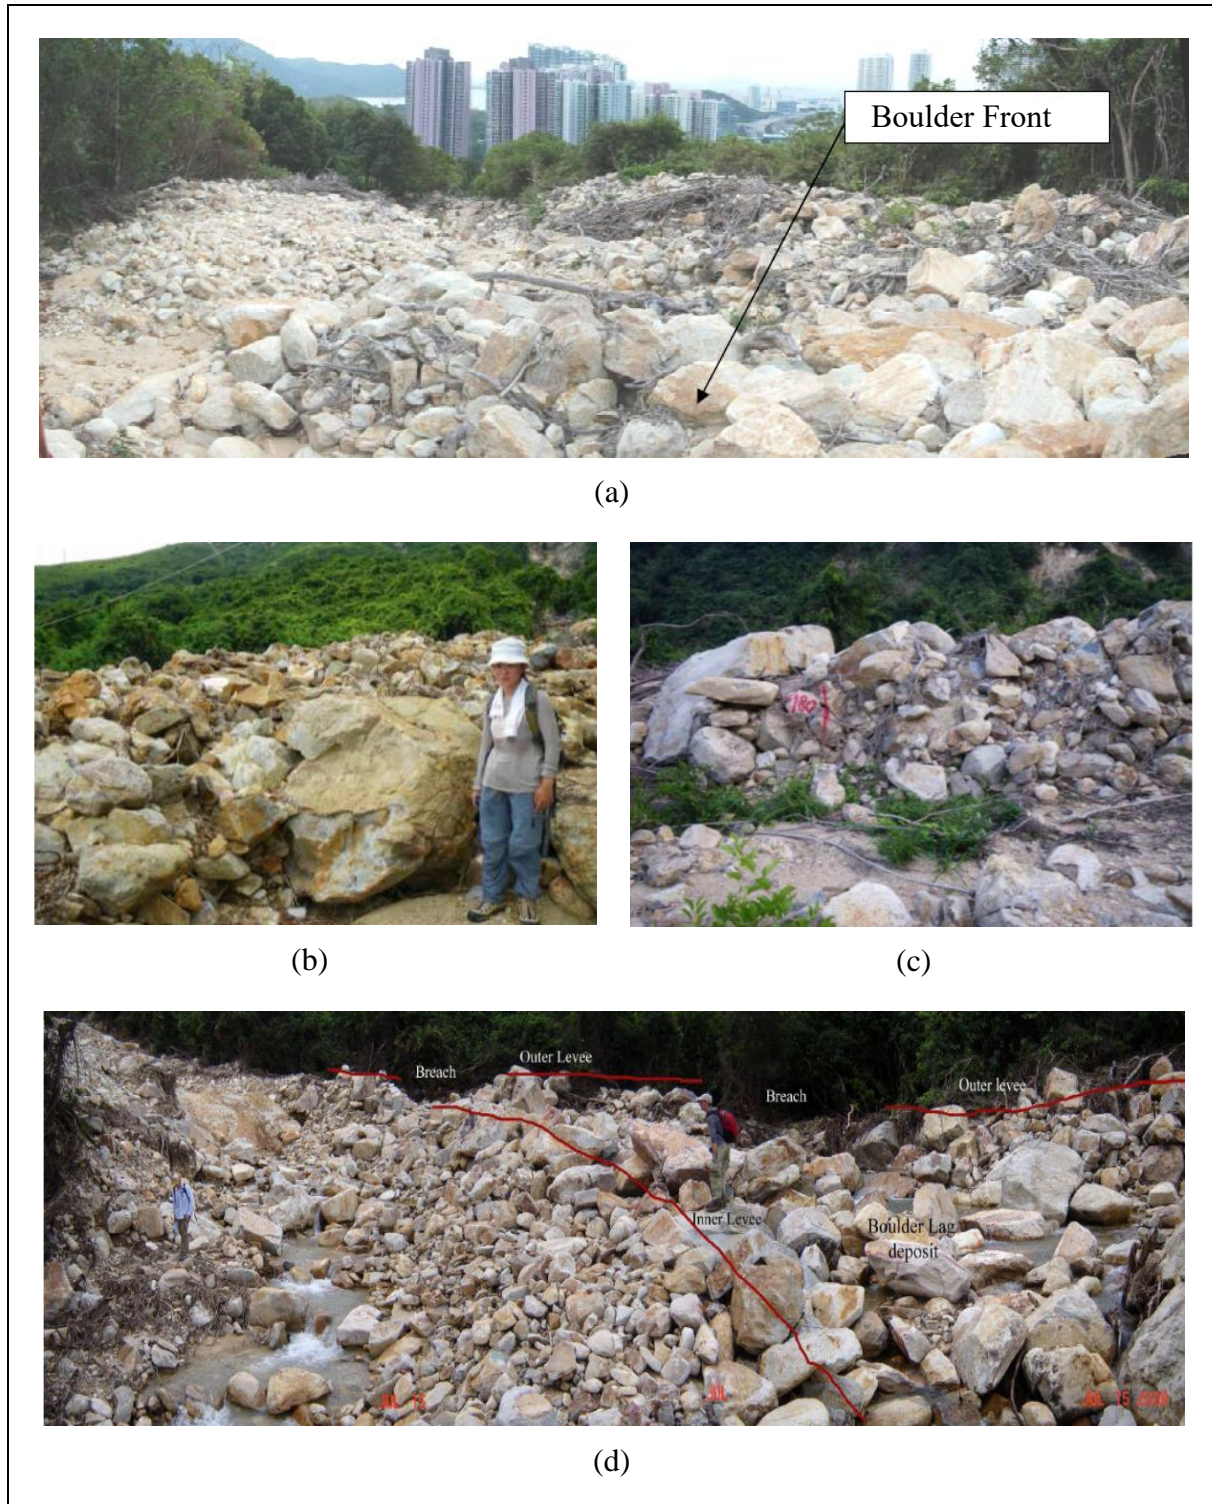
**Figure 5.2 Examples of Boulder Front Deposition Observed in 2008 at: (a) Yu Tung Road; (b) Yi O Village; (c) Shek Mun Kap; and (d) Shek Pik 2**

Field mapping reports of about 50 selected channelized debris flows (maximum active volume ranges from  $< 50 \text{ m}^3$  to  $> 2,000 \text{ m}^3$ ) that occurred in June 2008 in Hong Kong provide useful information on the composition of local debris flows (see Appendix C). Bouldery deposits were observed in many of these channelized debris flows as shown in Figure 5.2. A significant portion ( $> 10\%$ ) of frontal debris materials for these landslides was coarse-grained (i.e.  $> 200 \text{ mm}$  in size), with a maximum clast diameter ranging from 0.3 to 5 m (or typically 1 m to 2 m). The maximum clast diameter appears to be much larger than the mesh size of the principal net that are commonly used in Hong Kong (i.e. 80 mm to 420 mm in diameter, see also Table 5.1).

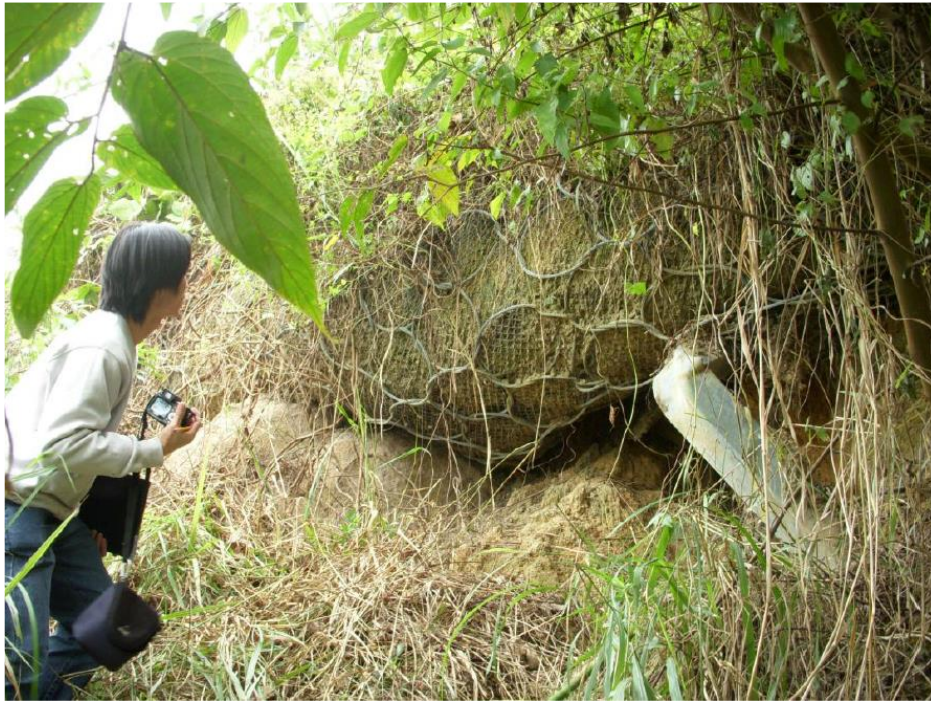
**Figure 5.3 Capturing of Landslide Debris by a Flexible Barrier with Secondary Mesh in Jordan Valley (Kwan & Koo, 2015)**

The effectiveness of retaining landslide debris by principal net and secondary mesh can be demonstrated by a local landslide case that occurred in Jordan Valley in 2008 where the landslide debris was successfully retained by a flexible rockfall barrier (Kwan & Koo, 2015). The landslide volume was about  $110 \text{ m}^3$ . The debris retained behind the net consisted of matrix-supported debris mixed with rounded to sub-rounded boulders and vegetation. The

barrier comprised of ring-nets of 350 mm in diameter and a secondary mesh with an aperture of 25 mm x 25 mm. As reported by Kwan & Koo (2015), the landslide debris, including fine grains, was largely arrested by the barrier (see Figure 5.3).

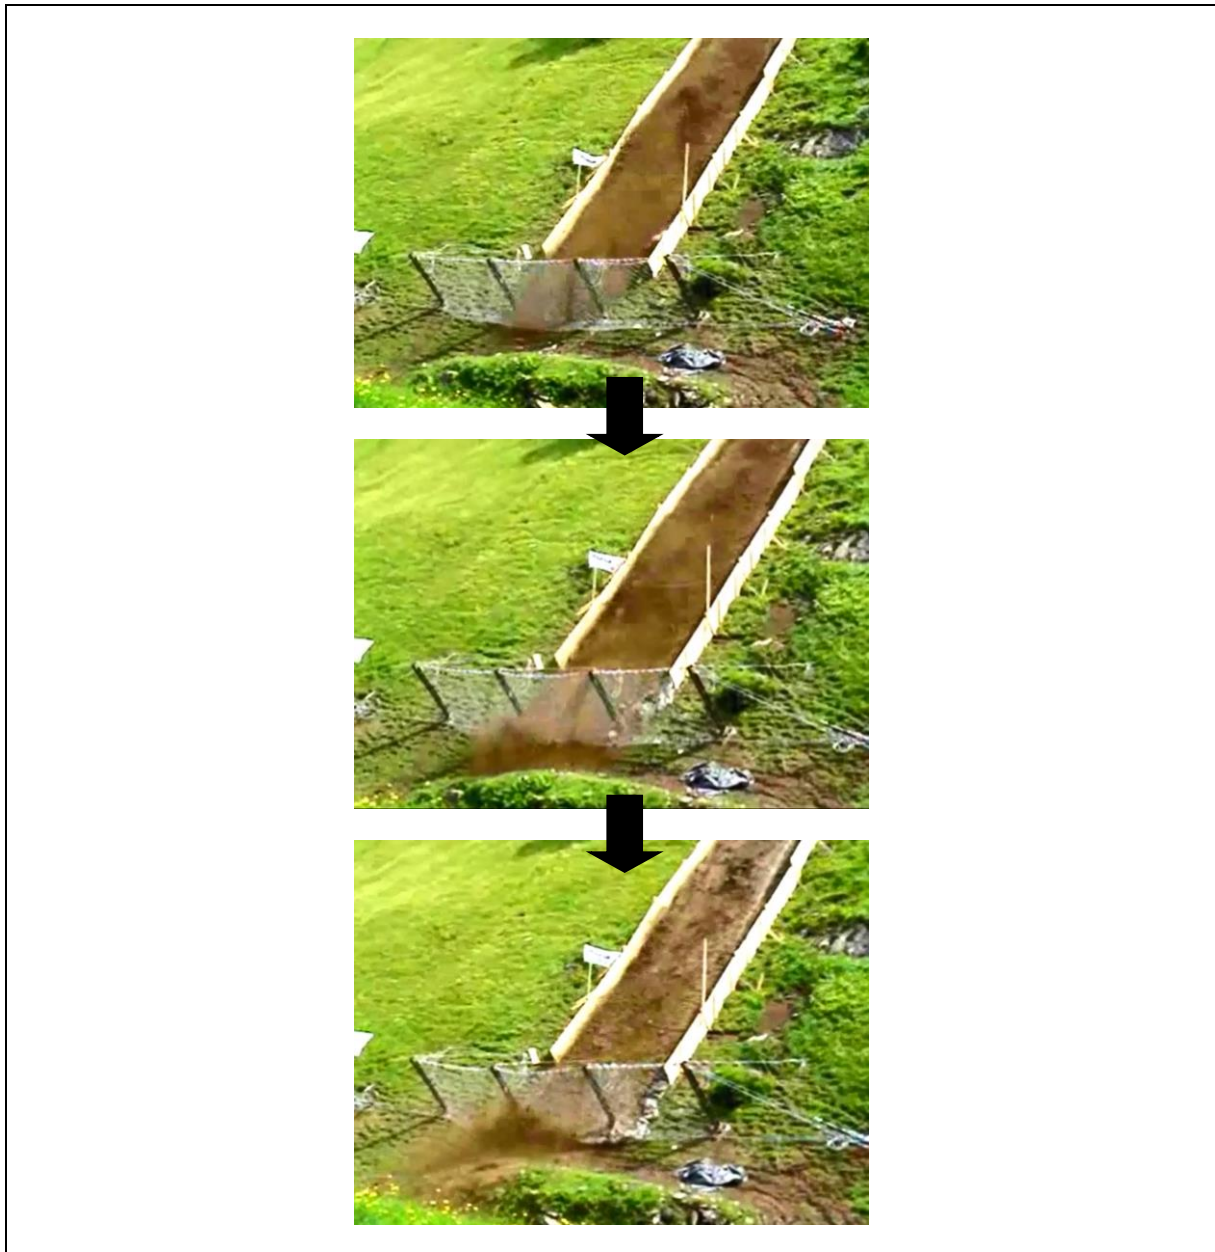
**Figure 5.4 Finer Fraction of Debris Passing through a Flexible Barrier with Secondary Mesh in a Large-scale Field Test (Isofer, 2012)**

Overseas field tests involving soil debris hitting flexible barriers were reviewed. In one of the large-scale tests where fine-grained soil debris was released and impacted onto a flexible barrier, it was observed that some 15% (by volume) of soil could pass through the flexible barrier, even though a secondary mesh was provided (see Table 5.2 and Figure 5.4 for the details of the field test). The fine-grained soil which passed through the principal net did not travel a long distance downstream in the test.

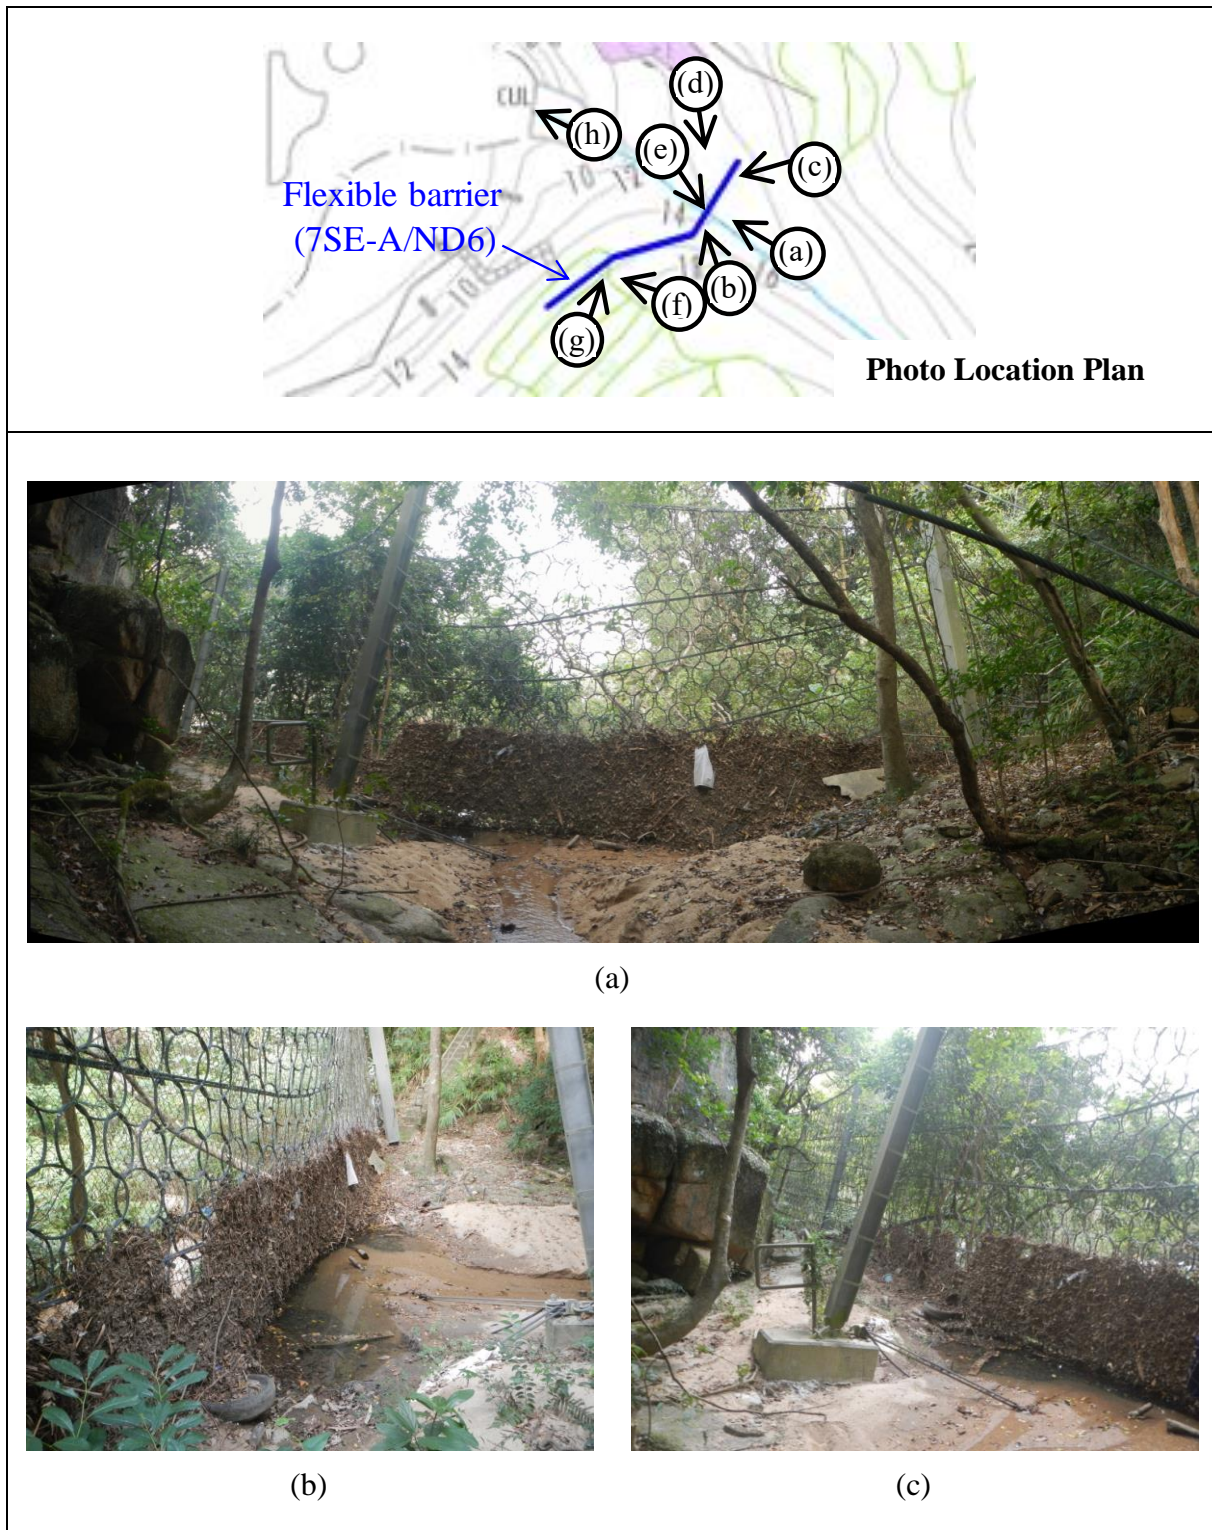
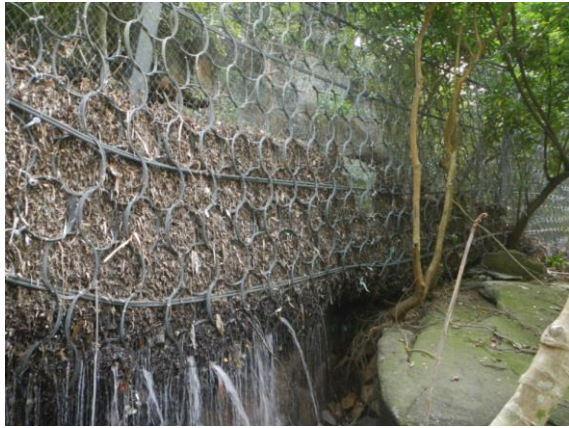
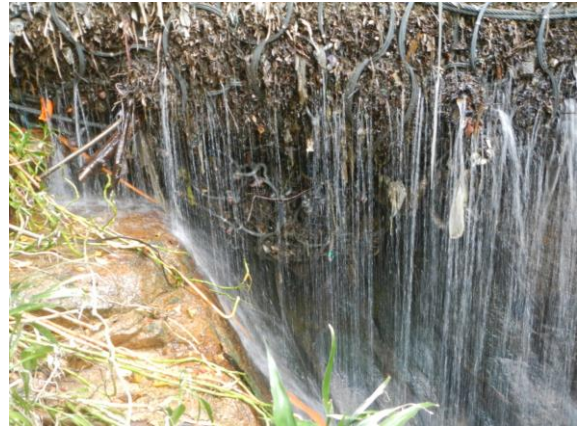
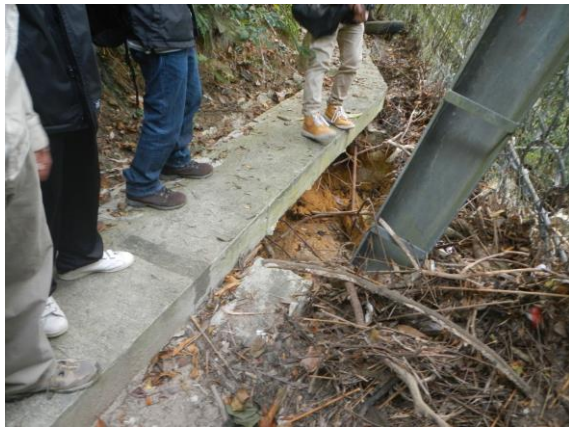
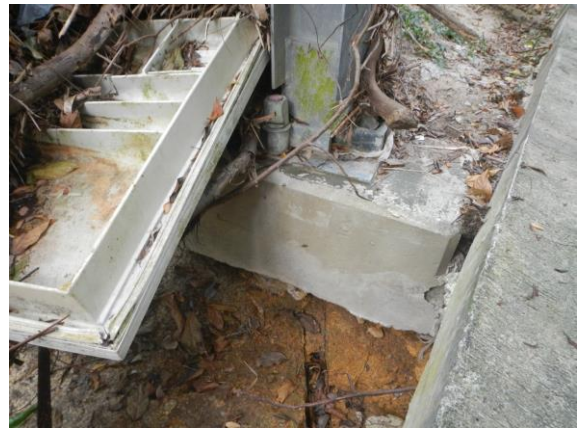
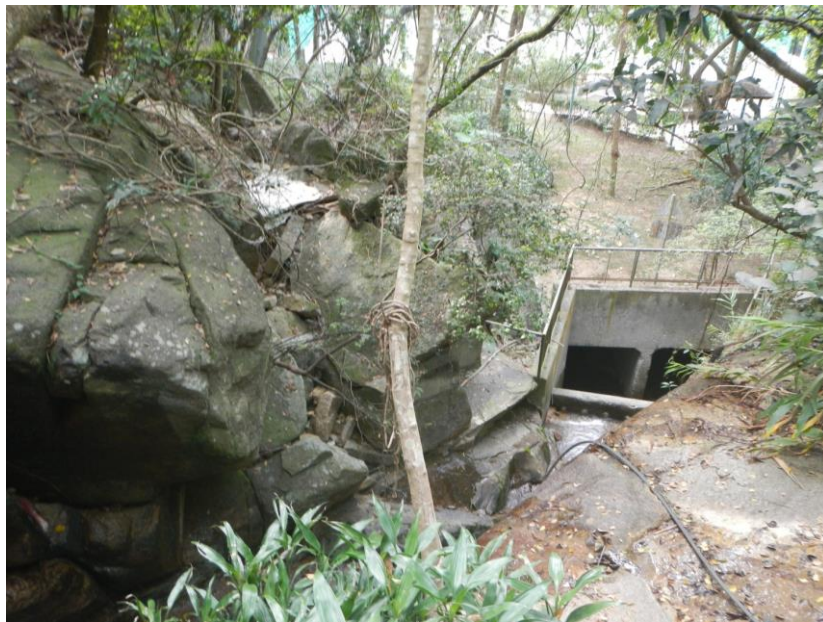
**Figure A2 Site Inspection Photos (Sheet 2 of 2)**

Subsequent to this incident, GEO inspected the natural hillside and identified that a significant amount of stream loads was trapped by a flexible barrier (Feature No. 7SE-A/ND6) installed across a natural stream course. A location plan is shown in Figure A1. These trapped stream loads included some soil sediments (about 2 m deep) that were accumulated at the stream course behind the flexible barrier. Some fallen leaves and branches were found trapped by the lower portion of the barrier (up to a level of 1.2 m above the top of soil sediments accumulated). Figures A2 (a) to A2 (e) show the conditions of the flexible barrier after the incident.

It was probable that, at the time of heavy rainstorm, the stream flow could have been obstructed by the trapped stream loads, resulting in over-spillage of stream flow undermining the adjacent footpath as shown in Figures A2 (f) and A2 (g). Immediately downstream of the flexible barrier is a box culvert that receives stream flow (see Figure A2 (h)). At the time of the incident, the stream flow could have been diverted to adjacent grounds and bypassed the box culvert, thereby inundating the downstream areas. The probable flow path is indicated in Figure A1.

The remedial works was completed in July 2017. A total of about 10 m<sup>3</sup> of stream loads was removed. The lower portion of the trapped stream loads (primarily within the gully) was found to be mainly boulders of irregular shape with an average size of about 300 to 500 mm (Figure A5 (a)). The upper portion of the trapped stream loads was uniformly-graded soil sediments (about 0.4 m thick). Turbulent flow in the stream was observed (Figure A5 (b)).

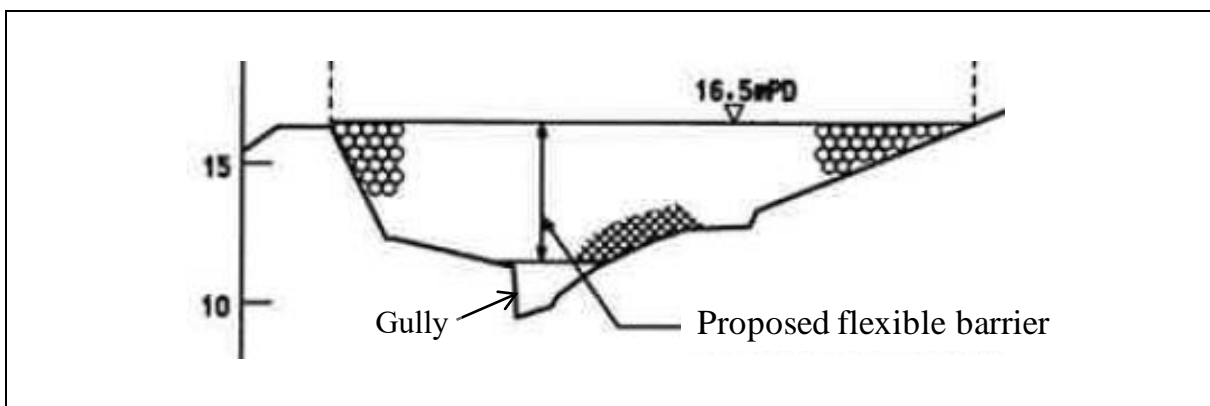
**Figure A3 Design Cross-section of the Stream Course (Extracted from Stage 3(H) report)**

The flexible barrier was installed across a major stream course, which is relatively broad (about 8 m to 12 m wide) with the presence of a 1.9 m wide and 1.8 m deep gully running along the middle of the stream course. Figure A3 shows the design cross-section of the channel at the barrier location. At the location of the gully, an additional panel of net was provided below the flexible barrier. This additional panel composed of principal net only and was anchored to the stream bed. The secondary mesh was extended to the top of the gully. An overview of the flexible barrier after construction and the netting details within the gully are shown in Figure A4.

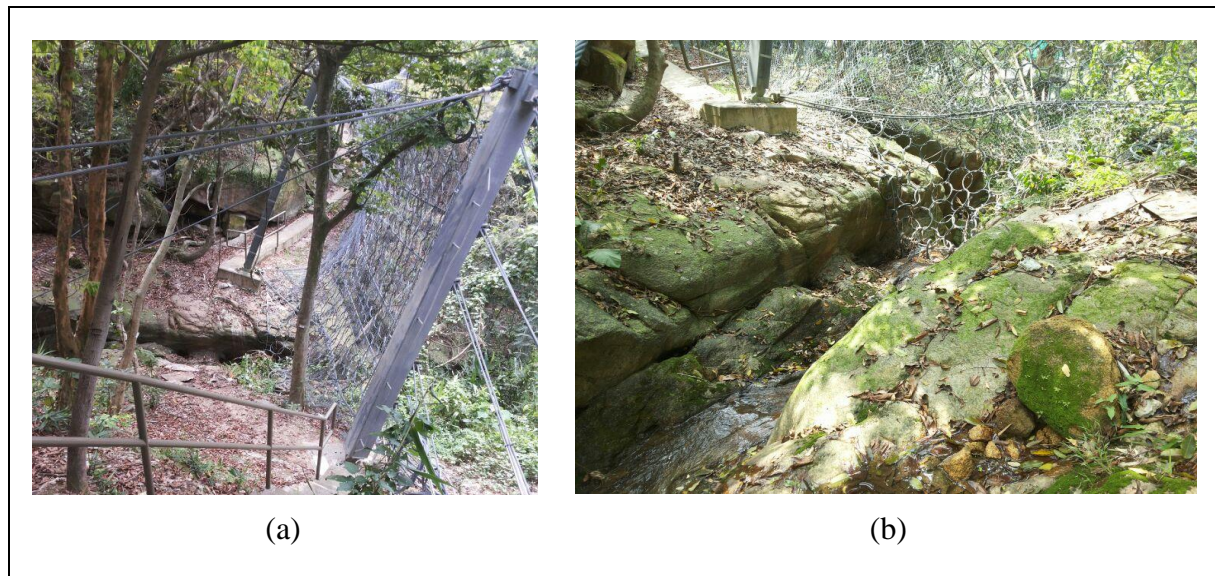
**Figure A4 Photos of (a) the Flexible Barrier; and (b) Netting Details after Construction**

The subject flexible barrier was constructed under the Landslip Prevention and Mitigation Programme (LPMitP) in 2012. According to the Stage 3(H) study (Halcrow, 2011), it was designed to mitigate the channelized debris flow hazard of a design volume of 200 m<sup>3</sup> arising from the natural hillside upslope. According to the as-built record, the flexible barrier was a proprietary rockfall barrier with an energy rating of 5,000 kJ. It was about 5 m high and 24 m long comprising three panels supported by four steel posts. The principal net layer was composed of 350 mm diameter ring-net. Attached to the upslope side of the principal net was a layer of secondary mesh with a mesh size of 60 mm x 80 mm.

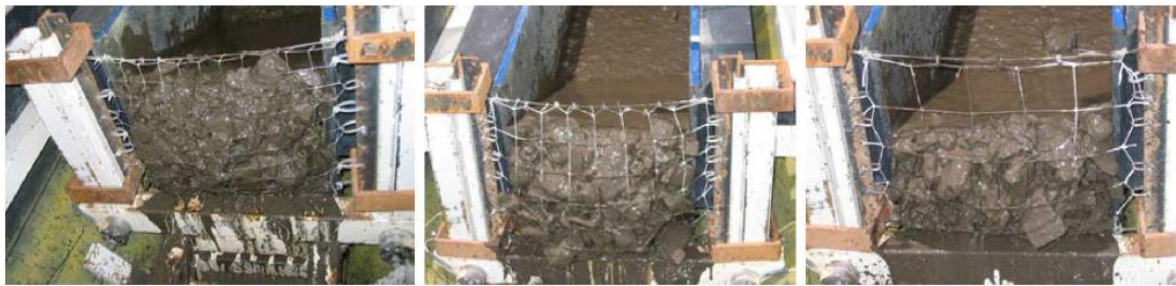
**Figure B1 Extracts of Some Test Results from the Laboratory Flume Study by Wendeler & Volkwein (2015)**

According to the laboratory flume study by Wendeler & Volkwein (2015) (see Figure B1), most of the debris material could be retained by the net if the net opening is smaller than the  $d_{90}$  grain size, where  $d_{90}$  is the maximum diameter of 90% of the particles composing the debris material. Volkwein (2014) also recommended that if the opening size of the principal net of a debris-resisting flexible barrier exceeds the grain fraction  $d_{90}$ , a small-sized secondary mesh should be provided.

Mesh size = 3 cm	Mesh size = 4 cm	Mesh size = 6 cm
Nearly all debris retained	About 80% of debris retained	About two-thirds of debris retained
Note: $d_{90}$ grain size of debris material = 3 cm.

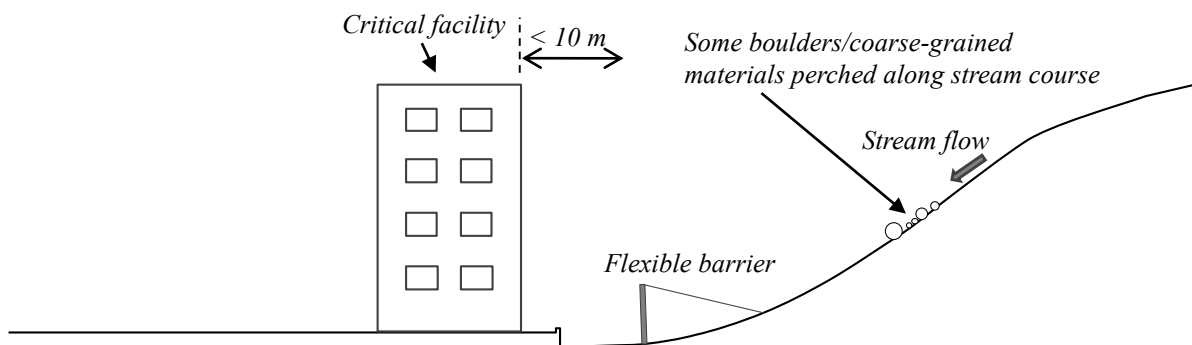
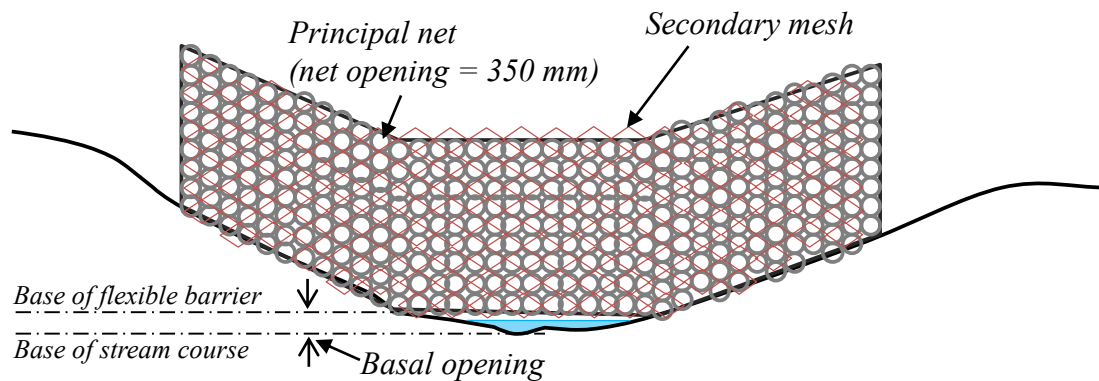
### Case 1 - flexible barrier in close proximity (e.g. < 10 m) to critical facility

Secondary mesh is provided and a small (up to 300 mm) basal opening (i.e. the clearance between the bottom side of the net and the base of stream course) is allowed to reduce any potential hazard due to leakage of landslide debris.

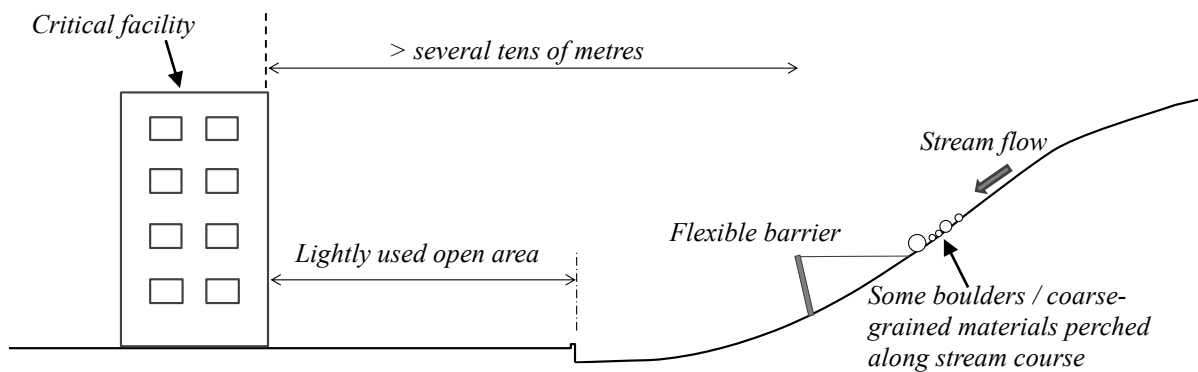
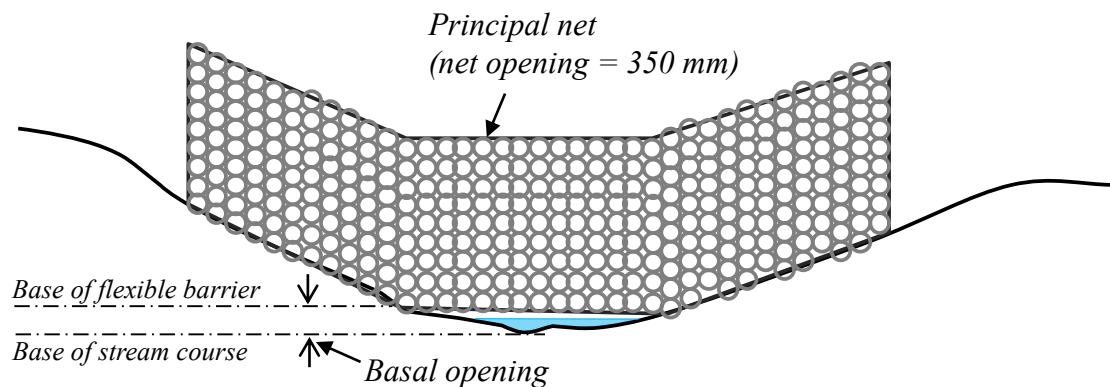
## Case 2 - flexible barrier far away (e.g. several tens meter) from critical facility

No secondary mesh is provided and a basal opening of 300 mm to 500 mm is allowed in this case.
