Factual Report on Hong Kong Rainfall and Landslides in 2017

GEO Report No. 345

R.C.T. Wai, R.W.H. Lee & V.W.W. Kong

**Geotechnical Engineering Office
Civil Engineering and Development Department
The Government of the Hong Kong
Special Administrative Region**

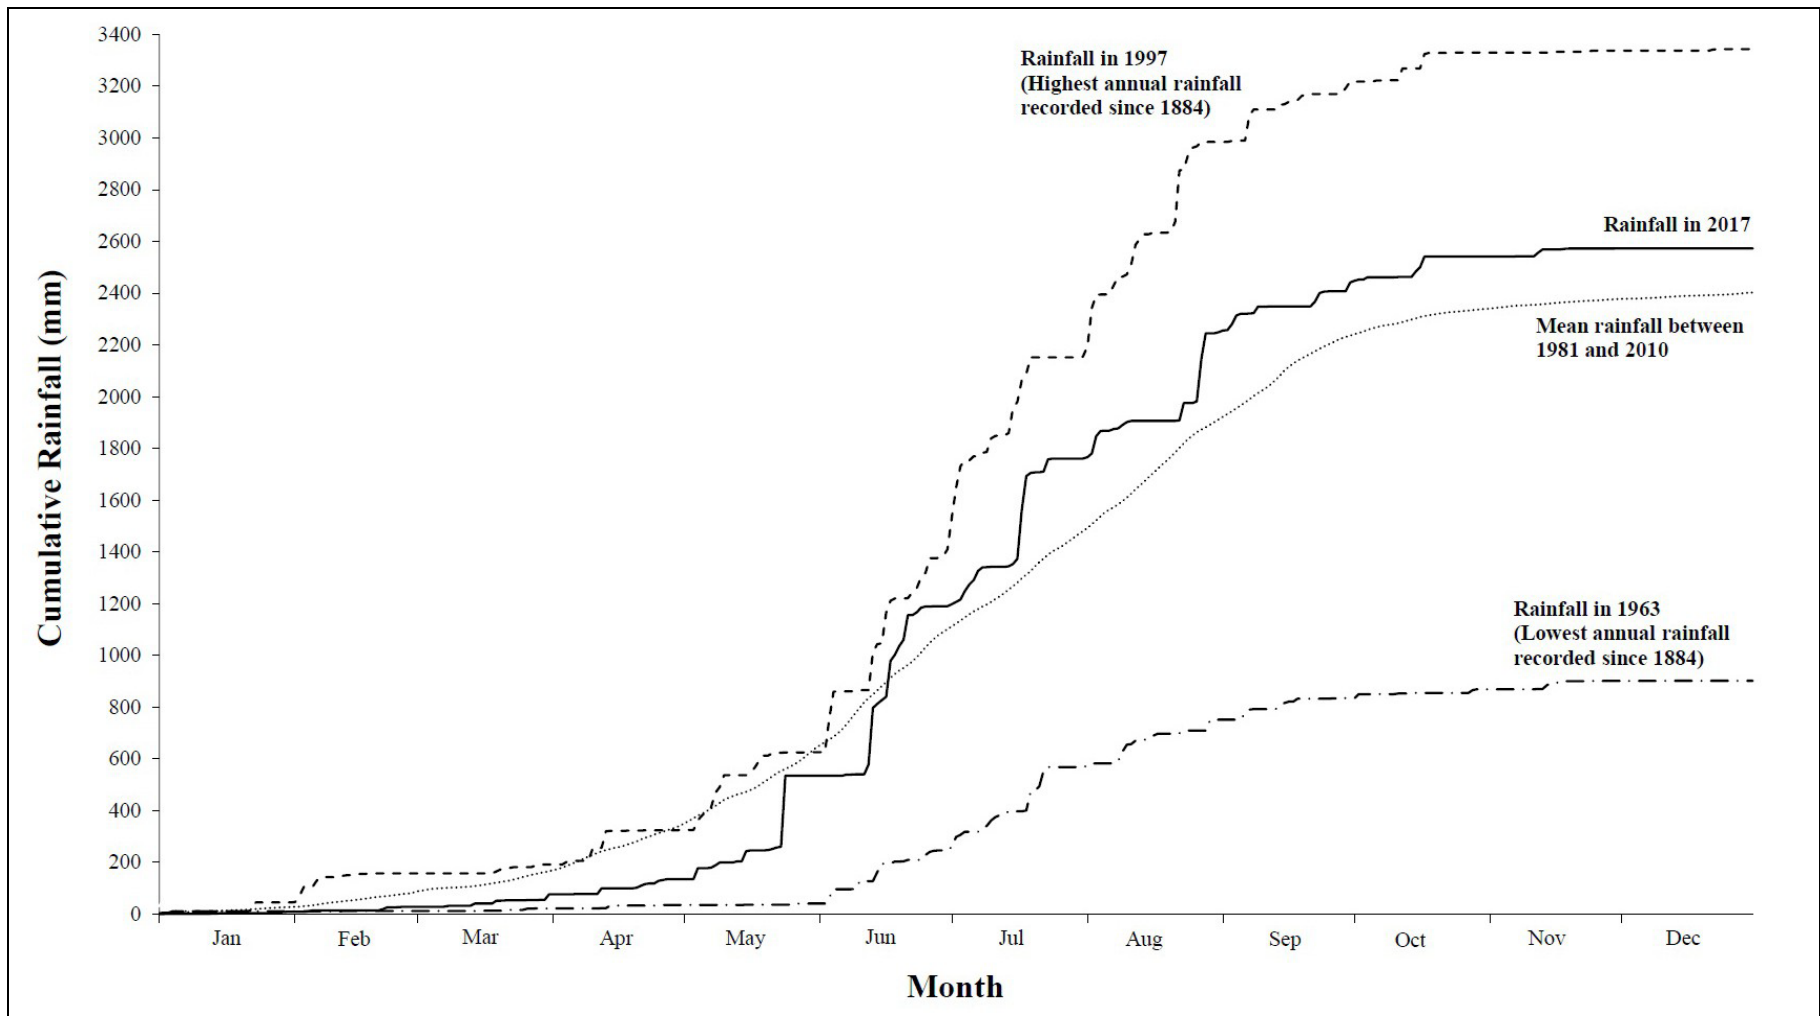
Note: Rainfall recorded at Hong Kong Observatory, Tsim Sha Tsui.

Figure 2.2 Cumulative Rainfall for 2017 at the Hong Kong Observatory and its Recorded Highest, Mean and Lowest Cumulative Rainfalls

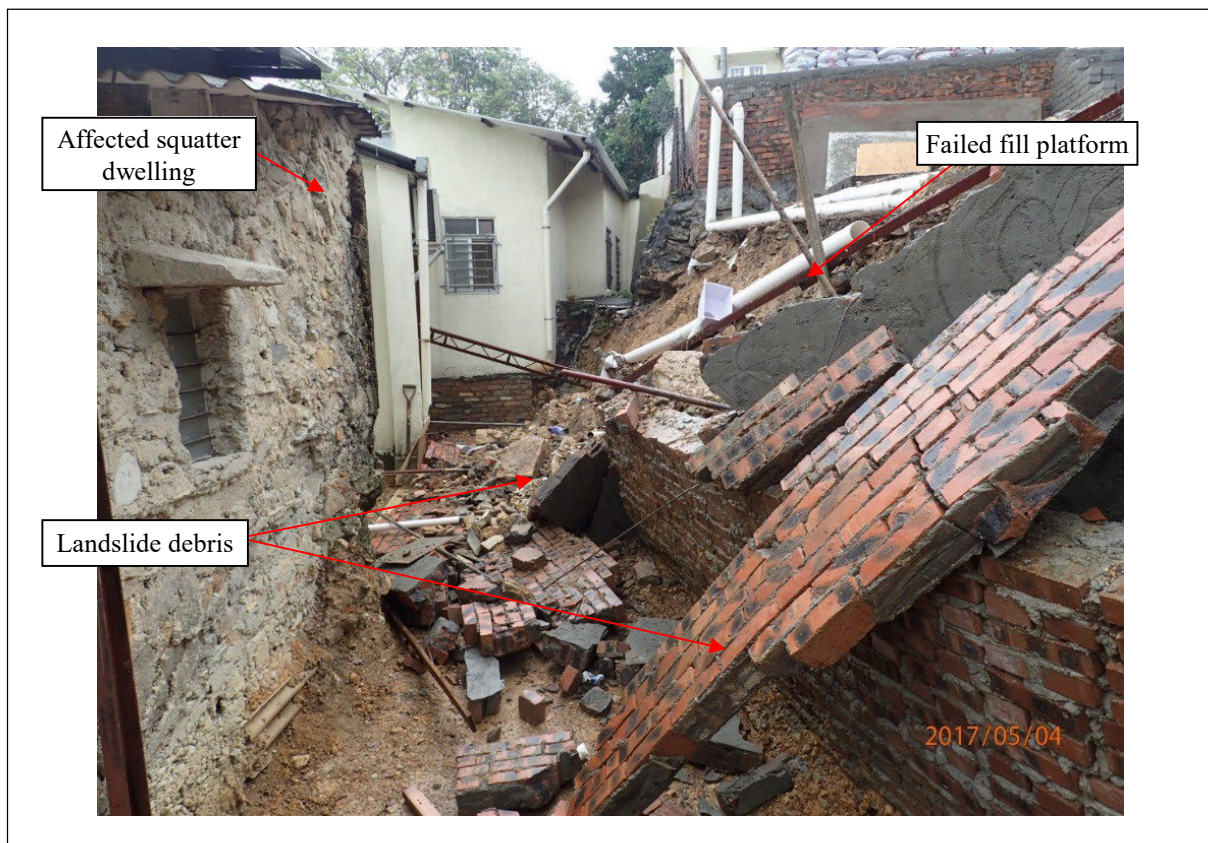
At about 10:00 a.m. on 4 May 2017, a landslide occurred on an unregistered fill platform behind a squatter dwelling at No. 101 Shung Him Tong Village, Fanling (Figure 4.1). The landslide, with an estimated failure volume of 7 m³, involved failure of a newly constructed unsupported fill platform and its vertical brickwork facing. The landslide debris, comprising fill materials and fragments of the severed brickwork facing, was deposited on the alleyway behind the squatter dwelling. A villager suffered a minor scratch from the fallen bricks while escaping. Following the landslide, the affected squatter dwelling was temporarily evacuated. The incident was widely reported by the media.

Figure 4.1 View of the 4 May 2017 Landslide at an Unregistered Fill Platform behind a Squatter Structure at Shung Him Tong Village, Fanling (Incident No. 2017/05/2009)

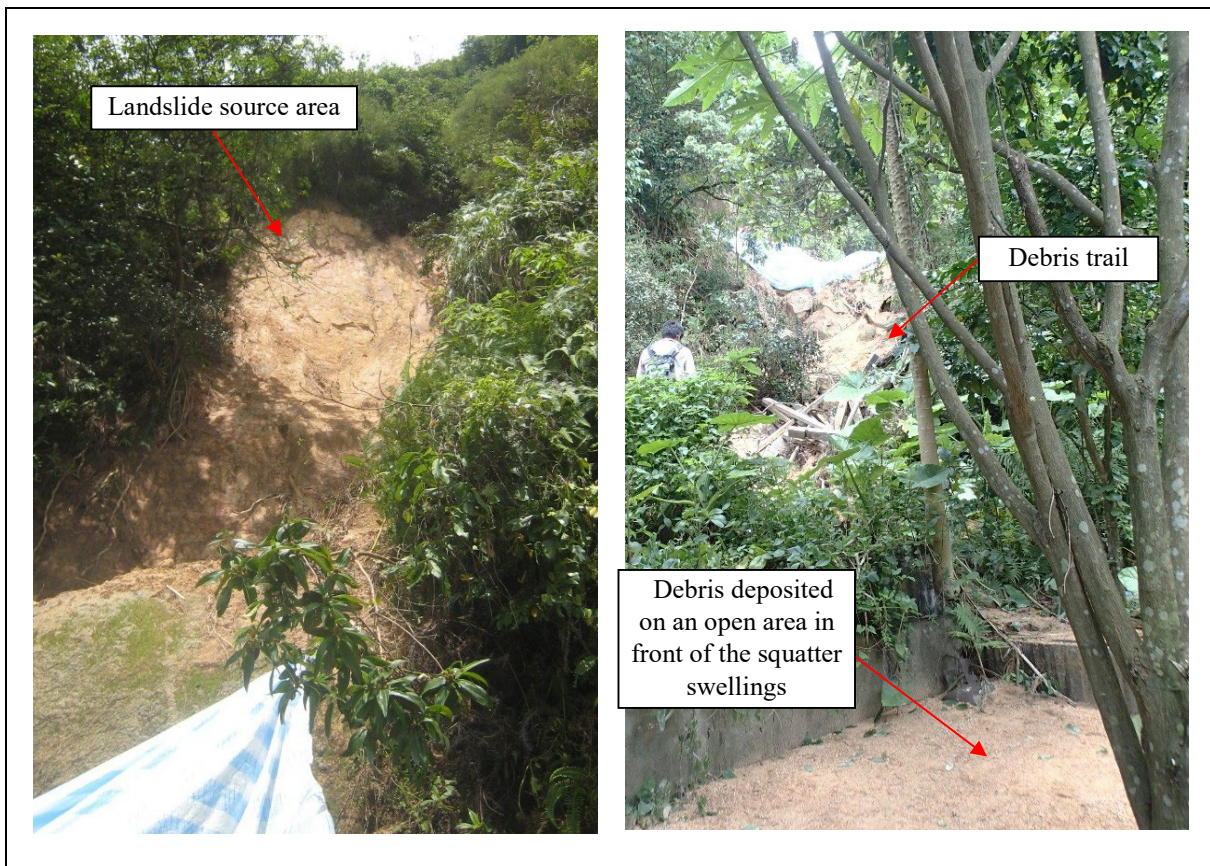
On 21 June 2017, a landslide was reported to have occurred on a soil/rock cut slope (Feature No. 11SE-B/C635) behind a squatter area at Sam Ka Tsuen, Lei Yu Mun (Figure 4.2). The landslide, with an estimated source volume of about 90 m³, involved a shallow failure within the zone of soil/rock interface. The landslide debris travelled over 30 m downslope and came to rest on an open area a few meters in front of the squatter swellings of Sam Ka Tsuen. Following the landslide, five squatter dwellings were temporarily evacuated. No casualty was reported as a result of the landslide.

Figure 4.2 View of the 21 June 2017 Landslide on Slope No. 11SE-B/C635 behind Sam Ka Tsuen, Lei Yu Mun (Incident No. 2017/06/2052)

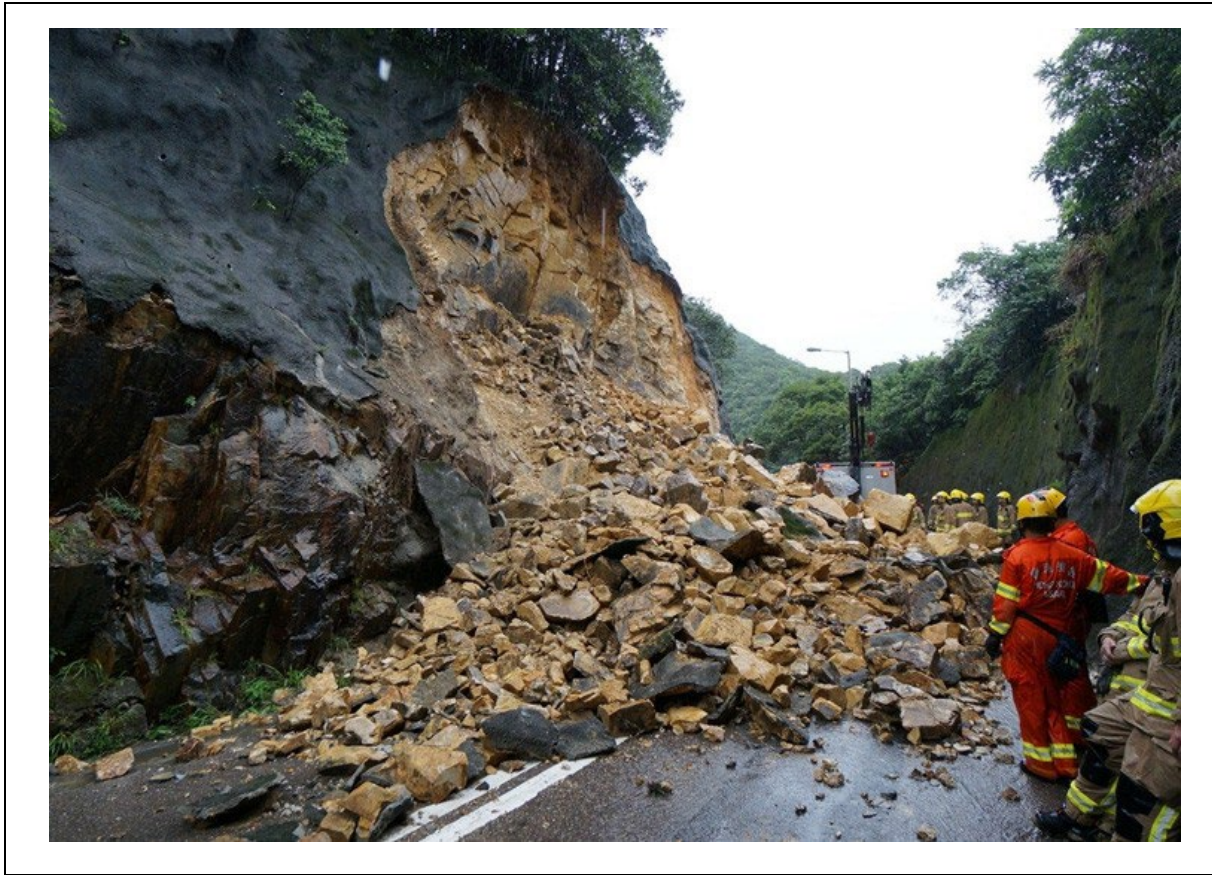
In the morning of 13 June 2017 when Landslip Warning was in effect, a landslide occurred on a soil/rock cut slope (Feature No. 11SE-C/C148) at Tai Tam Road (Figure 4.3). The landslide involved an estimated failure volume of about 60 m³ with the debris blocking both lanes of Tai Tam Road. No casualty was reported, but the affected section of road was completely closed which had resulted in substantial traffic disruption. The incident was widely reported by the media. One of the traffic lanes was re-opened in the morning of

Figure 4.3 View of the 13 June 2017 Landslide on Slope No. 11SE-C/C148 at Tai Tam Road (Incident No. 2017/06/2028)

14 June 2017 and the whole section of road was subsequently re-opened on 25 August 2017 following the completion of the remedial works.

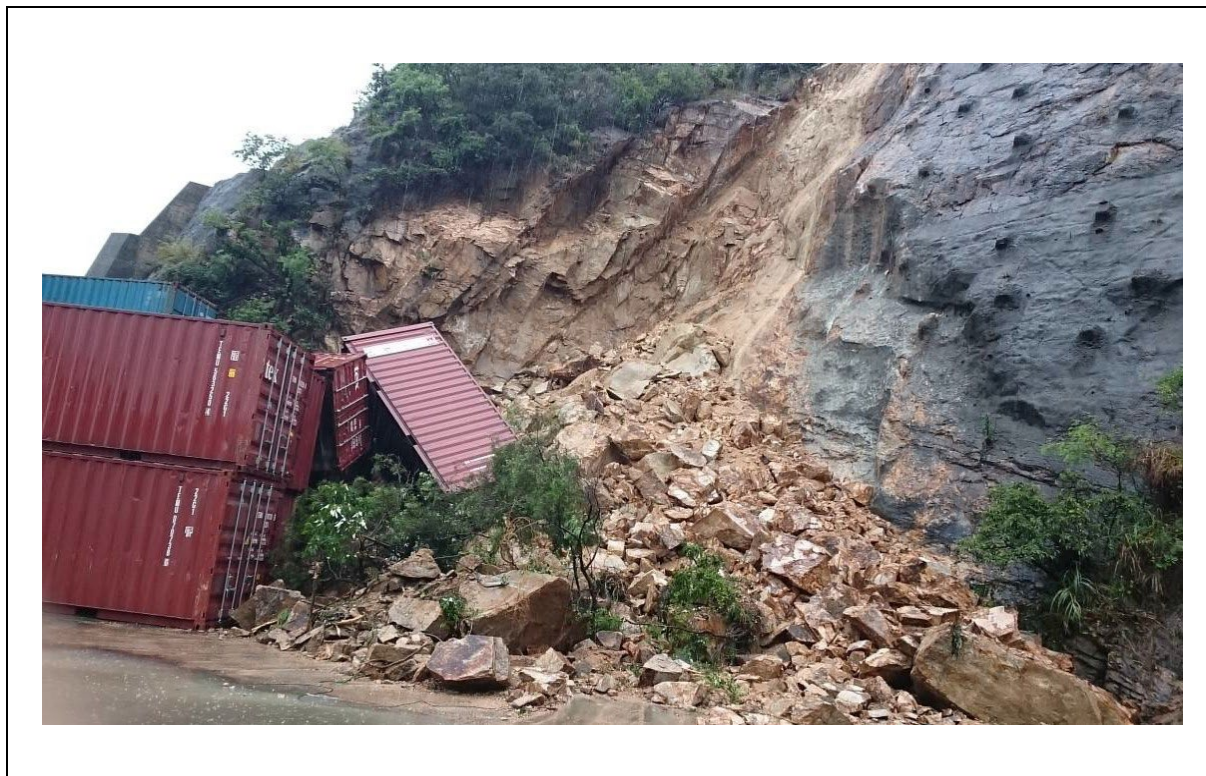
In the morning of 24 May 2017 when Landslip Warning was in effect, a landslide occurred on a rock cut slope (Feature No. 10NE-B/C57) below Tsing Yi Road, Tsing Yi (Figure 4.4). The landslide involved a rockslide with an estimated failure volume of about 1300 m³. The landslide scar is about 32 m long, 10 m wide and 10 m deep. The landslide debris damaged several containers at a storage area and blocked a nullah at the slope toe. No casualty was reported as a result of the landslide.

Figure 4.4 View of the 24 May 2017 Landslide on Slope No. 10NE-B/C57 below Tsing Yi Road, Tsing Yi (Incident No. 2017/05/2017)
