Factual Report on Hong Kong Rainfall and Landslides in 2018

GEO Report No. 347

**Geotechnical Engineering Office
Civil Engineering and Development Department
The Government of the Hong Kong
Special Administrative Region**

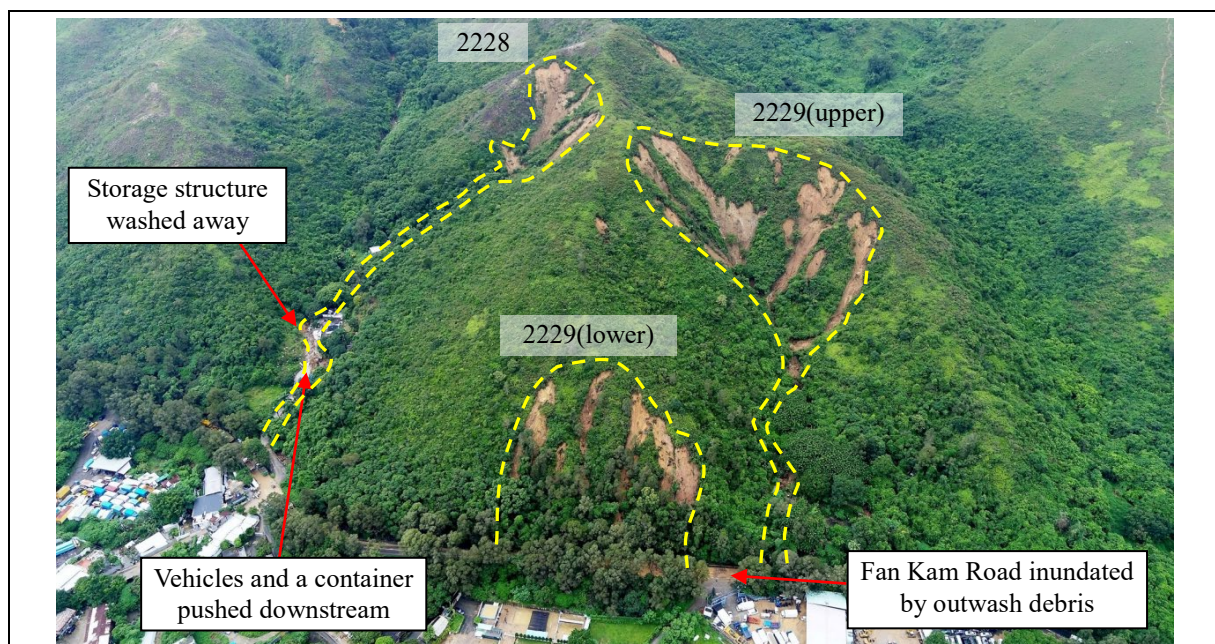
Figure 4.1 General View of the 29 August 2018 Landslides on the Natural Hillside above Fan Kam Road, Pat Heung (Incident Nos. 2018/08/2228 & 2018/08/2229)

On 29 August 2018 when Red Rainstorm Warning and Landslip Warning were in effect on that day, landslides in three distinct clusters, denoted as 2228, 2229(upper) and 2229(lower) in Figure 4.1, occurred on the natural hillside above Fan Kam Road with total source volume of 550 m³, 800 m³ and 200 m³ respectively. While the landslides initiated as open hillslope failures from multiple source areas within the landslide clusters, debris from landslide clusters 2228 and 2229(upper) converged into drainage lines and turned into channelised debris flows descending towards Fan Kam Road. No casualty was reported, but outwash debris inundated both lanes of Fan Kam Road resulting in closure of a section of the road (Figure 4.2(a)). One of the two traffic lanes was re-opened after four days upon completion of the immediate emergency works. The remaining traffic lane was re-opened in early January 2019 following the completion of additional emergency works which primarily comprised installation of soil nails. The debris impact also led to blockage of a cross-road culvert and pushing downstream and incurring damage on several vehicles and a container (Figure 4.2(b)). A storage structure adjoining a village house adjacent to the debris trail of landslide cluster 2228 was also reported to have been washed away (Figure 4.2(c)). The incidents were widely reported by the media.

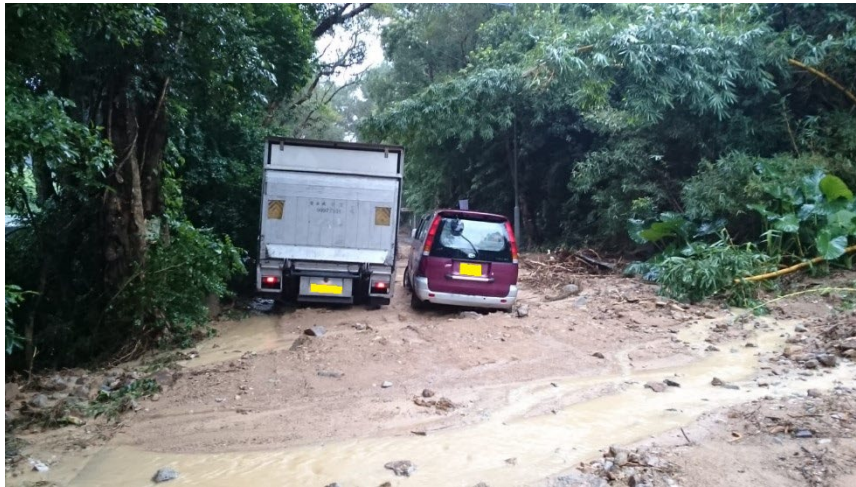
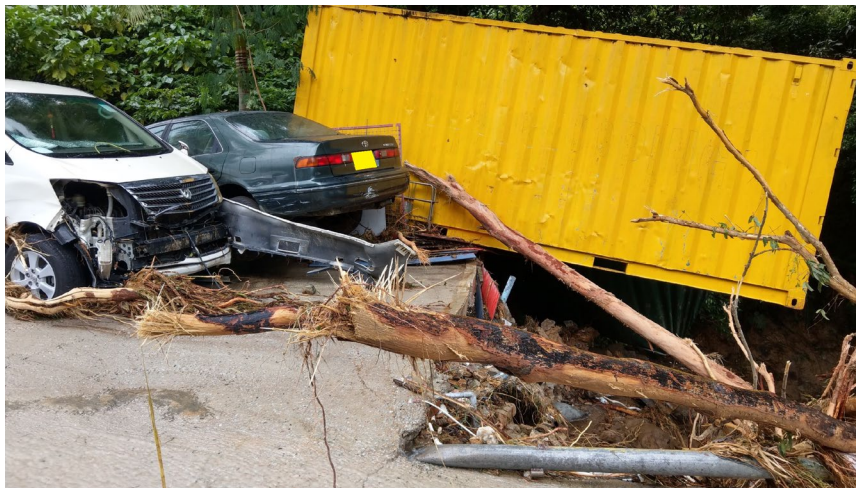
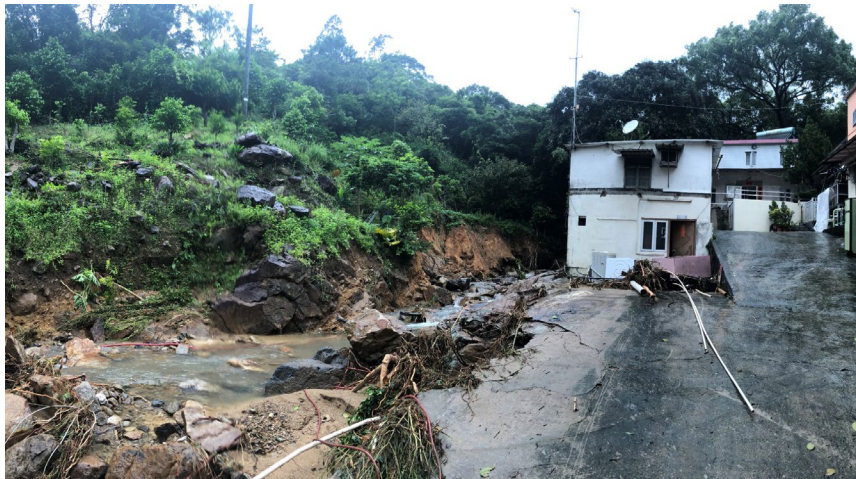
Figure 4.2 Views of the 29 August 2018 Landslides on the Natural Hillside above Fan Kam Road, Pat Heung (Incident Nos. 2018/08/2228 & 2018/08/2229)

(a) A section of Fan Kam Road inundated by outwash debris

(b) Vehicles and a container pushed downstream

(c) Storage structure adjoining a village house reported to have been washed away

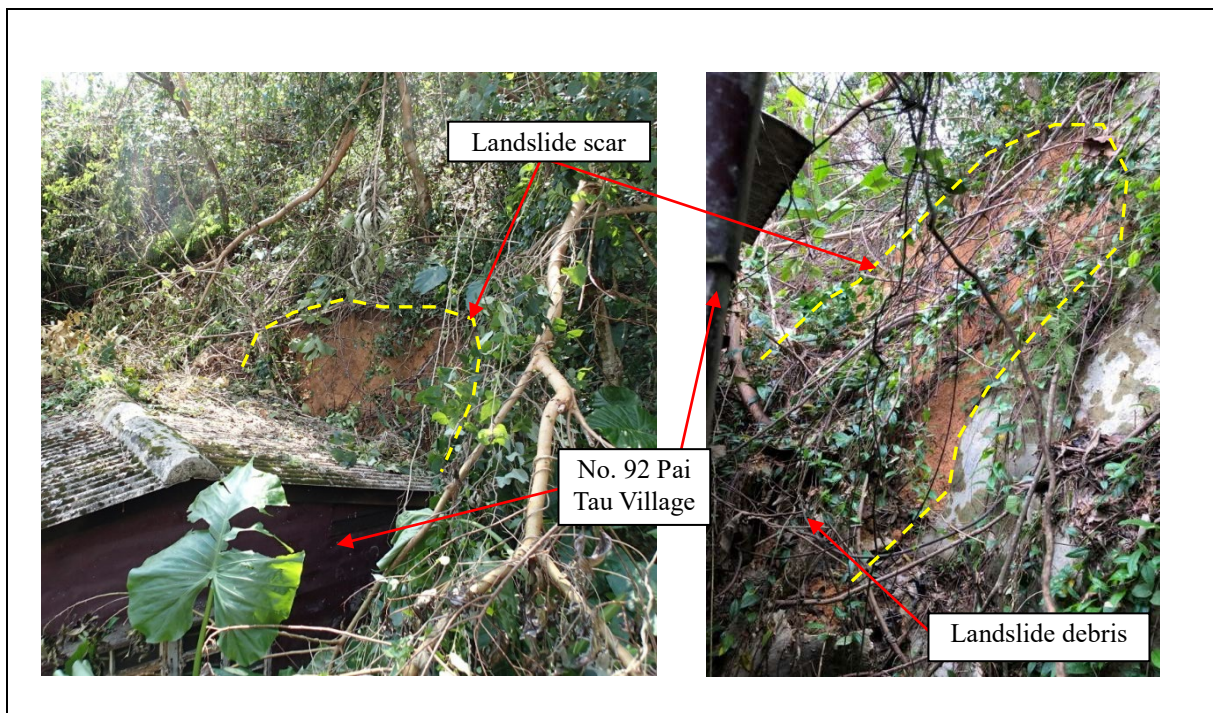
Figure 4.3 Views of the 16 September 2018 Landslide on an Unregistered Cut Slope behind a Squatter Structure at Pai Tau Village, Shatin (Incident No. 2018/09/2304)

At about 1:00 p.m. on 16 September 2018 when Red Rainstorm Warning was in effect followed by Landslip Warning, a landslide occurred on an unregistered soil cut slope below a squatter dwelling at No. 92 Pai Tau Village, Shatin (Figure 4.3). The landslide involved a shallow detachment with an estimated failure volume of 2 m³. The debris, comprising soil and vegetation, was piled up against the squatter without any major damage to the squatter structure. No casualty was reported as a result of the landslide.

According to available records, a Category 2 Non-development Clearance¹ (NDC) to the squatter dwelling at the slope toe was recommended by GEO in 1993. Subsequently, the squatter dwelling was permanently evacuated under a Category 1 NDC² recommended by GEO following the 2018 landslide.

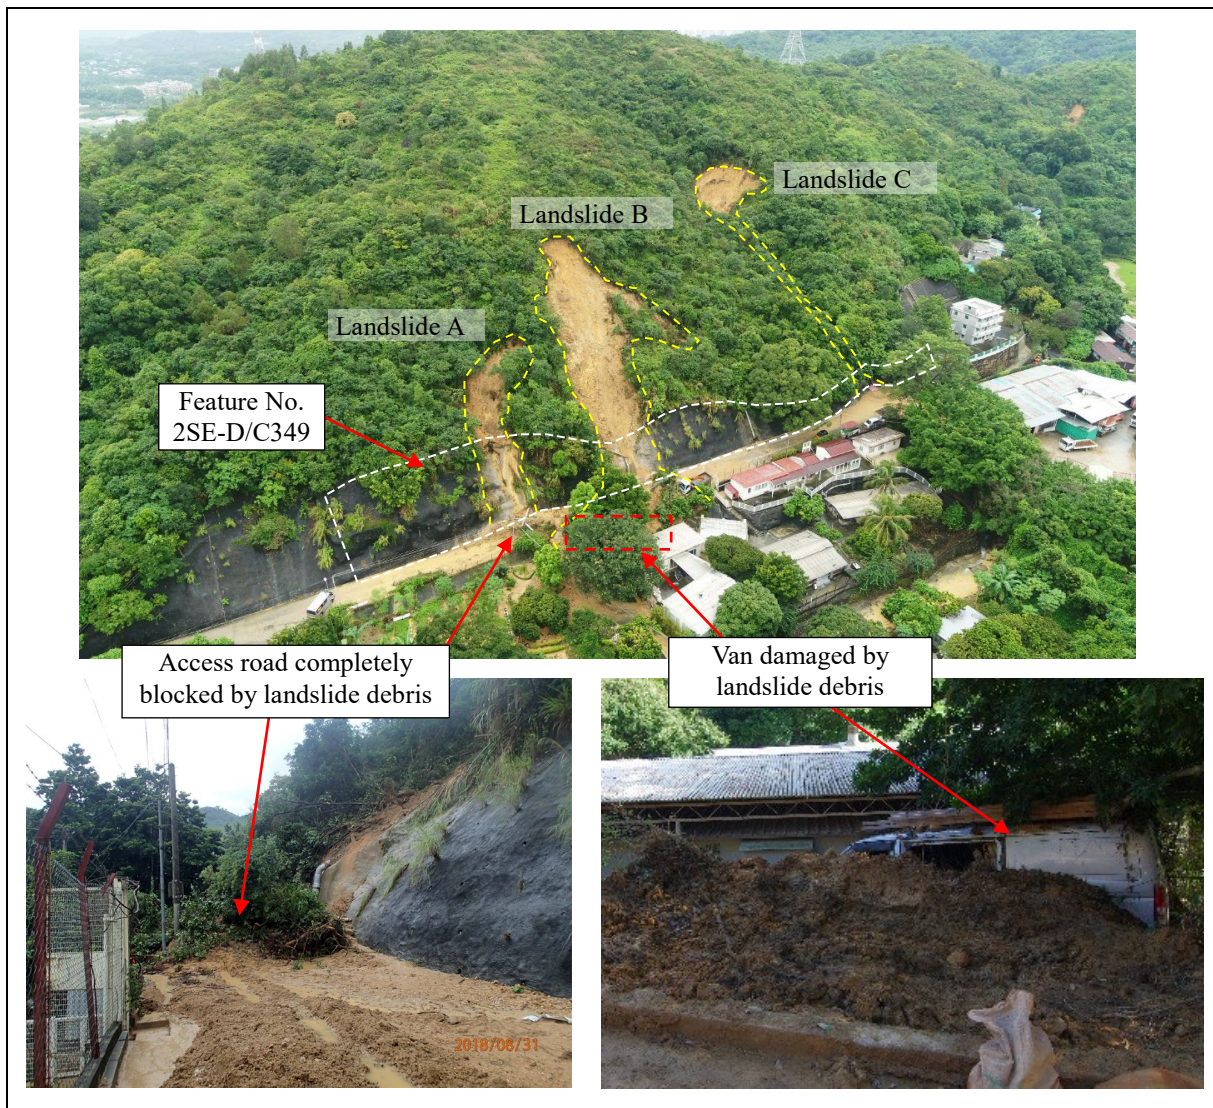
Figure 4.4 Views of the 29 August 2018 Landslides on the Natural Hillside at Ta Shek Wu Kiu Tau, Sheung Shui (Incident No. 2018/08/2231)

On 29 August 2018 when Red Rainstorm Warning and Landslip Warning were in effect on that day, three landslides, denoted as Landslides A, B and C in Figure 4.4, occurred on the natural hillside above a cut slope (Feature No. 2SE-D/C349) at Ta Shek Wu Kiu Tau with source volume of 70 m³, 125 m³ and 105 m³ respectively. The landslide debris was largely deposited on an access road at the slope toe and damaged a parked van at the opposite side of the road. While no casualty was reported, the affected section of access road was completely closed for about two weeks.

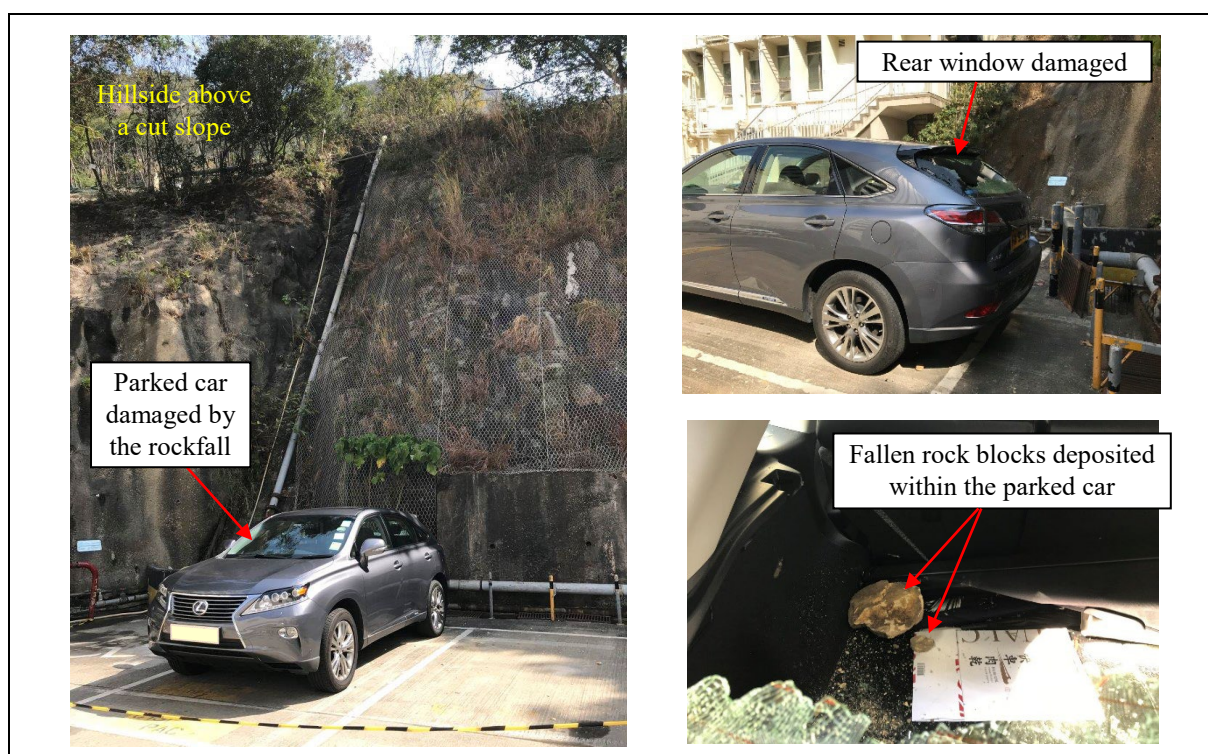
Figure 4.5 Views of the 13 February 2018 Rockfall from the Hillside behind Queen Mary Hospital (Incident No. 2018/02/2151)

On 13 February 2018, a rockfall incident occurred on the natural hillside above a cut slope (Feature No. 11SW-C/C76) behind the Clinical Pathology Building of Queen Mary Hospital under dry weather (Figure 4.5). The fallen rock blocks, with an estimated volume of 0.001 m^3 , impacted a car parked in the open car park at toe of the slope with most of the rock blocks punched into the car through its rear window. While the car was damaged, no casualty was reported as a result of the incident.

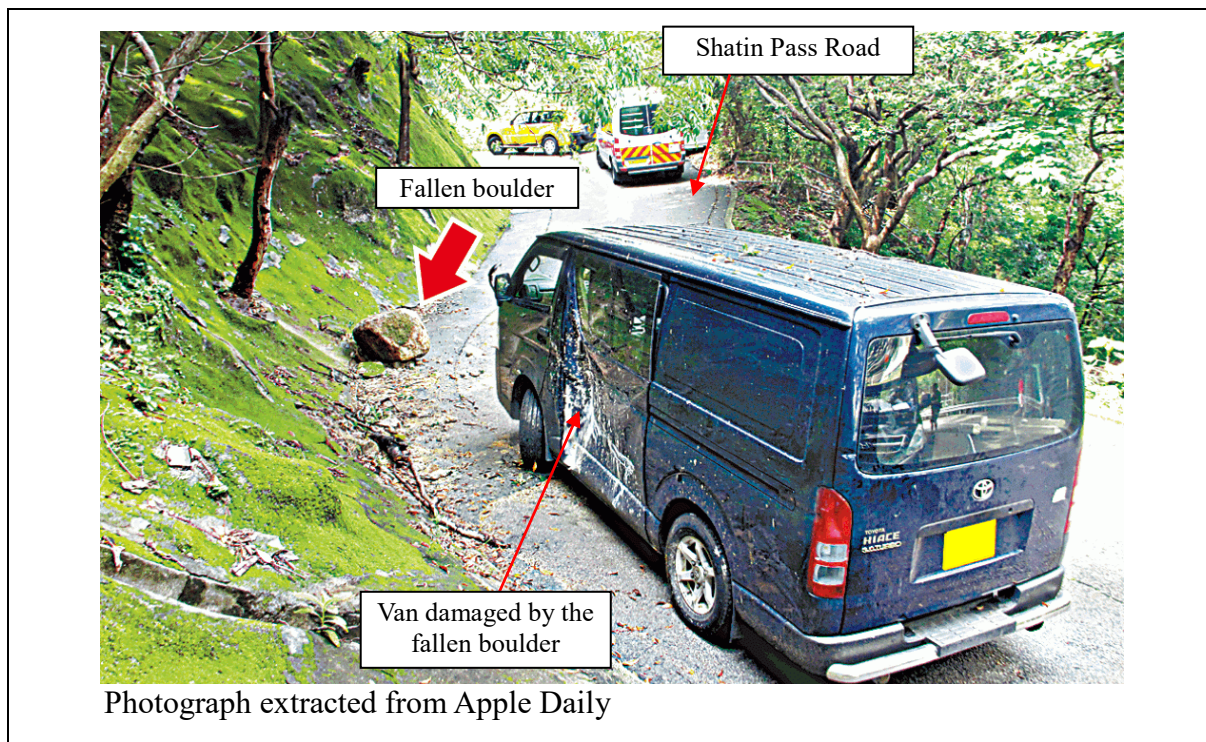
Figure 4.6 View of the 19 August 2018 Boulder Fall from the Natural Hillside above Shatin Pass Road, Wong Tai Sin (Incident No. 2018/08/2218)

On 19 August 2018 when Amber Rainstorm Warning was in effect on that day, a boulder fall incident occurred on the natural hillside above a cut slope (Feature No. 11NE-A/C3) at Shatin Pass Road (Figure 4.6). The fallen boulder, with an estimated volume of 0.25 m^3 , impacted a parked van at the slope toe resulting in damage of the door of the van and temporary closure of the affected road section. No casualty was reported as a result of the incident.
