Factual Report on Hong Kong Rainfall and Landslides in 2019

GEO Report No. 349

**Geotechnical Engineering Office
Civil Engineering and Development Department
The Government of the Hong Kong
Special Administrative Region**

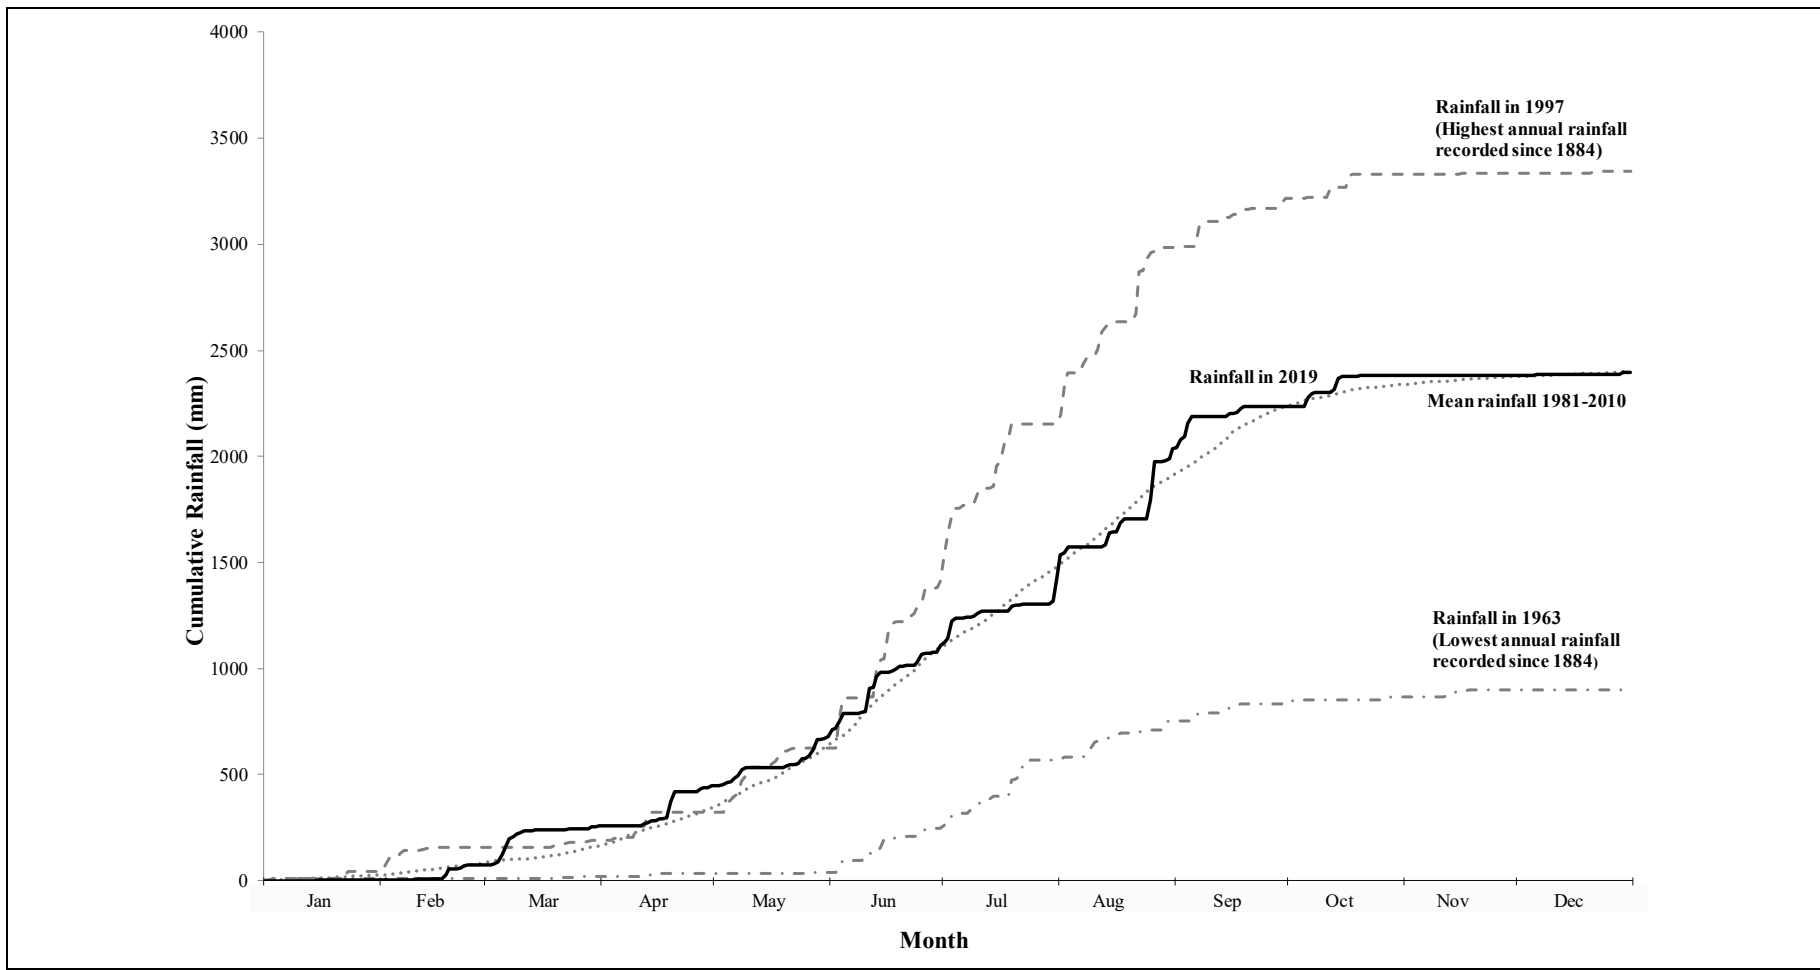
Figure 2.2 Cumulative Rainfall for 2019 at the Hong Kong Observatory and its Recorded Highest, Mean and Lowest Cumulative Rainfalls

The rainfalls recorded at the HKO in the first and second quarters of 2019 are 259.9 mm (61% above the normal rainfall) and 849.5 mm (9% below the normal rainfall) respectively. The total rainfalls recorded in the third and last quarters are 1123.8 mm (1% below normal) and 163.0 mm (1% below normal) respectively. The annual rainfall for 2019 is 2396.2 mm, near the annual normal of 2398.5 mm recorded between 1981 and 2010. The cumulative rainfall for 2019 is compared with the highest, lowest and mean rainfall in Figure 2.2.

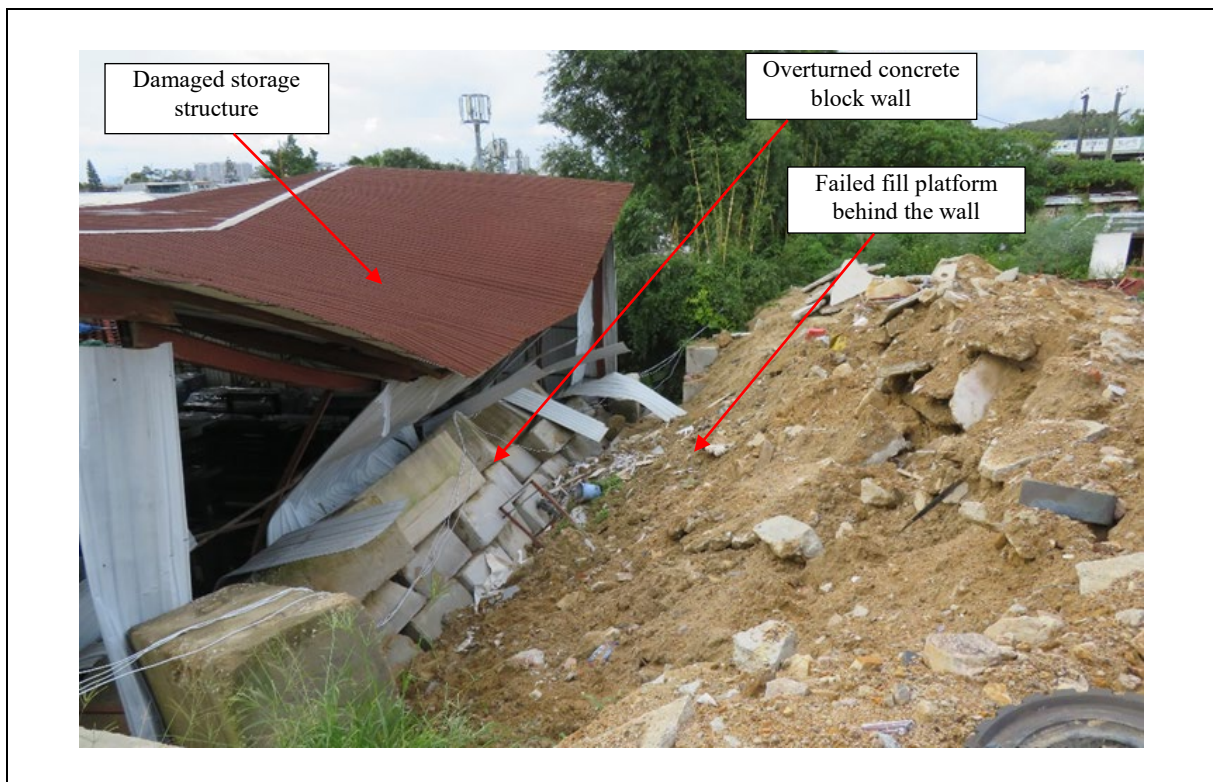
Figure 4.1 View of the 2 August 2019 Landslide on a Retaining Wall at Tai Tong Shan Road, Yuen Long (Incident No. 2019/08/2481)

On 2 August 2019, an incident involving a concrete block retaining wall was reported to have occurred at Tai Tong Shan Road, Yuen Long (Figure 4.1). The time of the incident was not known while there had been intense rainfall in precedent of the reporting time. Associated with Amber and Red Rainstorm Warnings, Landslip Warning was in effect between the night time of 31 July and the morning of 2 August 2019. The incident involved an overturning failure of concrete block wall with a failure volume of about 25 m³. The wall, of about 700 mm thick, was recently formed to retain a fill platform with a retaining height of about 2.5 m. The fallen concrete blocks damaged the steel cladding wall and supporting frame of a flimsy storage structure at the wall toe. No casualty was reported.

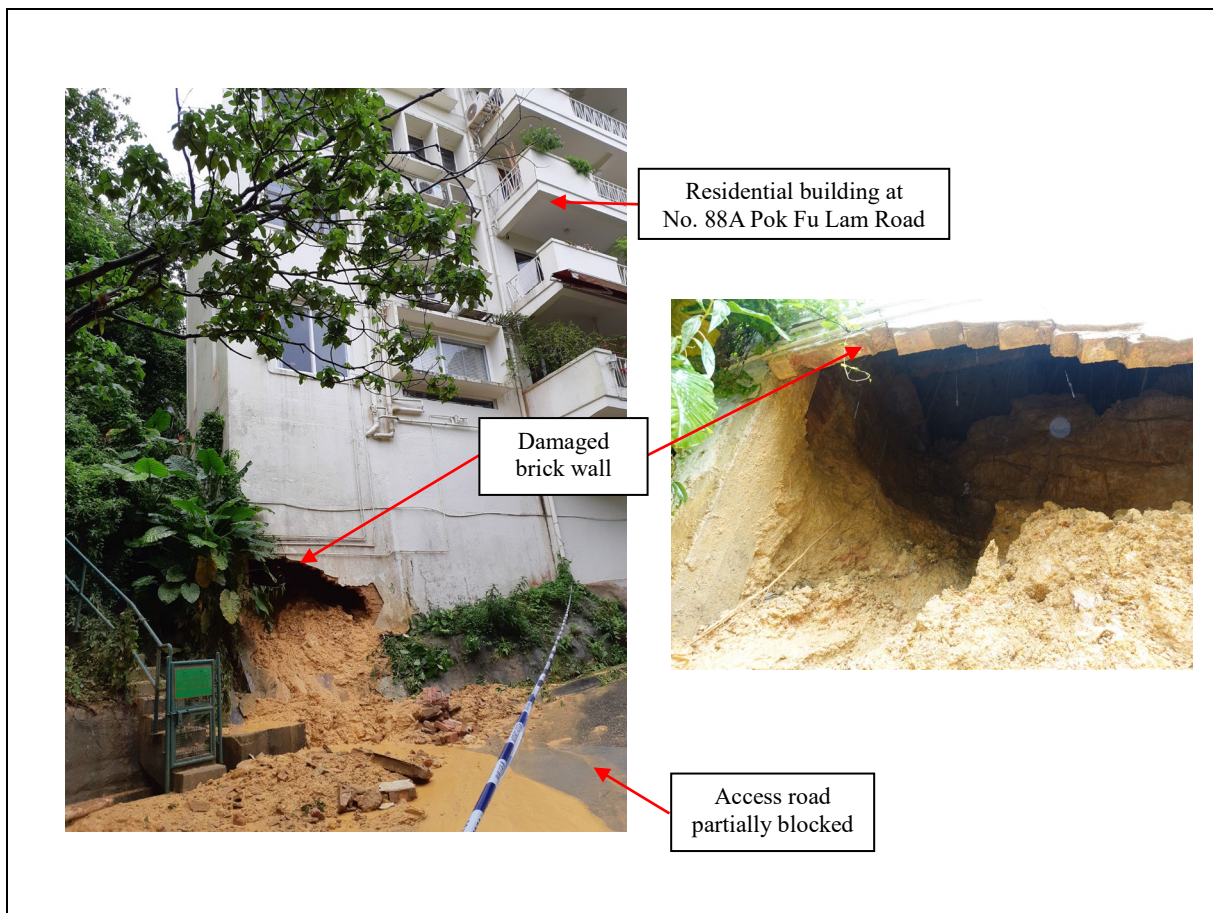
Figure 4.2 Views of the 26 August 2019 Landslide on a Cut Slope at No. 88A Pok Fu Lam Road, Hong Kong Island (Incident No. 2019/08/2488)

At about 6:45 a.m. on 26 August 2019 when Landslip Warning was in effect, a landslide occurred on a soil cut slope originally shielded behind the brick wall of a residential building at No. 88A Pok Fu Lam Road (Figure 4.2). The landslide, involving an estimated failure volume of about 10 m³, resulted in the collapse of a portion of the brick wall with the debris deposited and partially blocked the access road adjacent to the building. No casualty was involved and the incident was reported by several media sources.

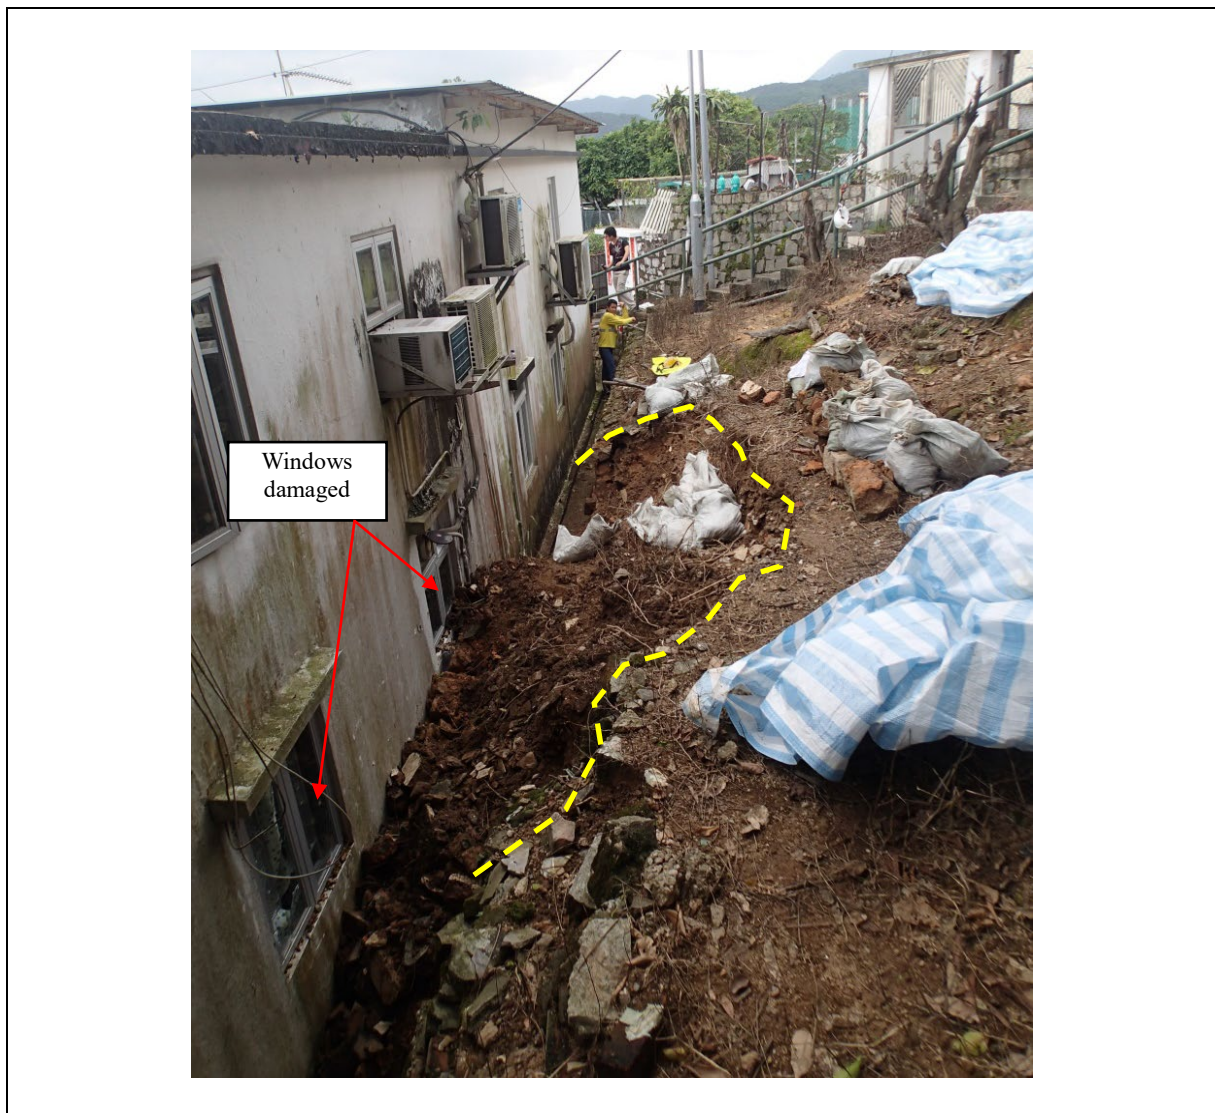
Figure 4.3 View of the 19 April 2019 Landslide on a Retaining Wall behind Nos. 24 and 25 O Long Village, Sai Kung (Incident No. 2019/04/2427)

At about 6:00 p.m. on 19 April 2019 when Amber Rainstorm Warning was in effect, a landslide occurred on a rubble retaining wall behind two squatter dwellings of Nos. 24 and 25 O Long Village, Sai Kung (Figure 4.3). The subject retaining wall was about 1.7 m in height at the failure location. The landslide involved a failure volume of approximately 2 m³. The landslide debris was deposited on the alleyway behind the two squatter dwellings and piled up against the external wall of the structures. The landslide resulted in damage of the windows of one of the two squatter dwellings. No casualty was reported.

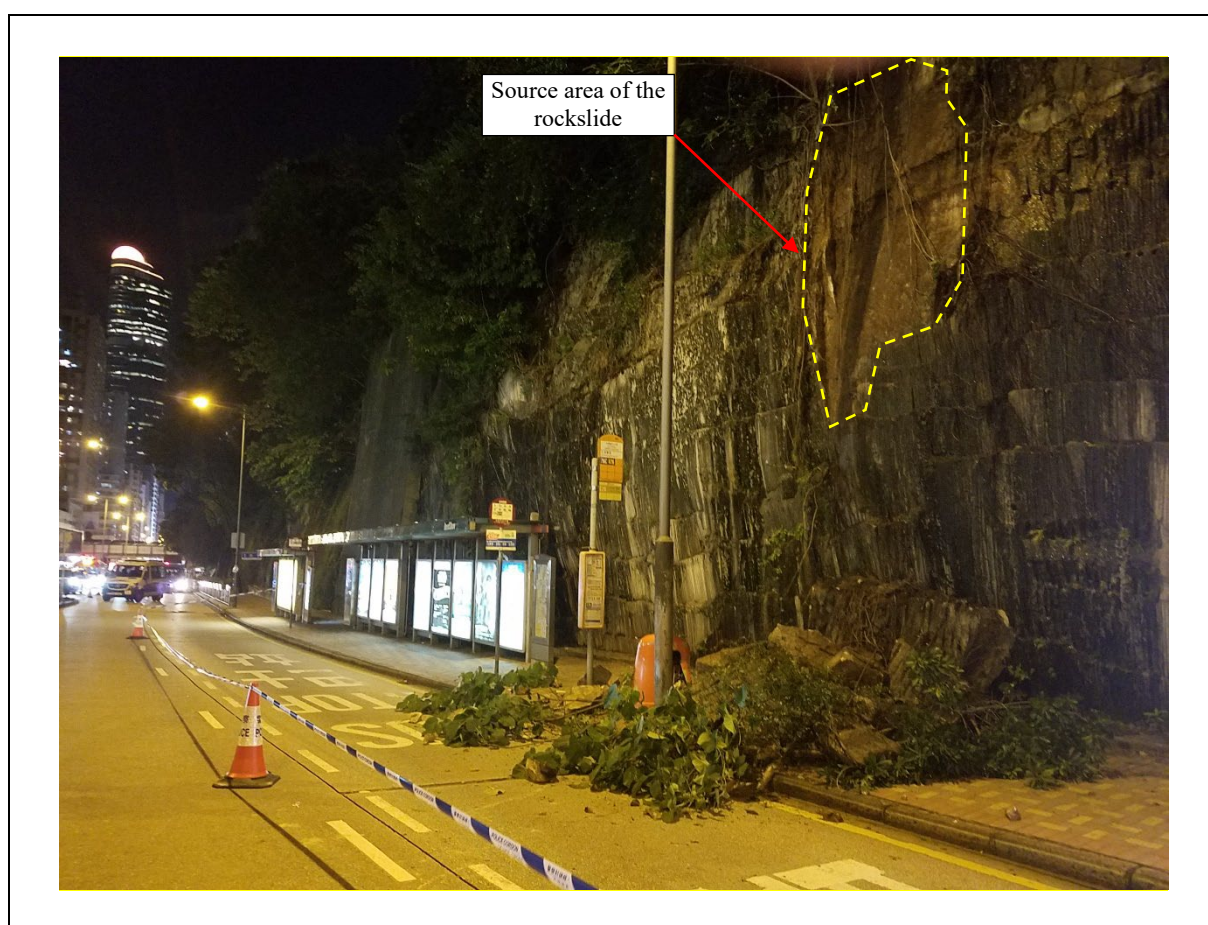
Figure 4.4 View of the 26 June 2019 Rockslide on Slope No. 11NW-D/C16 at Argyle Street, Mong Kok (Incident No. 2019/06/2456)

At about 6:30 p.m. on 26 June 2019, a rockslide occurred on the lower batter of slope No. 11NW-D/C16 at Argyle Street, Mong Kok (Figure 4.4). Little rain was recorded preceding the incident on that day. A rockslide with a failure volume of approximately 4 m³ originated from the bare rock cut face of the slope. The debris, comprising rock fragments and some vegetation, was largely deposited on the pedestrian pavement and some of it was found on a road lane. As a result, two road lanes, the pedestrian pavement and the bus stops at slope toe were temporarily closed. No casualty was involved. The incident was reported in the media.
