# **Detailed Study of the 29 August 2018 Landslides on the Natural Hillside above Fan Kam Road, Pat Heung**

**GEO Report No. 363**

**AECOM Asia Company Limited**

**Geotechnical Engineering Office  
Civil Engineering and Development Department  
The Government of the Hong Kong  
Special Administrative Region**

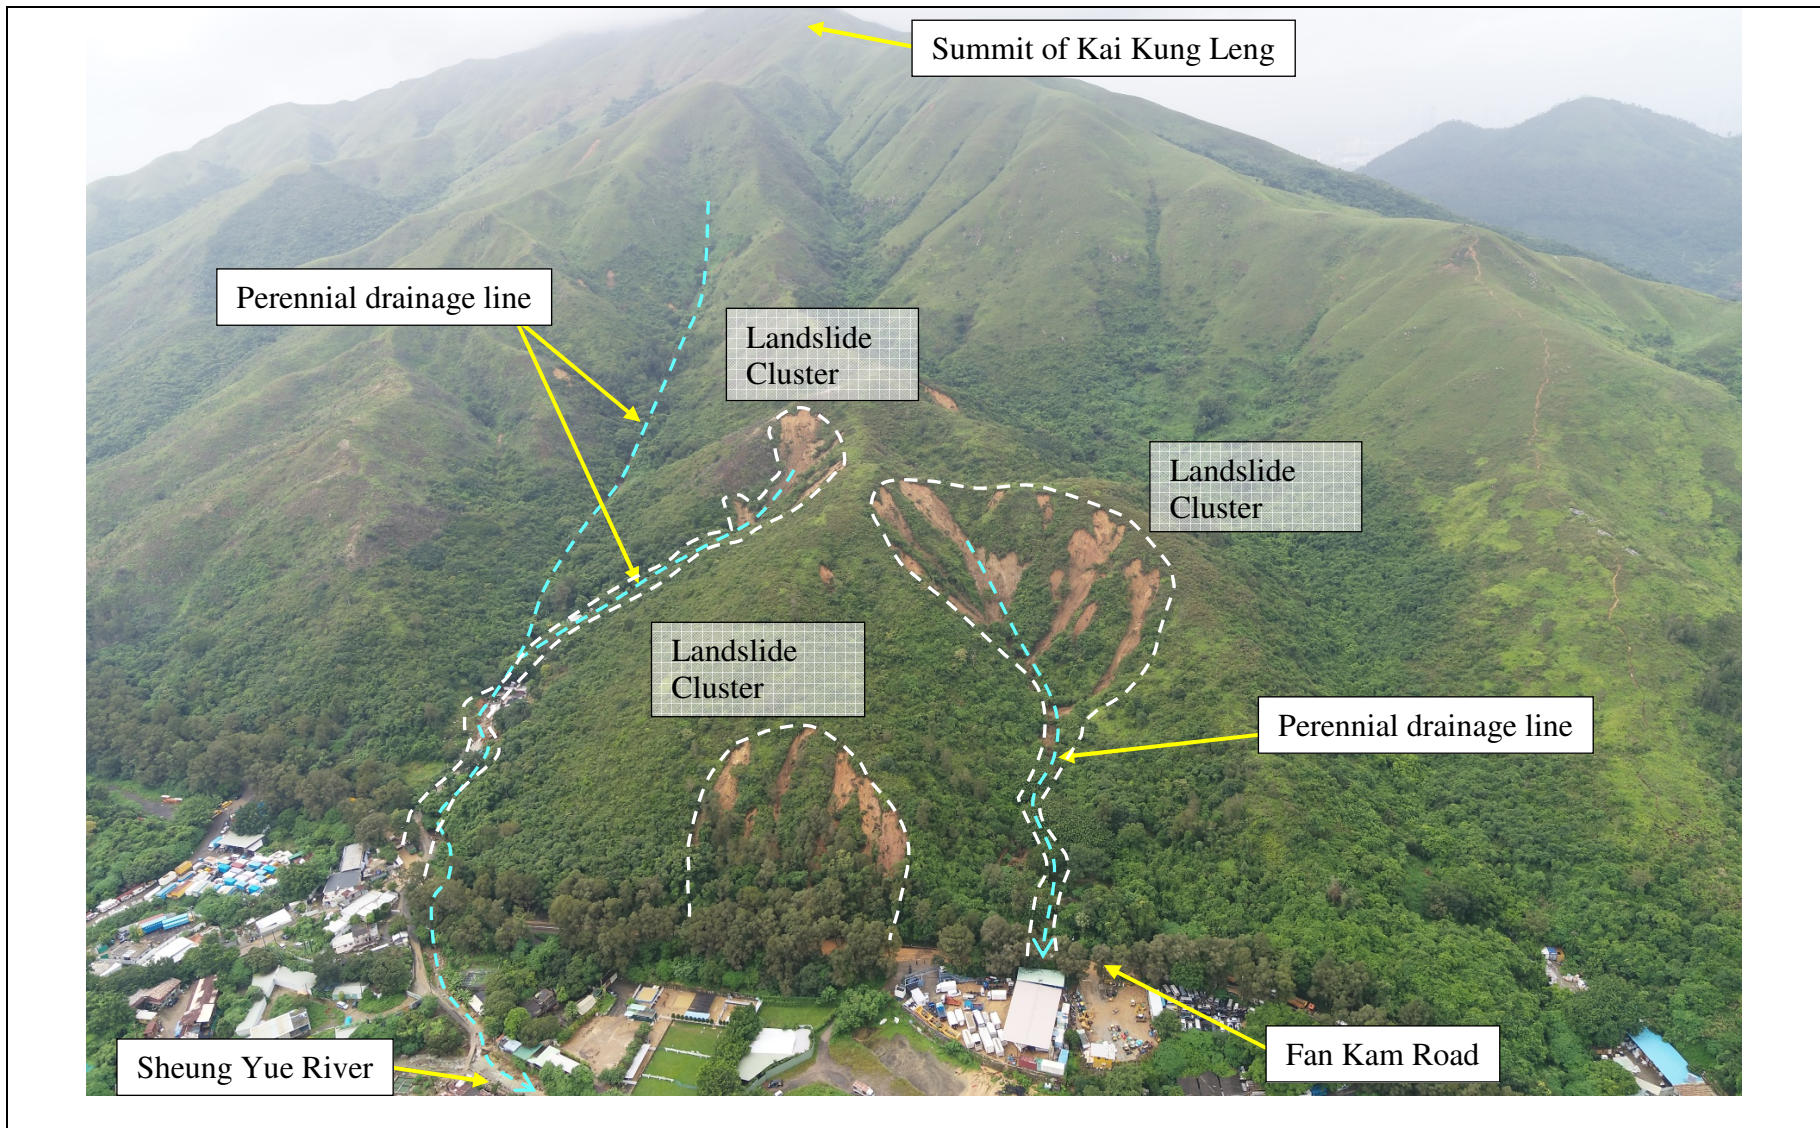
Figure 2.1 General View of the Landslides (Photograph taken on 30 August 2018)

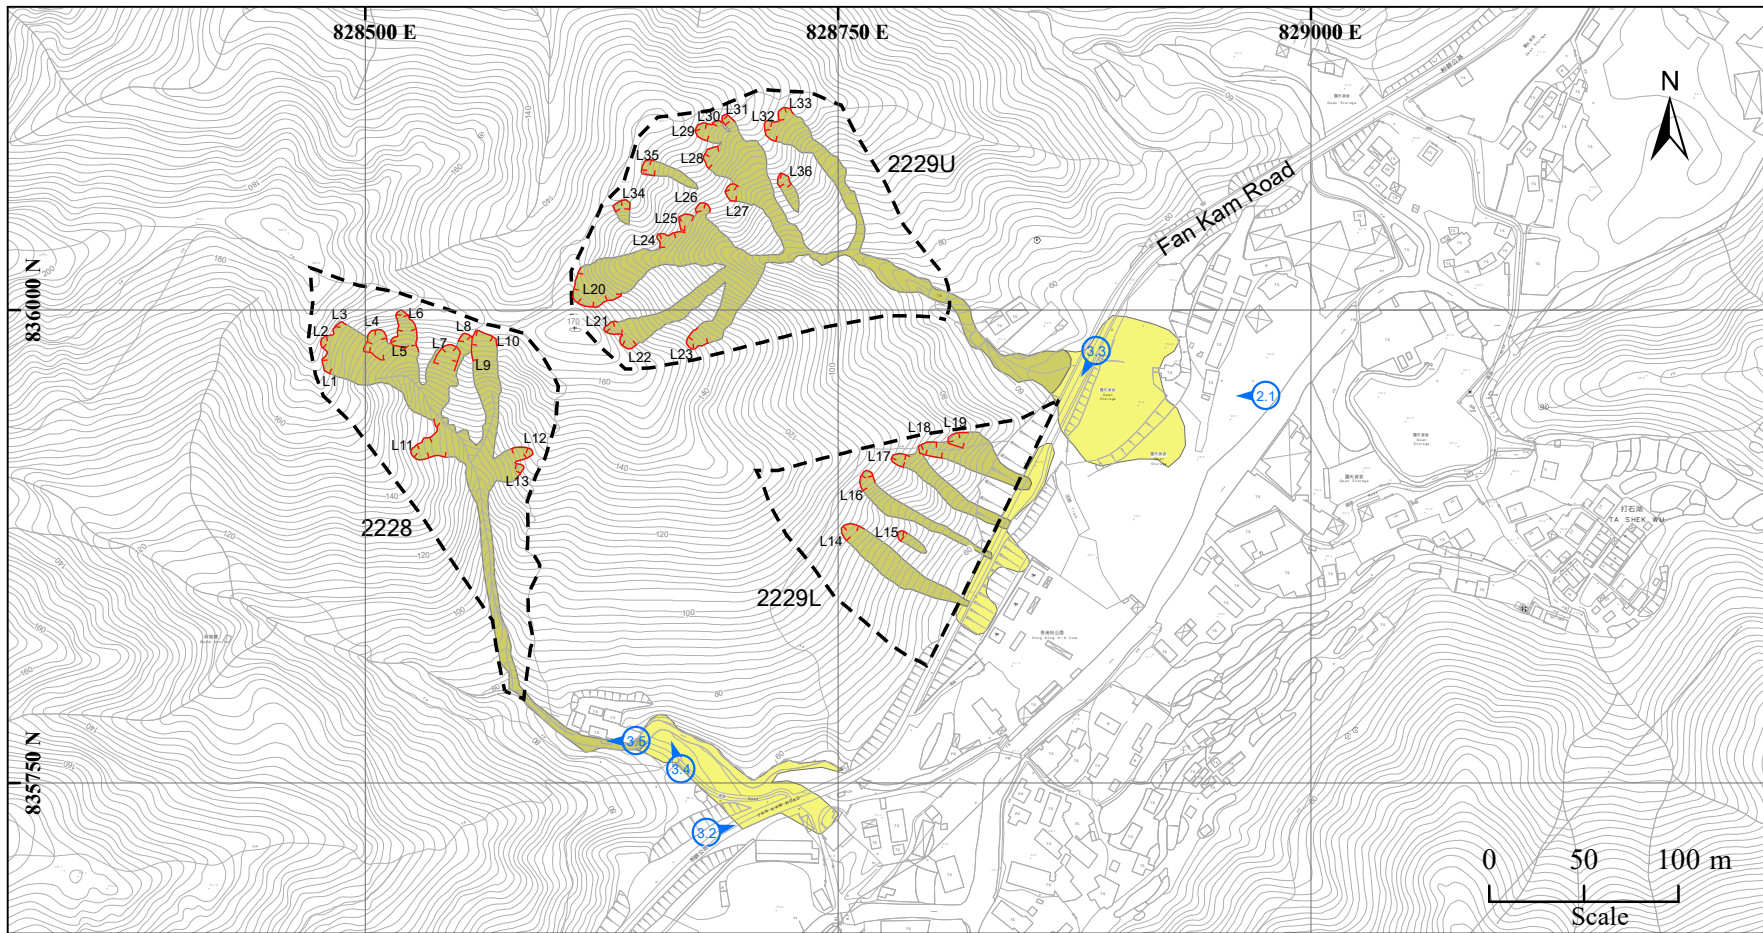
Figure 3.1 Site Layout Plan

The landslides forming the three landslide clusters notably comprise 36 individual landslide source areas (denoted as L1 to L36) in close proximity within catchments 2228, 2229U and 2229L (Figure 3.1). These source areas are generally located within steep terrain (typically 35° to 45°) between elevations of about 80 mPD and 170 mPD. Landslide clusters 2228 and 2229U are located within distinct topographic depressions draining into incised drainage lines, whilst landslide cluster 2229L is located on an open hillslope setting immediately above Fan Kam Road. Some isolated landslides are also noted on other parts of the hillside.

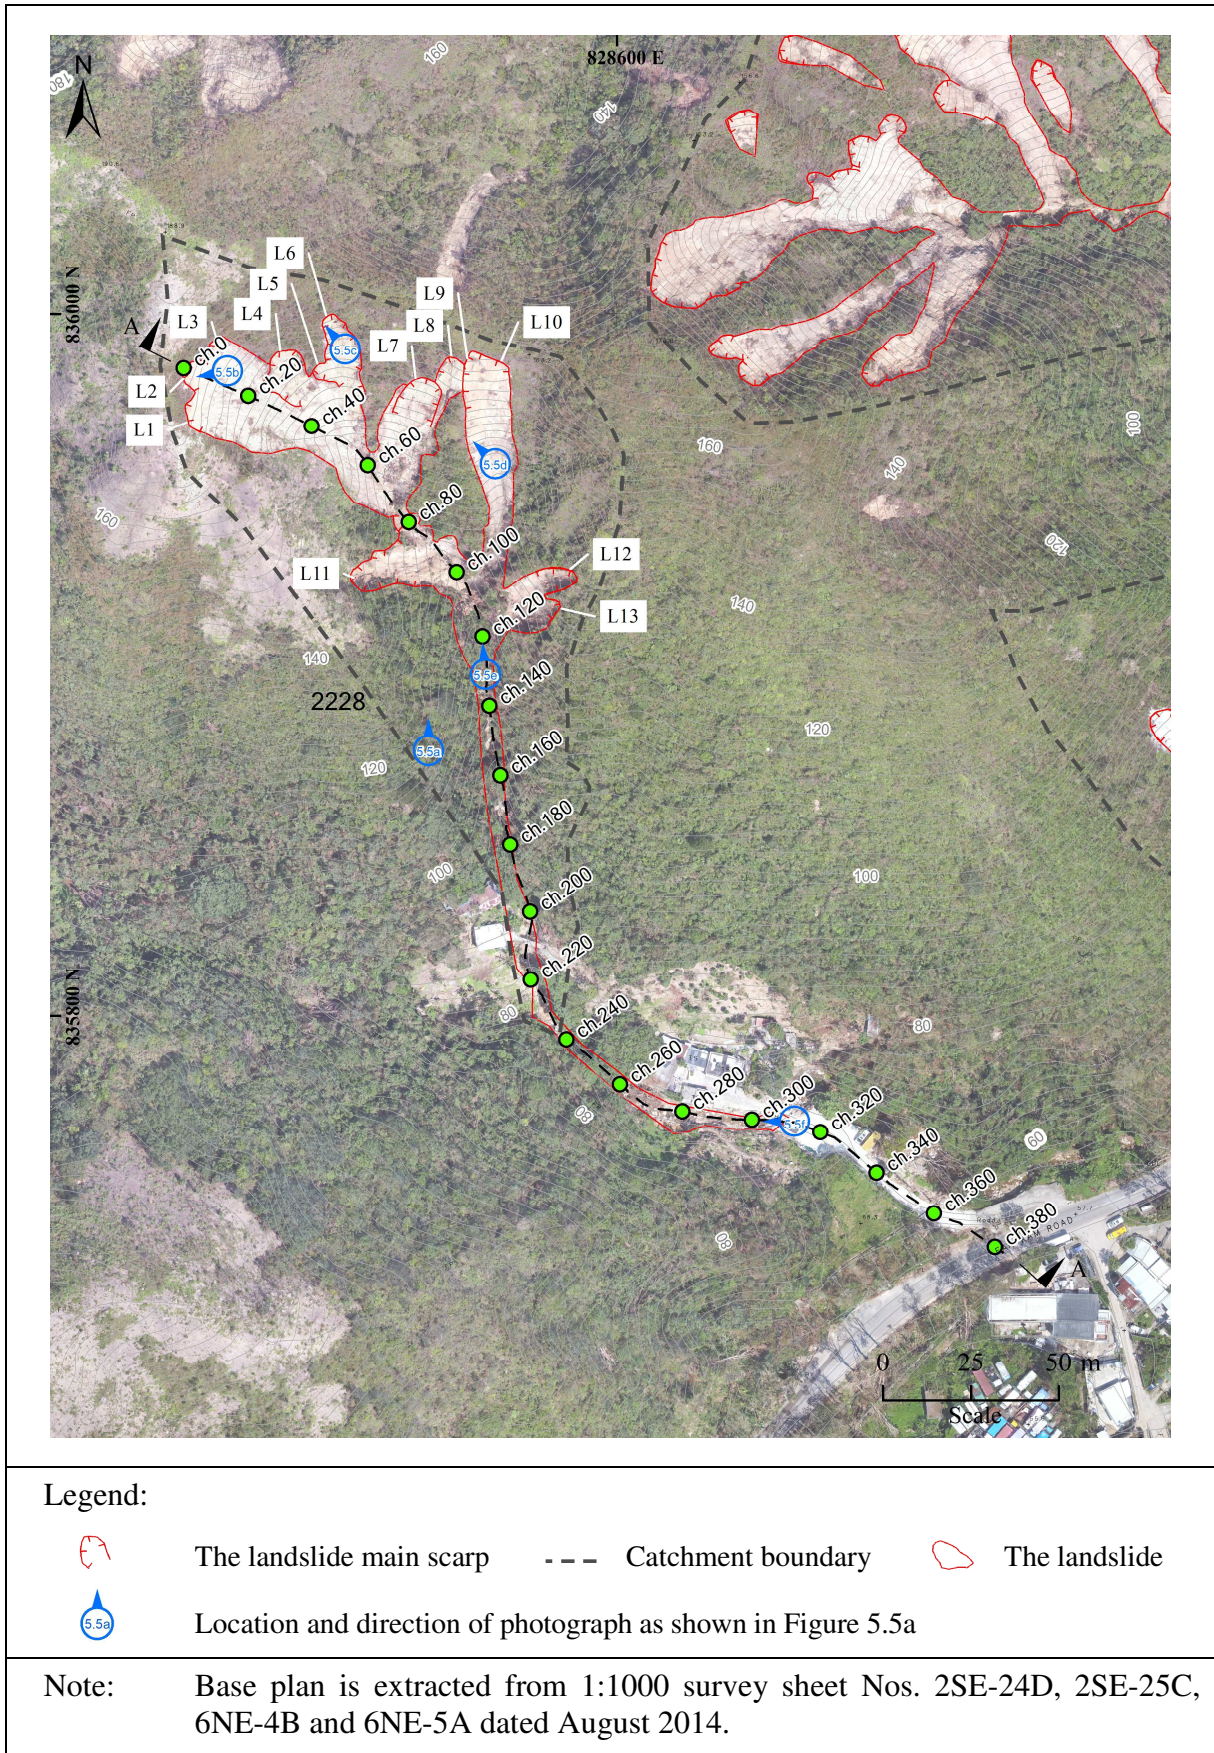
**Figure 5.1 Plan of Landslide Cluster 2228**

Landslide cluster 2228 is located within a distinct topographic depression and comprises 13 source areas, namely L1 to L13, some of which are adjoined and form five separate debris trails before converging into the central main drainage line of the catchment (Figure 5.5a). The source areas are generally located within the steep terrain of the upper catchment, and are relatively shallow with an average failure depth of about 0.7 m, giving a total estimated volume of detached materials of about 550 m<sup>3</sup> (Table 5.1). The maximum active volume of the channelised debris flow taken into account the material entrainment and deposition is about 620 m<sup>3</sup> (Figure 5.3).

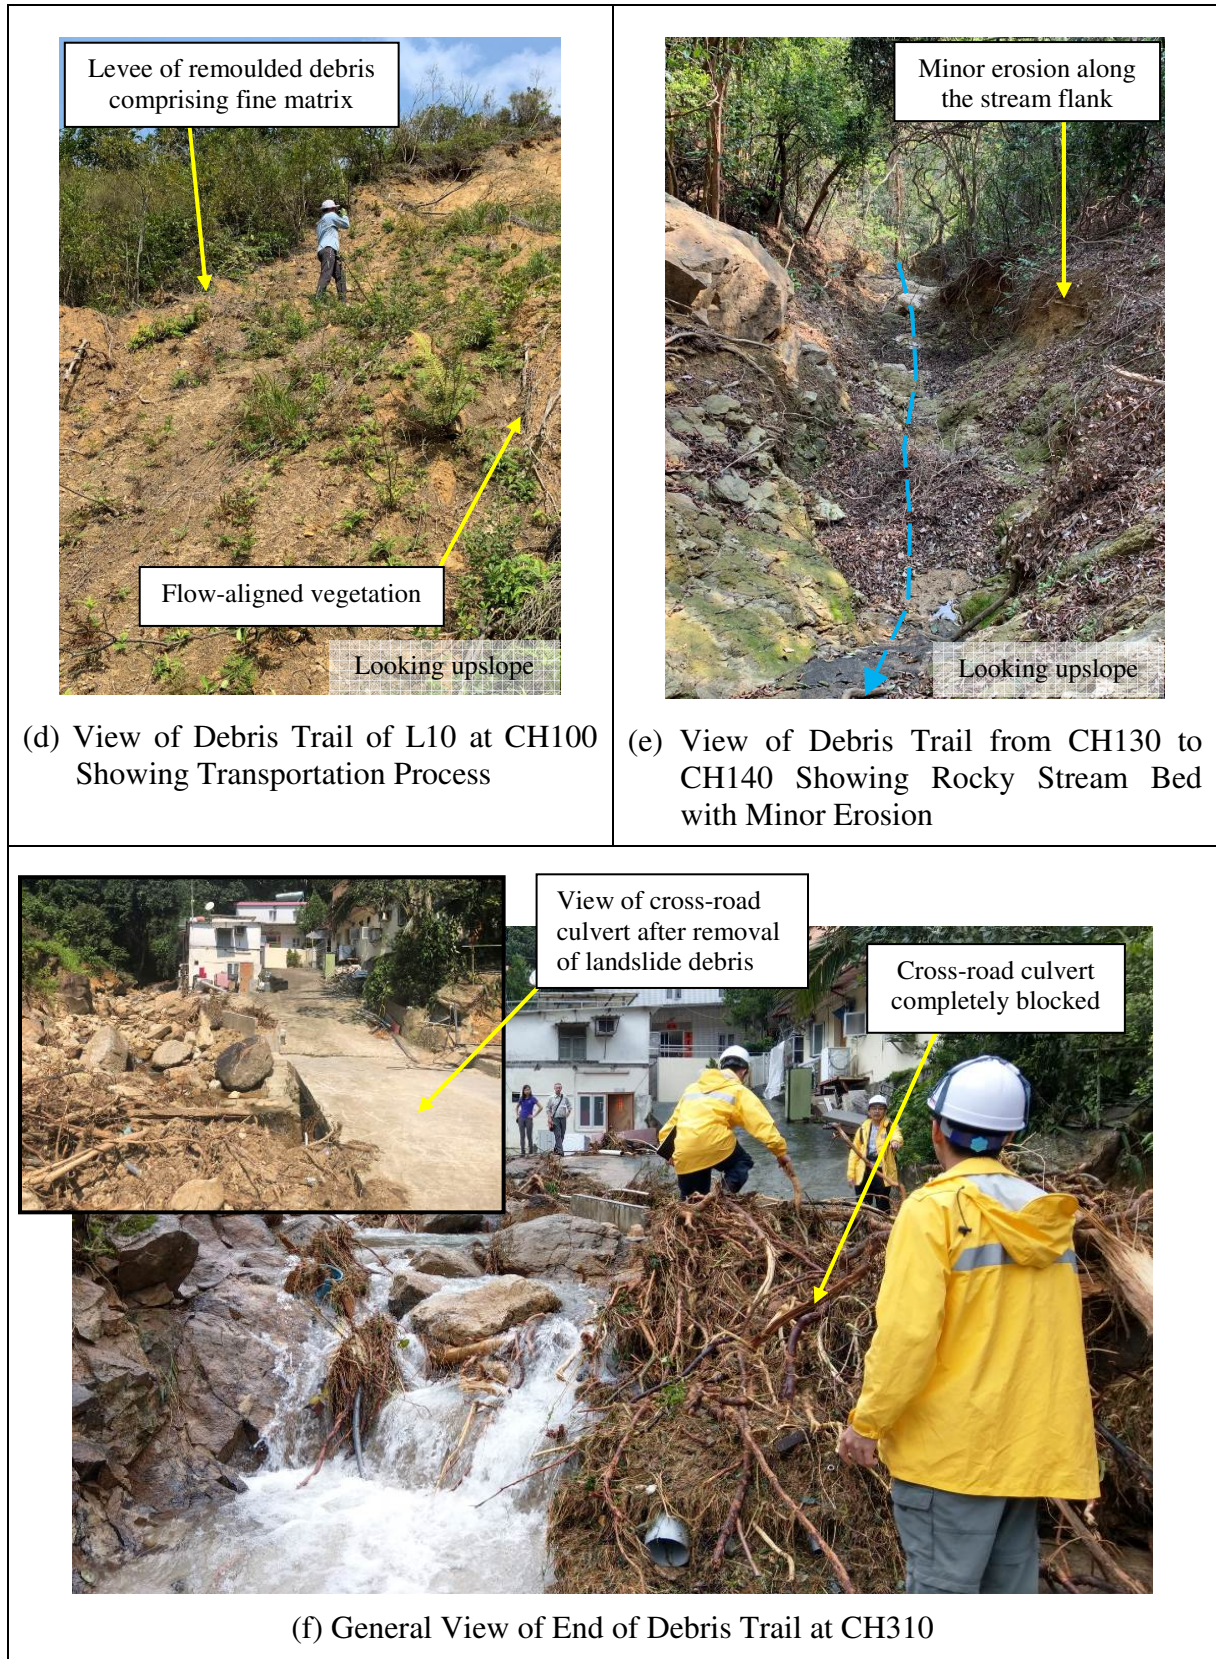
**Figure 5.5 Key Observations of Landslide Cluster 2228**  
(Photographs taken on 30 August 2018 and 12 March 2019)  
(Sheet 2 of 2)

The gradient of the debris trail decreases to about  $8^\circ$  at Chainage 230 where it merges with a perennial stream course draining a large catchment above the landslides. The debris trail is less confined with about  $450 \text{ m}^3$  of deposition of both remoulded and clastic debris. Post-event fluvial erosion of the debris from the stream course discharge is evident, forming downstream outwash. At Chainage 310, a significant proportion of cobbles, large boulders and tree branches was observed (Figure 5.5f) which likely formed the debris front, completely blocking a cross-road culvert. The blockage of the cross-road culvert consequently diverted the stream flow and outwash debris onto the access road where it deposited as sorted sand and gravel with cobbles and boulders that were pushed down by the significant water flow, damaging several parked vehicles and a container. The deposition of fine-grained fluvial outwash debris continued for a further 100 m downslope, reaching Fan Kam Road and continuing to flow and deposit northwards along the road (Figure 3.2).

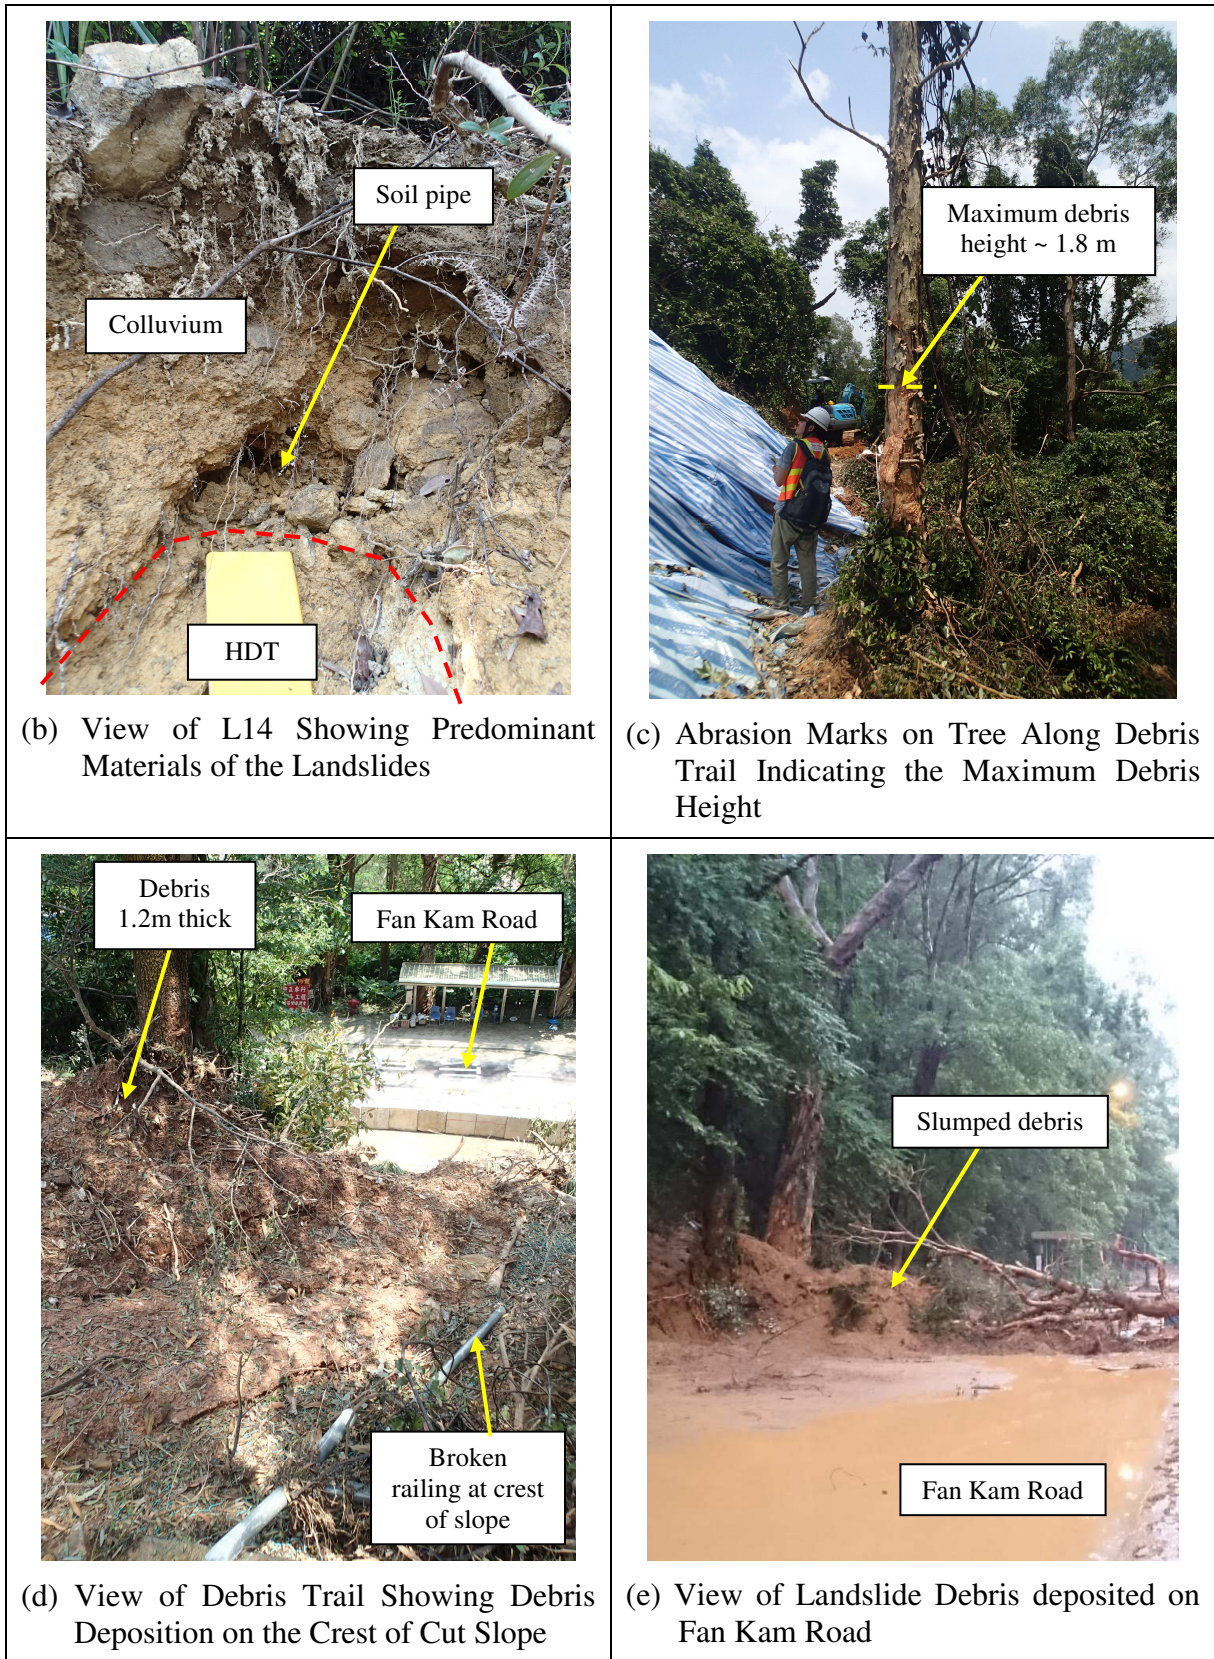
The landslide debris mostly comprises yellowish brown, silty sand with some occasional cobble-sized rock fragments and vegetation debris. Although some vegetation is entrained within the debris, some of the more robust trees remain on the debris trail giving an indication of the debris height from the abrasion marks (Figure 5.7c). These open hillslope failures differ from the debris flow events of landslide clusters 2228 and 2229U in that the travel distance is relatively short and most of the debris formed distinct lobes on Fan Kam Road (Figure 5.7d), although some could still be observed on the sloping ground above the cut slope (Figure 5.7e).

**Figure 5.7 Key Observations of Landslide Cluster 2229L**  
**(Photographs taken on 30 August 2018)**  
**(Sheet 2 of 2)**

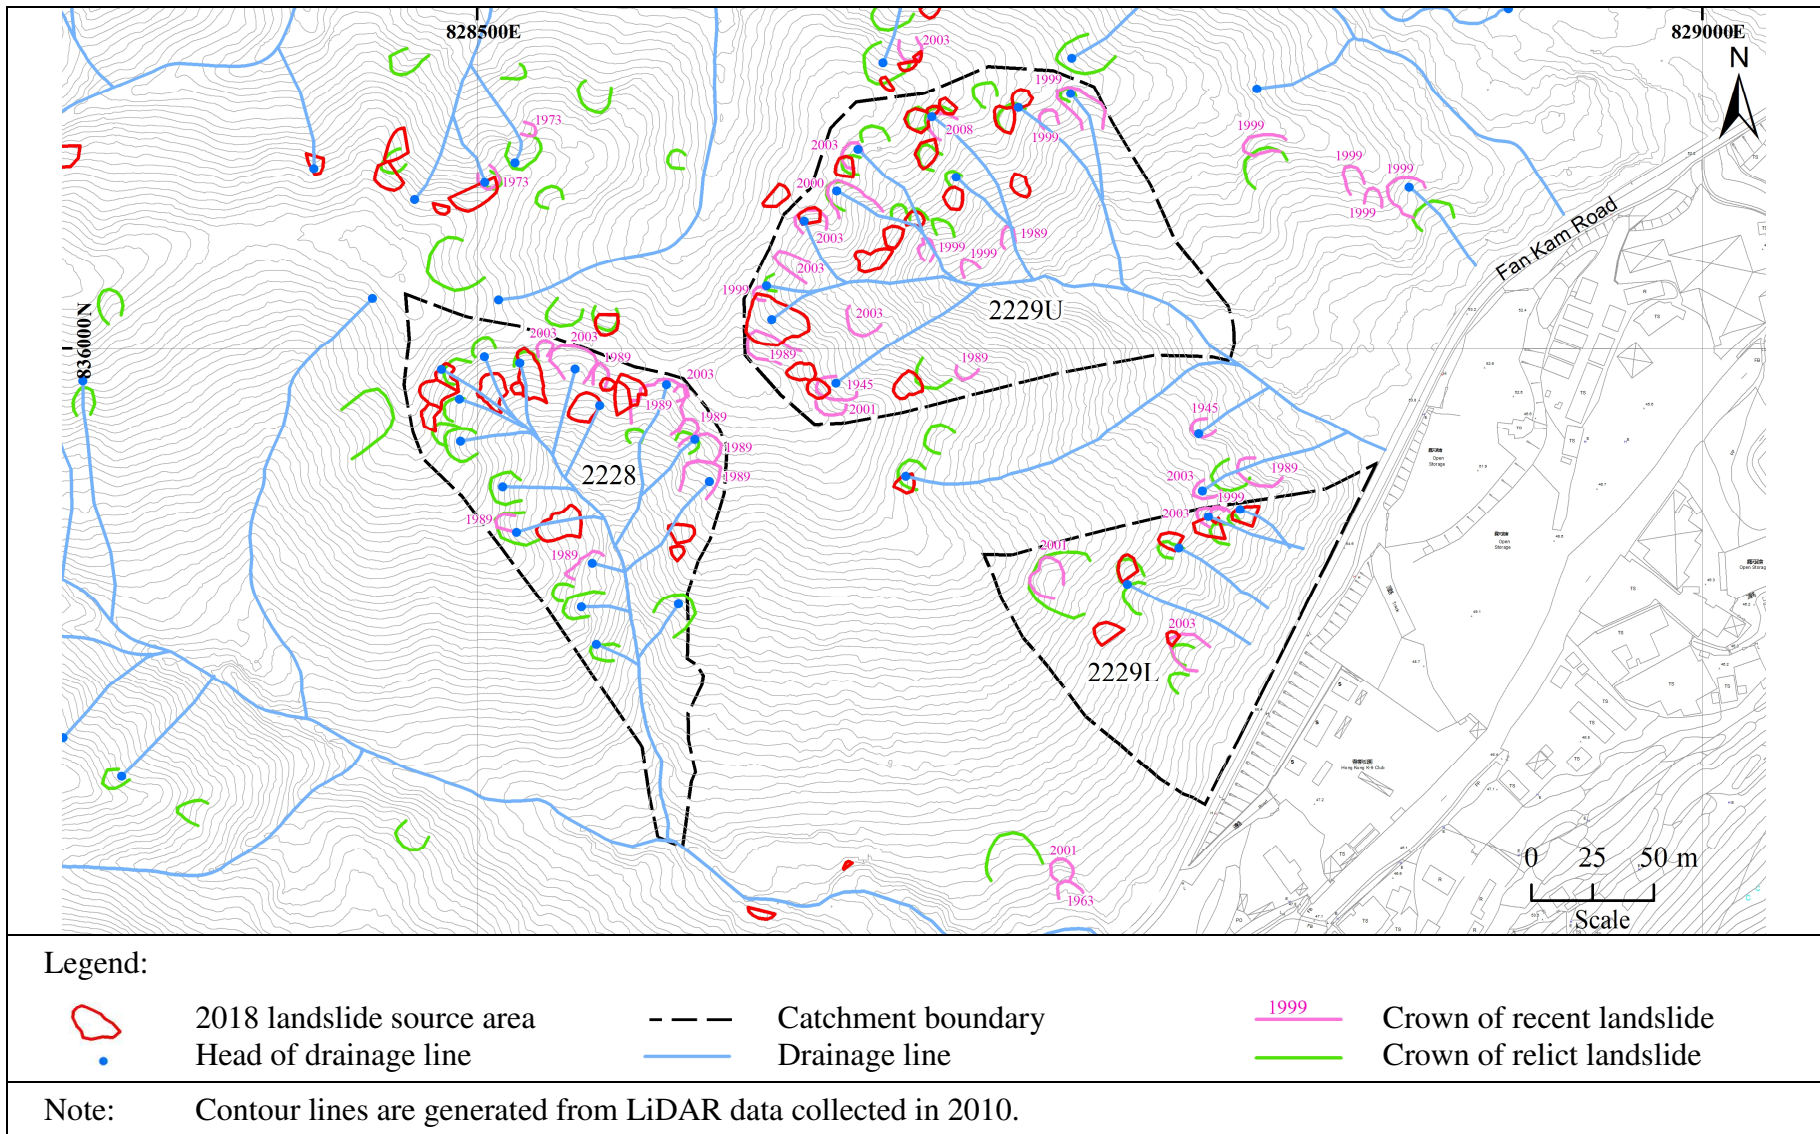
The landslides were mostly originated from the interface of two distinct landforms along the nearly continuous steep terrain below the ridgelines at the upper part of the catchments. The rounded, shallow gradient ridgelines at the crest areas of the three catchments above the three landslide clusters forming the upper landform are generally older. This upper landform is covered with a mantle of colluvium overlying the in-situ weathered tuff. The terrain below prominent convex break-in-slopes forming the lower landform is relatively younger. The boundary between these two landforms delineated the erosion front where the terrain gradient sharply increases. Around this boundary, mass wasting process in the form of retrogressive failures occurs on the over-steepened areas particularly adjacent to heads of drainage lines and locations of past landslides, resulting in gradual upward migration of the erosion front towards the ridgelines (Figure 6.2). This is supported by the fact that about 75% and 70% of the source areas of the 2018 landslides are in close proximity to or overlapped with heads of drainage lines and past landslides respectively. The hillside retreat process remains active as evidenced by the nearly continuous steep erosion front with a high concentration of past landslides and head of drainage lines rendering these boundary areas particularly vulnerable to landsliding (Figure 6.3).

**Figure 6.3 Spatial Relationship of the 2018 landslides with Drainage Lines and Past Landslide Activities**

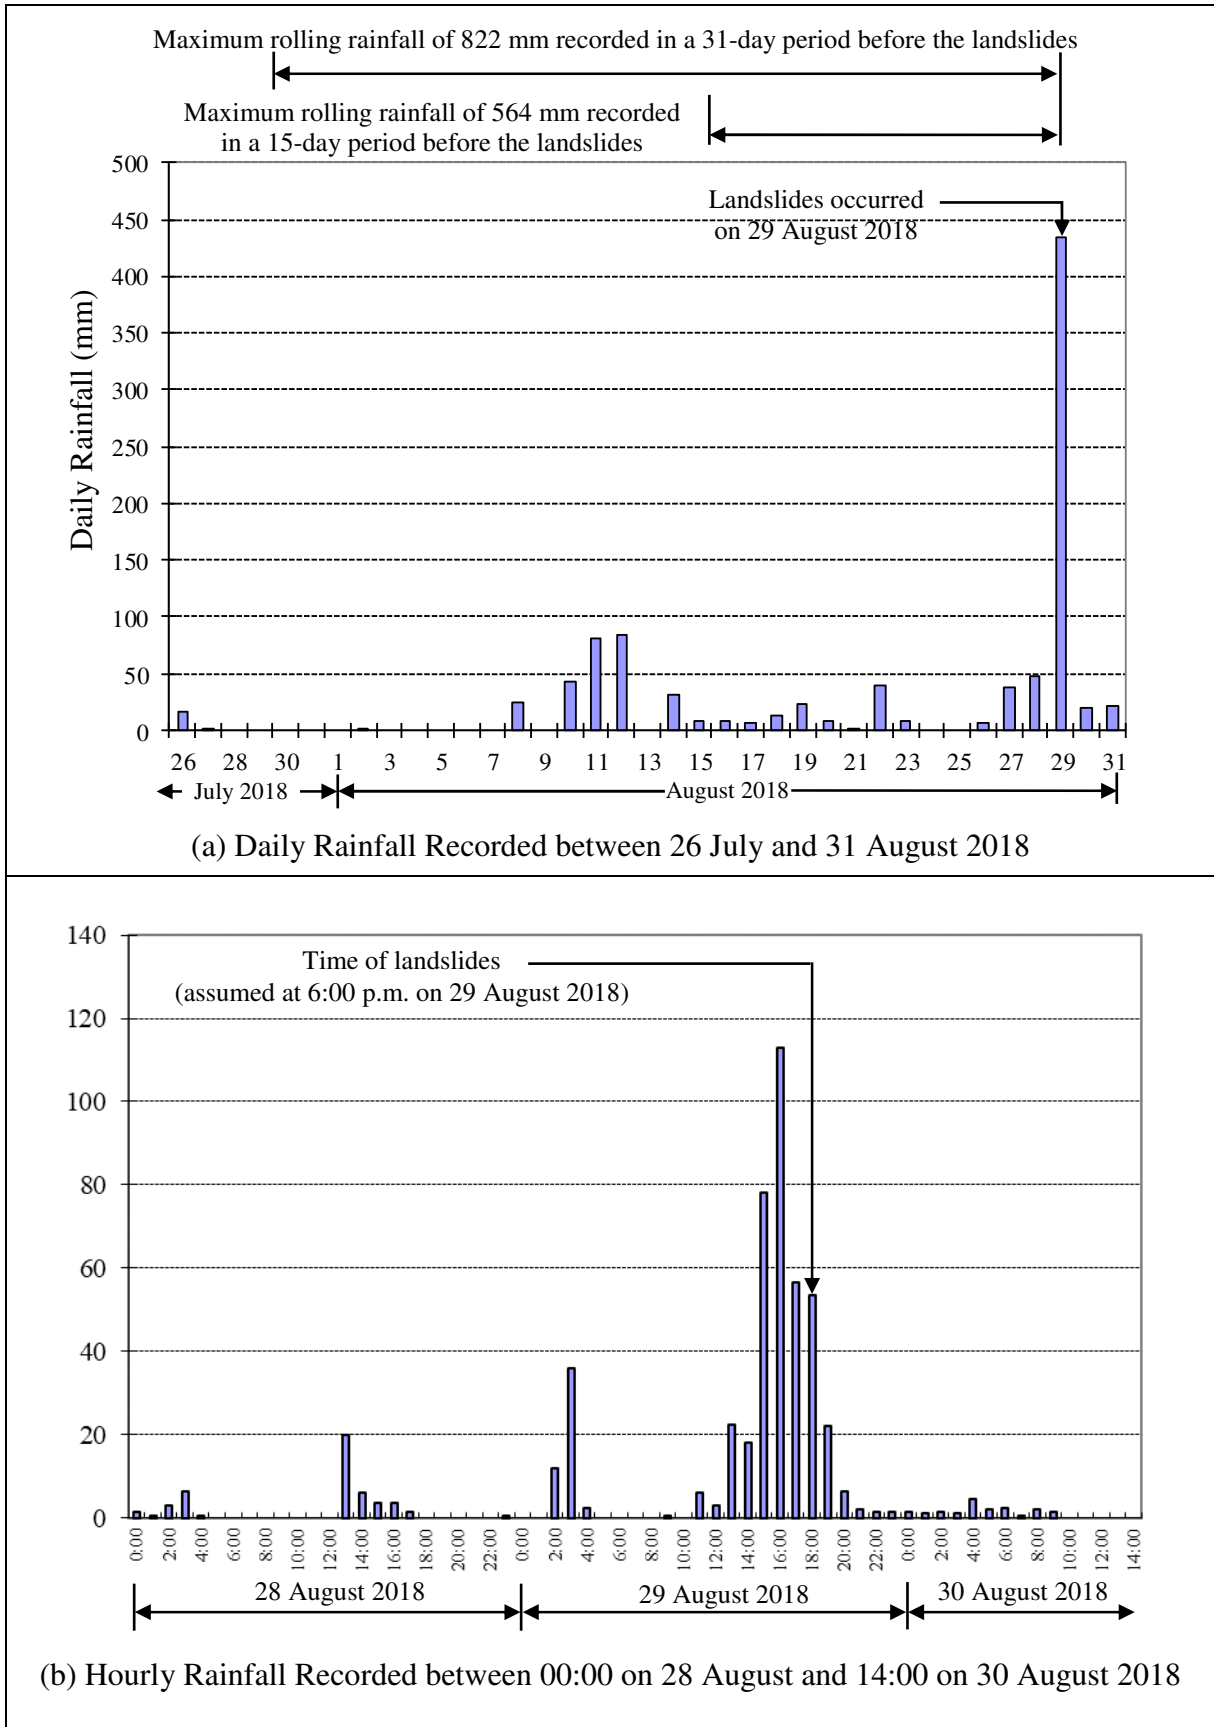
**Figure 8.1 Daily and Hourly Rainfall Recorded at DSD Rainguage No. D42**

Rainfall data was obtained from the nearest automatic raingauge No. D42 managed by Drainage Services Department (DSD), which is located at the Fire Services Department Pat Heung Training School some 1 km to the southwest of the landslide site (Figure 1.1). The raingauge was established in 1998 and records rainfall data at 5-minute intervals. The daily rainfall recorded over the month preceding the landslides and the hourly rainfall recorded between 12:00 a.m. on 28 August 2018 and 2:00 p.m. on 30 August 2018 are presented in Figure 8.1.

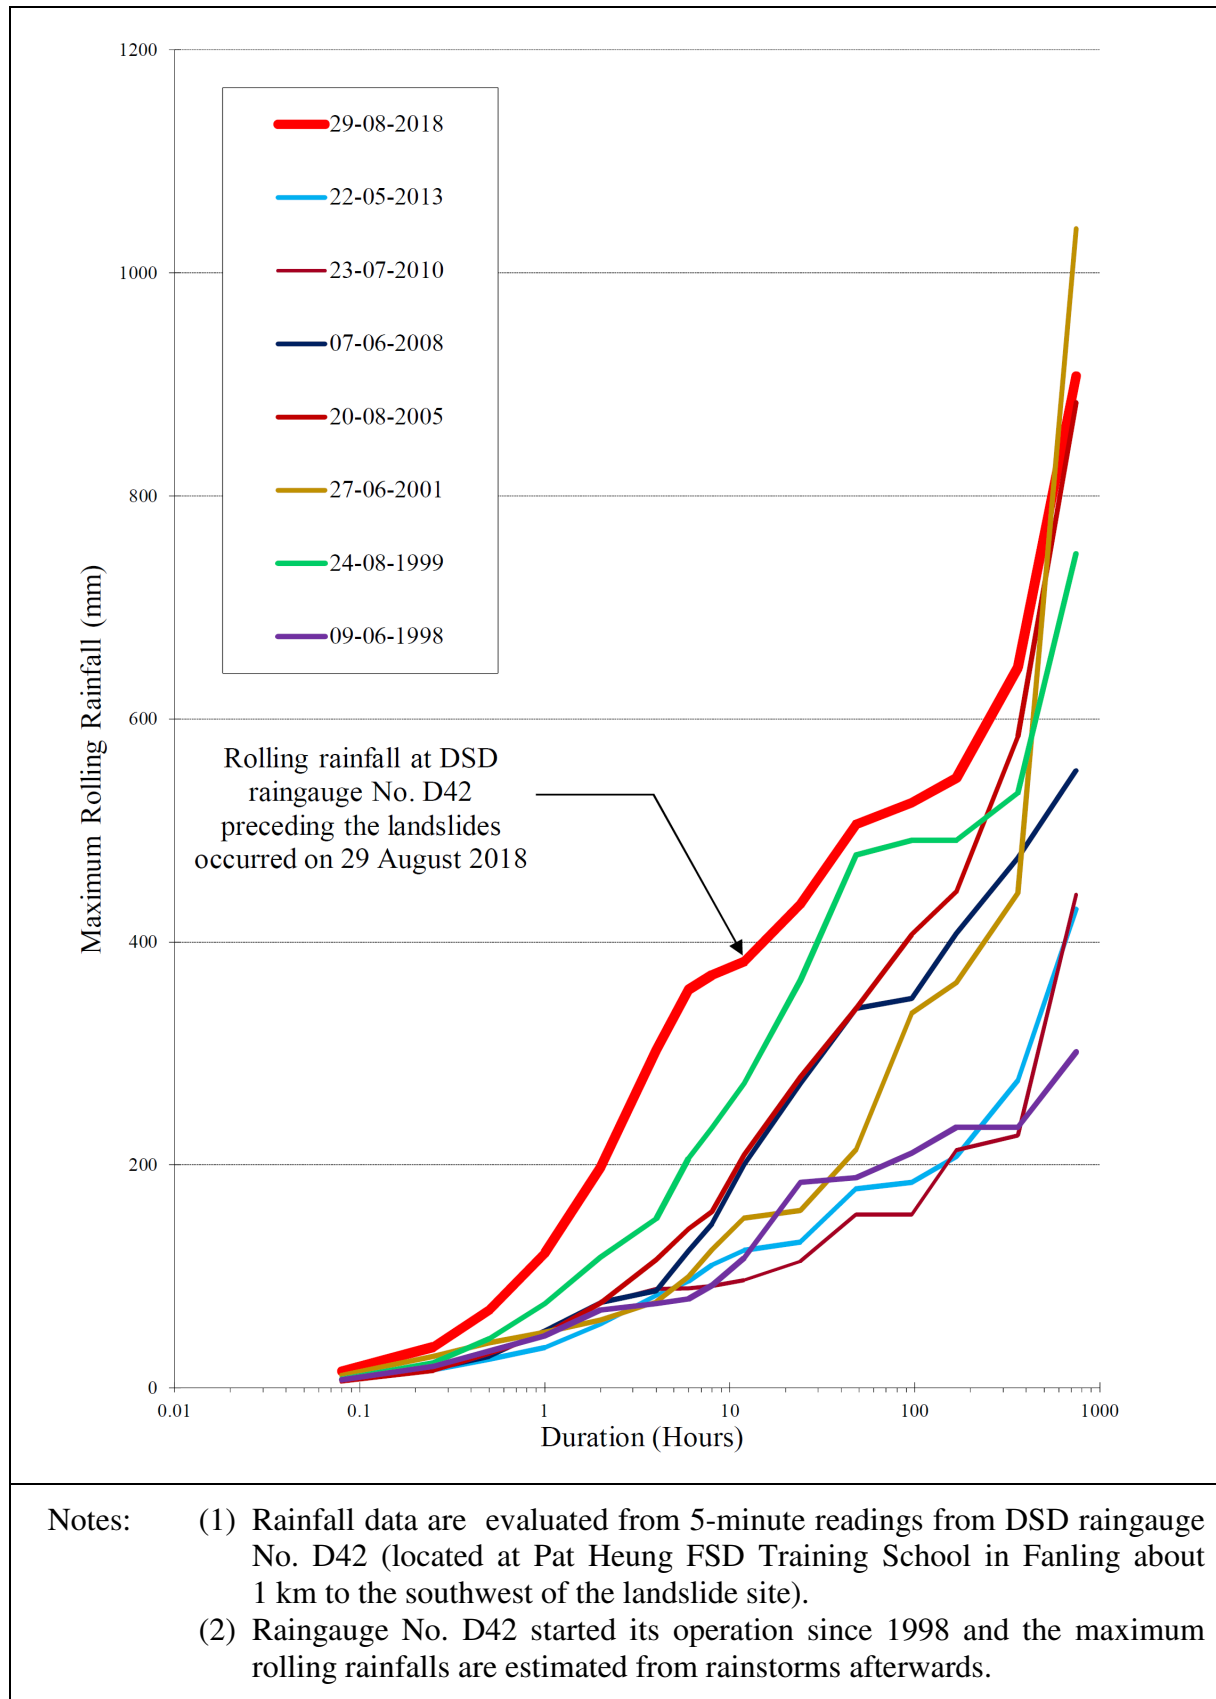
**Figure 8.2 Maximum Rolling Rainfall Preceding the Landslides and Selected Previous Major Rainstorms Recorded at DSD Raingauge No. D42**

The maximum rolling rainfall preceding the incidents on 29 August 2018 has been compared with that of the previous major rainstorms as recorded by DSD raingauge No. D42 and the results are presented in Figure 8.2. The 29 August 2018 rainstorm was the most severe for almost all rainfall durations since the operation of the raingauge in 1998.

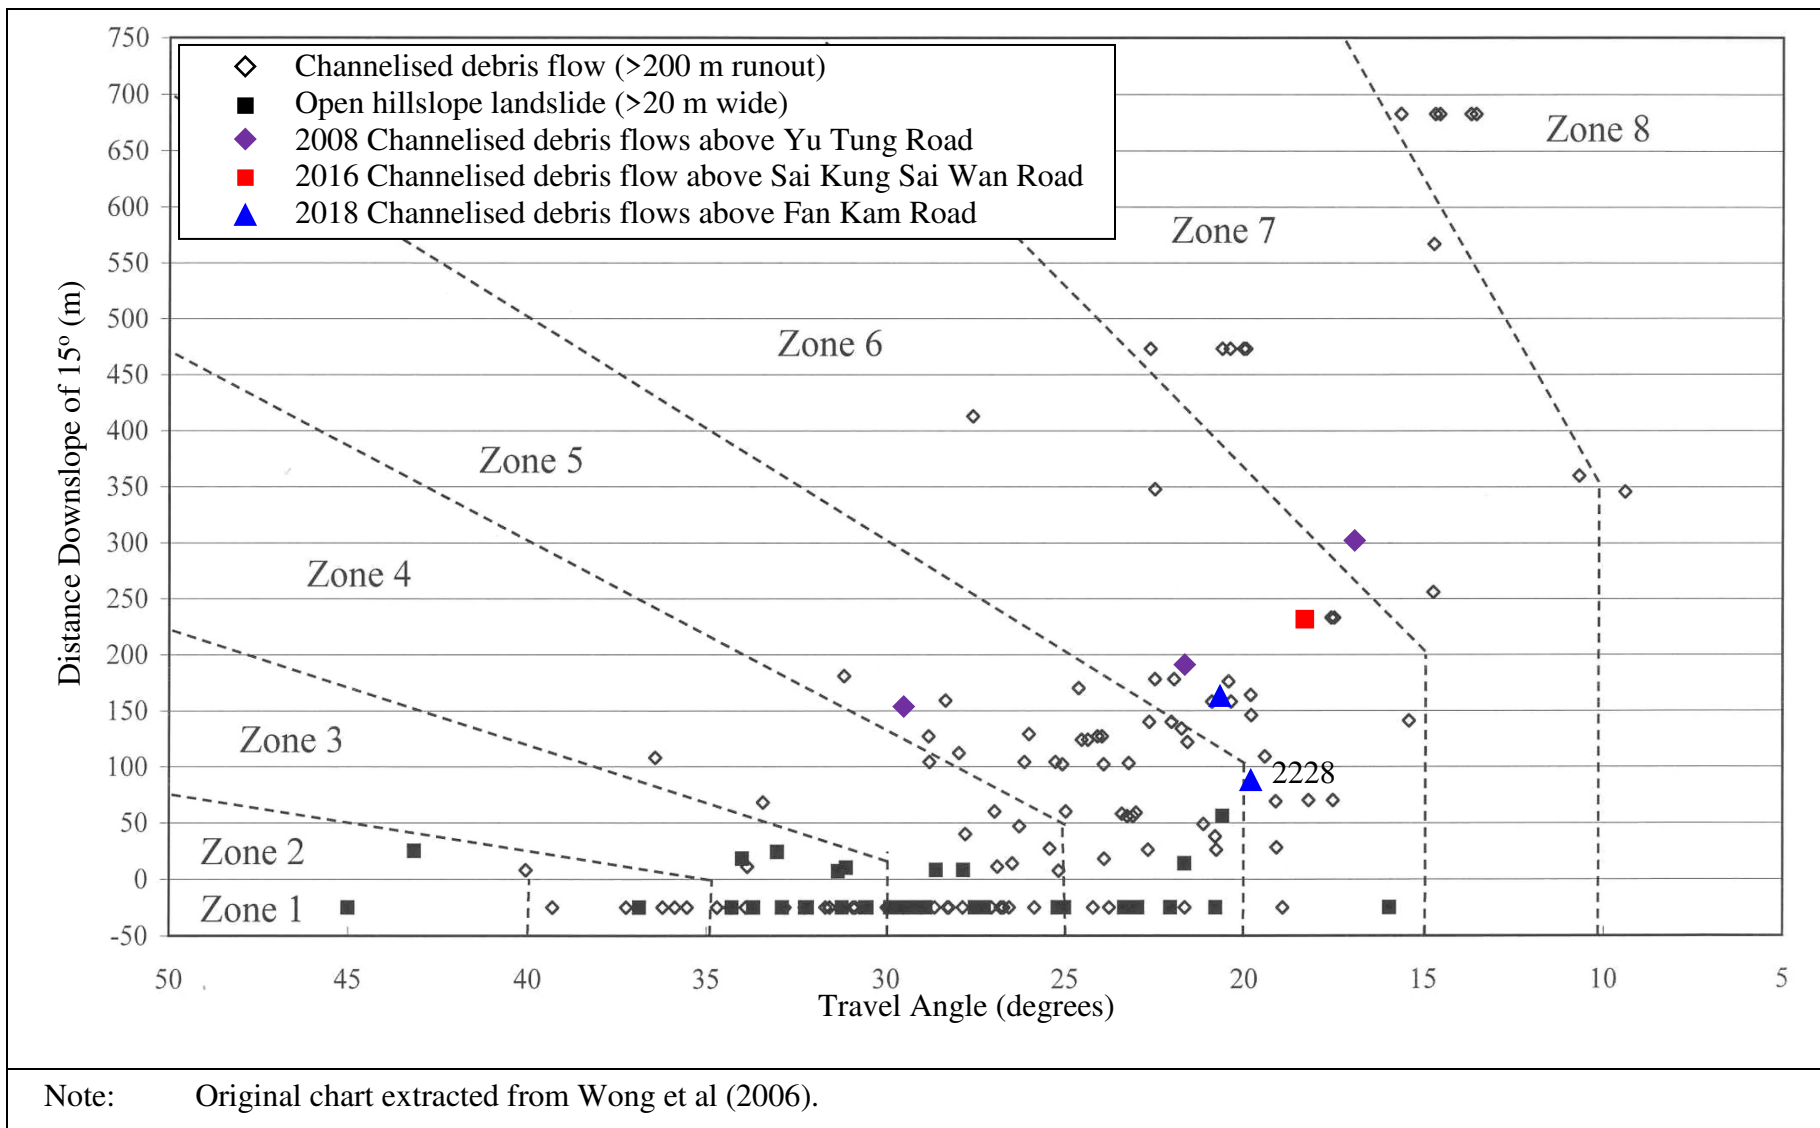
Figure 9.1 Proximity Zones and Debris Runout Data from the 2018 Landslides

The debris from the source areas entered the central main drainage lines of catchments 2228 and 2229U where the debris became confined and channelised before coming to rest at the relatively gentle terrain just before reaching Fan Kam Road. The total travel distance of both channelised debris flows was about 300 m (excluding the outwash) of which about 80 m and 160 m of the lowest segment of the debris trails of landslide cluster 2228 and 2229U respectively have an overall gradient of 15° or less. The travel angle measuring from the crown of uppermost source area to the end of debris trails are about 20° in both cases. The channelised debris flows appear fairly mobile based on a comparison with previous events of a similar scale in Hong Kong (Figures 9.1 and 9.2).
