**Detailed Study of the
3 August 2021 Landslide on the
Natural Hillside above Block 3,
Middleton Towers,
140 Pok Fu Lam Road**

GEO Report No. 369

Fugro (Hong Kong) Limited

**Geotechnical Engineering Office
Civil Engineering and Development Department
The Government of the Hong Kong
Special Administrative Region**

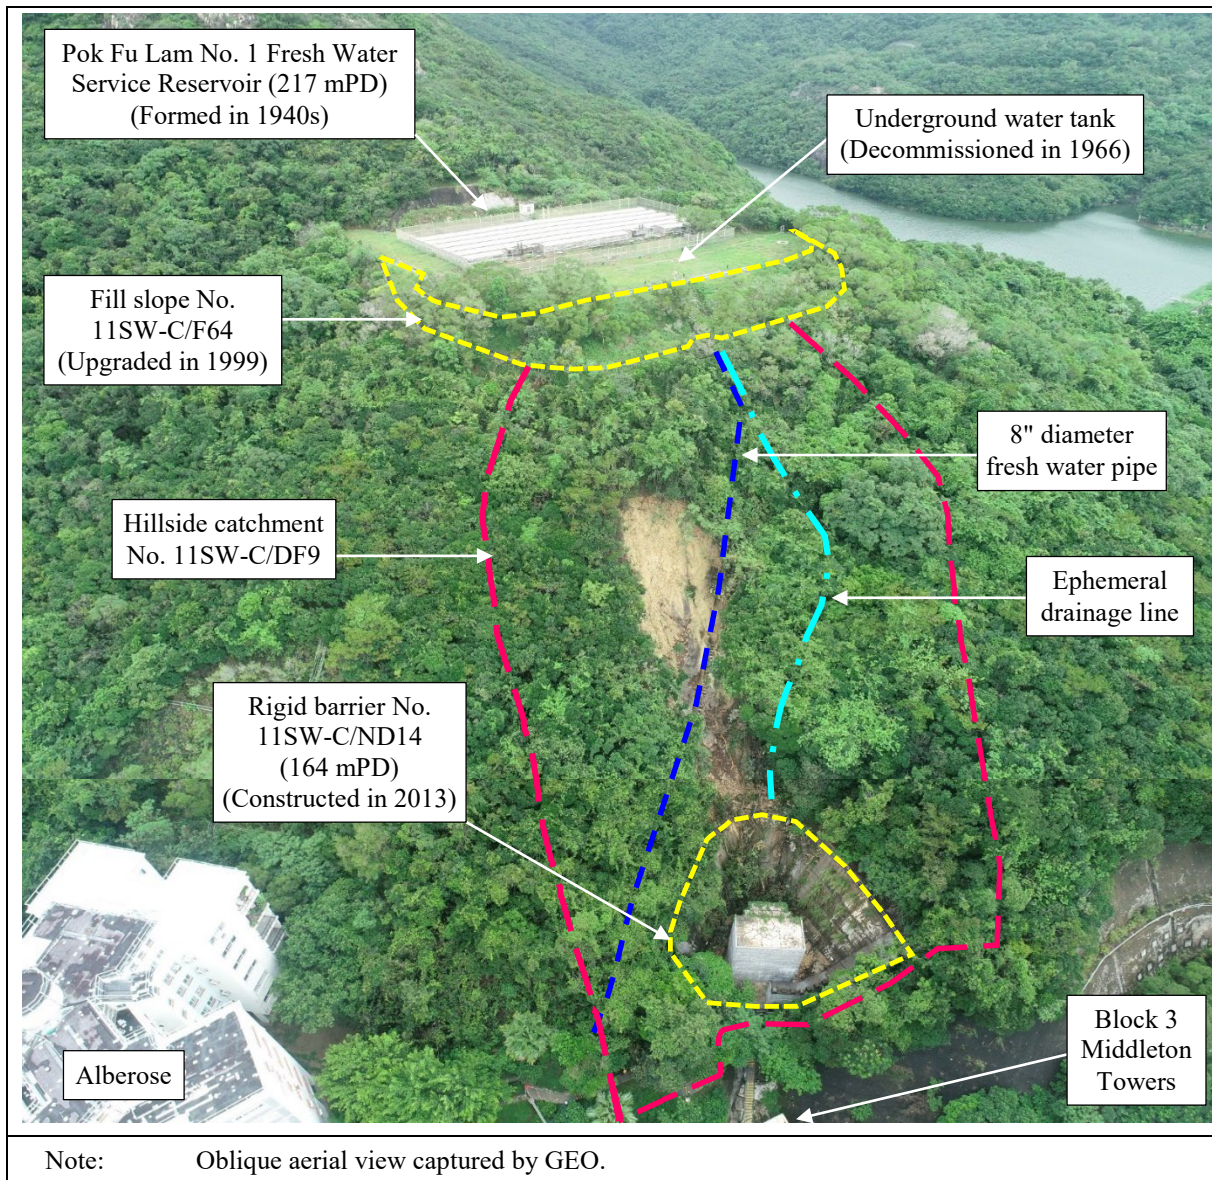
Figure 1.2 General View of the Landslide Site (Photograph Taken on 4 August 2021)

The 3 August 2021 landslide occurred on a southwest-facing natural hillside in Pok Fu Lam, Southern District of Hong Kong Island (Figure 1.1). The landslide is located on Historical Landslide Catchment (HLC) No. 11SW-C/DF9 between Pok Fu Lam No. 1 Fresh Water Service Reservoir at the crest and Block 3 of Middleton Towers, No. 140 Pok Fu Lam Road at the toe (Figure 2.1). The catchment is about 47 m high (from 164 mPD to 211 mPD) and comprises a heavily vegetated terrain sloping at 35° to 40°. The catchment is characterised by a small valley with a westerly trending ephemeral drainage line (Figures 1.2 and 2.1).

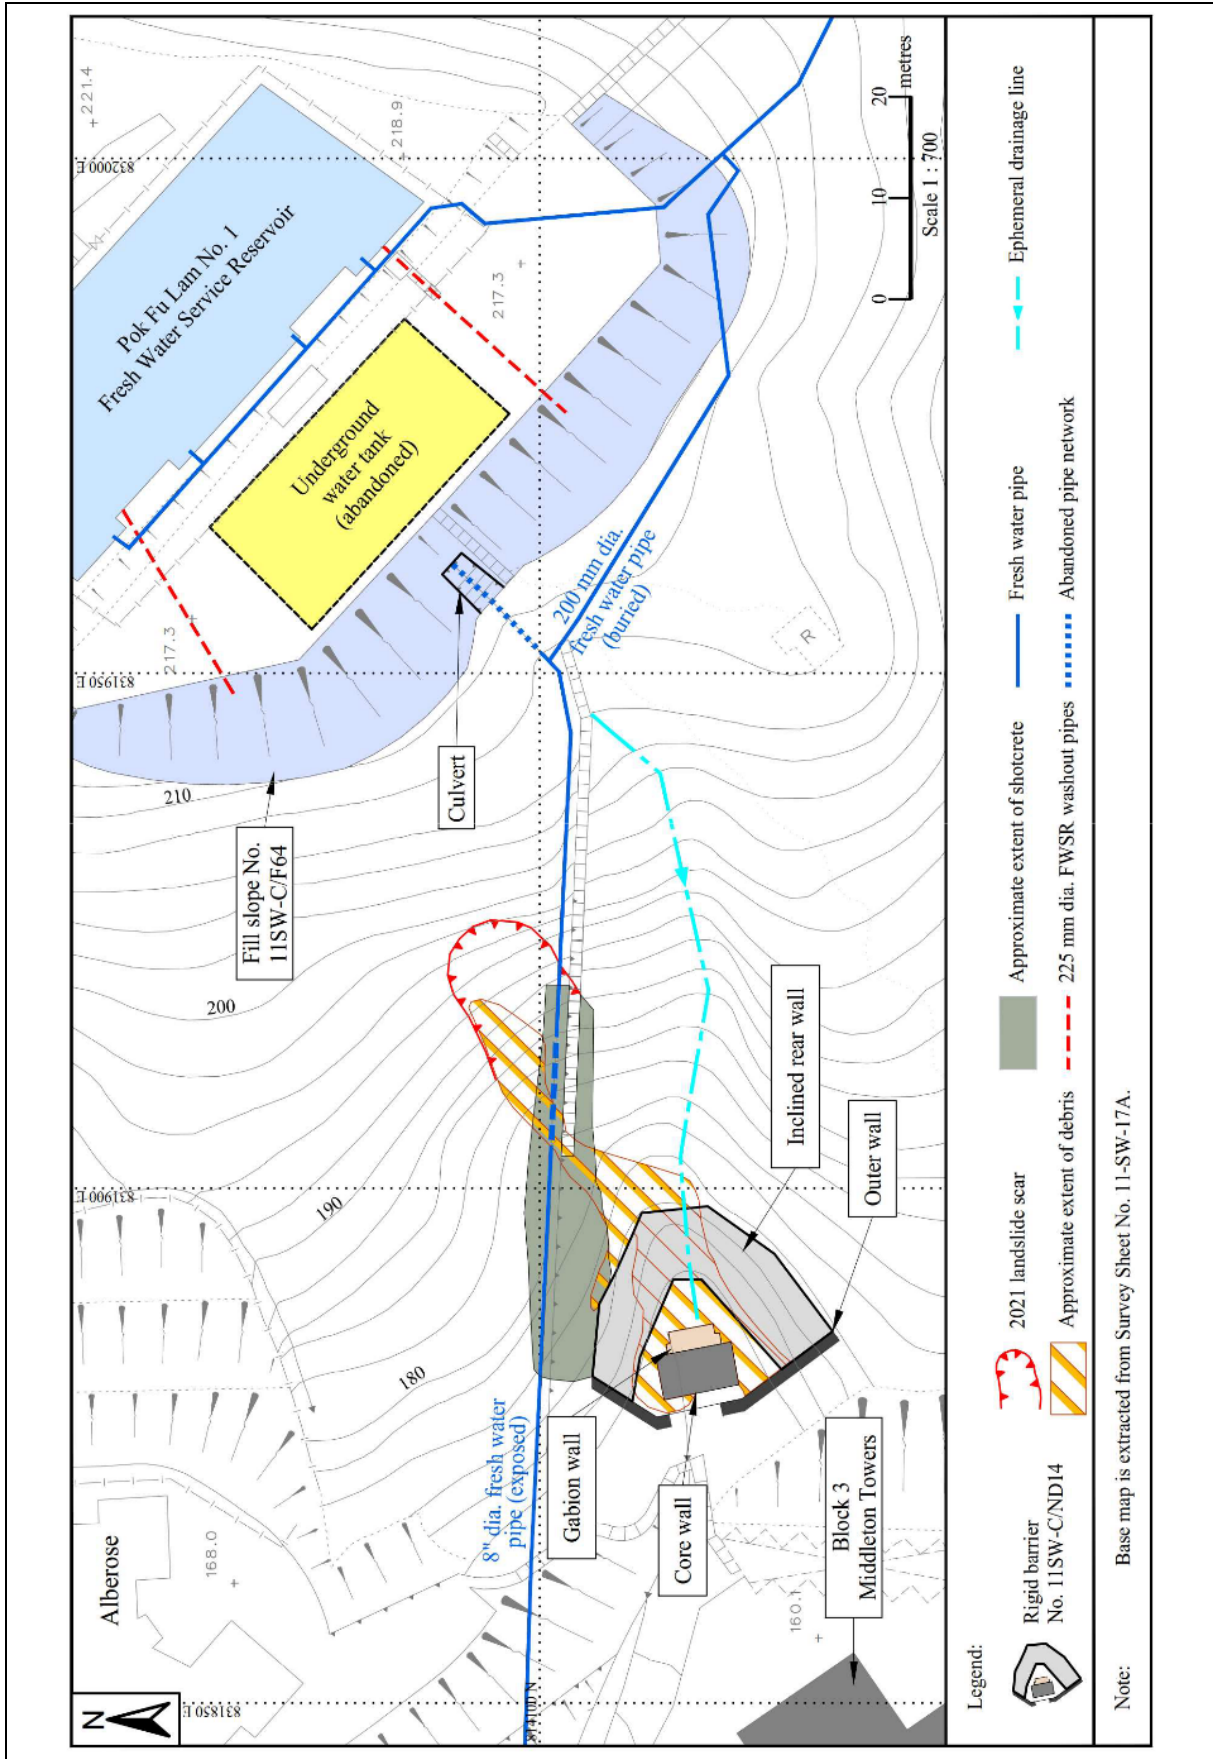
Figure 2.1 Site Plan

The 2021 landslide initiated on the planar-concave, west-facing sideslope at the upper part of the catchment at an area of localised steepening (about 45°) approximately midway between the toe of fill slope No. 11SW-C/F64 and the crest of rigid barrier No. 11SW-C/ND14 (Figure 2.1).

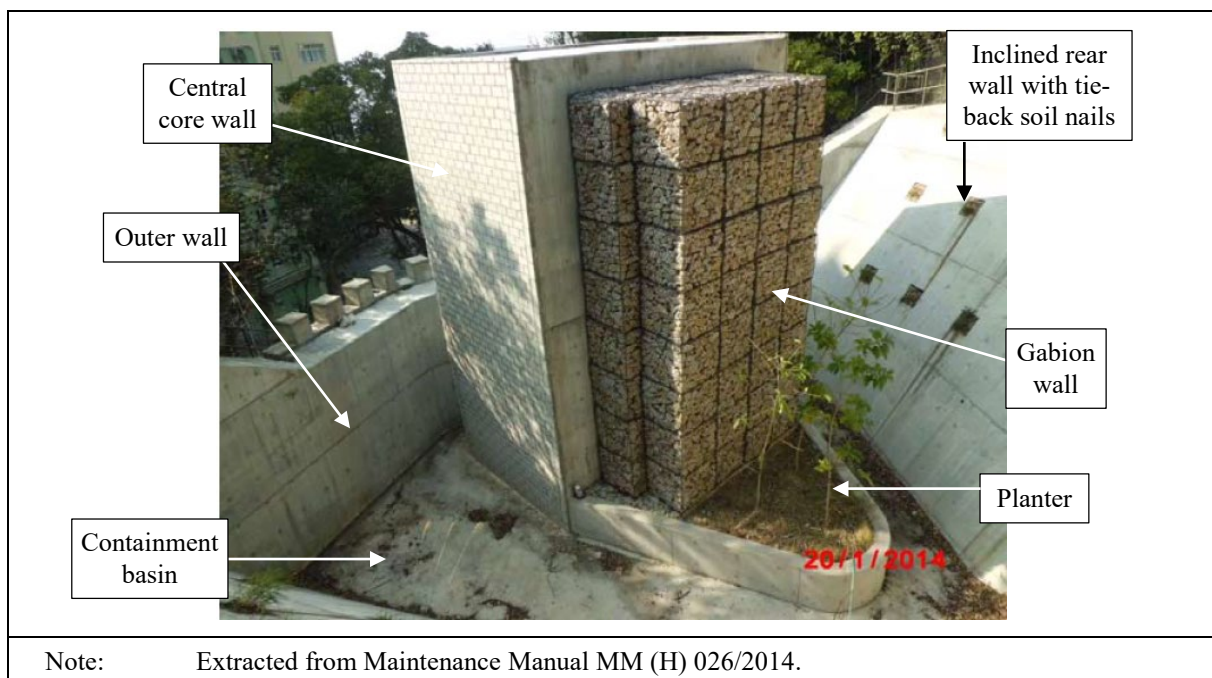
Figure 2.2 Rigid Barrier No. 11SW-C/ND14 (Photograph Taken on 20 January 2014)

Feature No. 11SW-C/ND14 is a reinforced concrete rigid barrier (Figure 2.2) constructed at the toe of the ephemeral drainage line within HLC No. 11SW-C/DF9 (see Section 3.4.1). The barrier comprises a central core wall, an outer wall and an inclined rear wall. The central core wall is 4 m thick and 9.5 m high with a 2 m thick and 8 m high cushioning gabion wall at the rear. The outer wall is 4 m high and 40 m long. The inclined rear wall is sloping at 50° to 60°, 45 m long and 9.5 m high and was installed with 4 rows of 7 m to 8 m long tie-back nails. A 1 m high planter is located in the containment basin, at the rear of the central core wall and the gabion wall.

The debris had deposited over the lower part of the natural slope and within the rigid barrier (Feature No. 11SW-C/ND14) at the toe of the catchment (Figures 5.3 and 5.12). The barrier had prevented further runout of the debris to Middleton Towers below.

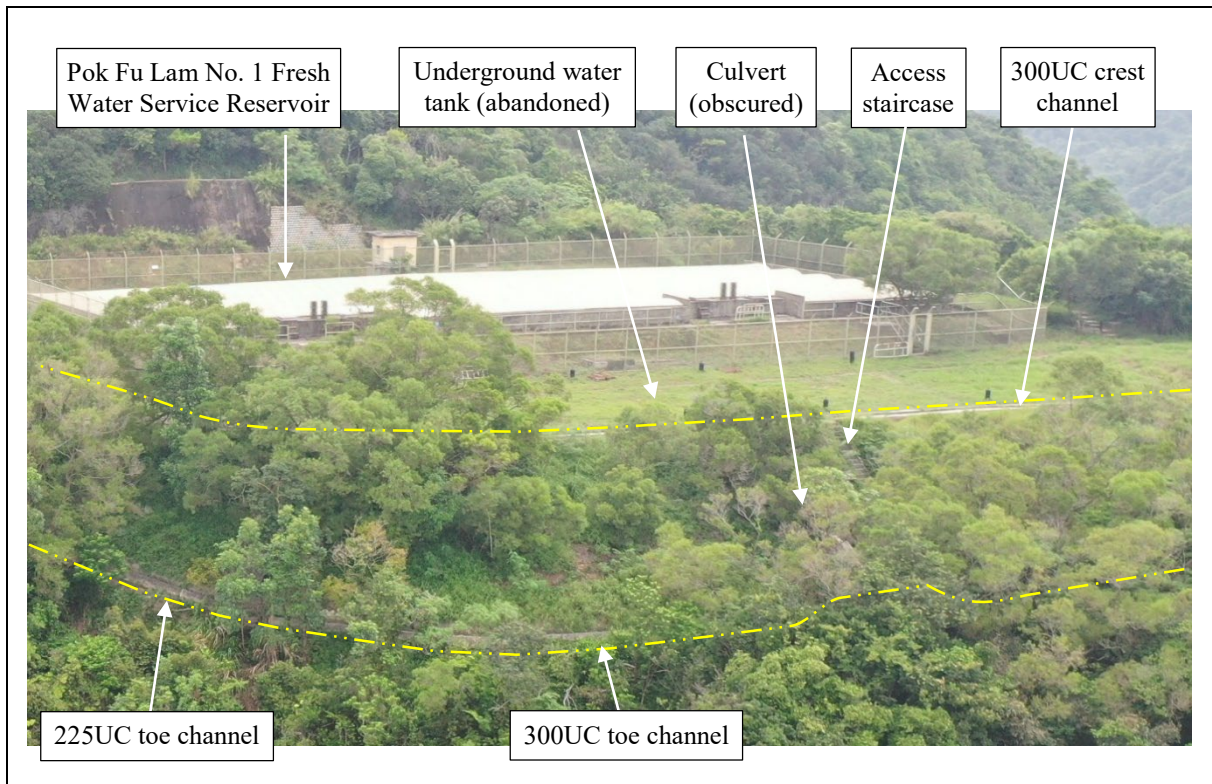
Figure 2.3 Fill Slope No. 11SW-C/F64 (Photograph Taken on 4 August 2021)

Feature No. 11SW-C/F64 is a 6 m high and 110 m long fill slope with an average gradient of about 30°. The slope comprises a single batter and is fully vegetated with trees, shrubs and grass (Figure 2.3). The slope has a surface drainage system which ultimately discharges into the ephemeral drainage line below the fill slope.

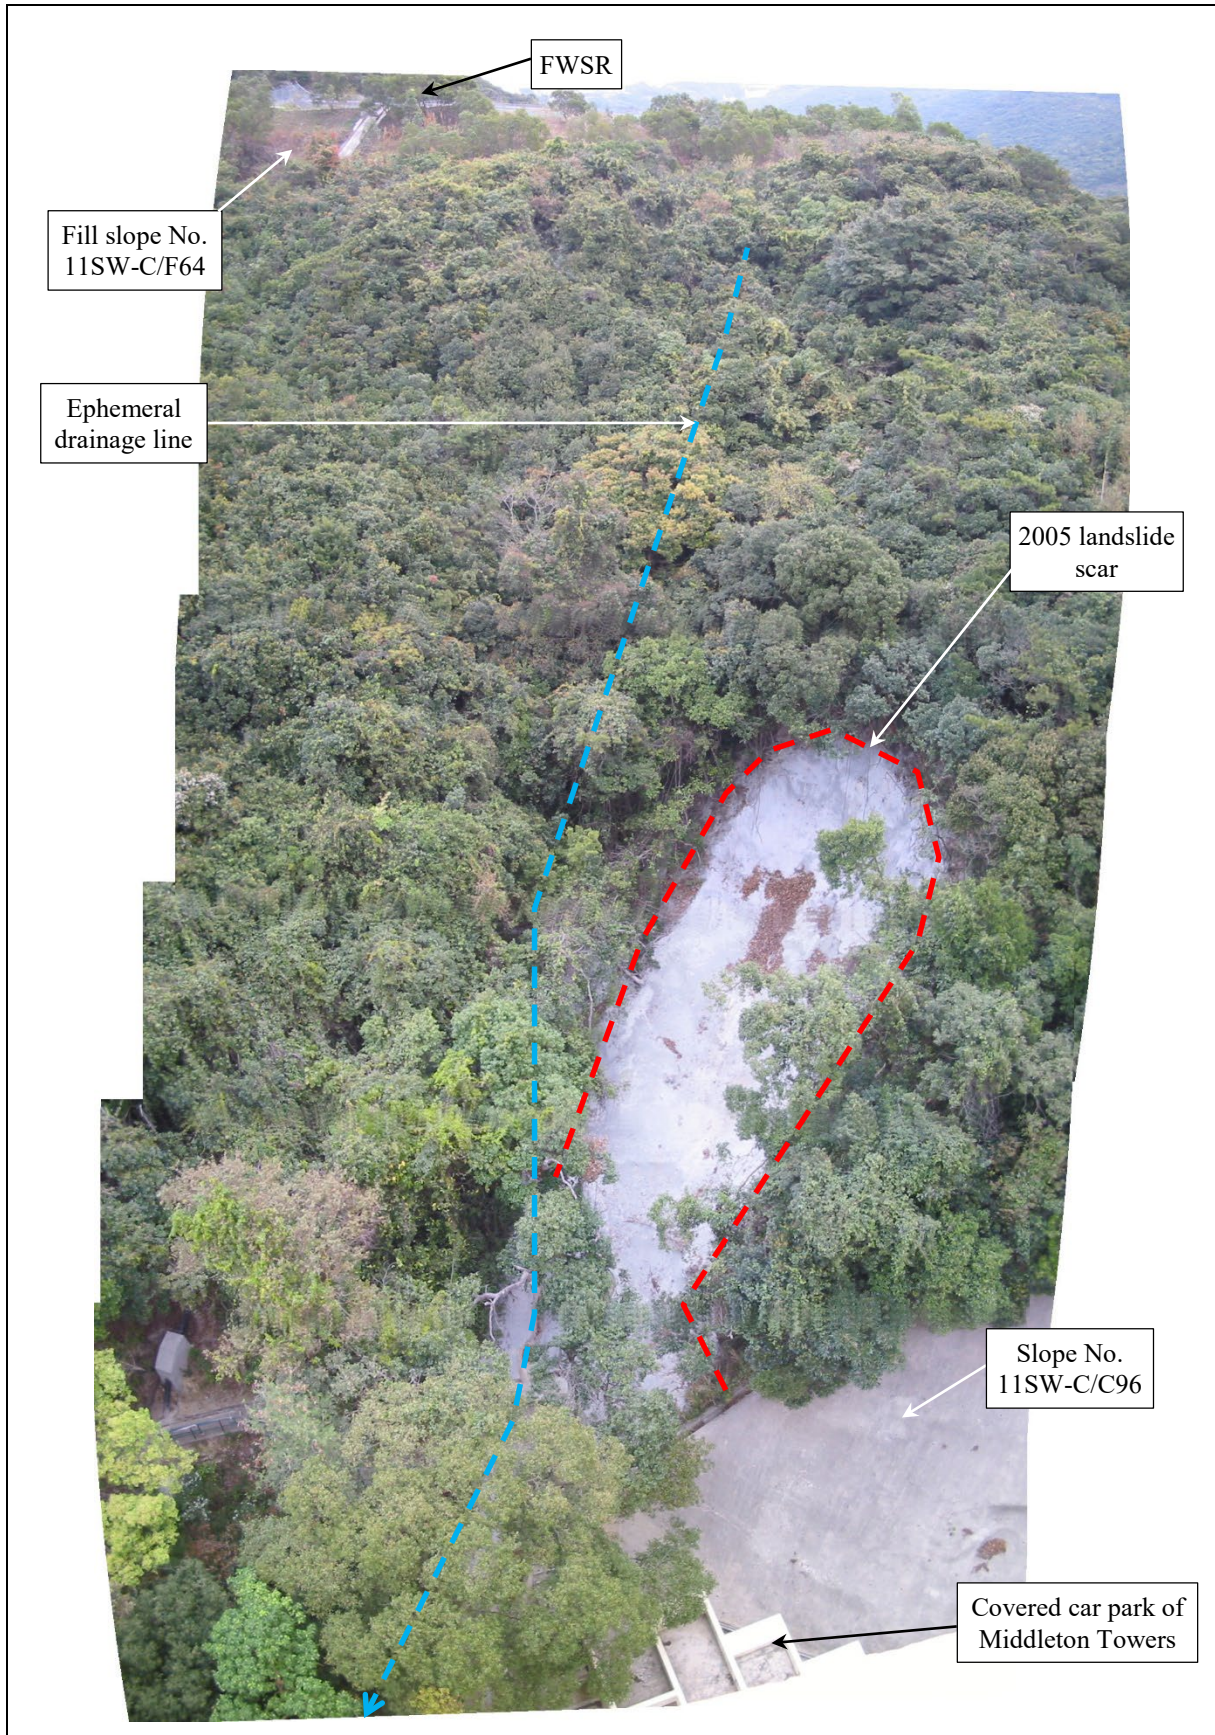
Figure 3.2 The 2005 Landslide (Photograph Taken on 13 March 2006)

The 2005 landslide (Incident No. 2005/08/0369) occurred on the steeply inclined (about 40° to 45°) southern flank of the catchment. The landslide was studied by Fugro Scott Wilson Joint Venture under Agreement No. CE 29/2003 (GE) (FSWJV, 2006). The landslide study has indicated that it was an open hillslope failure measuring 13 m wide by 20 m long by 2.5 m deep with an estimated volume of about 200 m³ (Figure 3.2). The landslide appeared to have occurred within completely decomposed tuff (CDT) overlain by a thin layer of residual soil and/or colluvium. The debris had deposited into the ephemeral drainage line and over-spilled onto the platform area of Middleton Towers together with outwash from the uncontrolled overflow of storm water. No casualties or notable damage were reported as a result of the landslide. The trigger of the landslide was attributed to heavy rainfall. The presence of a relict concave depression in the locality might have previously affected the area of the 2005 landslide.

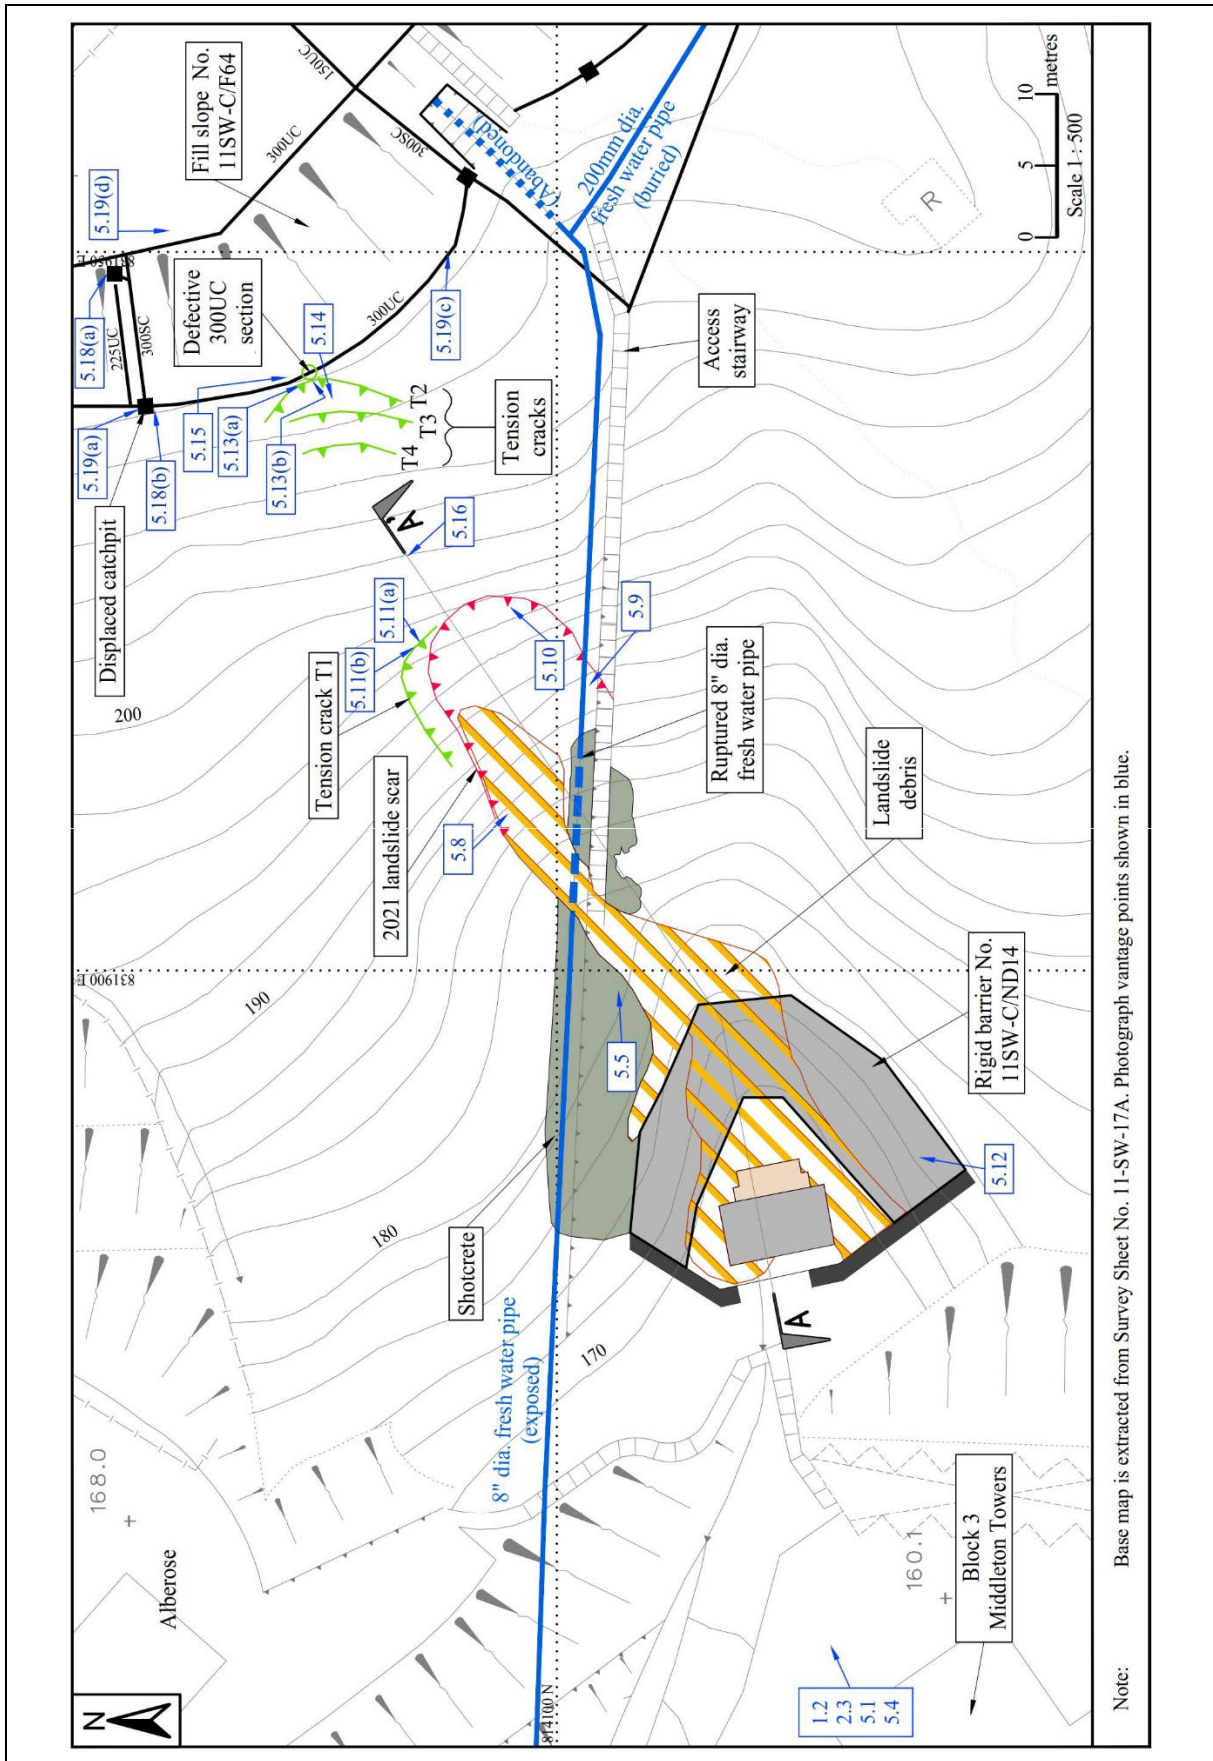
Figure 5.2 Post-Landslide Observations Plan

On the northern flank of the landslide, a tension crack (T1) was observed as a continuation of the head scarp with some signs of displacement (Figure 5.2 and 5.11). Tension crack T1 was about 12 m in length and was displaced by about 0.3 m vertically and 0.2 m laterally.

Directly above the landslide location, the natural slope changes to gently sloping, planar-slightly convex morphology and is densely vegetated by trees. Three tension cracks (T2 to T4) were observed on the gentle slope of about 25° inclination immediately below the toe of fill slope No. 11SW-C/F64 (Figure 5.2, 5.13 and 5.14).

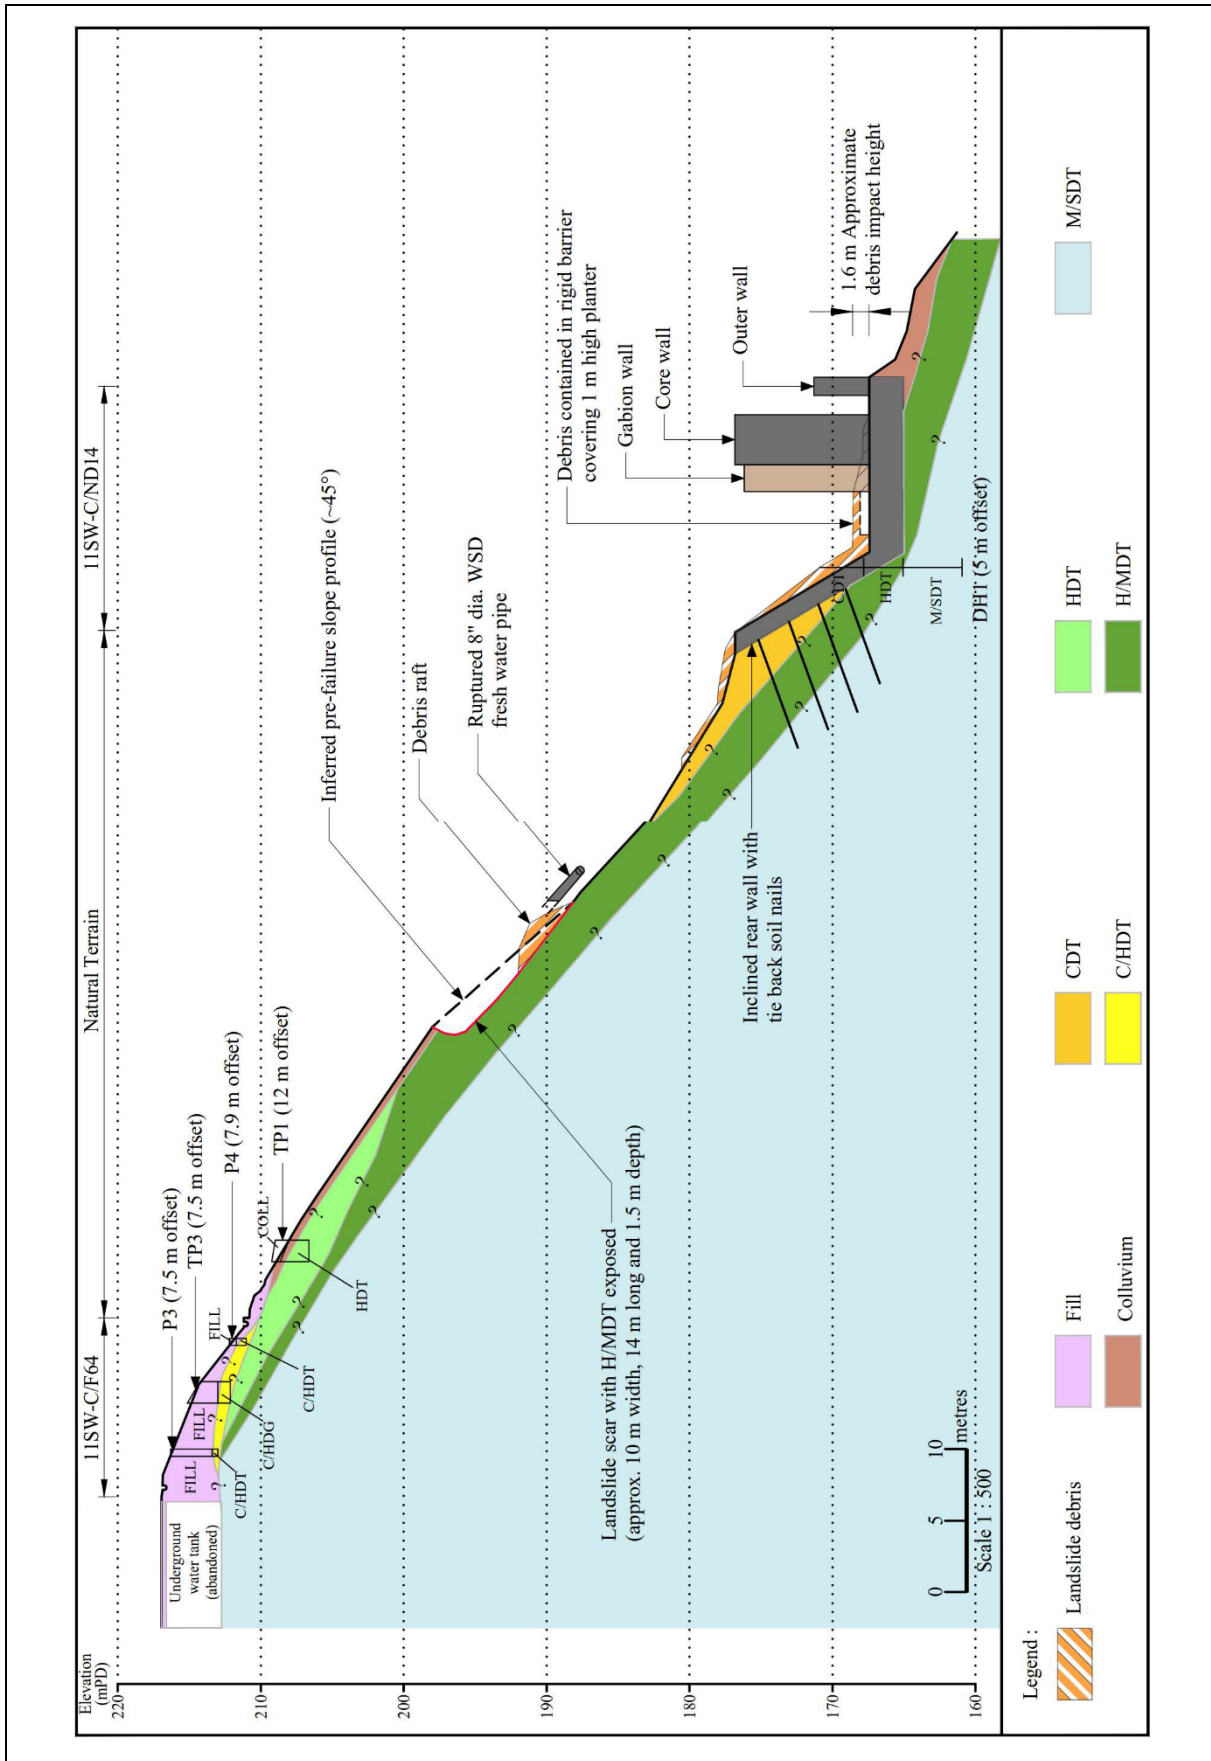
Figure 5.3 Cross-section A-A' through the 3 August 2021 Landslide

The travel distance from the head scarp to the furthest extent of debris deposition was about 50 m and the corresponding travel angle was approximately 35°, with the impedance of the rigid barrier (Figure 5.3). In order to discard the retarding effect of the central core wall and the planter, which were not considered in the model, the analysis results were gauged on the relative proportion of debris deposition on the natural slope above the barrier and that entering into the barrier for comparison with the post-landslide observations (Section 5.3.2). From the analyses, an apparent friction angle of 32° has yielded results best simulating the measured debris distribution and such angle is within the typical range of OHFs in Hong Kong (GEO, 2012b). Details of the debris mobility analyses are presented in Appendix C.

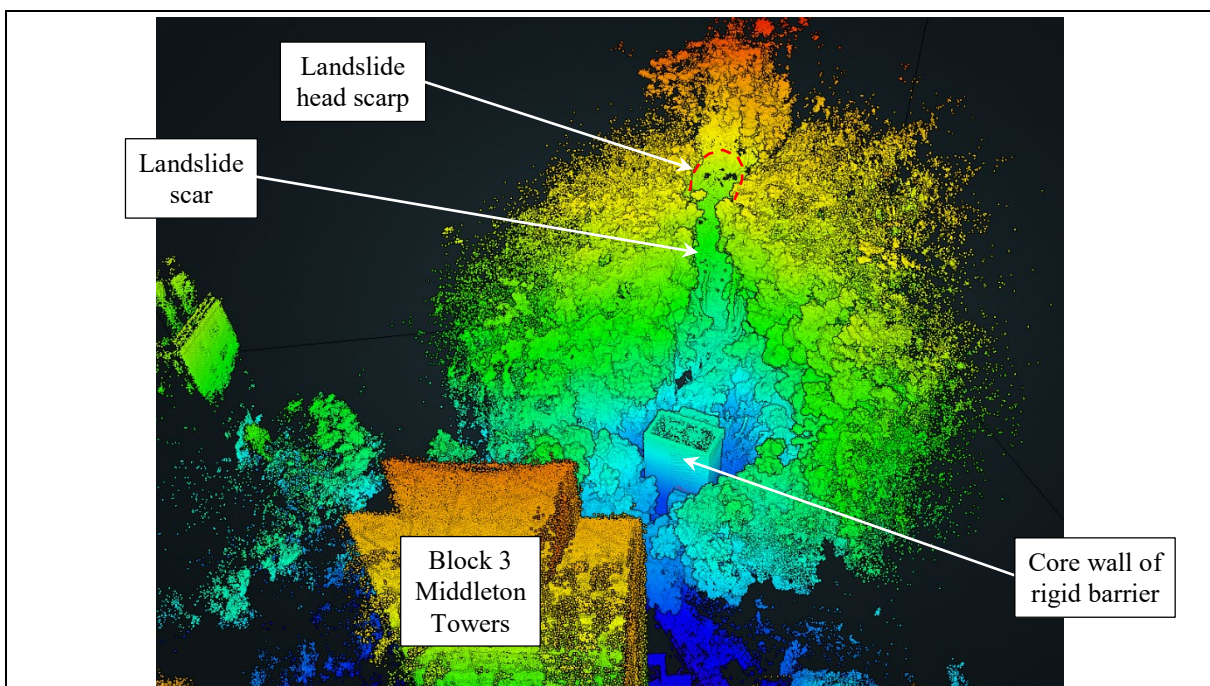
Figure 5.5 Point Cloud Model Generated from Handheld Laser Scanner

At the time of the initial field mapping, no works had been carried out on the failure scar and no debris had been removed. In addition to the field mapping, handheld laser scanning (HLS) of the landslide site and its vicinity, including the rigid barrier and the crest platform in

front of the FWSR, was conducted on 4 and 6 August 2021 to better appreciate the post-landslide site conditions (Figure 5.5).

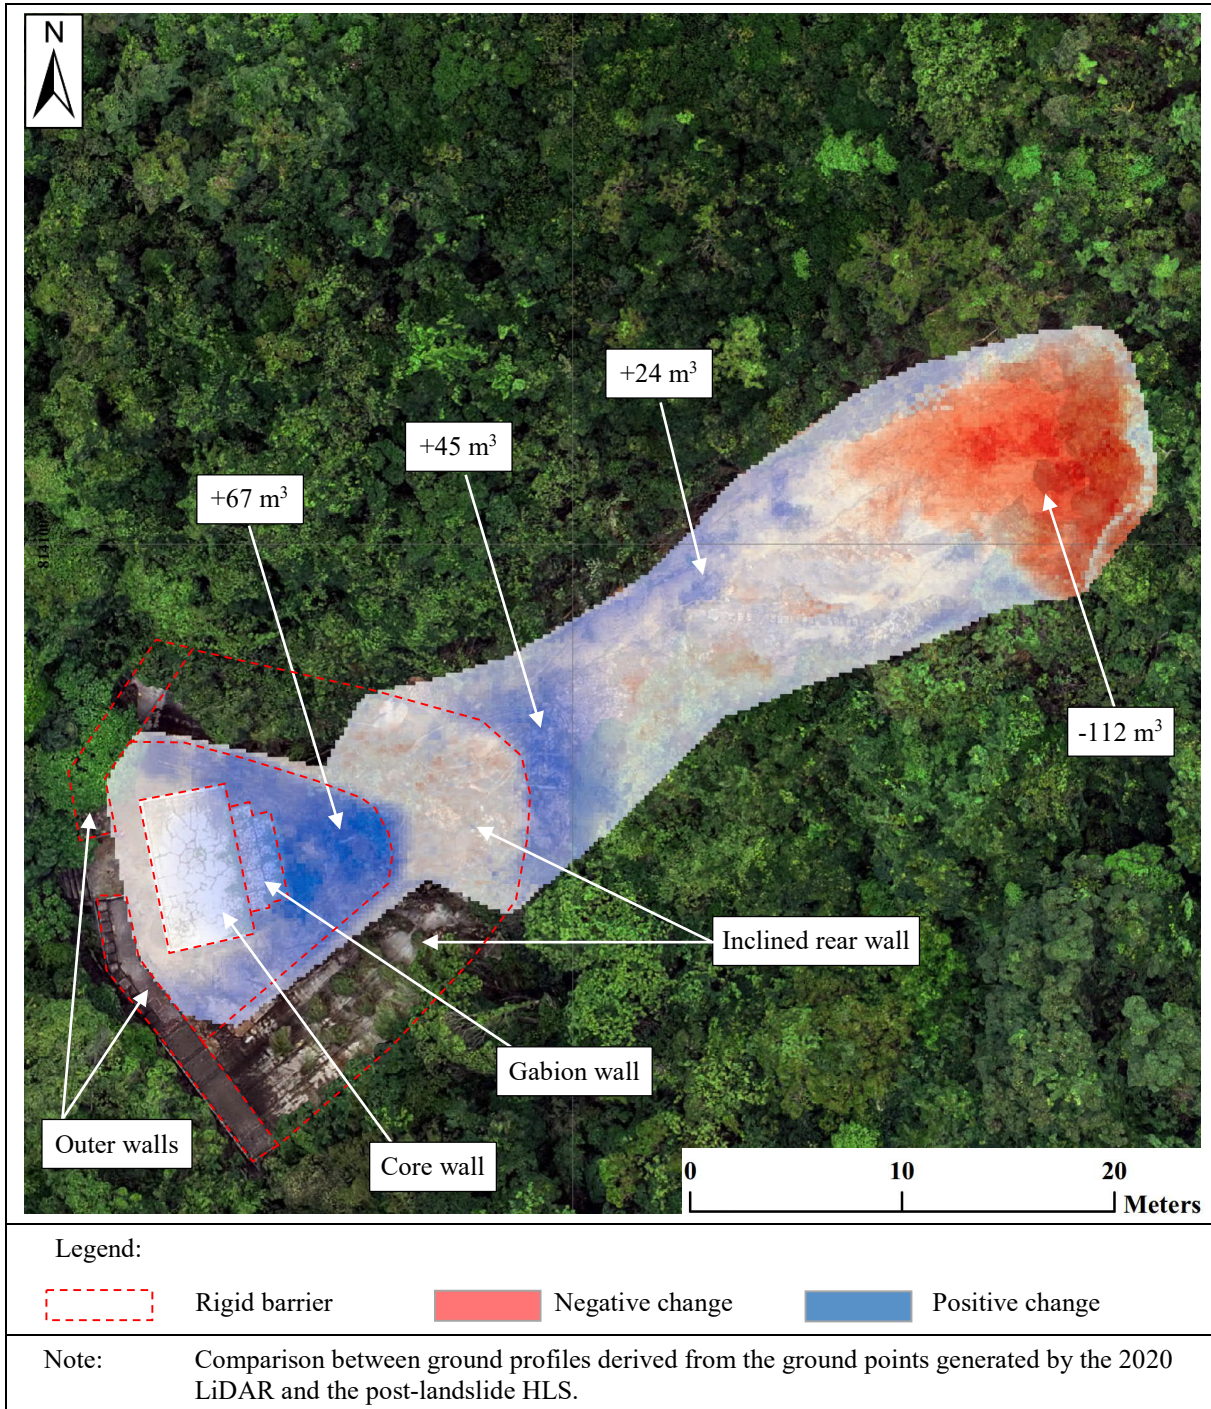
Figure 5.6 Change Detection Analysis

Change detection analysis was carried out by comparing the 3D point cloud model generated from the HLS with the pre-landslide 2020 Light Detection and Ranging (LiDAR) slope profile. The analysis results are presented in Figure 5.6. In general, a negative value from the analysis is considered indicative of failed ground while a positive value is considered indicative of landslide debris deposition. The landslide volume and debris distribution derived from the analysis were generally comparable with the field observations and mapping results (Sections 5.3.1 and 5.3.2).

The dimensions of the source area were measured on site as about 14 m long, 10 m wide with a maximum depth of about 1.5 m. Based on the field mapping, the estimated failure volume is about 110 m³ which is generally consistent with the results of the change detection analysis (Figure 5.6).

The debris volume was estimated as about 135 m^3 , with approximately half accumulated in the containment basin of the rigid barrier (about 68 m^3) and half deposited on the natural hillside above the crest of the barrier (about 67 m^3) (Figure 5.6). The debris consisted of soil, rock, uprooted trees and a large section of the ruptured 8" diameter fresh water pipe.

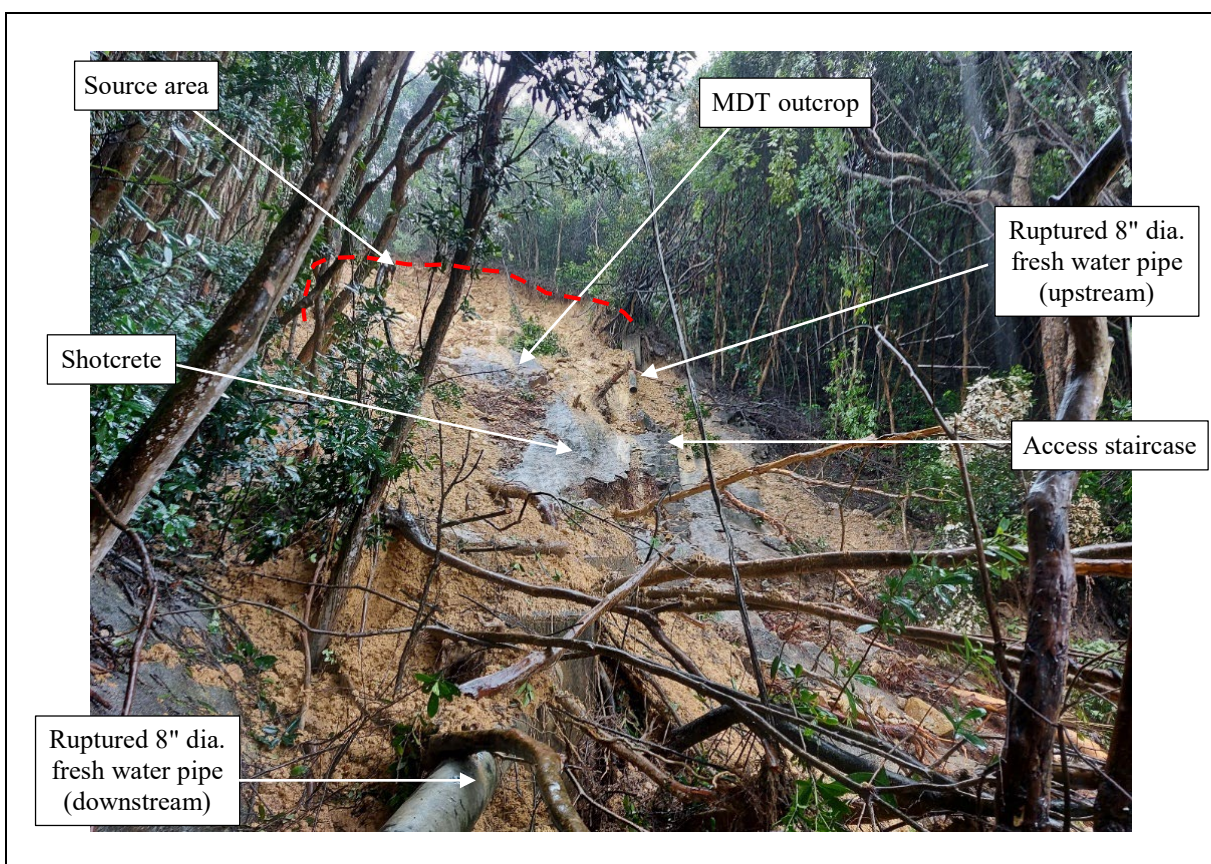
Figure 5.8 East-facing Lateral View of the Landslide (Photograph Taken on 3 August 2021)

The pre-failure slope profile was steeply inclined at about 40° to 45° and vegetated with shrubs and trees, as inferred from the adjacent slope surface (Figures 5.8 and 5.9). The landslide

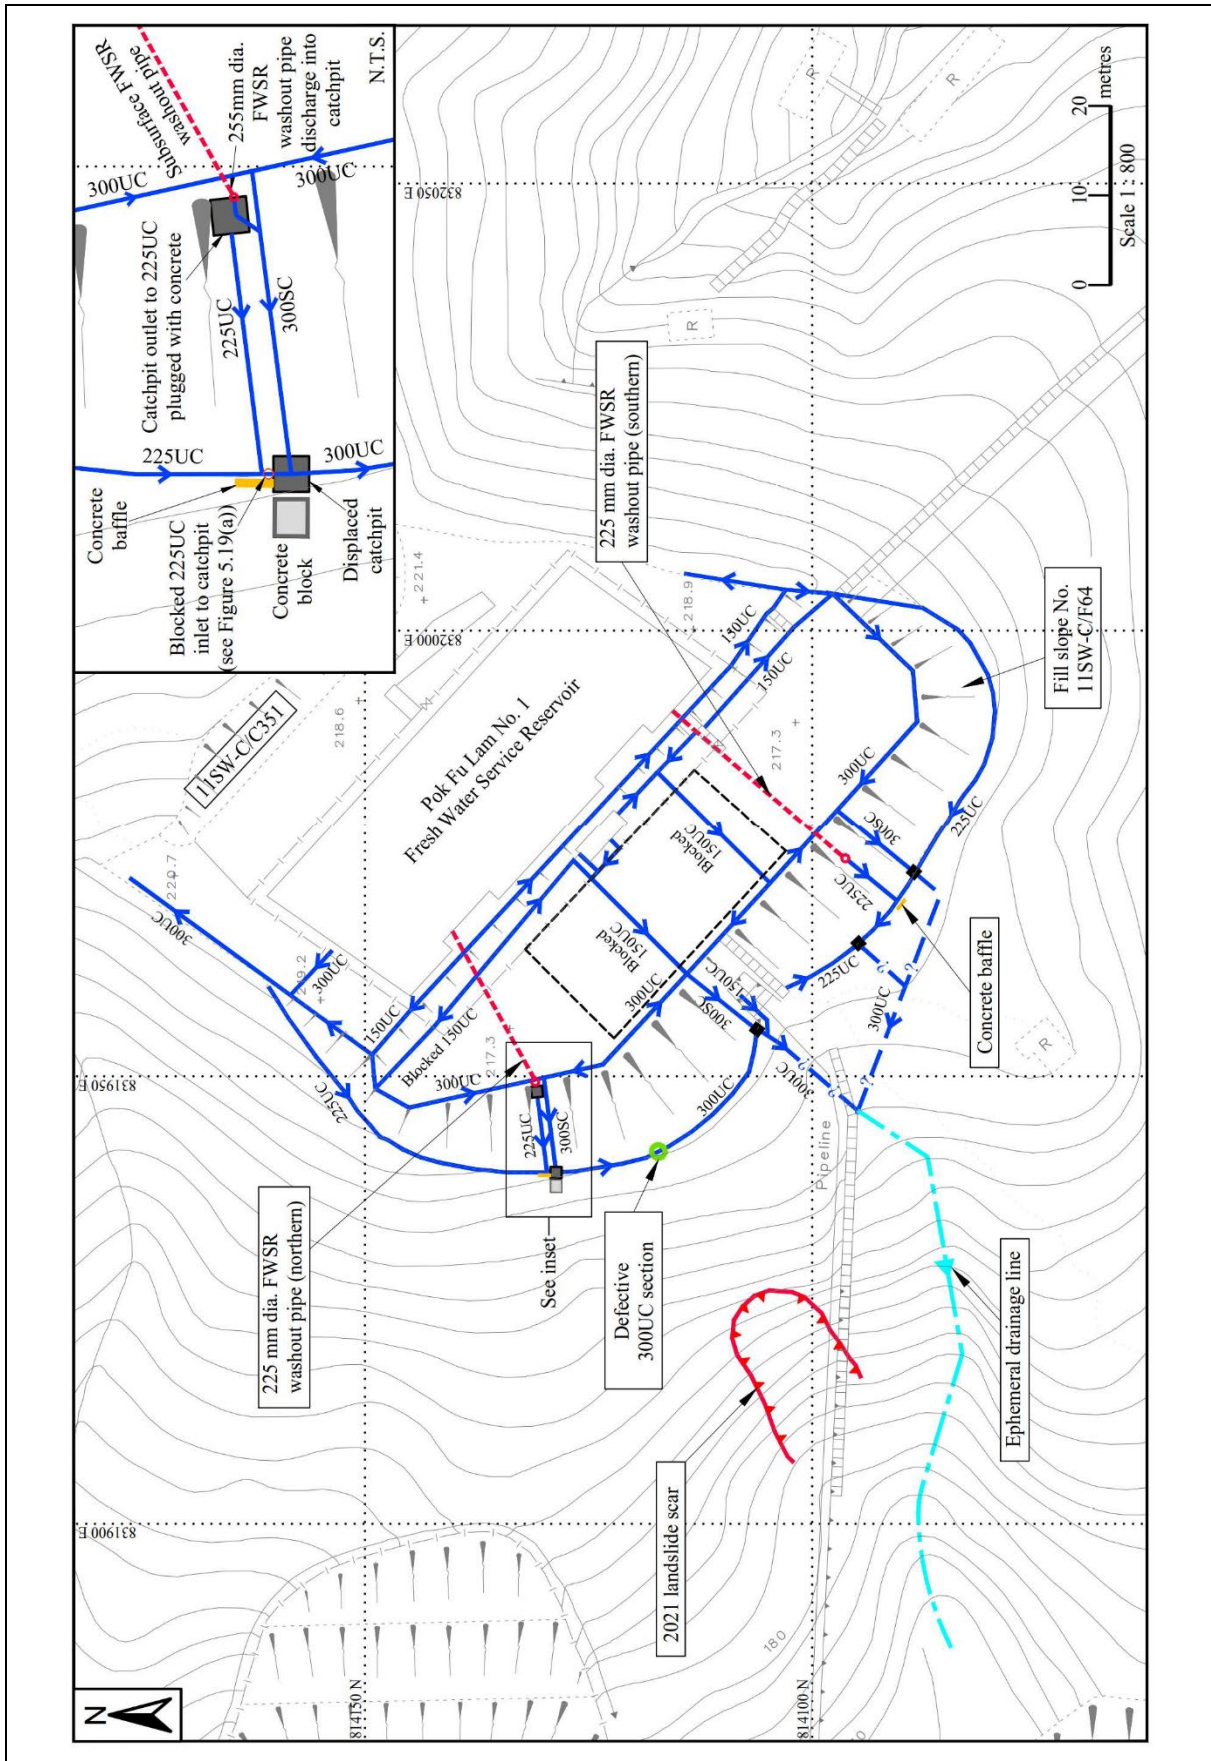
Figure 5.17 Drainage Layout of Fill Slope No. 11SW-C/F64

In connection with the defective 300UC section above the landslide location, the overall layout and condition of the drainage system of fill slope No. 11SW-C/F64 were reviewed. The slope surface drainage system comprises a crest channel (300UC), toe channels (225UC & 300UC), connecting stepped channels (300SC) and catchpits (Figure 5.17). On the crest platform above the underground water tank, U-channels (150UC) discharge into the crest channel of the fill slope. The fill slope drainage ultimately discharges into the ephemeral drainage line located downslope of the central slope toe area.

The southern FWSR washout pipe discharges at about 2 m below the slope crest directly into a down-the-slope 225UC connecting to a 225UC toe channel (Figure 5.17).

Apart from the blockage noted at the defective 300UC section, locally, the 225UC toe channel was heavily blocked at the catchpit inlet at the northern portion of the slope toe (Figures 5.17 and 5.19(a)). The remainder of the fill slope surface drainage system was generally clear. Other defects in the surface drainage system were observed including separation of the aforesaid catchpit from the connecting channels (by up to 45 mm), cracked channels and channel aprons, and loss of joint sealant at an expansion joint in the toe channel (Figure 5.19). Some of the defects appeared to have been present for some time as evidenced by vegetation growth and concrete discolouration. Signs of past repairs on the channels and aprons, possibly associated with previous maintenance works, were also apparent. It is noted that the routine maintenance inspections/works and the Engineer Inspection prior to the landslide were conducted in late 2020 and in April 2021 respectively.

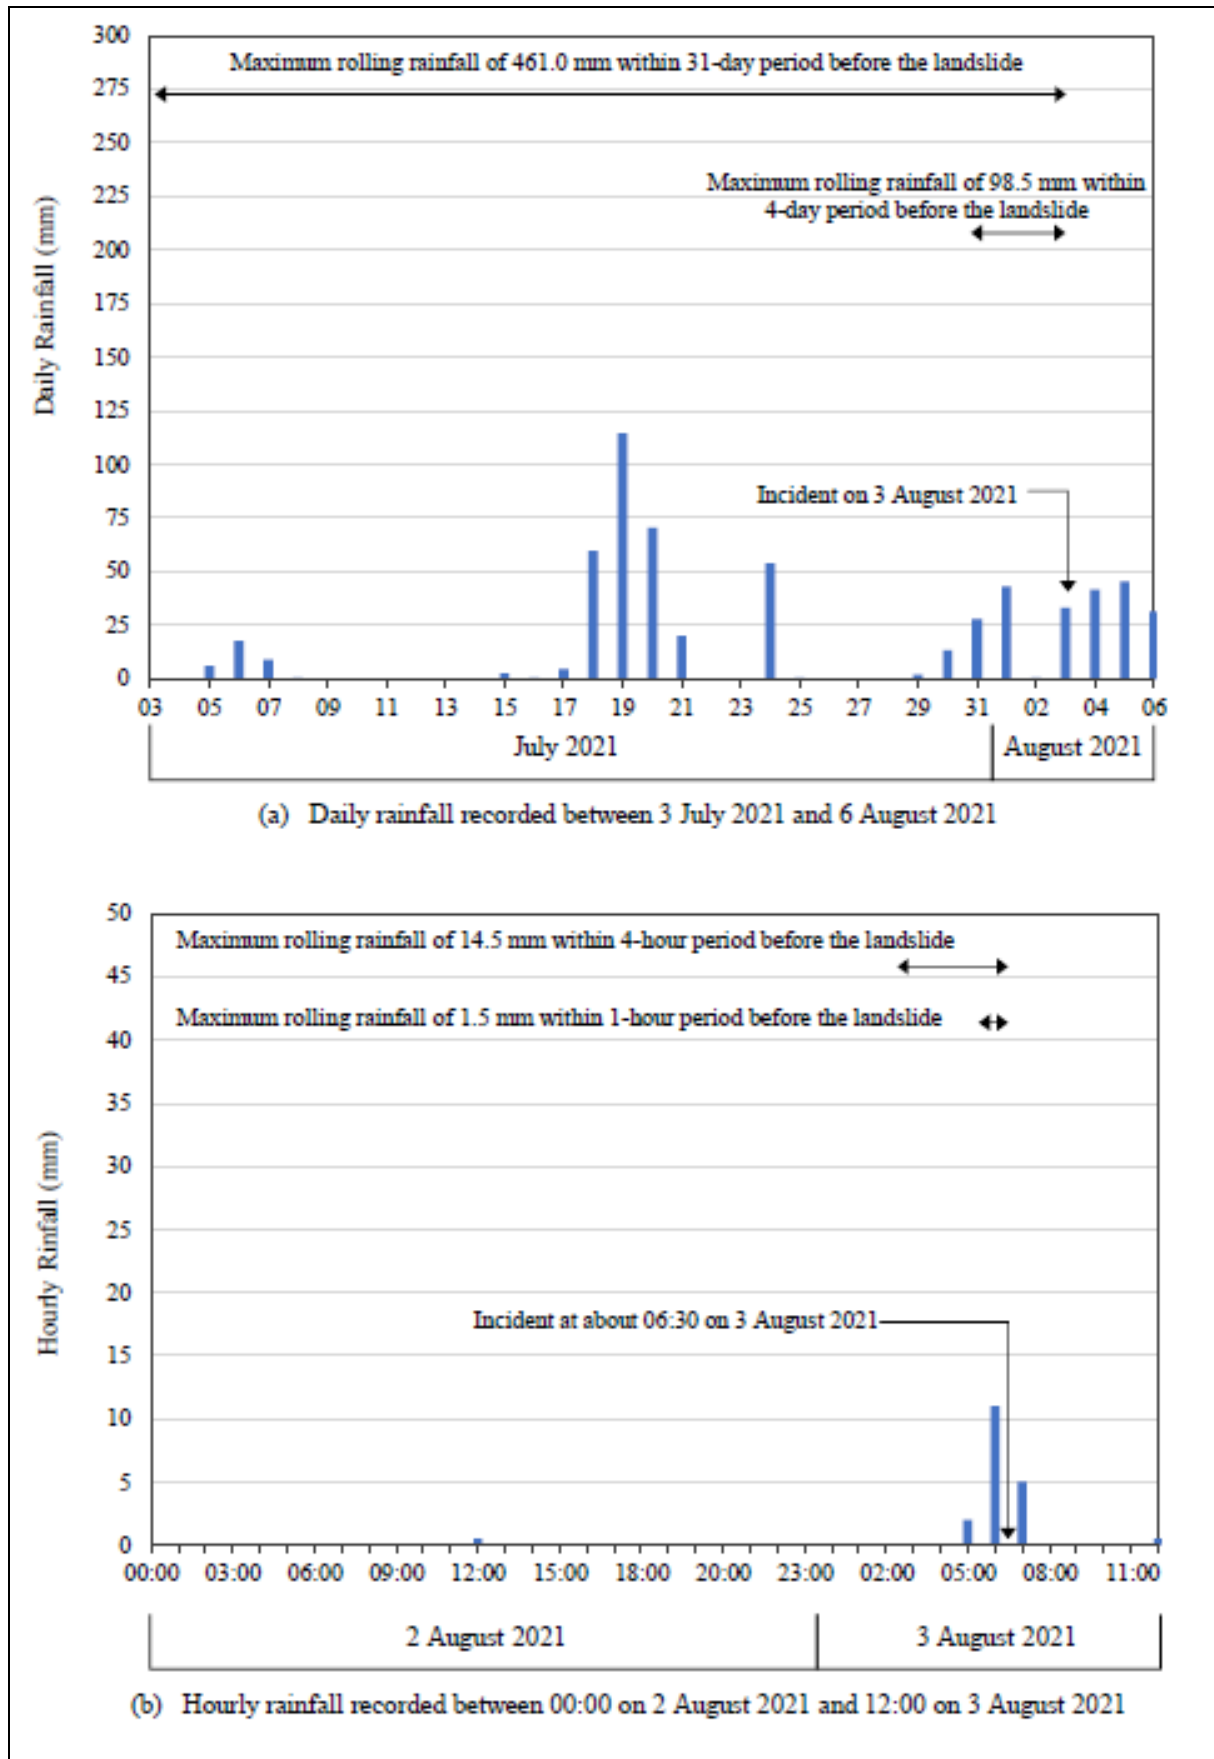
Figure 7.1 Daily and Hourly Rainfall Recorded at GEO Raingauge No. H03

An analysis of the return periods for various durations of rolling rainfall recorded by GEO Raingauge No. H03 was made with reference to the historical rainfall data recorded at the raingauge (Tang & Cheung, 2011). The analysis has shown that the rainfall was not intense and corresponded to a return period of less than two years for all the durations assessed (Table 7.1).
