**Detailed Study of the
3 August 2021 Landslide on the
Natural Hillside above Block 3,
Middleton Towers,
140 Pok Fu Lam Road**

GEO Report No. 369

Fugro (Hong Kong) Limited

**Geotechnical Engineering Office
Civil Engineering and Development Department
The Government of the Hong Kong
Special Administrative Region**

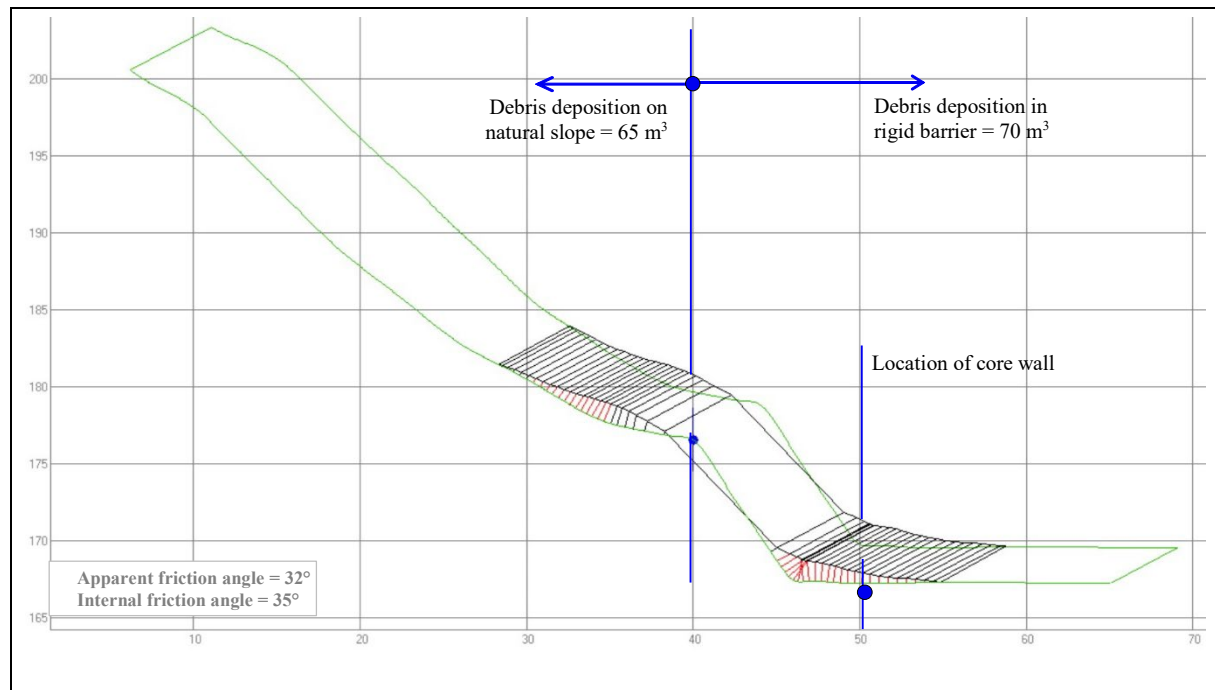
Figure C1 Results of Debris Mobility Analysis

The debris mobility analysis results comparing the landslide debris distribution obtained by field mapping are presented in Table C2 and Figure C1. An apparent friction angle of 32° was determined as being the most representative of the distribution of debris on the hillside and in the containment basin of the rigid barrier and is within the typical range for open hillslope failures (GEO, 2012).

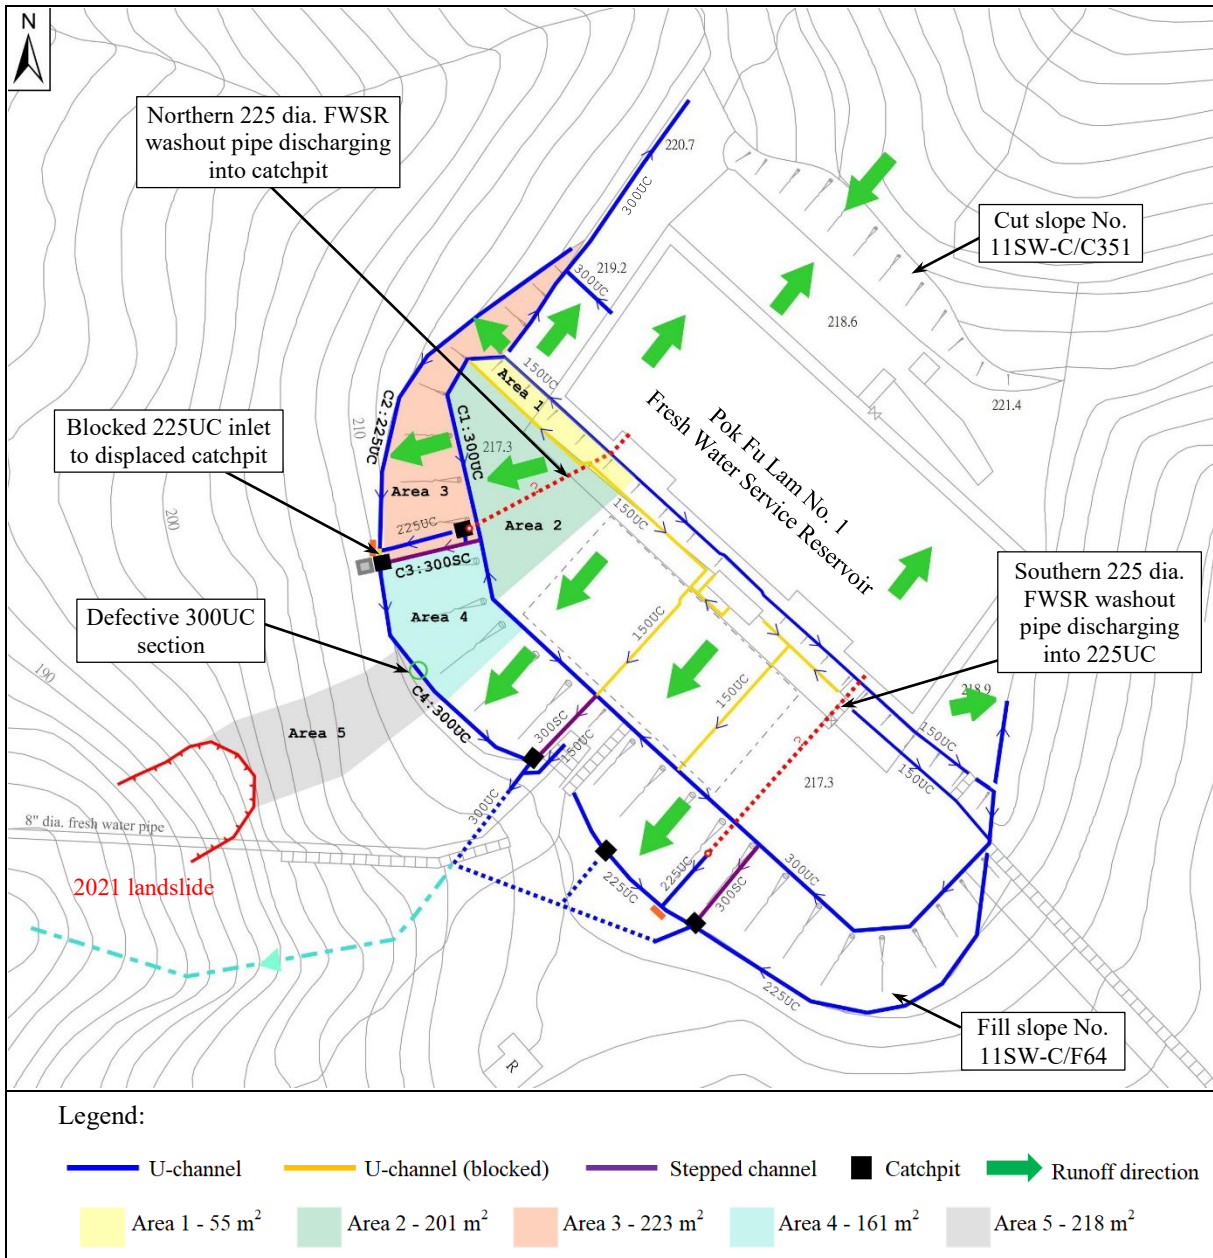
Figure D1 Catchment Area for the Defective 300UC Section and Landslide Head Scarp

This Appendix presents the assessment of surface runoff associated with rainfall that could have reached the 2021 landslide location at the time of the landslide. The catchment area that could contribute to surface runoff at the landslide location is shown in Figure D1. The surface runoff could have comprised both overflow from the defective 300UC section of fill slope No. 11SW-C/F64 (Areas 1 to 4) and the surface runoff from the natural slope immediately upslope of the landslide location (Area 5).
