**Detailed Study of the
8 September 2023 Landslides
on the Natural Hillside
above Yiu Hing Road,
Yiu Tung Estate,
Shau Kei Wan**

GEO Report No. 377

Fugro (Hong Kong) Limited

**Geotechnical Engineering Office
Civil Engineering and Development Department
The Government of the Hong Kong
Special Administrative Region**

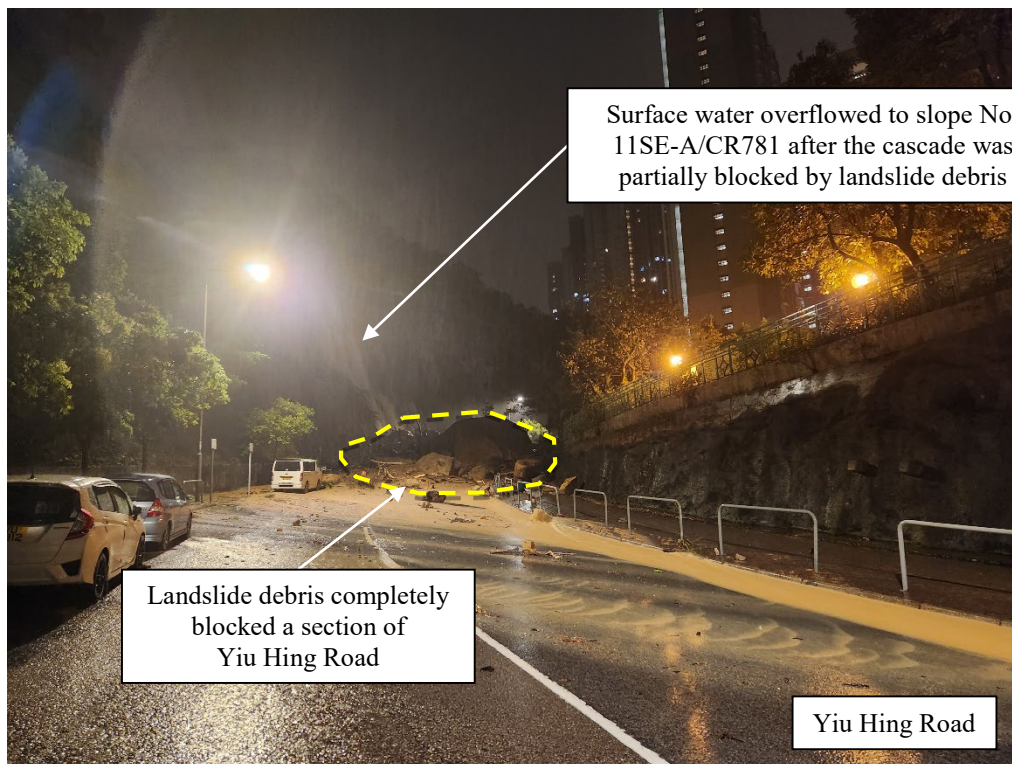
a) General View of Yiu Hing Road after the Incident

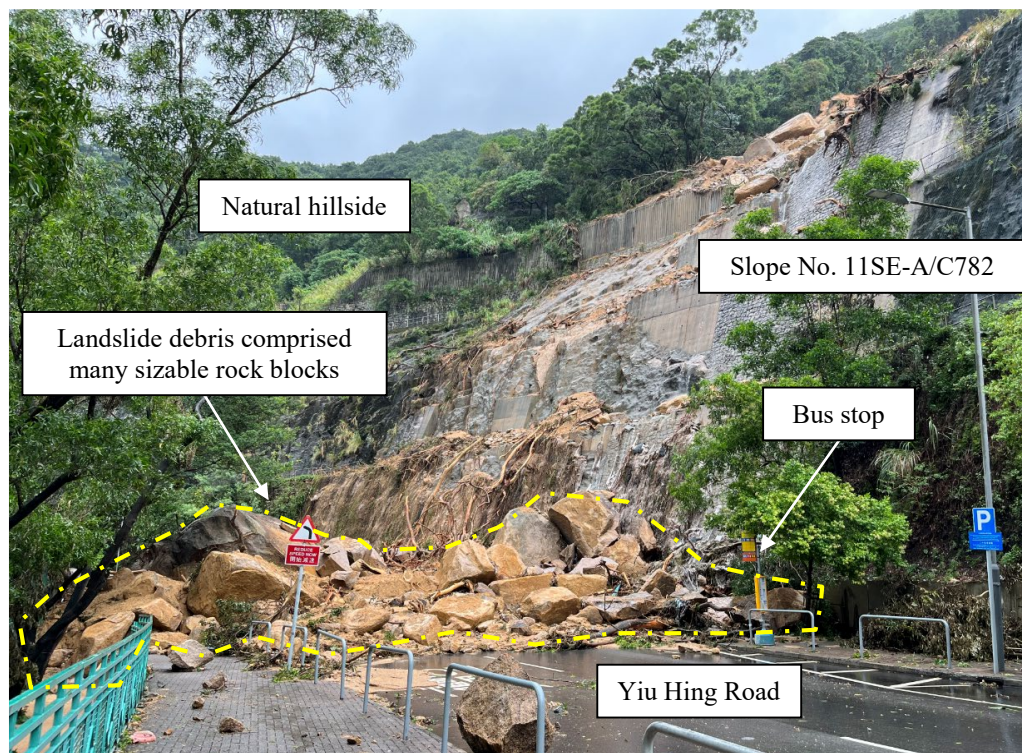
b) Complete Blockage of Yiu Hing Road after the Incident

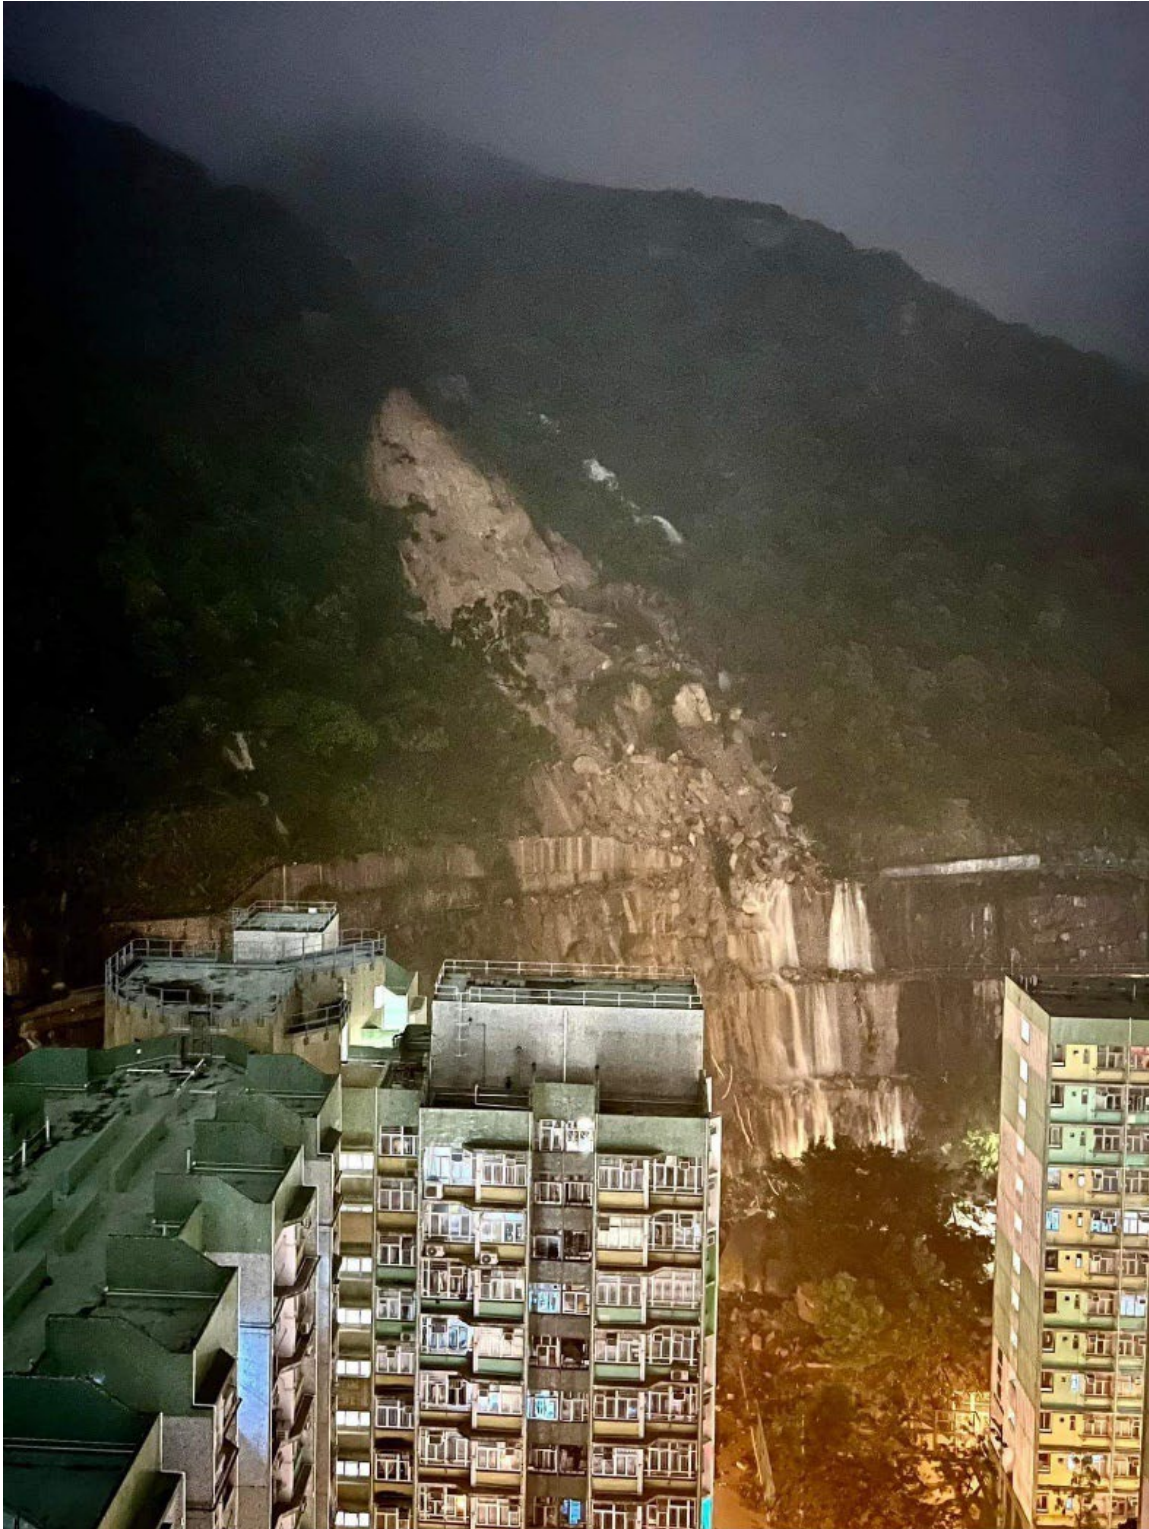
Figure 5.1 General View of the Landslide Site in the Early Morning on 8 September 2023 (Photograph taken by the nearby resident at about 4:00 a.m. on 8 September 2023)

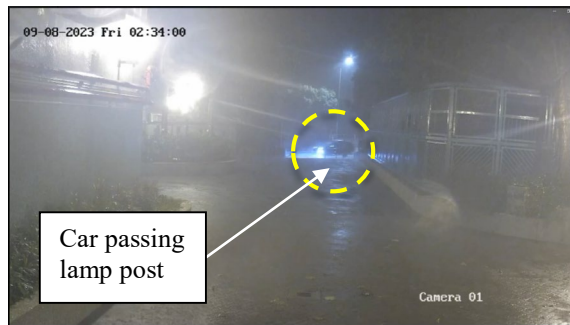
- a) At 02:34:00, a car driven along Yiu Hing Road, passing the lamp post before the incident.

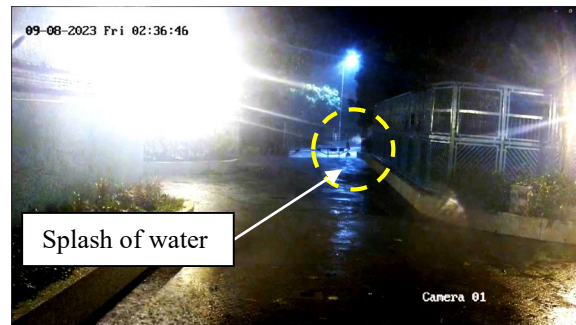
- b) At 02:36:46, a heavy 'splash' of water hit the lamp post immediately before falling debris.

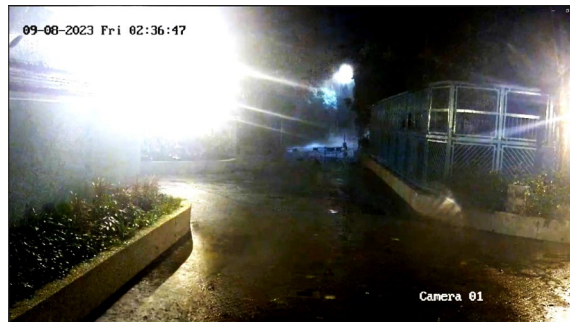
- c) At 02:36:47, clastic debris fell onto and across Yiu Hing Road.

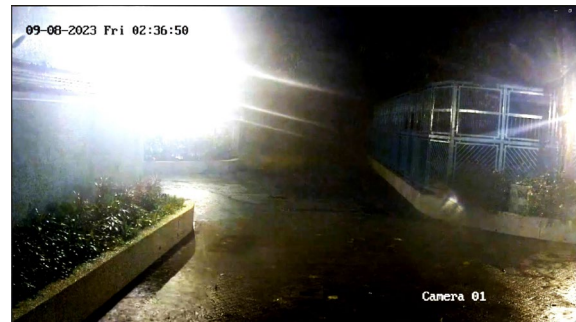
- d) At 02:36:50, the lamp post was knocked down by debris.

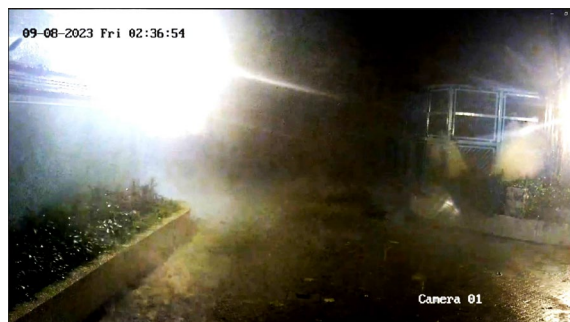
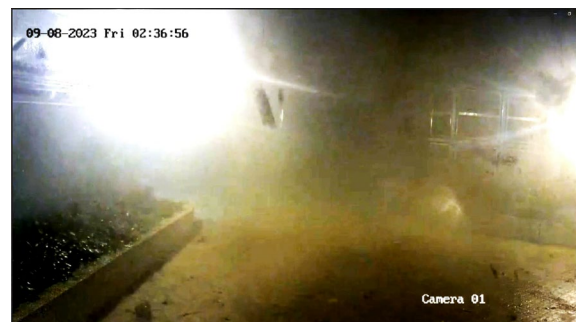
- e) From 02:36:54 to 02:36:56, a 'wave' of debris surged towards Yiu Kwai House, comprising large rock blocks hitting on the road.

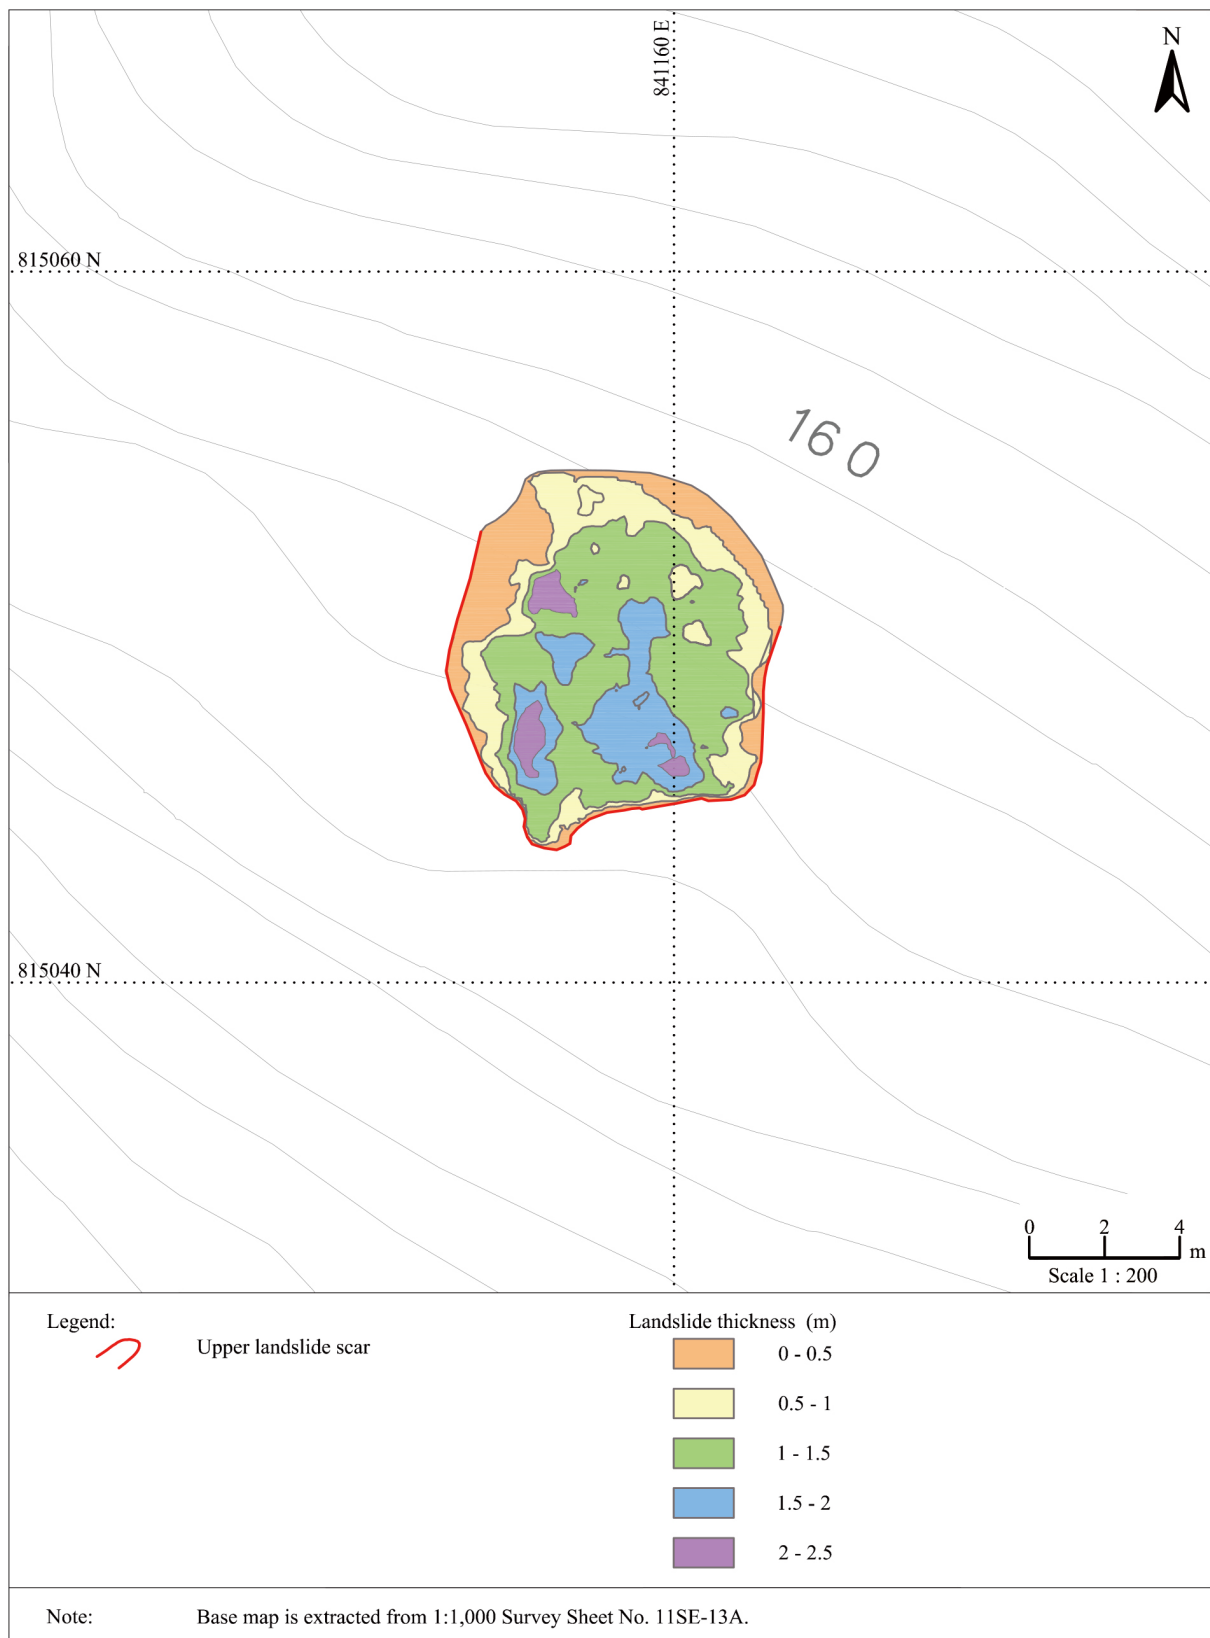
Figure 6.4 Source Volume Estimate of Upper Landslide Scar from LiDAR and Photogrammetry

The dimensions of the landslides varied significantly. Analysis of post-landslide photogrammetric data in comparison to the 2020 Light Detection and Ranging (LiDAR) data indicated that the source area of the upper landslide was about 8 m wide, 10 m long, and up to 1.3 m deep (measured perpendicular to the pre-landslide slope profile), with an estimated failure volume of about 100 m³ (Figure 6.4). The landslide debris travelled approximately 30 m downslope and was deposited on the natural hillside. Some debris outwash travelled further downslope to the lower landslide scar.

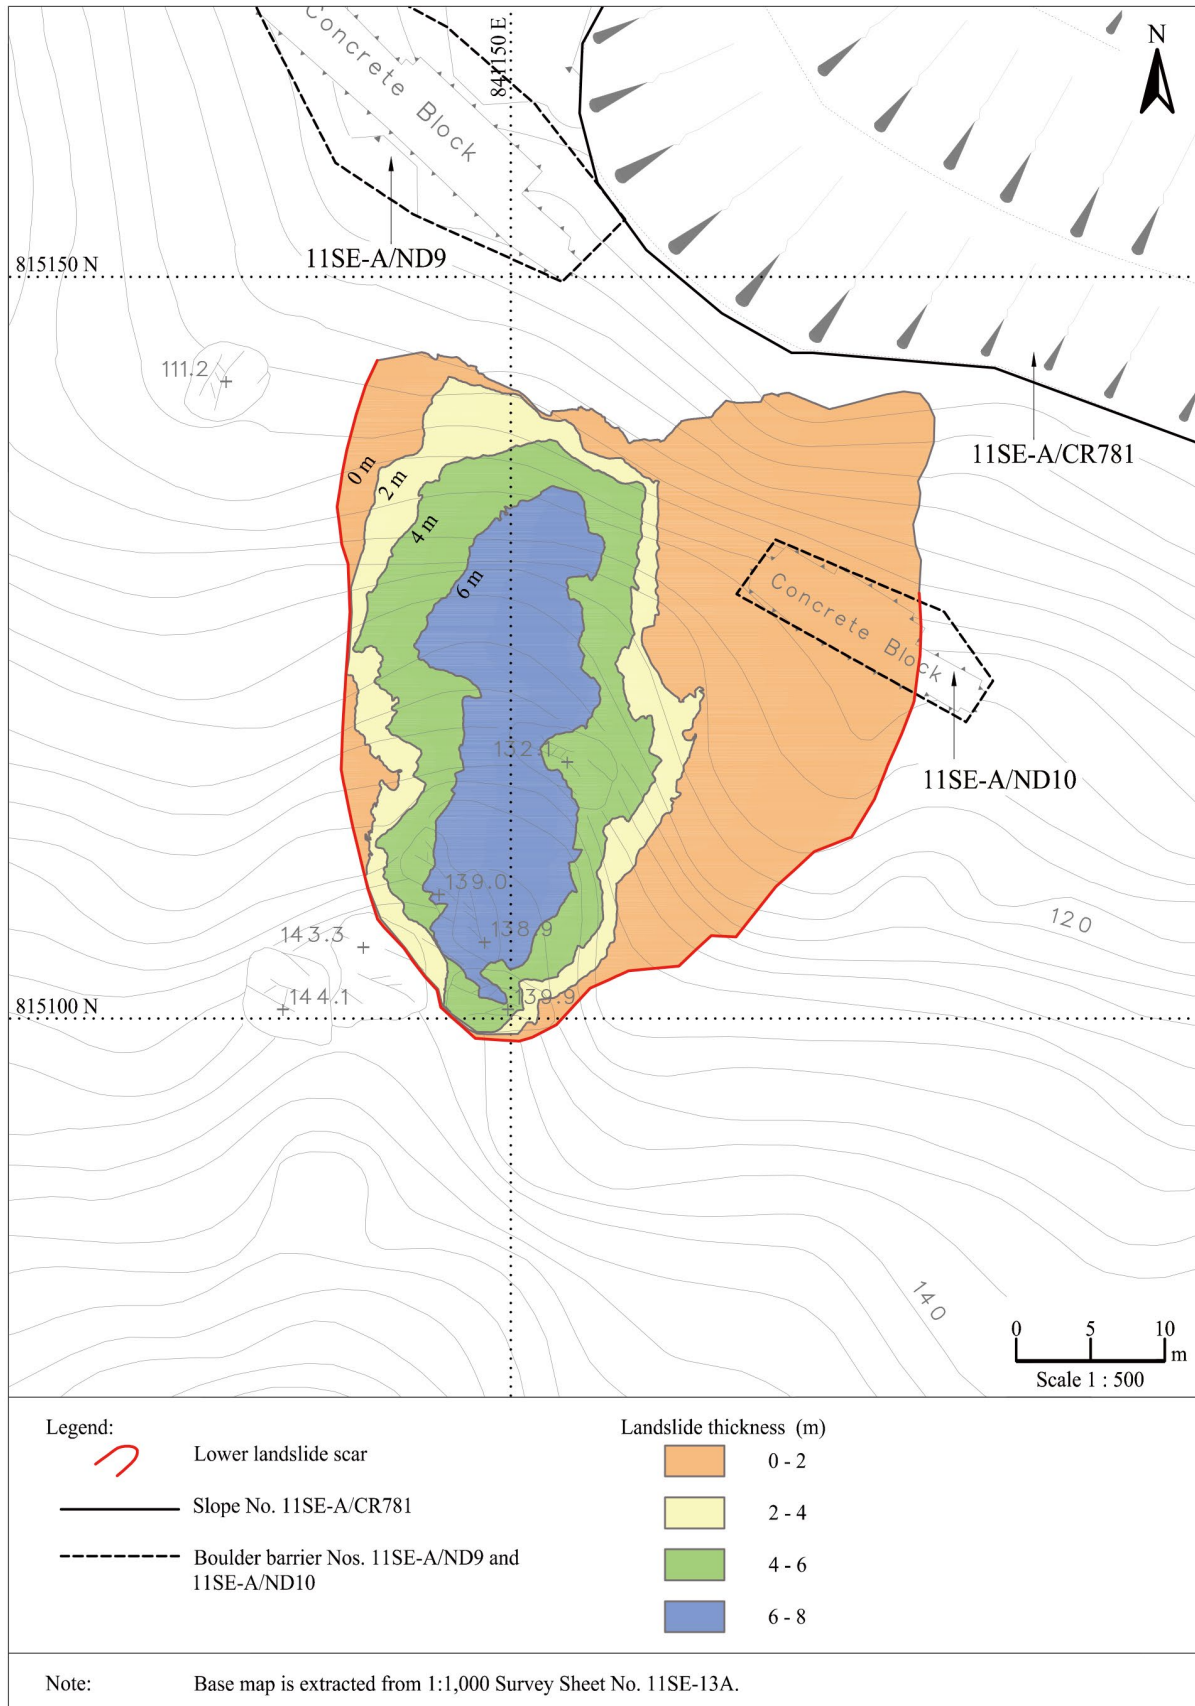
Figure 6.5 Source Volume Estimate of Lower Landslide Scar from LiDAR and Photogrammetry

The lower landslide was markedly larger, measuring about 40 m wide, 60 m long, and up to 6 m deep (also measured perpendicular to the pre-landslide slope profile), with an estimated failure volume of about 3,900 m³ (Figure 6.5). The landslide debris, excluding the outwash, travelled about 150 m on plan, with a debris travel angle of about 30°. The impact of the lower landslide was extensive and damaging. The landslide debris completely damaged gabion wall ND10 (Figure 6.6) and partially damaged gabion wall ND9 (Figure 6.7). These walls were built in the early 1990s as boulder barriers as part of the Shau Kei Wan East Public Housing Development (Section 3.3.4). The landslide debris also entirely blocked one of the drainage outlet pipes underneath gabion wall ND9 on the left and partially blocked the inlets of the other two drainage outlet pipes (Figure 6.8).

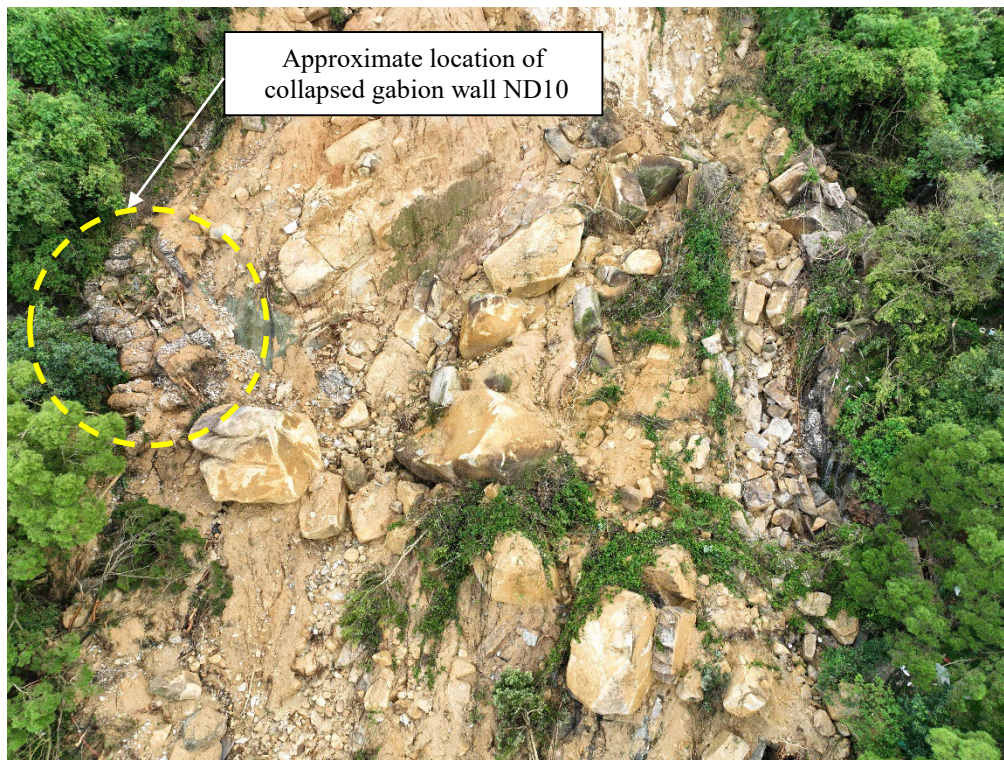
a) Collapsed Gabion Wall ND10

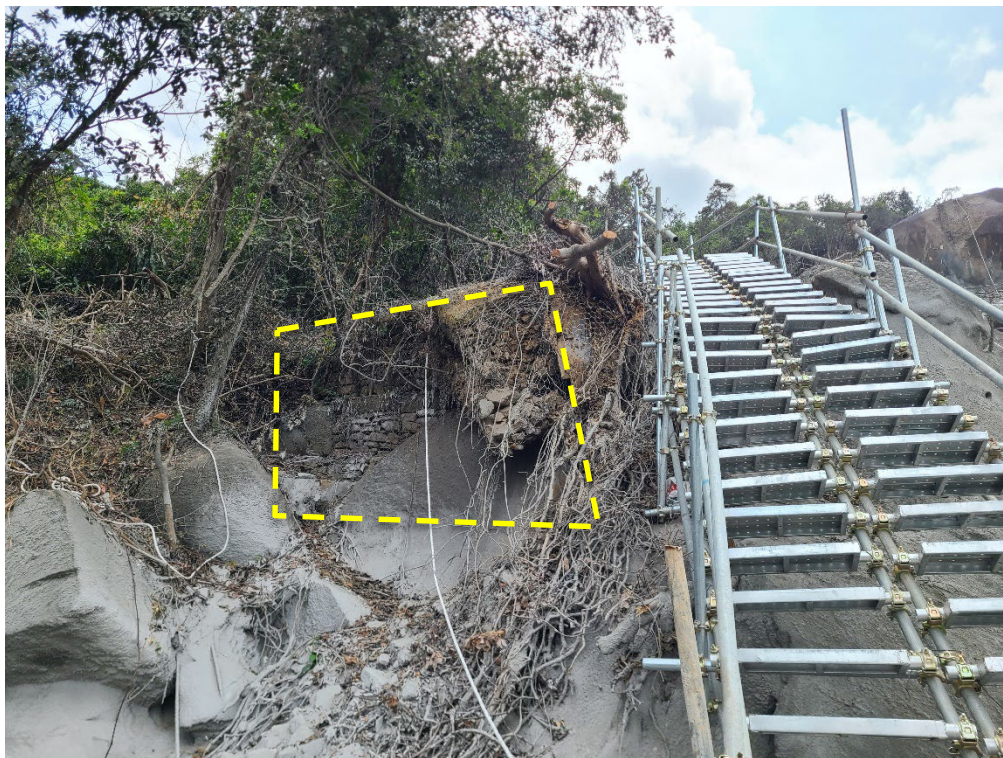
b) Remnant of Gabion Wall ND10

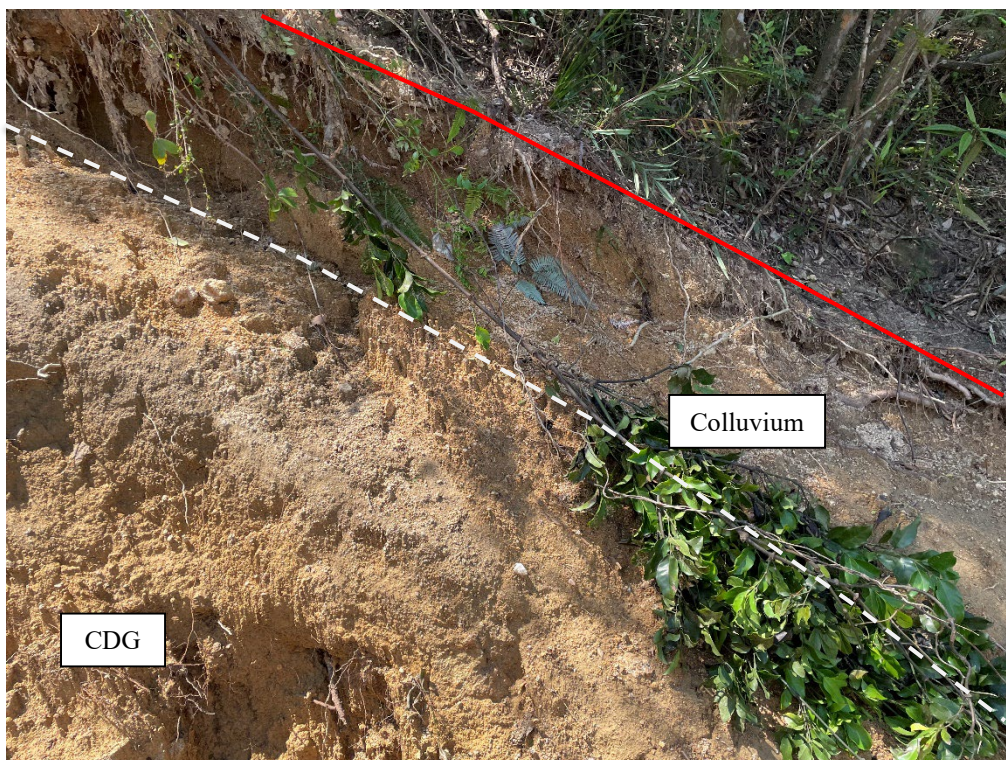
b) View of the Western Flank of the Upper Landslide Scar

Figure 6.13 Close-up View of the Upper Landslide Scar (Photographs taken on 19 September 2023)

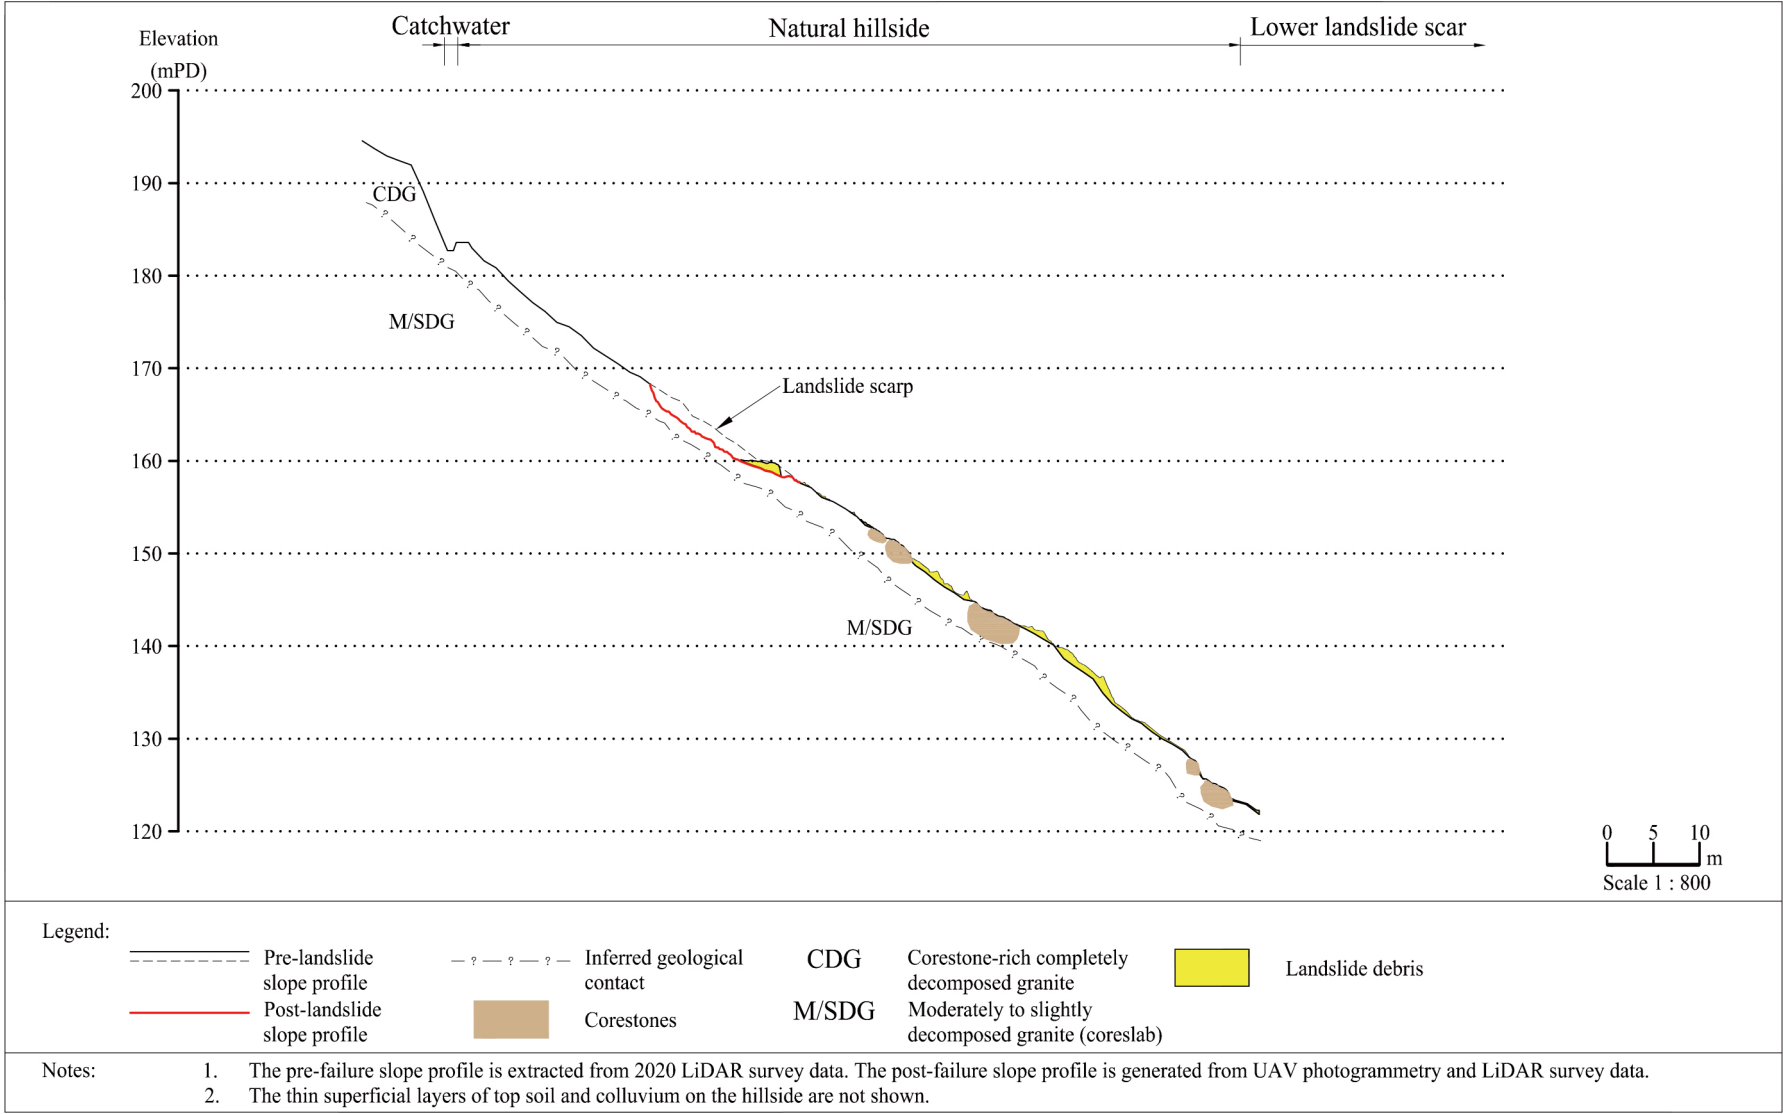
Figure 6.14 Geological Profile of the Upper Landslide Site (Longitudinal Section A-A')

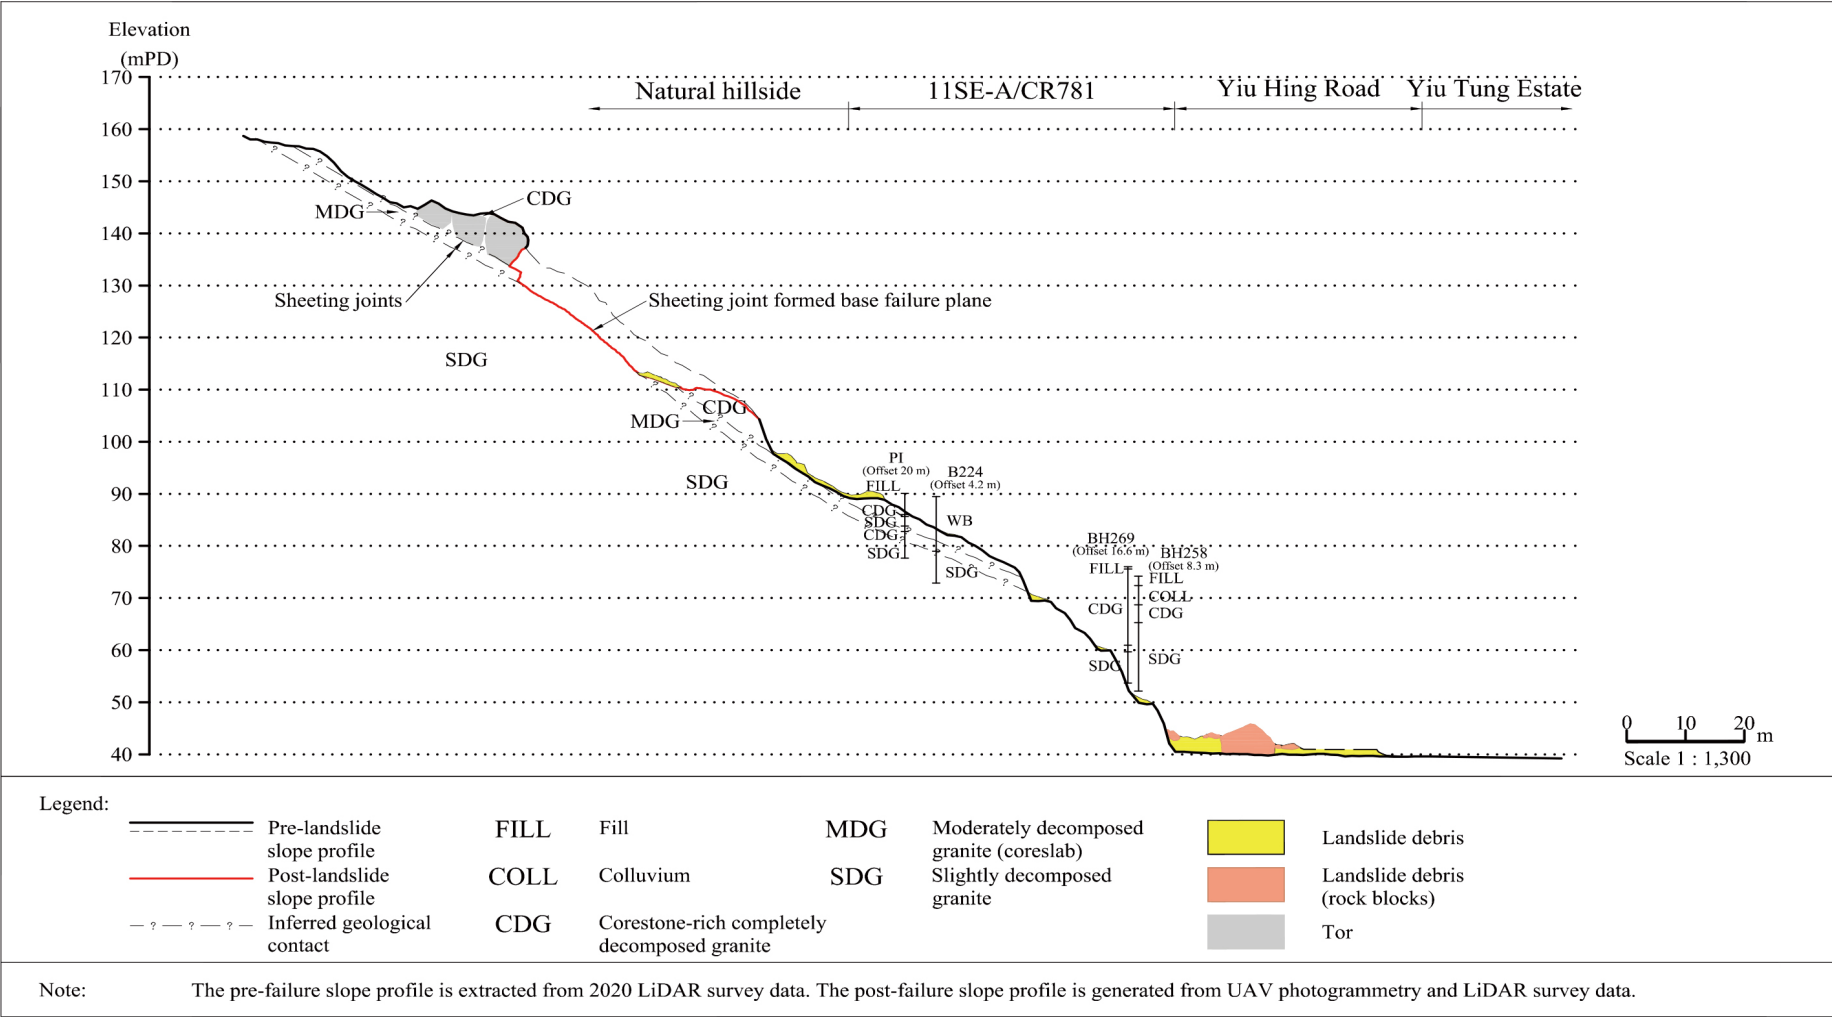
Figure 6.15 Geological Profile of the Lower Landslide Site (Longitudinal Section B-B')

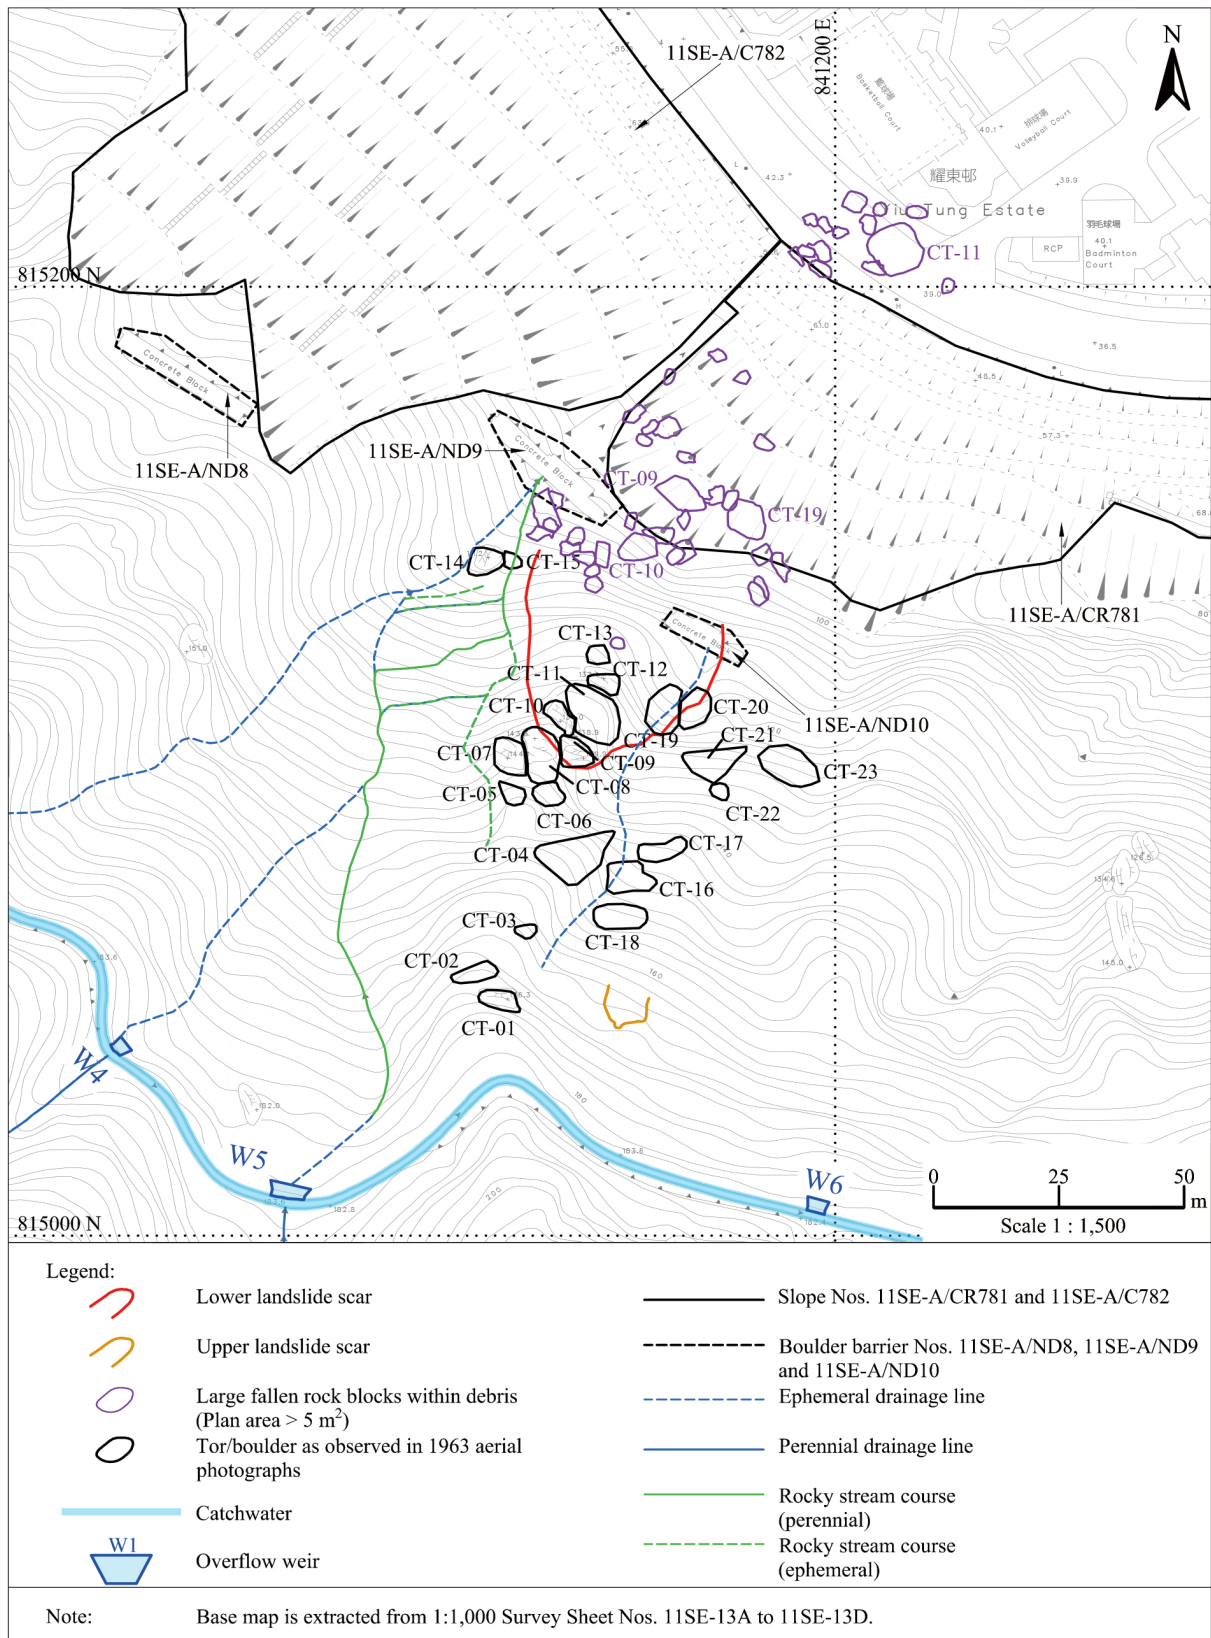
At the crest, partially exhumed corestones and tors along the spurline were exposed by the landslide. They were mapped (CT-01 to CT-23) based on the 1963 aerial photographs, the post-landslide UAV photographs and the field mapping (Figure 6.18). One tor, CT-08, was exposed at the crown of the lower landslide scar and rested on a large tabular coreslab of MDG (Figure 6.19). The lower contact of this coreslab was bounded by a locally stepped and undulating, persistent planar sheeting joint. Soil infill was observed at the toe of the tor but did not extend further, indicating that CT-08 was partly in direct contact with the coreslab. The dip and dip direction of the coreslab was measured at $28^{\circ}/025^{\circ}$ and $33^{\circ}/041^{\circ}$. Local dilation between the tor and the infill was observed around CT-08, and a 20 mm wide dilation was measured (Figure 6.20). Apparent soil pipes were observed between the basal failure plane and the coreslab. The postulated ground model for the crest scarp is shown in Figure 6.21.

Figure 6.18 Distribution Map of Tors and Partially Exhumed Corestones

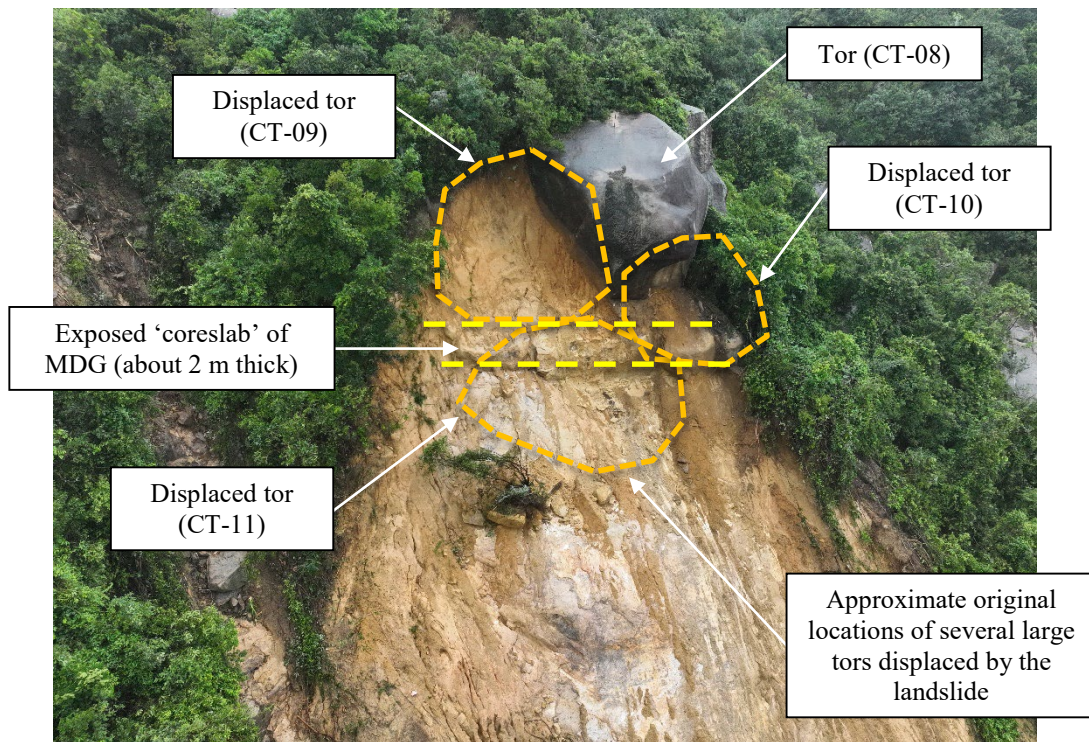
a) Tors at the Crest of the Lower Landslide Scar

Figure 6.19 Close-up View of the Lower Landslide Scar (Photographs taken on 9 and 14 September 2023)

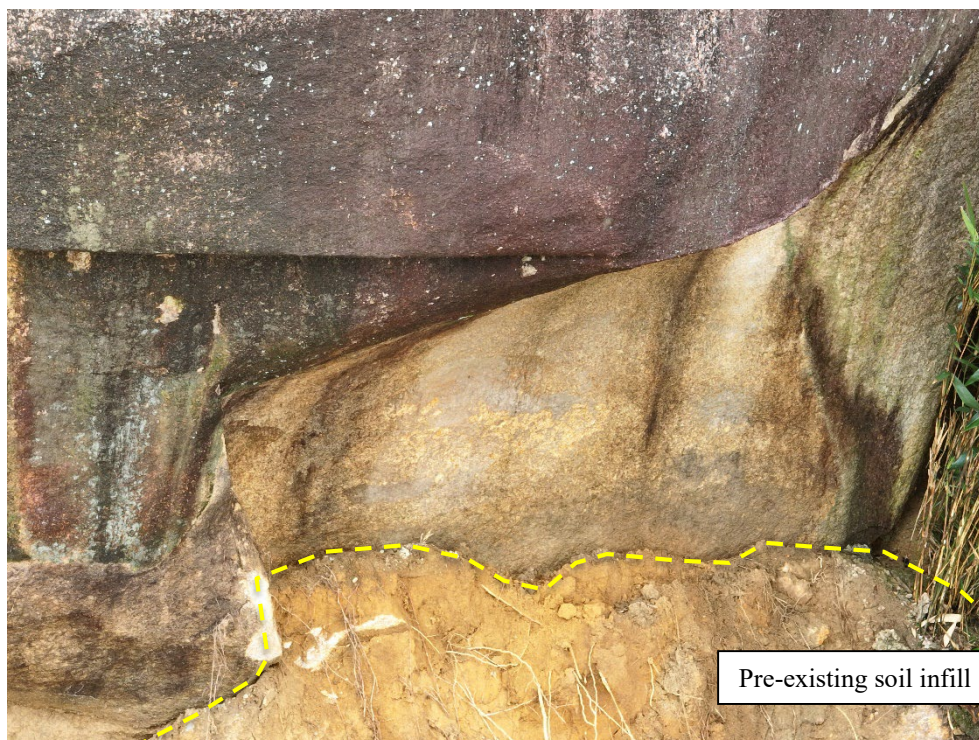
b) Close-up View of the Toe of Tor CT-08

As part of the emergency repair works, rock dowels were installed to stabilise tor CT-08 and the coreslab. A number of drillholes up to 6 m deep were completed and the available drill cores were examined (Figure 6.11(b)). The rock cores were generally described as moderately strong to strong, light yellowish grey, speckled pink and black medium to coarse-grained GRANITE with widely spaced, rough, planar joints.

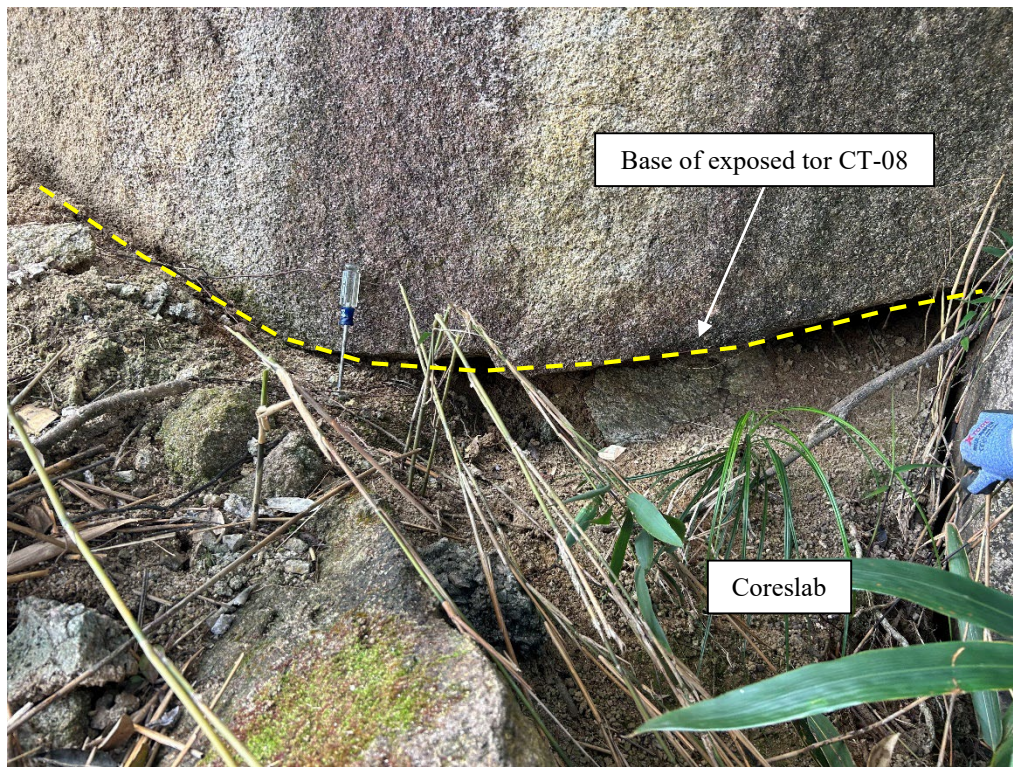
a) Contact between Tor and Coreslab

Figure 6.20 Close-up View of Tor CT-08 at the Crest of the Lower Landslide Scar (Photographs taken on 26 September 2023)

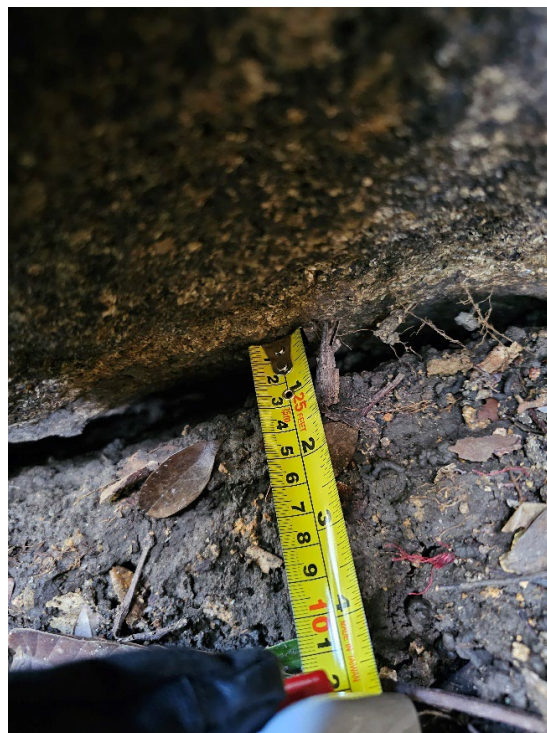
b) 20 mm Dilation at the Back of Tor

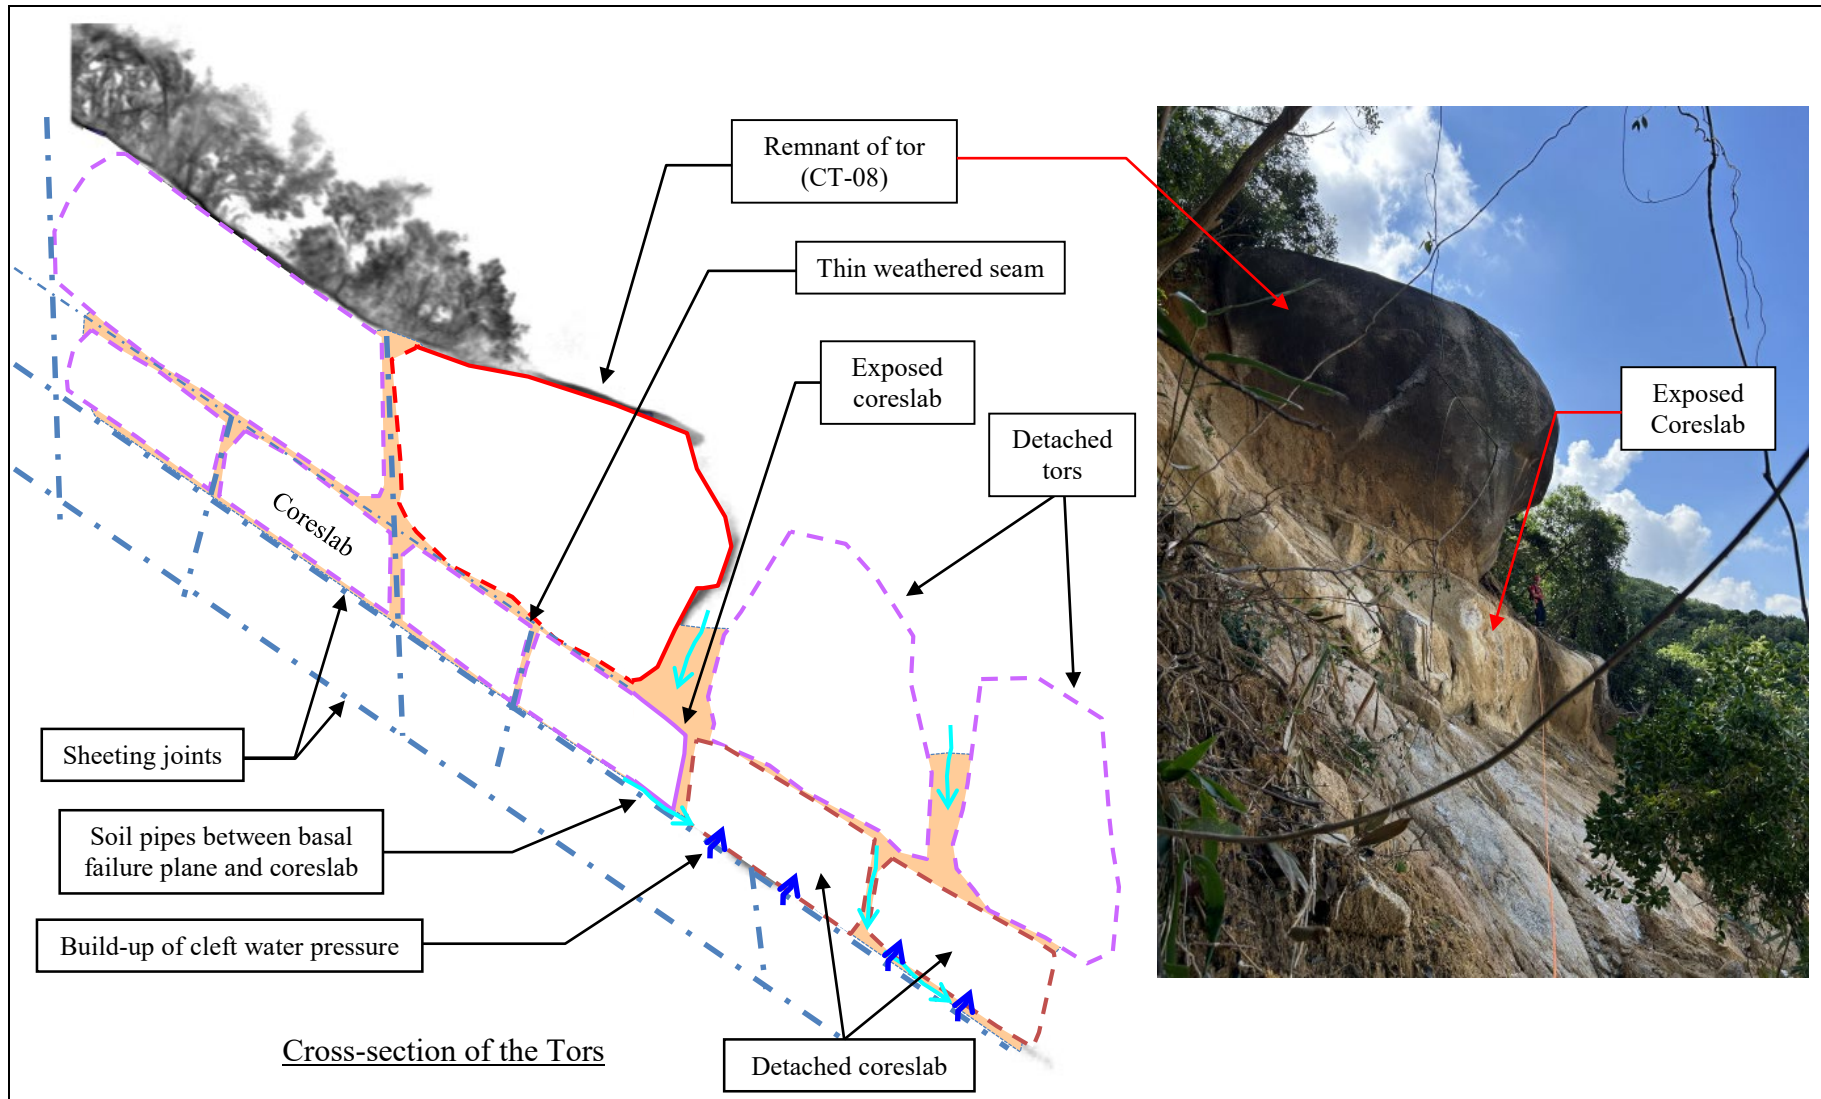
Figure 6.21 Ground Model for the Crest of the Lower Landslide Scar
