**Detailed Study of the
8 September 2023 Landslides
on the Natural Hillside
above Yiu Hing Road,
Yiu Tung Estate,
Shau Kei Wan**

GEO Report No. 377

Fugro (Hong Kong) Limited

**Geotechnical Engineering Office
Civil Engineering and Development Department
The Government of the Hong Kong
Special Administrative Region**

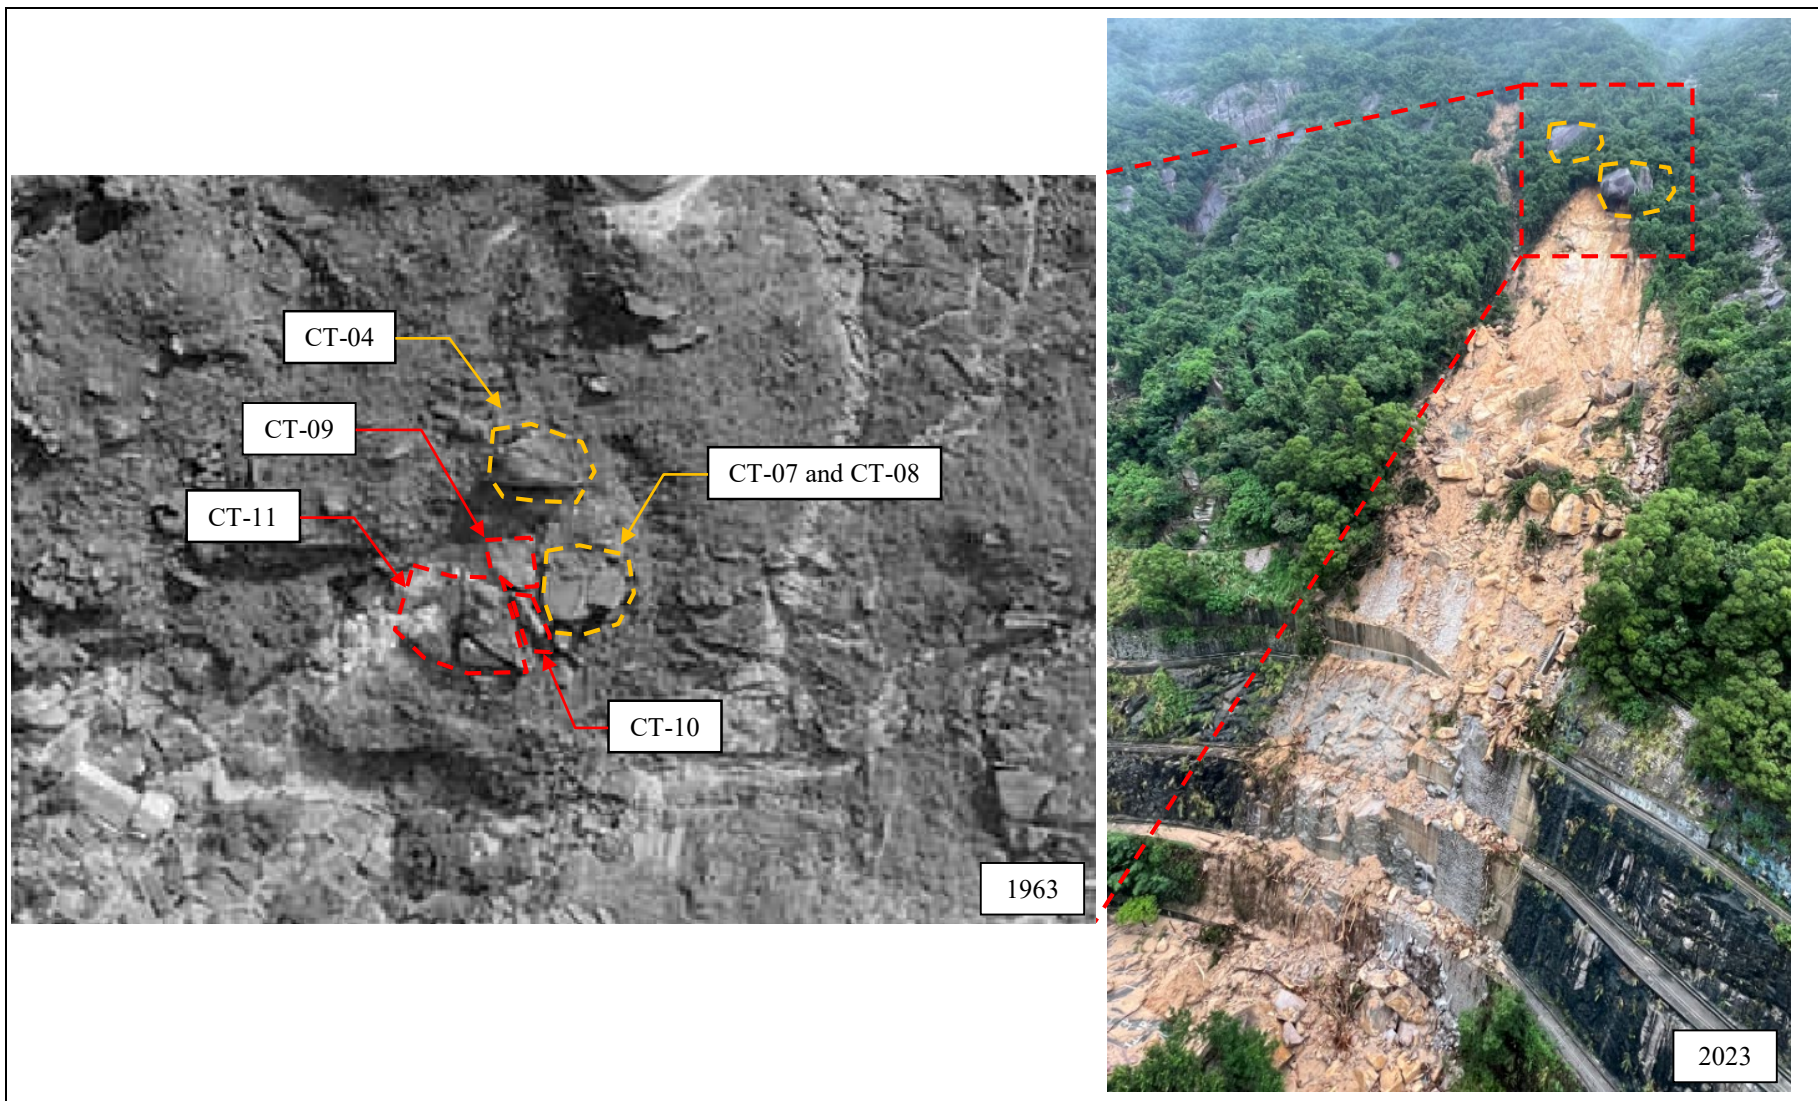
Furthermore, based on the findings from the API and field mapping, as well as the interpretation of the post-landslide UAV photographs, it was determined that a tor, CT-11, was the largest rock block that fell onto Yiu Hing Road following the failure (Figure 6.22).

Figure 6.22 Tors in 1963 Aerial Photographs

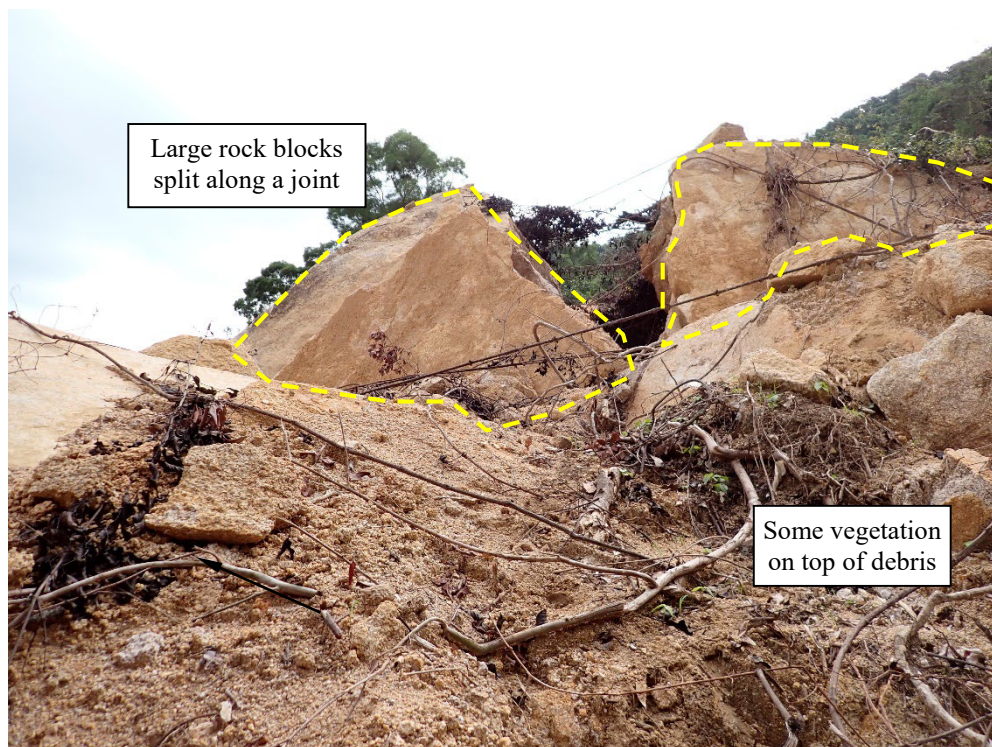
On the cut slopes and near the toe of the lower landslide scar, large rock blocks displayed clear signs of splitting along joints, indicating the forces at play during the landslide (Figure 6.26). Additionally, large tabular coreslabs were observed within the landslide debris, showing the complexity of the material involved. Remnants of concrete dentitions were observed within the landslide debris (Figure 6.27). They were probably part of the in-situ stabilisation works during the Shau Kei Wan East Public Housing Development in the early 1990s (Section 3.3.4).

a) Split Rock Blocks

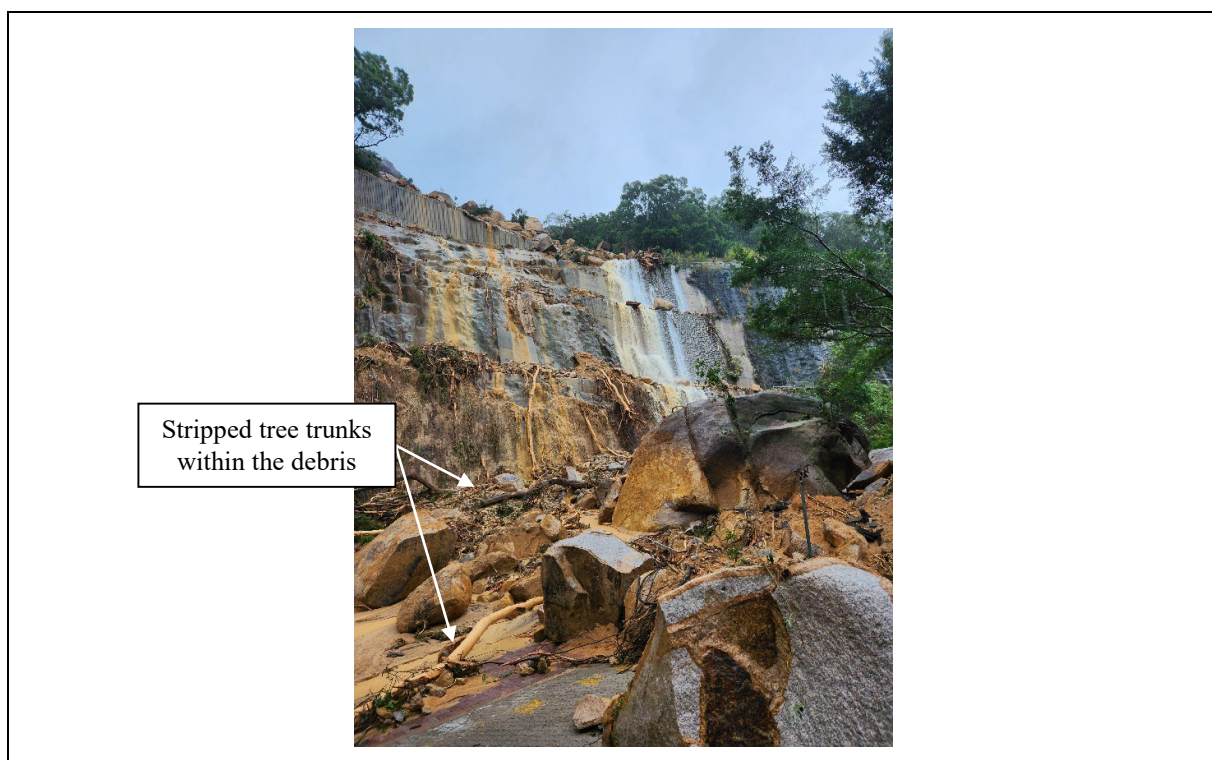
The lower landslide also stripped away most of the original vegetation, with tree trunks and foliage scattered across the debris field (Figure 6.28). Isolated rafts of vegetation were observed at the lower landslide scar. Minor damages also observed on the cut slopes (Figure 6.29).

Figure 6.28 General View of Landslide Debris at the Toe of the Landslide Site (Photograph taken on 8 September 2023)

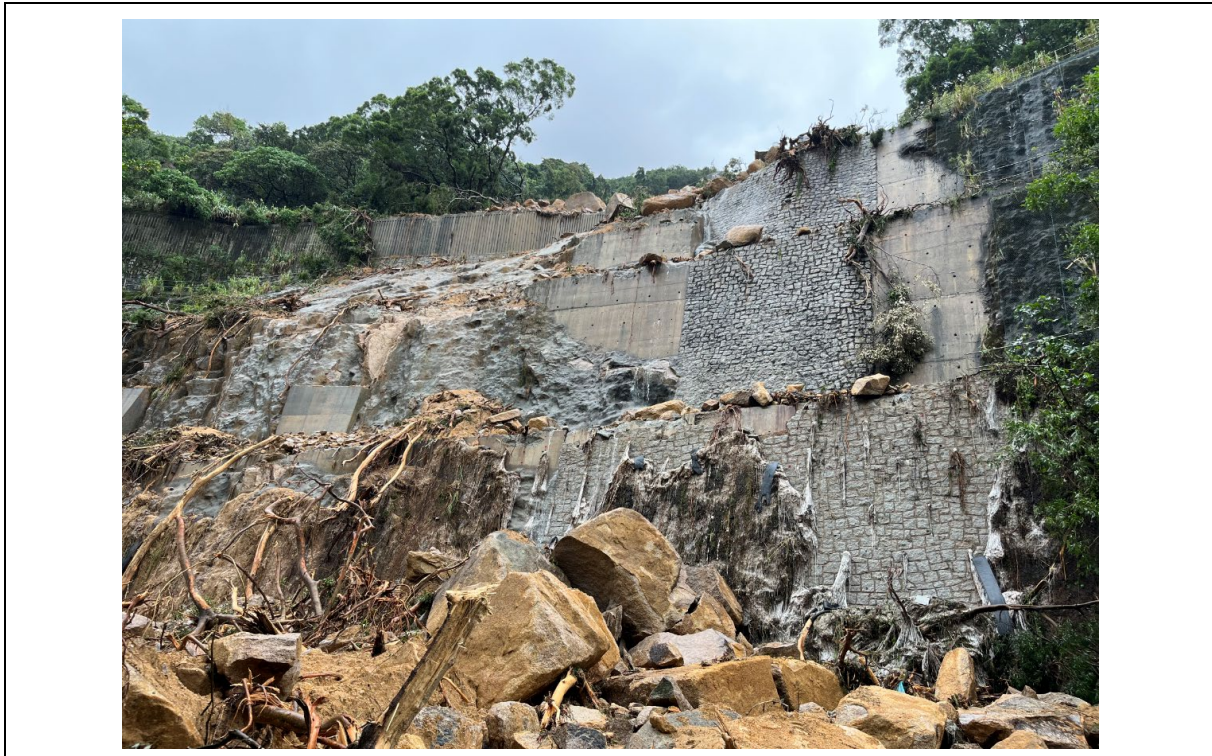
Figure 6.29 General View of Landslide Debris on the Cut Slope (Photograph taken on 9 September 2023)

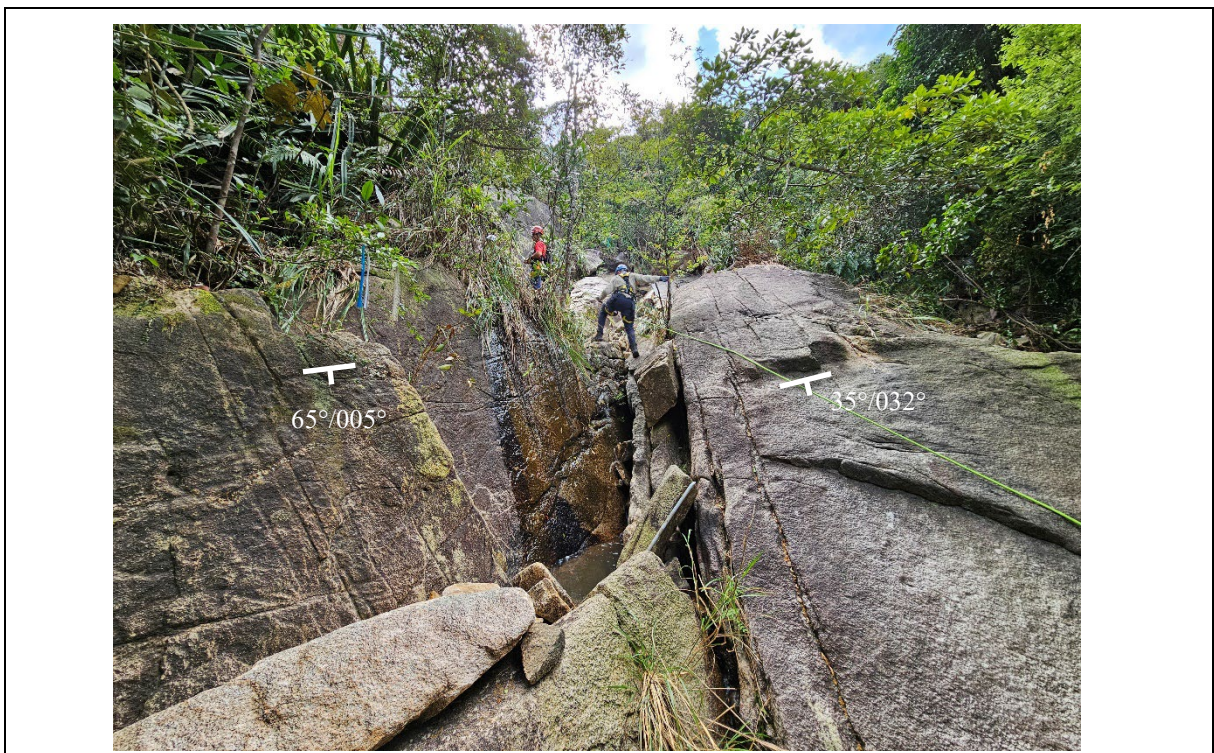
The hydrogeological conditions at the site were assessed by mapping the rocky stream course along the western flank. Exposed bedrock features in this area were inspected and their prominent joint sets were measured with typical orientations of $65^{\circ}/005^{\circ}$, $80^{\circ}/262^{\circ}$, $75^{\circ}/354^{\circ}$ and $35^{\circ}/032^{\circ}$ (Figure 6.31). In addition, steeply inclined open sub-vertical east-west striking rock joints at the rocky stream course were observed adjacent to the lower landslide scar (Figure 6.32).

Figure 6.31 Persistent Planar Joints Exposed along the Rocky Stream Course
(Photograph taken on 26 September 2023)

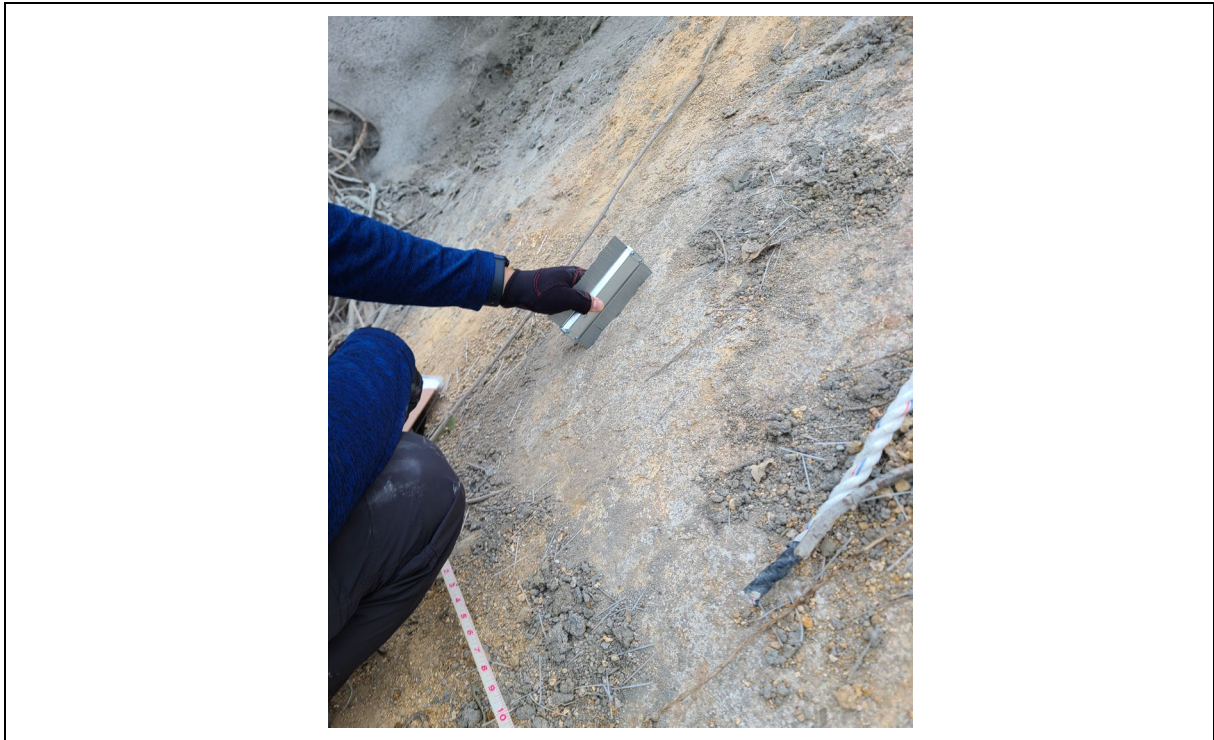
Field measurements of surface roughness have been made on the accessible portion of the exposed sheeting joint in the lower landslide source area. The measurements were made using a 100-mm long profilometer (Barton comb) (Figure 8.5). The corresponding JRC was determined based on a visual comparison with typical roughness profiles given in Barton & Choubey (1977) and the results ranged from 6 to 14. Given the scale of the exposed sheeting joint, a number of 5-m and 10-m long profiles were also extracted from a digital photogrammetric model of the landslide scar for further assessment of joint roughness and JRC (Figure 8.6) with reference to Du et al (2022). The JRC determined in this way ranged from 4 to 20. Records of surface roughness measurement and JRC are enclosed in Appendix D.

Figure 8.5 Field Measurements of Surface Roughness Using a Profilometer

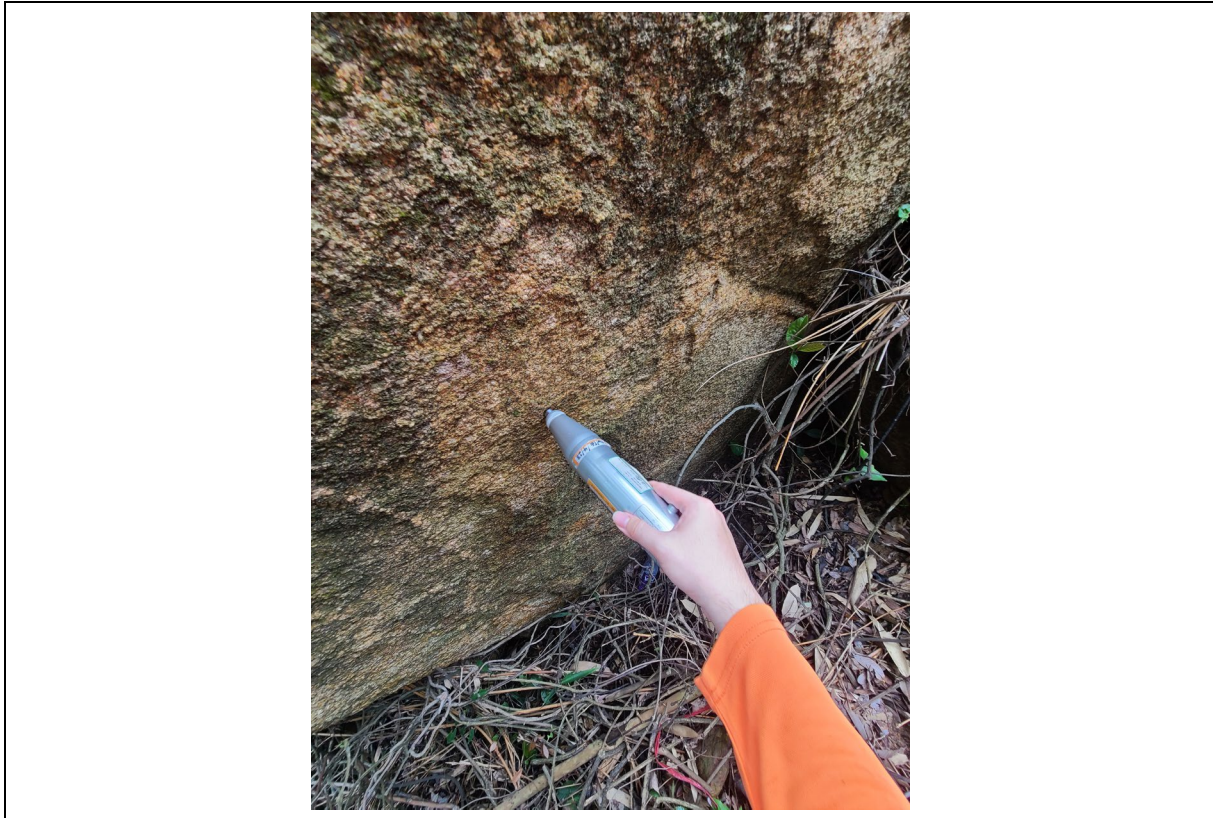
The JCS was determined by collecting Schmidt hammer readings (Type N) on rock outcrops and tors to assess the strength of the weathered rock joint, as well as on fresh drill cores to assess the strength of unweathered intact rock (Figure 8.7). The Type N hammer readings (R_N) were then converted to Type L readings (R_L) (Look, 2014) to obtain the JCS based on the graphical method proposed by Deere & Miller (1966). Table 8.3 summarises the JRC and hammer readings (measured and converted) on both weathered and unweathered rocks.

Figure 8.7 Schmidt Hammer Testing on a Tor

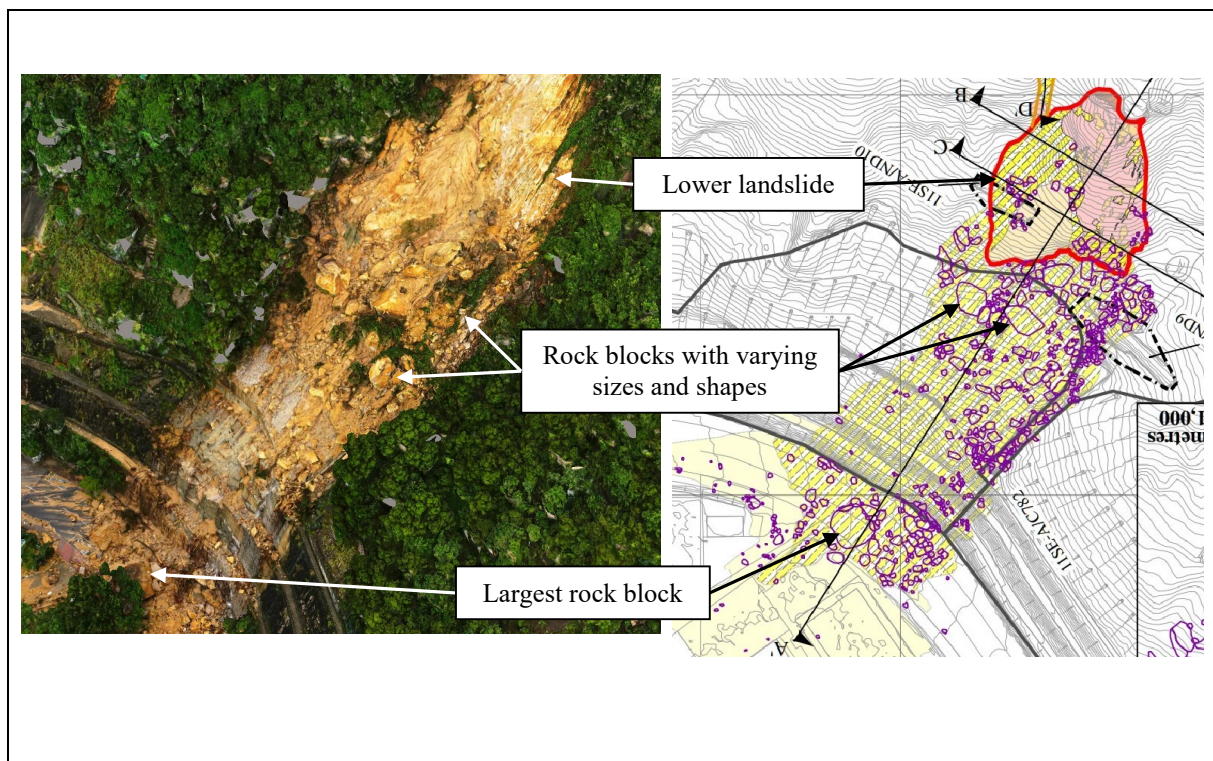
The largest fallen rock block, situated at Yiu Hing Road, measured approximately 11.5 m × 11 m × 5 m and weighted about 1,700 tonnes (Figure 6.25). In addition, there were several large rock blocks, ranging from 6 m to 10 m in length and scattering over the cut slopes, along with numerous smaller rock blocks measuring between 3 m and 5 m. Many of these rock blocks showed signs of weathering and staining, indicating that they had cropped out before the landslide occurred.

Figure 8.12 Fallen Rock Blocks of Varying Sizes and Shapes Deposited over Slope Nos. 11SE-A/CR781 and 11SE-A/C782 and Yiu Hing Road

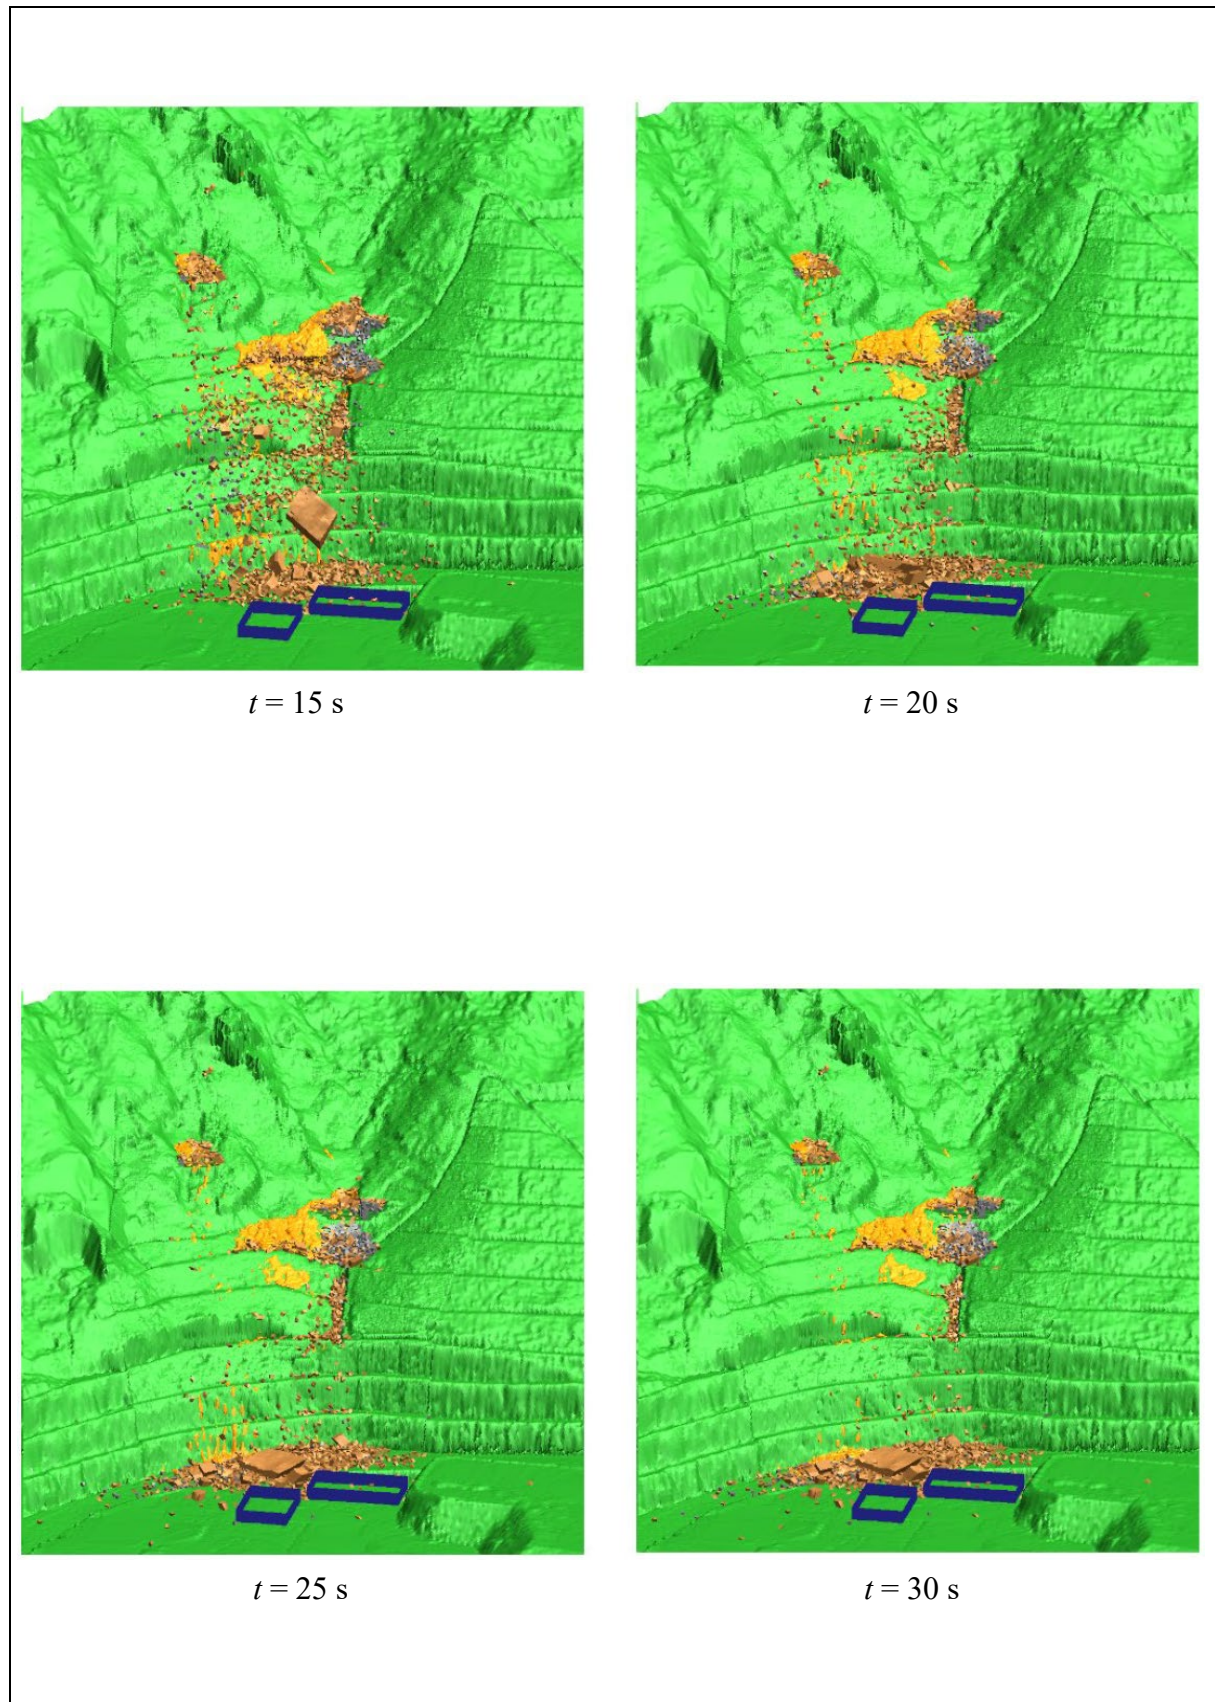
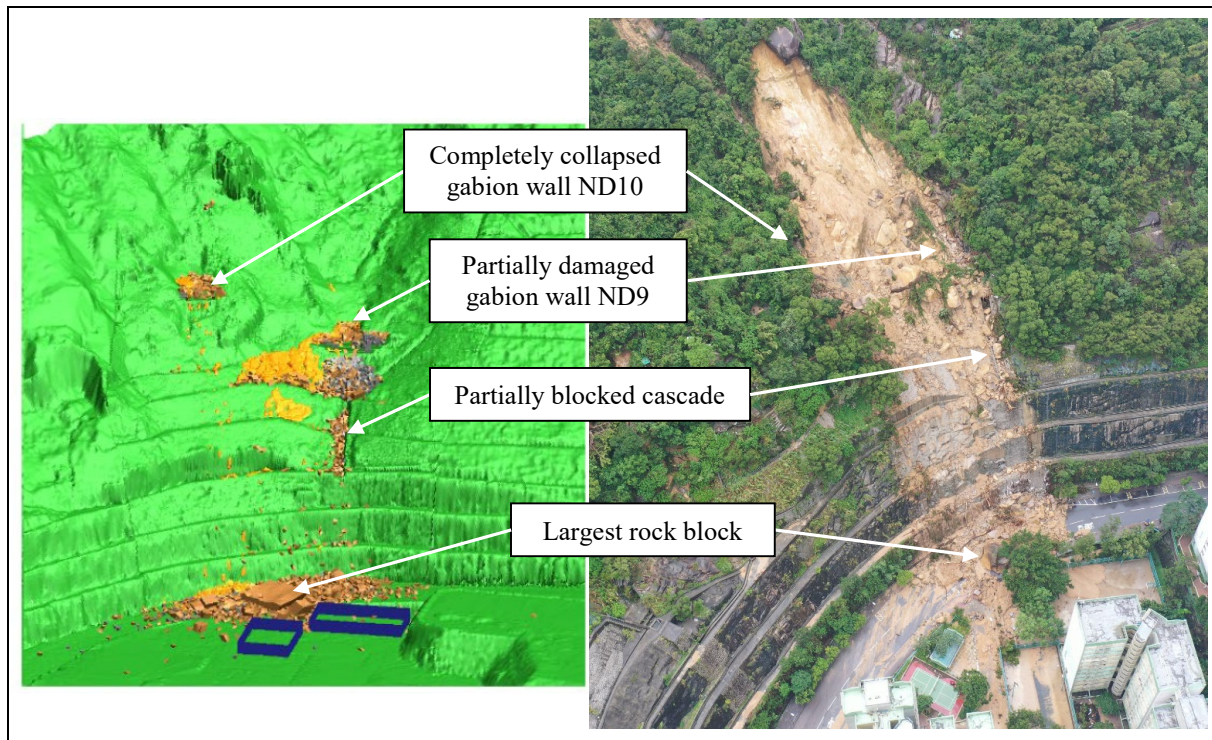
Figure 8.14 Simulation of the Lower Landslide (Sheet 2 of 2)

Figure 8.14 depicts the simulated movement of the landslide debris over time, from the onset of the landslide ($t = 0$ s) to the final deposition state ($t = 30$ s). The figure illustrates that the majority of the landslide debris reached its final deposition state by $t = 25$ s. The LS-DYNA simulation, enclosed in Appendix E, effectively captures several key features of the landslide event (Figure 8.15), including:

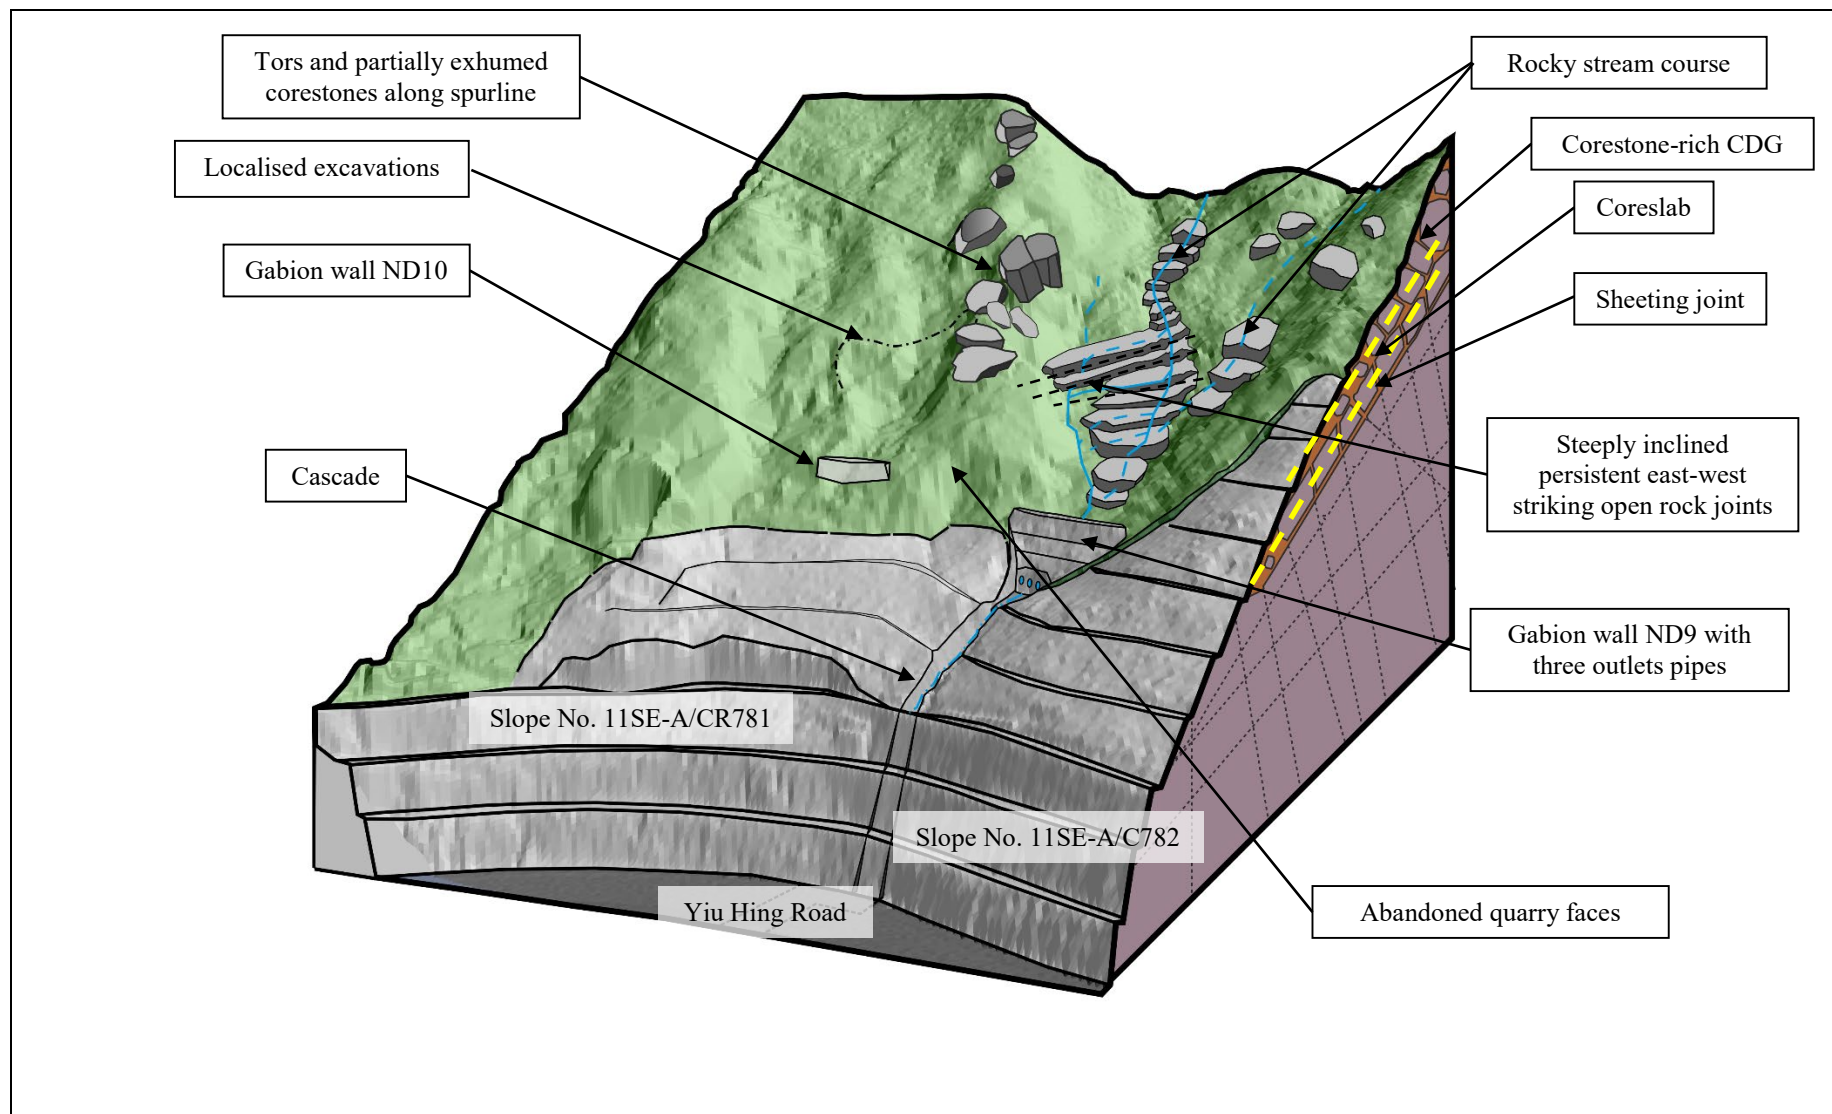
Figure 9.1 Ground Model - Before the Landslides

Figures 9.1 to 9.3 illustrate the reconstructed sequence of the events which led to the landslides on 8 September 2023.

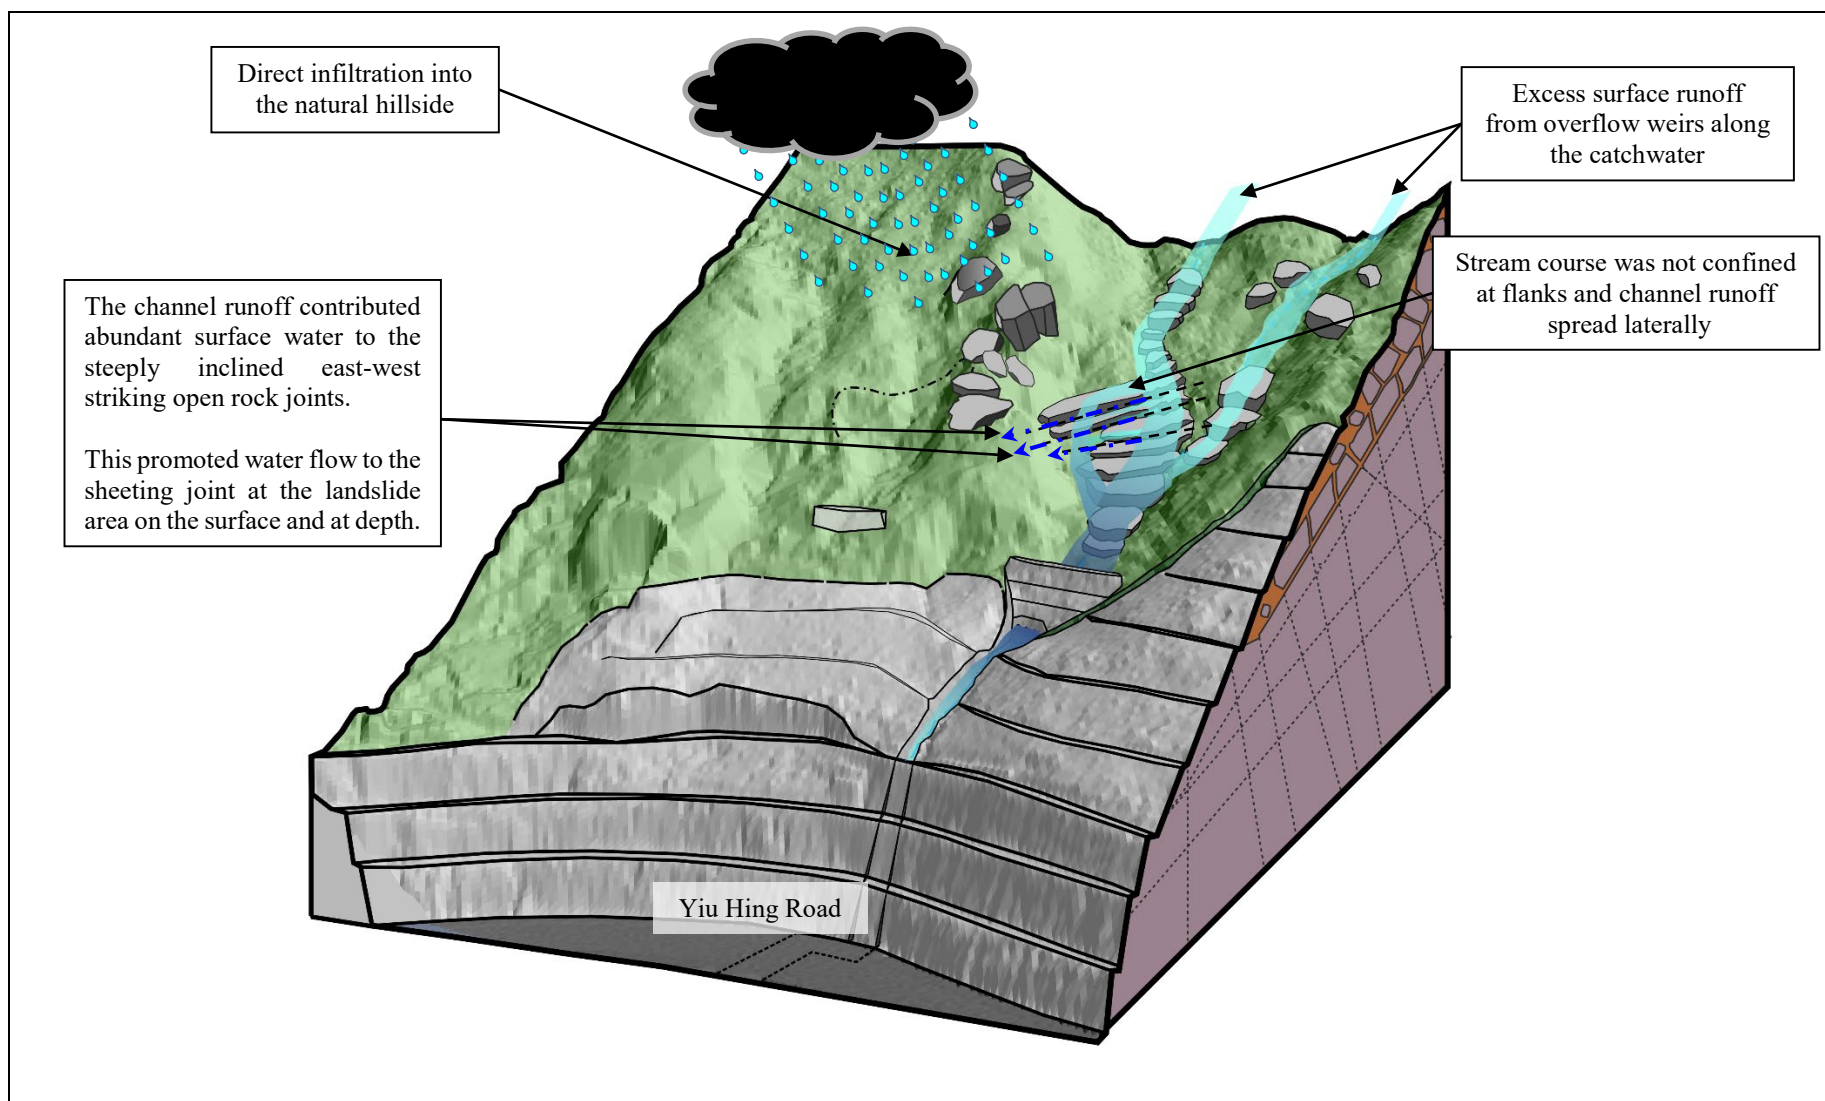
Figure 9.2 Ground Model - During the 7 to 8 September 2023 Rainstorm

Numerical analyses suggest that the rise in the cleft water pressure in the sheeting joint could have contributed to the lower landslide. Two probable sources of water may have led to this increase in cleft water pressure:

- (a) Direct rainwater infiltration: Seepage analyses suggest limited cleft water pressure could develop in the sheeting joint due to direct infiltration into the natural hillside (Section 8.3.2).
- (b) Channel runoff: The rocky stream course along the western flank plays a crucial role in the landslide by providing a concentrated source of water. Furthermore, an ephemeral stream course in the hillside depression on this flank exacerbated the situation (Section 6). Seepage analyses indicate a build-up of transient cleft water pressure in the sheeting joint, with channel runoff seeping into the sheeting joint through the open rock joints (Section 8.3.2).

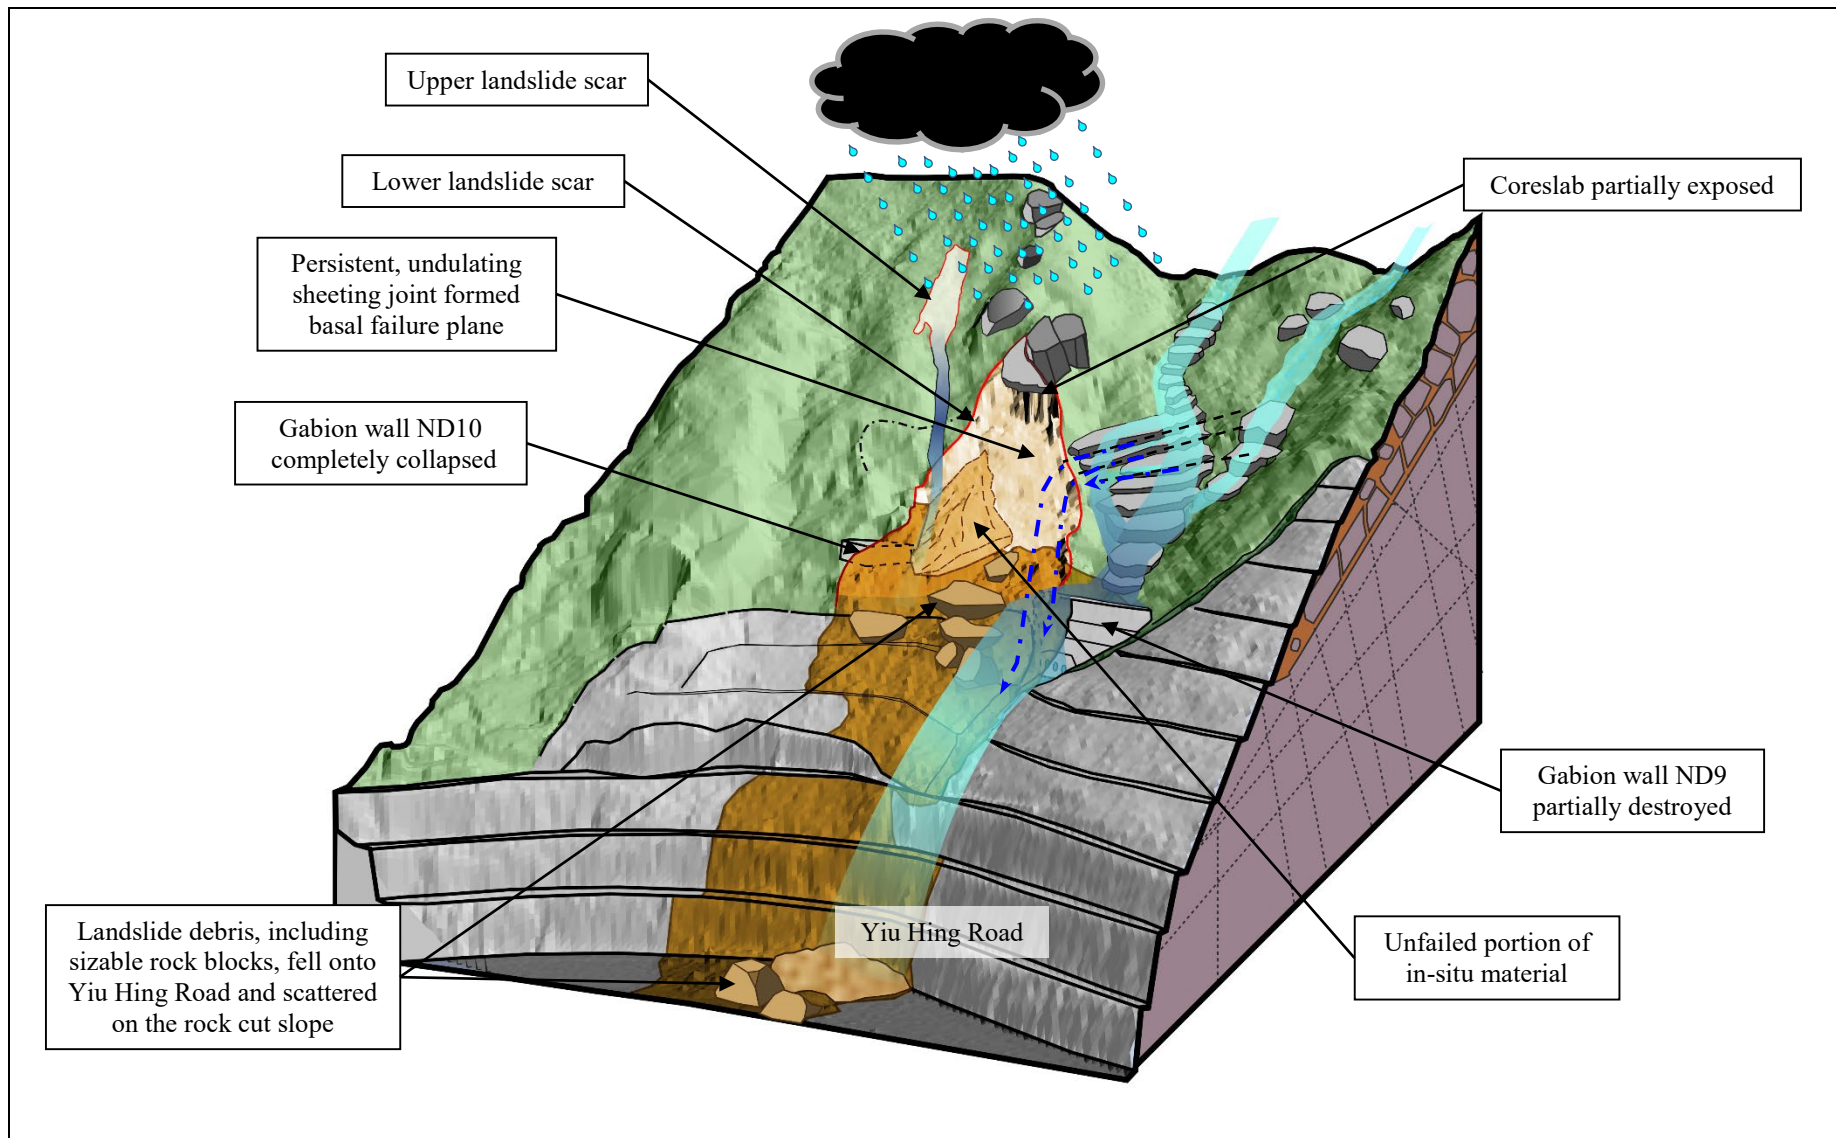
Figure 9.3 Ground Model - After the Landslides

In contrast, the lower landslide was a massive-scale, structurally controlled translational rockslide involving basal failure along a persistent, locally stepped, undulating to planar sheeting joint, with an estimated failure volume of 3,900 m³. This type of failure is unusual and is believed to be caused by a combination of several contributory factors specific to the location.

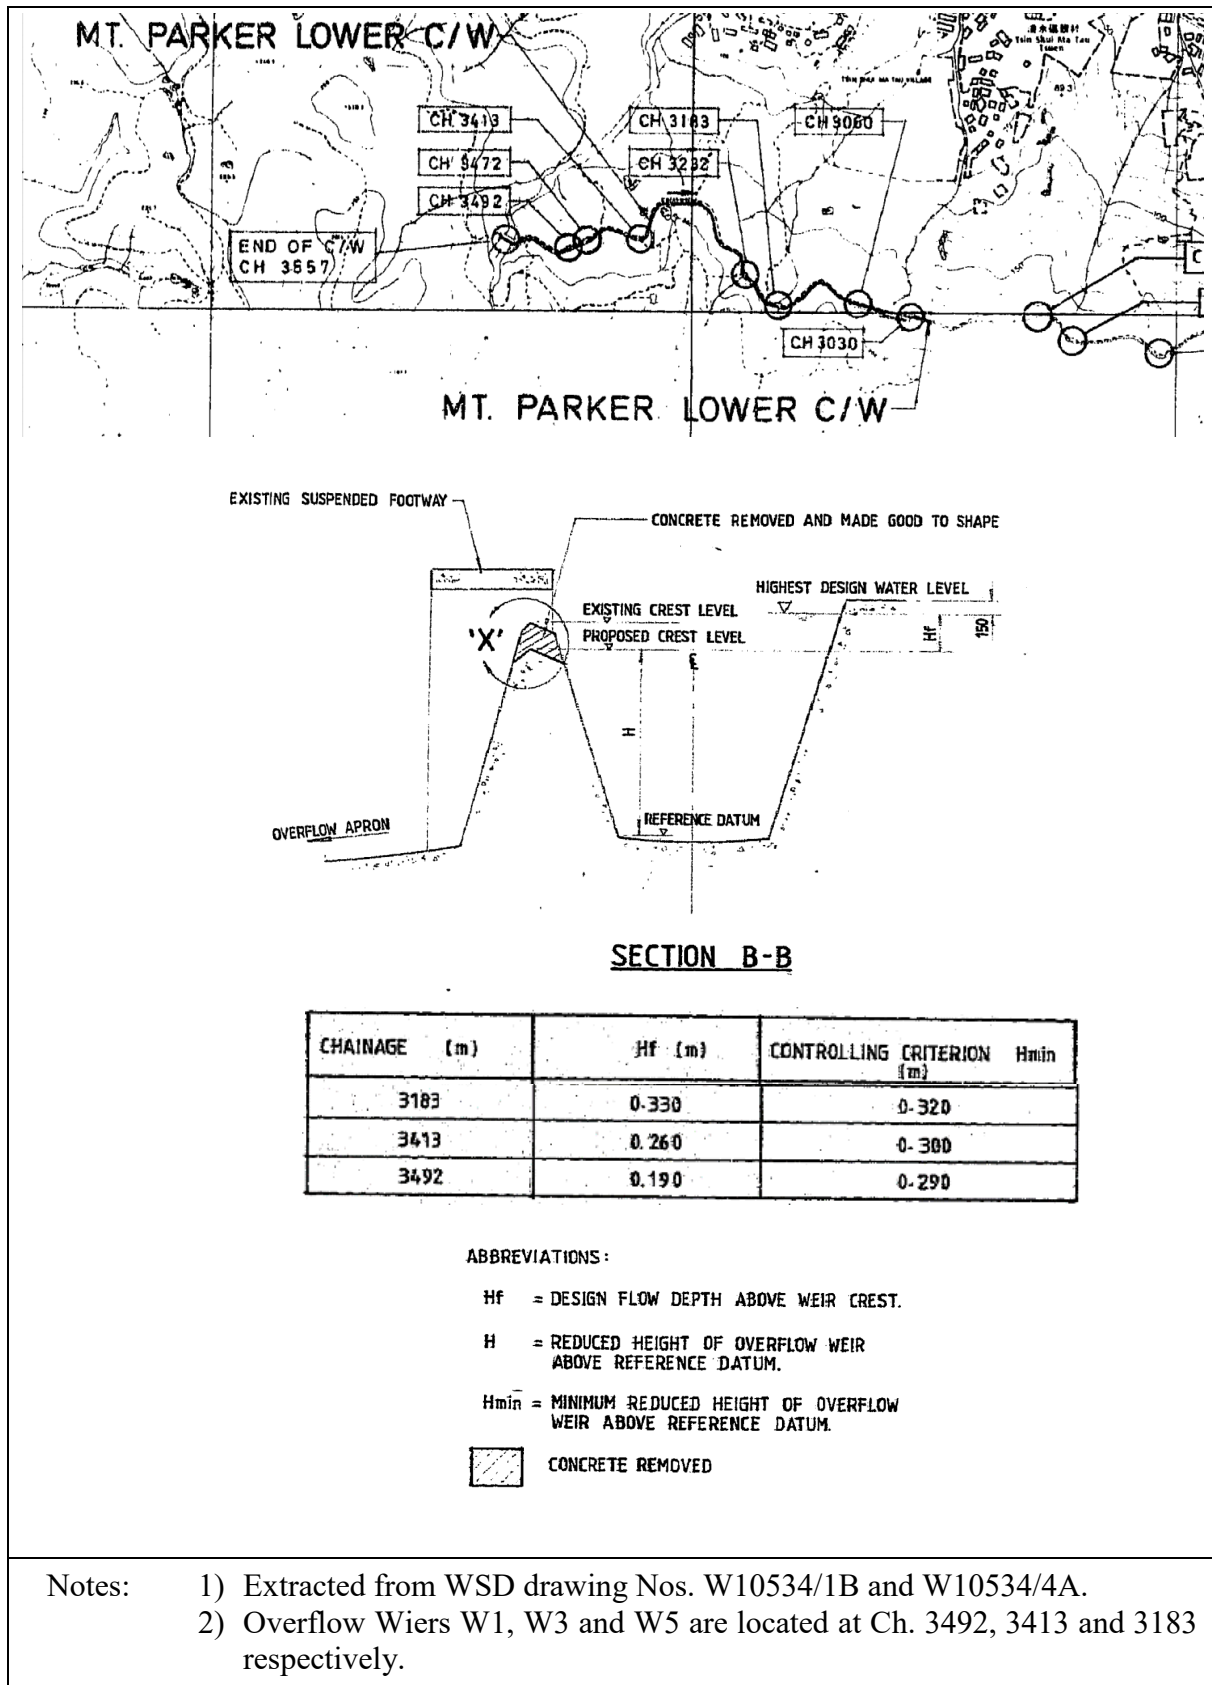
Figure C3 Record Drawings showing Modifications of Overflow Weirs W1, W3 and W5

- (a) Overflow weirs W1, W3 and W5 were not modified until around 1995, and
- (b) The catchwater was not constructed before 1945, while all else remains the same.
