**Detailed Study of the
8 September 2023 Landslides
on the Natural Hillside
above Yiu Hing Road,
Yiu Tung Estate,
Shau Kei Wan**

GEO Report No. 377

Fugro (Hong Kong) Limited

**Geotechnical Engineering Office
Civil Engineering and Development Department
The Government of the Hong Kong
Special Administrative Region**

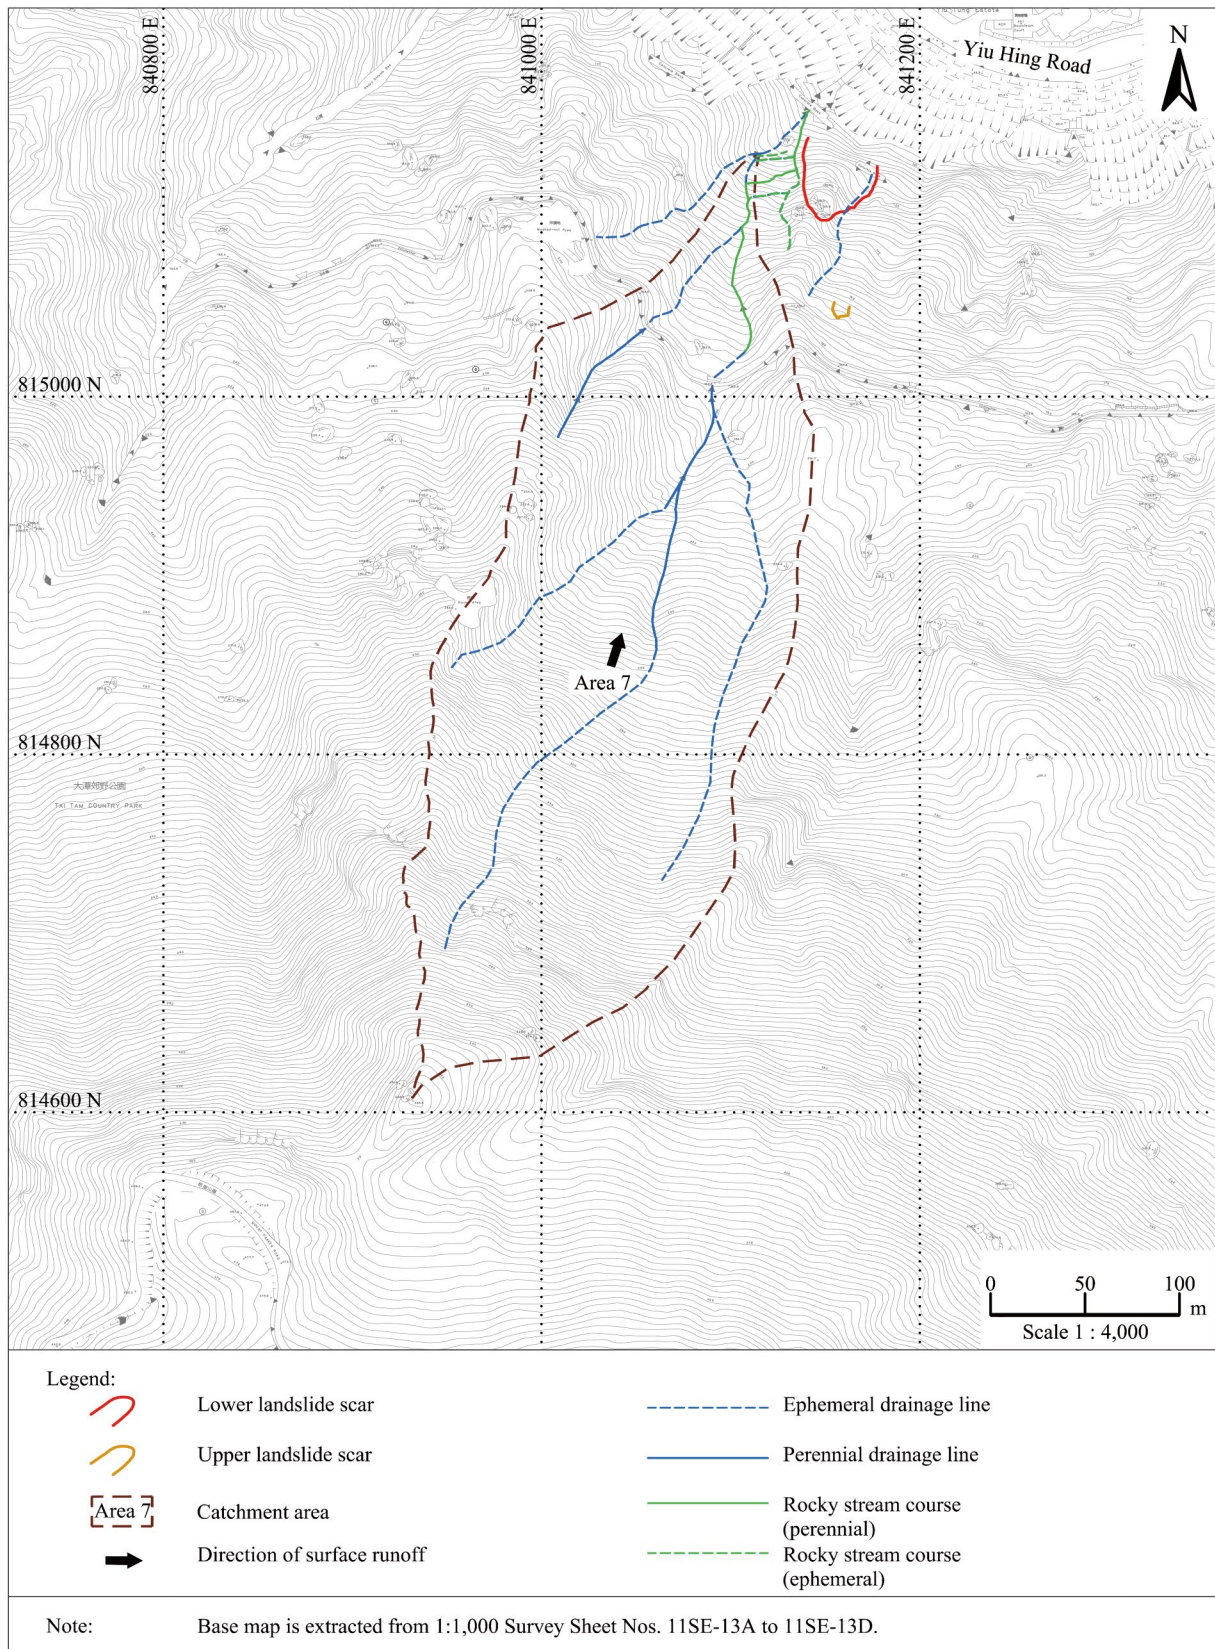
Figure C5 Catchment Area without a Catchwater

The catchment area (Area 7) considered in the second hypothetical scenario is shown in Figure C5.
