# **RAINFALL AND LANDSLIDES IN 1984**

**GEO REPORT No. 1**

**J. Premchitt**

**GEOTECHNICAL ENGINEERING OFFICE  
CIVIL ENGINEERING DEPARTMENT  
HONG KONG**

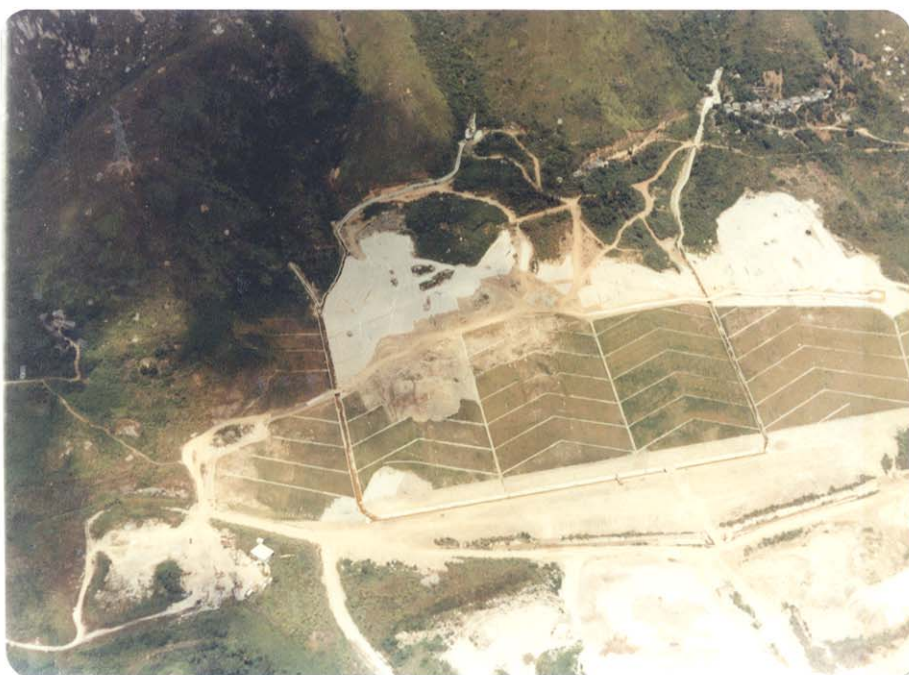
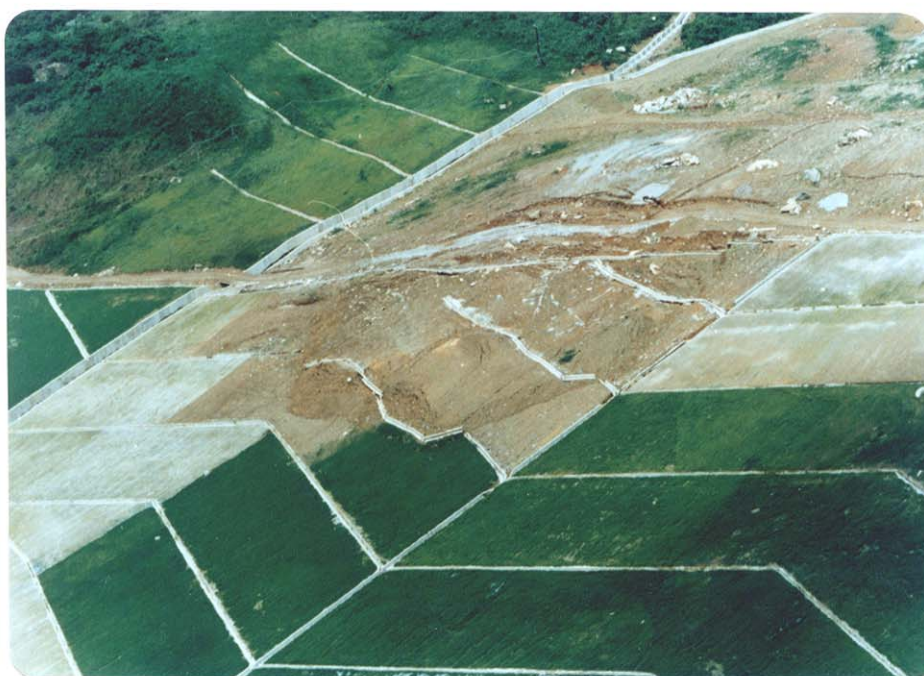
Plate 35 : Negative No. API 466/5      Date : 1.8.84

(Continuing major movement of soil cut slope, Plates 35 & 36)

seen in Plates 35 and 36. The persistent occurrence of slope instability has affected the original planned use of Area 19. One possible cause of the prolonged instability is that formation of the borrow area has disrupted the existing subsurface and surface drainage pattern.

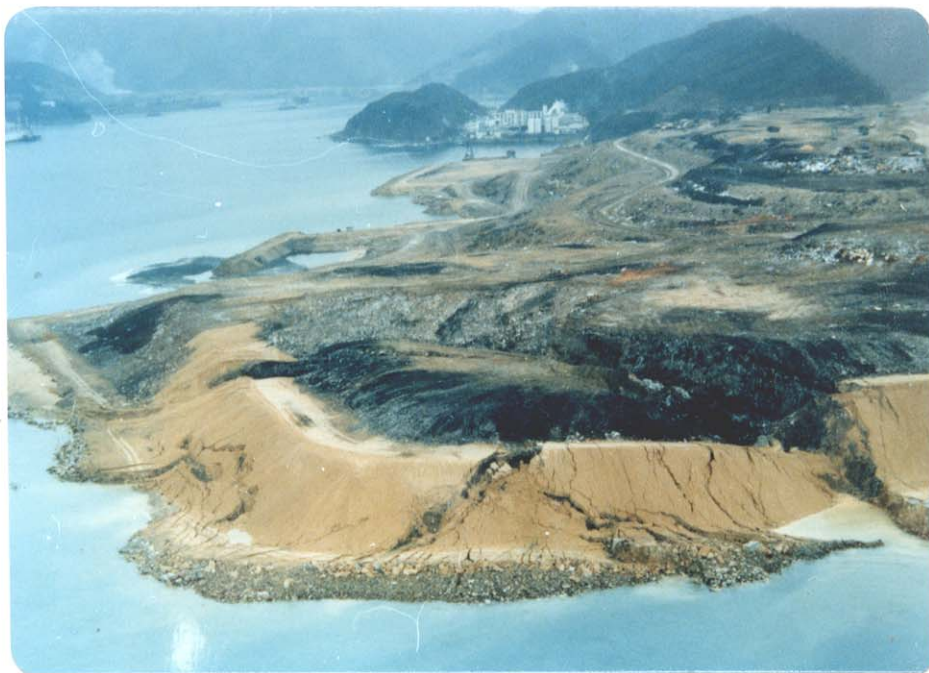
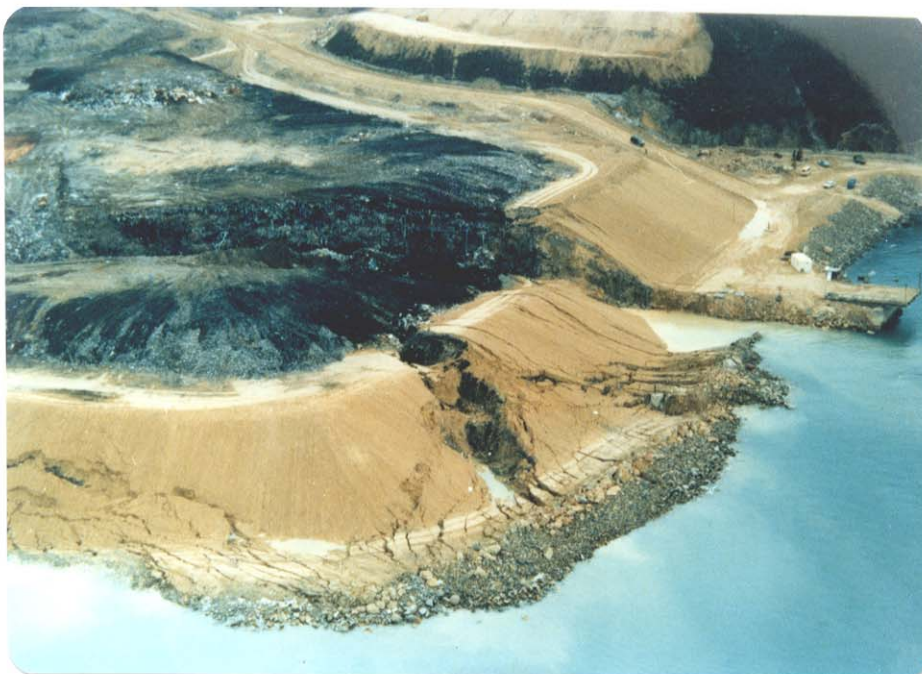
Plates 37 & 38 - Junk Bay Controlled Tip

(Date : 18th March, major failure of controlled tip on top of soft marine clay, Plates 37 & 38)

A major failure involving 500,000 m<sup>3</sup> of material occurred on 18th March, 1984 when the tip had been built up to a height of +22 mPD. Maximum movements recorded were 8 m vertically and 20 m horizontally. Aerial views of the failure are given in Plates 37 and 38. Details of these movements are discussed in Advisory Report ADR 17/84 (Powell et al, 1984).
