HONG KONG RAINFALL AND LANDSLIDES IN 1988

GEO REPORT No. 5

J. Premchitt

**GEOTECHNICAL ENGINEERING OFFICE
CIVIL ENGINEERING DEPARTMENT
HONG KONG**

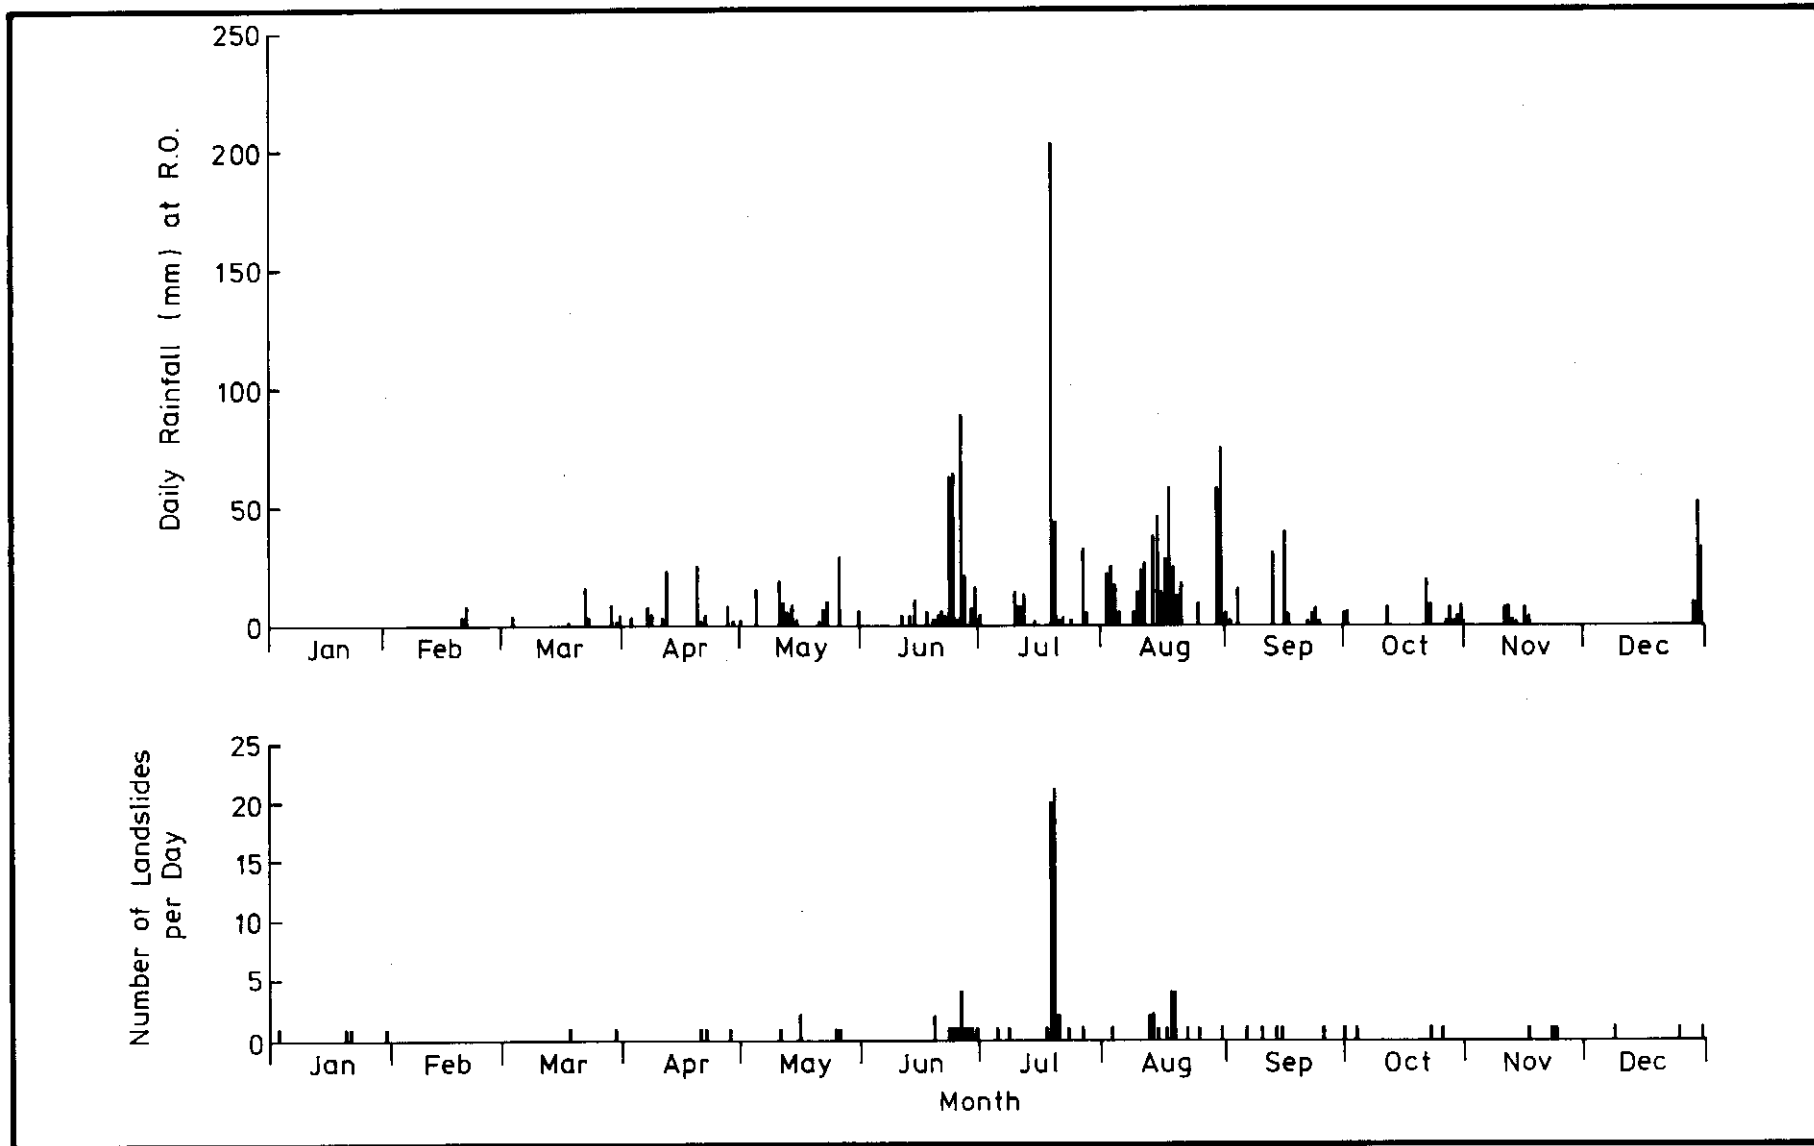
Figure 3 - Daily Rainfall and Distribution of Number of Landslides during 1988

A simple relationship between rainfall and landslides is demonstrated by the plot of daily rainfall and daily number of landslide occurrences throughout 1988 in Figure 3. The majority of landslides tend to occur at times of heavy rainfall, in particular during the rainstorm on 19-20th July. The geographical distribution of rainfall also has a considerable influence on the occurrence of landslides in various areas. Figure 6 shows the location of landslides for which dates of occurrence are known (see Section 3.1), imposed on the 24-hour rainfall maps for the corresponding time period for the event on 19-20th July. This rainstorm is noteworthy : it had the highest rainfall of all rainstorms in 1988 (the hourly rainfall was more than 70 mm), and it resulted in 41 incidents out of a total of 157 incidents for the whole year.
