# **HONG KONG RAINFALL AND LANDSLIDES IN 1990**

**GEO REPORT No. 14**

**K.Y. Tang**

**GEOTECHNICAL ENGINEERING OFFICE  
CIVIL ENGINEERING DEPARTMENT  
HONG KONG**

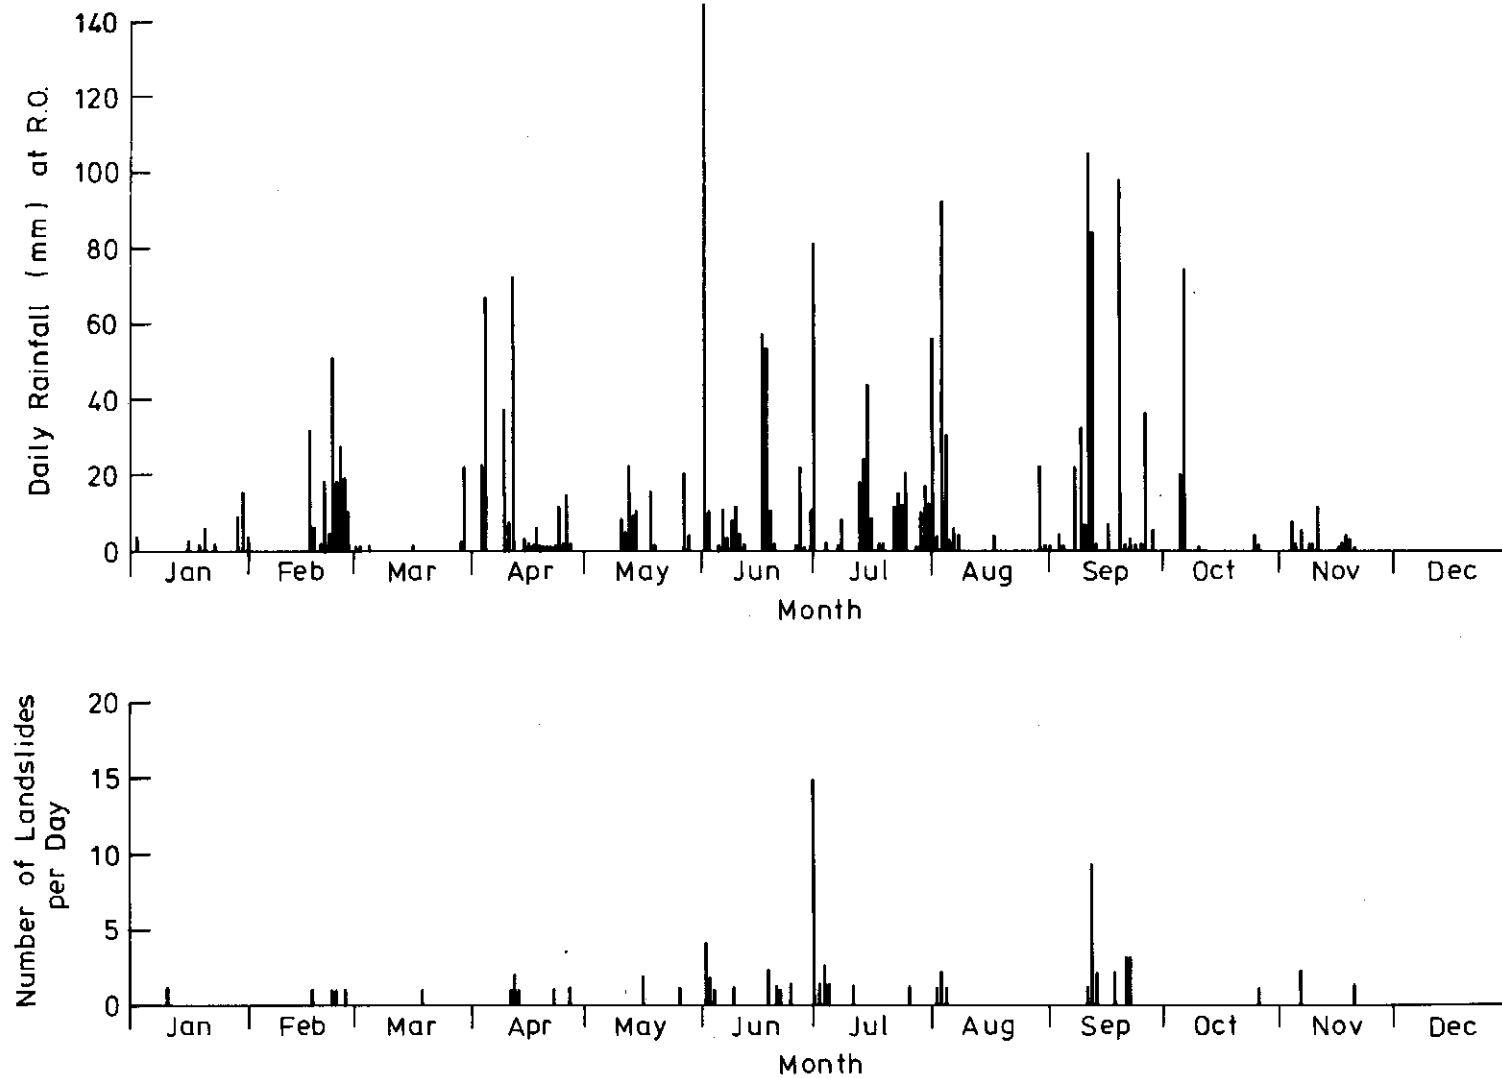
Figure 3 - Daily Rainfall and Distribution of Number of Landslides during 1990

A simple relationship between rainfall and landslide is demonstrated by the plot of daily rainfall and daily number of landslide occurrences through 1990 in Figure 3. The great majority of the recorded landslides occurred at times of heavy rainfall. The geographical distribution of rainfall in the heavy storms also had a considerable influence on the occurrence of landslides in various areas. Figures 6 and 7 show the location of landslides for which dates of occurrence are known (see Section 3.1), imposed on the 24-hour rainfall maps for the corresponding time period for the events on the 30 June to 1 July and 10 to 11 September. These Figures indicate that most of the landslides occurred in those areas which had the highest concentration of rainfall and in squatter areas (particularly East Kowloon).
