REPORT ON THE RAINSTORM OF AUGUST 1982

GEO REPORT No. 26

**GEOTECHNICAL ENGINEERING OFFICE
CIVIL ENGINEERING DEPARTMENT
HONG KONG**

This report was produced in 1982 as a permanent record of the effects of the rainstorms that occurred in the period of 15th to 19th of August 1982 with particular emphasis on the location, type and size of the more serious landslide incidents. It is a factual report and, apart from acknowledging that the landslides were caused by intense rainfall, does not attempt to explain the mechanisms and causes of failure.

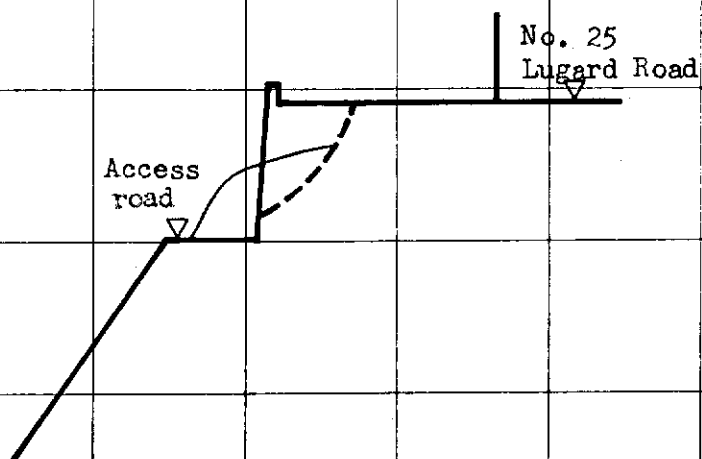
Figure 13

- (b) 25, Lugard Road
(Incident No. GCB 6/8, Figure 13, Plate 15)

25, Lugard Road, HK
(Incident No. GCB 6/8)

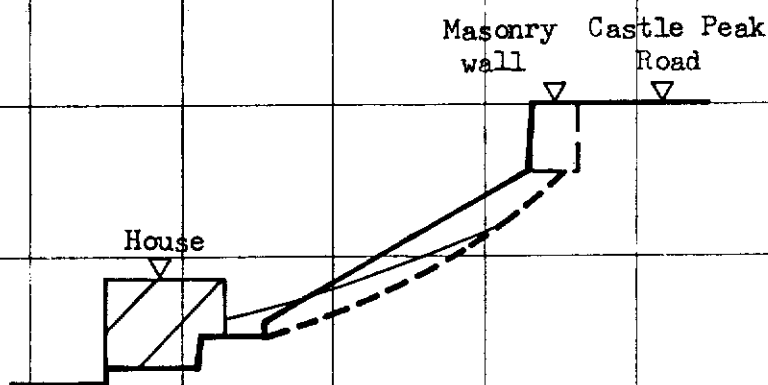
Figure 14

- (c) 9½ MS Castle Peak Road
(Incident No. NT/8/16, Figure 14, Plates 16 and 17)

9½ MS Castle Peak Road
(Incident No. NT/8/16)

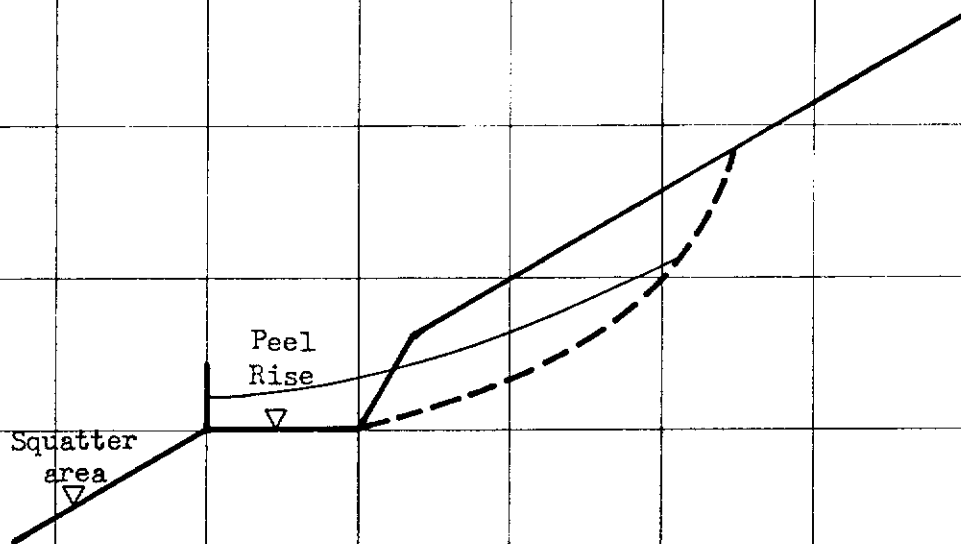
Figure 21

- (a) Peel Rise Squatter Area, Aberdeen
(Incident No. HK/8/16, Figure 21, Plate 26)

Peel Rise Squatter Area, Aberdeen
(Incident No. HK/8/16)

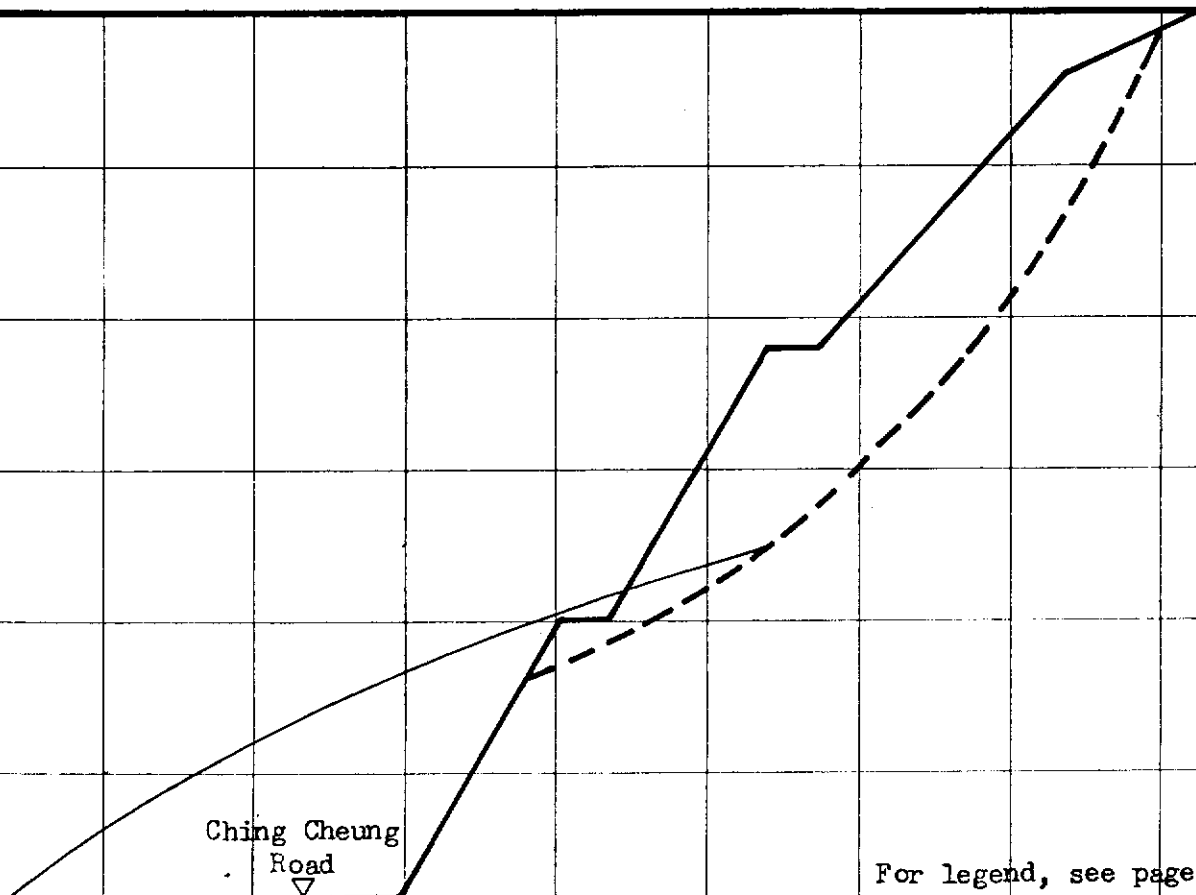
Figure 22

- (b) Ching Cheung Road, Kowloon
(Incident No. K/8/29, Figure 22, Plates 27 and 28)

Ching Cheung Road, Kowloon
(Incident No. K/8/29)

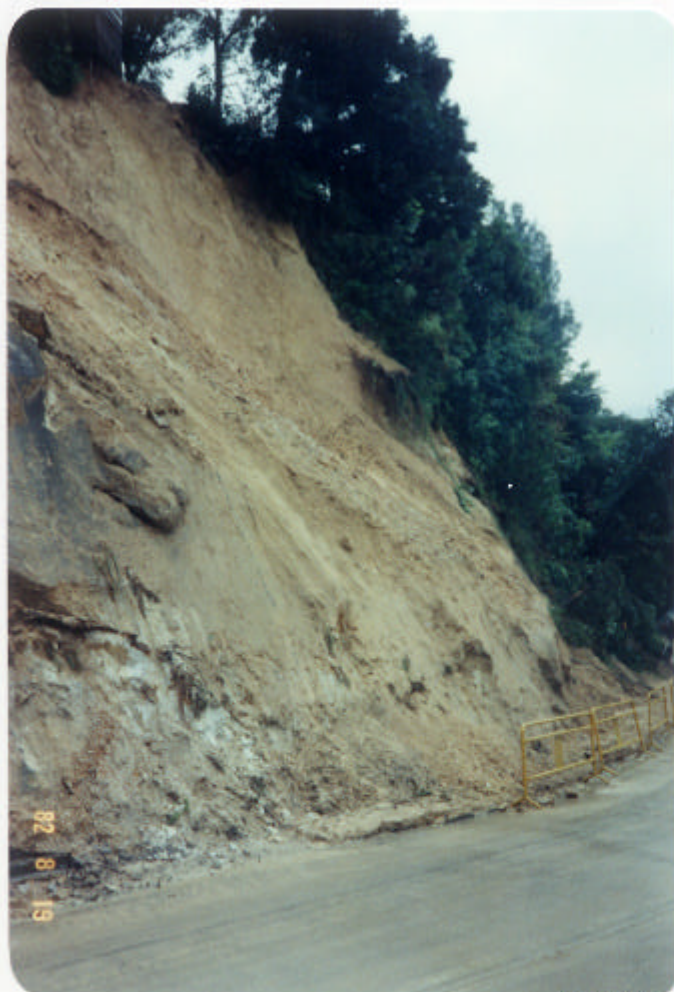
- (b) 13½ MS Castle Peak Road
(Incident No. NT/8/34, Figure 9, Plate 4)

Plate 4 : 13½ MS Castle Peak Road
(Incident No. NT/8/34)

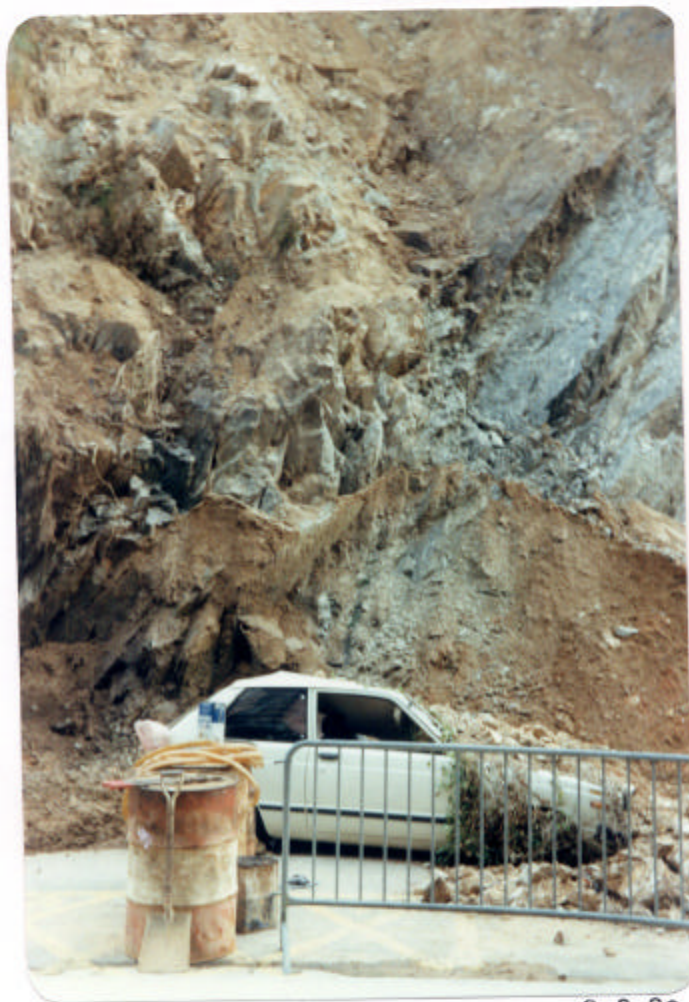
- (d) Shek Tau Street, Tai Wo Hau Estate, Tsuen Wan
(Incident No. NT/8/33, Figure 24, Plate 29)

Plate 29 : Shek Tau Street, Tsuen Wan
(Incident No. NT/8/33)

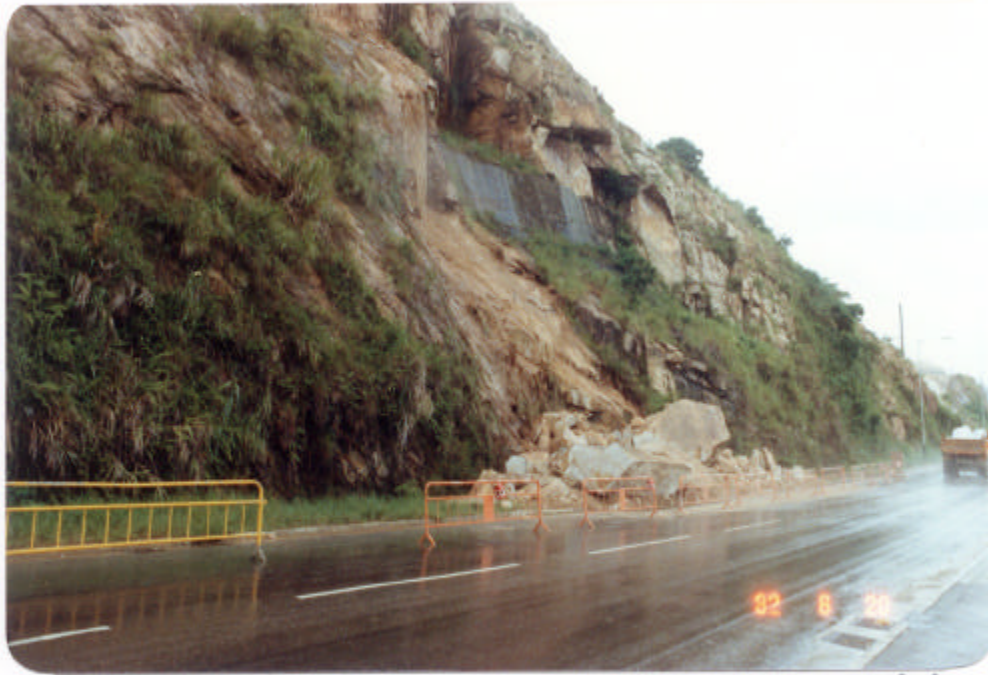
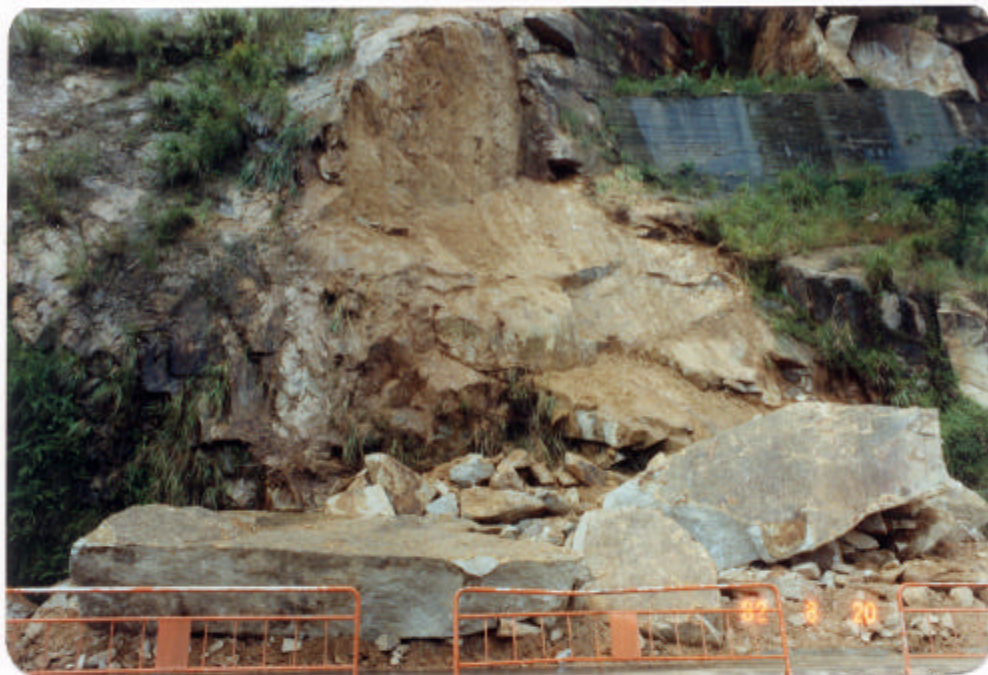
Road TY1 was affected by four landslips within one kilometre of each other. There was significant deterioration of the large failure near the Euroasia site at Chainage 2400 that was initiated by the May rainstorm (Incident No. NT/8/15). A further 4 m movement downslope was noted. Nearby, above the PEPCO Power Station, a similar failure occurred four days after the end of the rainstorm. This resulted in a movement of the slope, mainly between the first and third berms, of up to 1.5 m. This failure appeared to be controlled by relict jointing in the grade IV granite (Incident No. NT/8/44). The other two failures were rockfalls which both resulted in the closure of one lane of Road TY1 (Incident Nos. NT/8/38 and 81, Plates 11 and 12, and Plates 34 and 35).

Plates 32 and 33 : Road TY1, Ch. 2400, Tsing Yi Island
(Incident No. NT/8/15)

: One lane of road closed
