LANDSLIPS CAUSED BY THE JUNE 1983 RAINSTORM

GEO REPORT No. 27

**GEOTECHNICAL ENGINEERING OFFICE
CIVIL ENGINEERING DEPARTMENT
HONG KONG**

**This report was originally produced in August 1984
as GCO Special Project Report No. SPR 1/84**

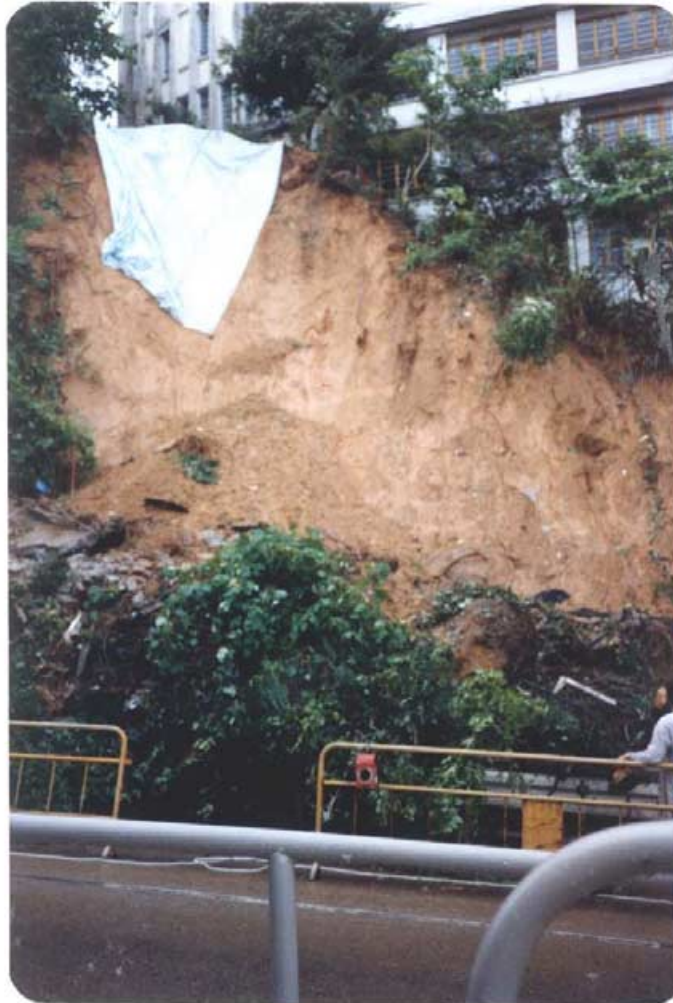
Plate 3 - Stubbs Road near Lingnam College (Incident No. HK 6/22)

1. Major soil cut slope failure.
2. Probably caused by intense infiltration at the top of the slope.
3. Slope was approximately 45° and 10 m high.
4. Stubbs Road was partially blocked by slide debris.

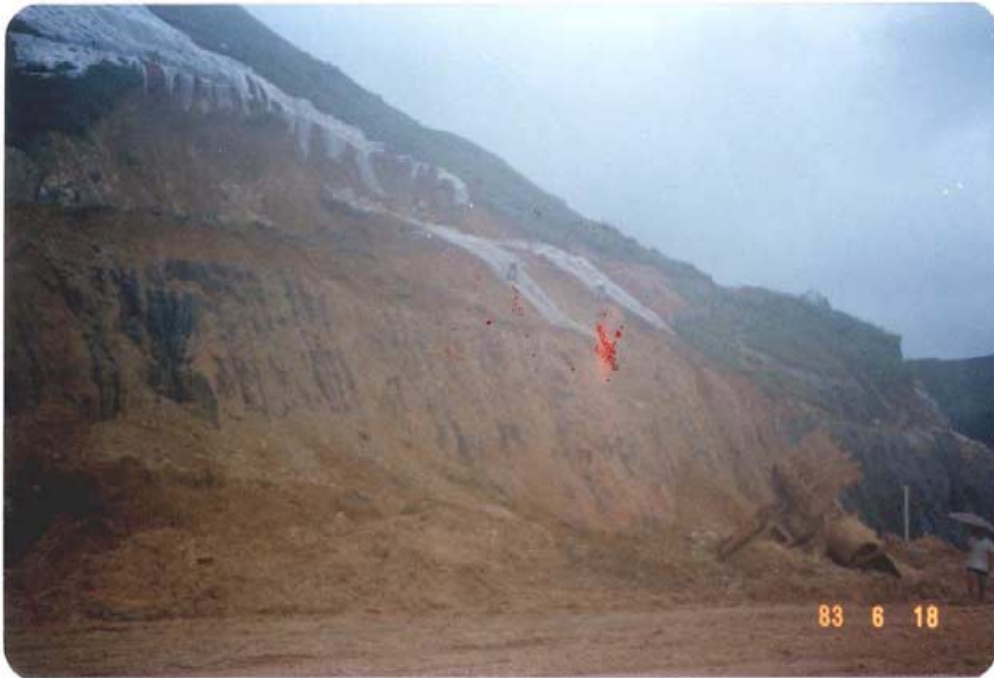
Plate 5 - Ap Lei Chau near Power Station (Incident No. HK 6/43)

1. Major soil/rock cut slope failure.
2. Slope adjacent to WSD access road was under construction and temporarily unprotected.
3. Rainwater infiltrated into the slope via the unlined drainage channels on the slope.
4. A backhoe on the 2nd berm was brought down by the slide debris.

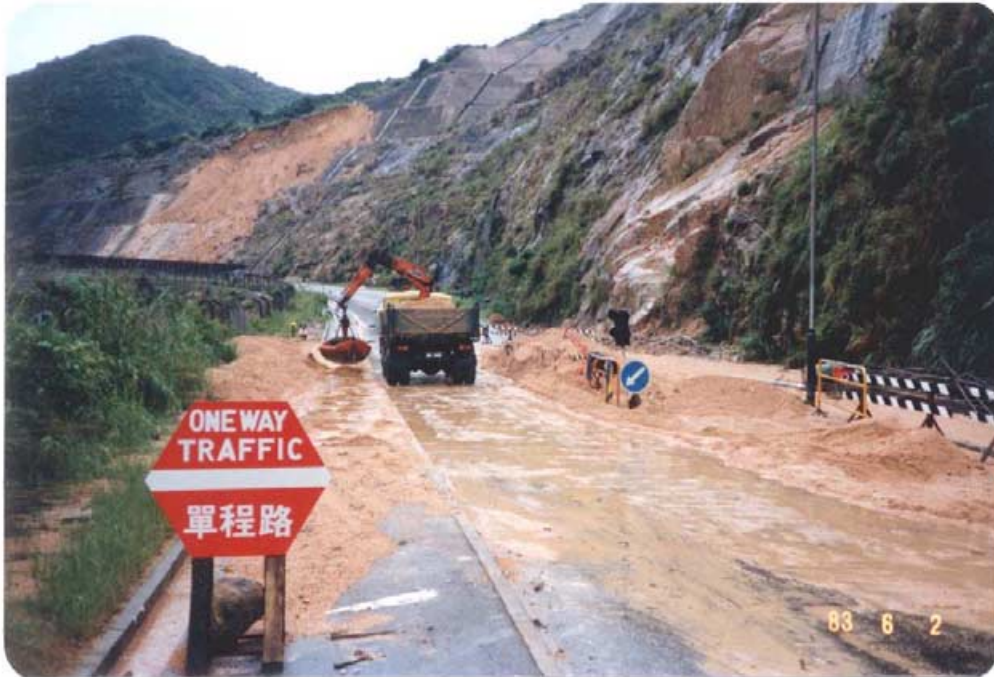
Plate 6 - Tsing Yi Road - PEPCO slope (Incident No. N 6/5)

1. Major soil cut slope failure.
2. Enlargement of a previous failure.
3. Slide debris very fluid and travelled several hundred metres along Tsing Yi Road and collected in the foreground of the picture.
4. PEPCO slope is in the background.
5. Tsing Yi Road was totally blocked.

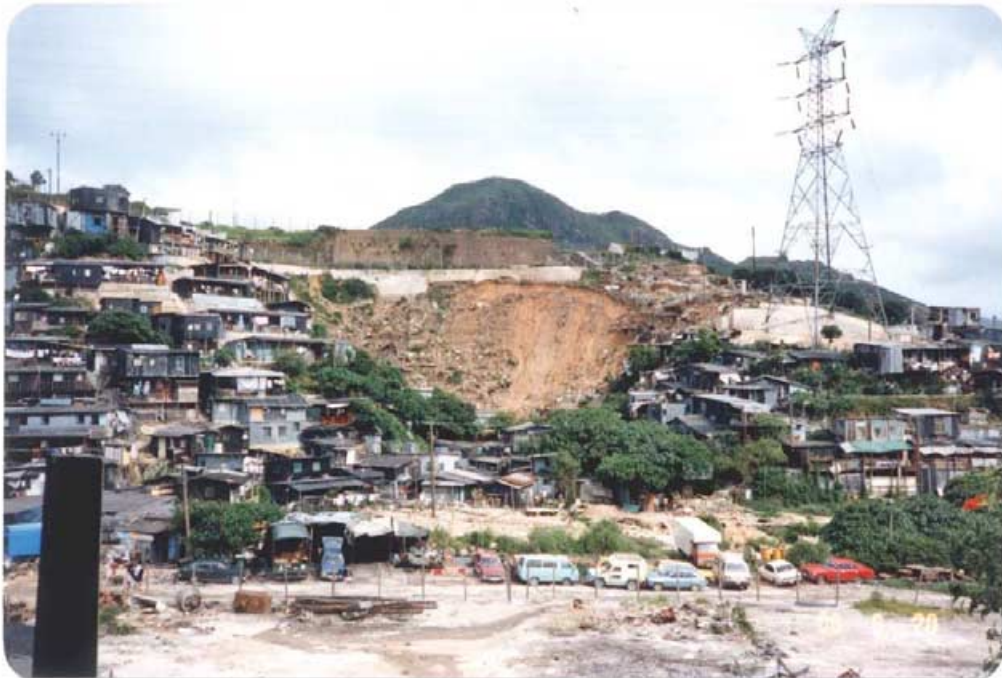
Plate 7 - Chung Ling Tin Village (Incident No. K 6/8)

1. Major soil cut slope failure.
2. Slope failed previously and the present failure was an enlargement of the previous failure.
3. Previous failure was not well protected and the slope was open to infiltration during the June 83 rainstorm.
4. Many squatter huts were damaged and evacuated as a result of the previous failure.

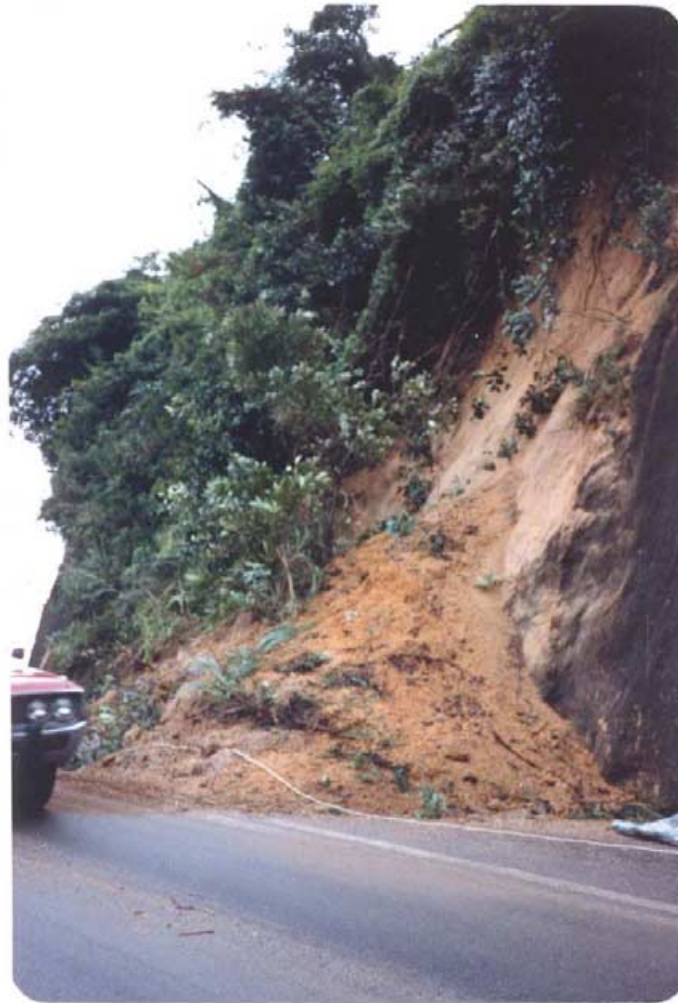
Plate 8 - Tai Hang Road, 100 m up from Junction of Mt. Butler Road
(Incident No. HK 6/26)

1. Minor failure of a steep old soil cut slope.
2. Slope partly chunamed and near vertical at certain areas.
3. Slope situated adjacent to a slope under the LPM (Landslide Preventive Measure) programme whose boundary was extended to include this slope following the failure.
4. Road was partially blocked by the failure debris.

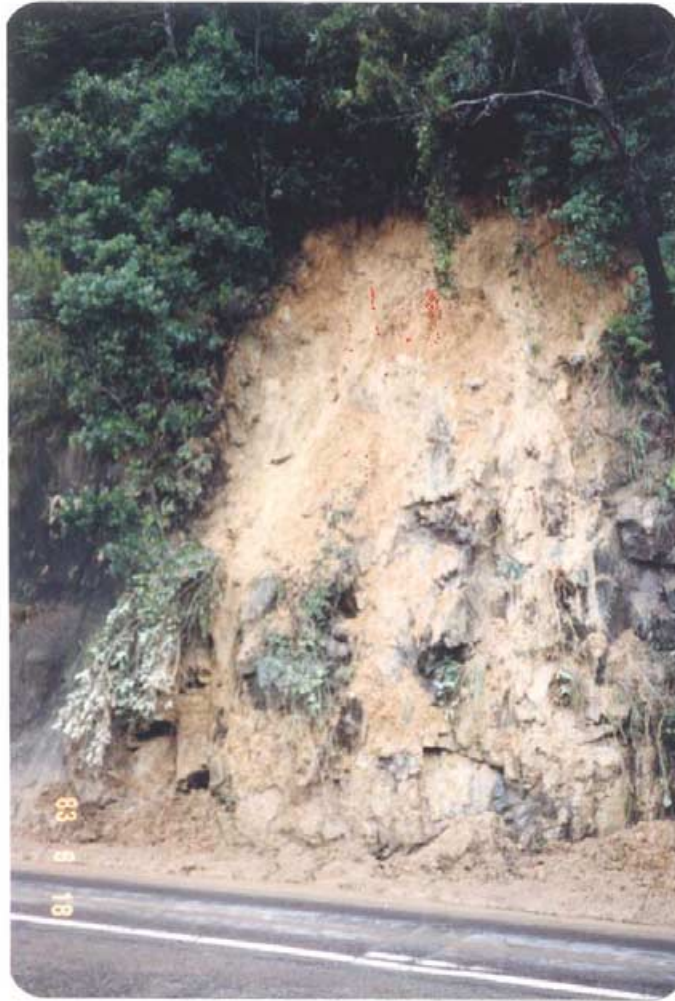
Plate 9 - 45 Repulse Bay Road (Incident No. HK 6/41)

1. Minor soil cut slope failure.
2. Slope old and steep, approximately 60° .
3. Slope failed previously and chunamed as indicated by its concave profile.
4. Road partially blocked.

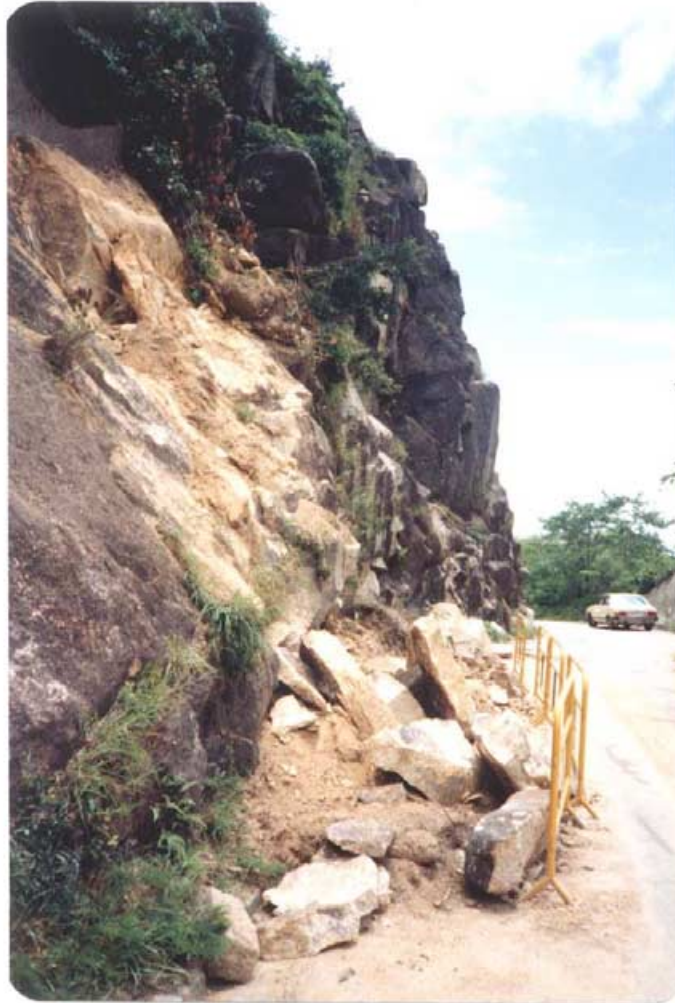
Plate 10 - Chung Hom Kok Road, No. 1 Failure (Incident No. HK 6/55)

1. Minor rock cut slope failure.
2. Joint-controlled.
3. Road partially blocked.

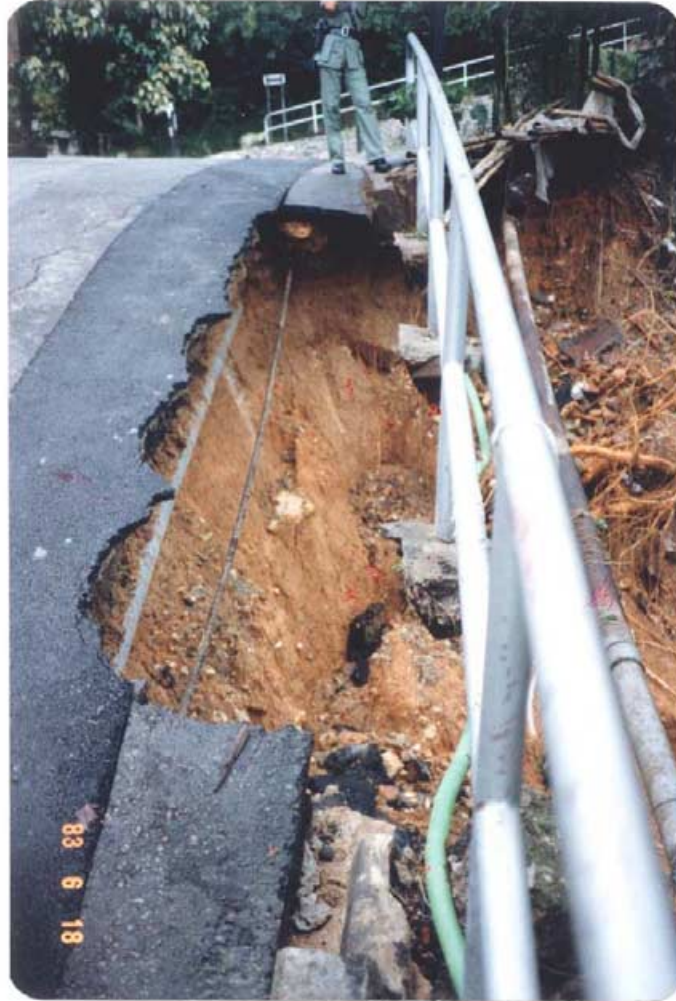
1. Erosion of fill embankment due to heavy runoff from the road possibly infiltrating into a small excavation on the footpath.

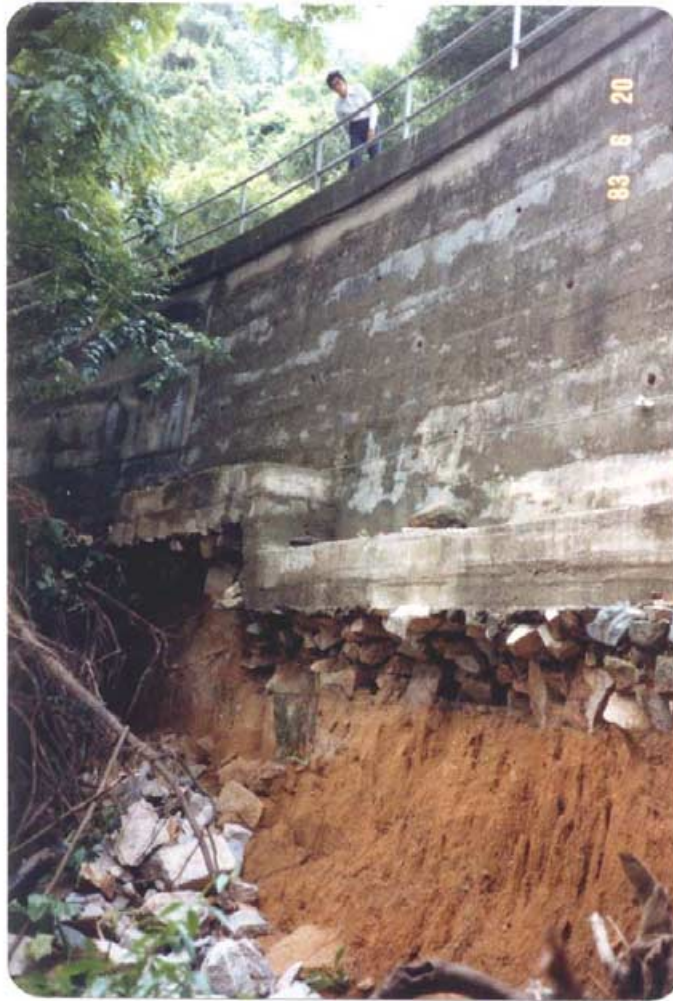
Plate 24 - Tai Hang Road near Bridge 17 (Incident No. HK 6/45)

(Major natural slope failure affecting road, Plate 24)

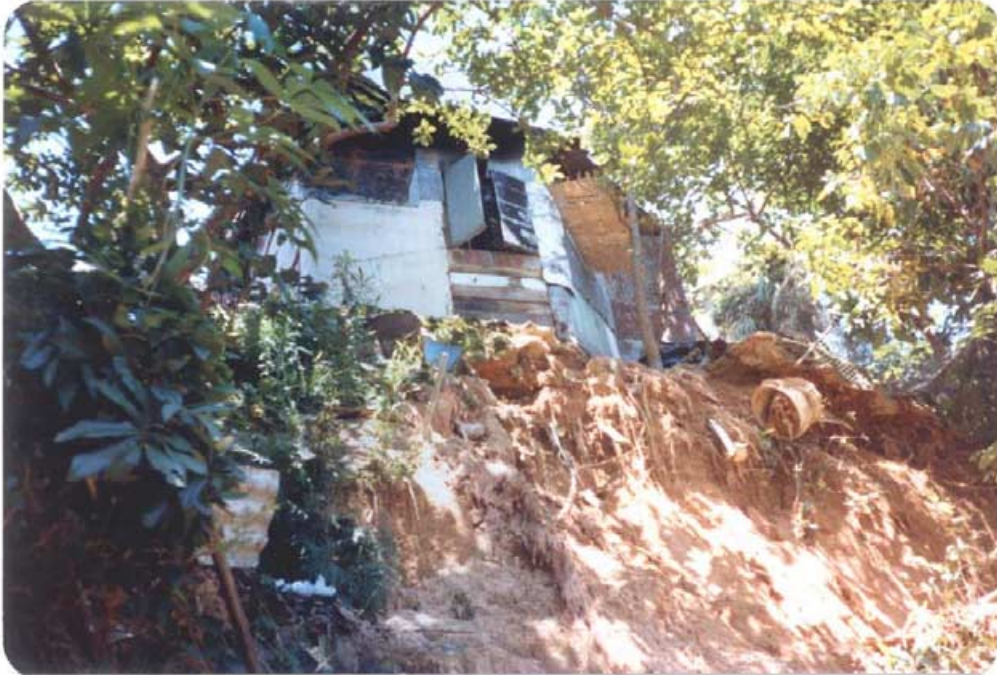
Plate 42 - Po Toi Island (Incident No. N 6/42)

The incident involved the failure of 10 metre high natural soil and rock slope behind a squatter area which caused the collapse of 6 squatter huts. One of the collapsed squatter huts as shown on Plate 42 was carried by debris into the sea. As a result of the natural slope failure, 10 squatter huts were permanently evacuated. There were also other huts in the island which were evacuated. These huts had partially collapsed due to high wind, rather than due to landslide incidents.

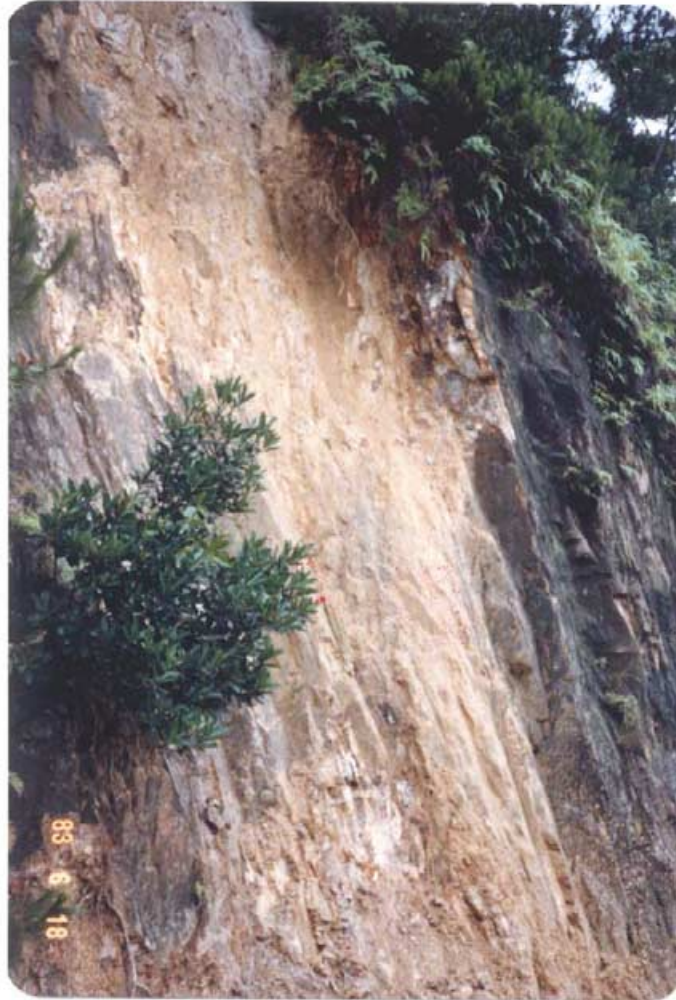
Plate 53 - 14 Headland Road, Repulse Bay (Incident No. HK 6/35)

(Major soil cut slope failure affecting private driveway, Plate 53)

On 18.6.83 a row of temporary sheet piles were installed to stabilize the slope as noted on Plate 53.

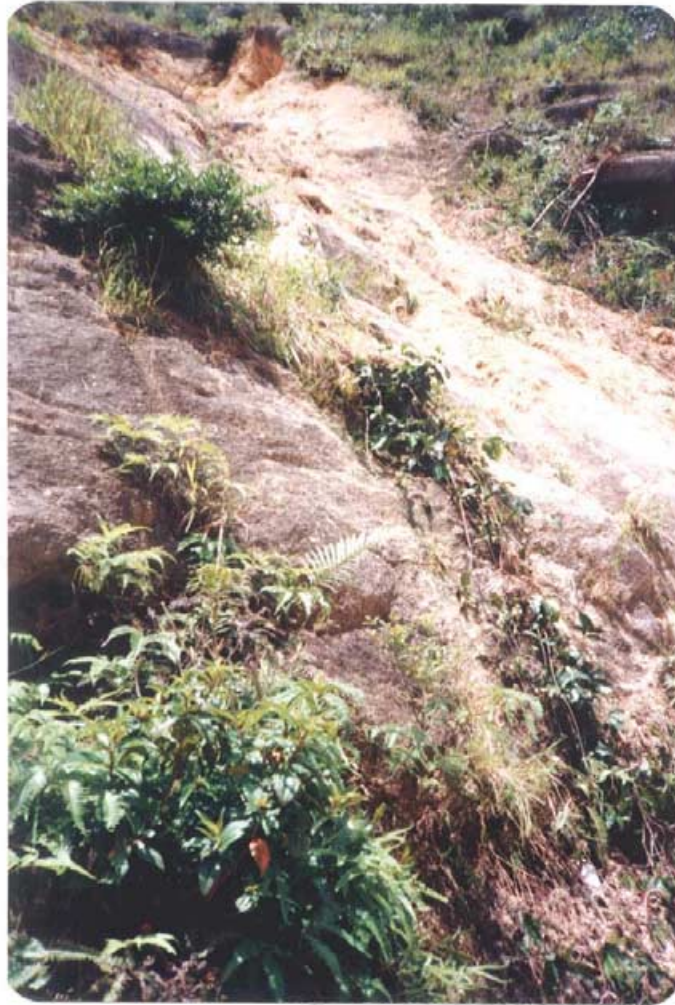
1. Major soil cut slope failure affecting road.
2. One of 3 failures in the area.
3. Chung Hom Kok Road blocked by debris.

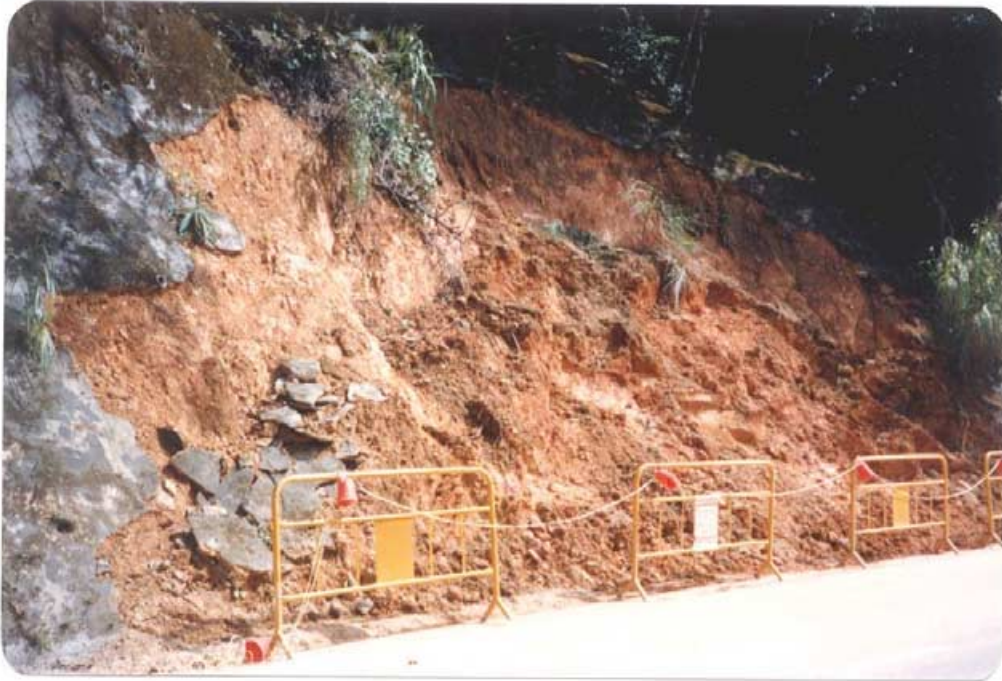
Plate 56 - Nam Long Shan Road (Incident No. HK 6/56)

1. Soil cut slope failure affecting road.
2. Probably caused by infiltration from surface channel at the top of the slope which was blocked and cracked by vegetation.

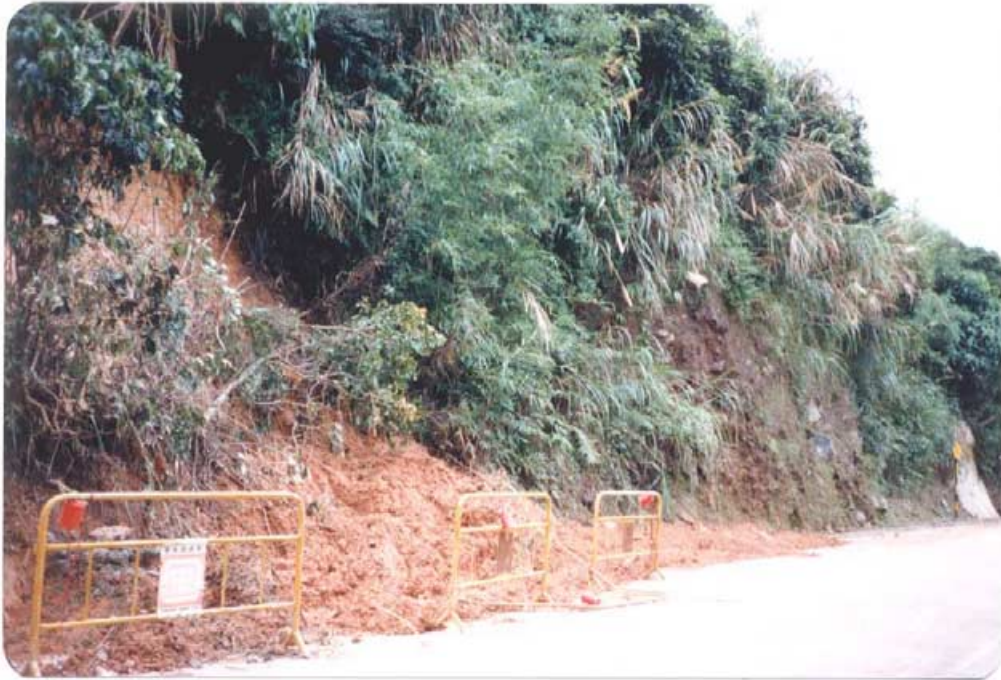
Plate 57 - Big Wave Bay Road (Incident No. HK 6/58)

1. Soil cut slope failure adjacent to road.

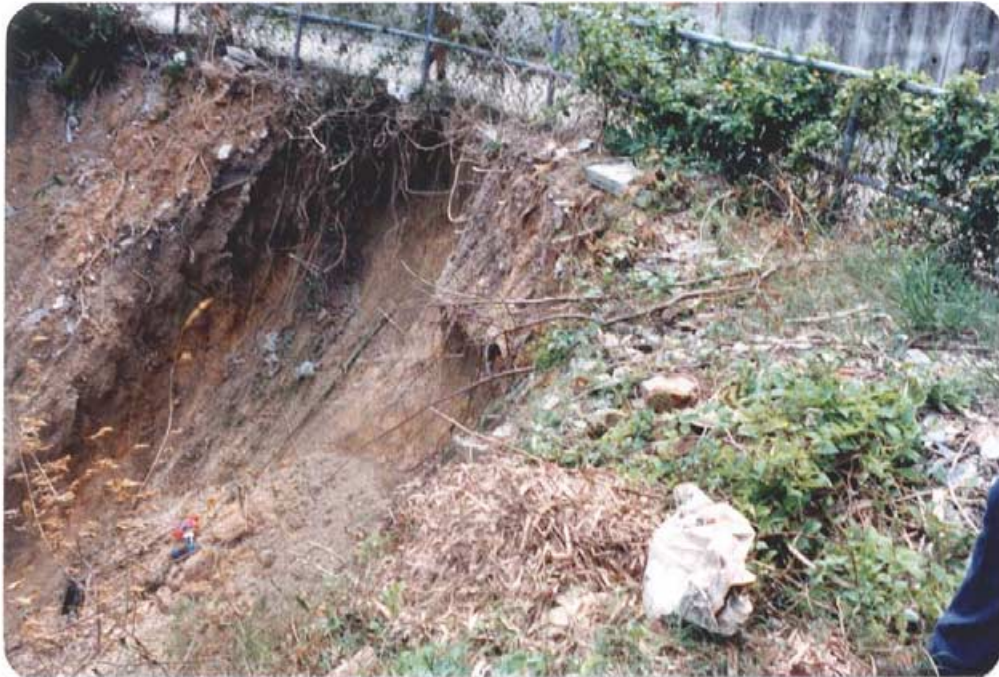
Plate 58 - Peak Road, Cheung Chau (Incident No. N 6/41)

1. Natural slope failure below road.
2. Caused by broken sewer.

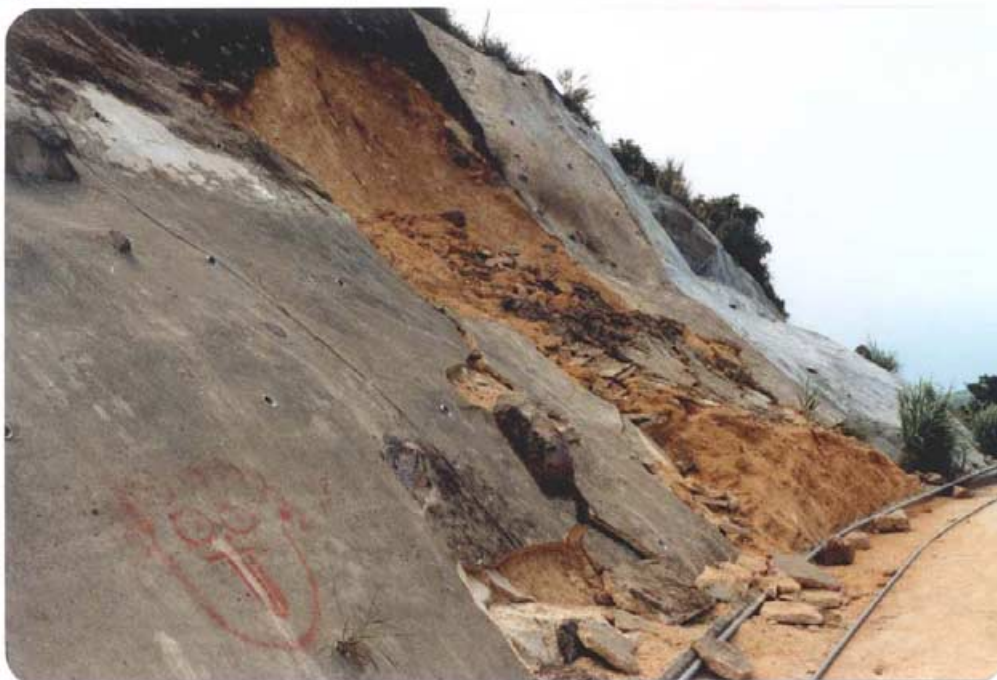
Plate 59 - Country Path between Yueng Che Wan, San Tsuen, and Tai Ping Tsuen in Lamma Island (Incident Nos. N 6/19 and N 6/20)

1. Major soil cut slope failure adjacent to country path.
2. One of numerous failures along the country path.

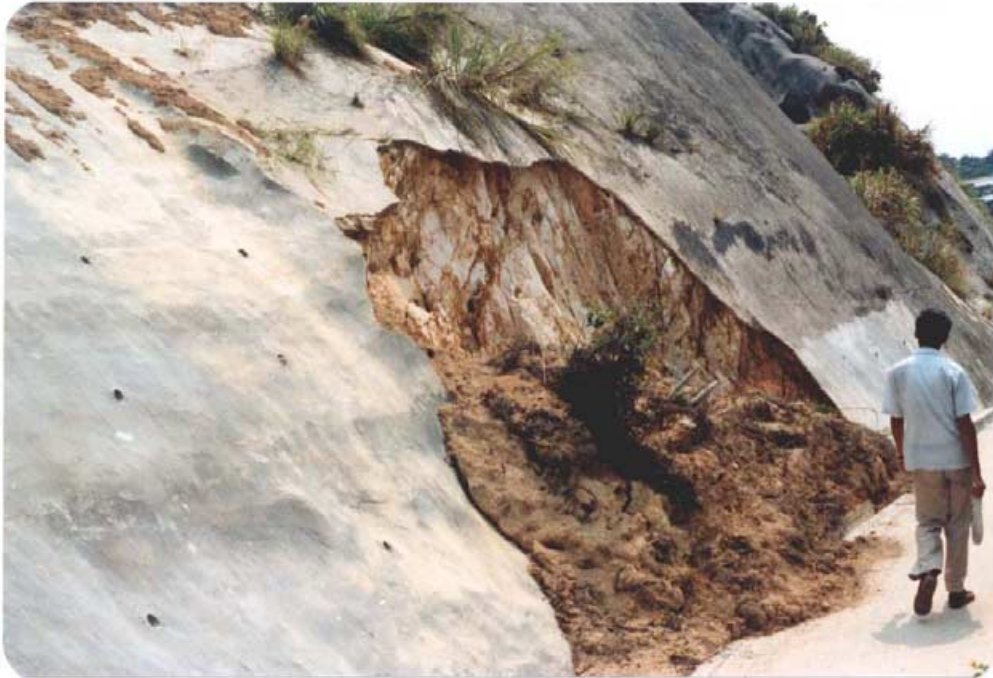
Plate 60 - Country Path between Yung Che Wan, San Tsuen, and Tai Ping Tsuen in Lamma Island (Incident Nos. N 6/19 and N 6/20)

1. Minor failure through closely jointed decomposed granite along country path.

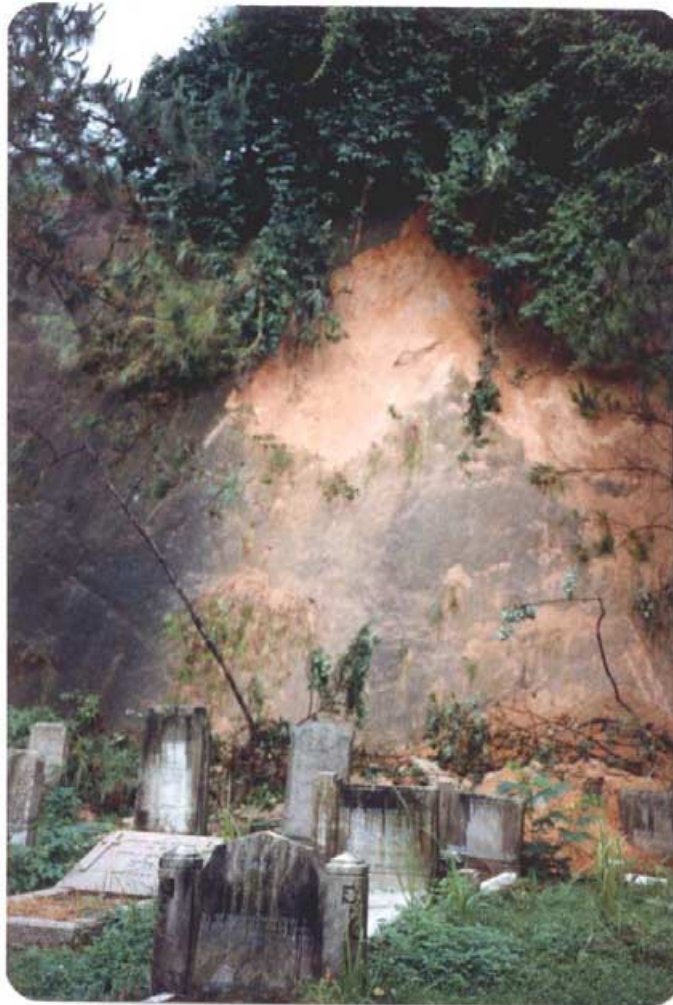
**Plate 61 - Stubbs Road across from Shui Fai Terrace
(Incident No. HK 6/21 (ii))**

1. Minor soil cut slope failure in cemetery area.

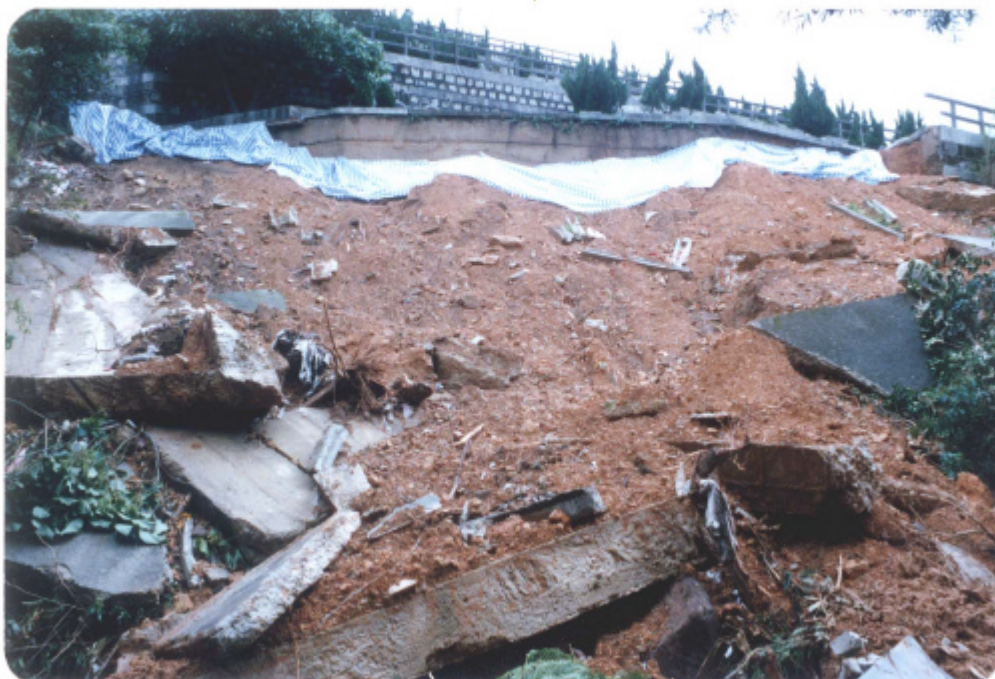
Plate 62 - Mount Collinson and Lin Shing Road (Incident No. HK 6/33)

1. Failure in cemetery area.
2. Soil cut slope failure and collapse of small retaining wall supporting a footpath.

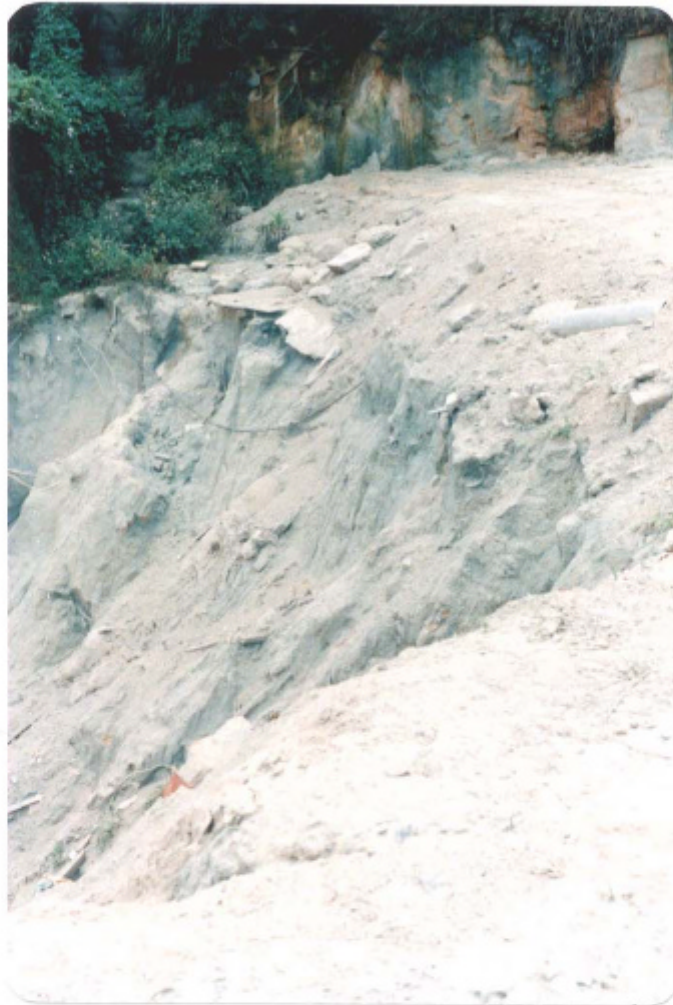
1. Failure of a fill slope in open area.
