APPENDIX A

REPORT ON THE STUDY OF OLD MASONRY RETAINING WALLS  
BY GCO (1980)

APPENDIX D

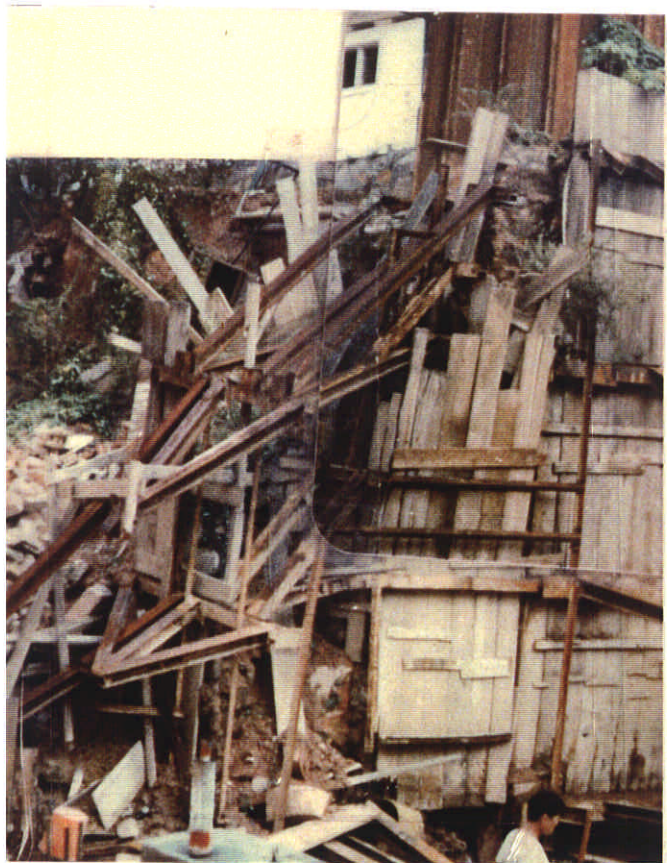
Negative No. R/W 81.09.04

Plate D9.1 -  
Retaining Wall at Wing Wa Terrace  
- the Wall before Failure
