**GENERAL REPORT
ON LANDSLIPS
ON 5 NOVEMBER 1993
AT MAN-MADE FEATURES
IN LANTAU**

GEO REPORT No. 44

H.N. Wong & K.K.S. Ho

**GEOTECHNICAL ENGINEERING OFFICE
CIVIL ENGINEERING DEPARTMENT
HONG KONG**

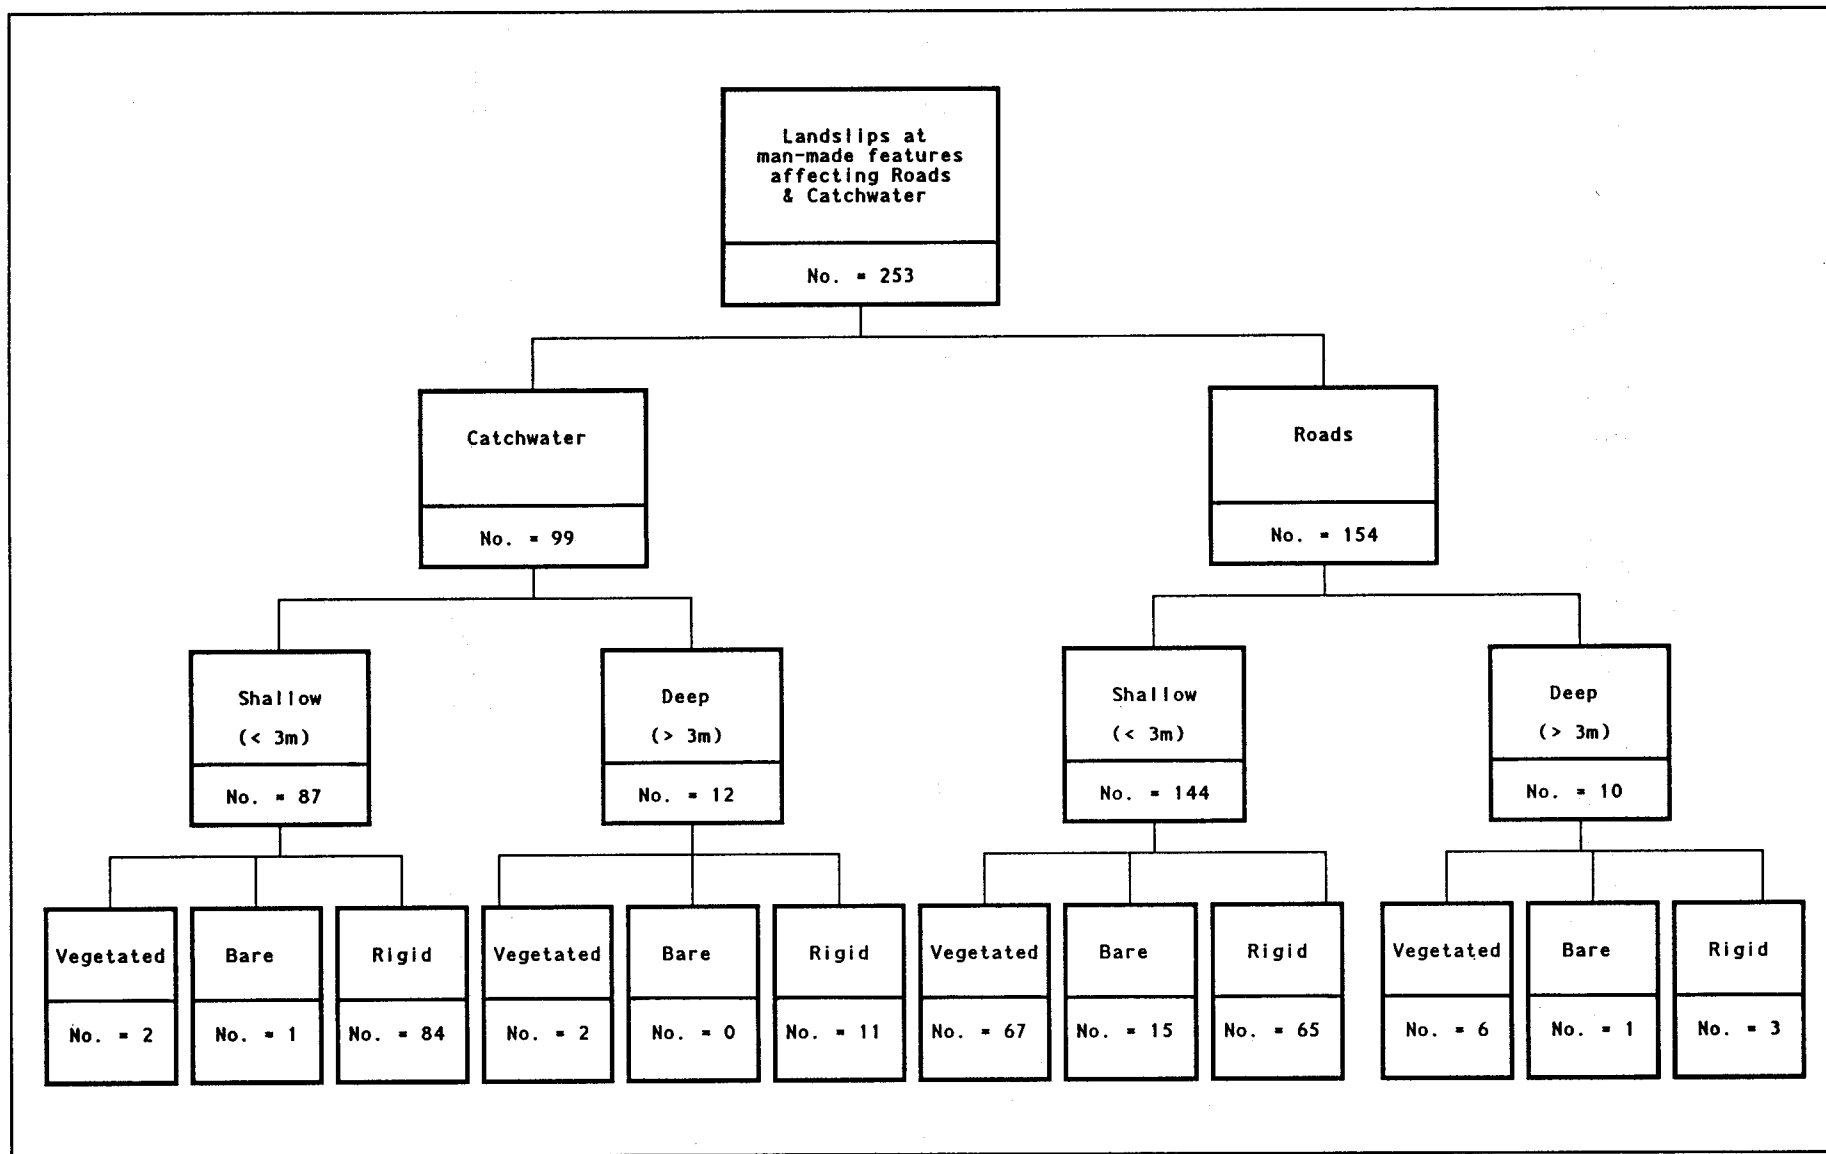
Figure 5 - Depth of Failure and Nature of Slope Surfacing

As shown in Figure 5, more than 90% of the landslips were shallow failures (depth

Also shown on Figure 5 is the nature of the slope surfacing in relation to the depth of failure. A significant proportion of the landslips occurred at features with a rigid cover. However, as the total number of man-made features with and without a rigid cover is not known, it is not possible to assess the percentage of failures of slopes with different types of surface cover (i.e. rigid cover or vegetated cover).

The relationship between the depth of failure and the nature of slope surfacing is shown in Figure 5. It may be noted that approximately the same proportion of shallow and deep failures occurred in roadside slopes with and without a rigid surface.

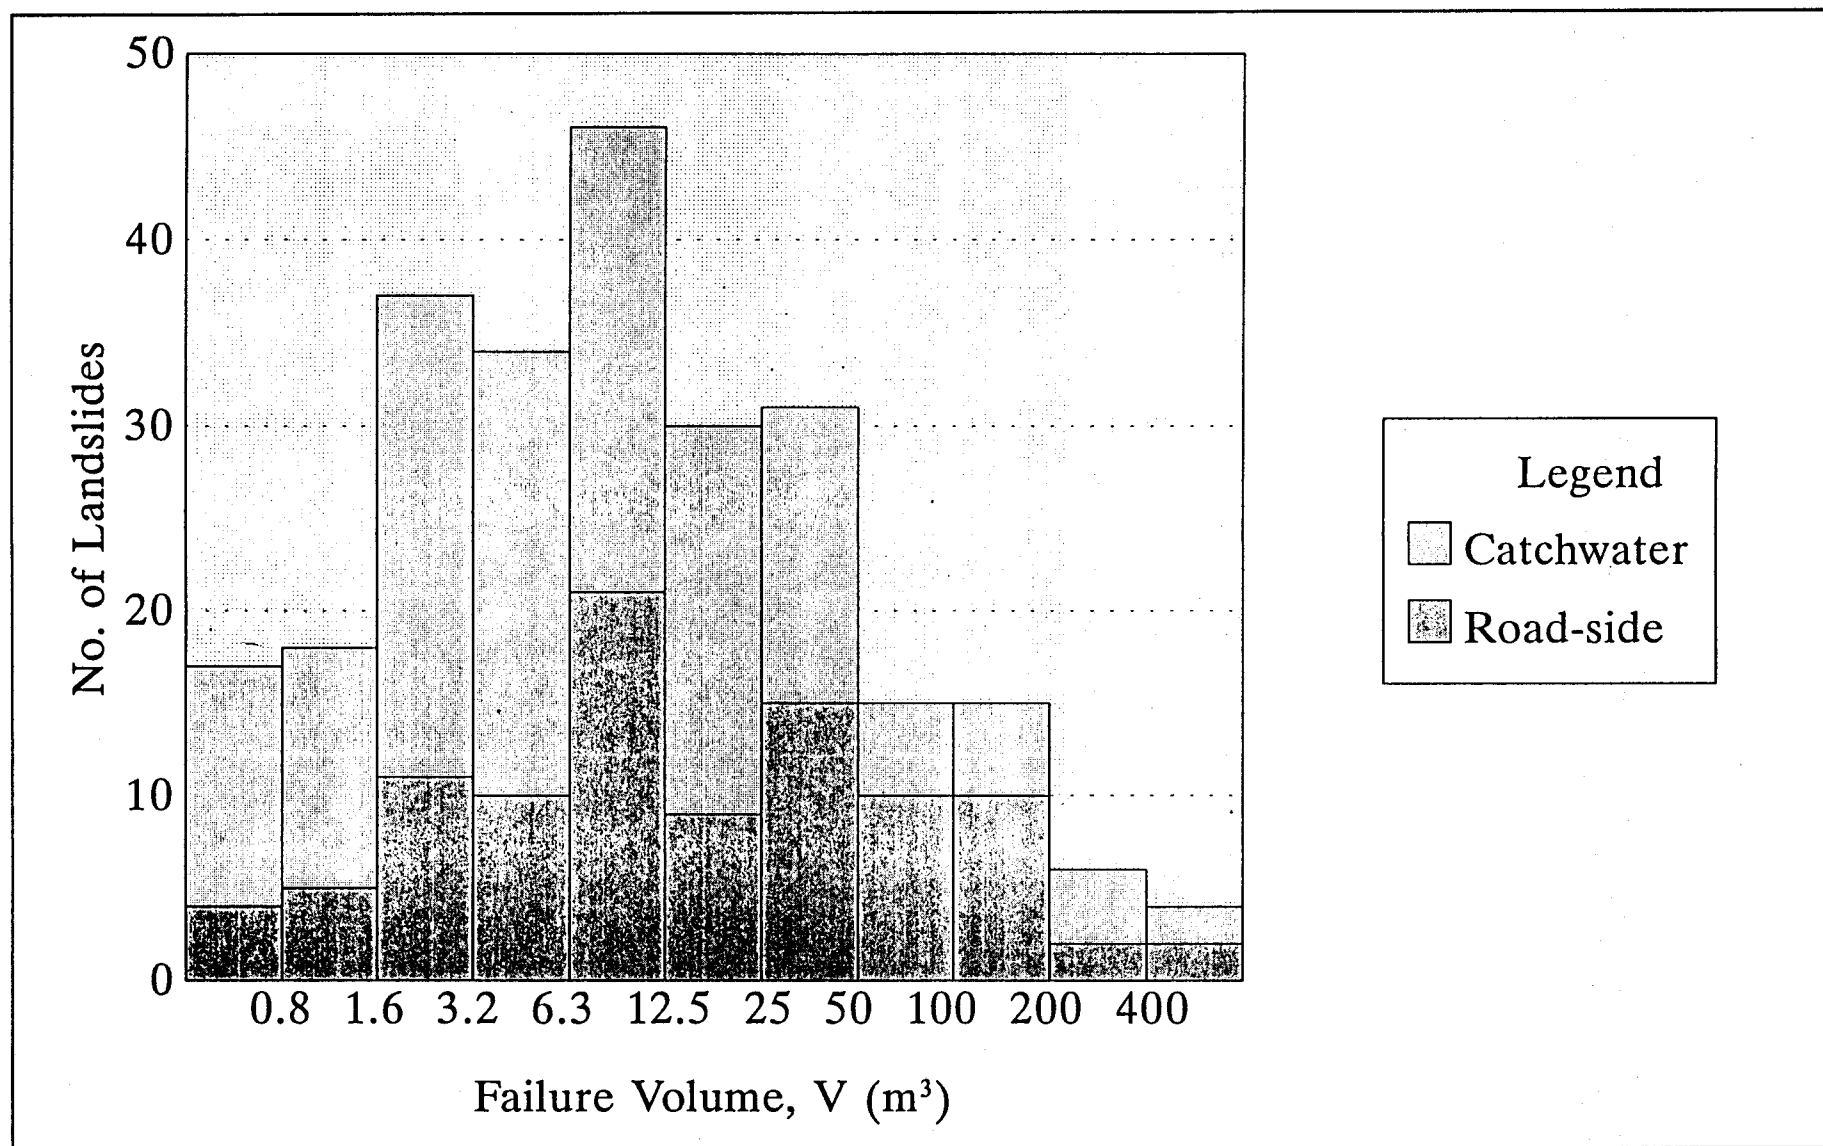
Figure 6 - Failure Volume

Information on the failure volume is shown in Figure 6. Overall, about 12% of the landslips involved an estimated volume of failure debris greater than 50 m³. Thus, most of the landslips were shallow failures and would not have been classified as major failures.

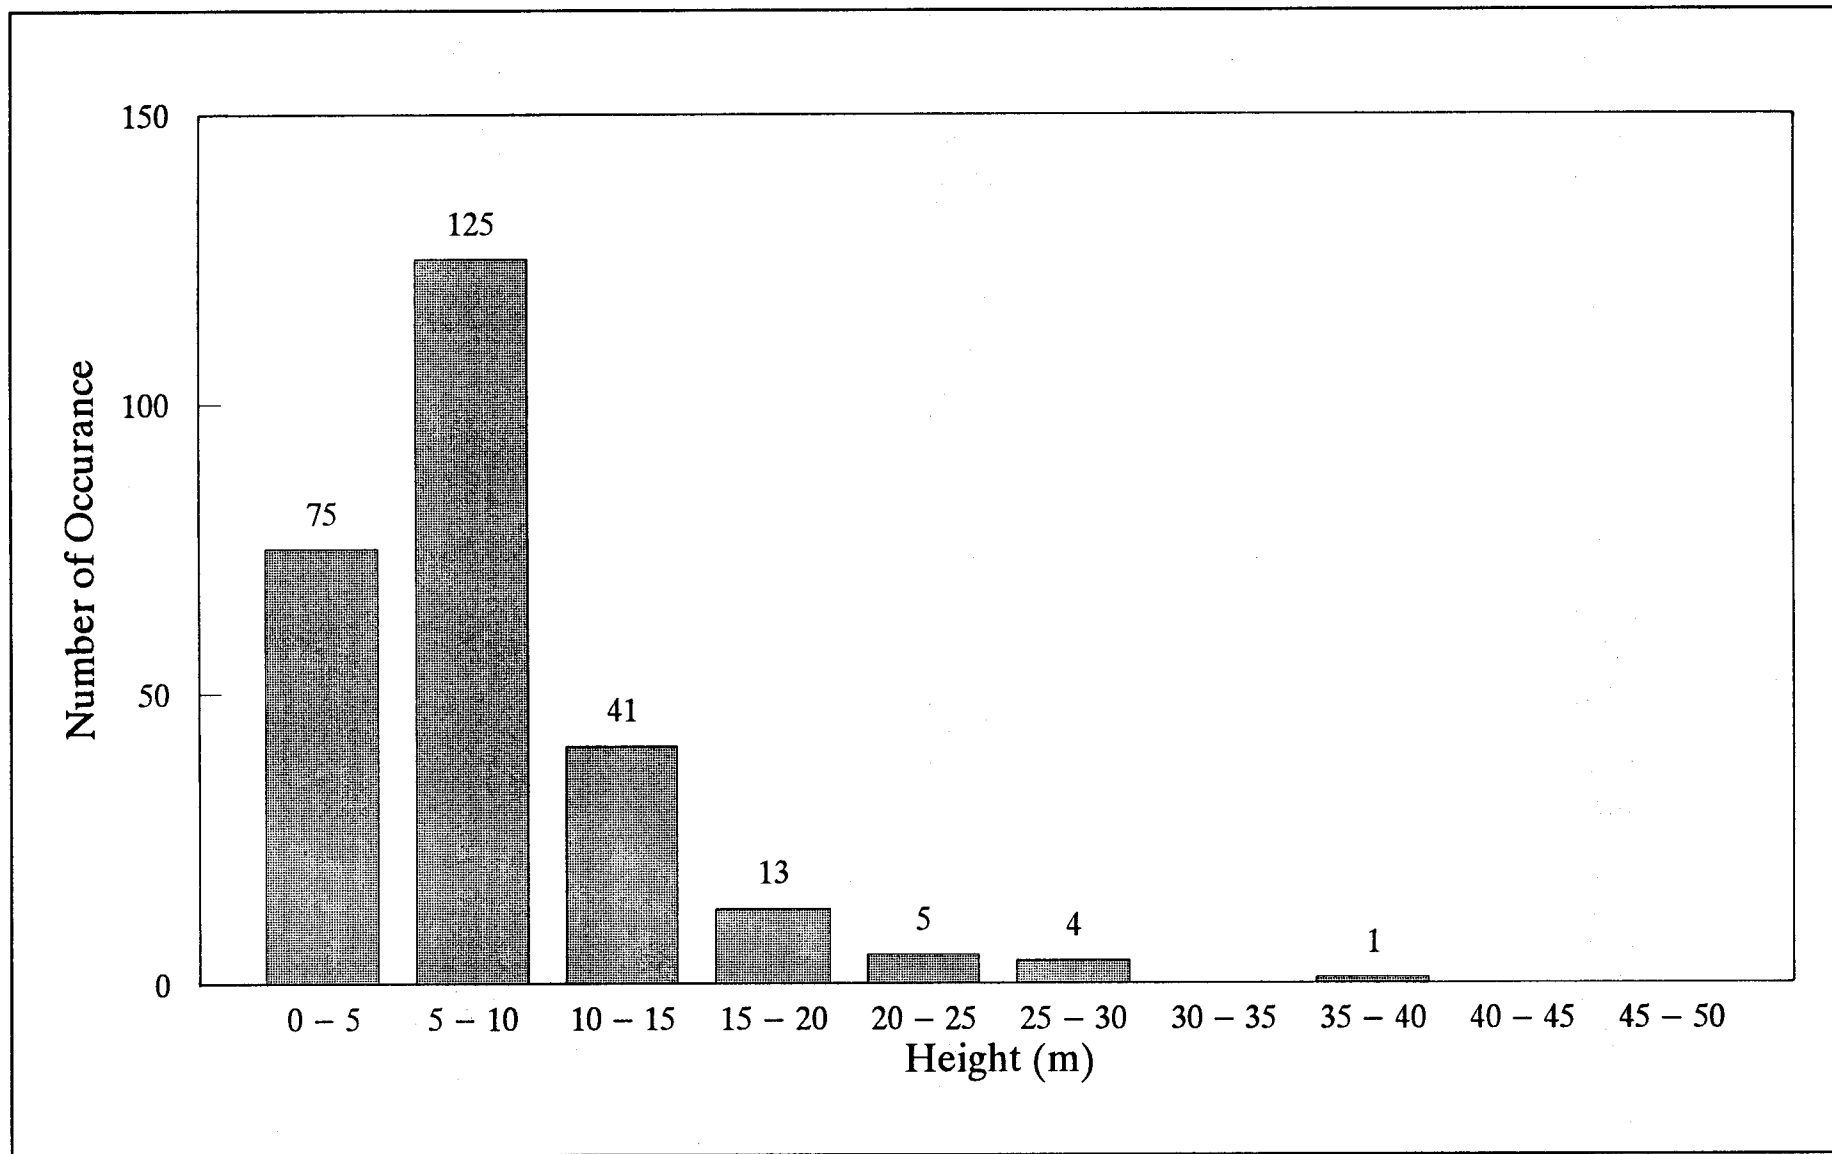
Figure 7 - Height of Cut Face of Failed Slopes

The distribution of landslips with respect to the height of the cut face is shown in Figure 7. It is noted that the majority of the failures occurred at slopes between 5 m and 10 m high. The landslips that occurred at slopes with a height of less than 10 m constitute about 80% of the total number of landslips that had been included in this study. This fact may be simply because most of the man-made slopes on Lantau Island are within this range of heights.

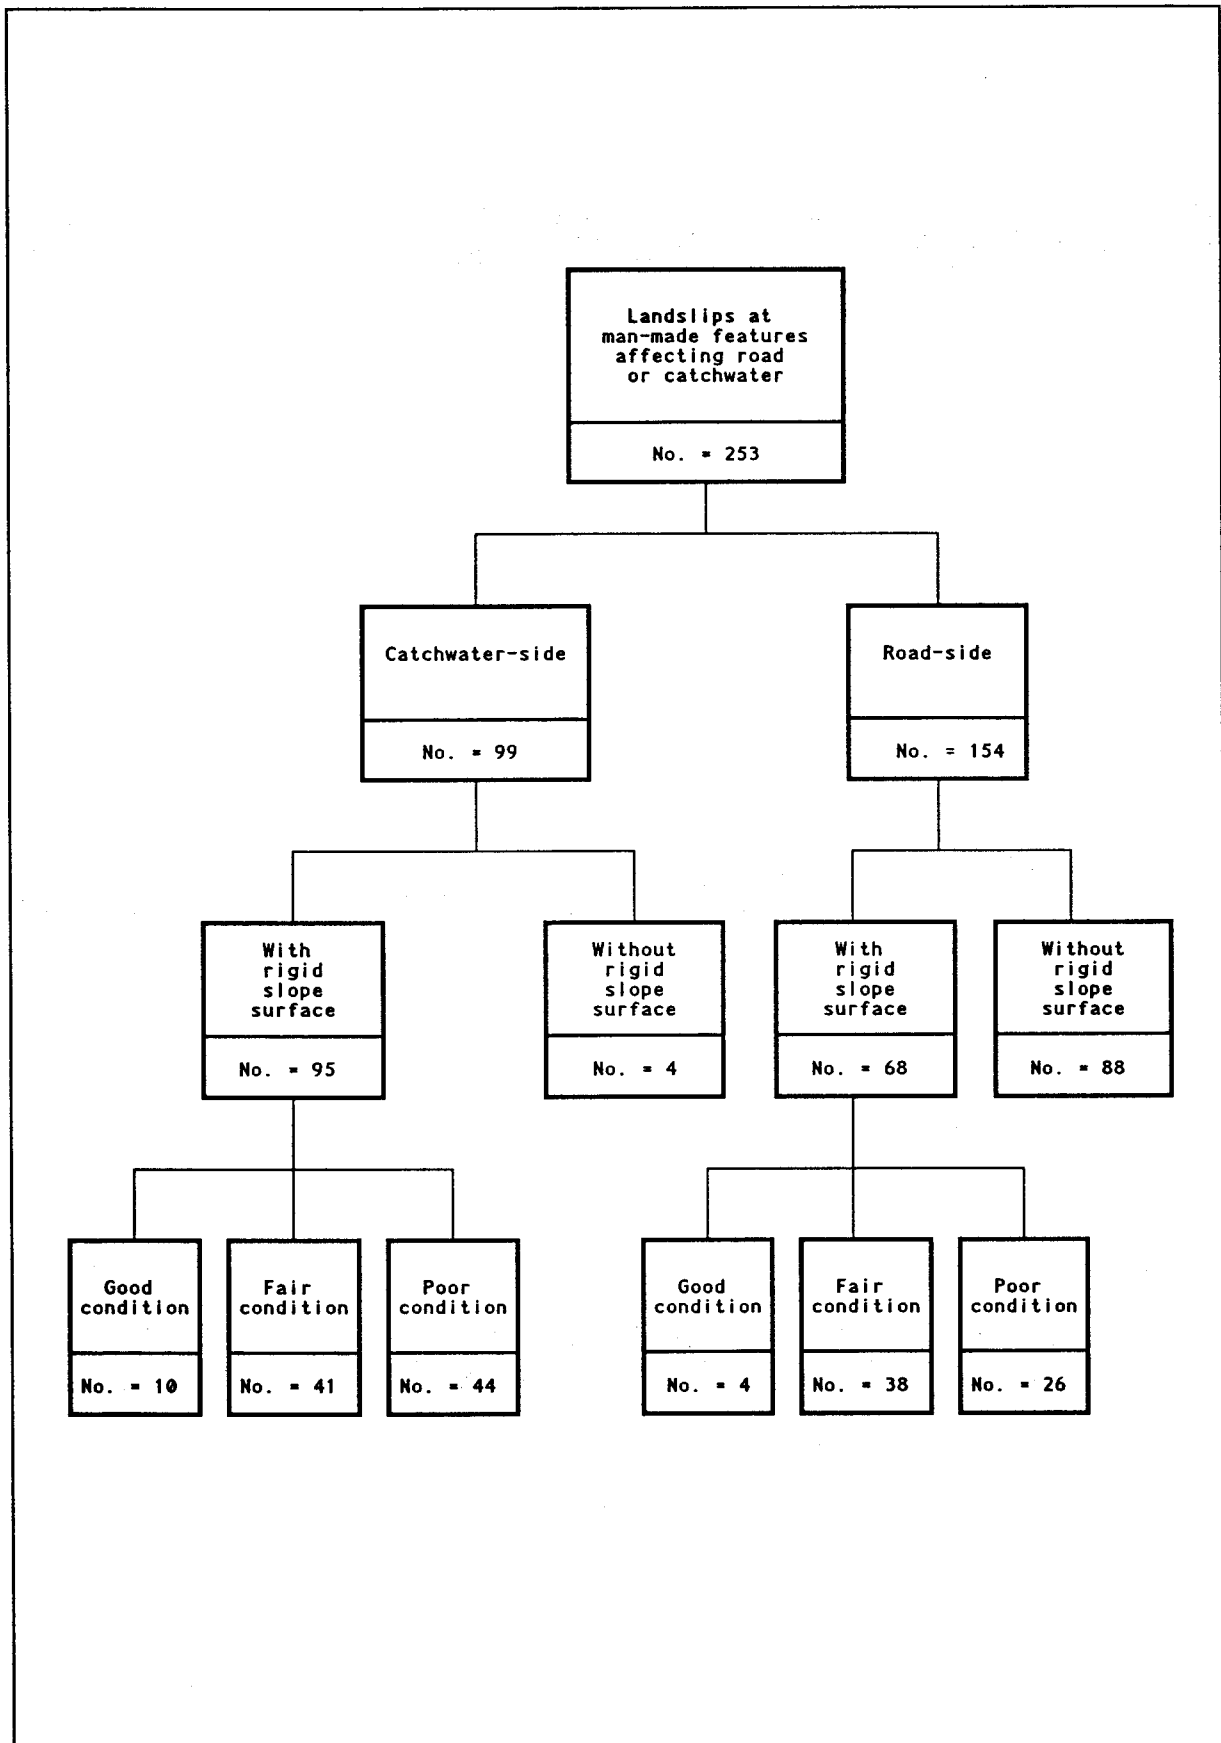
Figure 8 - Condition of Slope Prior to Failure

The condition of the surface protection of the slopes that failed have been inferred during the inspection by observation of the adjoining areas. The findings are summarised in Figure 8. Where the slope had drainage channels, 'poor', 'fair' and 'good' conditions

corresponded to where the channels were 'fully-blocked', 'partly-blocked', and 'clear from blockages' respectively. In the case of a rigid cover, 'poor', 'fair' and 'good' conditions corresponded to where the surface cover exhibits 'severe cracking', 'minor random cracking', and 'little or no cracking' respectively. The assessment of the condition of the rigid surface is illustrated in Plates 1 to 3. Further examples of the classification of the condition of the rigid cover are given in Appendix B.

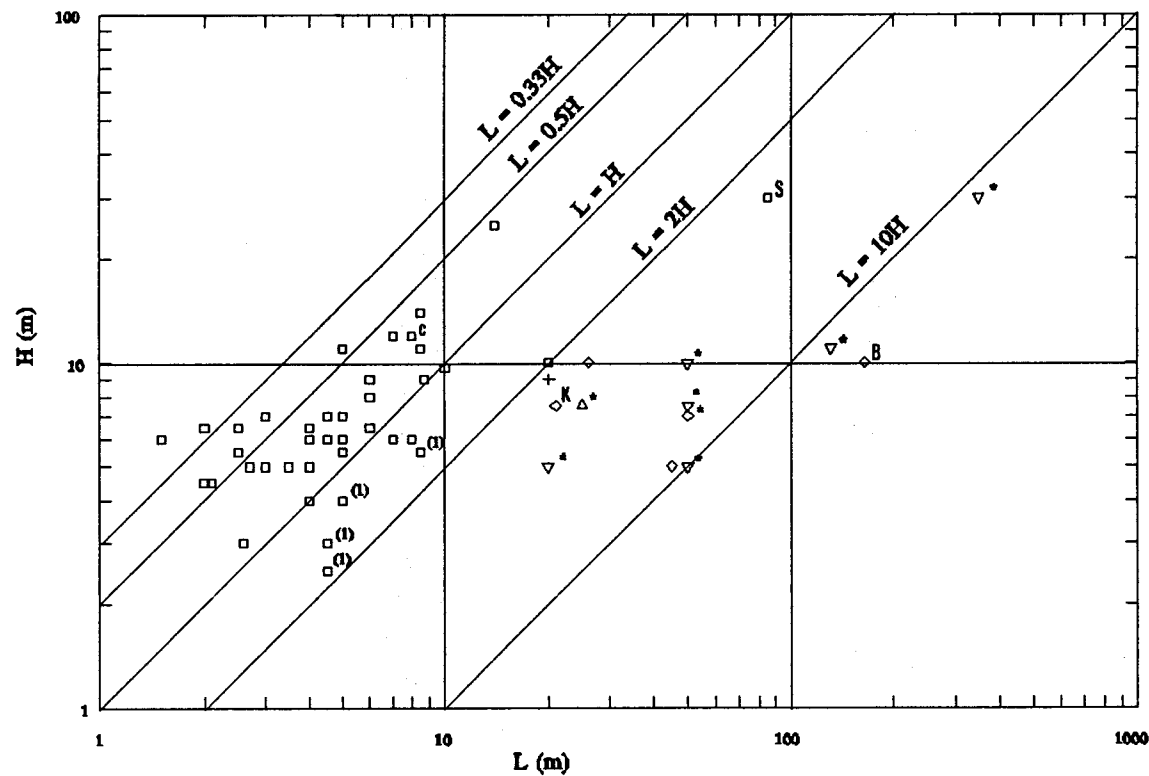
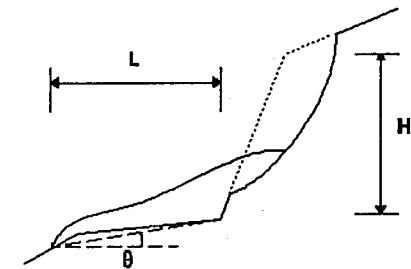
Figure 9 - Relationship Between Height of Cut Face and Reach of Debris

The relationship between the height of the cut face (H) and the travel distance of the debris (L) as measured from the toe of the failed slope is plotted in Figure 9. The failure mode has been distinguished as to whether it involved wash-out or not. In addition, the field

Based on the observations made in the present study, for failures involving mainly the cut face and which are not caused by wash-out, the likely travel distance of the debris generally ranges from $1/3H$ to H , with a mean of about $0.7H$ (Figure 9). Where the failure involves a substantial part of the slope uphill of the cut face, the likely travel distance may exceed H . Large debris run-out distance is also expected if the downslope gradient is steep, or if wash-out mechanism is involved. Further work is clearly necessary to extend this database, and to formulate detailed guidelines for use in assessing the risk category of slopes and the consequence of landslides.

The landslip debris reached 8.5 m beyond the slope toe, and completely buried the access road. The H/L (Figure 9) ratio is 1.5, suggesting that a relatively long debris run-out distance for this mode of failure which involve a large area upslope of the cut face.

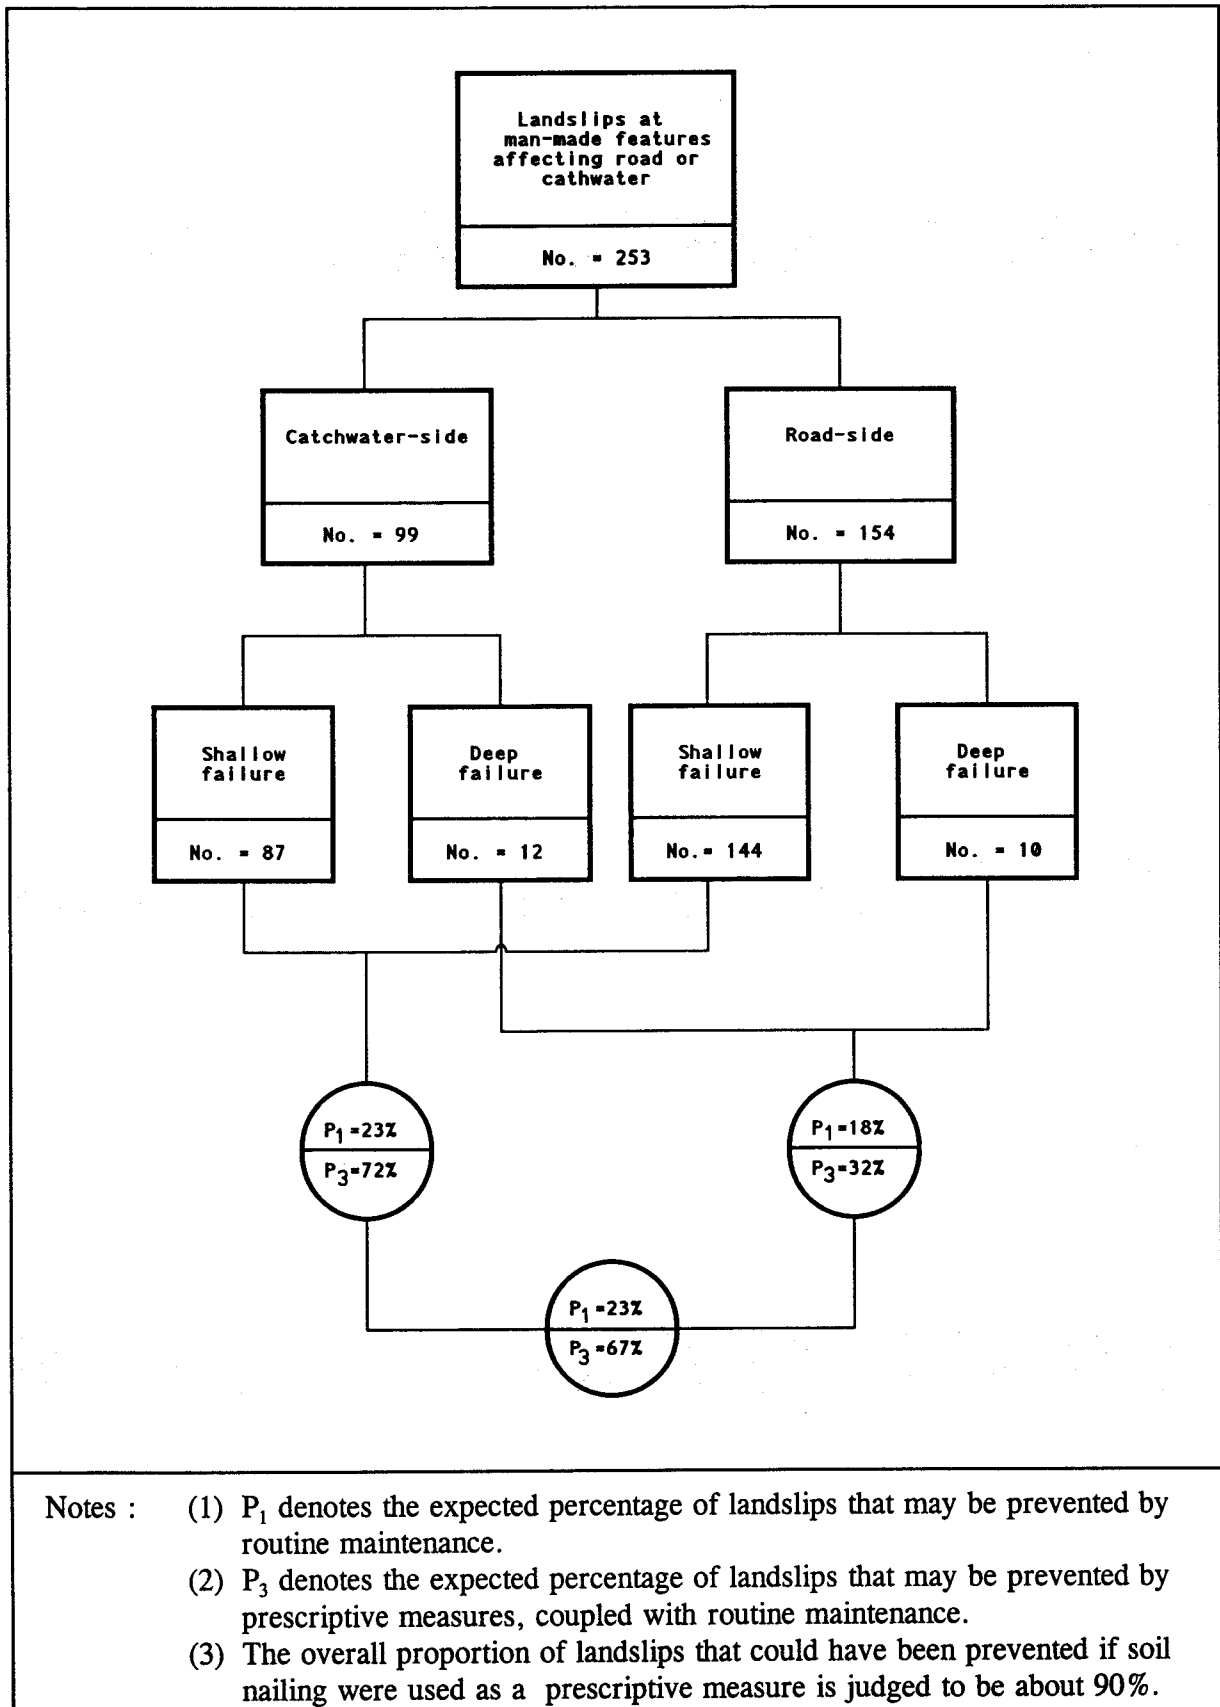
Figure 10 - Effectiveness of Routine Maintenance and Prescriptive Measures in Preventing Landslips of Different Depth

The assessed effectiveness of routine maintenance in preventing failures of differing depths and of different scale is shown in Figures 10 and 11 respectively. Overall, approximately one-fifth of the landslips are likely to have been prevented given routine maintenance.

The likely influence of routine maintenance in preventing landslips of differing failure mode and debris volume has also been examined (Figures 10 & 11). Routine maintenance is considered comparatively more effective in the case of small-scale and/or shallow failures. For large-scale or deep failures, the adequacy of 'conventional' protective and drainage measures is questionable and routine maintenance alone is therefore unlikely to be particularly effective in preventing failure.

The assessed effectiveness of prescriptive measures in preventing failures of differing depths and of different scale is shown in Figures 10 and 11 respectively. Such measures are considered effective in the case of small-scale and/or shallow failures. For large-scale and/or deep failures, the adequacy of prescriptive measures could be less but a general improvement in the stability can be expected.
