# **INVESTIGATION OF SOME MAJOR SLOPE FAILURES BETWEEN 1992 AND 1995**

**GEO REPORT No. 52**

**GEOTECHNICAL ENGINEERING OFFICE  
CIVIL ENGINEERING DEPARTMENT  
HONG KONG**

# **SECTION 1 : REPORT ON THE INVESTIGATION OF THE 8 MAY 1992 BAGUIO LANDSLIDE**

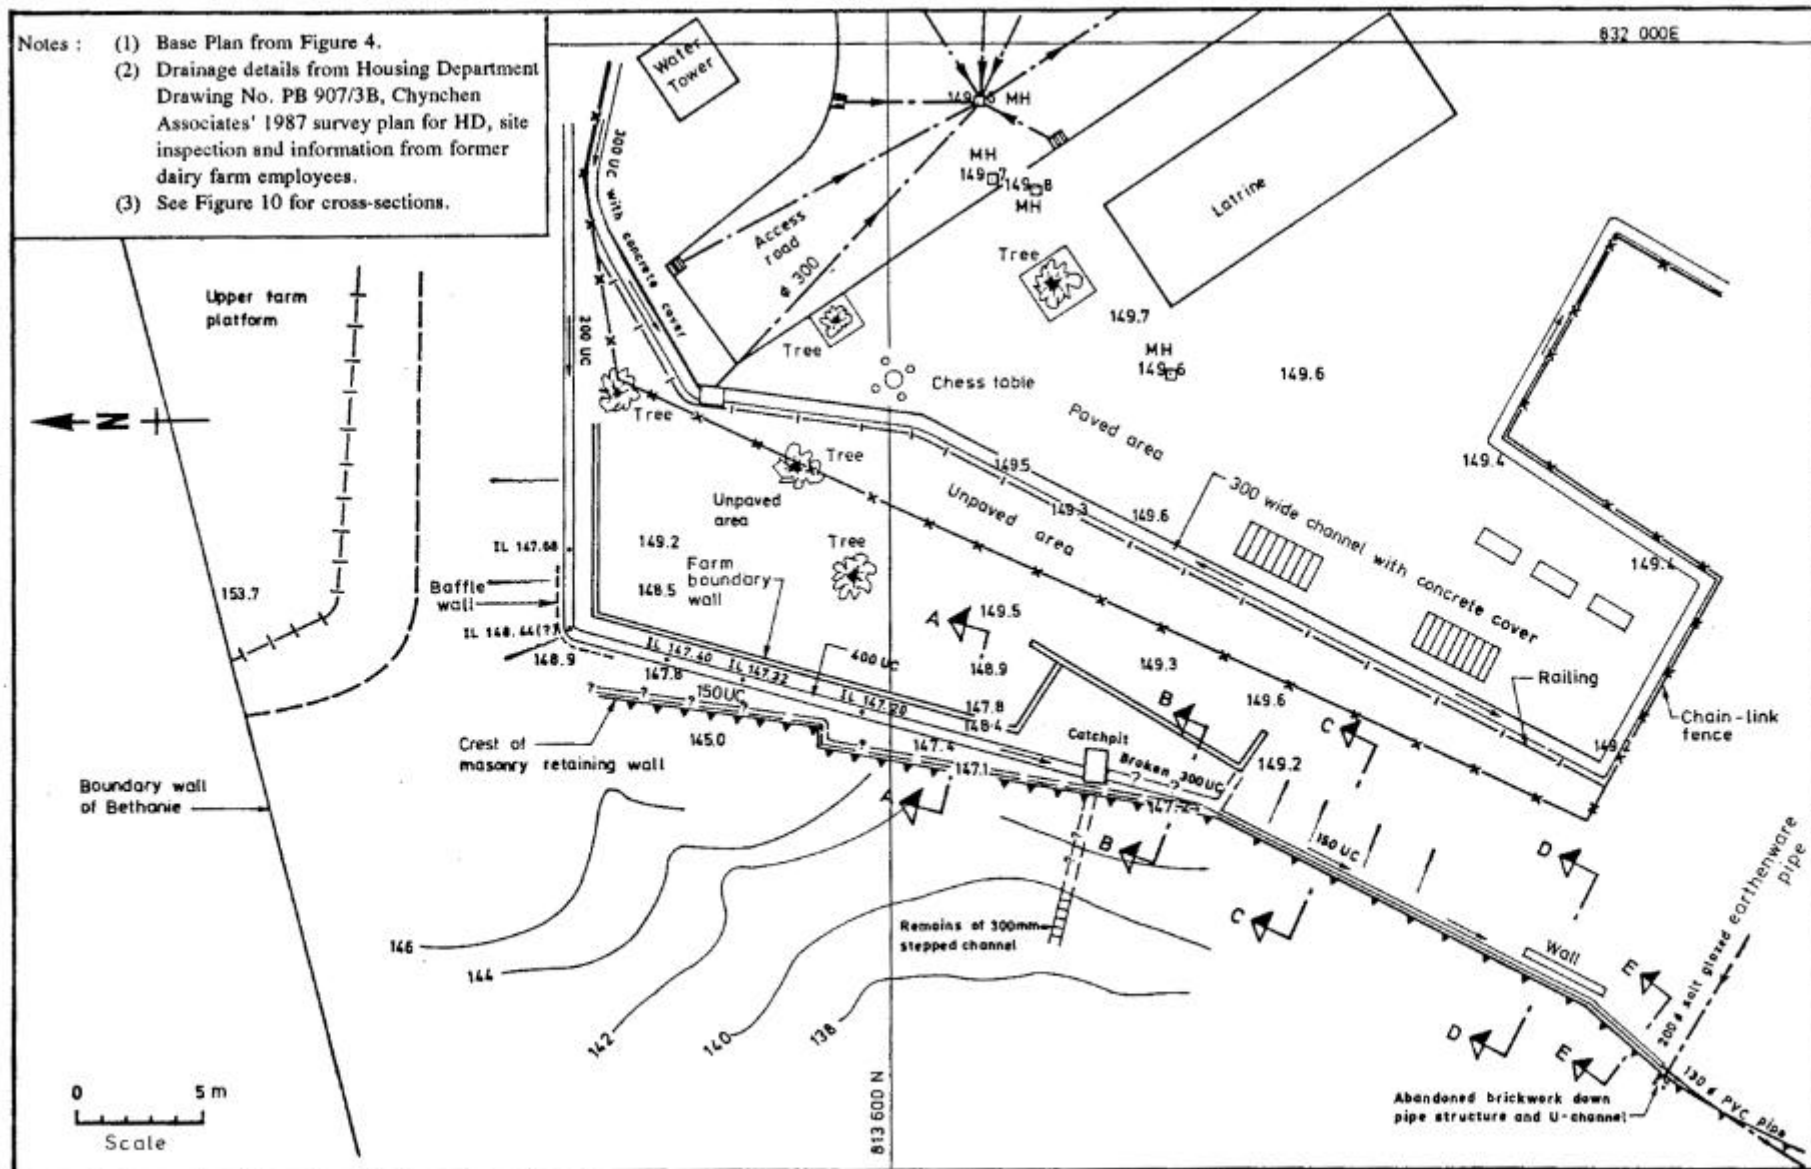
Figure 9 - Stormwater Drainage System of the Fill Platform

The drainage system shown in Figure 9 in the area enclosed by the chain link fence was installed by Housing Department. That outside is the old farm drainage system.

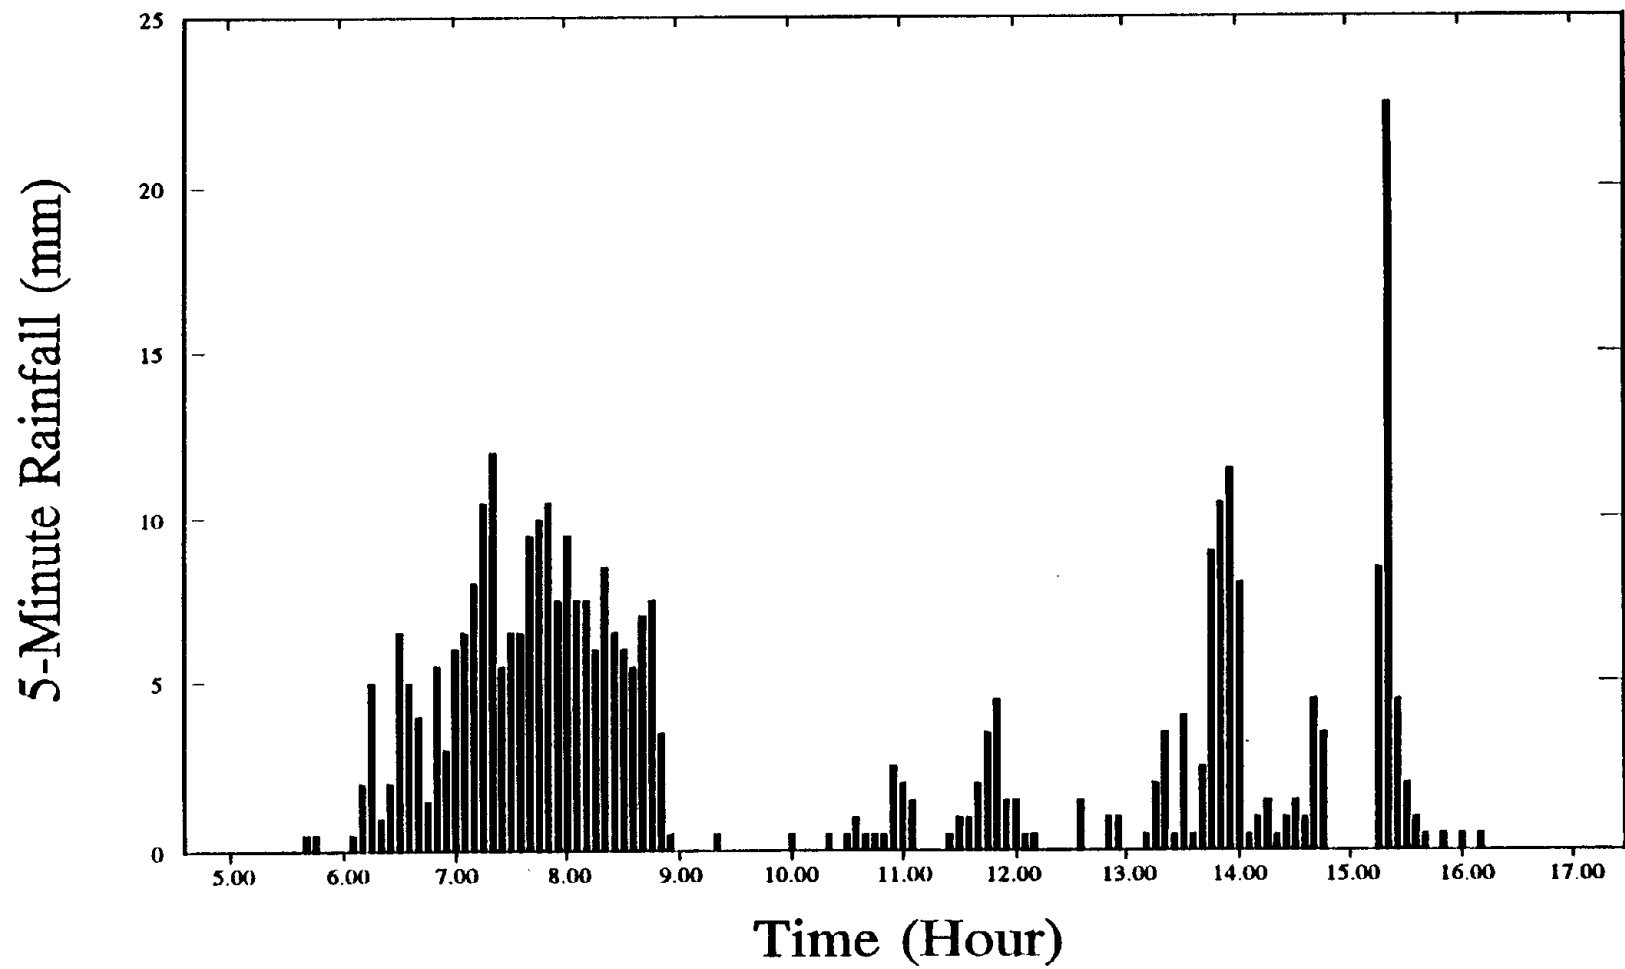
Figure 12 - Rainfall Recorded at Raingauge H03 at 5-minute Intervals on 8 May 1992

The five-minute rainfall intensities recorded by the raingauge H03 on 8 May are shown in Figure 12. On that day, heavy rain started at about 6 a.m. and continued until shortly before 9 a.m. A total of 216 mm of rain was recorded in this period, out of which about 180 mm fell in two hours. The two-hour rainfall corresponds to a 1-in-30-year event according to statistical data from the Royal Observatory. The peak hourly rainfall was 102.5 mm between about 7 and 8 a.m.

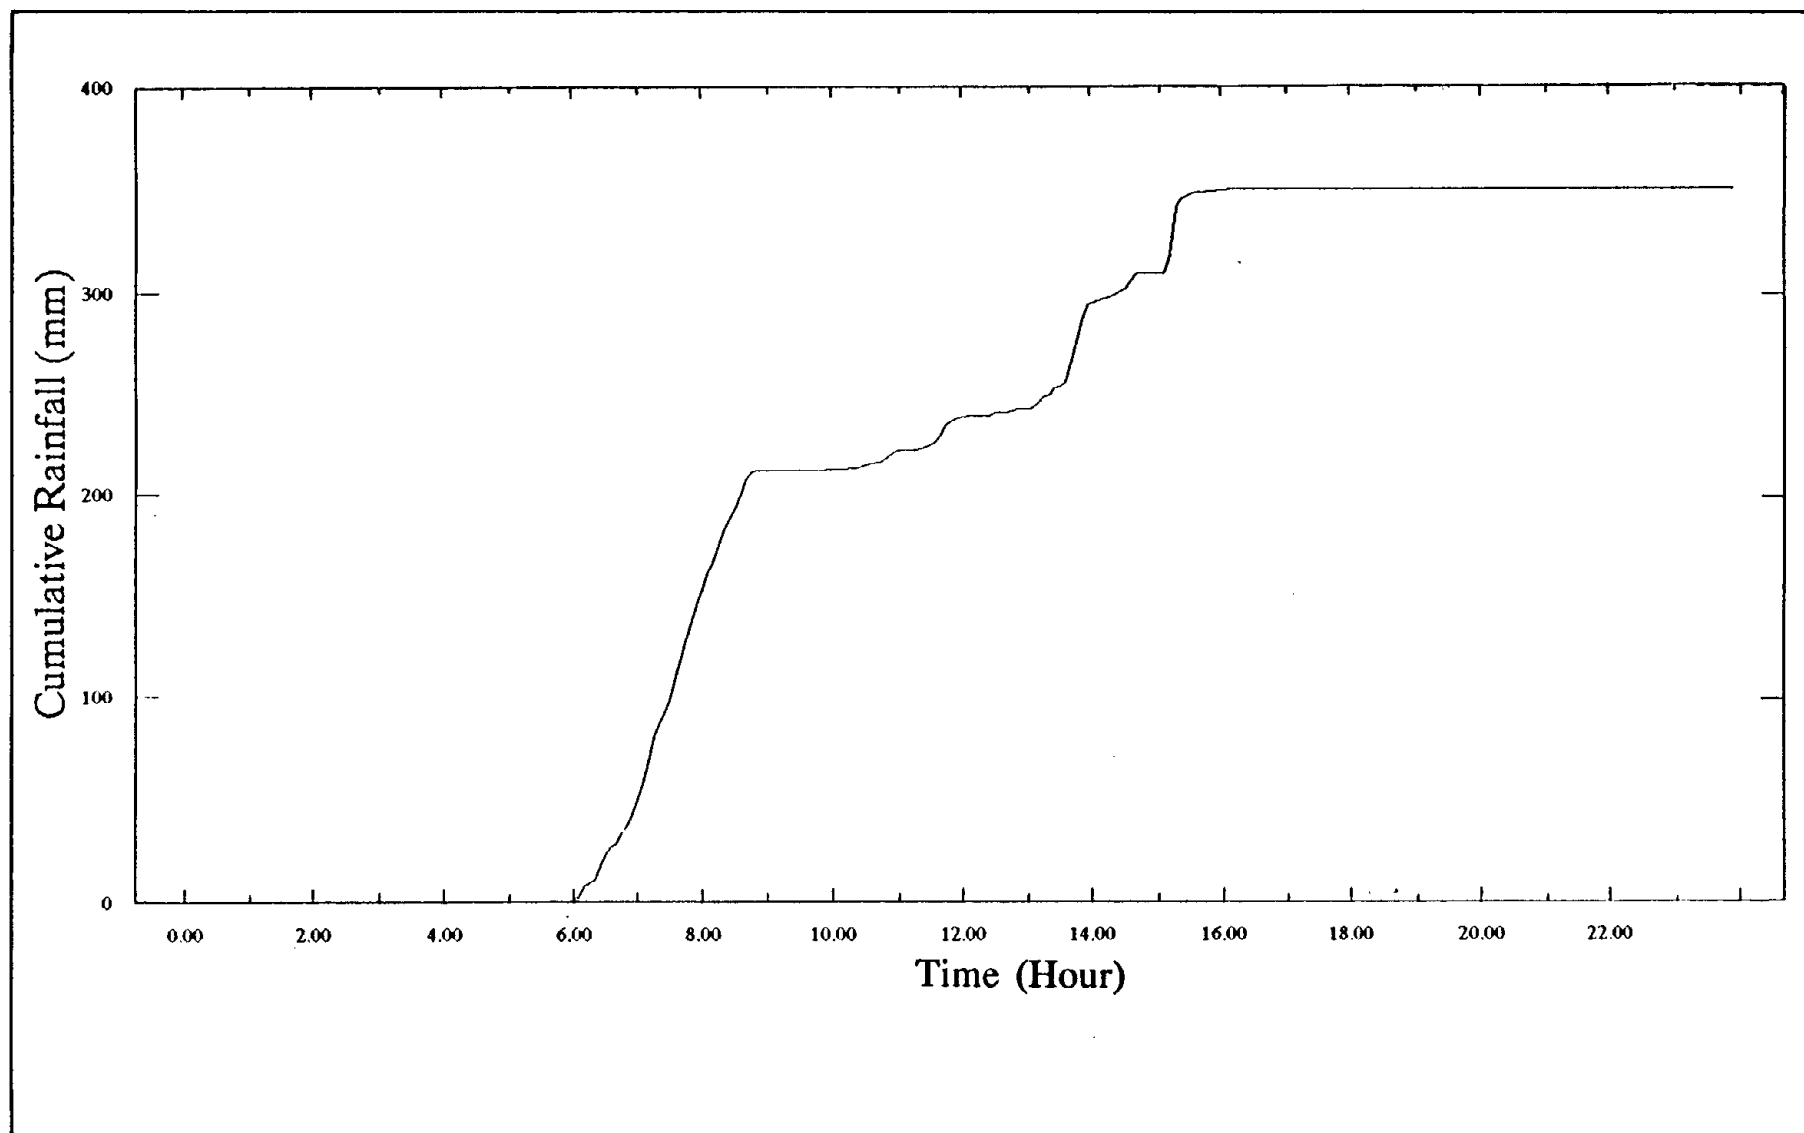
Figure 13 - Cumulative Rainfall Recorded at Raingauge H03 on 8 May 1992

Short bursts of rain resumed at about 11 a.m., intensifying at around 1:40 p.m.; 40 mm of rain fell in the following 20 minutes. By 2 p.m., the cumulative rainfall since 6 a.m. amounted to about 295 mm (see Figure 13).

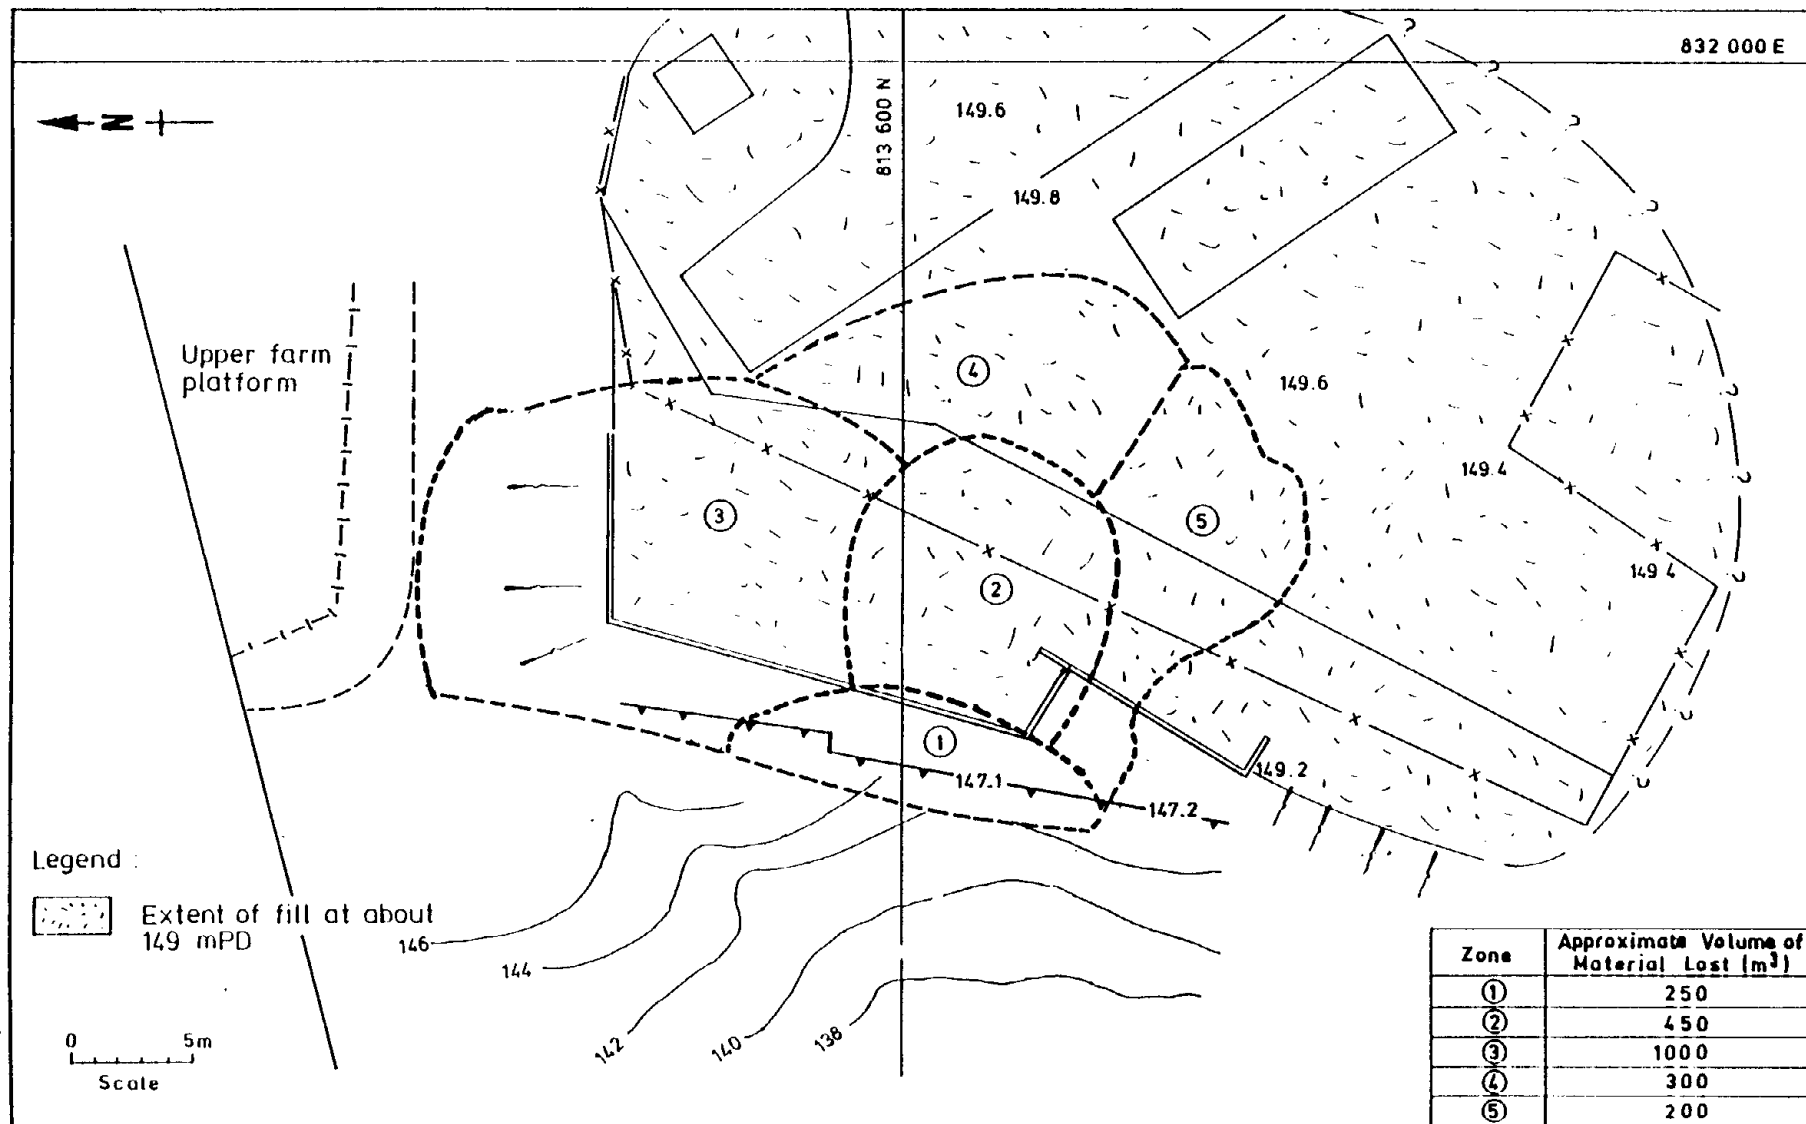
Figure 14 - Zoning of Landslide Scar at the Sitting-out Area

Intense rainfall resumed at around 1:40 p.m. and the central part of the masonry retaining wall (zone (1) in Figure 14) collapsed at about 2 p.m. This released into the natural gully about 250 cubic metres of material comprising stone blocks, soil and some building debris which included pipes and pieces of concrete.

Thereafter, the unsupported fill of the THA platform gradually collapsed. About 450 cubic metres of material are estimated to have been lost from the fill platform in this phase of gradual slumping. The approximate extent of ground affected in this phase is shown as zone (2) in Figure 14.

During the period of very intense rainfall which started at about 3:10 p.m., the northern part of the fill platform and the side slope of the upper farm platform (zone (3) in Figure 14) collapsed and released about 1 000 cubic metres of material into the natural gully. The landslide debris was fluidised by the large volume of surface water entering the natural gully. The fluid debris was carried down the gully, scouring out more material along its

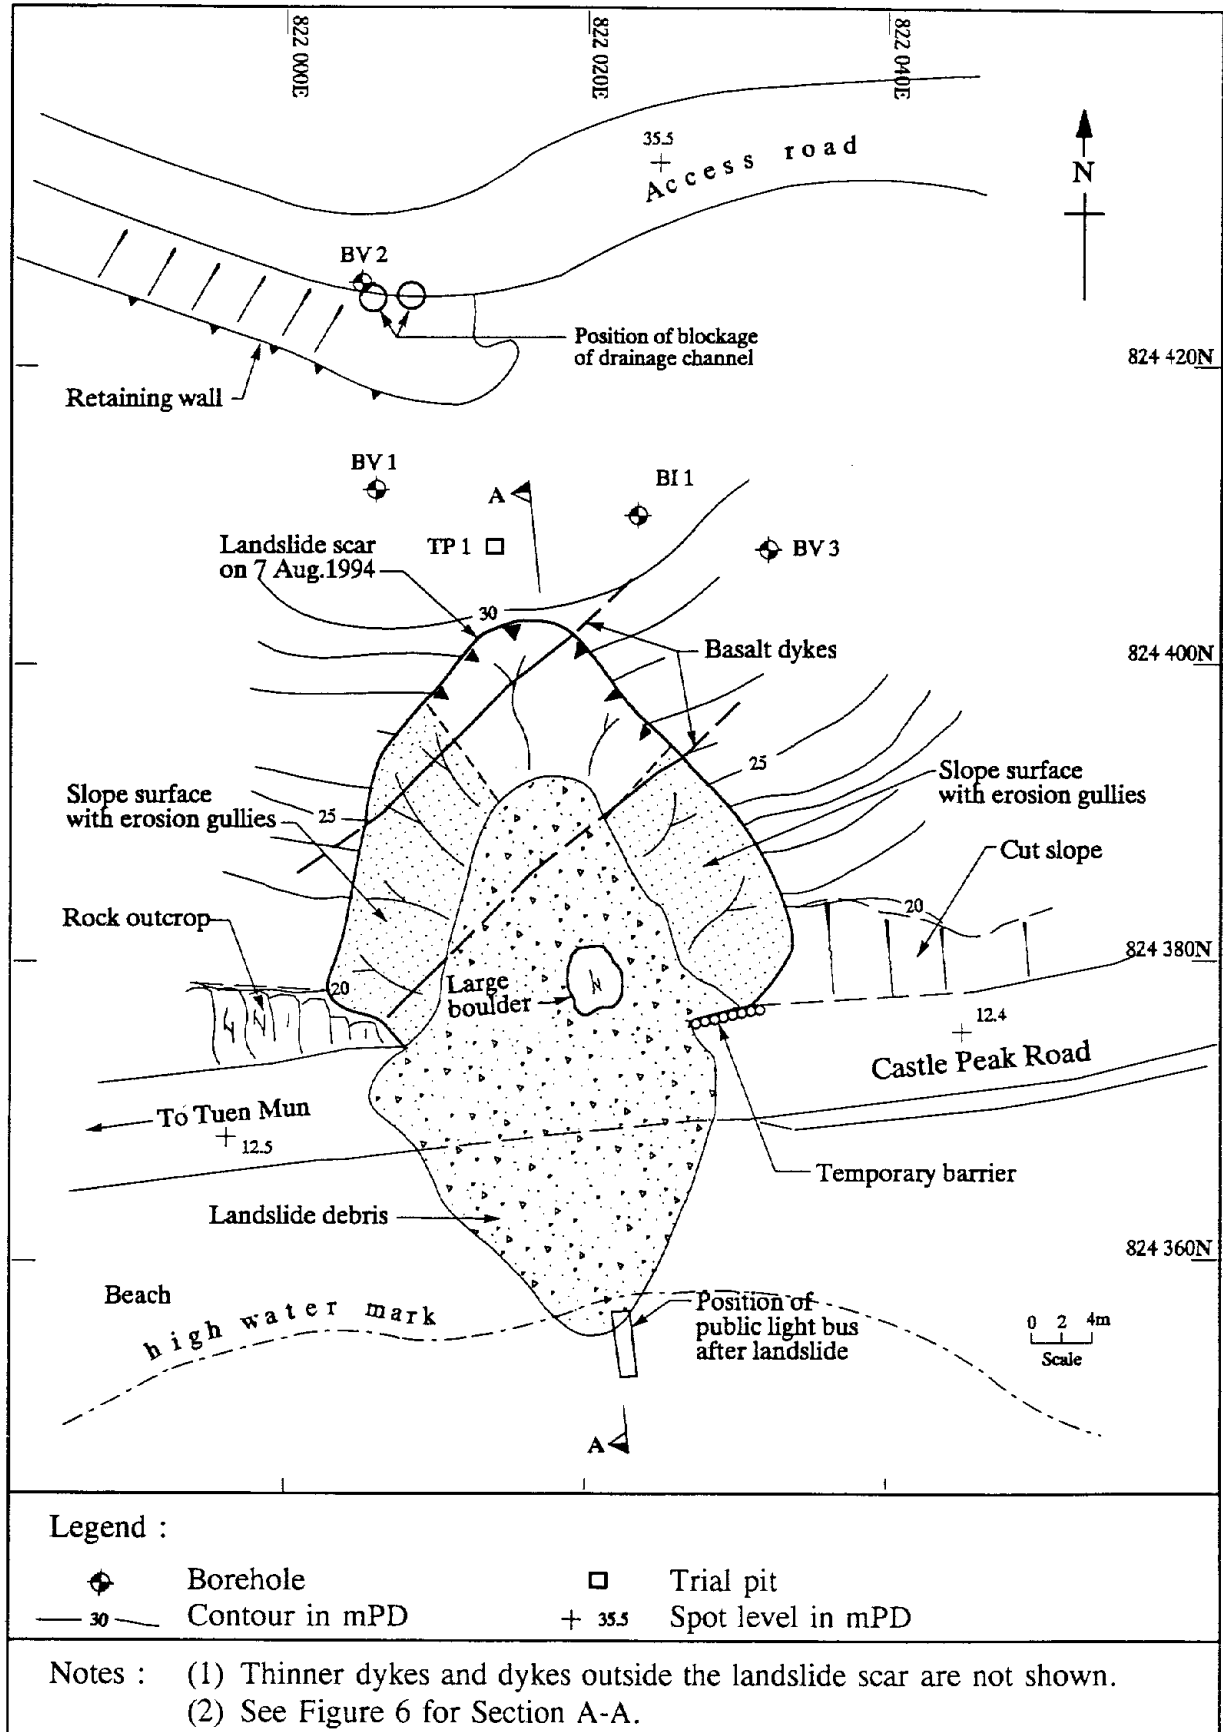
Figure 5 - Plan of the Landslide Scar on 7 August 1994

The groundwater regime in the landslide area was controlled by a number of decomposed basalt dykes and by the rock that outcrops on the western side of the landslide scar (Figure 5). The dykes are relatively impermeable to water and could have dammed the groundwater flow and raised the groundwater level (Figure 7). Furthermore, the orientation of the dykes and the position of the rock outcrop would have allowed groundwater to converge to the cut slope in question. Surface water overflowing from the blocked drainage channel at the access road on the hillside above the failed slope could have contributed to the water infiltration into the natural ground. Theoretical analyses have shown that the second landslide could have occurred as a result of the high groundwater level.
