**ASSESSMENT OF
GEOLOGICAL FEATURES
RELATED TO RECENT
LANDSLIDES IN VOLCANIC
ROCKS OF HONG KONG
PHASE 2A -
CHAI WAN STUDY AREA**

GEO REPORT No. 60

S.D.G. Campbell & N.P. Koor

**GEOTECHNICAL ENGINEERING OFFICE
CIVIL ENGINEERING DEPARTMENT
THE GOVERNMENT OF THE HONG KONG
SPECIAL ADMINISTRATIVE REGION**

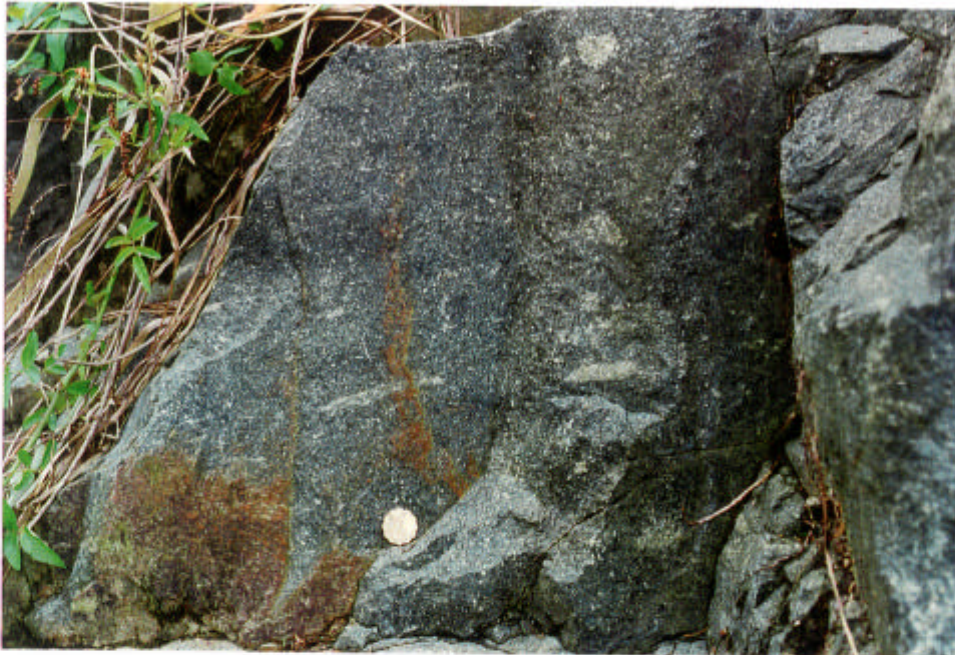
Plate 2 - Typical Volcanic Fabric with Aligned Lapilli and Fine Eutaxitic Foliation (844500 813614) in Slope 11SE-D/C181, Southeast of Siu Sai Wan Estate (Taken 26/6/96)

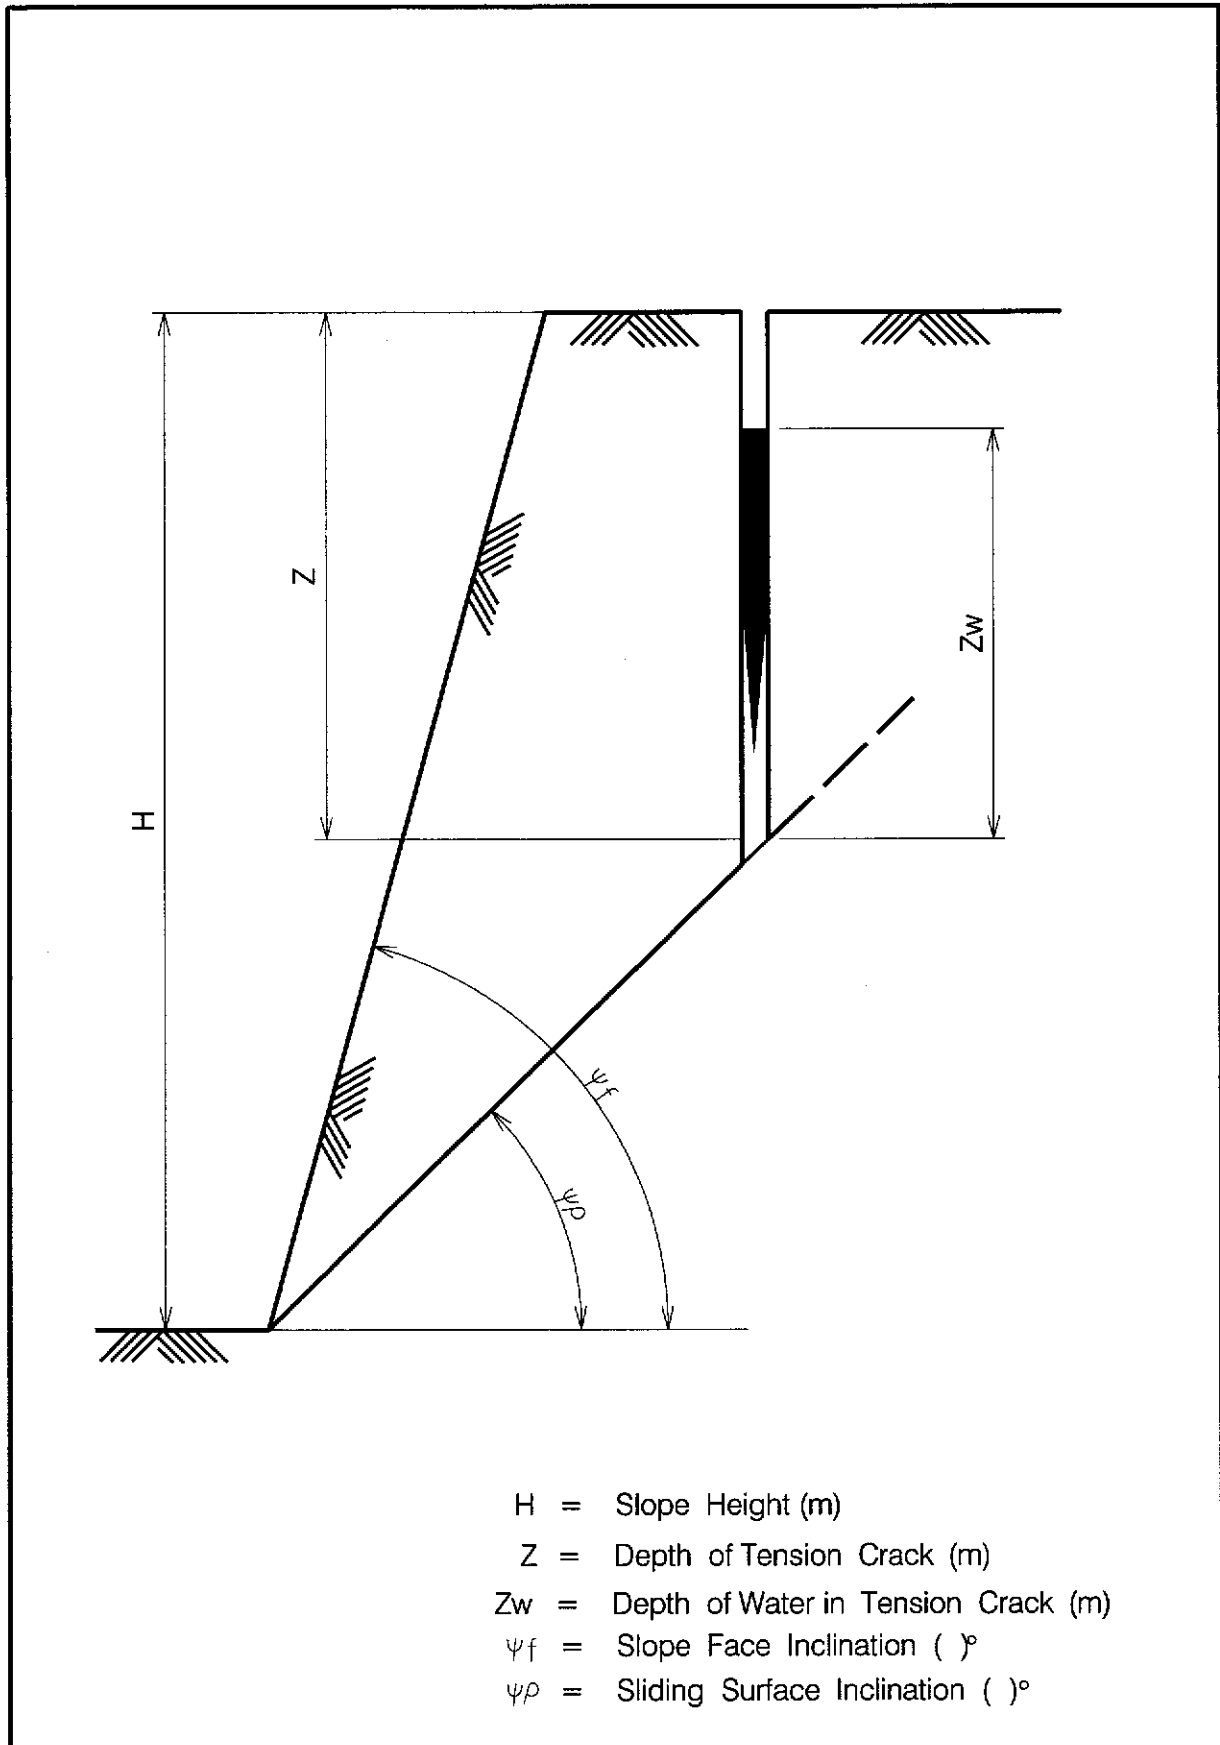
Figure 5.1 - Model Used in the Sensitivity Analysis (after Hoek & Bray ,1981)

- (g) The geological model assumed in the sensitivity analysis is as shown on Figure 5.1.

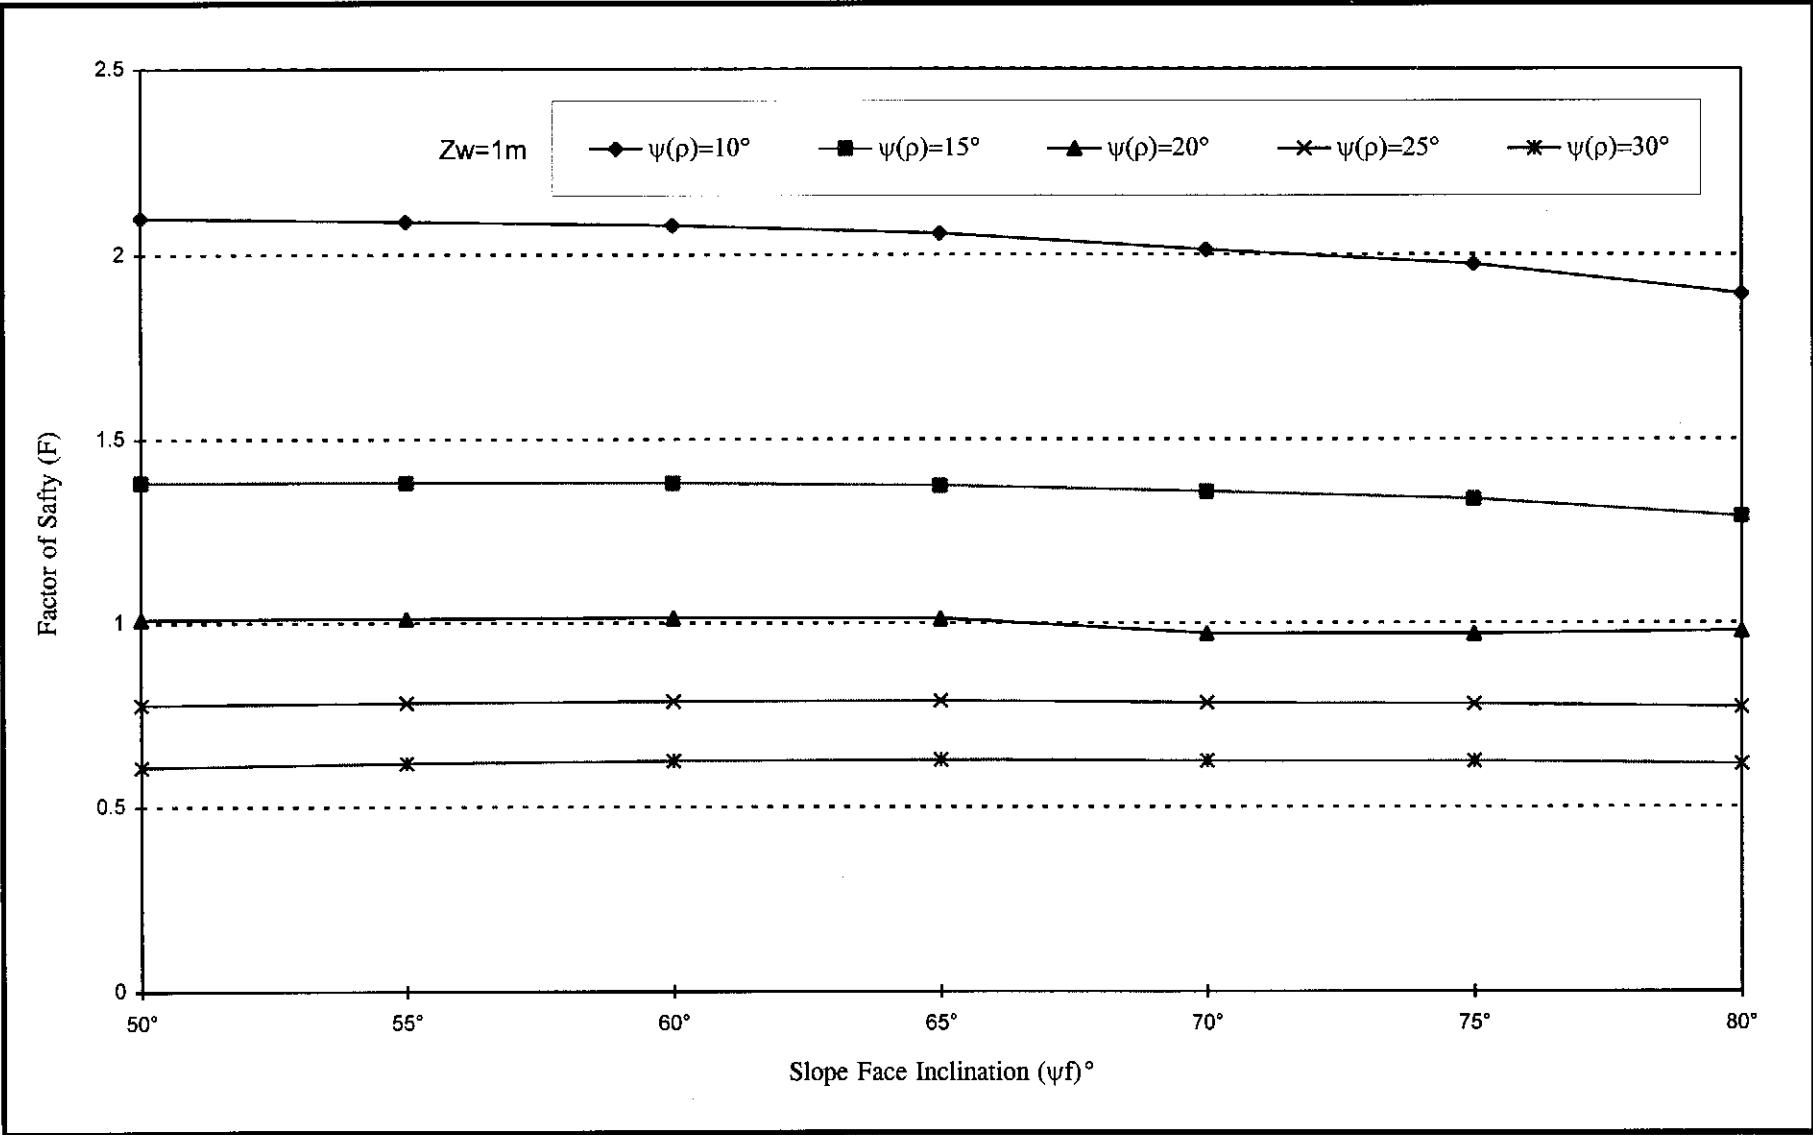
Figure 5.3 - Factor of Safety (F) vs Slope Face Inclination (ψ_f)° for Various ($\psi(\rho)$)°

Figure 5.2 demonstrates that the factor of safety drops below unity when the ratio between the depth of water in the joint and the depth of joint is about 0.4 for a sliding surface inclination of 15°. Any sliding surface at a higher inclination is less stable. Figure 5.3. demonstrates that the inclination of the slope surface has very little influence on the stability of the slope.
