FACTUAL REPORT ON THE NOVEMBER 1993 NATURAL TERRAIN LANDSLIDES IN THREE STUDY AREAS ON LANTAU ISLAND

GEO REPORT No. 61

H.N. Wong, Y.M. Chen & K.C. Lam

**GEOTECHNICAL ENGINEERING OFFICE
CIVIL ENGINEERING DEPARTMENT
THE GOVERNMENT OF THE HONG KONG
SPECIAL ADMINISTRATIVE REGION**

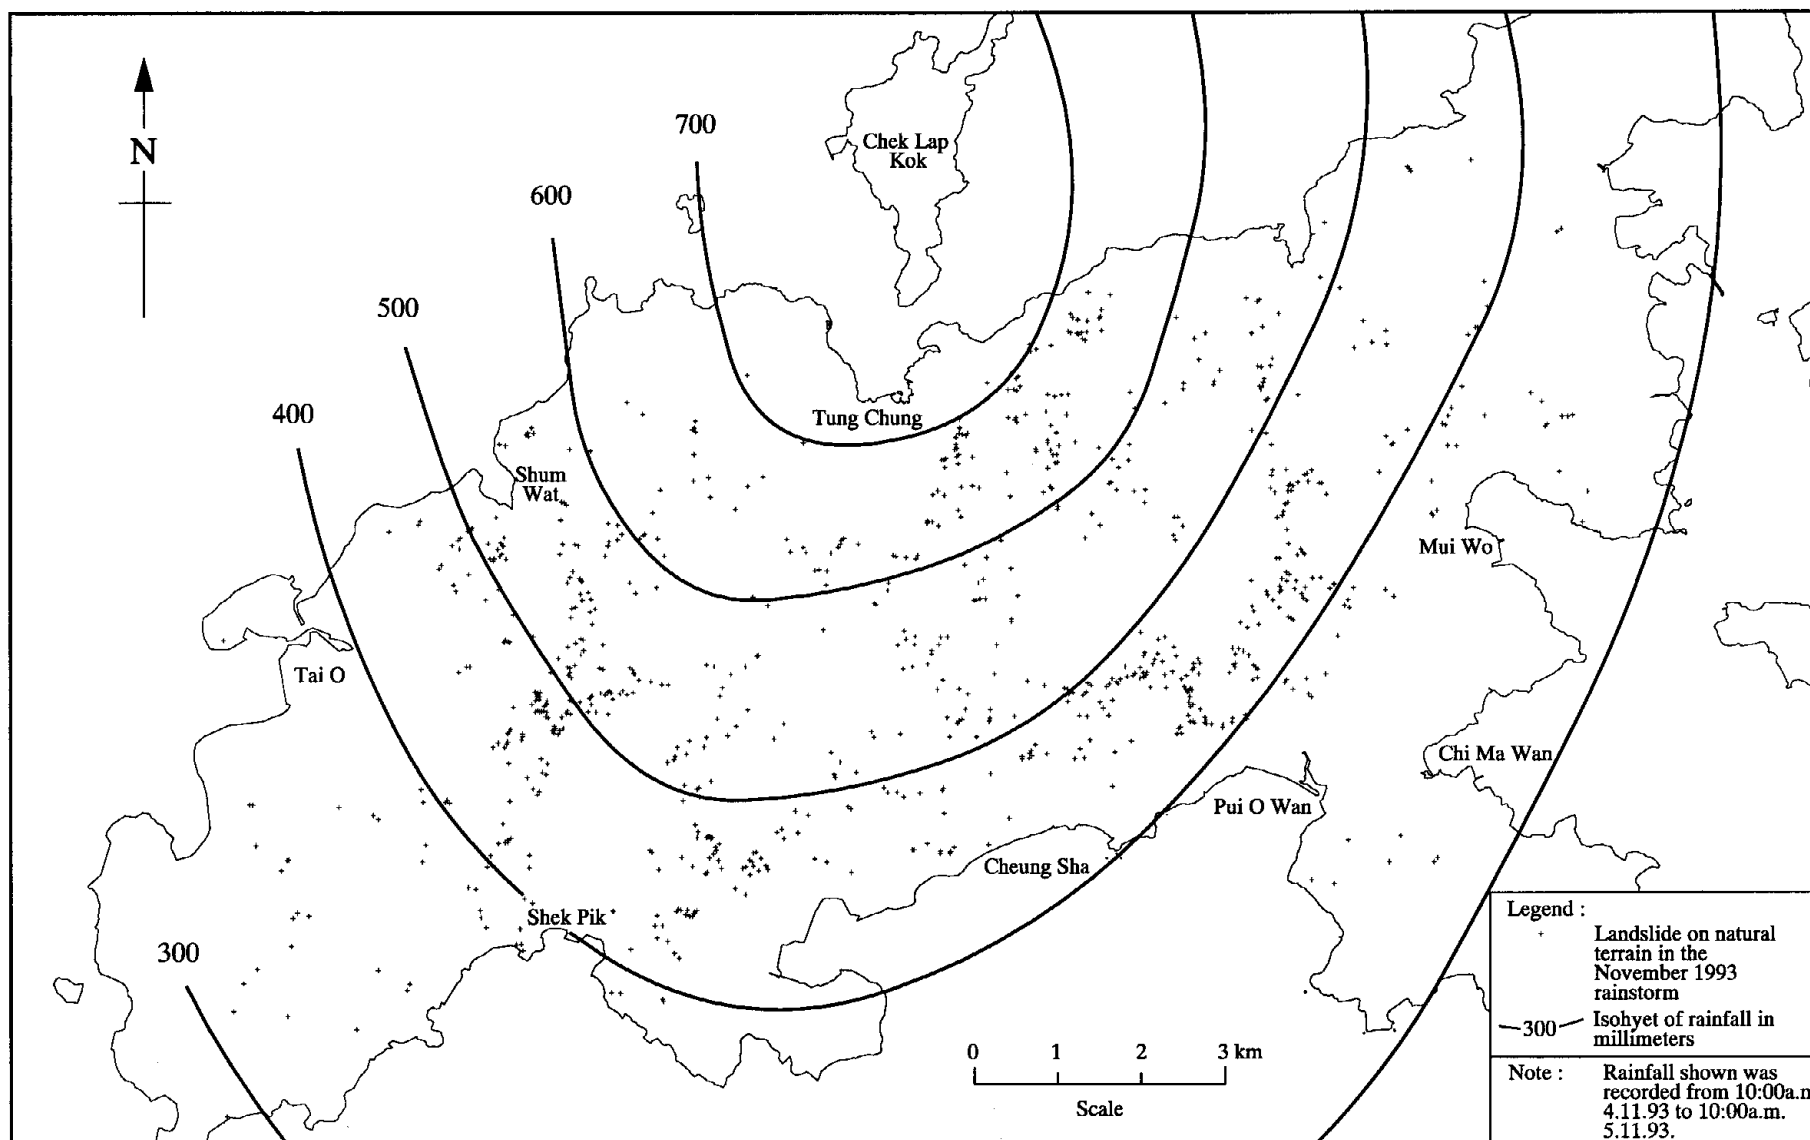
Figure 1 - Location Plan of Landslides on Natural Terrain

Lantau Island was subjected to a severe rainstorm on 4 and 5 November 1993, which resulted in over 800 landslides on the natural terrain there (Figure 1). These landslides have provided valuable data for a systematic examination of the characteristics and mechanisms of natural terrain failures in Hong Kong.

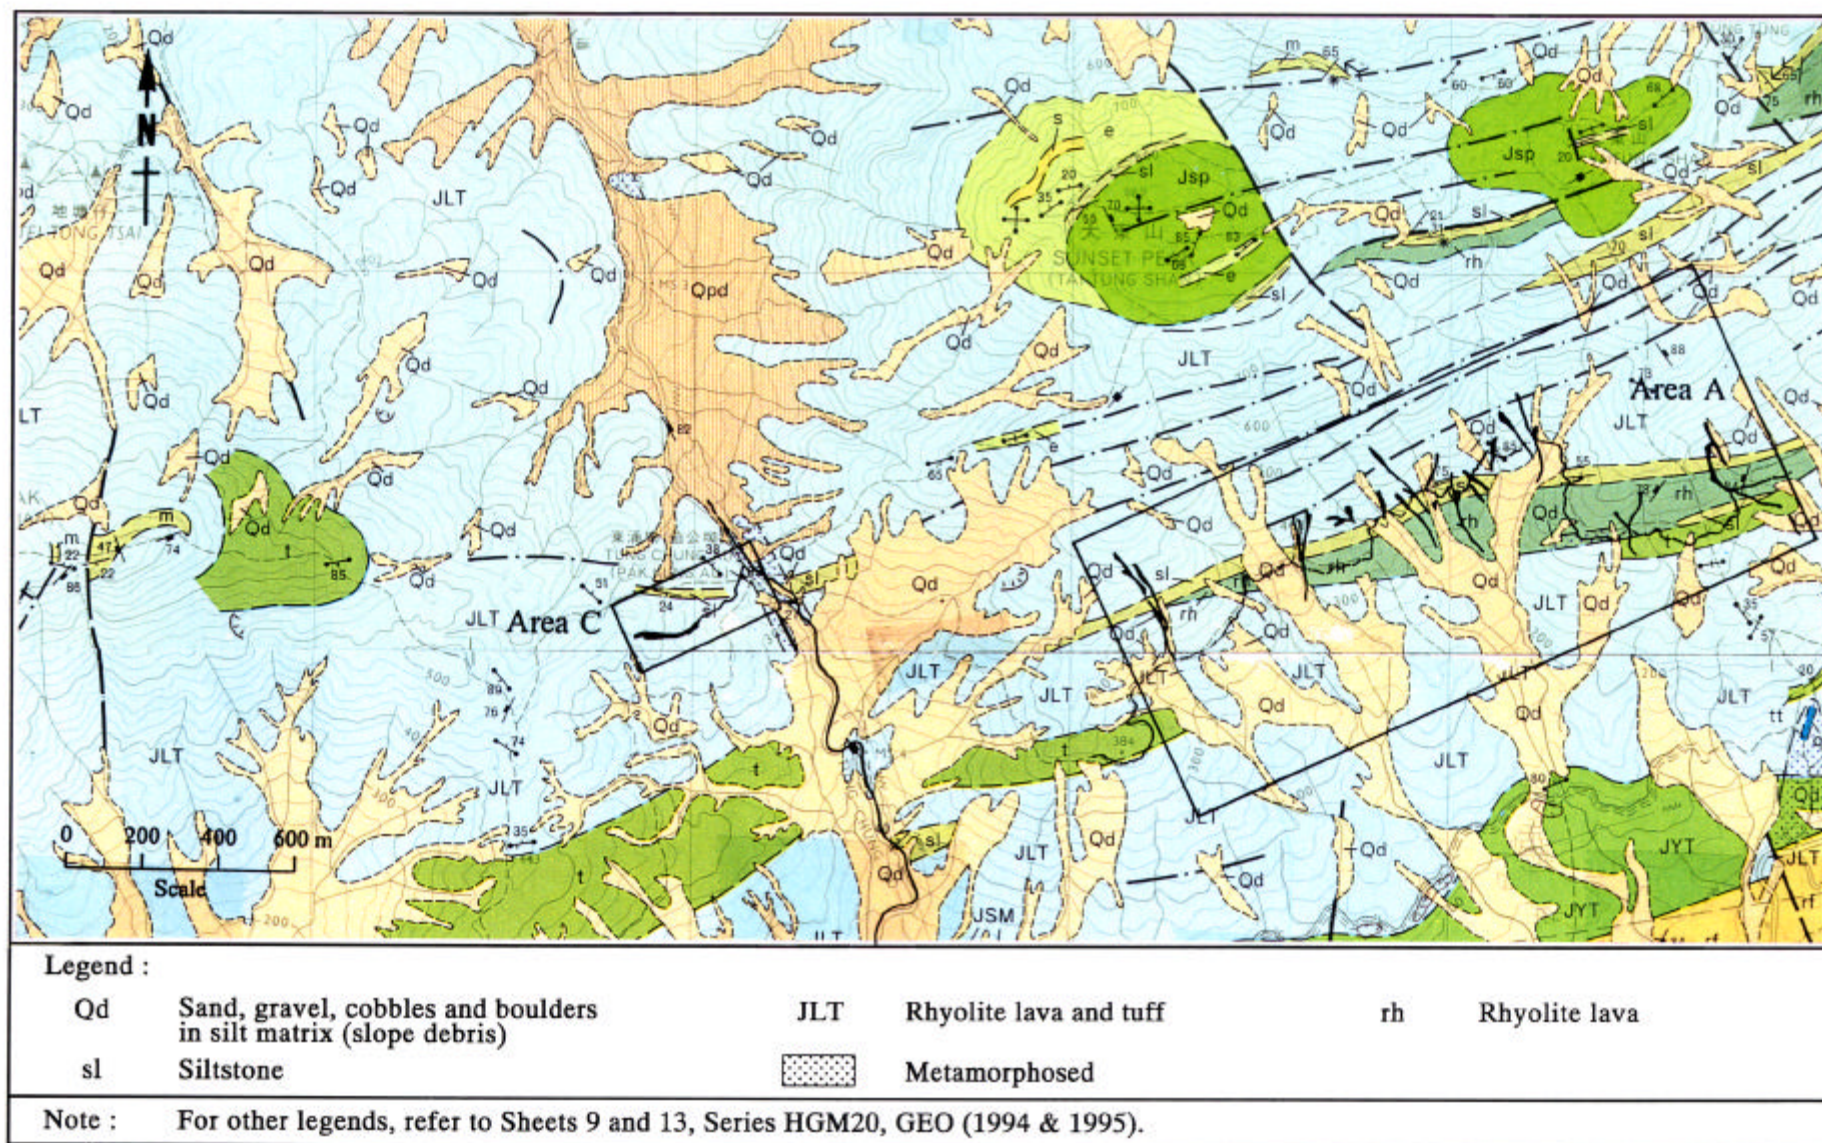
Figure 6 - Solid Geology of Study Areas A and C

The solid geology of the areas, which is based on GEO (1994 & 1995), is shown in Figures 6 and 7. The landslides in Areas A and C occurred in an area where the solid
