**ASSESSMENT OF
GEOLOGICAL FEATURES
RELATED TO RECENT
LANDSLIDES IN VOLCANIC
ROCKS OF HONG KONG
PHASE 2B -
ABERDEEN STUDY AREA**

GEO REPORT No. 67

C.A.M. Franks, S.D.G. Campbell & W.W.L. Shum

**GEOTECHNICAL ENGINEERING OFFICE
CIVIL ENGINEERING DEPARTMENT
THE GOVERNMENT OF THE HONG KONG
SPECIAL ADMINISTRATIVE REGION**

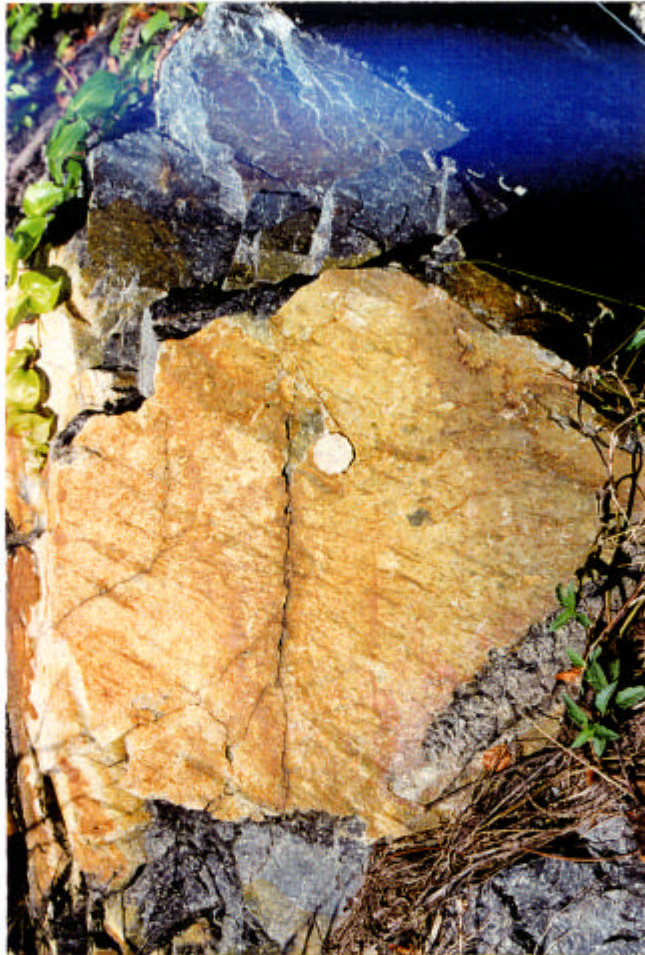
Plate 1 - Typical Volcanic Fabric with Aligned Lapilli and Fine Eutaxitic Foliation
in Slope 15NW-B/C87 (833830E 811315N). (Taken 25/10/96)
