一九九七年七月二日  
萬佛寺山泥傾瀉事件報告  
**REPORT ON THE LANDSLIDE  
AT TEN THOUSAND  
BUDDHAS' MONASTERY  
OF 2 JULY 1997**

土力工程處報告系列第 77 號  
GEO REPORT No. 77

合樂亞洲顧問公司  
Halcrow Asia Partnership Ltd.

香港特別行政區政府  
土木工程署  
土力工程處  
**GEOTECHNICAL ENGINEERING OFFICE  
CIVIL ENGINEERING DEPARTMENT  
THE GOVERNMENT OF THE HONG KONG  
SPECIAL ADMINISTRATIVE REGION**

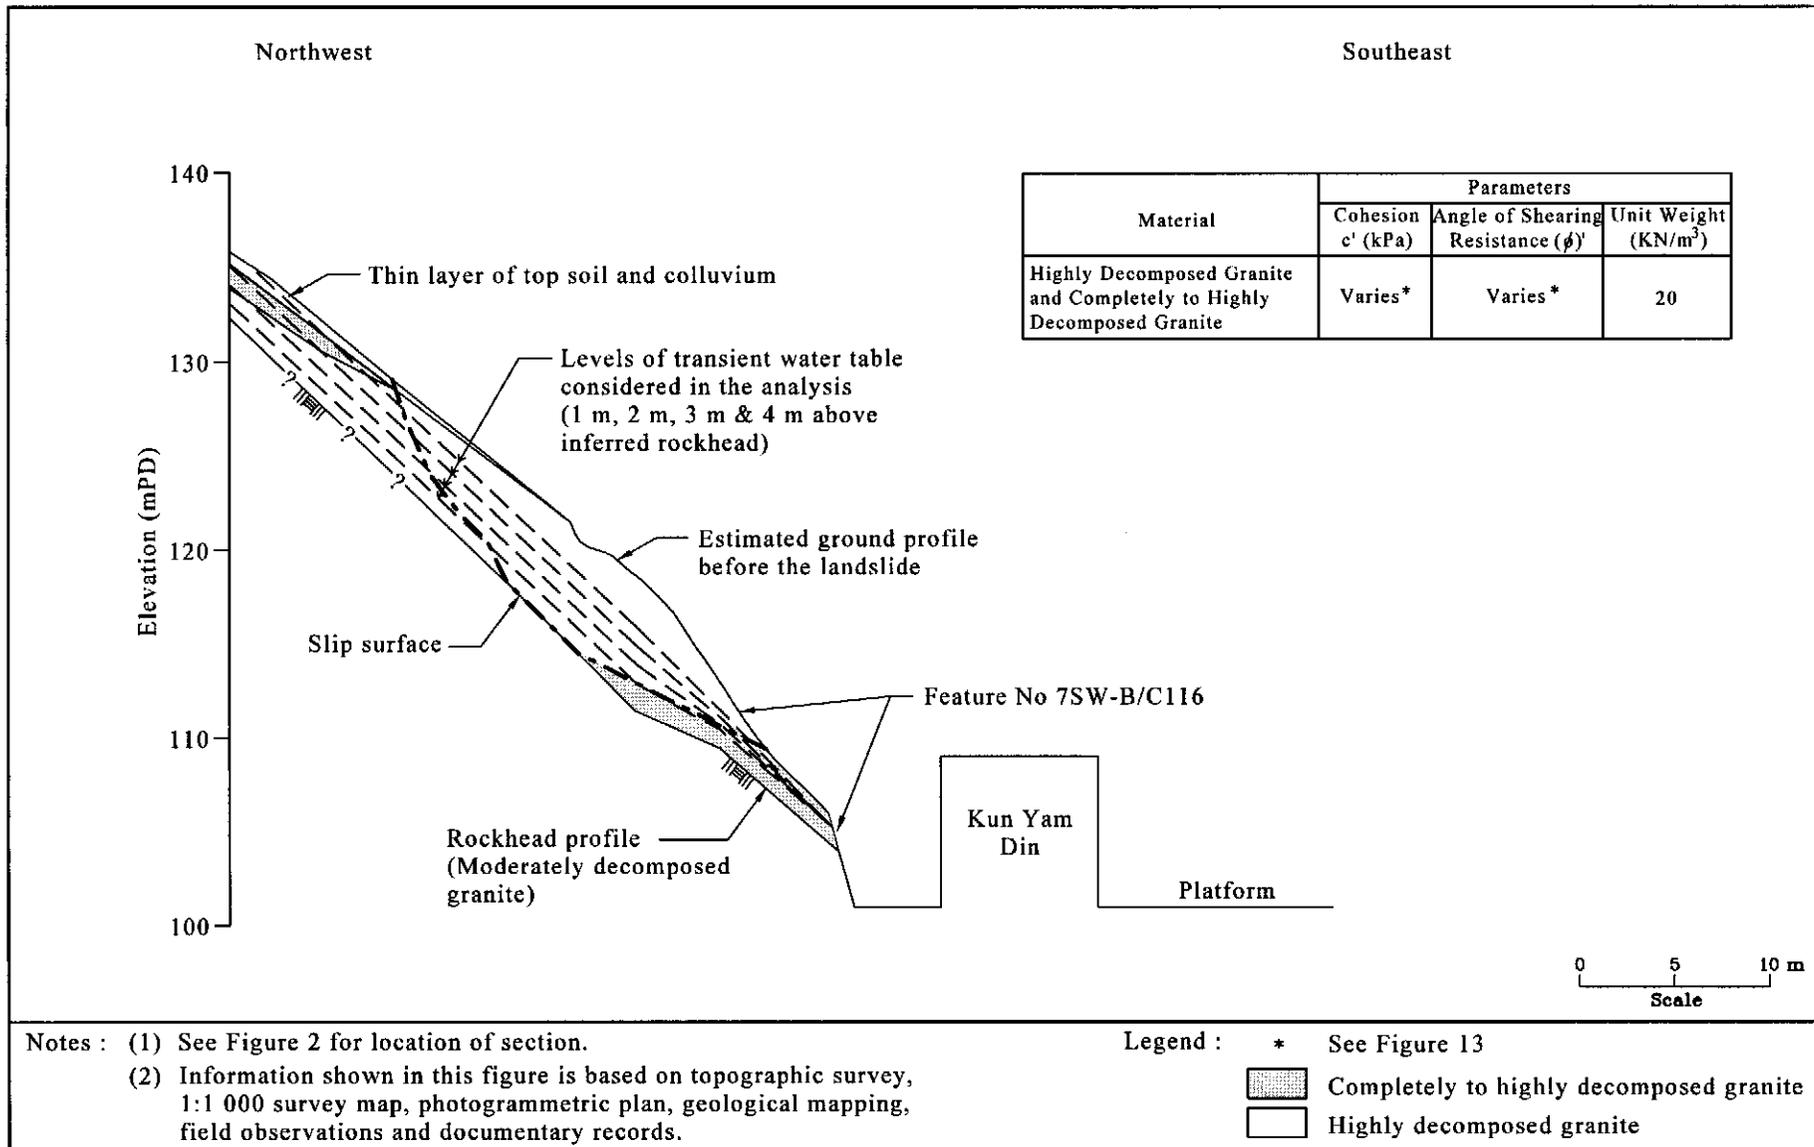
Figure 12 - Representative Cross-section of the Landslide for Theoretical Stability Analysis

The information used in these analyses was obtained from the post-failure ground investigation, fieldwork, laboratory testing, and site observations and measurement. A representative cross-section of the landslide site and the input parameters adopted in the analyses are shown in Figure 12. A transient water table up to 4 m above the inferred rockhead was used in the analyses to simulate the possible range of groundwater conditions at the time of the failure.

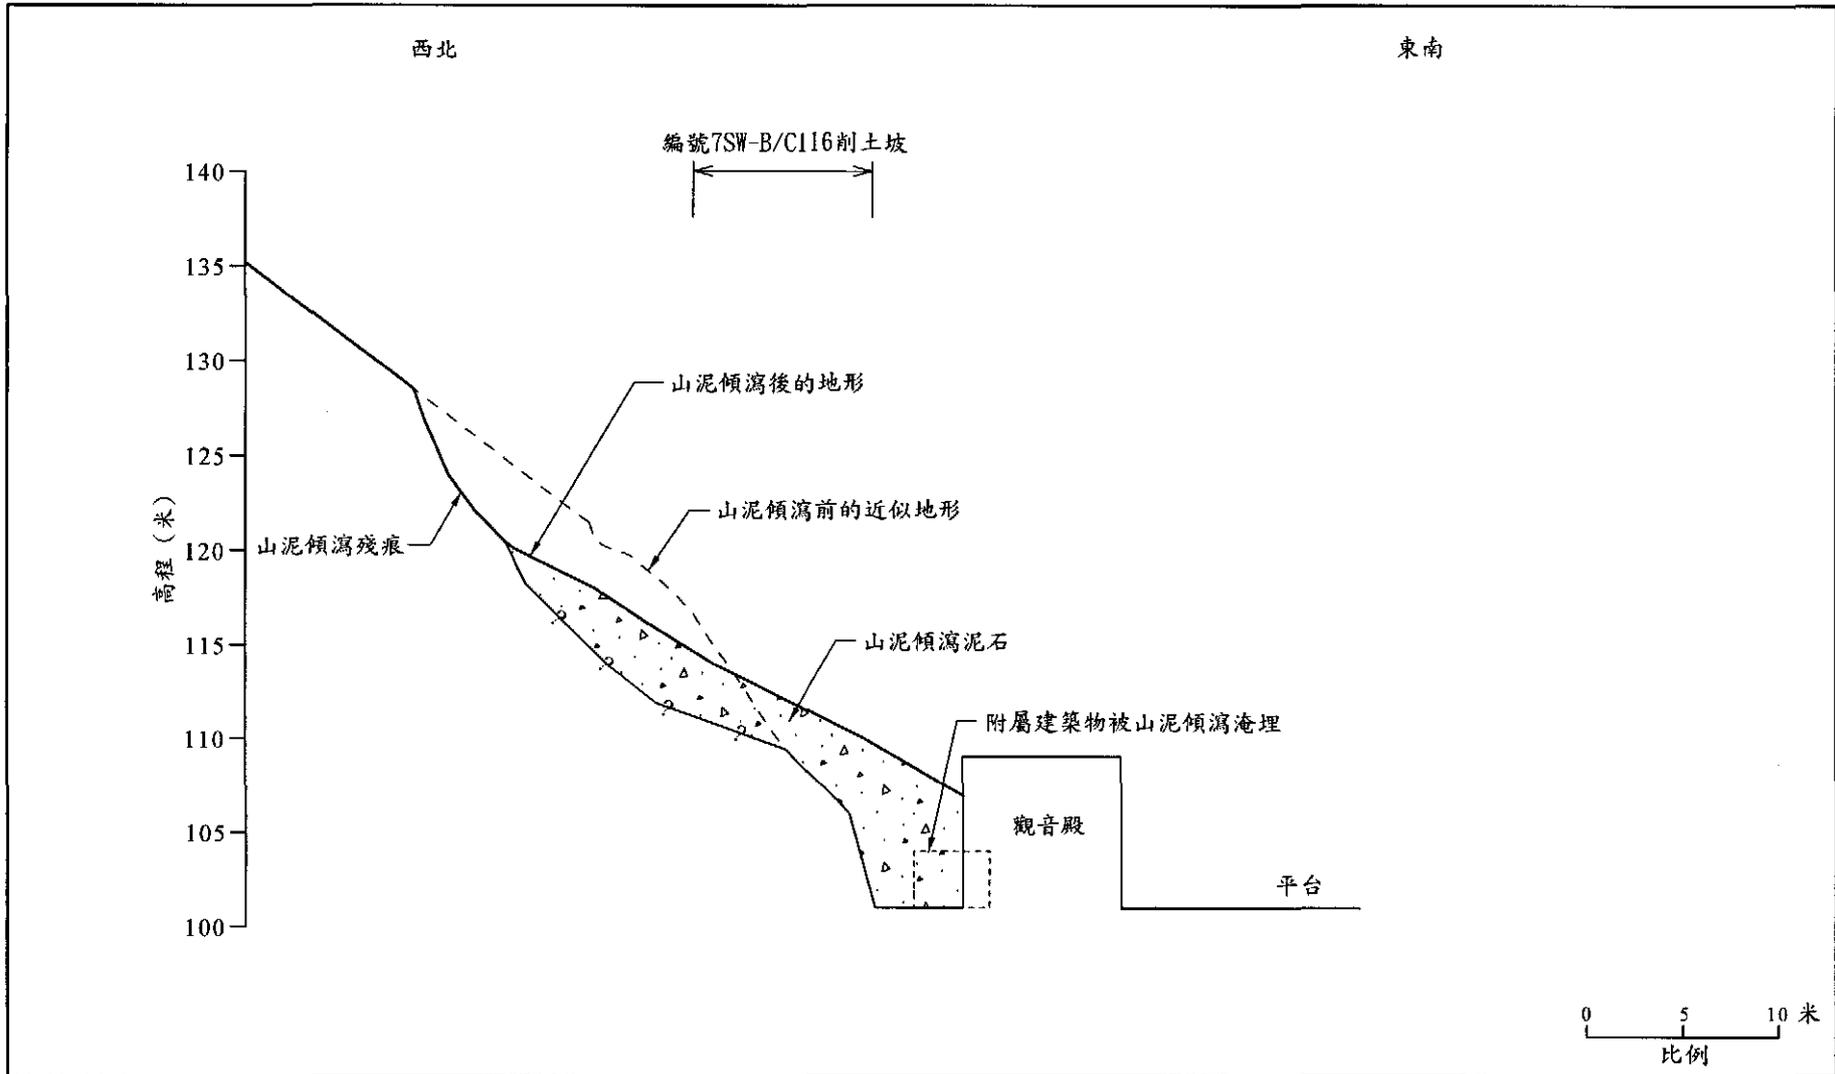
圖3 - 剖面 A-A 顯示山泥傾瀉地點的詳情

導致一人死亡的山泥傾瀉照片載於照片 2，其平面圖及橫貫山泥傾瀉地點的剖面圖則分別載於圖 2 和圖 3。

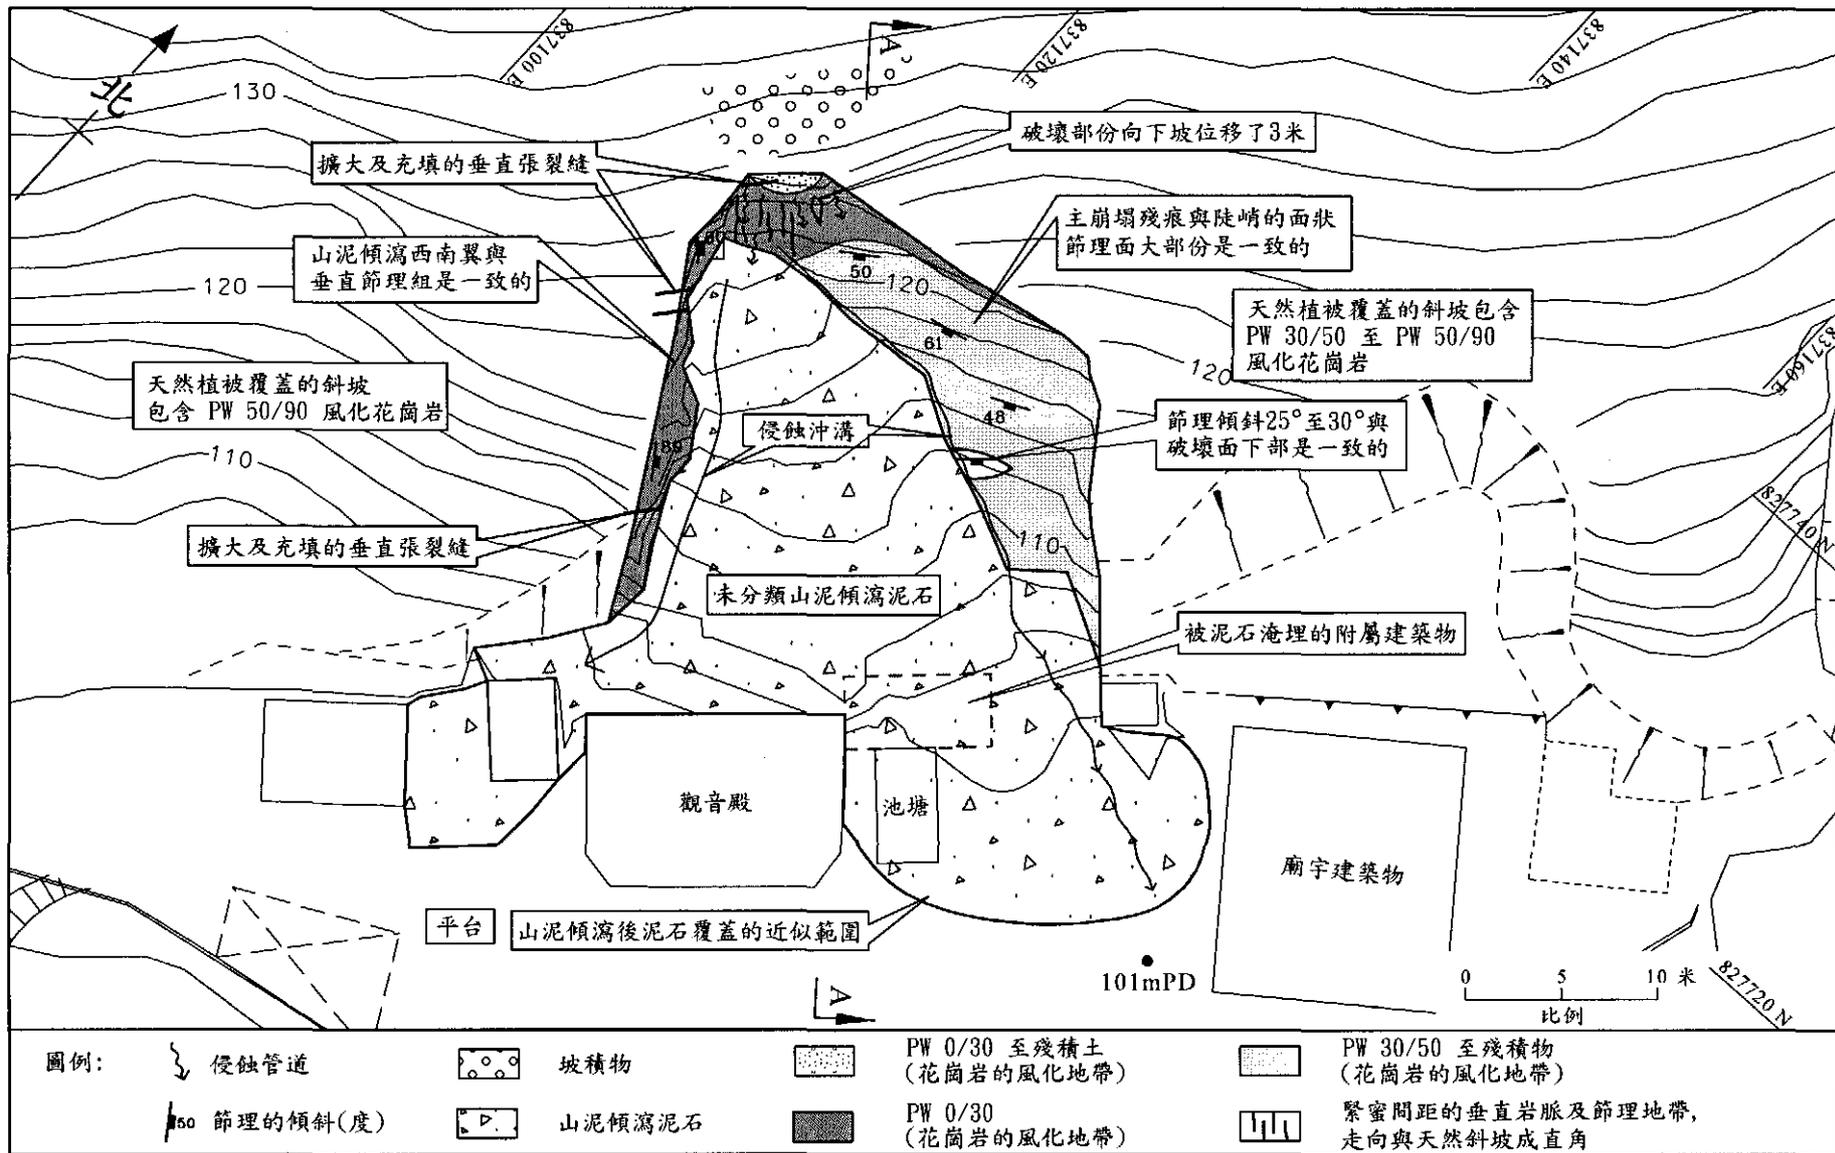
圖8 - 山泥傾瀉地點的地質圖

在山泥傾瀉部位的西南側出露的非均勻的風化花崗岩帶，觀察到與山坡具有相同傾向的，部份被充填的近於垂直的裂縫（圖 8 與照片 7）。典型地，裂縫中等程度地狹窄（20 毫米到 60 毫米），並且部份地充填有干硬至潮濕、微黏土質、含砂粉土殘留物，其可能是來自山坡面上沖刷進去的物質。在主滑坡崖，偶然觀察到殘餘節理，具有與裂縫相似的走向，延續一般小於一米。由此認為，這些節理可能在過去業已張開而形成裂縫，儘管在一些情況下，裂縫已經明顯地沿著"岩石塊體"與較弱的高度風化花崗岩的垂直的邊界面形成。

一九九七年七月二日山泥傾瀉發生後在很短時間內，觀察到大量的滲水從低於地表約 2 米的主滑坡崖上流出(圖 8)。滲水源自貫穿土體的侵蝕管(照片 9)和微張開的殘餘節理及石英岩脈。滲水量大體在一九九七年七月三日豪雨停頓約一周後大幅減少了。

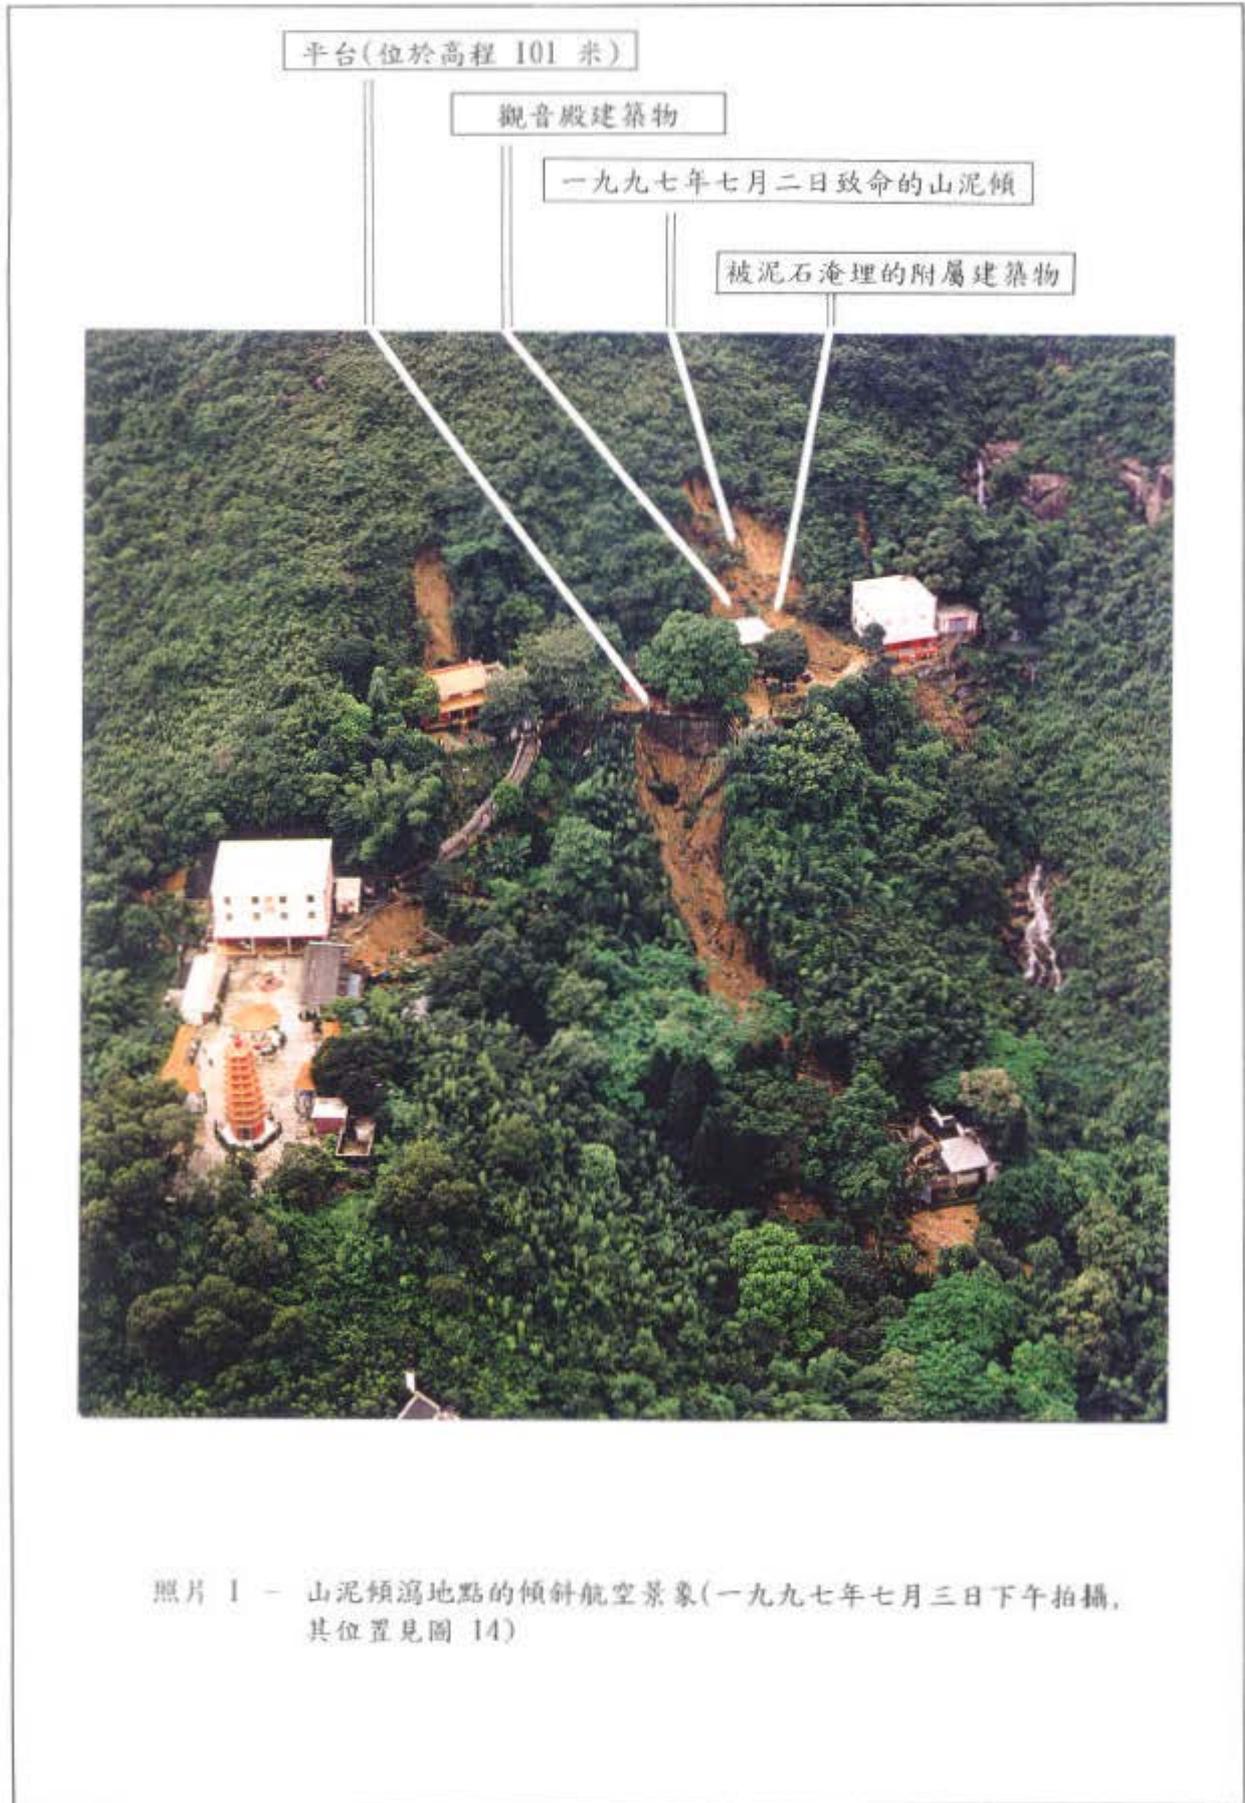
一九九七年七月二日，萬佛寺發生了五處山泥傾瀉，其中四處均影響到觀音殿所處的填挖平台（圖 1 及照片 1）。根據沙田地政署的資料，導致一人死亡的山泥傾瀉發生於私人地段編號 323 及 324 的界線內（圖 1）。觀音殿後面削土坡的一部份（編號 7SW-B/C116）及其頂部的部份天然山坡涉及於這次事件中（圖 2）。

照片 1 - 山泥傾瀉地點的傾斜航空景象(一九九七年七月三日下午拍攝, 其位置見圖 14)

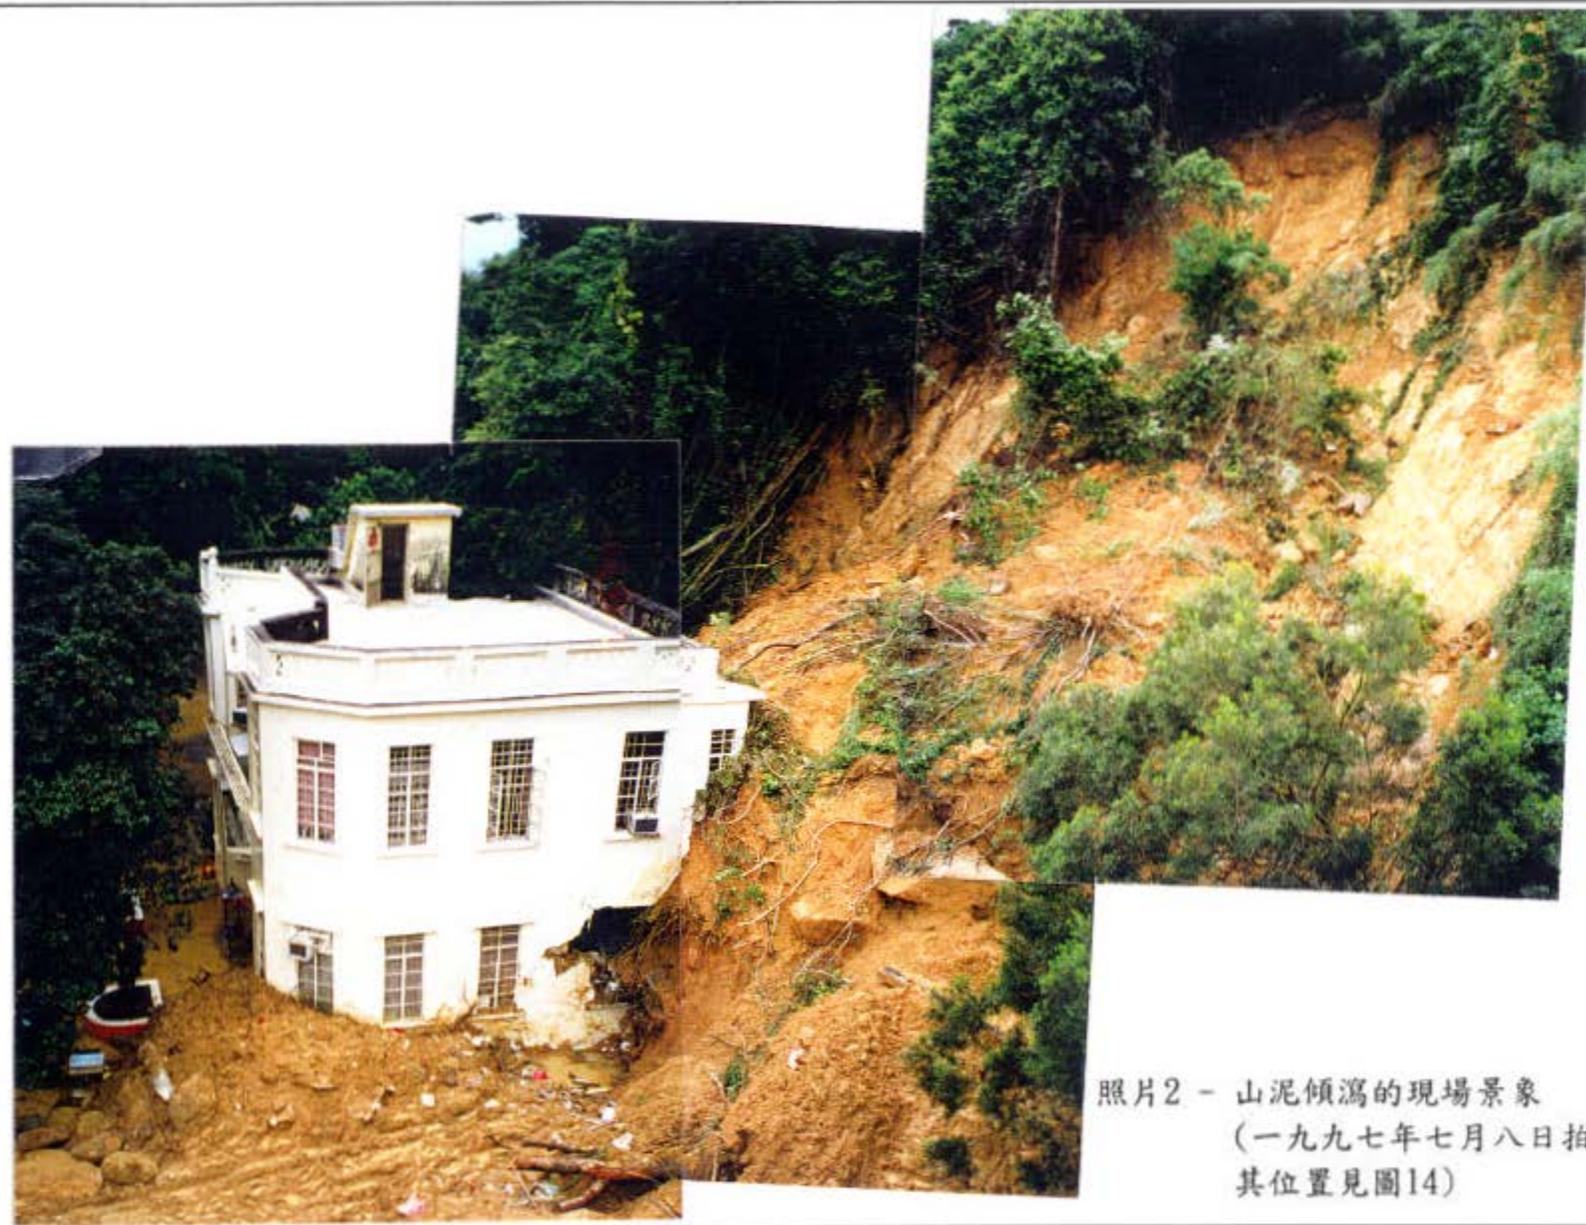
照片2 - 山泥傾瀉的現場景象  
(一九九七年七月八日拍攝，  
其位置見圖14)

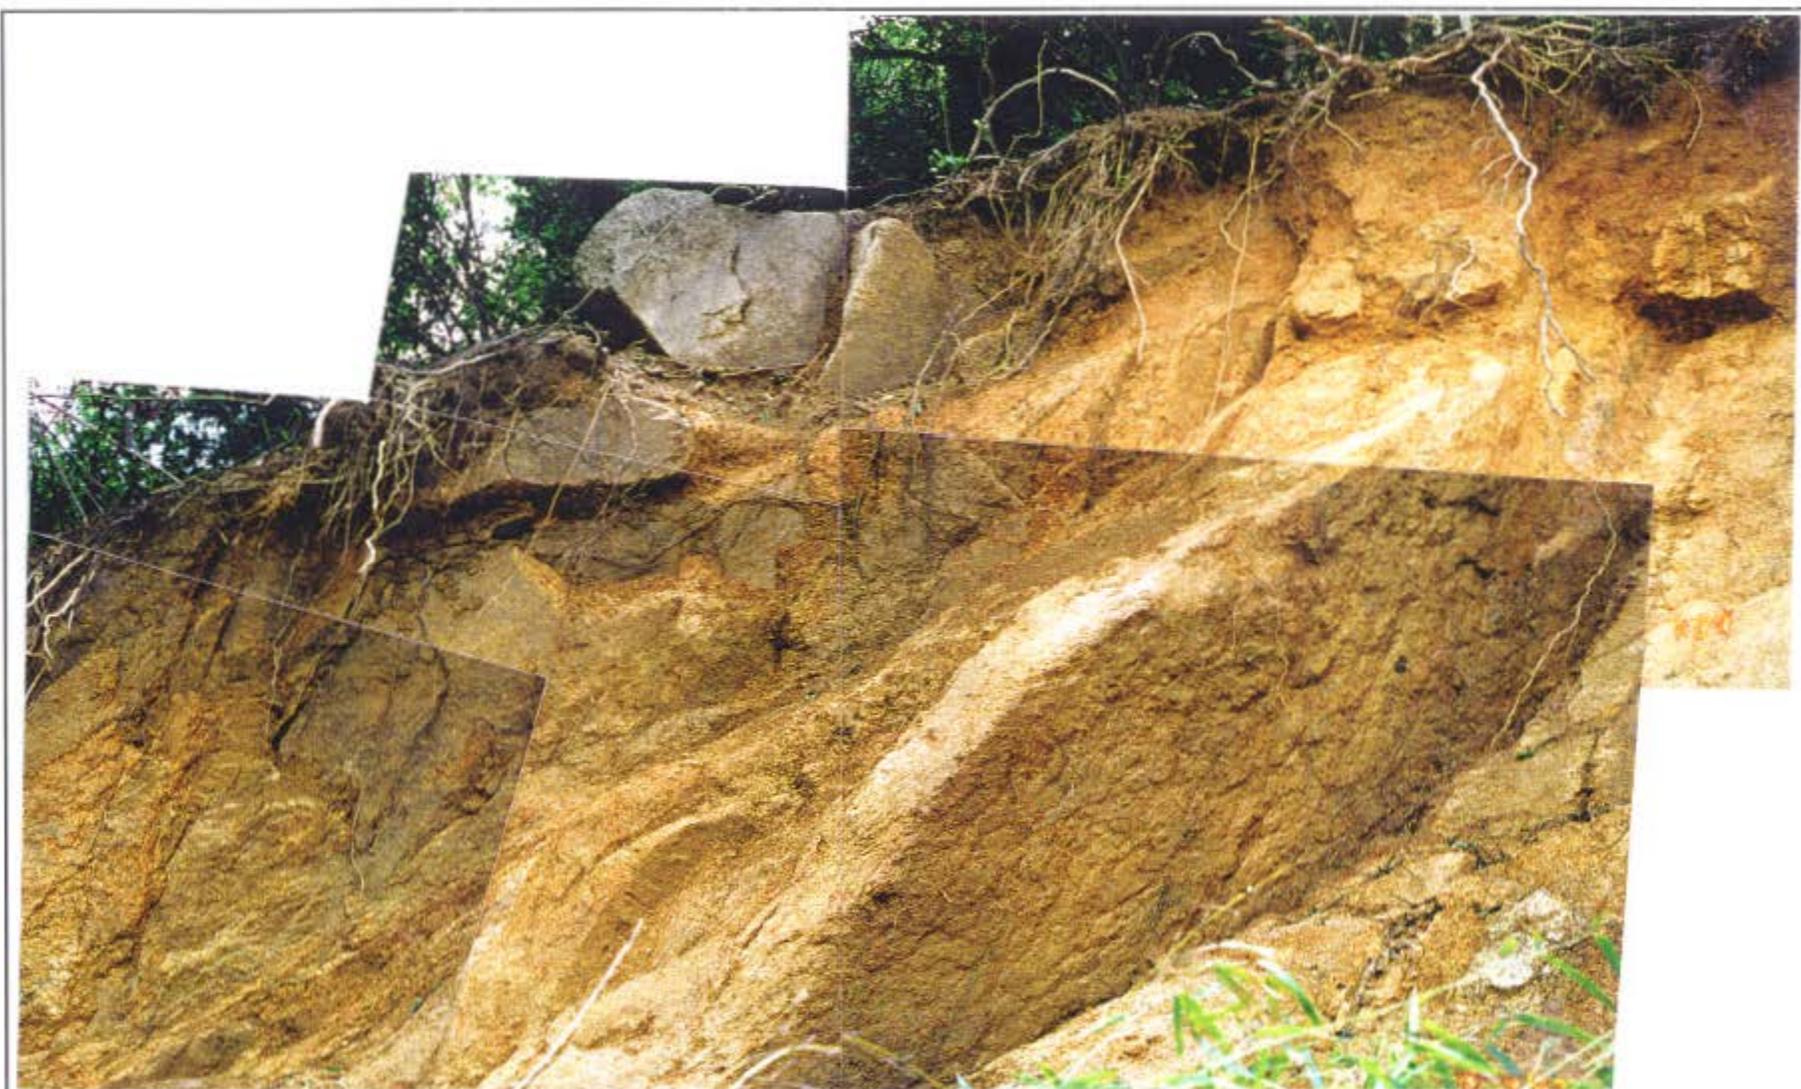
崩塌部位最深的部份是在中部和滑坡殘痕的西南側，其典型深度爲四米至六米。這種情況同該部份是由 PW0/30 部份風化花崗岩帶組成是相一致的。經由此風化帶的部份在山泥傾瀉部位西南翼露出，在那裏，一非均質的風化花崗岩層，由岩塊和較軟的高度風化的花崗岩組成，典型地出現在地表下一米至三米處（照片 3）。隨著深度的增加，岩塊消失，而花崗岩則變得更均勻。

照片3 - 山泥傾瀉西南翼的景象(一九九七年七月七日拍攝，其位置見圖14。注意地表的灰色的風化花崗岩塊體及在照片右下角的垂直面狀的不連續面，與一組主要的近於垂直的紋理和節理相互聯系)

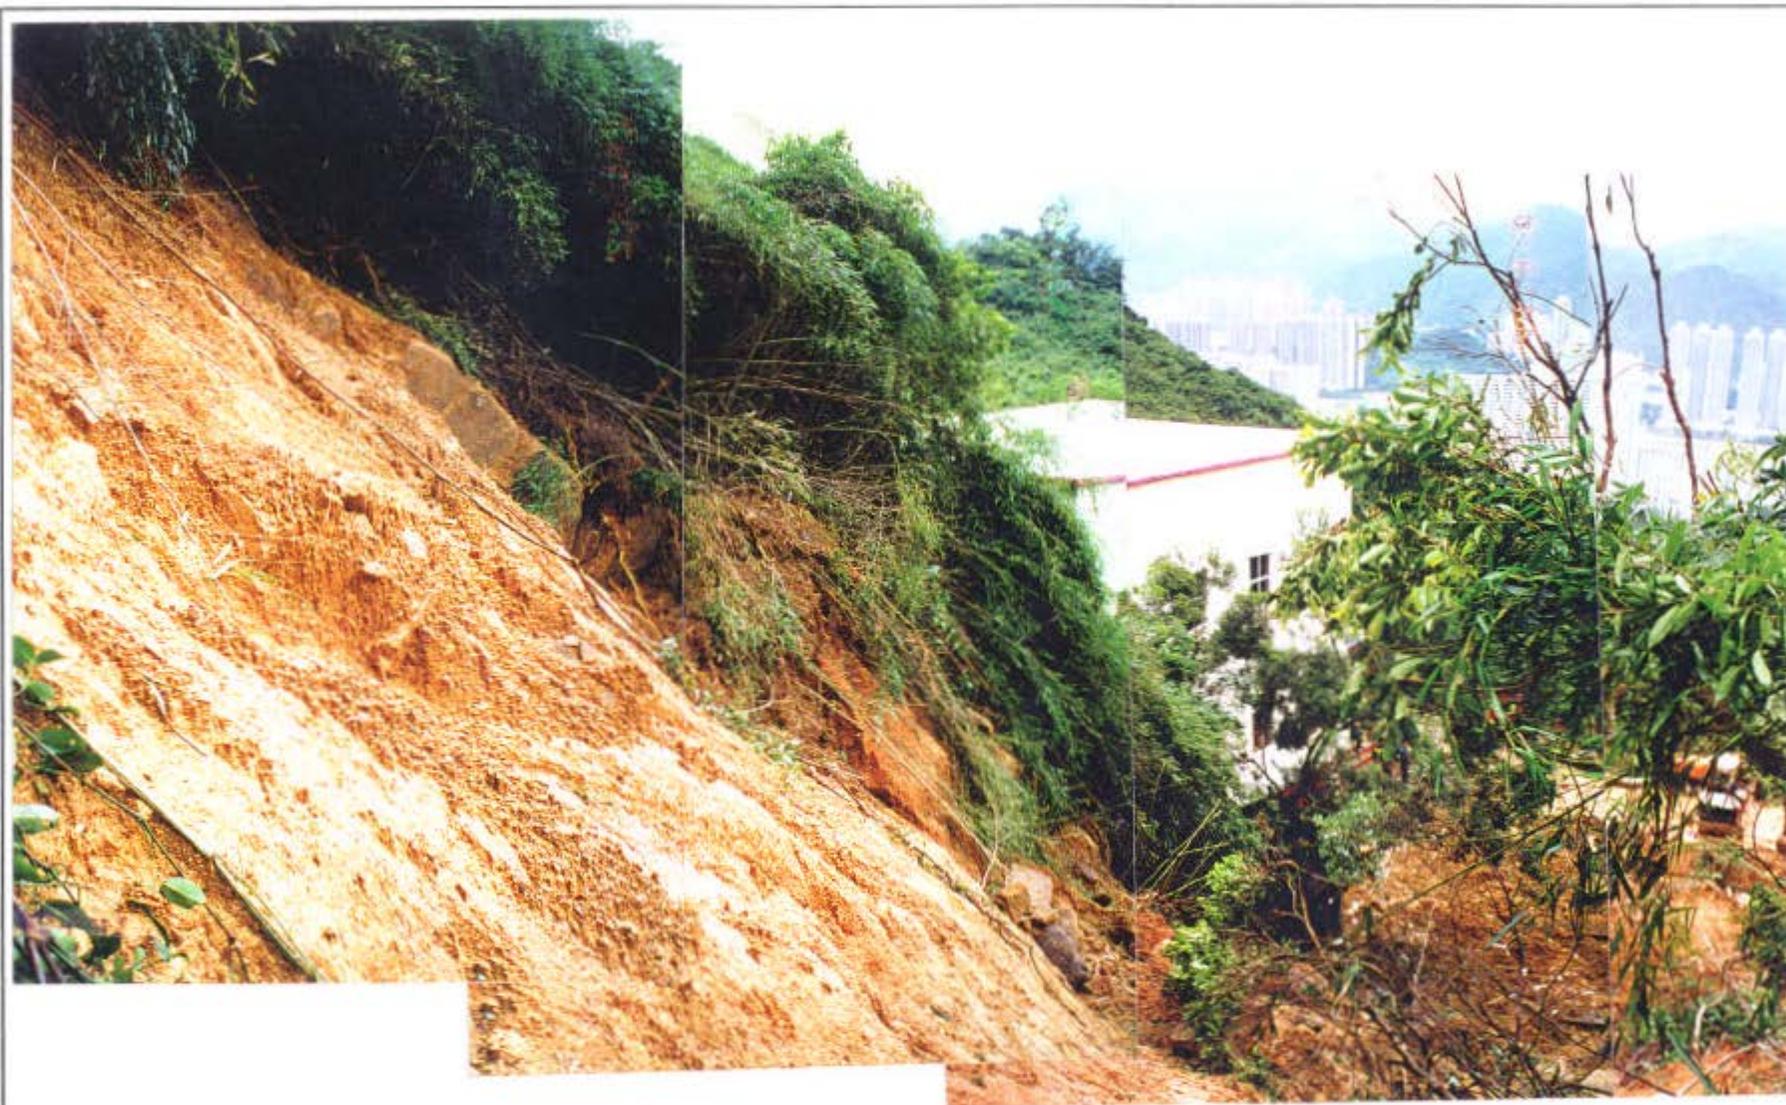
一九九七年七月二日的山泥傾瀉大體由事前已存在的不連續面所控制。破裂面在滑坡殘痕部份地露出，沿業已存在的、持續的、起伏不平及粗糙的節理，分別在主斷層崖的上部和下部傾向南到東南面約 52 度和 43 度（照片 4）。順著山泥傾瀉西南側，滑坡深度增加是由於節理的走向稍微傾向於自然山坡的走向。測得的波狀節理的波長達 5 米，變化幅度達 0.8 米，節理面上最大的粗糙角度約爲 16 度。節理與自然山坡有關的方位特徵及它的持續和起伏特徵，表明其可能爲一面狀節理。

照片4 - 面狀節理面的景象(一九九七年七月七日拍攝，其位置見圖14，注意山泥傾瀉的東北翼與天然斜坡結合成一體 )

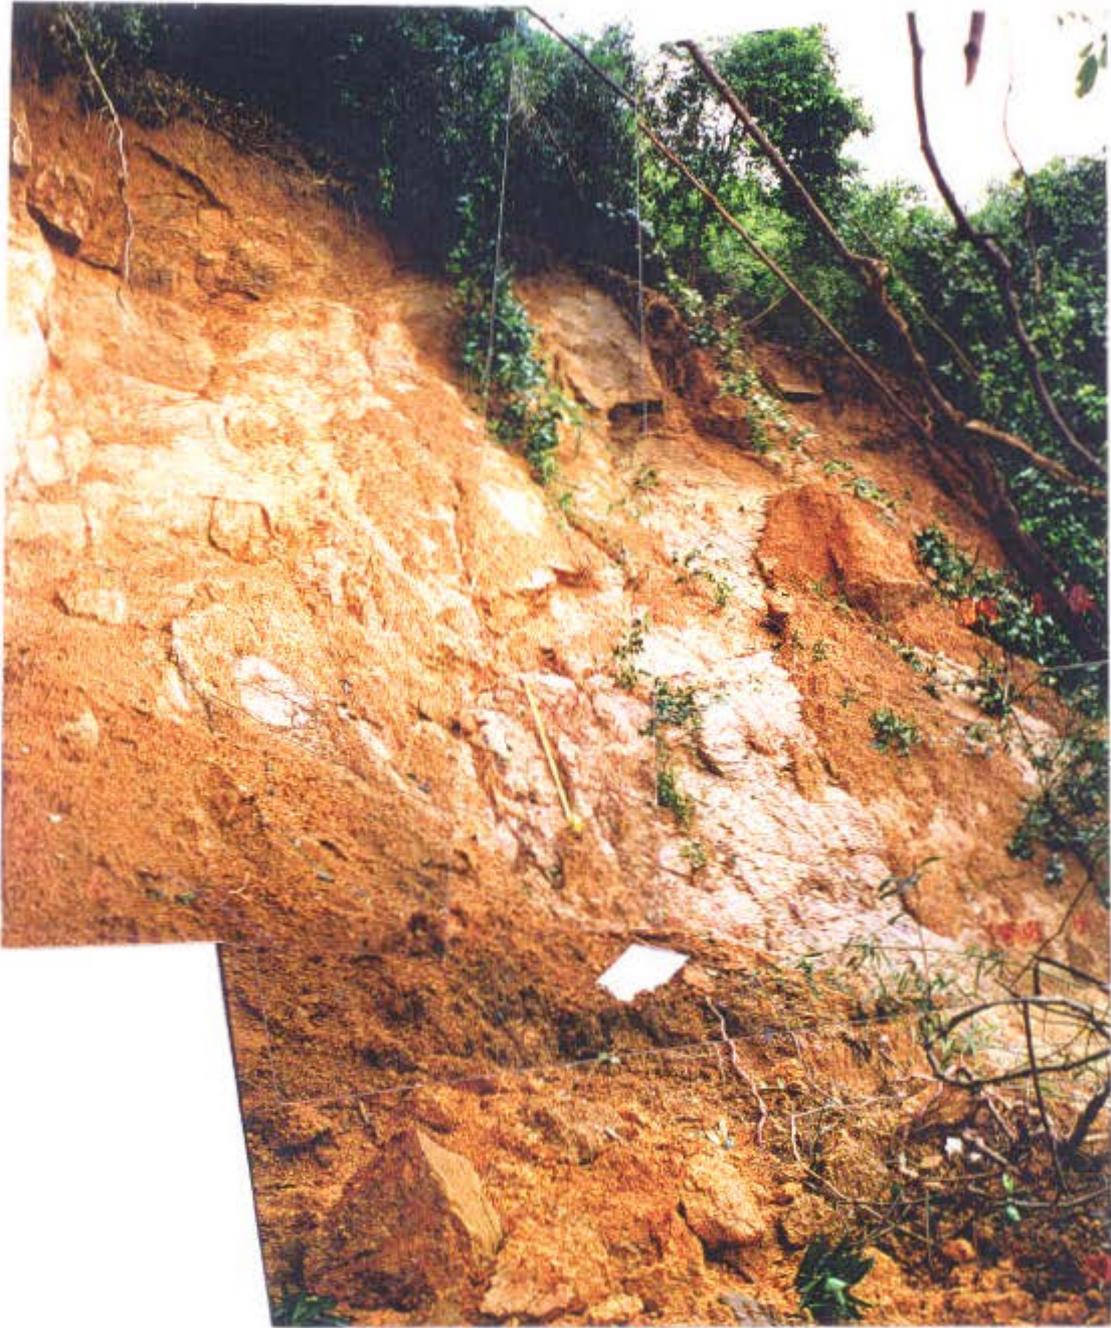
山泥傾瀉破裂面的上半部份沿面狀節理及穿過完整風化花崗岩而形成，導致形成一陡曲的表面（照片 5），而最大的破裂面的中心部份完全沿著面狀節理形成。破裂面的下半部份，在山泥傾瀉部位東北側的侵蝕谷裏及四個探井中出露，與一組不易見到的、間斷的起伏不平並傾向東南，以 30 度角穿出斜坡的節理是一致的（照片 6）。一淡灰色、微黏土質粉土薄層，達 20 毫米厚，局部地蓋在或充填在一些節理上。

照片5 - 主滑坡崖上部的景象，顯示部分風化花崗岩帶  
(0-30%岩石至殘積土)及面狀節理面  
(一九九七年七月七日拍攝，比例為1米的  
卷尺，其位置見圖14)

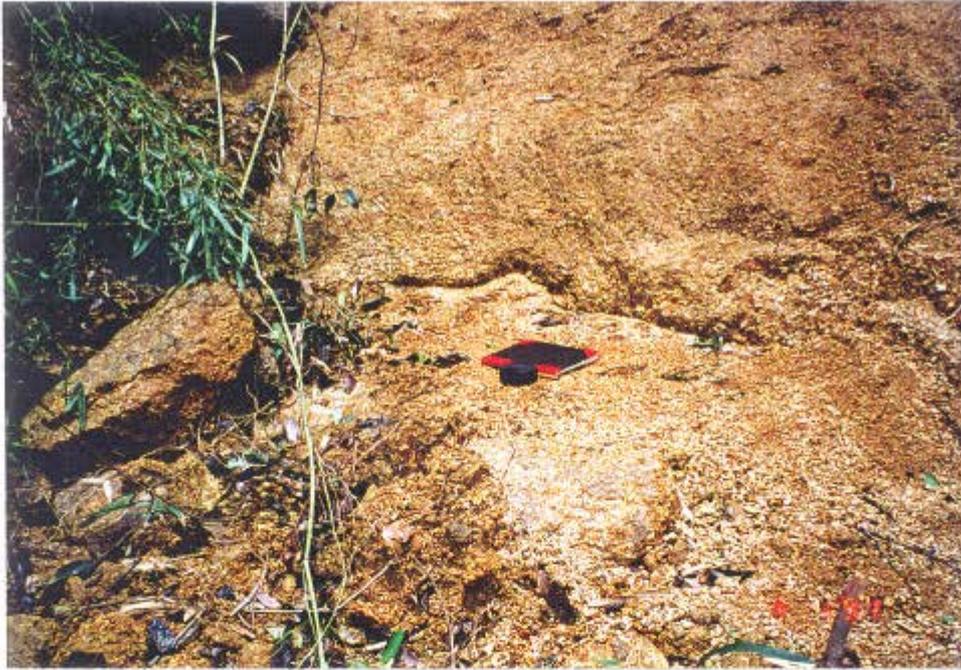
照片6 - 在侵蝕沖溝裏外露的節理，傾角為30度，形成破裂面的下部  
(一九九七年八月四日拍攝，其位置見圖14 )

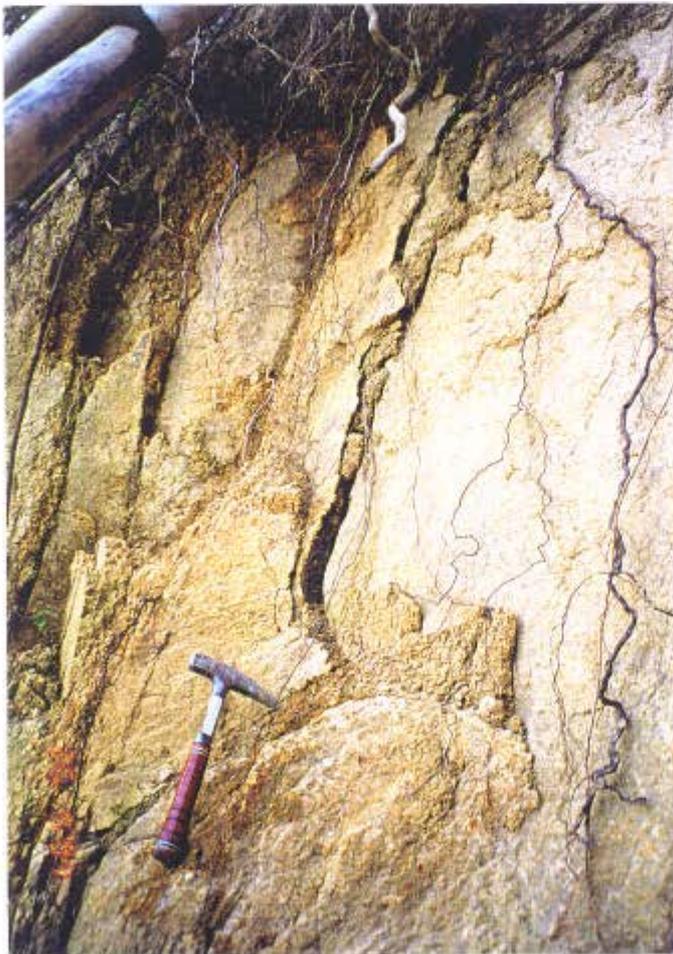
照片7 - 位於山泥傾瀉的西南翼近於垂直有充填的裂縫的景象  
(一九九七年九月二十六日拍攝，其位置見圖14 )

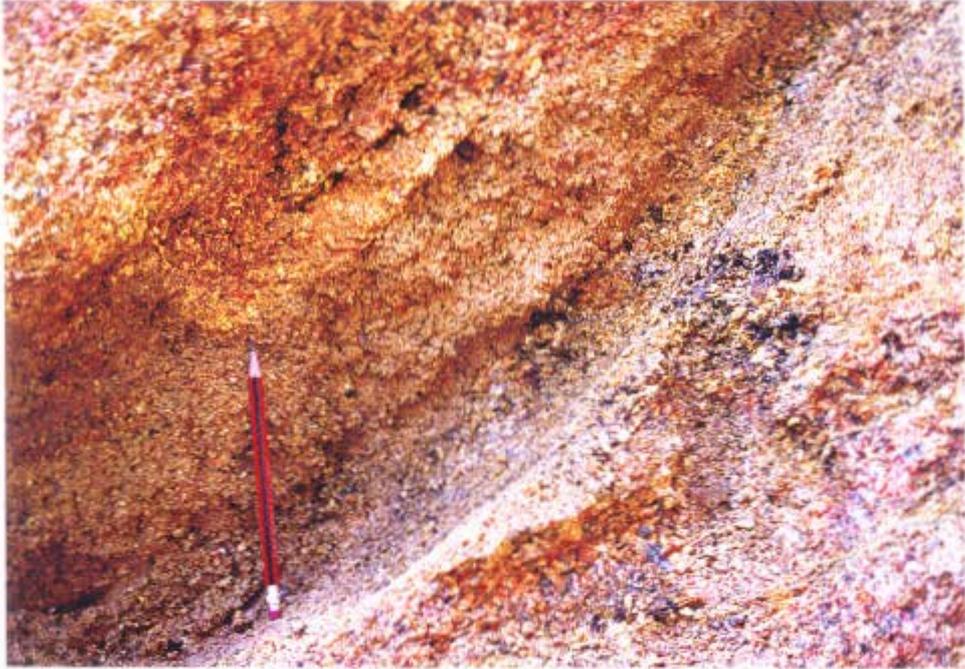
緊鄰破裂面下部之上的部位，在探井中發現有一層 0.2 米厚，軟、潮濕、中棕色、微黏土質、含碎石的粉土質砂（照片 8）。這層物質表明了明顯的擾動信號及代表了山泥傾瀉底層強烈剪切的最終產物。其表明該層之上的大部份的泥石在土體中有如一整體的，漂浮的物質移動。

照片8 - 沿著山泥傾瀉破裂面的下部的棕色軟黏土質砂  
(一九九七年十一月十二日拍攝，注意棕色的黏  
土層的厚度與鉛筆長度相同，其位置見圖14 )

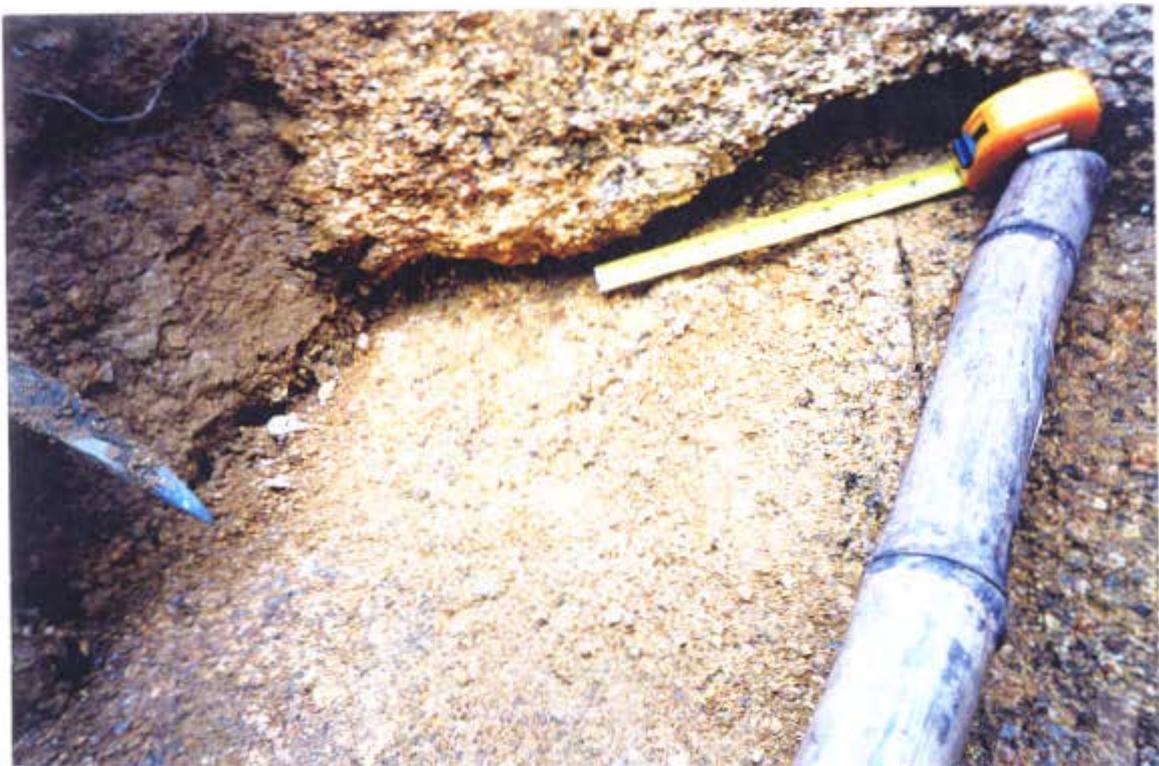
照片9 - 在主崩塌崖東北角的侵蝕管的景象(一九九七年  
九月二十三日拍攝，其位置見圖14 )
