INVESTIGATION OF SOME SELECTED LANDSLIDE INCIDENTS IN 1997 (VOLUME 1)

GEO REPORT No. 79

**SECTION 1 :
DETAILED STUDY OF THE
LANDSLIDE AT UNIVERSITY
KOWLOON-CANTON
RAILWAY CORPORATION
STATION ON 2 JULY 1997**

**This report was originally produced in March 1998
as GEO Landslide Study Report No. LSR 1/98**

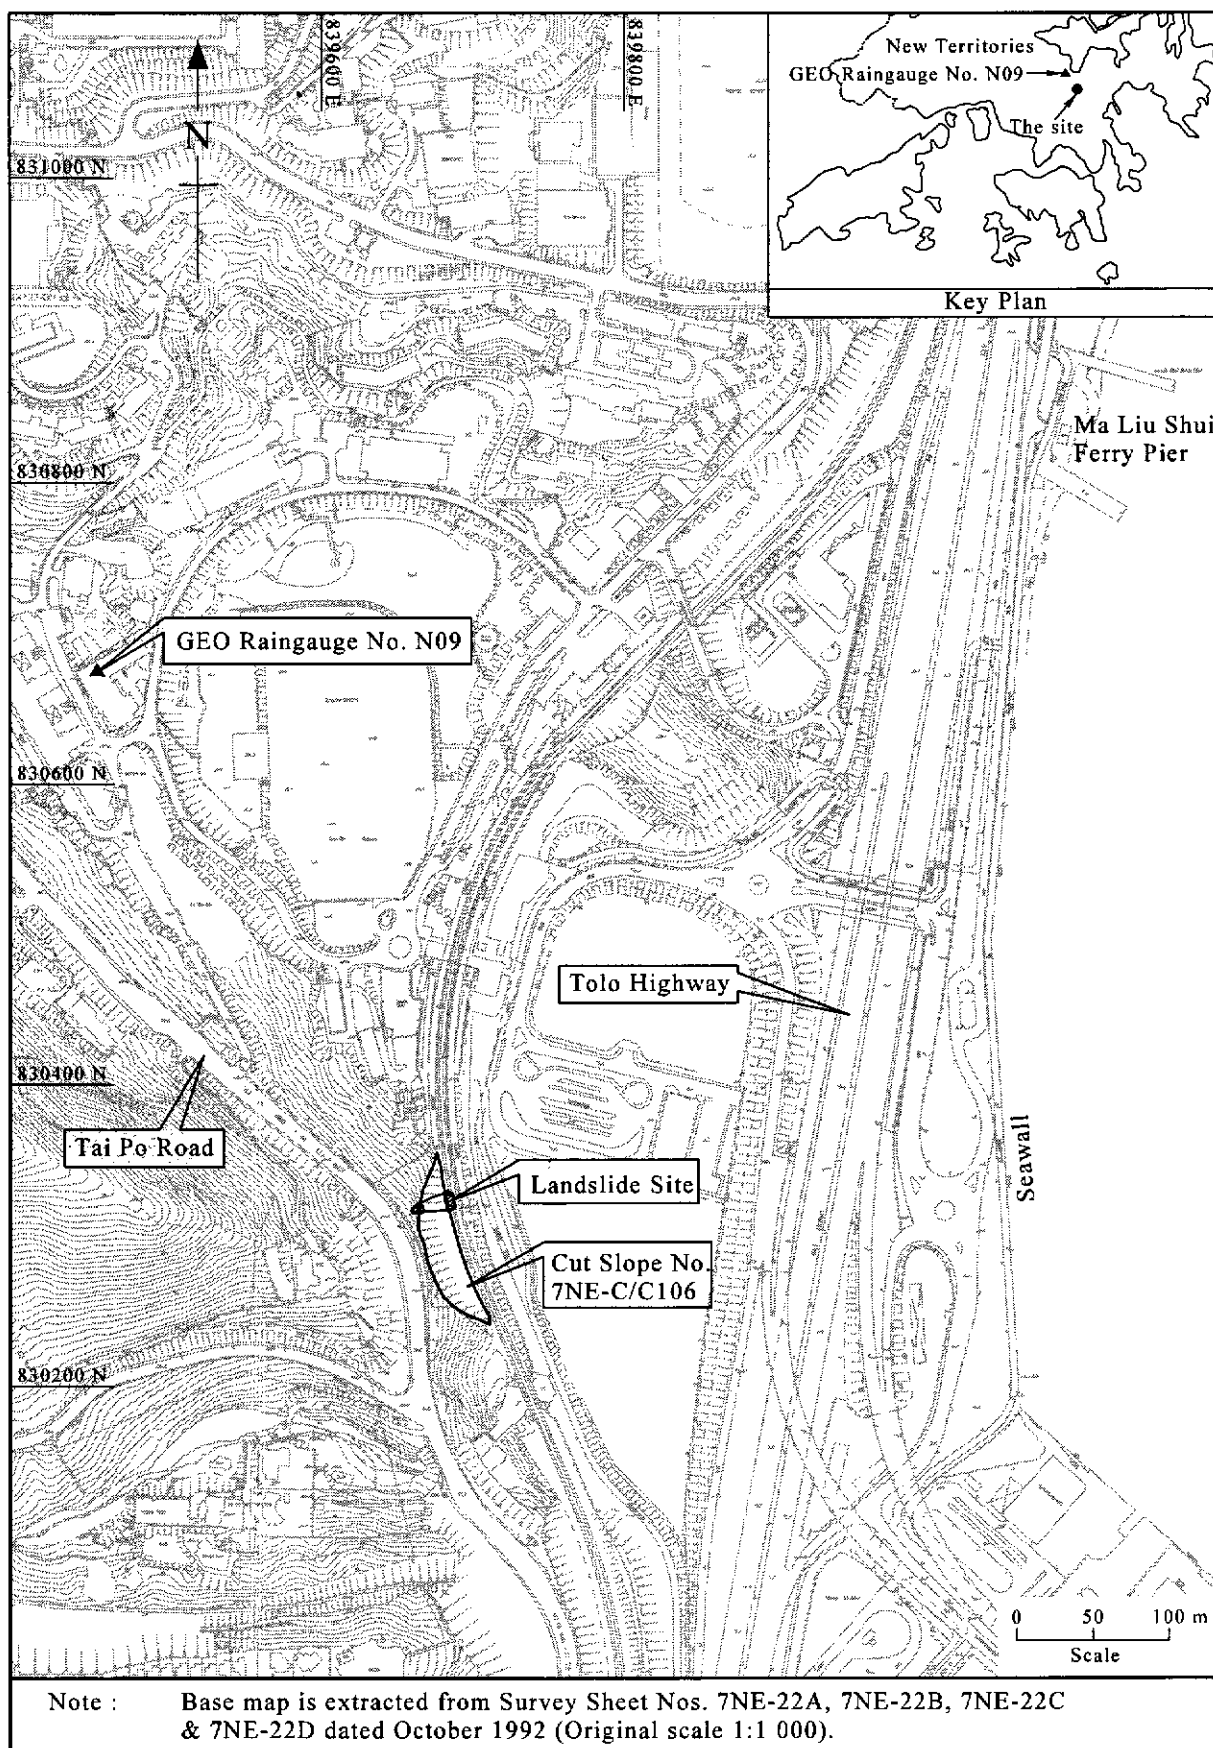
Figure 1 - Site Location Plan

On the morning of 2 July 1997, a landslide (GEO Incident No. ME97/7/29) occurred on a slope south of the Kowloon-Canton Railway Corporation (KCRC) University Station (Figure 1). Debris from the landslide blocked the north-bound KCRC rail track and caused significant disruption to rail services throughout the morning. No fatalities or injuries were reported.

The nearest GEO automatic raingauge No. N09 is located at the Meteorology Laboratory at Chinese University, about 400 m northwest of the site (Figure 1). The daily rainfall recorded by the raingauge between 1 June 1997 and 6 July 1997 together with hourly rainfall between 29 June 1997 and 2 July 1997 are presented in Figure 7a and 7b respectively. Isohyets of rainfall recorded between the onset of the storm on 2 July 1997 and 06:10 hours are shown in Figure 8.

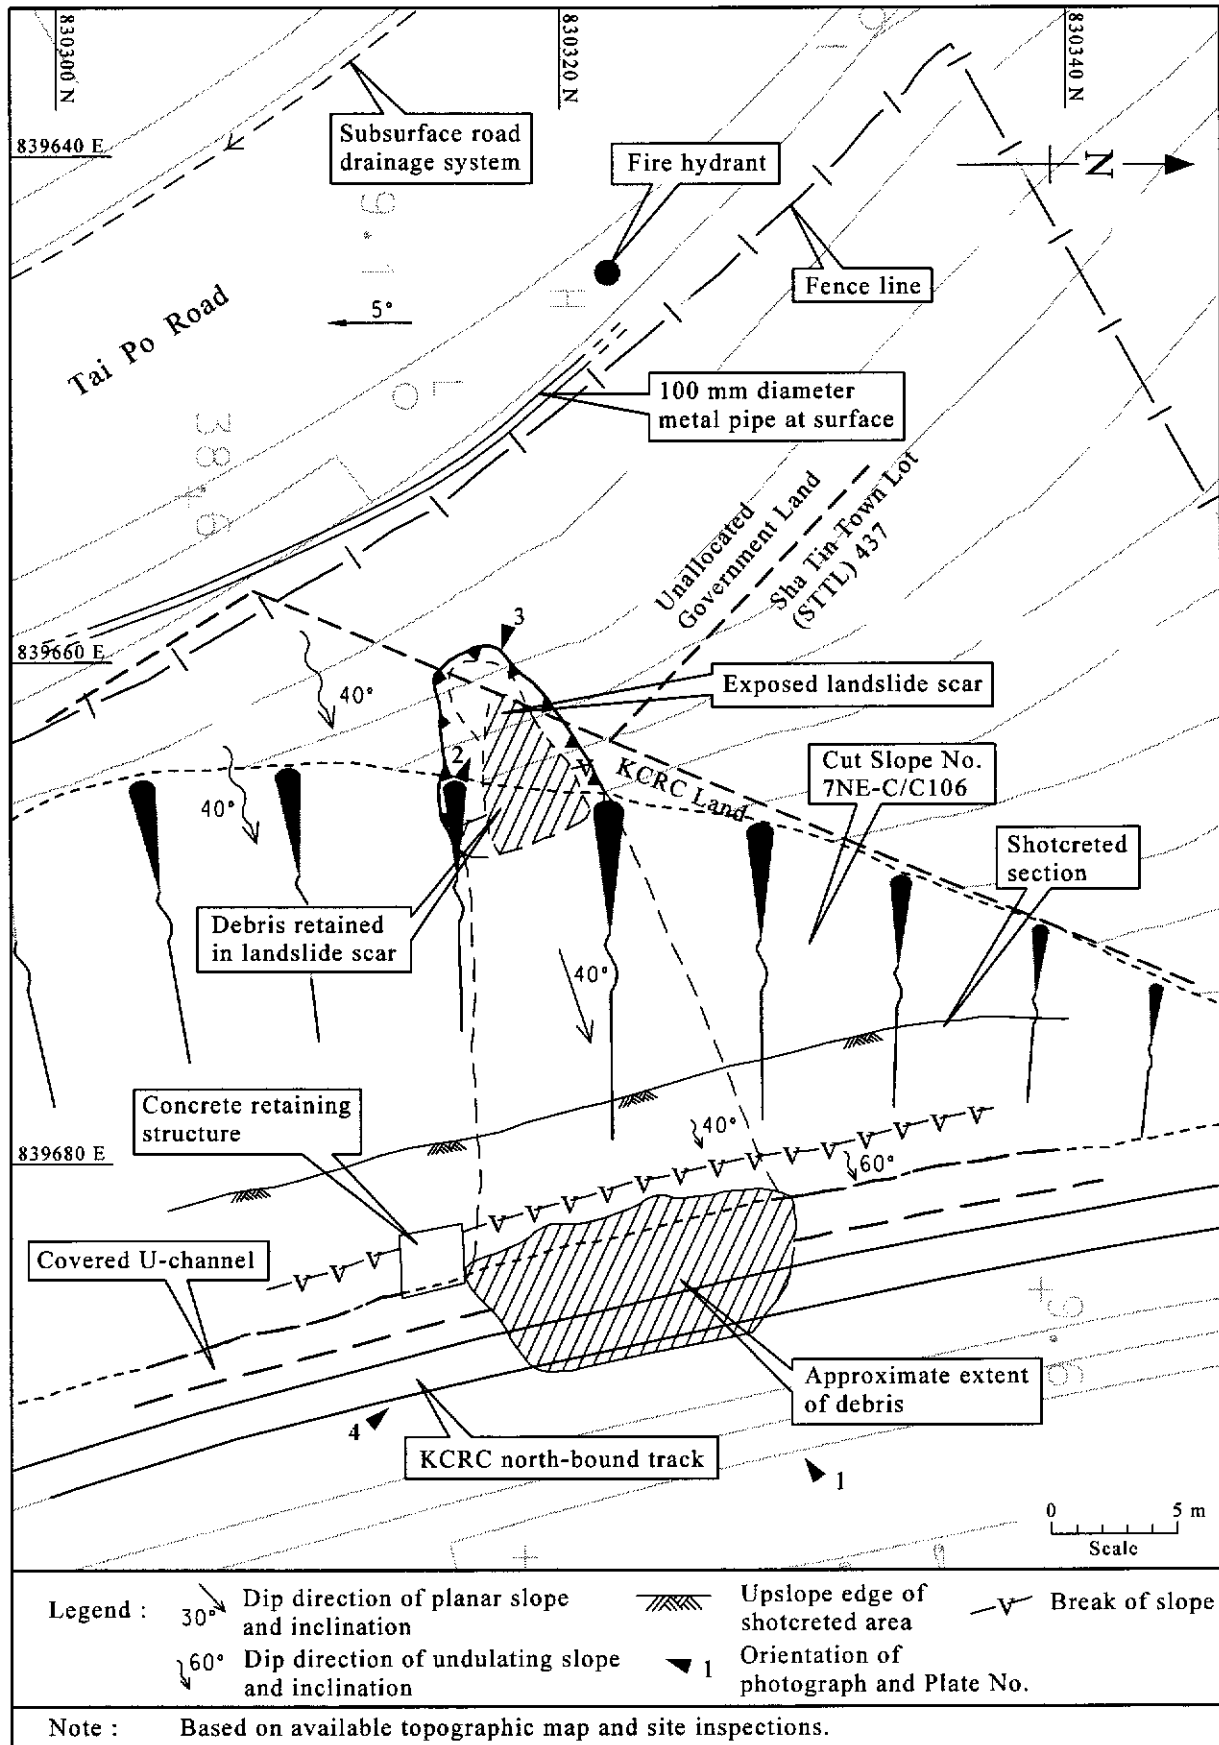
Figure 2 - Plan of the Landslide Site

The location of the landslide is shown in Figure 2. The failure occurred at the crest of registered cut slope No. 7NE-C/C106 and extended upslope into the sloping ground below Tai Po Road. The total height of the slope, from the toe of the cut to Tai Po Road, is about 28 m. The KCRC north-bound rail track is approximately 3 m from the toe of the cut slope section.

Prior to failure the lower 6 m section of the cut slope had been shotcreted, but elsewhere the slope was densely vegetated (Figure 2 and Plate 1).

A 2.5 m high concrete retaining structure, approximately 3 m long and inclined at about 55°, is present at the toe of the slope immediately south of the failed section (Figure 2).

The landslide principally occurred on land within the KCRC boundary but its western part also affected unallocated Government land (Figure 2). Sha Tin Town Lot (STTL) No. 437 is located near to the northern part of the landslide but was not directly affected by the incident.

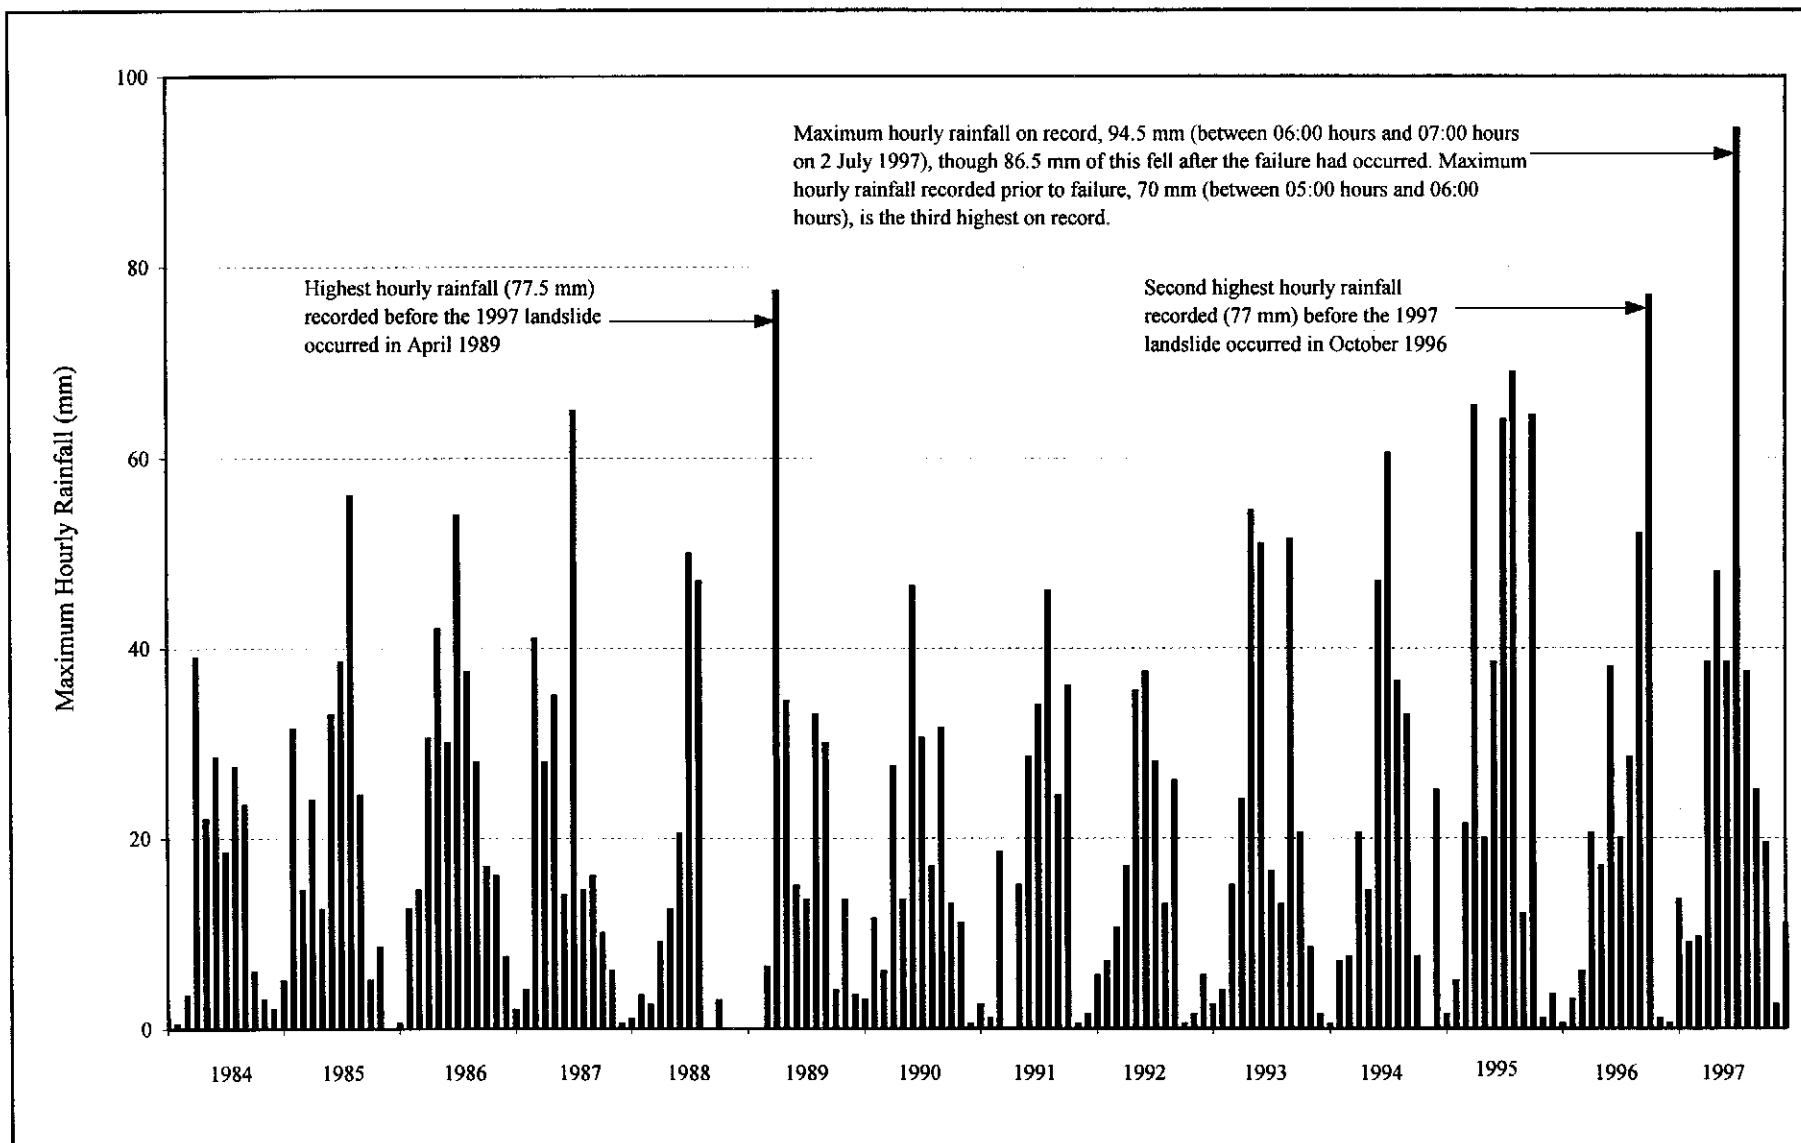
Figure 9 - Maximum Hourly Rainfall (mm) Recorded in Each Month at GEO Raingauge No. N09 from 1984 to 1997

The historical maximum hourly rainfalls recorded in each month at GEO raingauge No. N09 are shown in Figure 9. The figure shows that the maximum hourly rainfall of 94.5 mm for July 1997 was recorded between 06:00 hours and 07:00 hours on 2 July 1997, though 86.5 mm of this fell after the landslide had occurred. Prior to the landslide, the maximum clock-hourly rainfall in July 1997 was 70 mm, recorded between 05:00 hours and 06:00 hours on 2 July 1997 (Hong Kong Observatory, 1997). This is the third highest on record, with rainstorm events in April 1989 and October 1996 recording greater maximum hourly rainfalls.
