**SECTION 2 :
DETAILED STUDY OF THE
LANDSLIDE NEAR
KOWLOON-CANTON RAILWAY
CORPORATION FO TAN
STATION ON 2 JULY 1997**

Halcrow Asia Partnership Ltd

**This report was originally produced in March 1998
as GEO Landslide Study Report No. LSR 4/98**

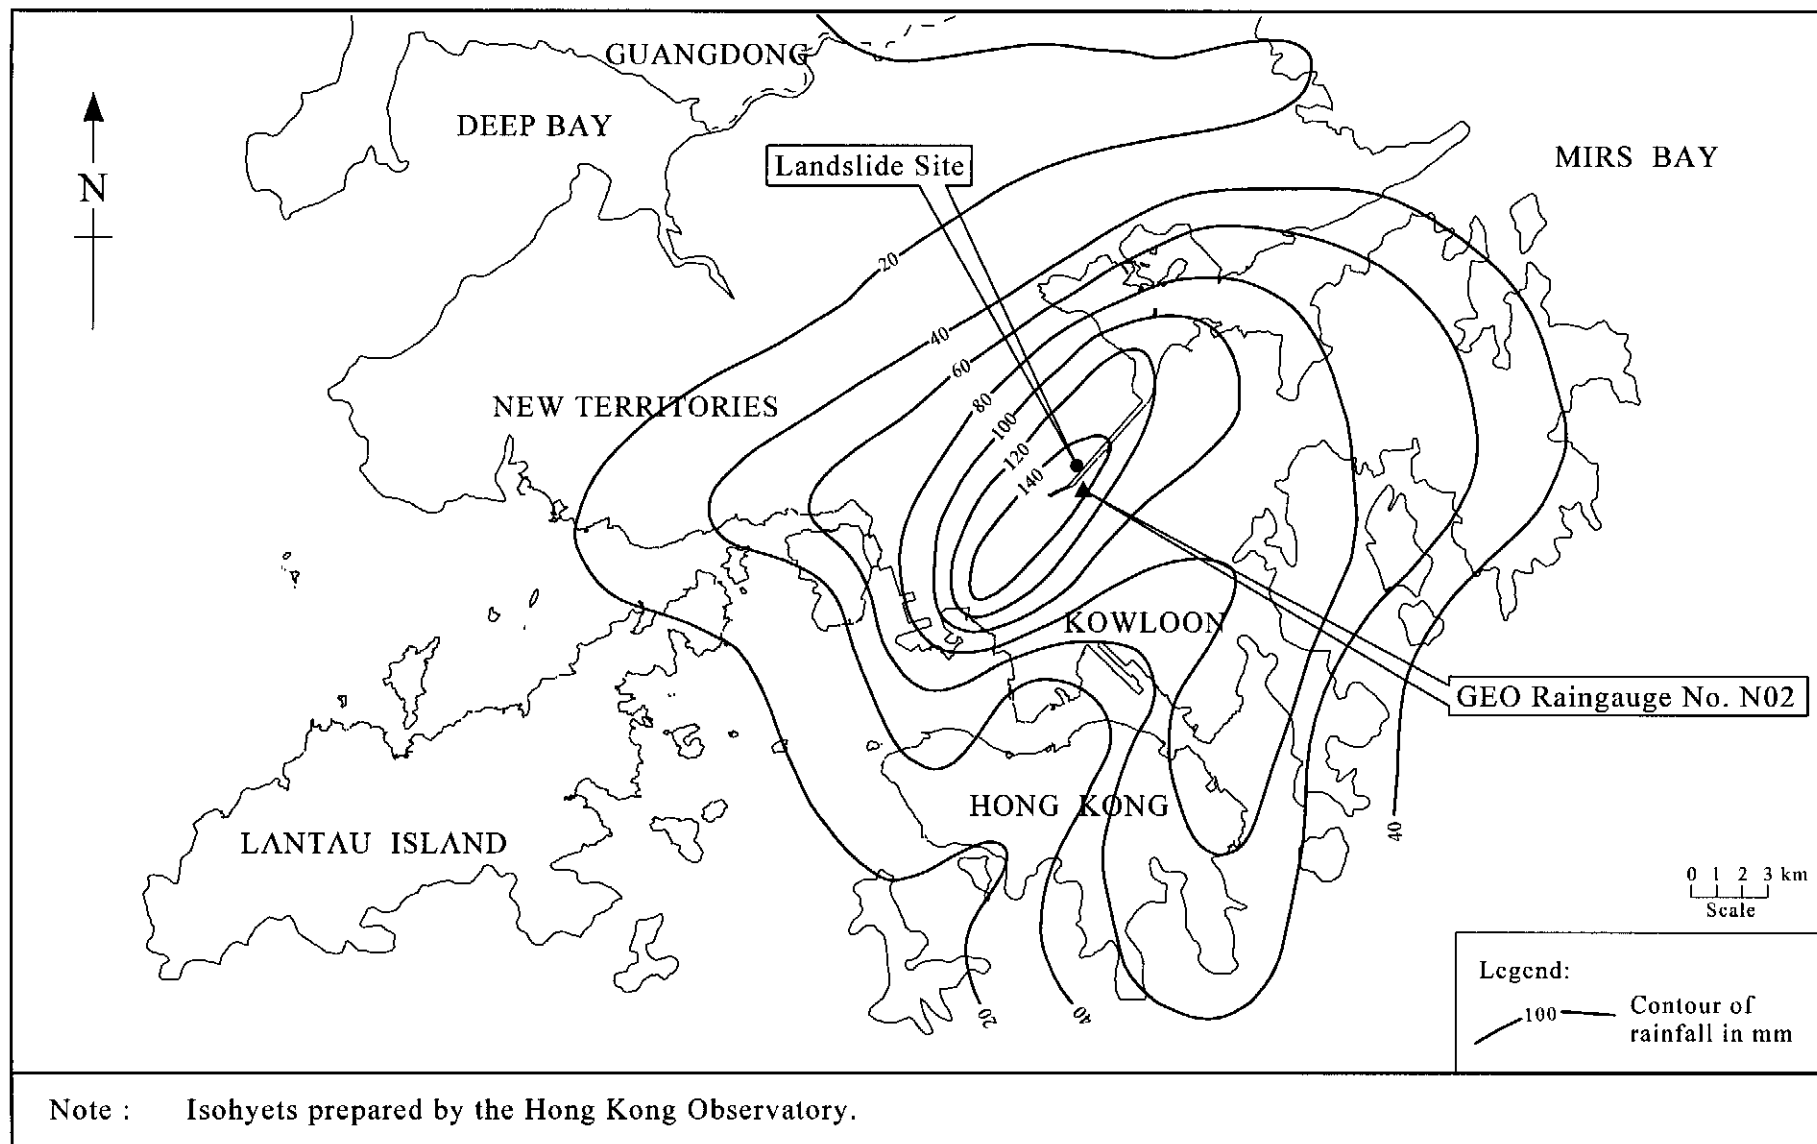
Figure 8 - Isohyets of Rainfall between 18:00 Hours on 1 July 1997 and 06:00 Hours on 2 July 1997

The nearest GEO automatic raingauge No. N02 is located at Shun Wo House, Wo Che Estate, Sha Tin, about 650 m southwest of the landslide. Figure 8 shows the location of raingauge and presents isohyets of rainfall recorded between 18:00 hours on 1 July 1997 and 06:00 hours on 2 July 1997. Daily rainfall recorded at the raingauge from 2 June to 9 July 1997 and hourly rainfall between 30 June and 3 July 1997 are shown in Figures 9a and 9b respectively.

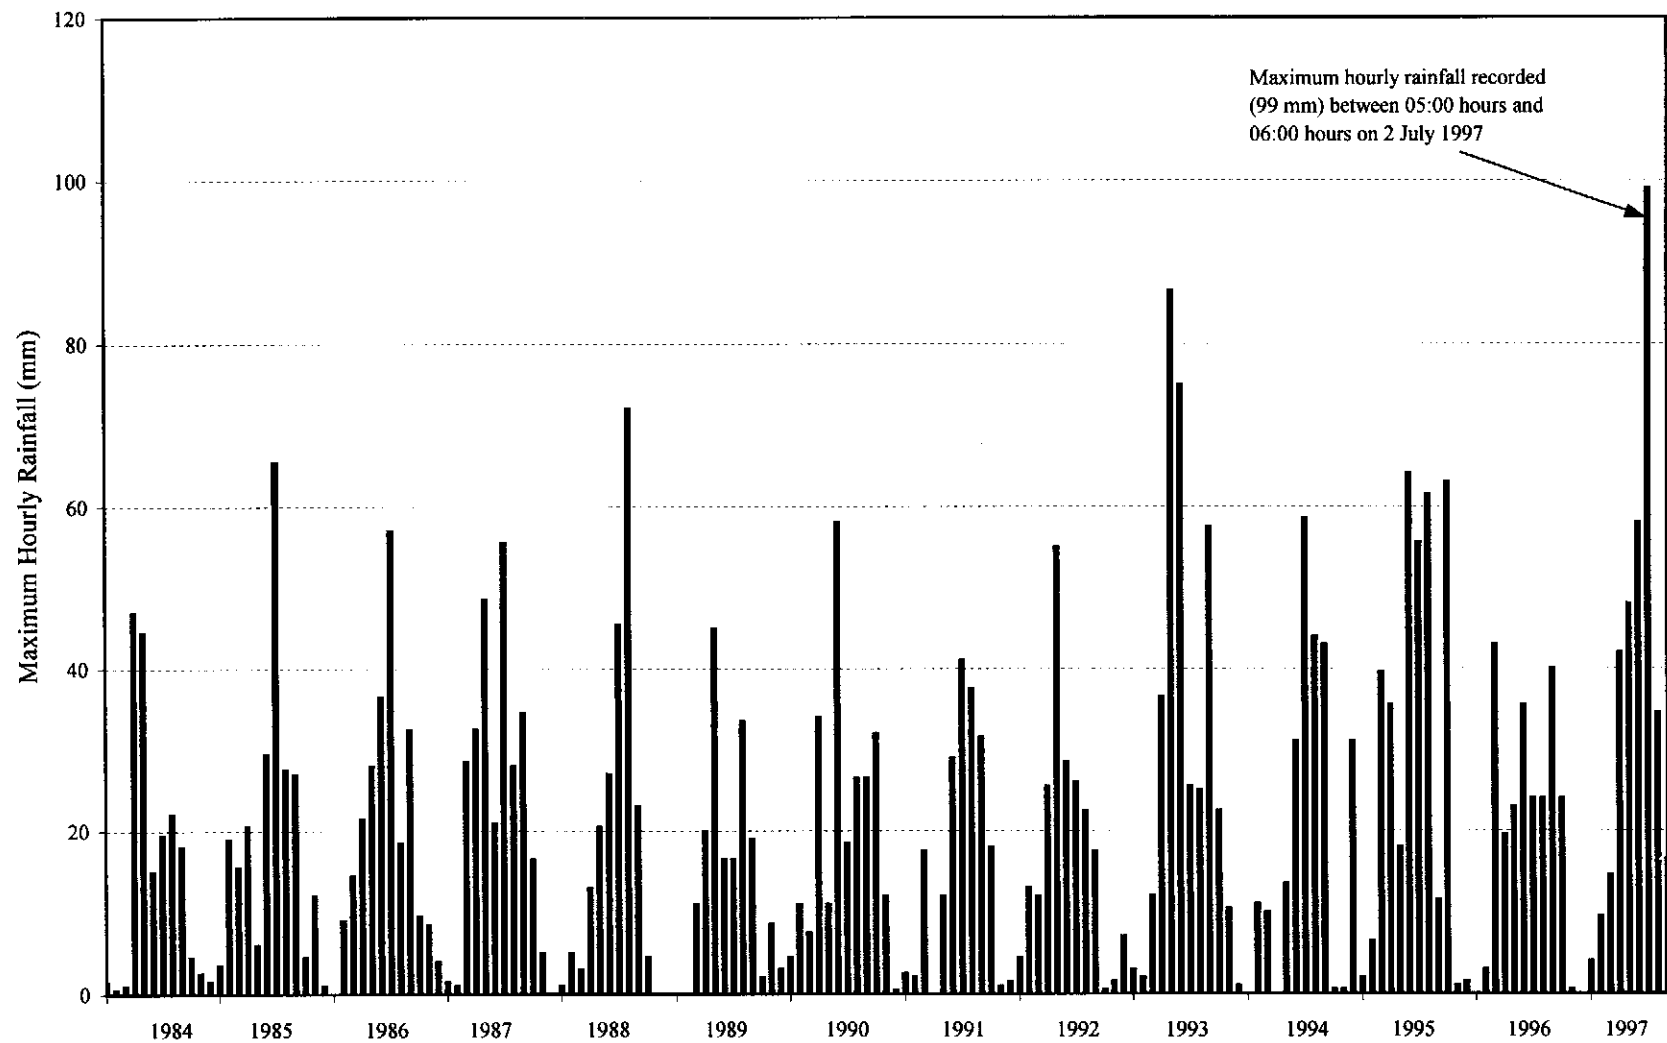
Figure 10 - Maximum Hourly Rainfall (mm) in Each Month at GEO Raingauge No. N02 from January 1984 to September 1997

Historical maximum hourly rainfall totals recorded in each month at raingauge No. N02 since installation are presented in Figure 10. Figure 10 indicates that the maximum hourly rainfall for July 1997 (99 mm recorded between 05:00 hours and 06:00 hours on 2 July 1997), was associated with the landslide and may be among the highest recorded.
