**SECTION 3 :
DETAILED STUDY OF THE
FLOODING INCIDENT
AT MEI CHUNG COURT,
SHATIN ON 2 JULY 1997**

Halcrow Asia Partnership Ltd

**This report was originally produced in May 1998
as GEO Landslide Study Report No. LSR 6/98**

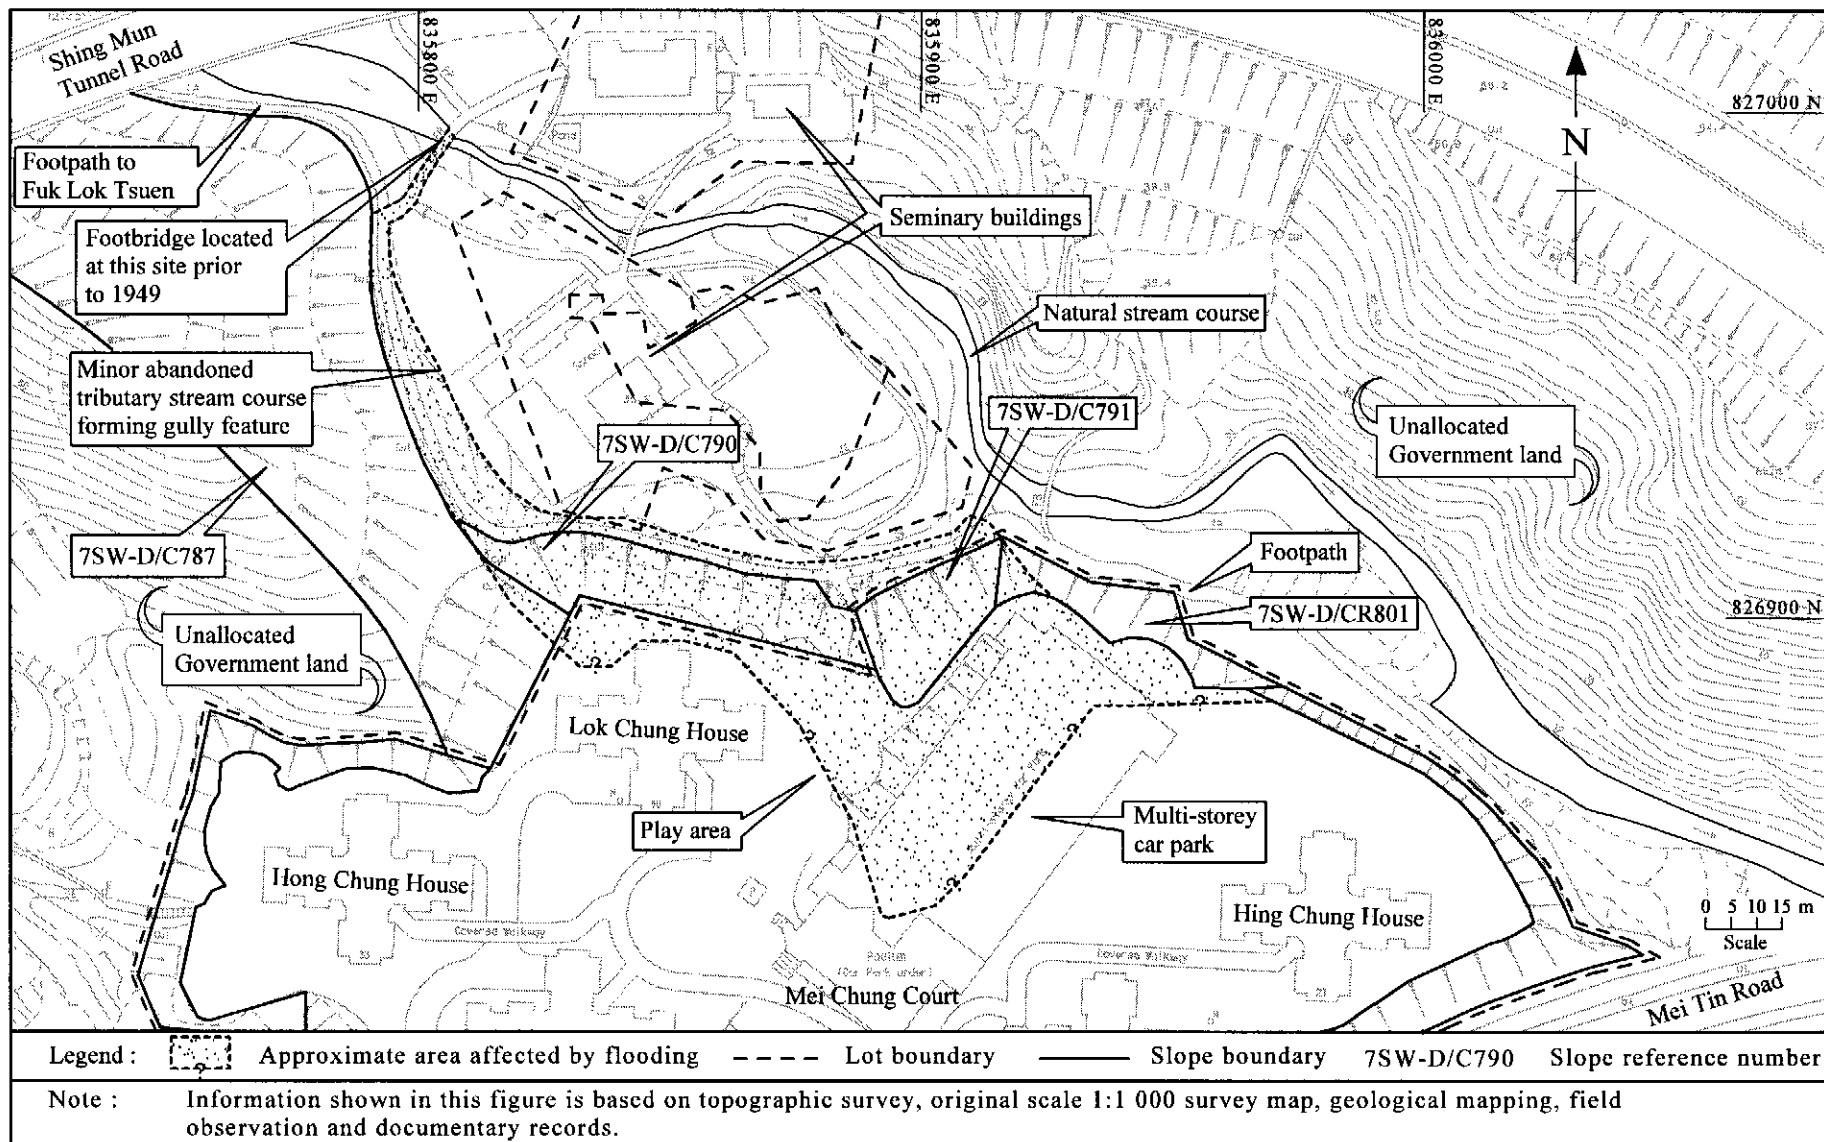
Figure 2 - Plan of the Flood Affected Areas

Other sources of floodwater, such as run-off from the cut slope (No. 7SW-D/C787) to the west of the footpath (Figure 2), are considered minor in comparison with the amount of stormwater from the stream.

The floodwaters which reached the estate caused serious erosion to two cut slopes (Nos. 7SW-D/C791 and 7SW-D/CR801), to the north of the multi-storey car park and Slope No. 7SW-D/C790 to the north of Lok Chung House (Figures 2 and 3).

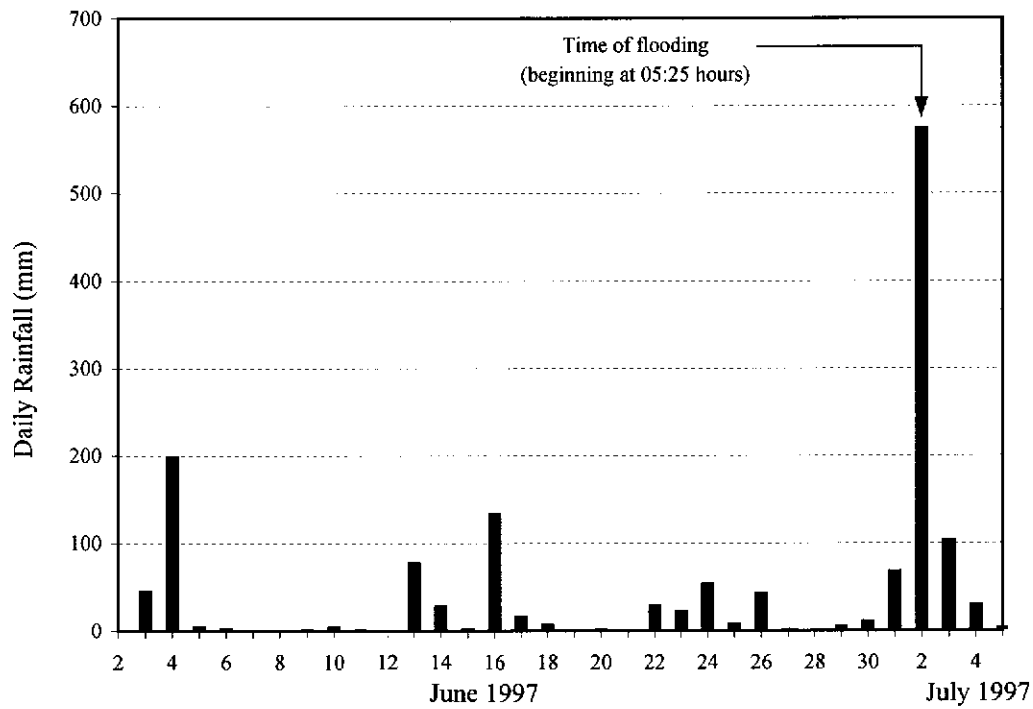
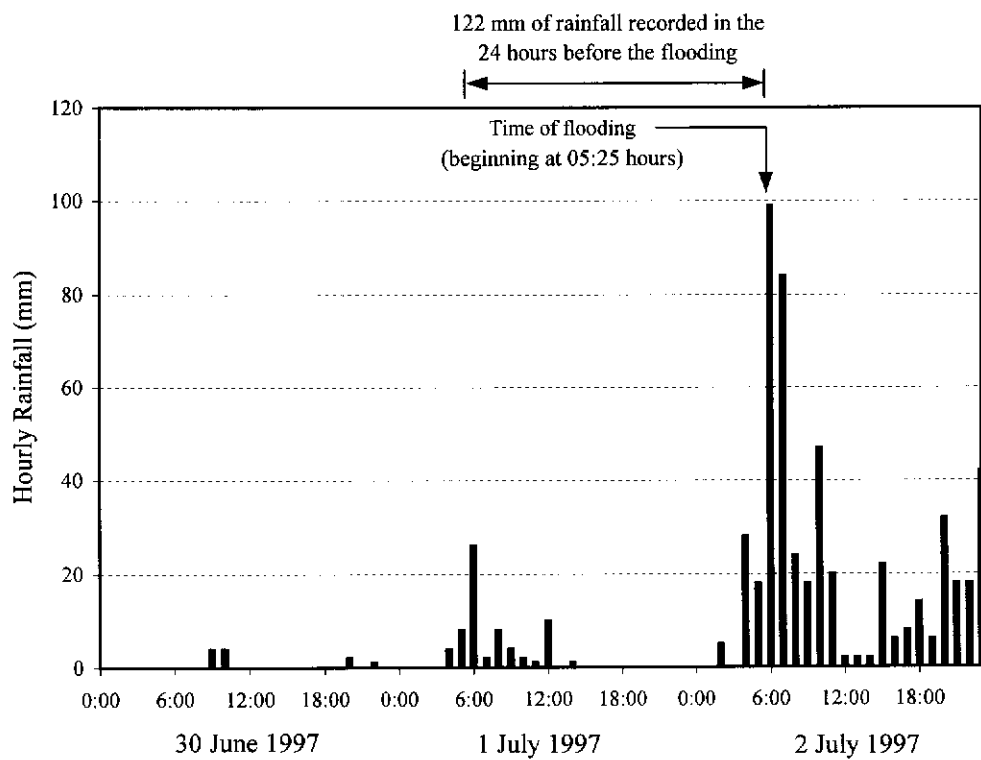
Figure 4 - Rainfall Records at GEO Raingauge No. N02

(a) Daily Rainfall Recorded between 2 June and 5 July 1997

(b) Hourly Rainfall Recorded between 30 June and 2 July 1997
